# HOTEL ELLIOTT / HAHN BUILDING

Designation Hearing  
January 20, 2021

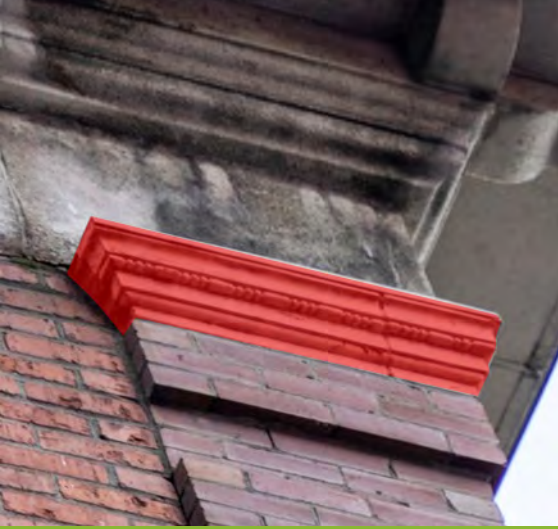
Terra cotta at cornice (shaded red)

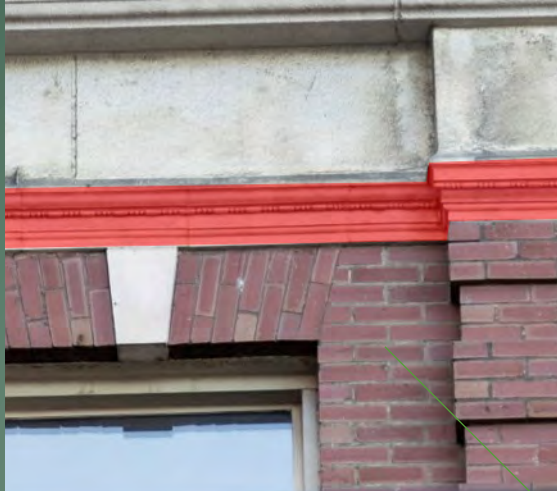
Jack arch, terra cotta key stone and band at cornice (shaded red)

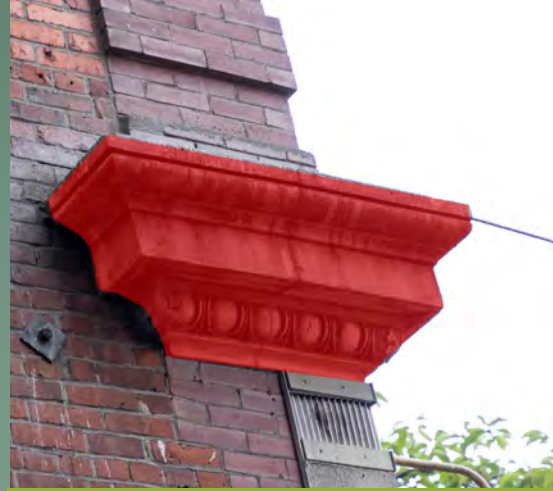
Terra cotta belt course (shaded red) and brick quoins

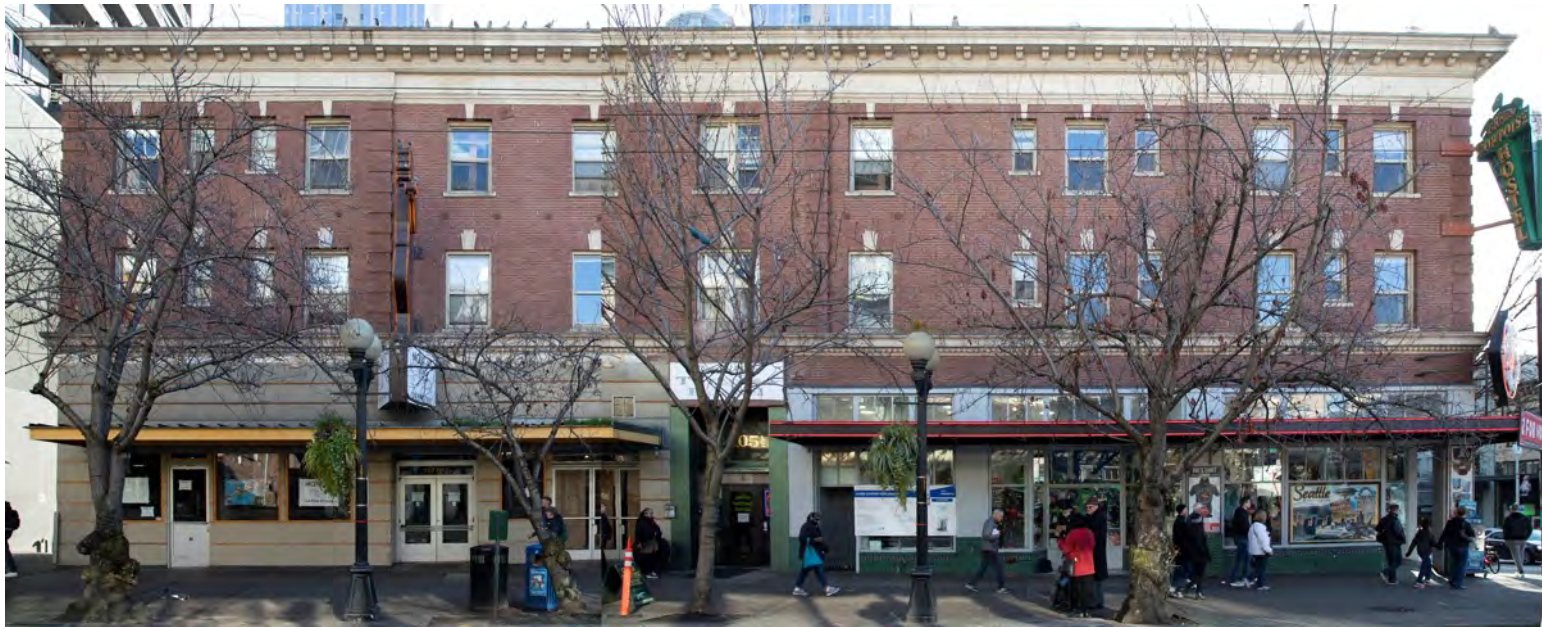
North facade, fronting 1<sup>st</sup> Avenue

## Intact design elements:

- Massing
- Upper story fenestration pattern
- Brick
- Terra cotta belt course, windowsills
- Brick jack arches with keystones

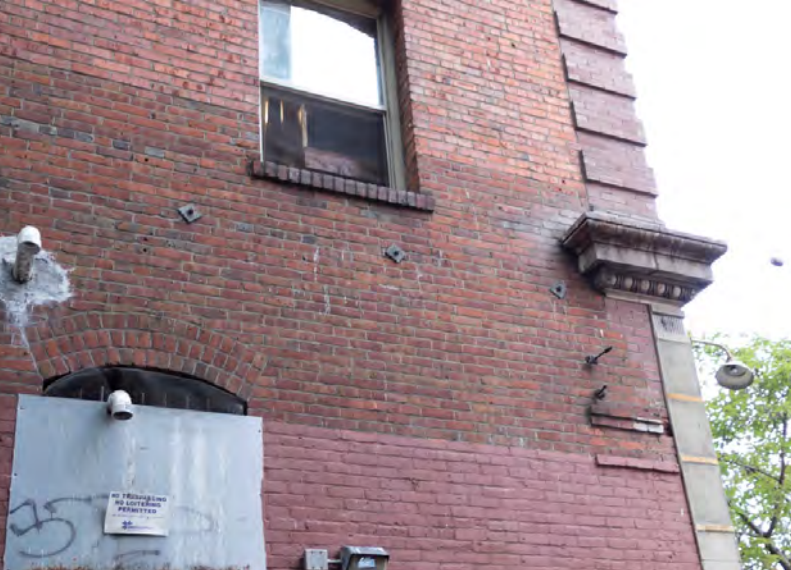
- 1897 brick
- 1908 brick & quoins

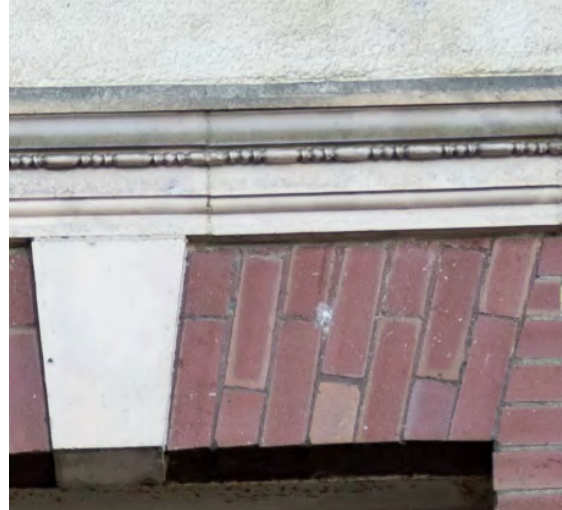
- Terra cotta key stone and band at cornice
- Brick jack arch

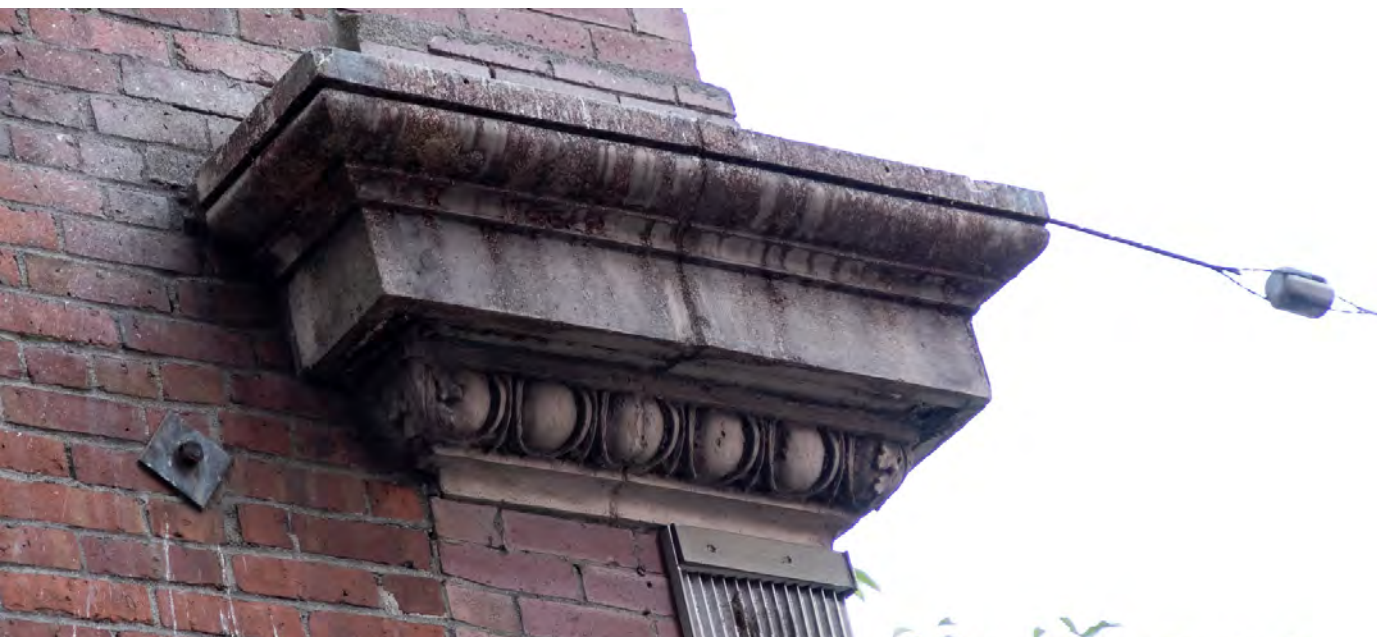
- Terra cotta beltcourse

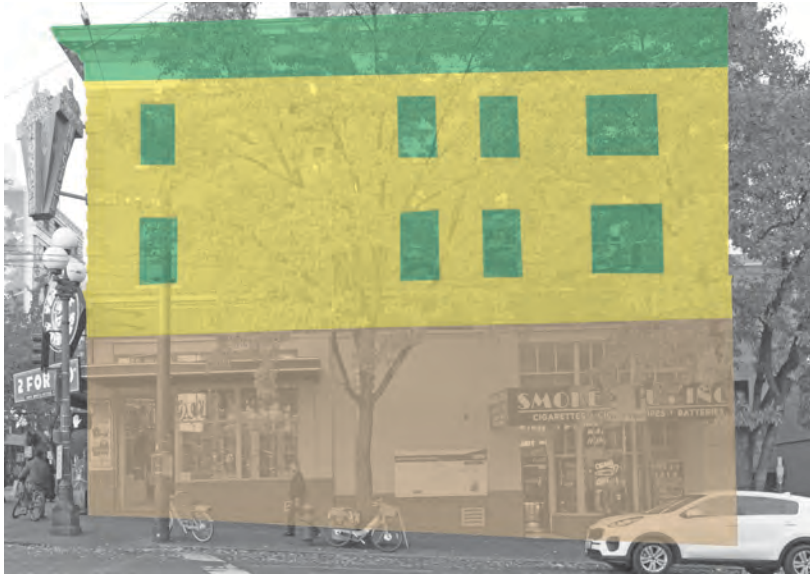
East facade

Legend

Intact original features

Compatible alterations

Altered

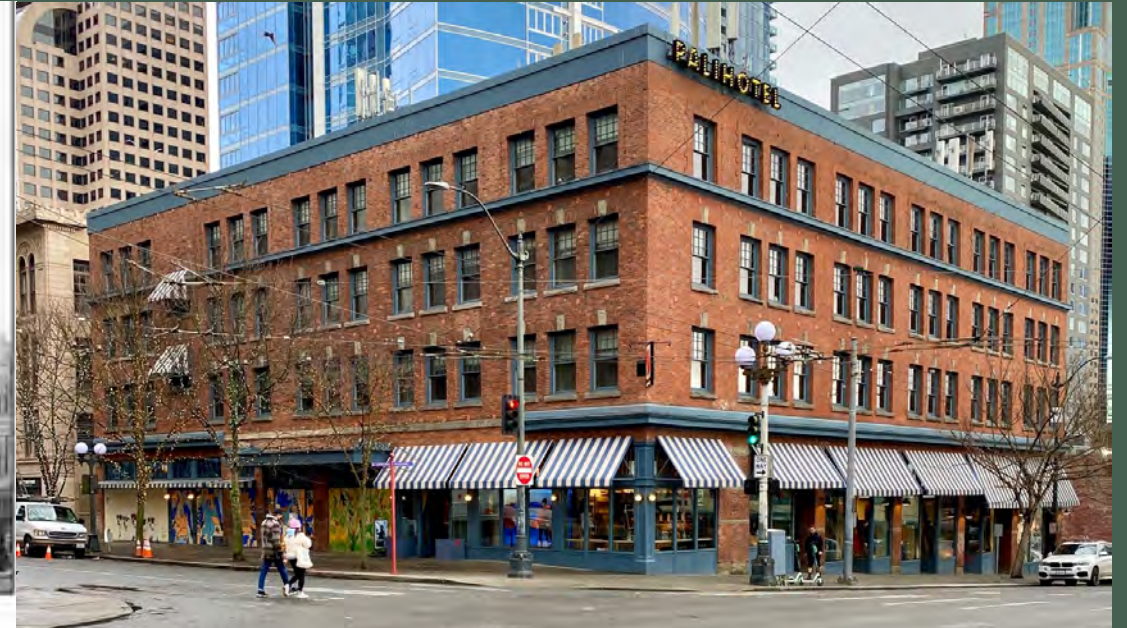
Figure 46. Colonnade Hotel, 1905

- Constructed 1900
- Style: Vernacular/Classical revival
- Upper cornice and parapet removed 1951
- All storefronts and upper windows are non-original
- Replacement windows are same configuration as originals (16-over-1)
