Conceptual Design Report Briefing
Christa Dumpys
8/12/2021 Department of Transportation

Project Overview

We've evaluated options to rehabilitate or replace the 33rd Ave W Pedestrian and Bicycle Bridge in Magnolia.

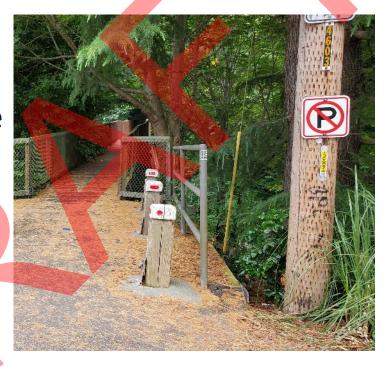
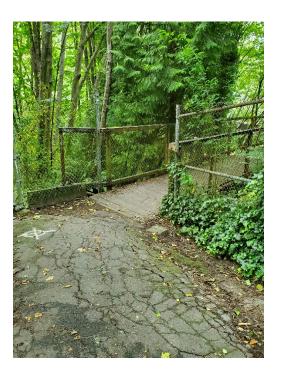
Existing conditions: Approaches

- South approach
 - The asphalt path is cracking and drops before it meets the timber deck
- North approach
 - Access off of 33rd Ave NW
- Not vertically ADA compliant
 - ■8% grade at north approach
 - ■Up to 14% grade at south

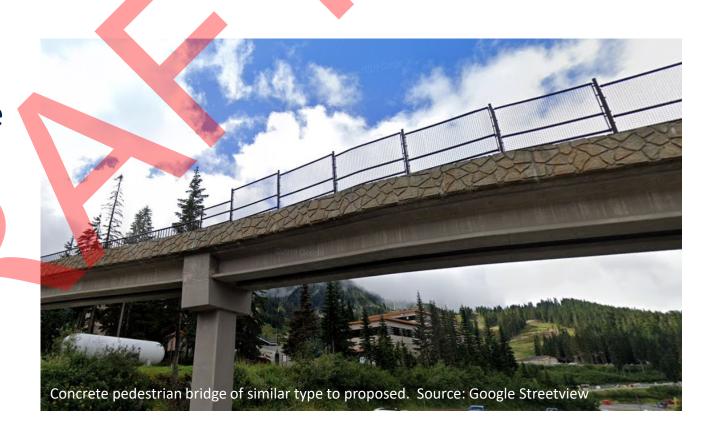
Alternative 3: Replacement of existing bridge - angled alignment

- Realigns structure to be centered within city ROW (current bridge skirts the edge of the private property to the NW.
- Requires construction of intermediate pier at north slope, but still >25' away from BNSF tracks and out of BNSF ROW.
