COLMAN VISTA RESTORATION

# Geotechnical Considerations

# Slope Geotechnical Assessment

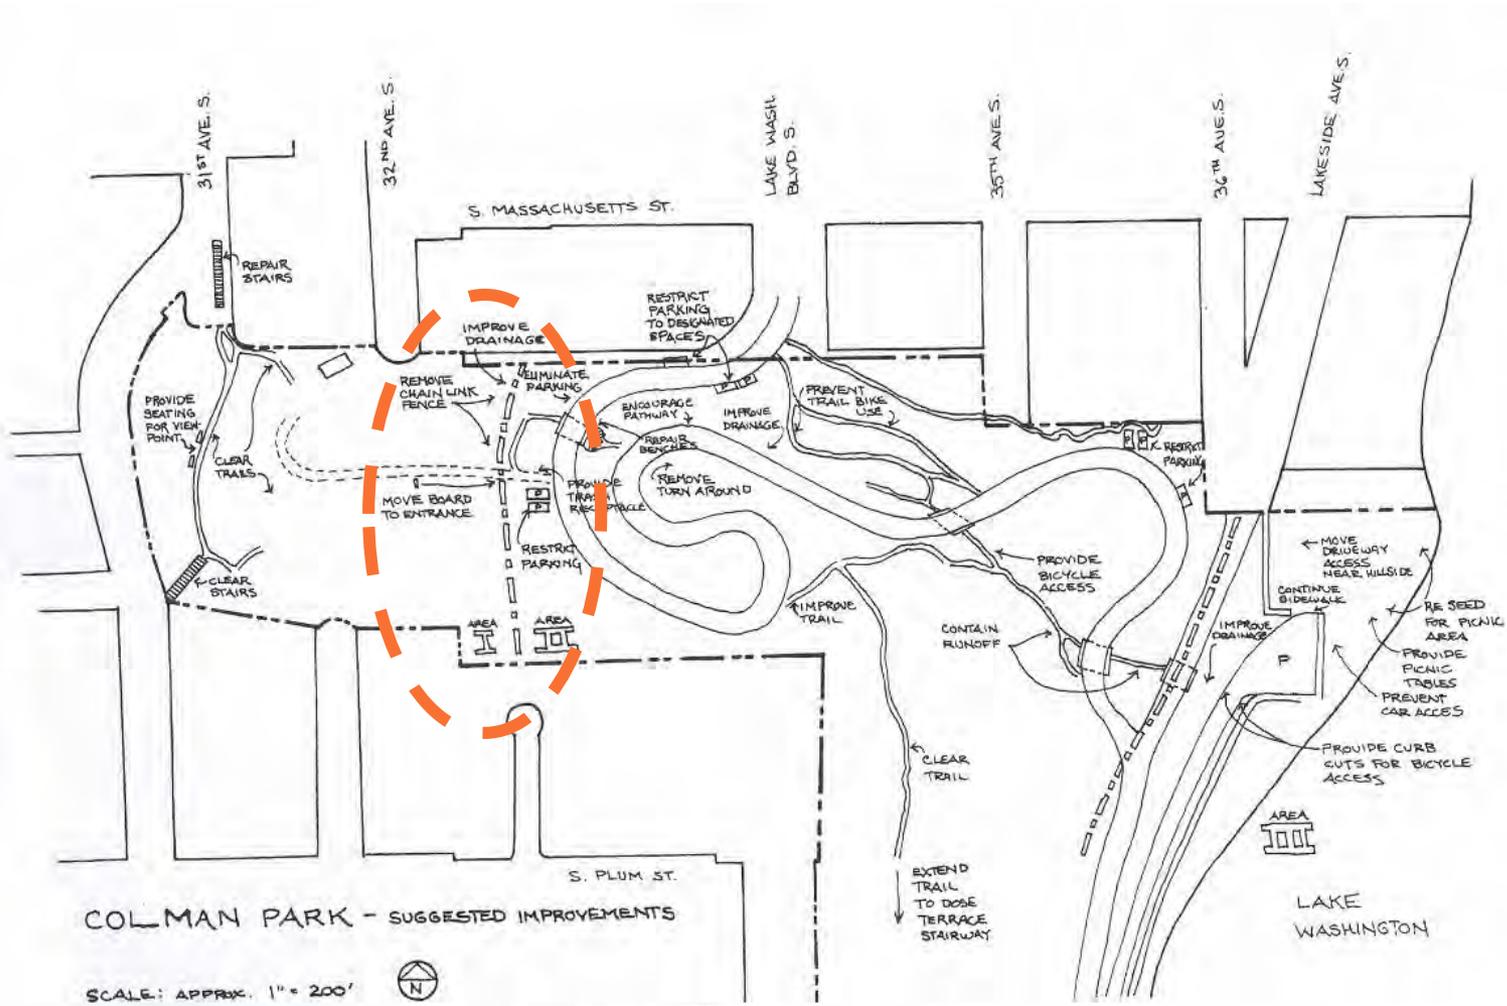
### COLMAN PARK - SUGGESTED IMPROVEMENTS

- » EXISTING TRAIL
- - - OLD ACCESS ROAD
- REFERENCE AREAS' BOUNDARIES
- PRIMARY ACCESS FOR PEDESTRIANS
- OPTION B
- SECONDARY ACCESS
- BICYCLE ACCESS
- PARKING
- DRIVE WAY ACCESS

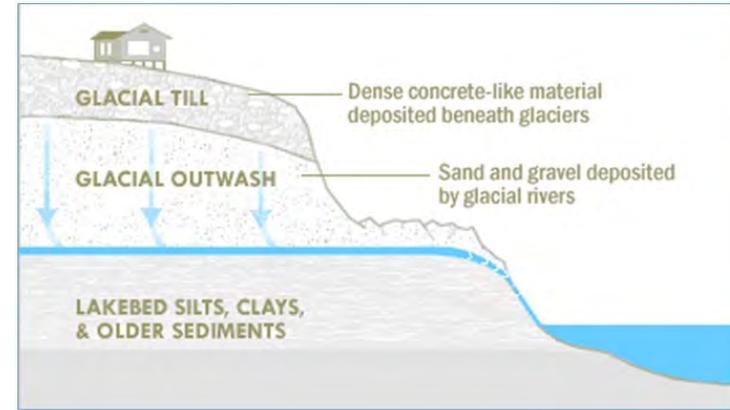
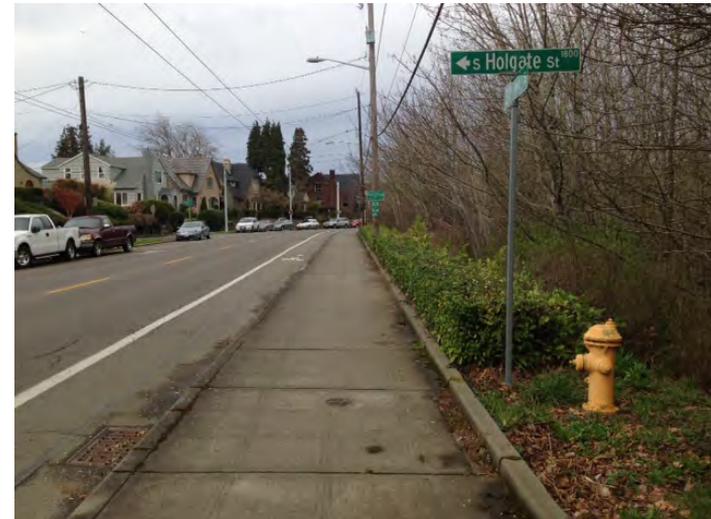
- Dense glacial till “cap”
- Dense advance outwash below “cap”
- Dense/hard older glacial deposits extending down below lake level

- No recent activity
- No significant settlement, tilting, or cracking of road and sidewalk

- Curbs prevent direct runoff from road or sidewalk
- No daylighting pipes observed

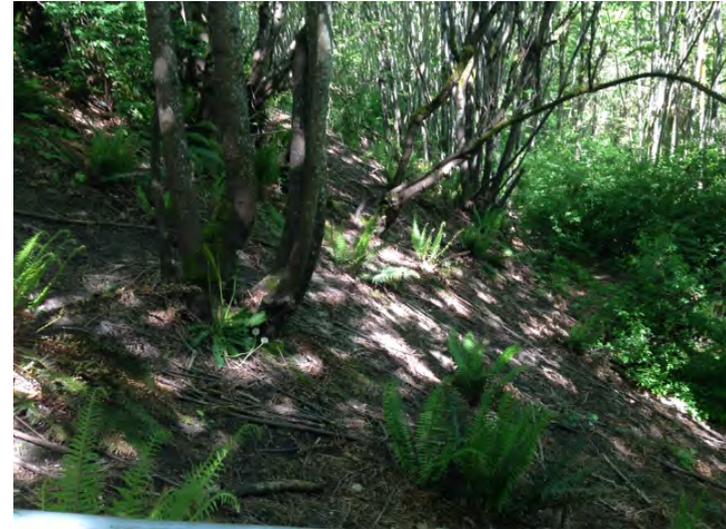
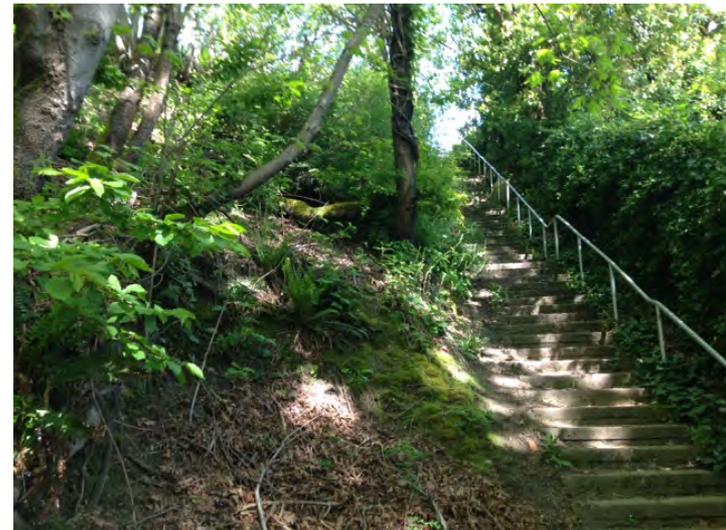
- Steep grades (3H:1V average; 1.5H:1V maximum)
- Very steep cut banks (near-vertical)

- Colluvium and Topsoil: 1-2 feet thick
- Recessional Outwash: 1.5 to 3.5 feet thick
- Glacial Soils: medium dense to dense

- No evidence of significant erosion
- No evidence of recent sloughing
- No evidence of recent slumping

- Overall stable soil conditions
- Existing deciduous trees provide shallow soil support
- Removal feasible if shallow root network is restored

- Slope disturbance should be minimized during all work
- Bare/Disturbed areas should be protected with matting, wattles
- Slope should be replanted with groundcover immediately

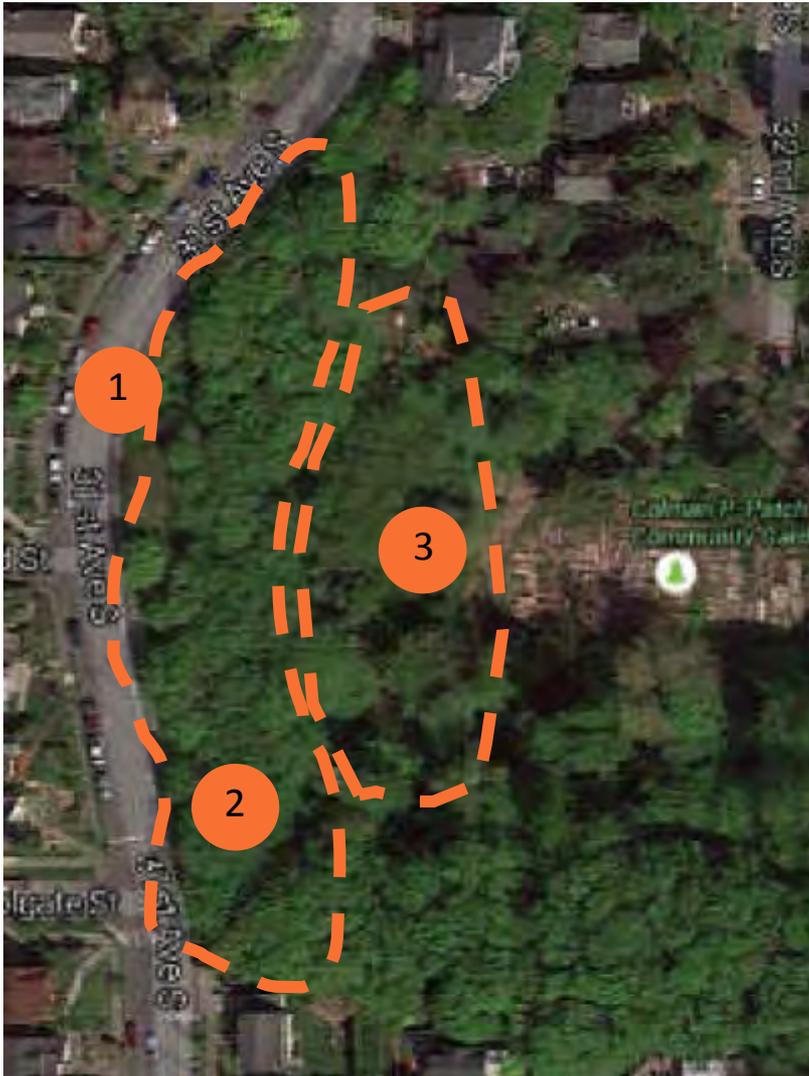
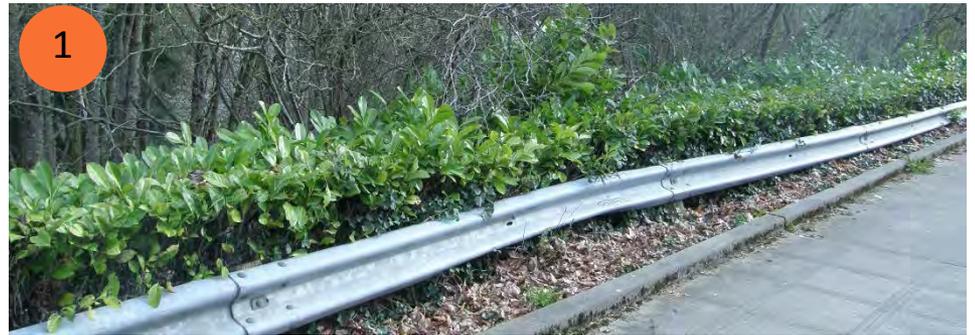
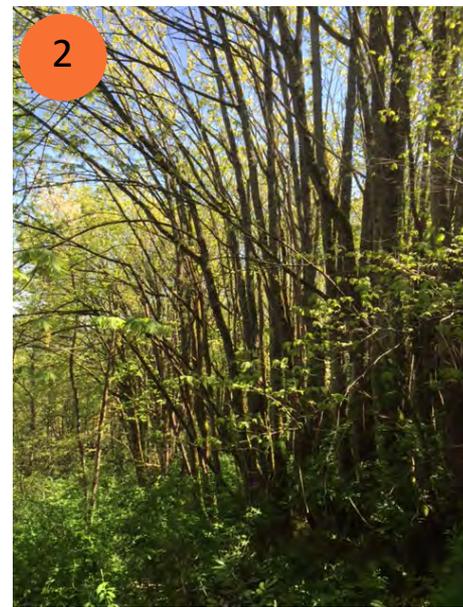
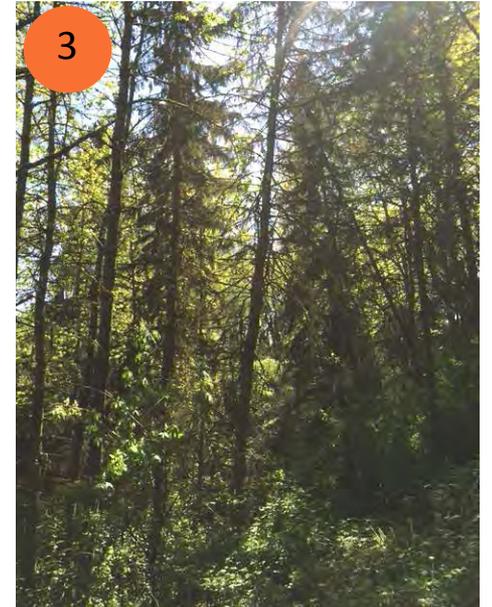
- 1 Sheared hedge
- 2 Steep slope, big leaf maple stump sprouts
- 3 Ornamental trees and shrubs

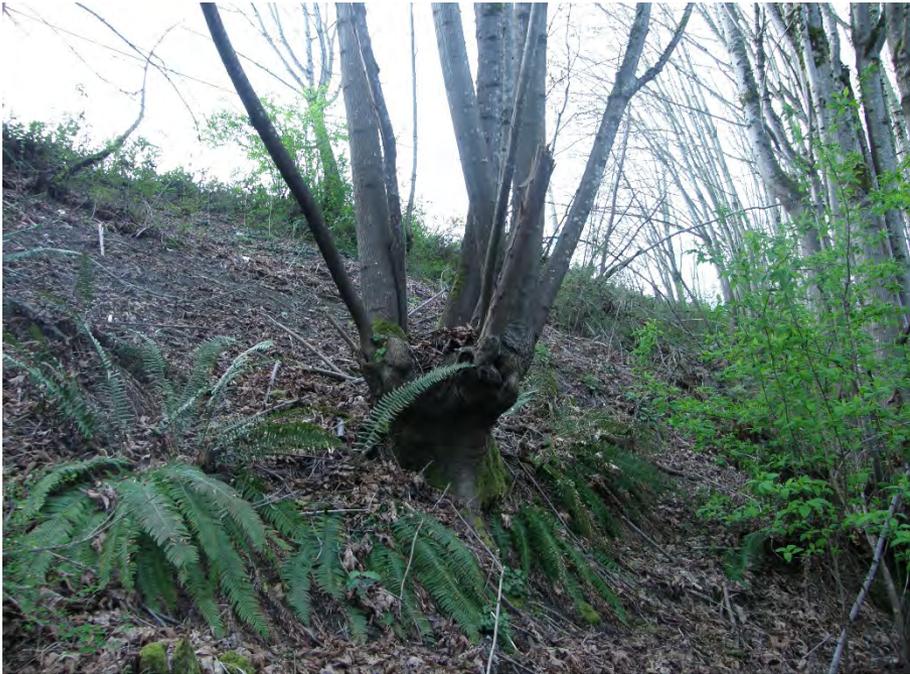
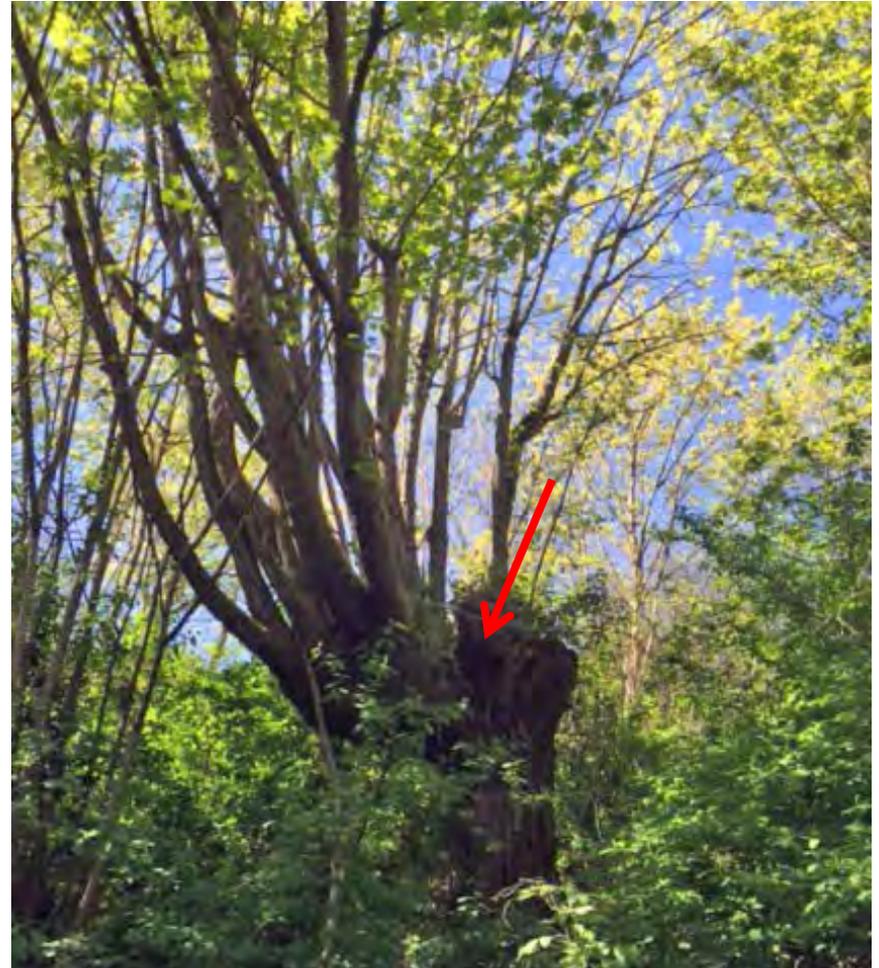
## Stump sprout trees are unsustainable over long-term

- Poor forest structure
- “Stump sprout” architecture is inherently weak
- Basal trunk decay observed

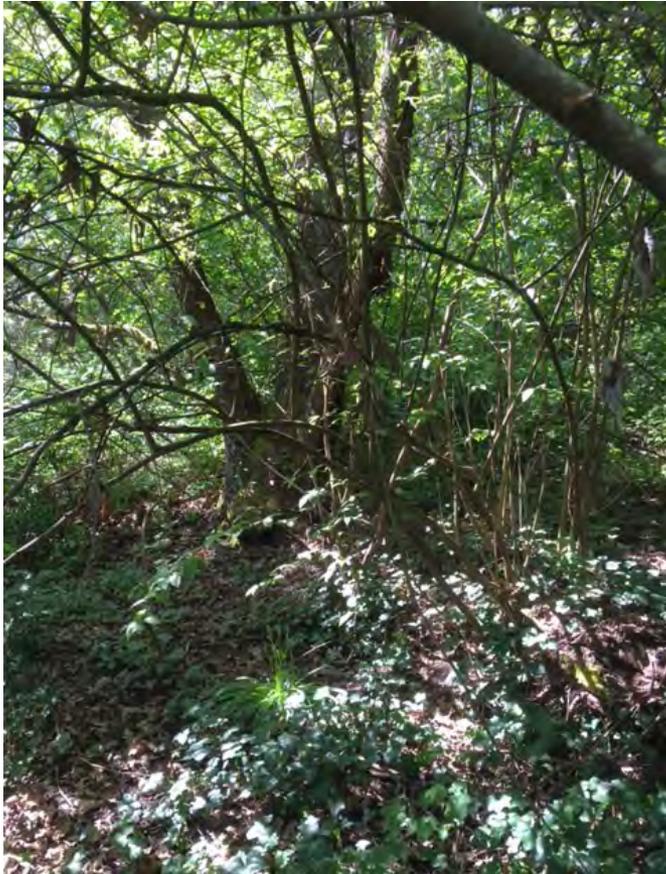
## Dense vegetation below the steep slope

- Mix of native, introduced, and invasive species
- Mature conifers and ornamental shrubs
- Observed recent plantings along trails

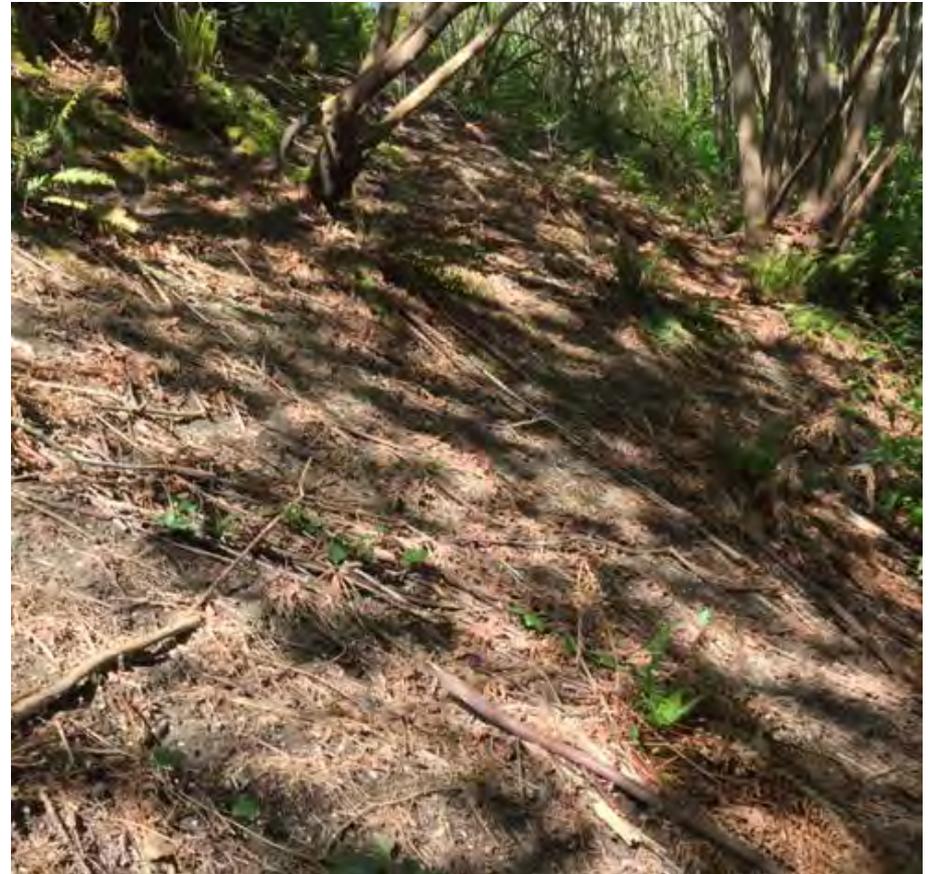
## Bare ground on steep slope

- Maple understory sparse and lacking in diversity
- Invasive species present
- Native tree and shrub seedlings present
- Evidence of restoration efforts: recent plantings of ferns and perennials

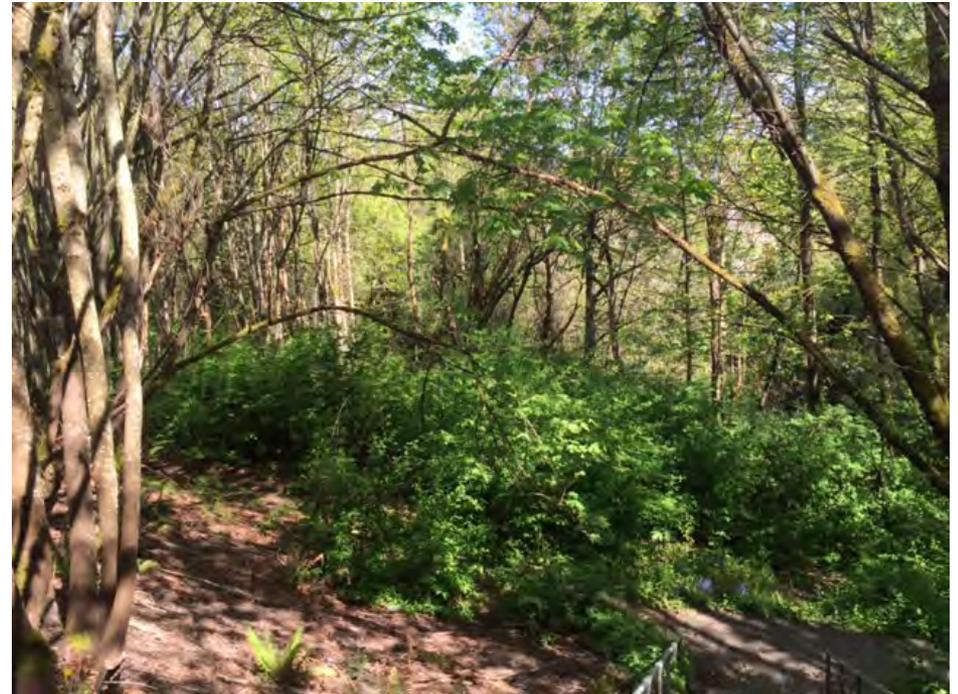
- Identify and prioritize management of problem trees

- Provides more optimal conditions for establishment of woodland understory

- Replace sheared hedge low-growing species

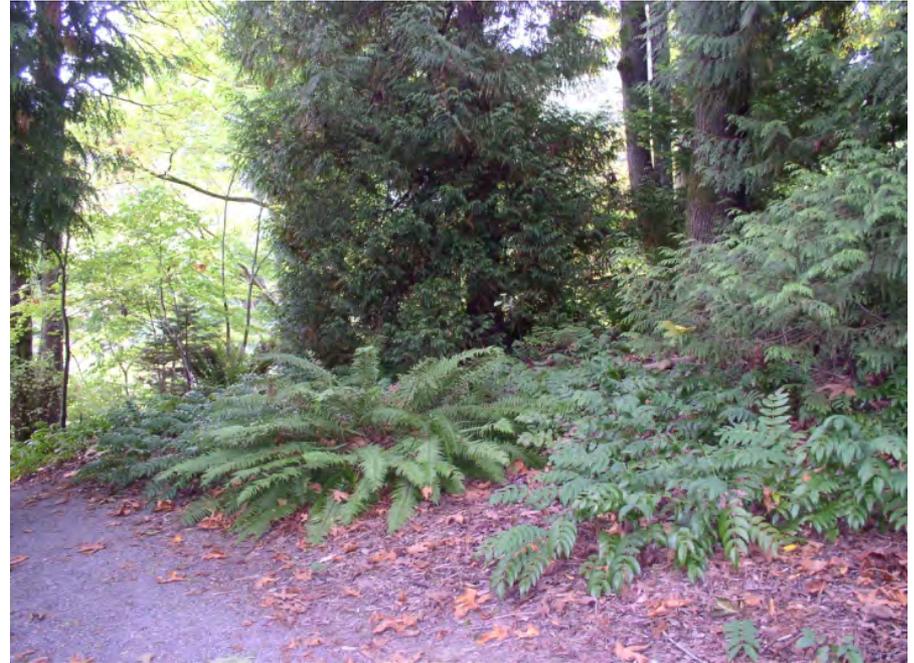
Example of trail edge with low growing vegetation, Washington Park Arboretum. Photo courtesy of Chris Pfeiffer.

## Low-growing vegetation next to trails

- Reduced maintenance requirements
