LOWMAN BEACH PARK SHORELINE RESTORATION

Draft 90% Design Report

Prepared for
Seattle Parks & Recreation Department

February 2020

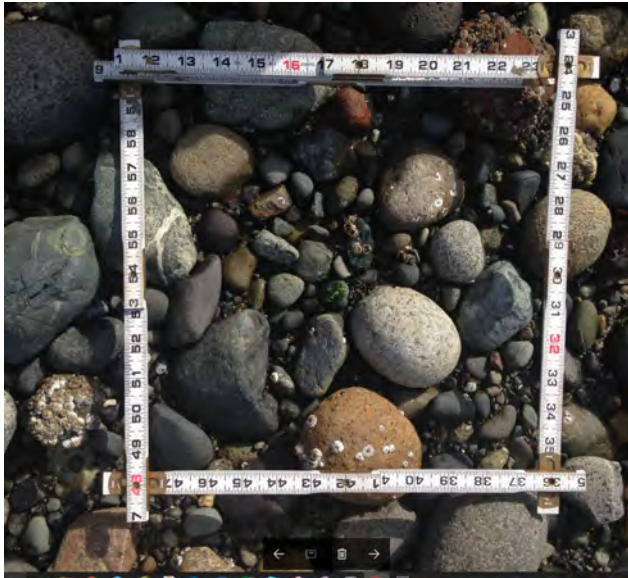
Beach Toe - Cobble and Gravel

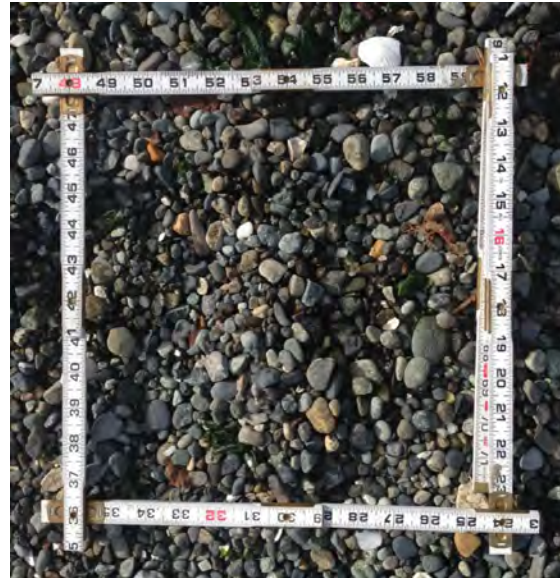
Foreshore - Mix Gravel and Coarse Sand

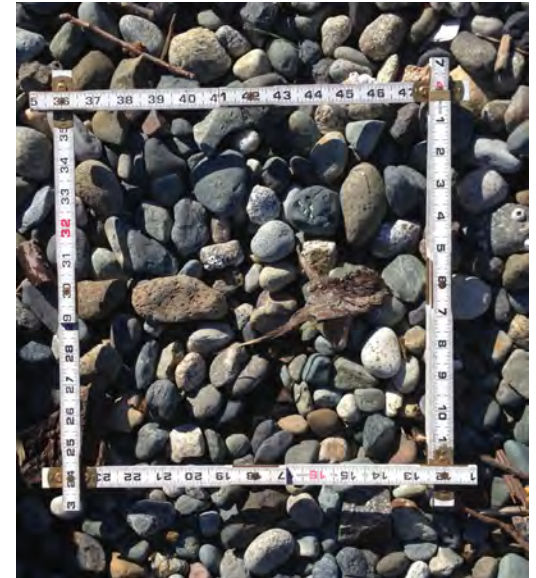
Backshore – Coarse Gravel
