Seattle Department of Transportation

# 2019 QUARTER 2 BIKE SHARE SUMMARY REPORT

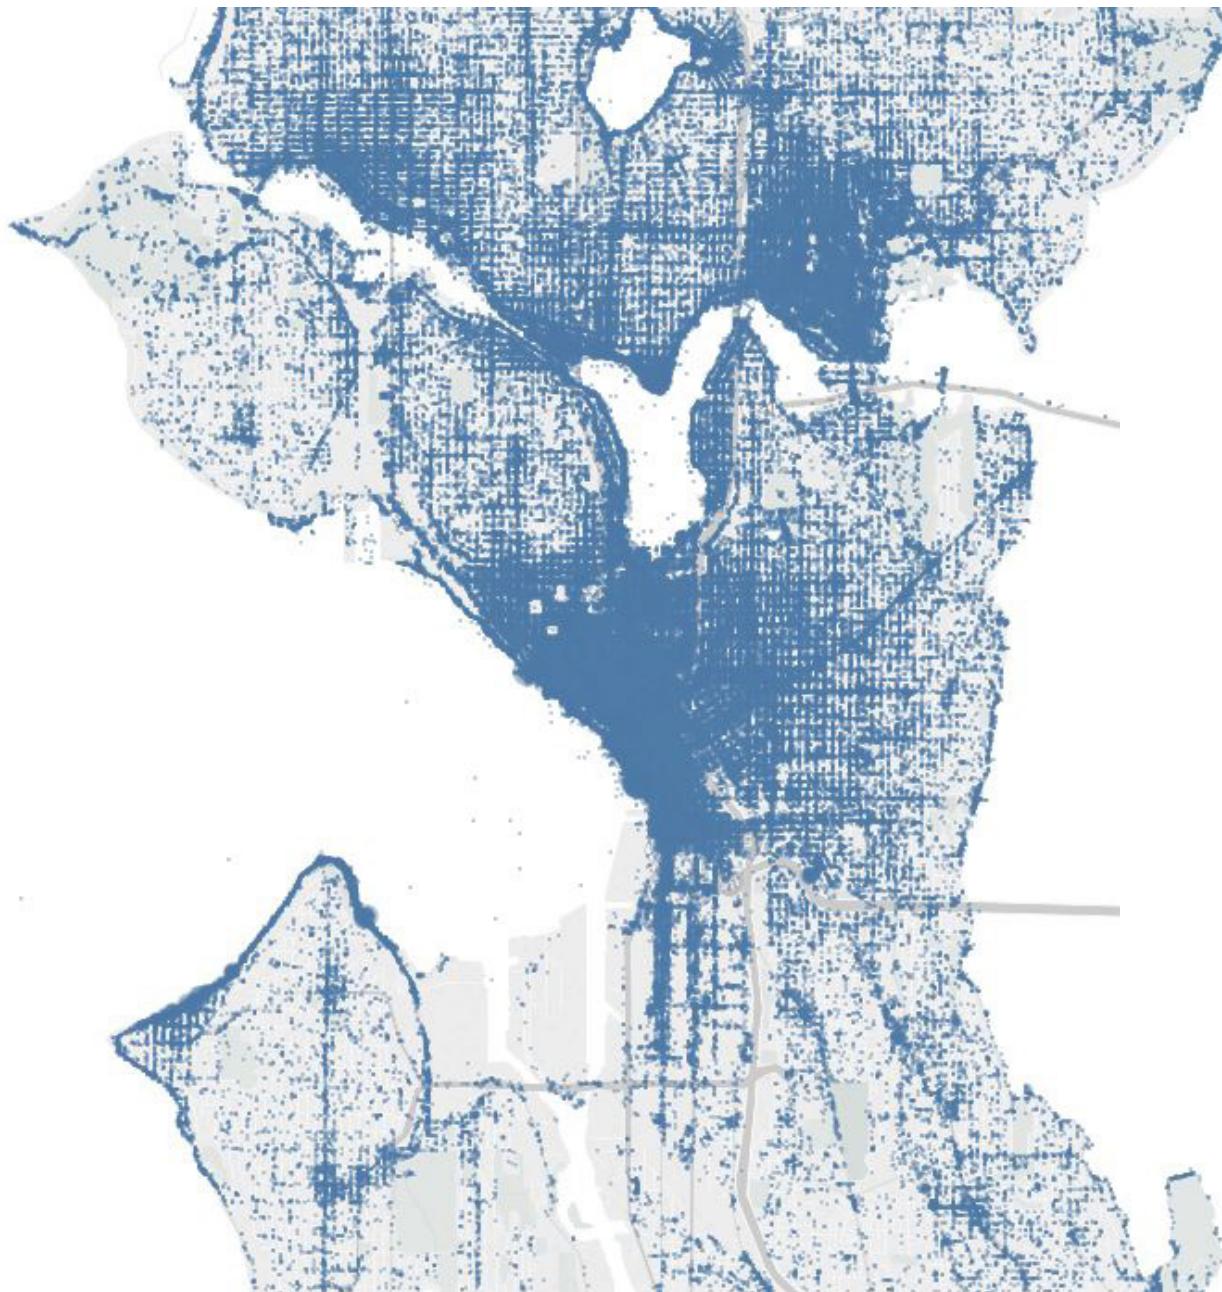
*Figure 1: Q2 Trips ends: This map shows the location, as reported by the bike share vendors, of each trip end in Q2 2019. This type of data will give SDOT a rich understanding of how and where people are using bike share.*

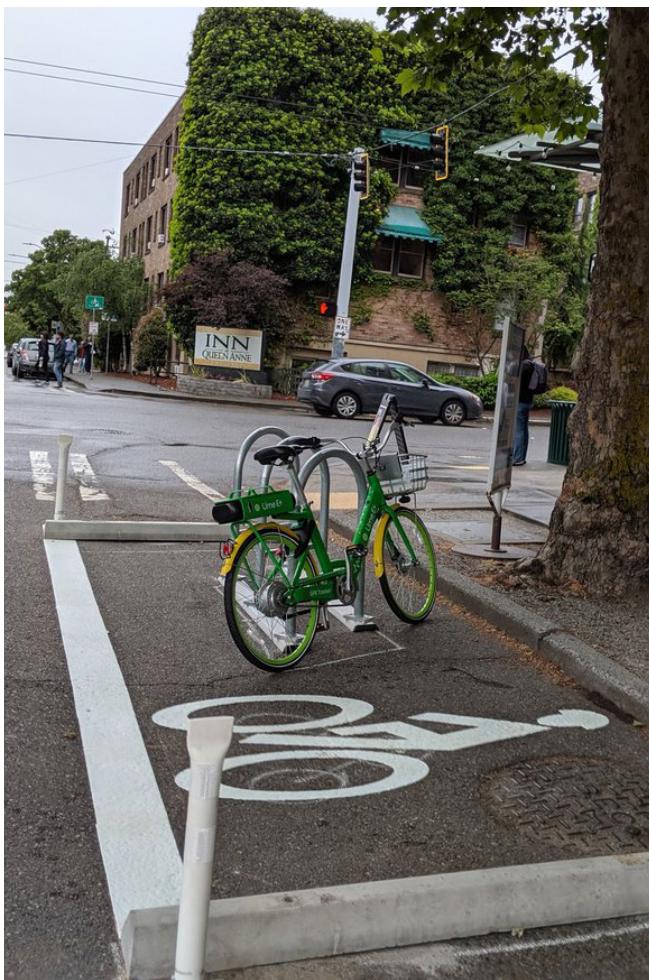
Figure 2: On-street corral on Republican St, at 1st Ave N

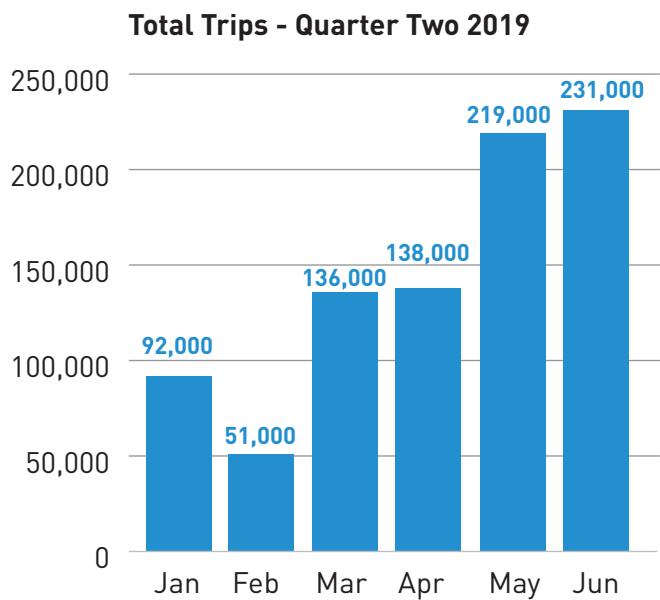
Total Trips (rounded to the nearest thousand)<sup>1</sup>

Quarter two 2019 saw dramatic ridership growth as the weather improved from the cooler and wetter winter months. This trend tracked similarly in 2018, with **588,000 total rides** taken in the second quarter. This more than doubled the trips taken in Q1 2019, and about even with trips taken in Q2 2018 with about half the total number of bikes.

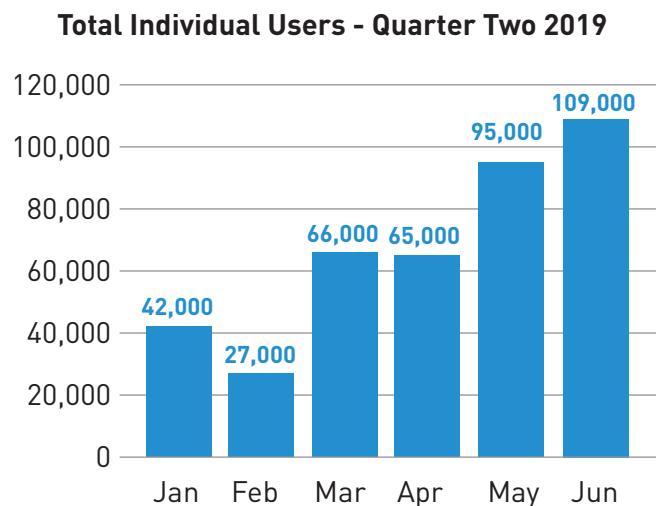
Total Individual Users (rounded to the nearest thousand)<sup>2</sup>

The total number of individual users also grew as the weather improved each month, topping more than 100,000 individual users in June 2019. In all of Q2, there were **224,000 individual users**, more than double the 102,000 individual users in Q1.

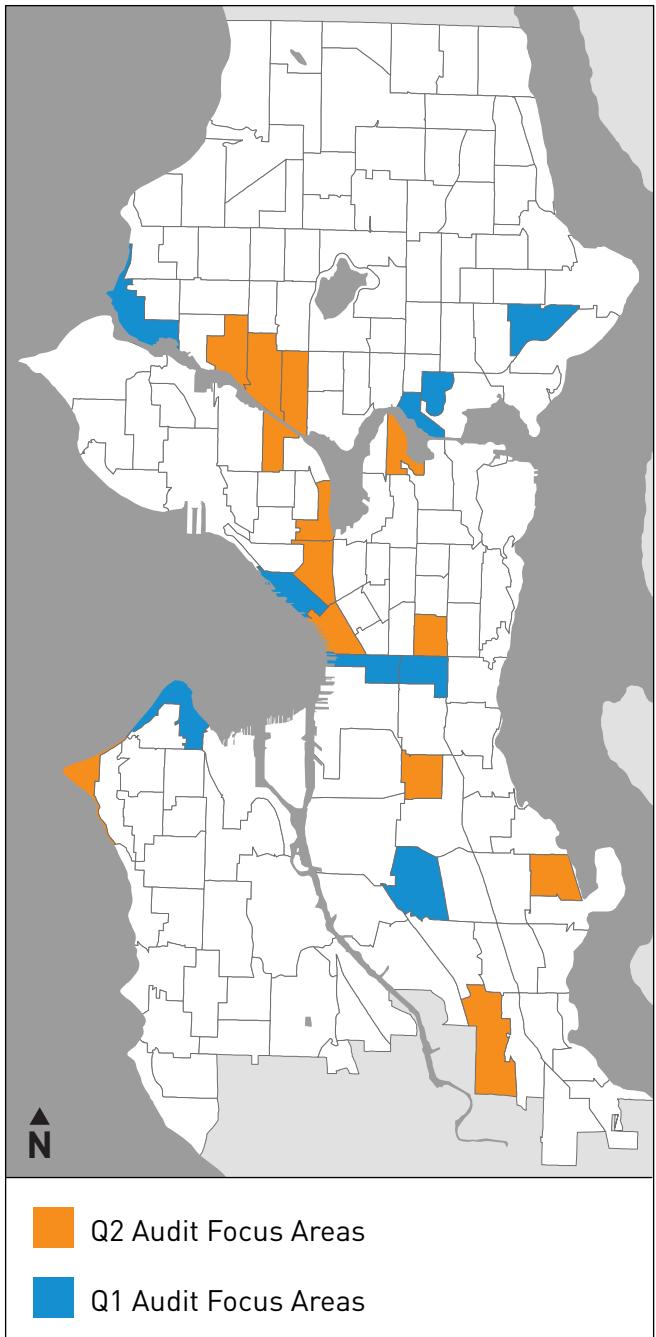
Figure 3: Map depicting Seattle's 162 audit focus areas, including areas audited in Q1 and Q2, 2019.

2. Developed a **stratified random selection process** of audit focus areas: SDOT and consultant staff collected data from thirteen audit focus areas across Seattle throughout the quarter. These areas were selected via a stratified random sampling process. Based on bike parking data, the 162 areas were split into four tiers, with Tier 1 having the most trip ends and Tier 4 the least. We randomly selected out of each tier the following number of audits:

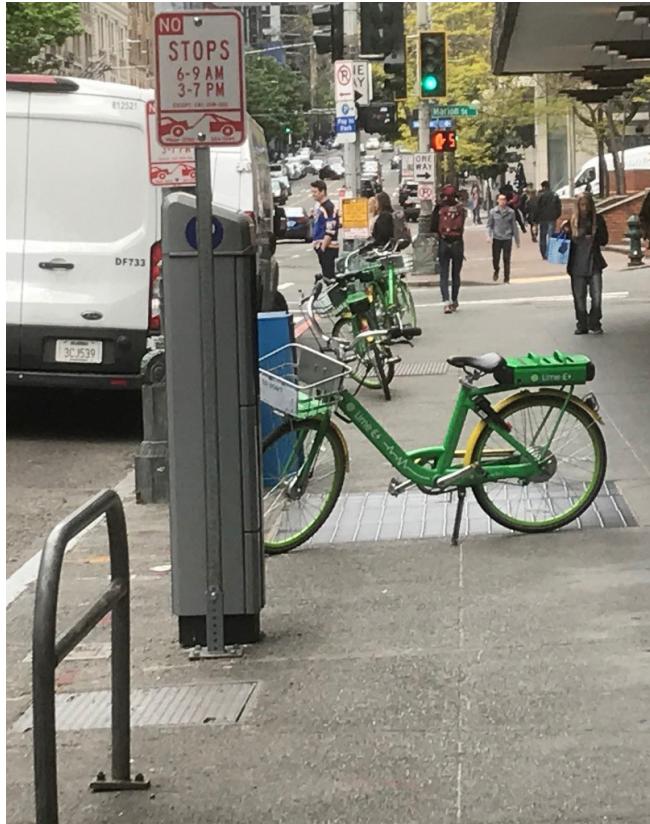
Figure 4: This bicycle blocks the sidewalk and is categorized as an obstruction hazard. It does leave over 4' of passage so is not an ADA-prohibited obstruction hazard.

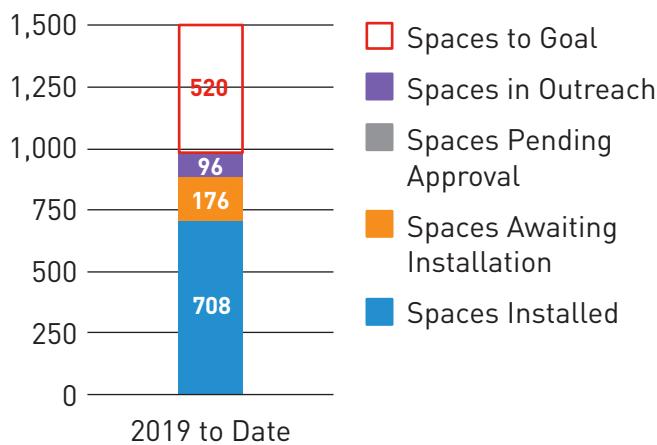
**Figure 5. Bike share parking construction progress**

January 1, 2019 to June 30, 2019: 47% of the 2019 goal delivered, with another 18% currently in the delivery process.

At the end of Q2, SDOT has installed 708 total spaces (see Table 1), with an additional 176 approved spaces awaiting installation and 96 in outreach (see Figure 5). Of the installed locations, 69% were in the form of on-street corrals, with the remaining 31% located as either sidewalk corrals or individual bike racks. Looking forward to Q3, staff will shift focus to center city neighborhoods, looking to install more corrals in Queen Anne, Belltown, the Downtown Core, Pioneer Square, and the Chinatown International District.

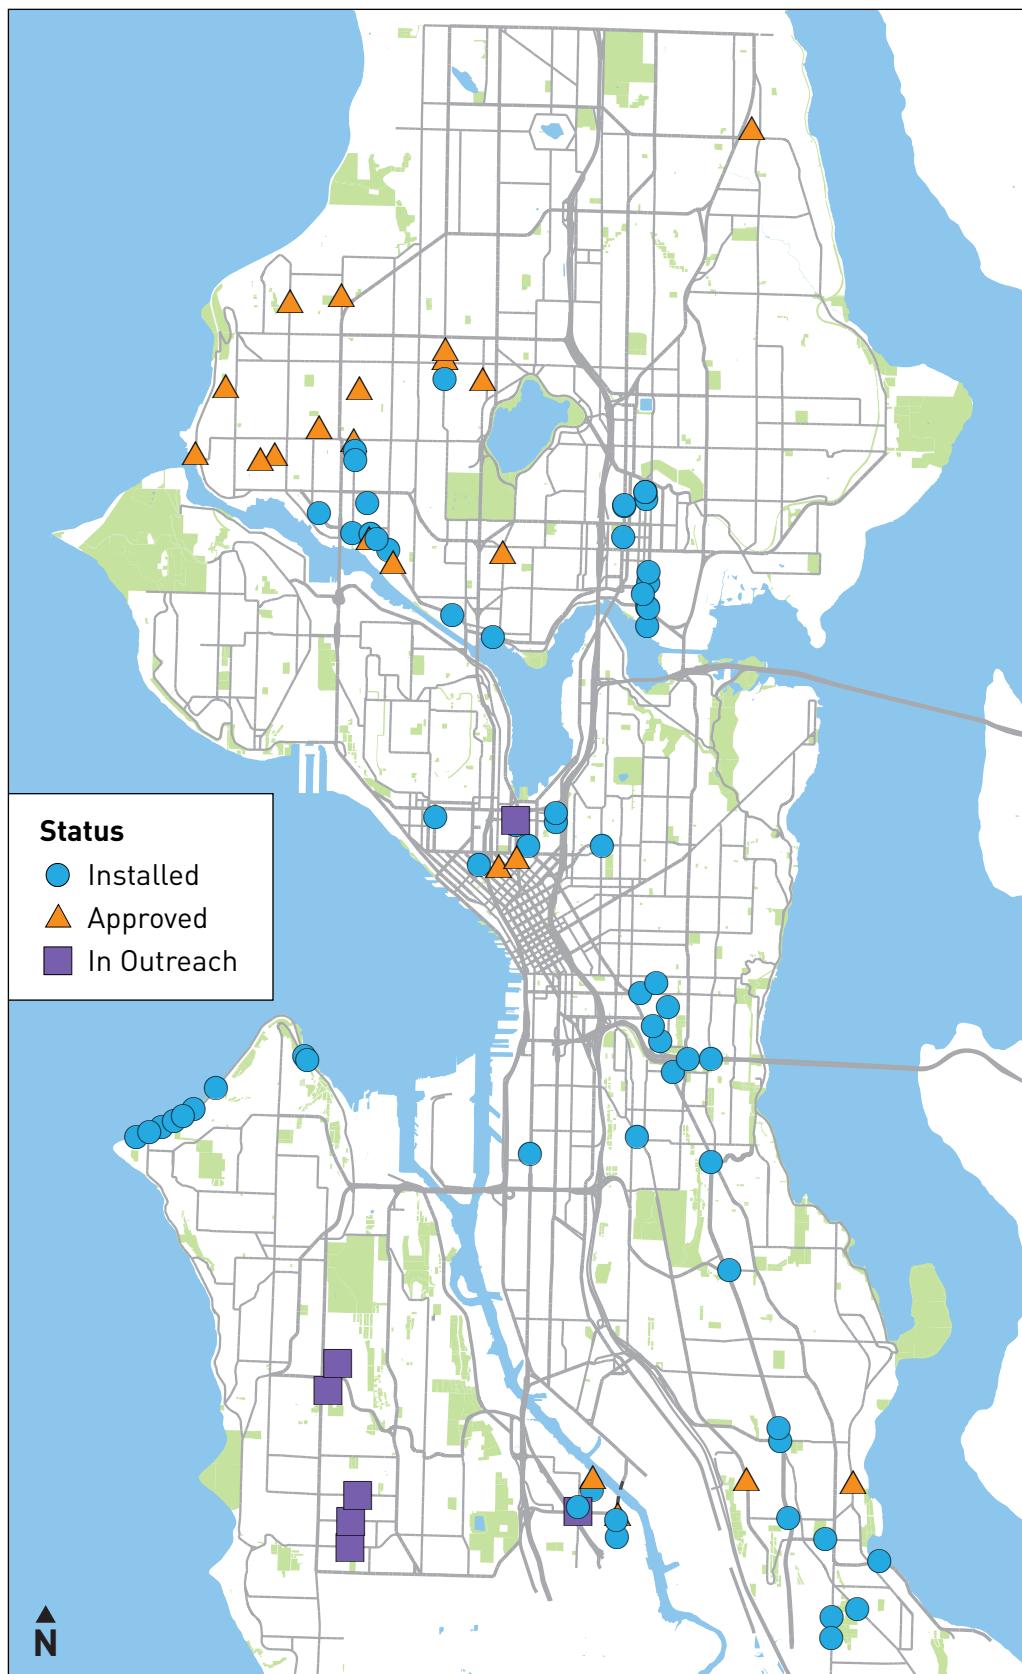
**Figure 7: Bike parking installation locations**

January 1, 2019 to June 30, 2019
