# Queen Anne Pedestrian Crossing Safety Enhancements Across Arterials

# Seattle Department of Transportation (SDOT) Review

## Project Description:

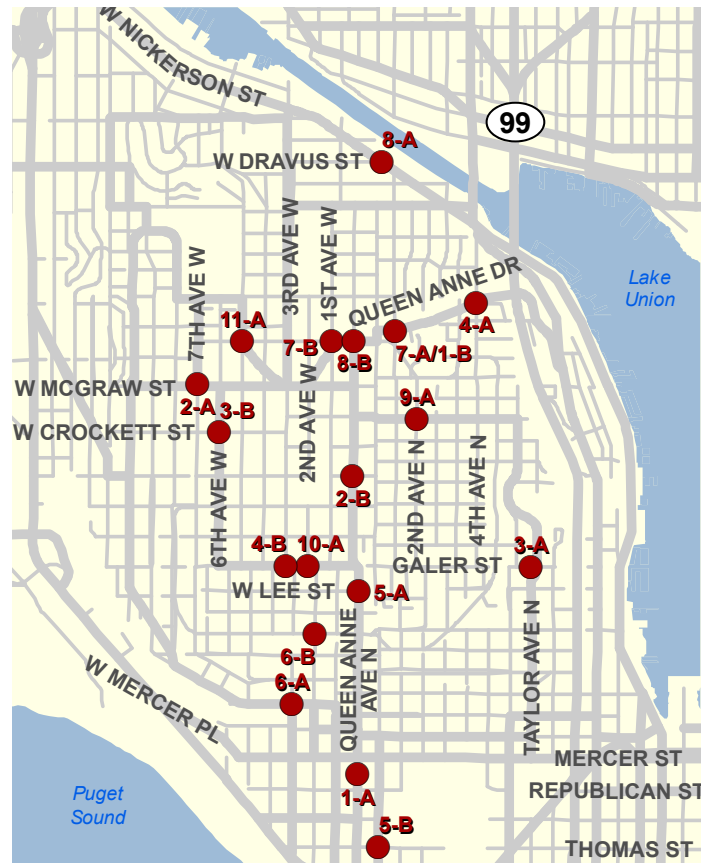
Map of reviewed proposed crossings

During the conceptual design phase, each proposed crossing location was assessed for modifications by collecting traffic data, counting the number of pedestrian crossing the street, and reviewing the site to see if physical improvements are already present. Ten intersections were determined to have met either warrants for a marked crosswalk (where one was not currently present), a rectangular rapid flashing beacon (RRFB), or both. These sites are described in detail below.
