### Thornton Creek Channel Encroachment

Produced by the City of Seattle  
June 2007

Map 42

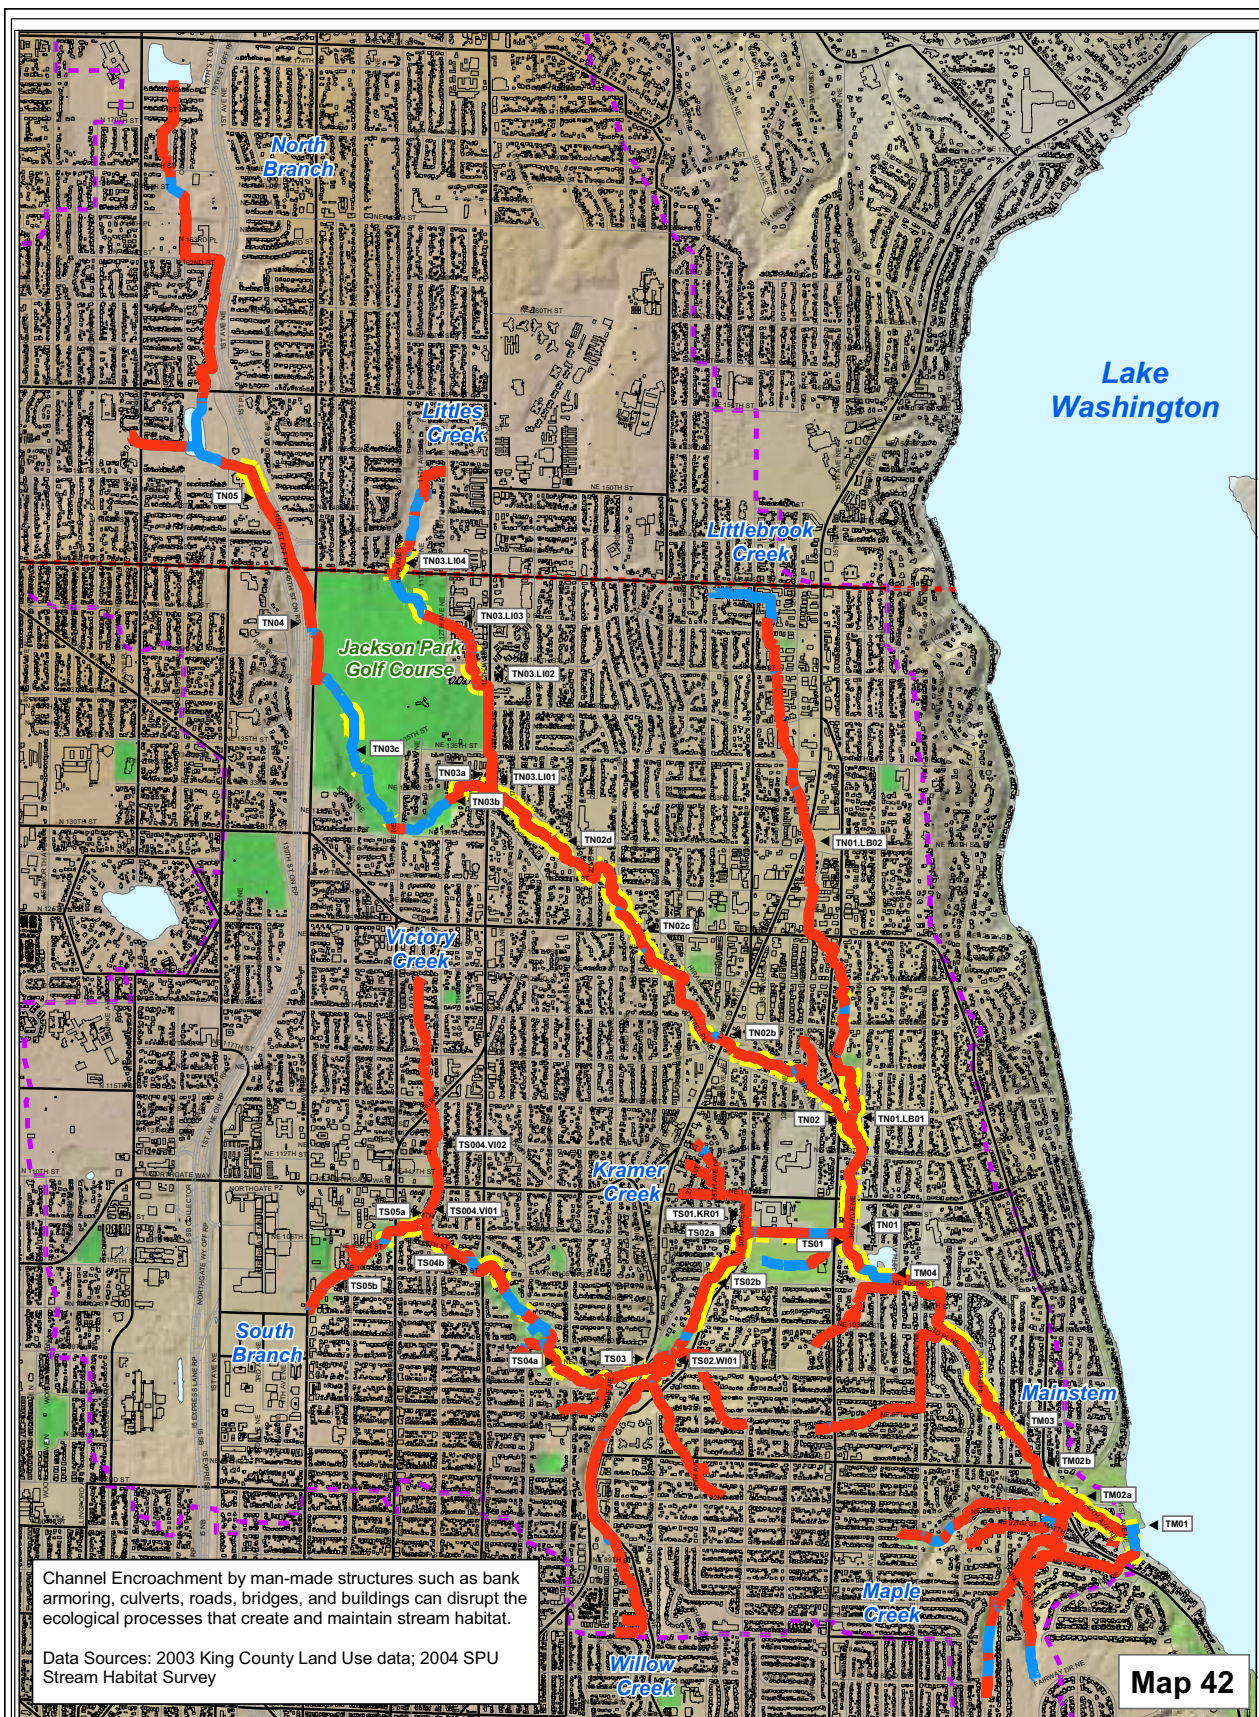
Channel Encroachment by man-made structures such as bank armoring, culverts, roads, bridges, and buildings can disrupt the ecological processes that create and maintain stream habitat.

Data Sources: 2003 King County Land Use data; 2004 SPU Stream Habitat Survey
