# **Rock Creek Wetland Habitat Restoration Project**

## **As-Built Document, 2002 - 2017**

Sally Nickelson  
Watershed Management Division  
Seattle Public Utilities

January 16, 2018

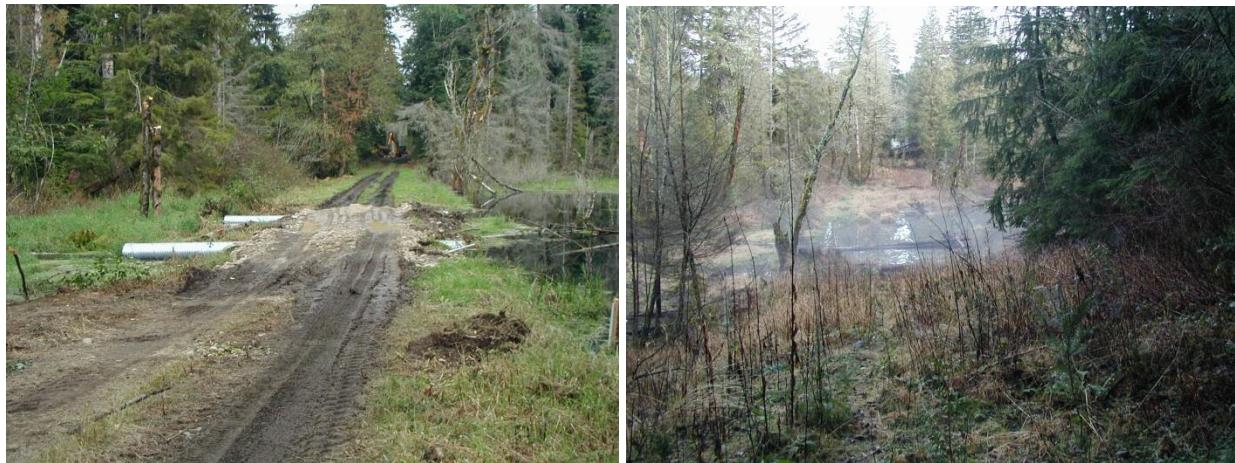
**Figure 4.** Section of the 16 Road in RCW in 2002 (left) and after removal in 2006 (right).

Decommissioning the 16 Road was the highest priority and was completed by Seattle Public Utilities Watersheds Operations staff in 2002. Road fill was removed from strategic locations and major portions of the wetland were hydrologically reconnected. Portions of the roadbed where fill was removed now have water at or near the surface for much of the year and native vegetation has completely recolonized these sites (figure 4). Fill was removed from the two major channels of Rock Creek and the channels were restored to natural streambeds. Wood was strategically placed near the channel closest to the 10 Road to minimize the chances the creek would flow along the old 16 Road roadbed and threaten the integrity of the 10 Road. In subsequent years, flow in Rock Creek has moved between the two major channels; at times all

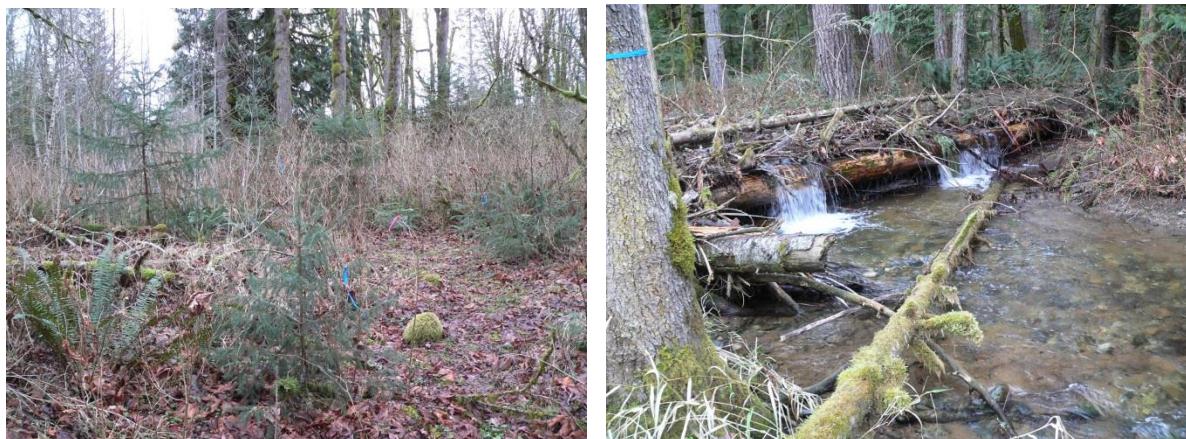
**Figure 5.** Planted conifers ten years after road decommissioning of the 16 Road (left) and restored Rock Creek channel at the 16 Road crossing (right).

In areas where fill was not removed, the roadbed surface was broken and was initially planted with over 1,600 native trees and 70 native shrubs shortly after the decommissioning was completed in 2002. This helped to diversify the native plant community as well as suppress some non-native invasive species. There was vigorous plant growth of some species over the next ten years, particularly Sitka spruce and by 2014 in some areas it was becoming difficult to tell where the old roadbed had been (figure 5).

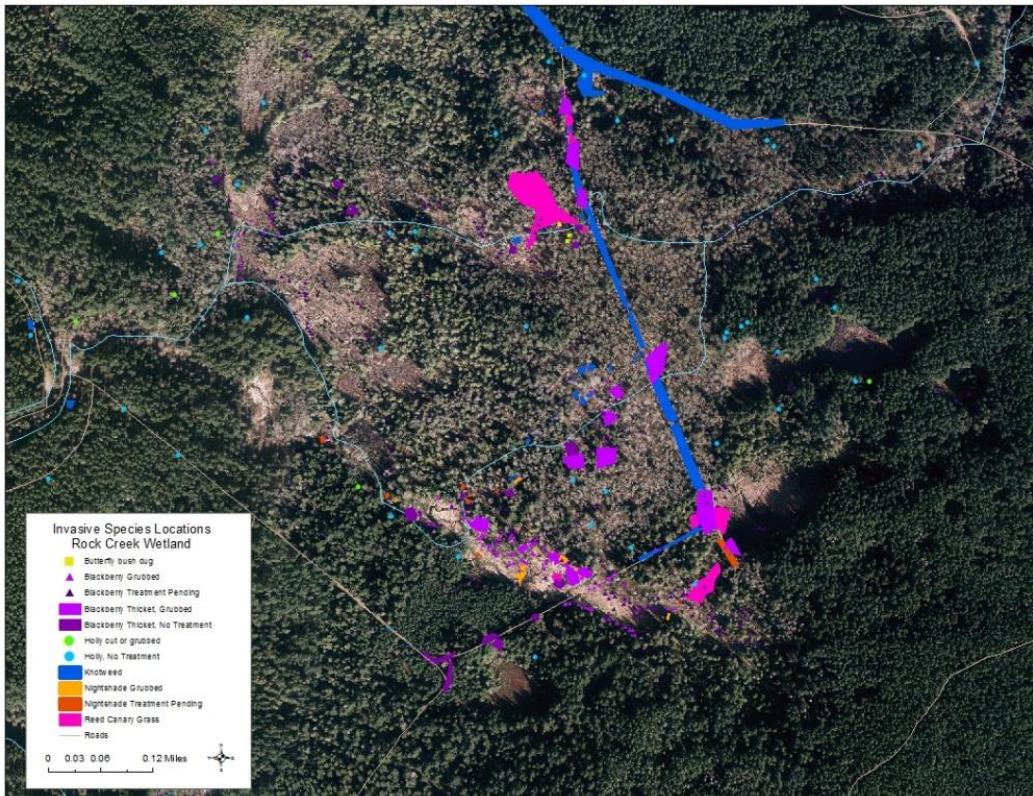
**Figure 7.** Location of major invasive species in RCW

RCW was surveyed intensively for invasive species 2007-2014 (figure 6). During these surveys, all knotweed, Himalayan and evergreen blackberry thickets and individual large blackberry plants, nightshade mats, butterfly bush, and English holly were mapped on a geographic information system using global positioning system points taken in the field (figure 7). In 2014

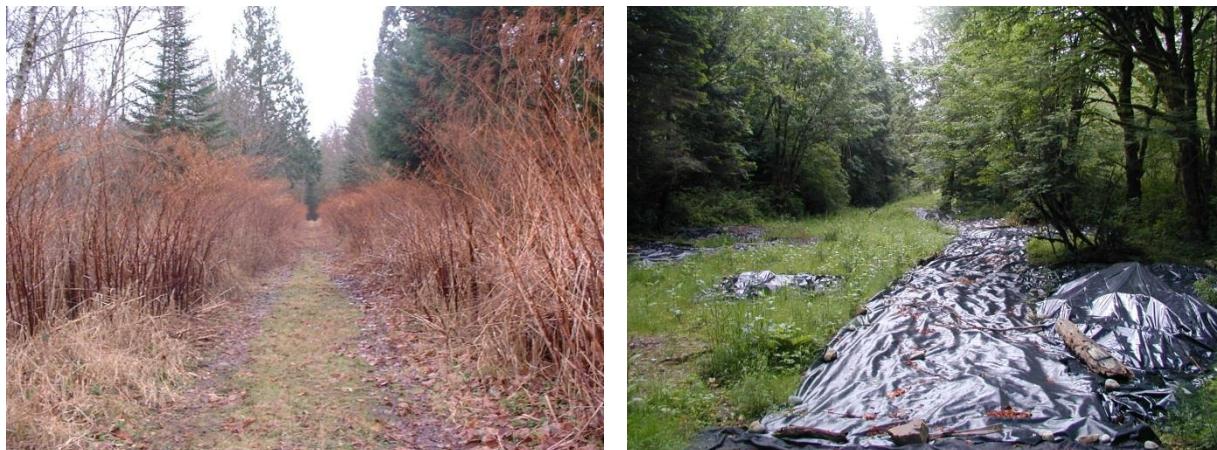
**Figure 8.** Knotweed during winter lining Road 16 prior to decommissioning (left) and fabric placed over the knotweed in 2004 along the edges of the decommissioned road (right).

In the early 2000s herbicide use (the preferred and often only effective treatment for knotweed) within the municipal watershed was completely prohibited, leaving only mechanical treatment options. Since pulling large established infestations is ineffective, in 2004 we attempted to starve the knotweed roots by covering over  $25,000 \text{ ft}^2$  of the dense infestation along the old roadbed. We initially used three different types of fabric – heavy black plastic, woven plastic geotextile fabric, and non-woven felt geotextile fabric. The black plastic tore easily, so over the next several years we replaced torn sections with the more durable geotextile fabric. The fabric was placed over the most heavily infested areas, i.e., those areas along the roadbed adjacent to the forest edge. The center of the roadbed generally had isolated individual knotweed plants, and was left uncovered to function as a wildlife travel corridor. The fabric was placed loosely over the dense patches and anchored at the edges with rocks or logs (figure 8). This allowed some

plant growth underneath without tearing through the fabric. Significant growth under the fabric generally only occurred during the first two growing seasons after the fabric was placed.

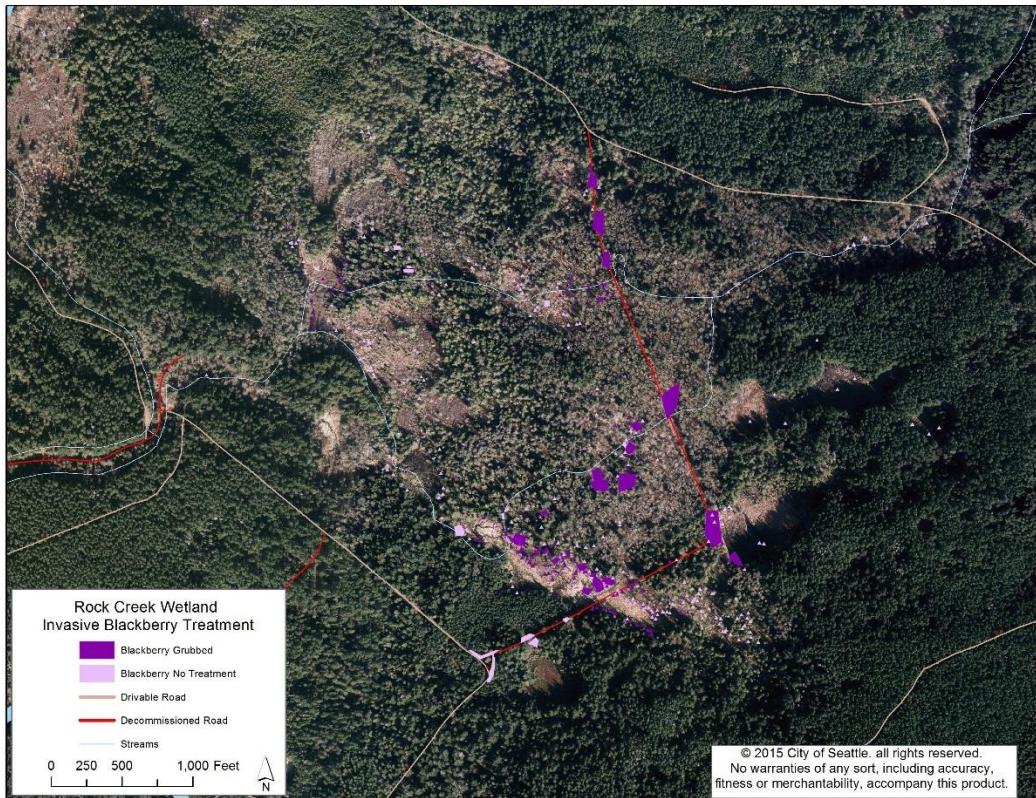
**Figure 9.** Invasive blackberry treatment in RCW

Both Himalayan and evergreen blackberry form large thickets that out-compete and displace native wetland plants. Because these species are so common in King County, they are not legally required for control. However, control is highly recommended, especially in wetland and riparian areas, because of the large negative ecological effects they exert. We began grubbing out blackberry thickets and individual plants along the 16 Road and within the wetland in 2005. We continue to work on removing blackberry as resources allow, and have made significant progress (figure 9). Because blackberry can re-growth from root fragments and seeds are viable for many years, each blackberry site needs to be treated for multiple years to significantly reduce its footprint. Large efforts were conducted in 2006, 2008, 2009, 2010, 2013, 2014, 2015, and 2017, primarily using contractors. Currently, virtually all large thickets have been reduced to scattered individual plants, and many individual plants have been eliminated. It is much more cost-effective to treat blackberry when they are still individual plants, and we will continue to control these species throughout the wetland as resources allow, to further reduce their impact on native ecological functions.

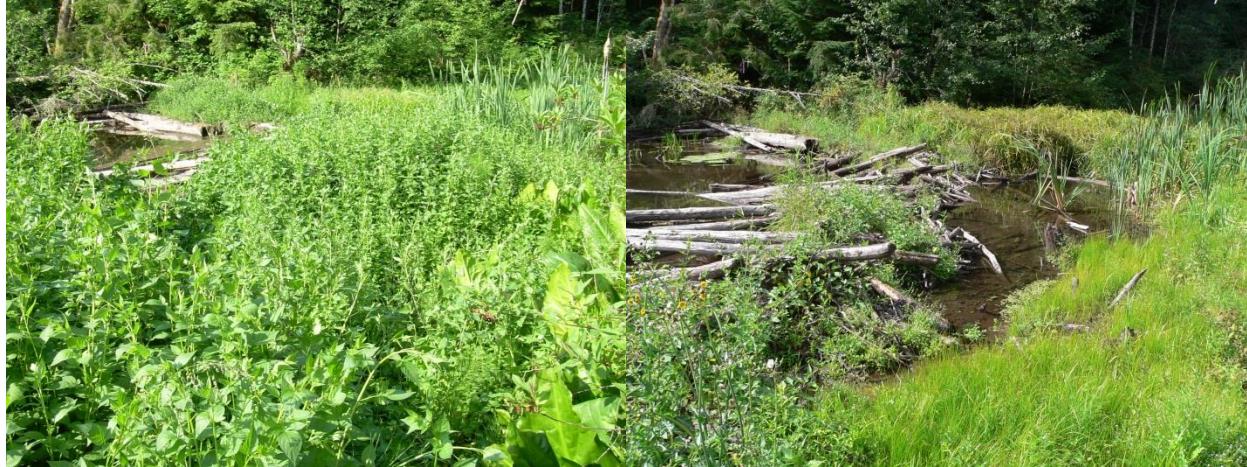
**Figure 10.** Nightshade mat along a beaver dam before (2006, left) and after (2009, right) removal.

Bittersweet nightshade is not legally required for control, but King County recognizes it is invasive and lists it as a weed of concern recommended for control. It is highly toxic, and has caused fatal poisoning of both children and livestock. Its effects on native wildlife are unknown, but it likely causes death if eaten in sufficient quantities. During RCW surveys, huge dense mats of nightshade were found that completely blanketed large areas. It was so thick that a person could walk on the mats over open water. These mats were clearly displacing native plants and likely disrupting native ecosystem functioning, so were a high priority for removal. The largest mats of nightshade were grubbed out and removed from the wetland in 2009 and 2010, (figure 10).

Numerous smaller nightshade mats were removed in 2012, 2013, and 2014, with much of the work grant funded. Grubbing out the roots and piling the plants in dry areas to desiccate appeared to be largely successful. We temporarily covered many of the root piles with fabric to prevent regrowth. There was some limited re-growth in the original matted sites that had to be treated in following years to prevent a recurrence of the mats. Individual nightshade plants are still scattered widely throughout the wetland, but recent surveys have revealed no further large mats. If any large mats are discovered, they will be grubbed out as resources allow. Treated sites will continue to be monitored and re-grubbed periodically as needed.

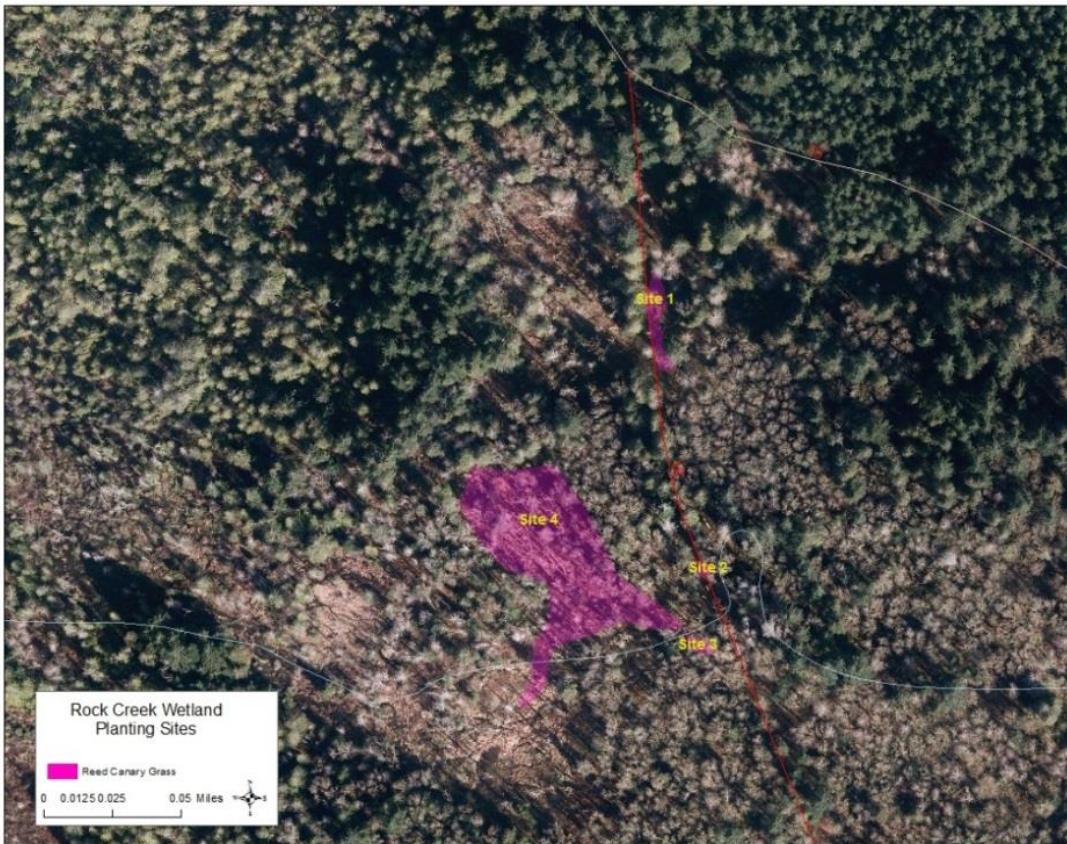
**Figure 11.** 2014 reed canary grass treatment sites

Reed canary grass has recently been recognized as one of the most invasive and damaging non-native species creating monocultures in western Washington wetlands. By late 2014 knotweed, blackberry, and nightshade were largely under control, so staff turned to the next highest priority, reed canary grass. Initial mapping of the large patches of reed canary grass adjacent to the old decommissioned roadbed was completed (figure 7). There were large canary grass patches deep in the wetland (about 3,000 feet south of the 10 Road) in an area that was until recently the bottom of a beaver pond, as well as a very large site near the active Rock Creek channel about 1,000 feet south of the 10 Road. Because the former beaver pond area was immediately adjacent to an active beaver colony that would likely cause major damage to a restoration project (eat planted seedlings), we decided to focus first on the sites closest to the 10 Road (figure 11).

The covering of the small reed canary grass patches appeared to successfully suppress the growth. However, the grass grew aggressively through the holes, along the edges, and on top of the large fabric patches. The main large site (Site #4 in figure 11) was cleared again in 2015, 2016, and 2017. The initial late-2014 planting in this site had very high mortality during the summer of 2015, one of the driest summers on record. It was replanted in late 2015 with a smaller suite of more drought-resistant species. Native plantings were densified in early 2017 and early 2018.

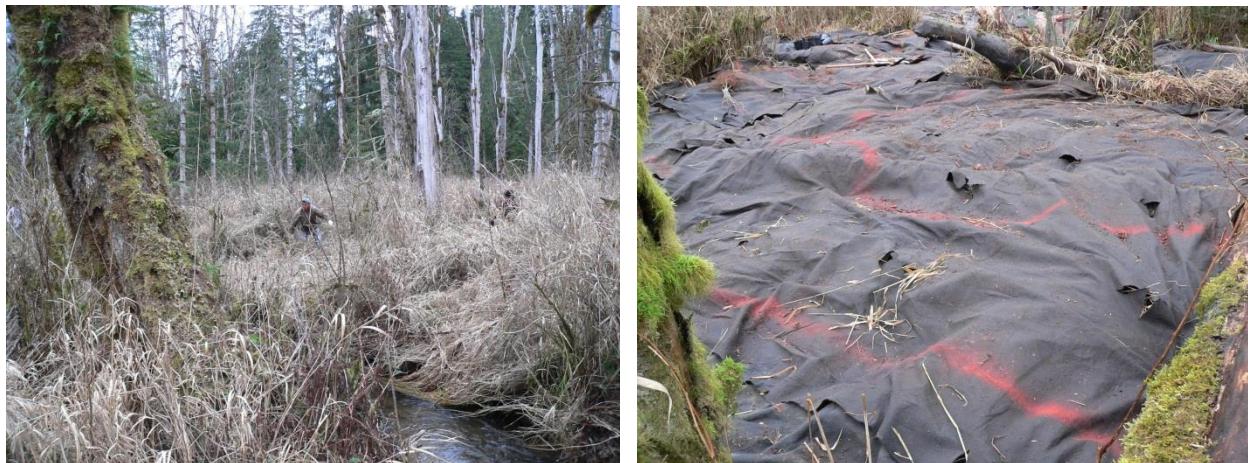
**Figure 12.** Reed canary grass before (left) and during the 2014 treatment (right), when fabric was placed and areas for species groups were delineated by orange paint.

Other western Washington land managers have found that smothering growth with some type of mulch and planting very densely with native trees and shrubs has been successful in reducing canary grass cover in wetland areas. In late 2014 we first spread geotextile fabric over the bulk of the infestation in the four treatment sites, to help suppress the grass and allow the seedlings to grow to sufficient height to overtop and out-compete the grass. We then cut holes in the fabric and planted 4300 native shrubs and 125 native trees (figure 12). Shrub species were generally planted in small groups by species (clusters of 10 or so plants of each species), while trees were scattered. Willow was planted very densely (two feet on center), while other shrubs were generally planted four feet apart (figure 13). The goal of this very dense planting is to provide long-term shade that will suppress the grass, as well as to diversify the native plant community.

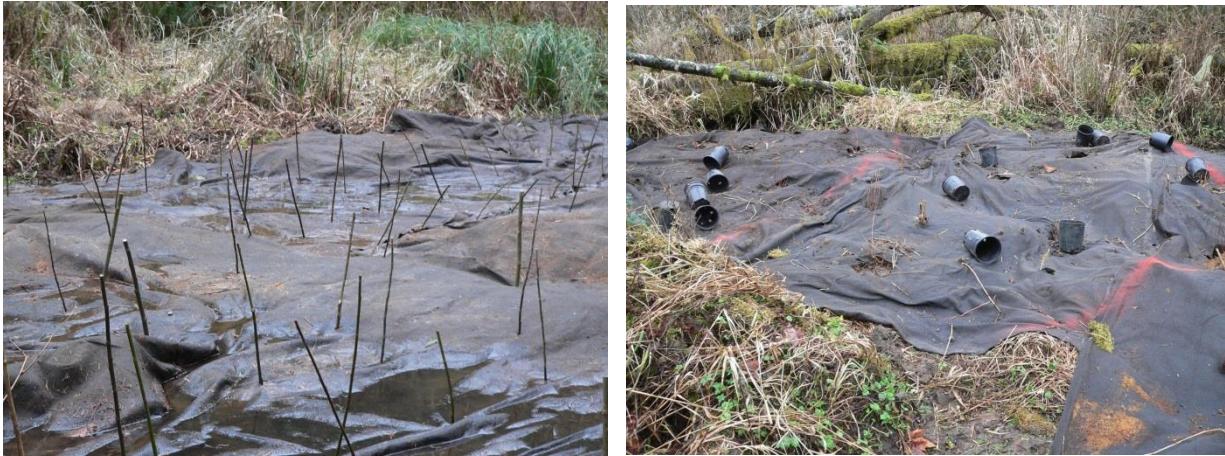
**Figure 13.** Densely planted willow (left) and other native shrubs (right) during 2014 planting.
