# Taylor Townsite Habitat Restoration Project As-Built Document, 2007 – 2017

Sally Nickelson  
Watershed Management Division  
Seattle Public Utilities

December 11, 2017

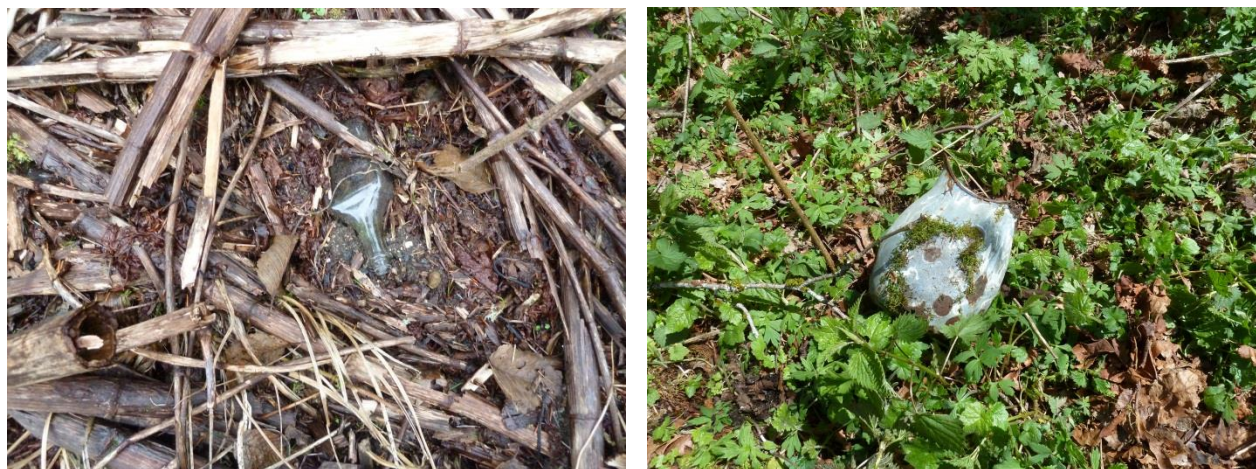
**Figure 4.** Historical artifacts seen and protected during restoration activities.

Project objectives will be achieved in phases over many years. Treatments are prioritized and implemented as funding and staffing allows (discussed in order of priority below). During all work, historical artifacts are protected and left in place (figure 4). Details of all treatments by year can be found in Appendix I.

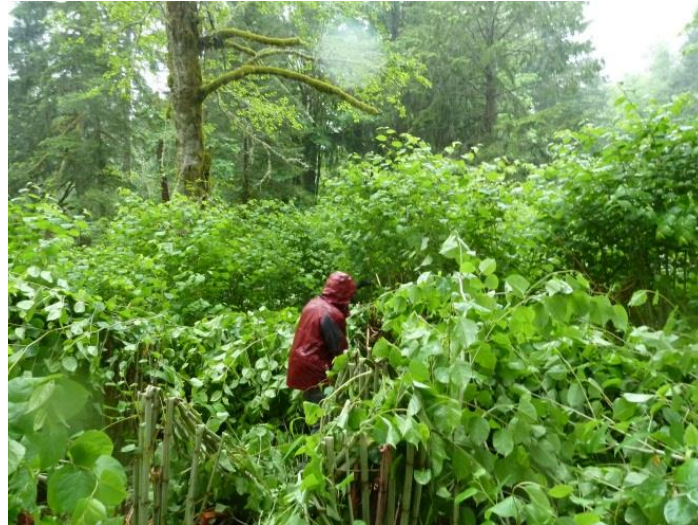
**Figure 6.** Pre-treatment of knotweed by bending canes

The first herbicide treatment at Taylor took place in 2011 on 7.66 acres. Knotweed canes were pre-treated by bending four to six weeks prior to the first herbicide application (figure 6). This allowed sprayers access through the dense mass of canes and ensured the applicators could safely

2011	Knotweed	Prepare for herbicide treatment	Prepare all patches (7.5 ac) by bending canes	1	5	\$750	16
	Knotweed	Herbicide treatment	Apply herbicide with backpack spray	1	13.5	\$4,175

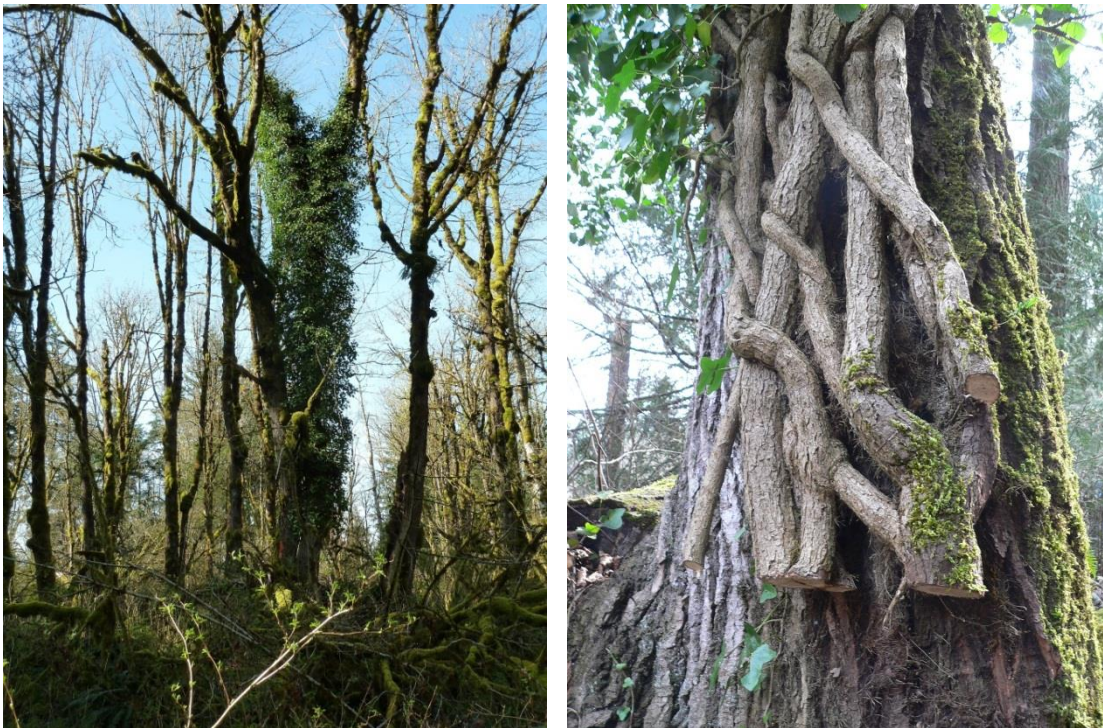
**Figure 9.** Ivy blanketing a tree at Taylor and extremely large ivy stems growing up a tree.

English ivy is a very aggressive perennial woody vine that poses an especially serious ecological threat because it can grow in a wide range of conditions, from dry to moist soils and from full sun to full shade. It easily outcompetes native species and forms thick mats that blanket the forest floor, the shrub layer and individual trees and into the tree canopy (figure 9). It often girdles trees, killing them. It also adds substantial weight to a tree, contributing to premature blowdown and shortening the useful lifetime of the snag. The entire ivy plant contains slightly toxic compounds, and essentially no native wildlife species use it for forage or nesting.

We began grubbing out the easternmost patch of ivy in 2009, removing and bagging all roots and disposing of them in the garbage. Any vines growing up trees are severed and left in place to die. Work has continued annually, using staff, volunteer, and contractor labor (see Appendix I). Each patch needs to be grubbed for several years to remove all roots and eradicate the patch. We began work on patches as they were found, and currently all known patches have been grubbed from two to 13 times, depending on when they were discovered and how extensive the patch was. All patches are checked and controlled at least every two years until they are eradicated.

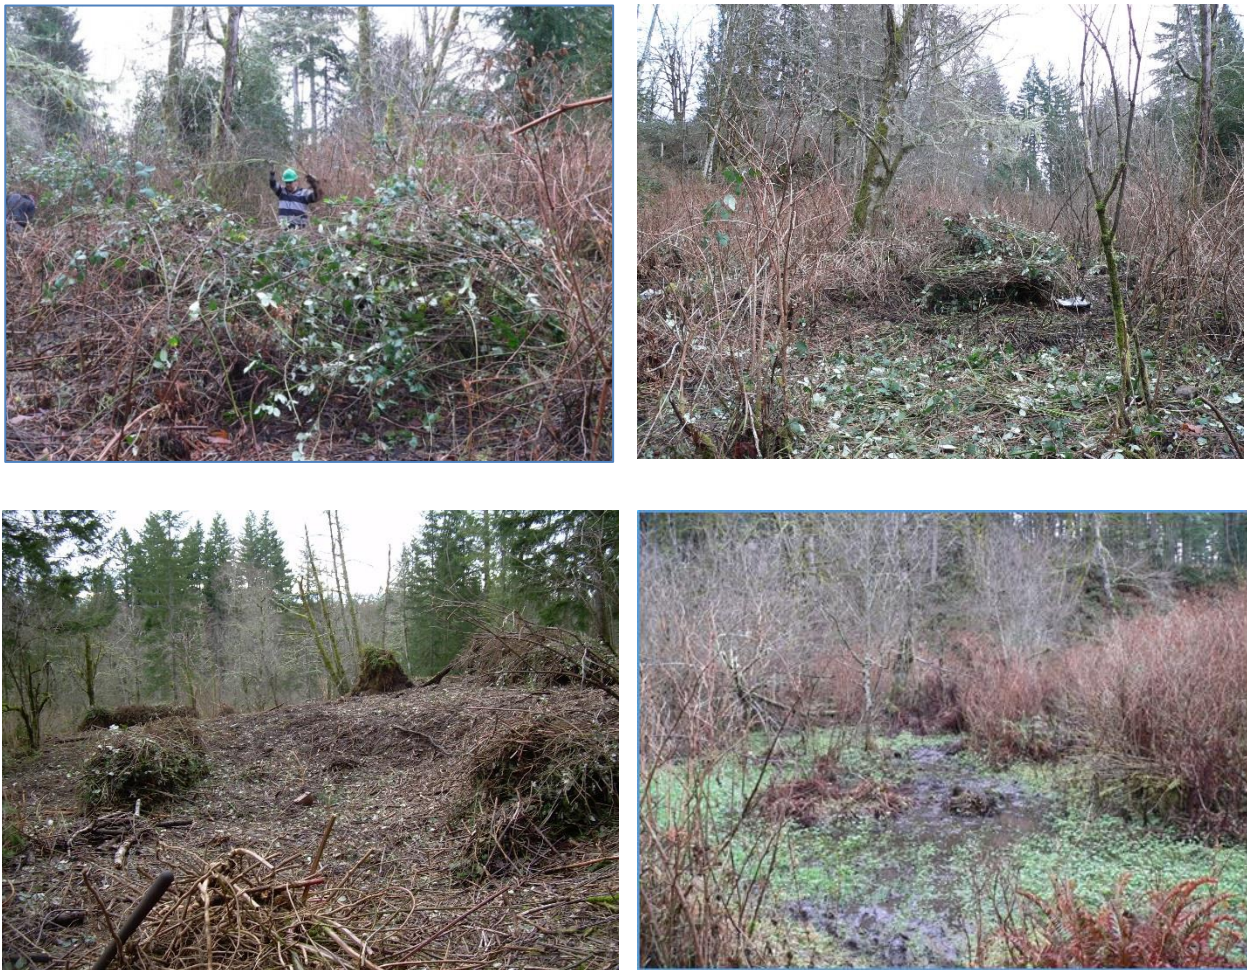
**Figure 10.** During and after blackberry clearing in the Taylor townsite

We use contract crews to hand-grub the blackberry, removing as much root as possible. We pile the canes and roots and allow them to desiccate on site (figure 10)

Once the canes and roots are dead, they are chopped into small pieces and scattered so they decompose more quickly. We started the work in 2011, and continue as funding allows. There were major efforts to clear the wetland in 2013, 2014, and 2015. In 2015 and 2016 the thickets to the south of the workers housing area were initially cleared, and all sites were re-grubbed in 2017. All blackberry thickets require annual re-clearing for several years until the seed bank is greatly reduced and native plants become dominant.

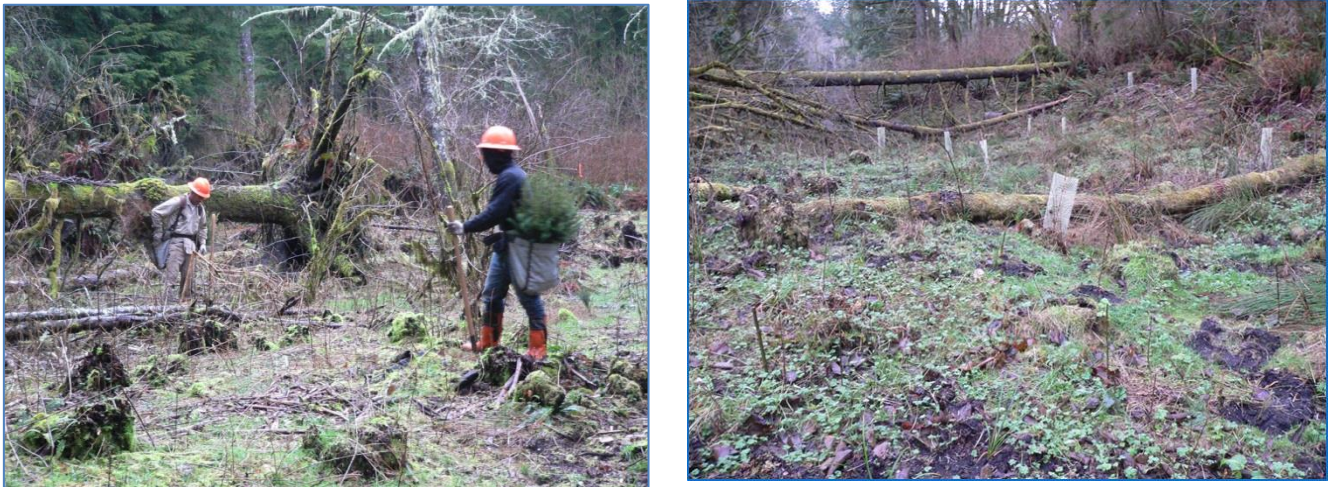
**Figure 12.** Planting in former knotweed-dominated sites, with browse protectors installed on western redcedar

Browse protectors were installed around all western red cedar because both black-tailed deer (*Odocoileus hemionus*) and elk (*Cervus elaphus*) browse extensively on cedar in the CRMW (figure 12).
