Ballard Roadside Raingardens

Phase 1 Hydrologic Monitoring Report

September 2012 through May 2013

Seattle
Public
Utilities

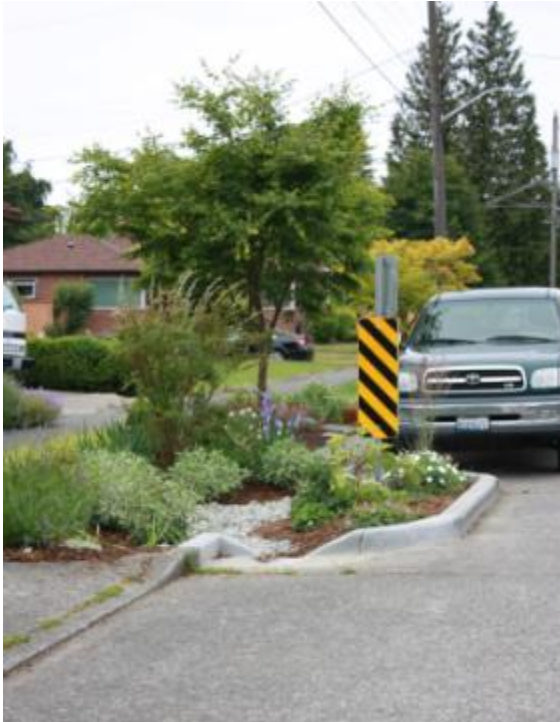
In CSO basins, roadside raingardens are located in one of two places, depending on site conditions: (1) within a curb extension (Figure 3), for which the curblines turn 90 degrees to run 5 feet into the roadway and then runs parallel to the road for a short length before turning back to rejoin the original curb, or (2) behind the curb in an existing planting strip between the curb and sidewalk (Figure 4). The 30th Avenue rain garden is of the latter design, and is located completely in the planting strip.

Figure 3. Curb Extension Design (31st Avenue NW)

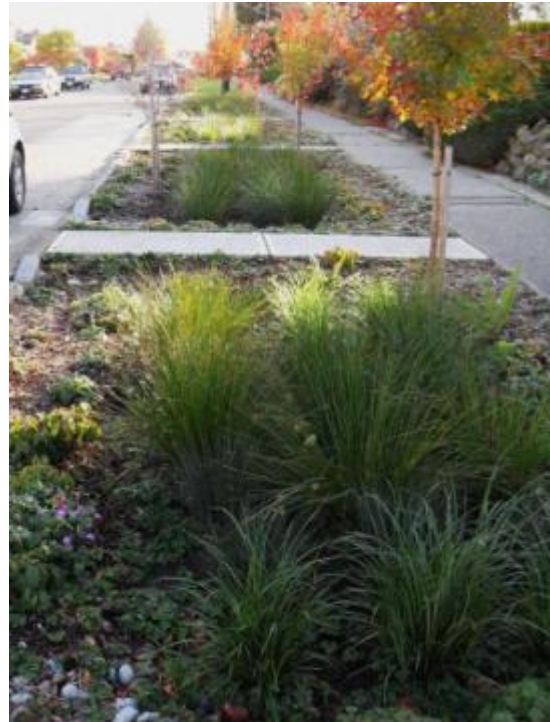
Figure 4. Planting Strip Design (30th Avenue Rain garden)

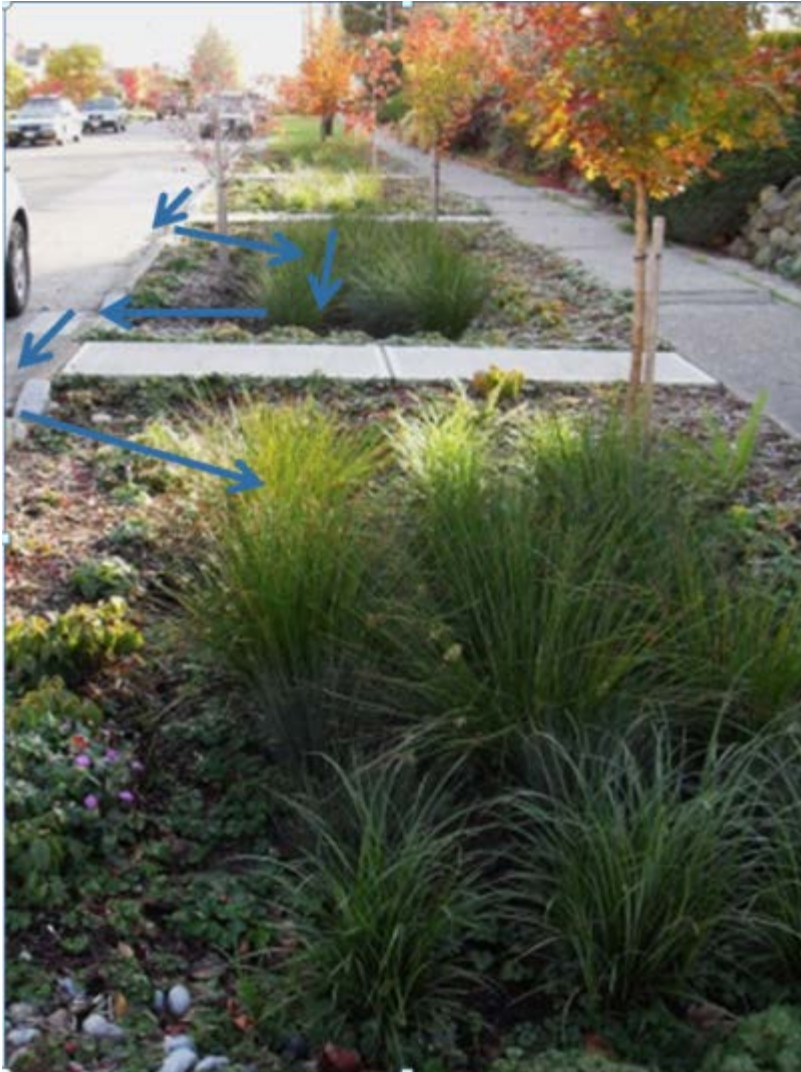
Raingardens are generally placed between driveways or other obstructions at several locations along a block on either side of a street. For the CSO control target of limiting overflows to one per year, raingardens are designed to capture approximately 95 percent of the average annual volume of stormwater (which typically equates to infiltrating storms equal or less than the 1-year-recurrence-interval storm) through curb cuts as the water travels down the curblines. Up to 6 inches of ponding is allowed to provide additional storage and help with infiltration. With ponding greater than 6 inches, the water overflows the raingarden cell via a curb cut on the downstream end and either enters the next raingarden cell downstream or continues down the existing curblines, entering the CSS via an existing inlet. Figure 5 illustrates the typical flow path.

Figure 5. Typical Flow Pathway through the 30th Avenue Raingarden

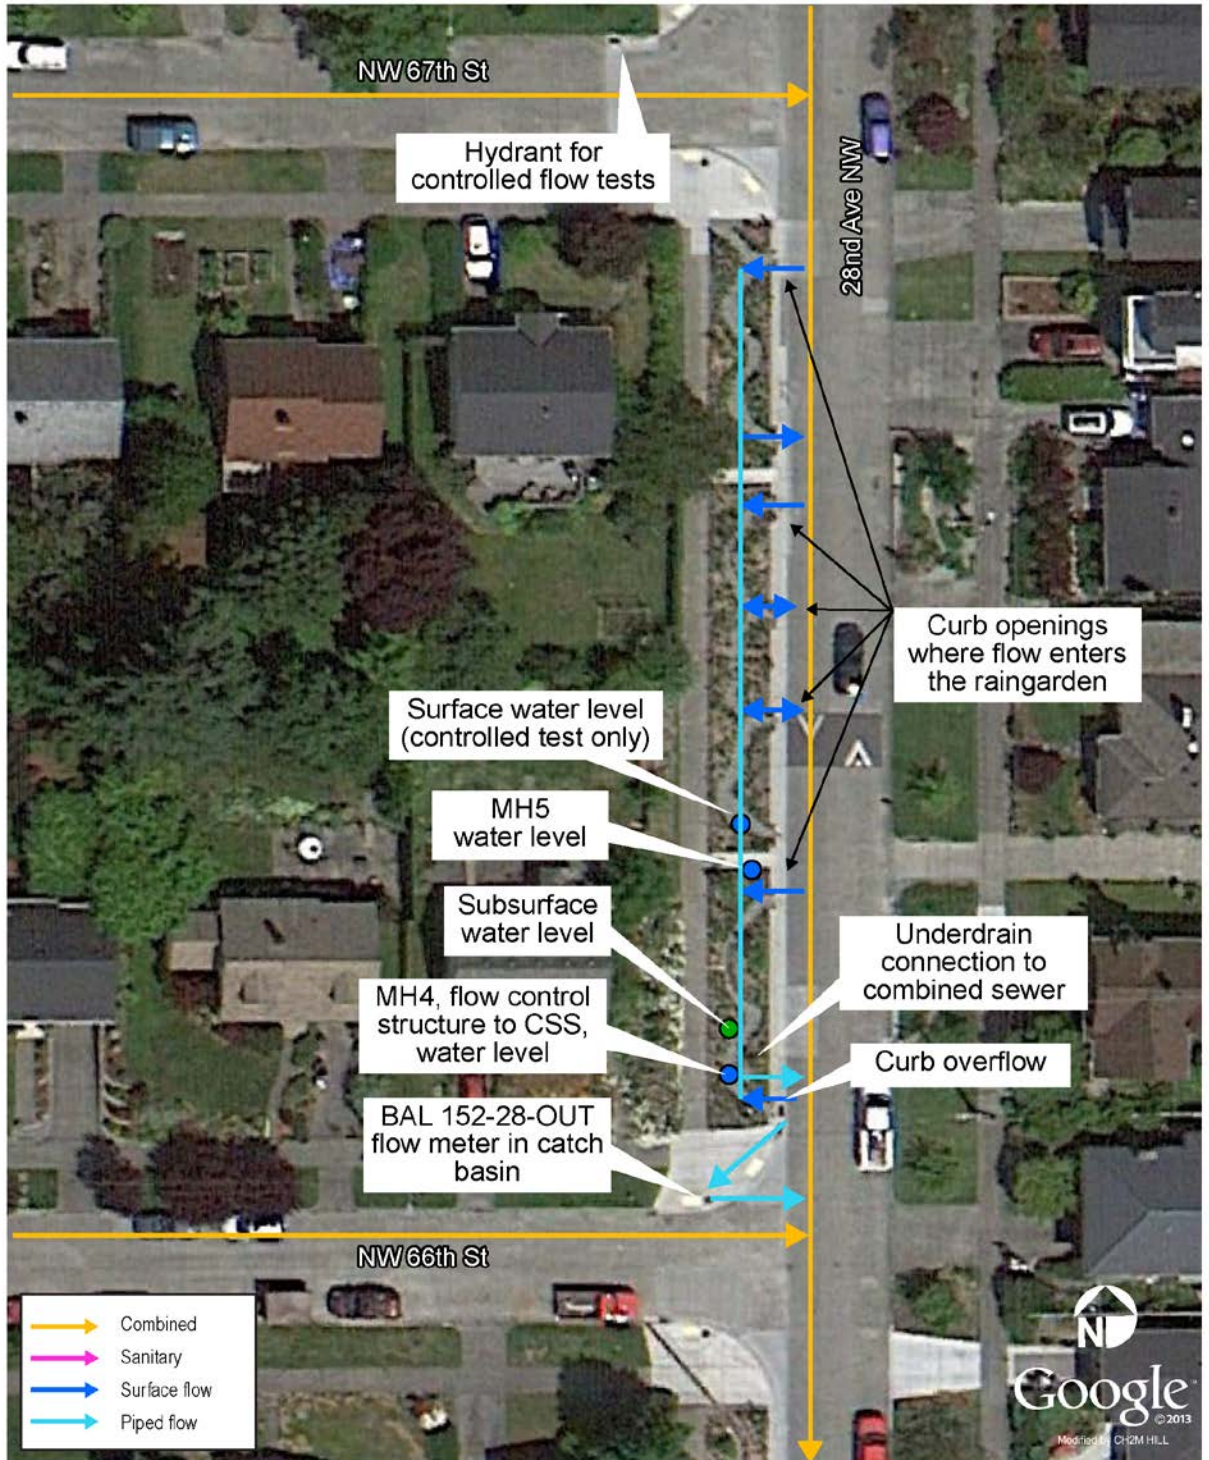
Figure 11. 28th Avenue Raingarden Monitoring Locations

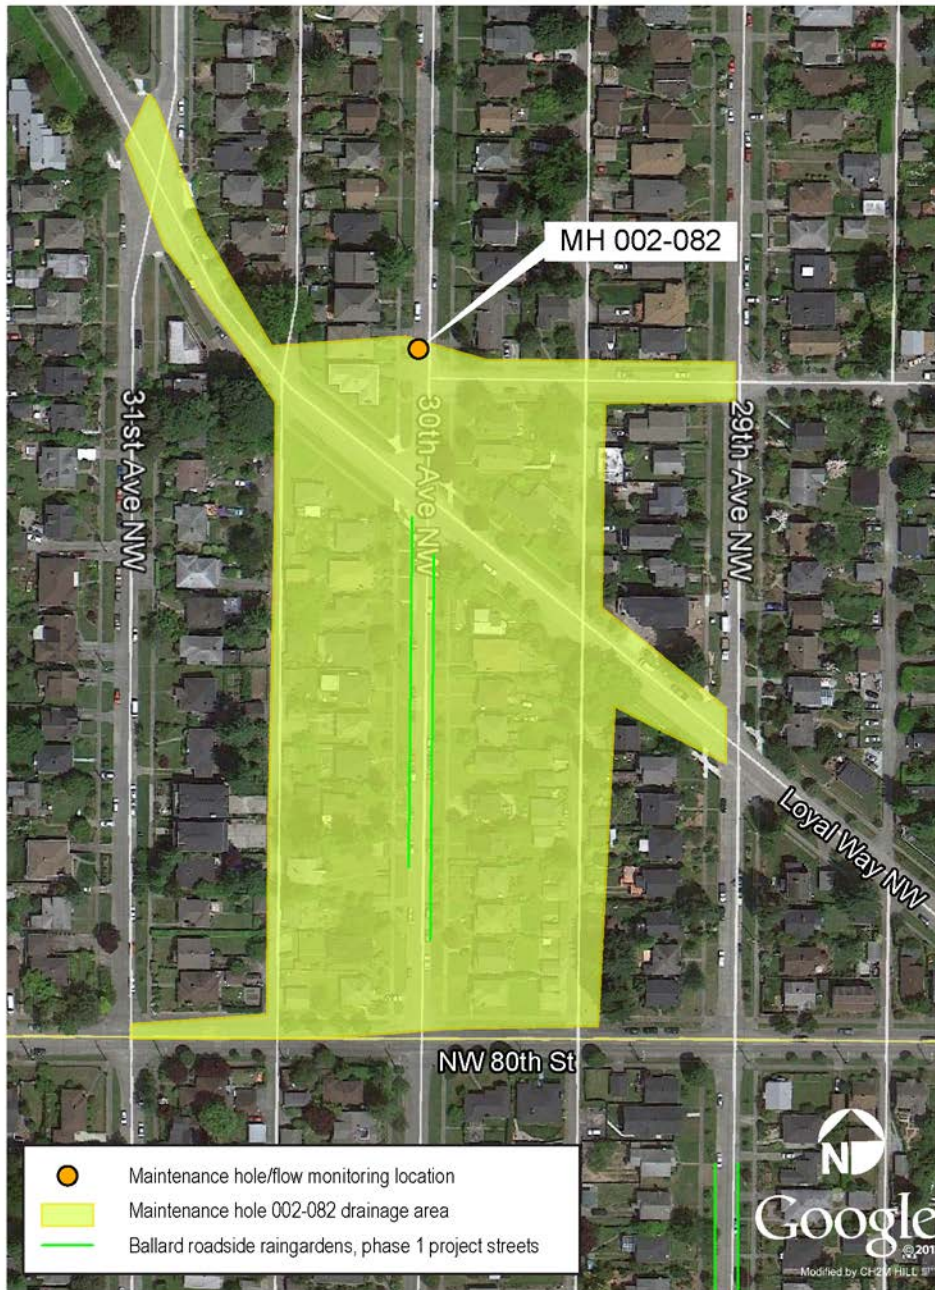
The downstream flow monitor at the 30th Avenue rain garden was in an 8-inch combined sewer immediately upstream of MH 002-082 (in 30th Avenue NW), in the block north of Loyal Way NW. This combined sewer receives both sanitary flow from adjacent residences and stormwater flow from roadway runoff from a basin area much larger than the basin draining to the rain garden. See Figure 12 for the entire basin boundary draining to this monitor location.

Figure 12. 30th Avenue Drainage Area to Flow Monitor in MH 002-082

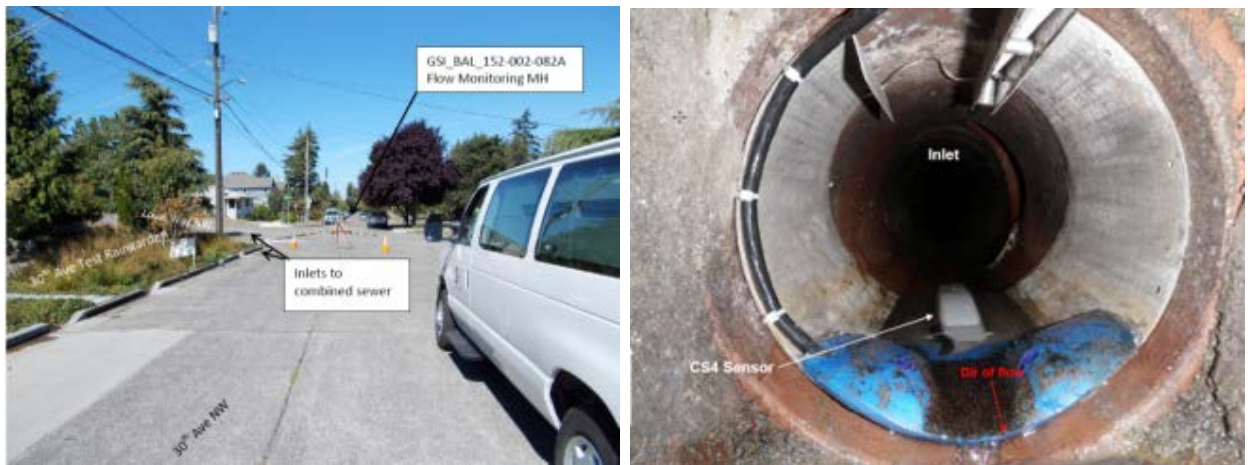
Due to expected low-level conditions, a low-flow dam (custom flume) was installed just downstream of the flow-monitoring sensor to back up the water level to a minimum depth of approximately 1 inch to improve the accuracy of the water level and velocity data. Level and velocity readings upstream of the low-flow dam were measured with an area-velocity sensor consisting of a submerged pressure transducer and a Doppler velocity sensor. Flow was calculated by multiplying area by velocity. See Figures 13a and 13b, respectively, for an area view and a close up of this monitoring station (GSI_BAL_152-002-082A).

Figures 13a and b. Overview and Close up Photo of Flow Monitoring Location GSI_BAL152-002-082A

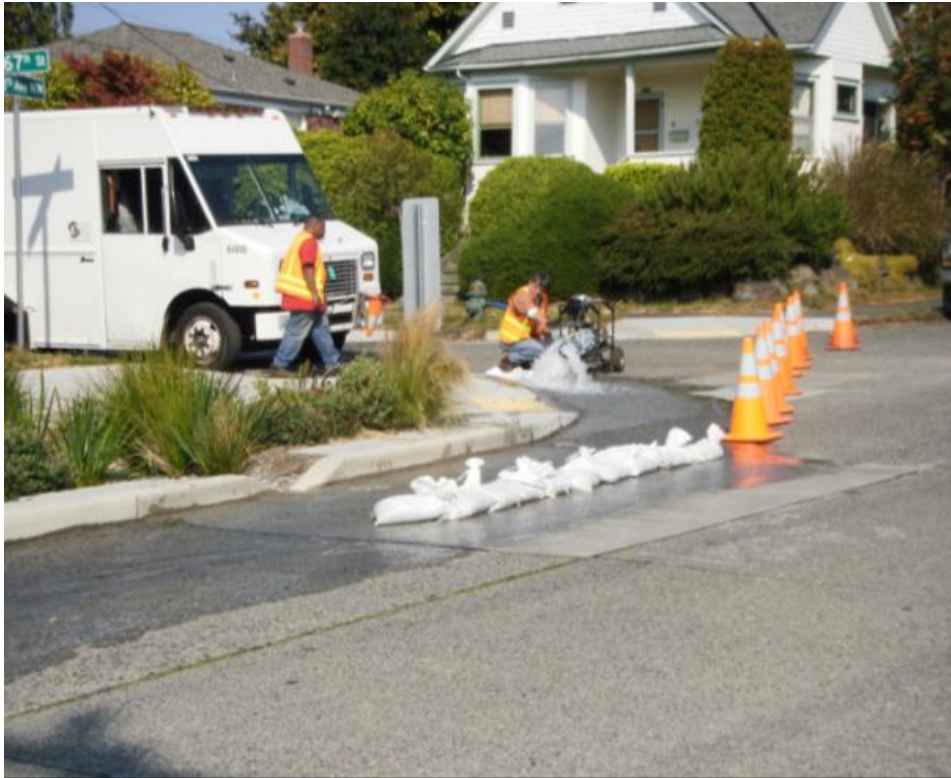
Figure 18. Controlled Flow Testing on 28th Avenue NW at NW 67th Street

Flow rates were controlled by throttling valves on the meter. Application rates were adjusted at predetermined times and rates based on the design storm rates. Water flowing through the meter causes a rotor with an attached magnet to turn, and the magnetic force is converted to velocity, or the speed of the flow. The velocity is multiplied by the known, constant area of the meter's channel to calculate the flow. The time and actual flow achieved was manually recorded for each change in rate and the inflow rate and volume was calculated from these recordings.

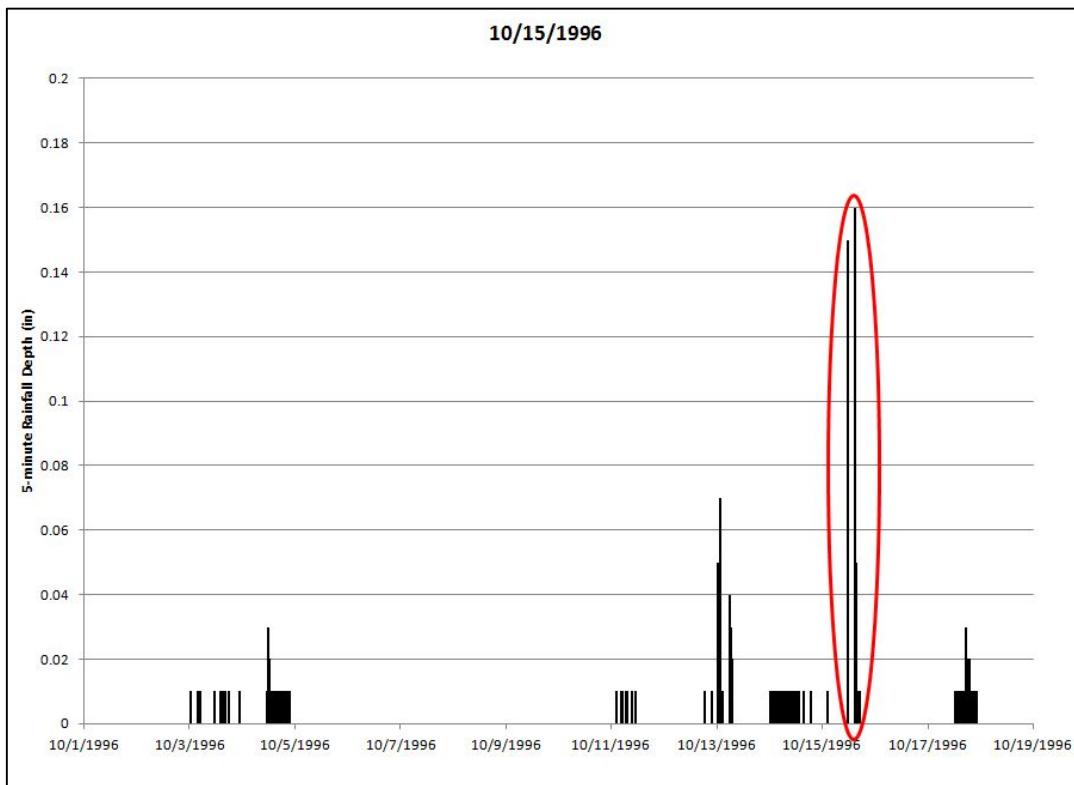
Figure 19. October 15, 1996, Rainfall Selected for Controlled Flow Tests

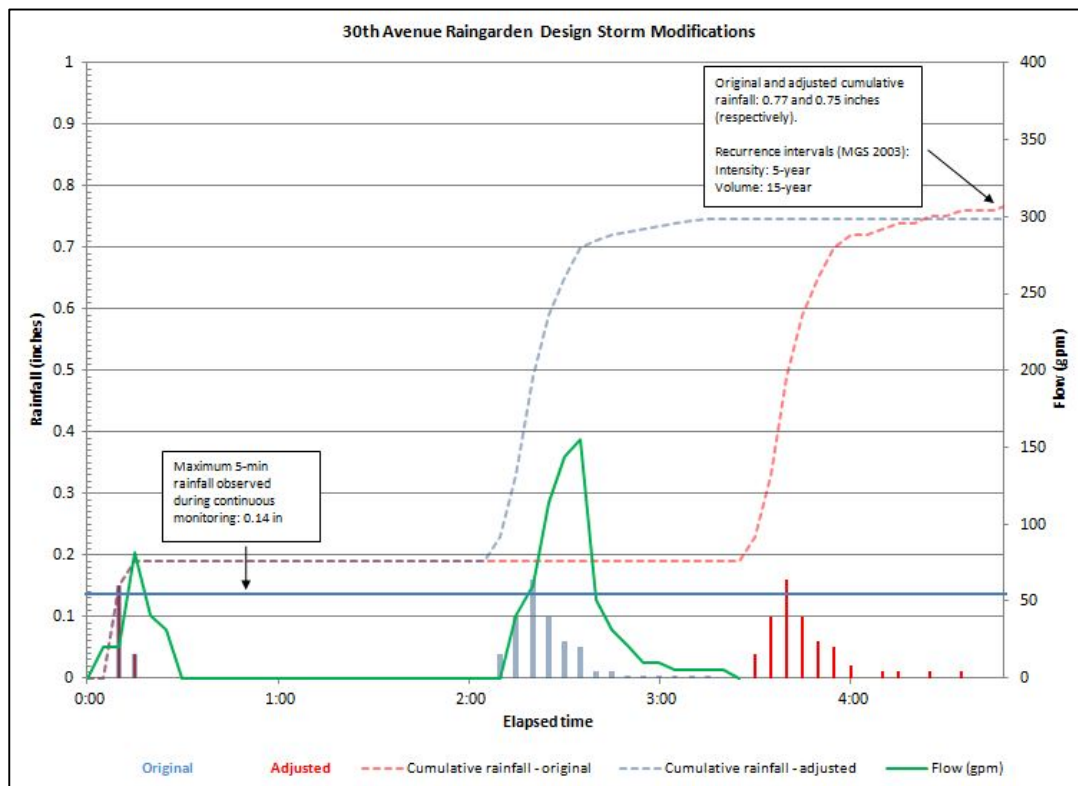
In addition, the original measured rainfall data for this event was flashy in nature and difficult to replicate in the field. Therefore, minor modifications were made to the simulated storm hydrograph to provide smooth flow transitions while maintaining flow volume and duration for each peak of the simulated hydrograph (see Figures 20 and 21). The total design storm volume was 3,092 gallons for the 30th Avenue raingarden and 8,040 gallons for the 28th Avenue raingarden.

Figure 20. Design Storm Modifications for Controlled Flow Test at 30th Avenue

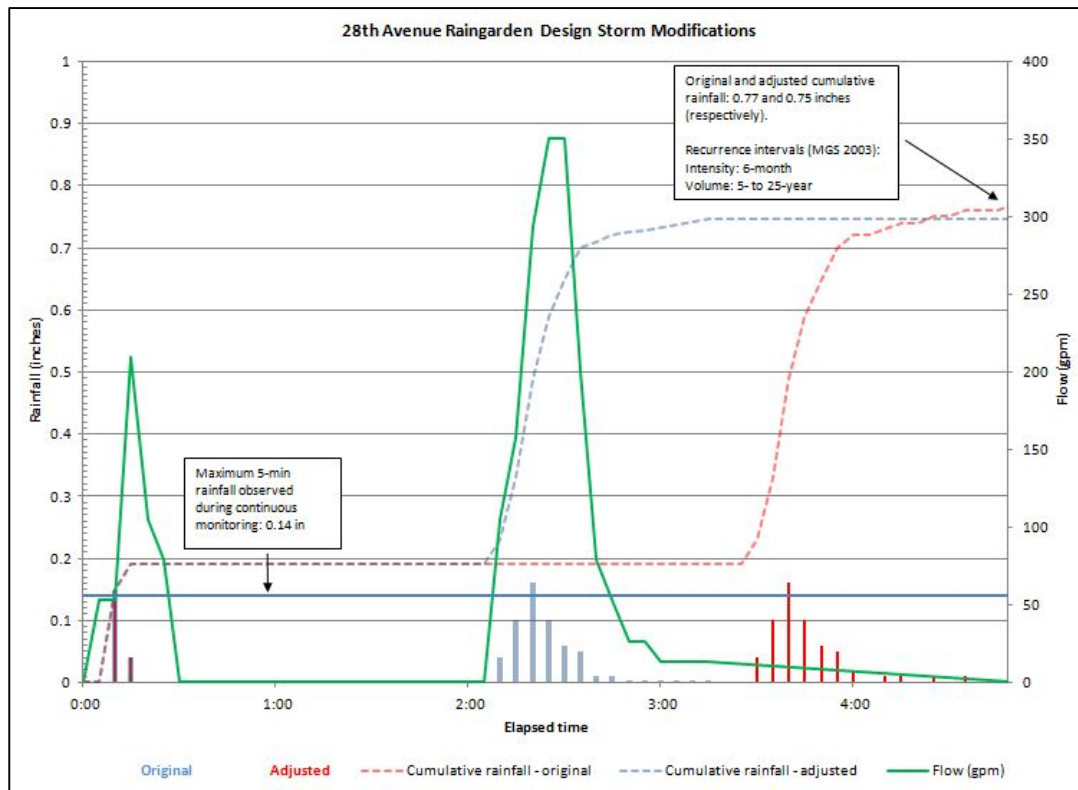
Figure 21. Design Storm Modifications for Controlled Flow Test at 28th Avenue

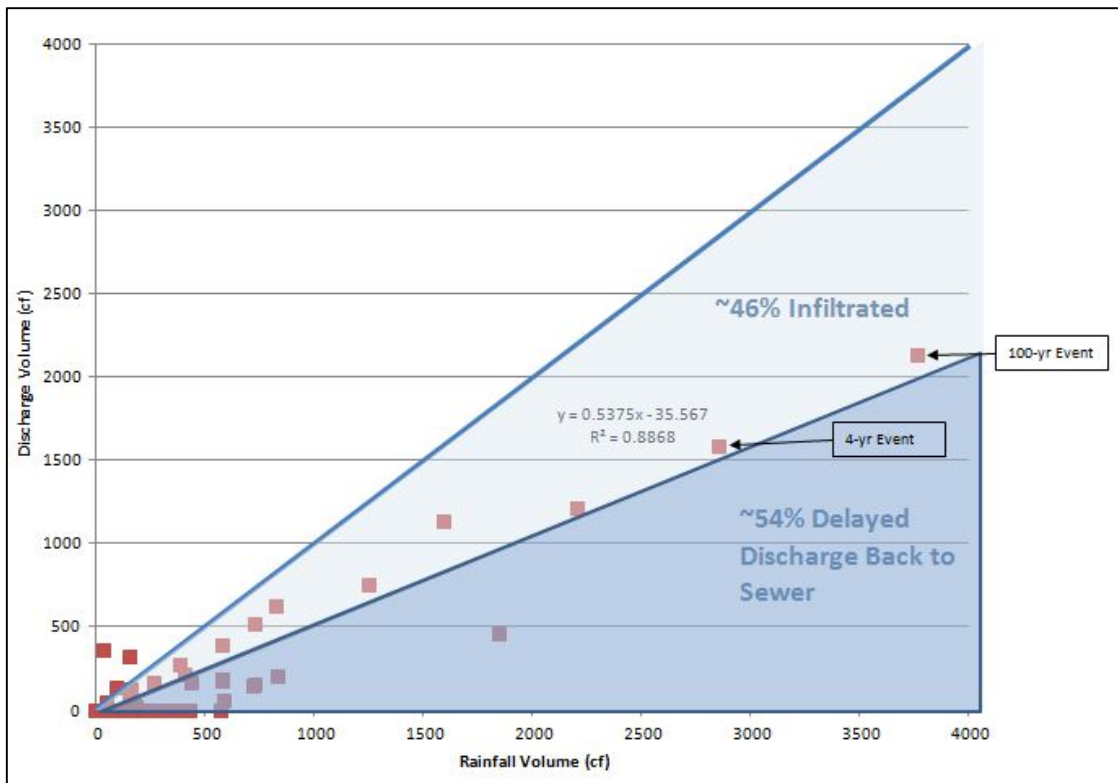
The 28th Avenue raingarden provided peak flow reduction for an average of approximately 54 percent of the inflow (of the 20 storm events of the monitoring period) – see Figures 24 and 25. This peak flow reduction directed storm inflow into the CSS later and at a lower flow rate than would have been seen otherwise, which represents a benefit in terms of potential CSO reduction. The raingarden fully infiltrated the remaining 46 percent, more than was expected from a raingarden with an underdrain to the sewer.

Figure 24. Volume Reduction by Event for the 28th Avenue Raingarden, October 2012 to May 2013

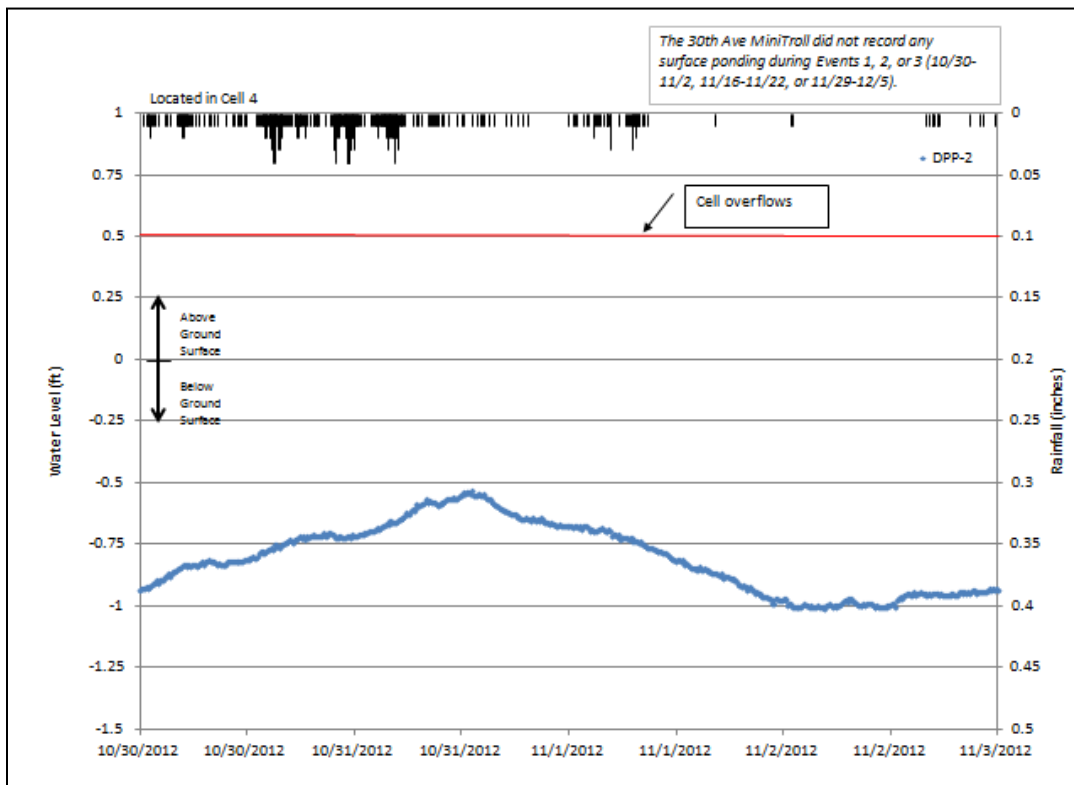
Figure A-6. 30th Avenue Raingarden, October 31, 2012 Storm Water Level (Cell 4)

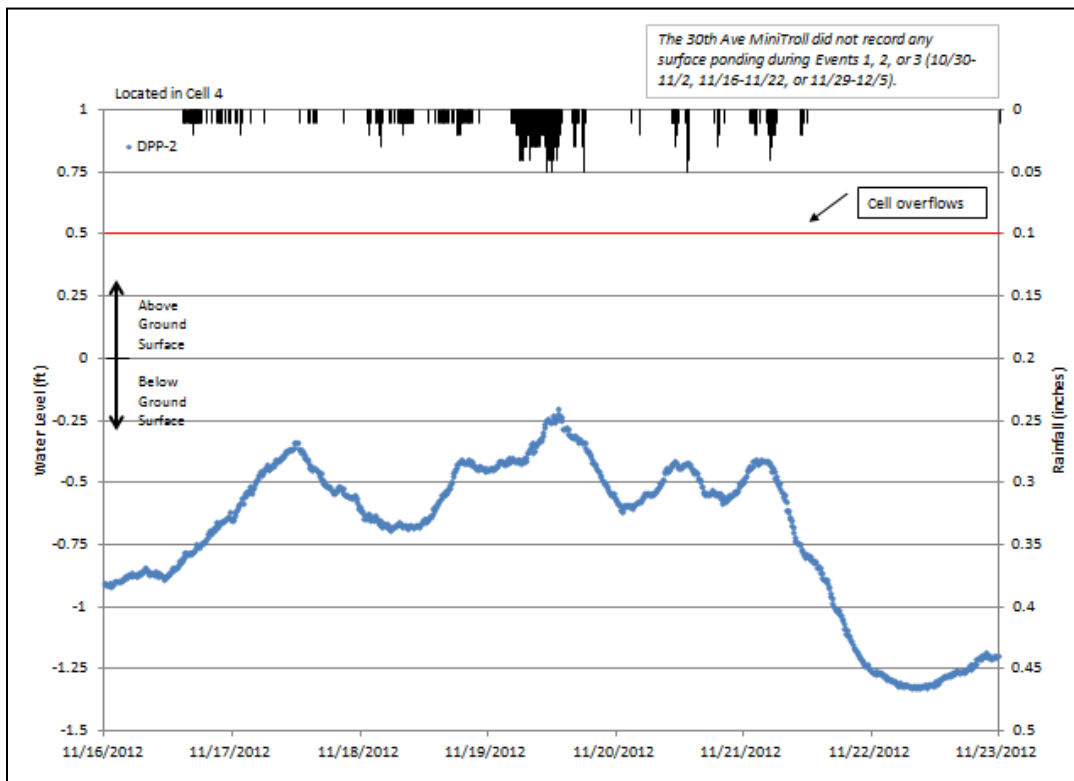
Figure A-8. 30th Avenue Raingarden, November 19, 2012 Storm Water Level (Cell 4)

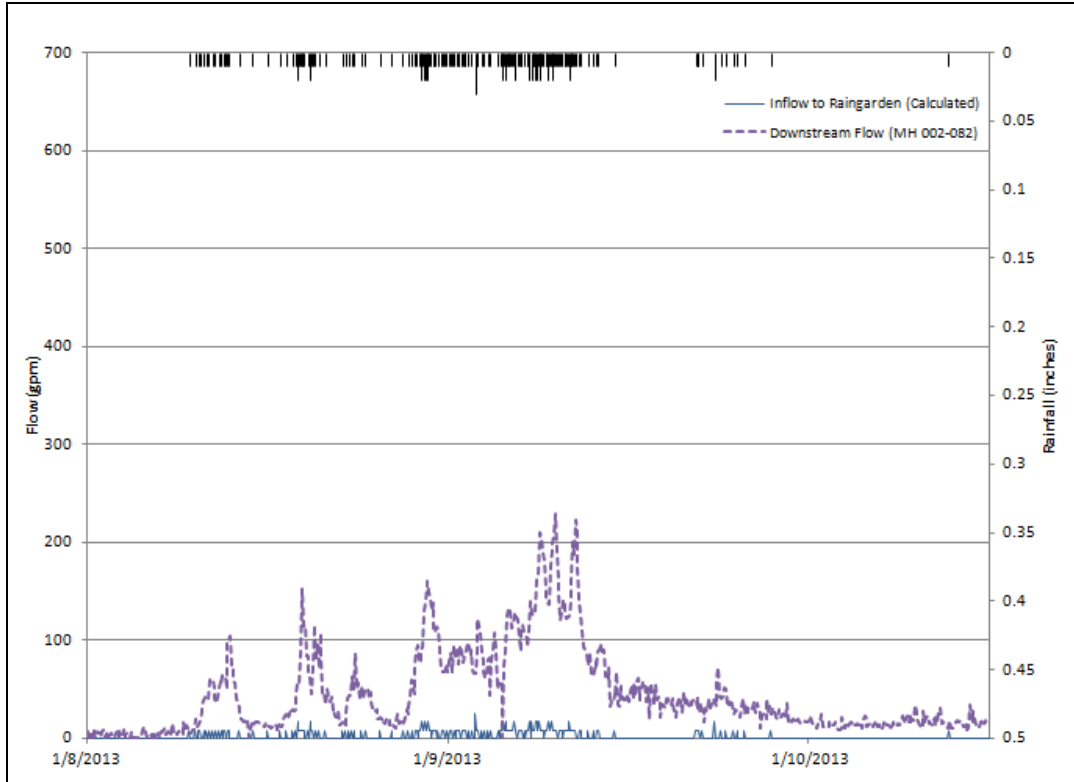
Figure A-13. 30th Avenue Raingarden, January 9, 2013 Storm Hydrograph

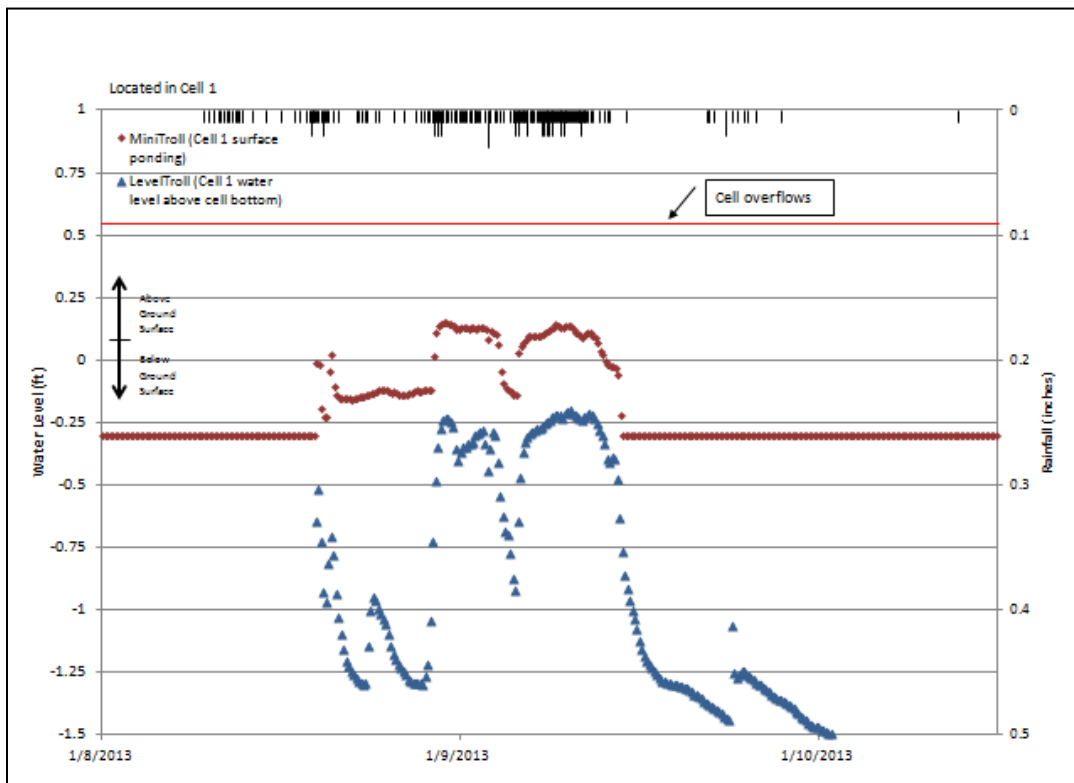
Figure A-14. 30th Avenue Raingarden, January 9, 2013 Storm Water Level (Cell 1)

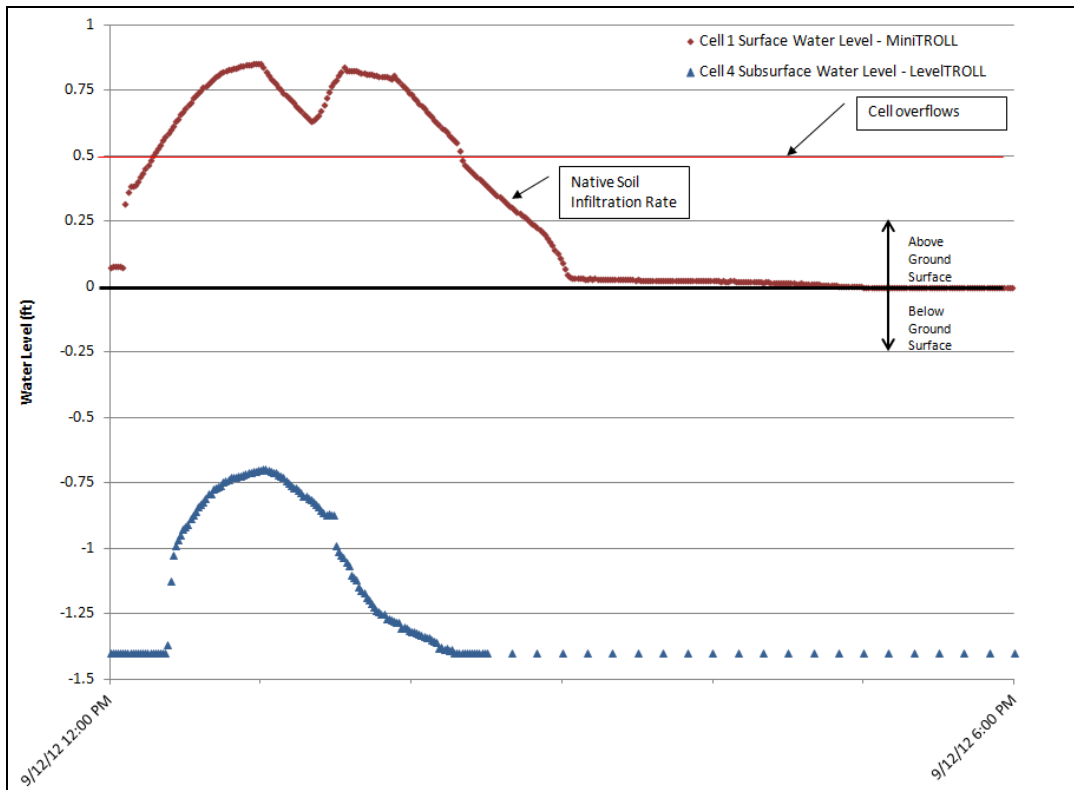
Soil storage volume was measured as the ratio of water level drop measured above the surface of the bioretention soils and measured below the soil surface.

Figure B-15. September 12, 2012 Controlled Flow Test at the 30th Avenue Raingarden – Infiltration

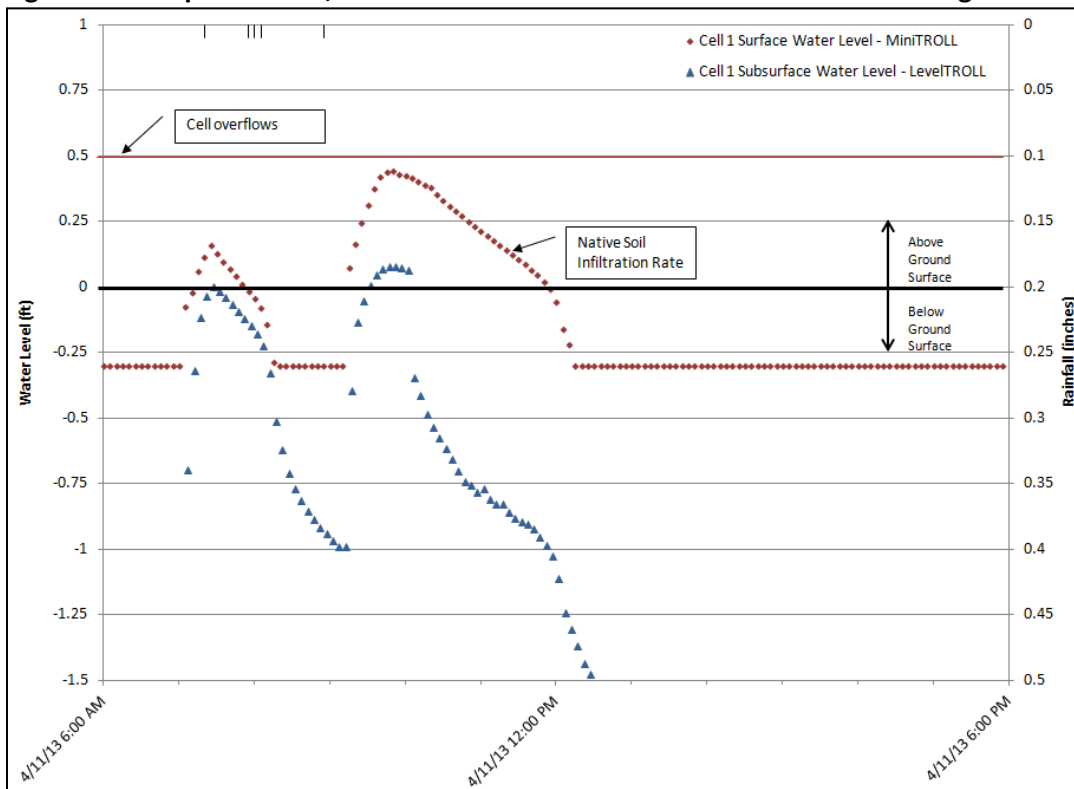
Figure B-16. April 11, 2013 Controlled Flow Test at the 30th Avenue Raingarden – Infiltration

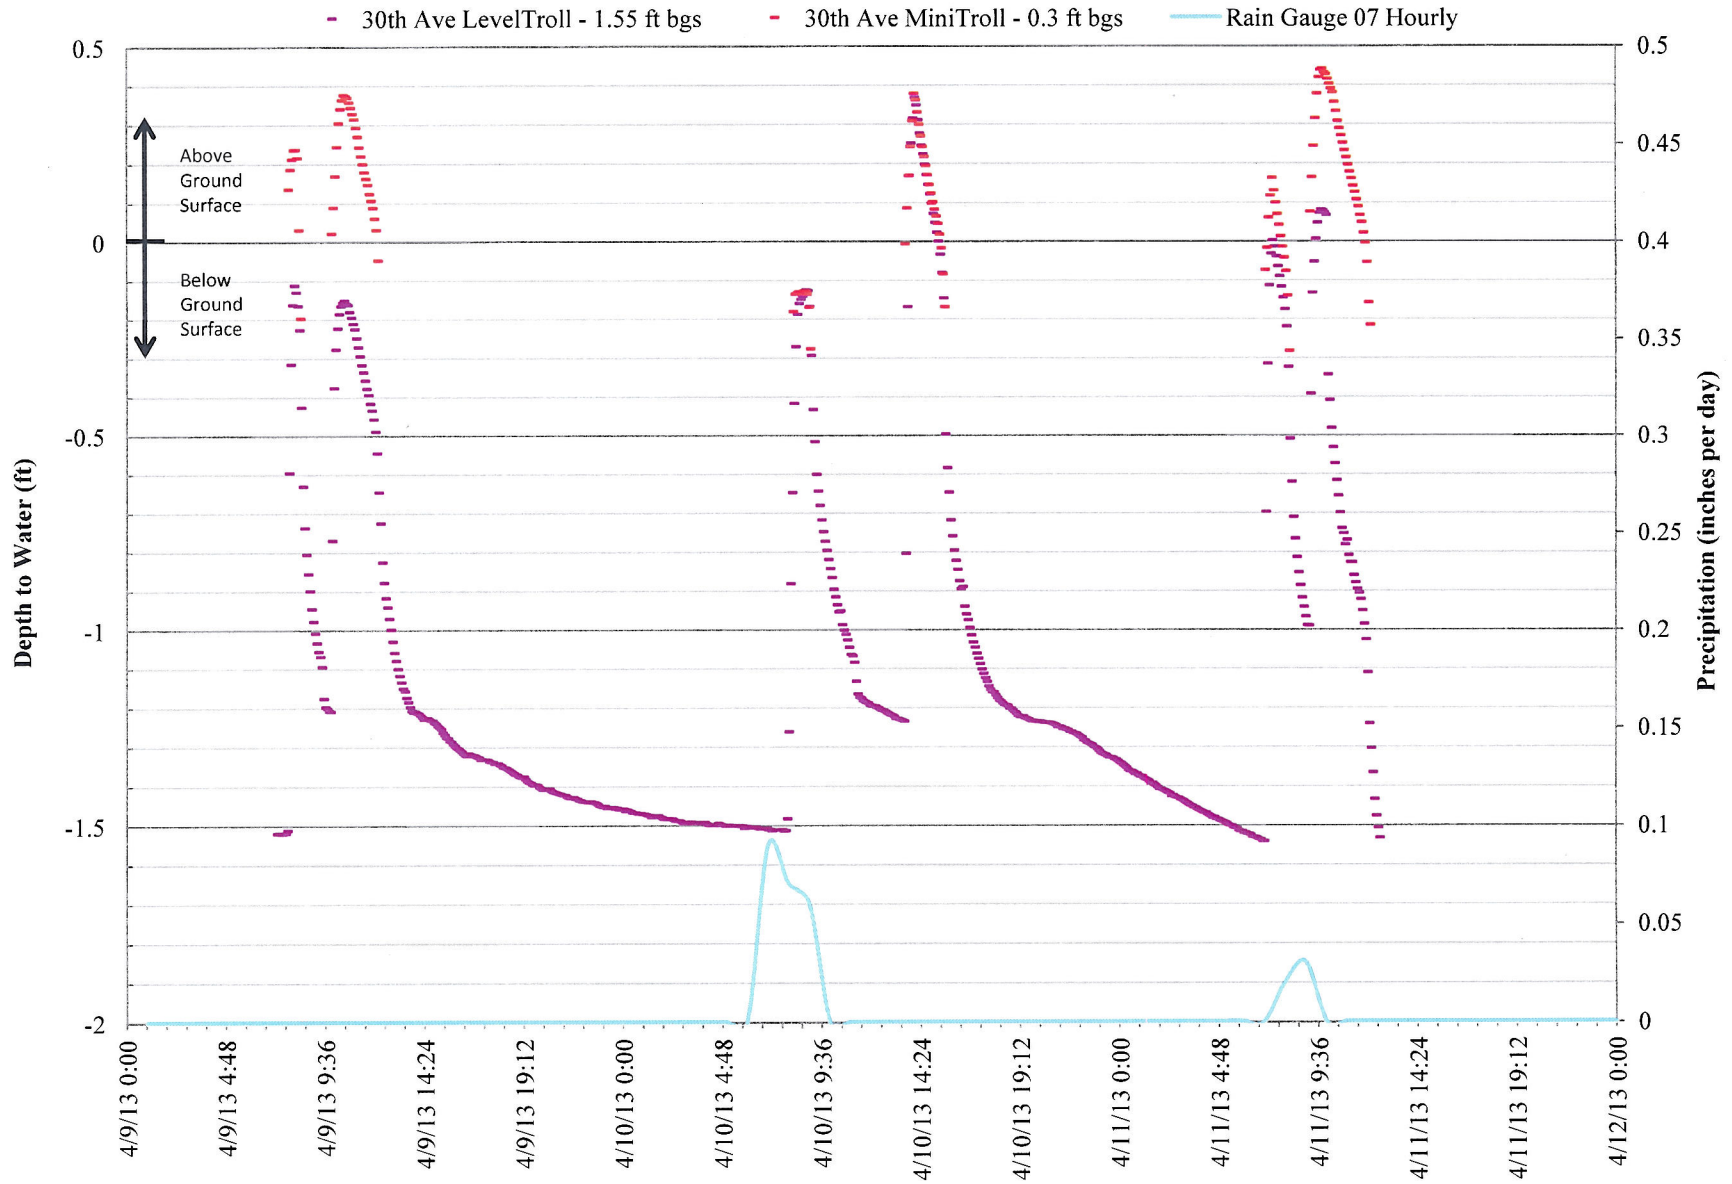
Ballard RRG Flow Testing – Groundwater Response Data 4/9 to 4/11/13 30th Ave NW
