**Map 24**

**Piper's Creek Channel Encroachment**

Produced by the City of Seattle  
June 2007

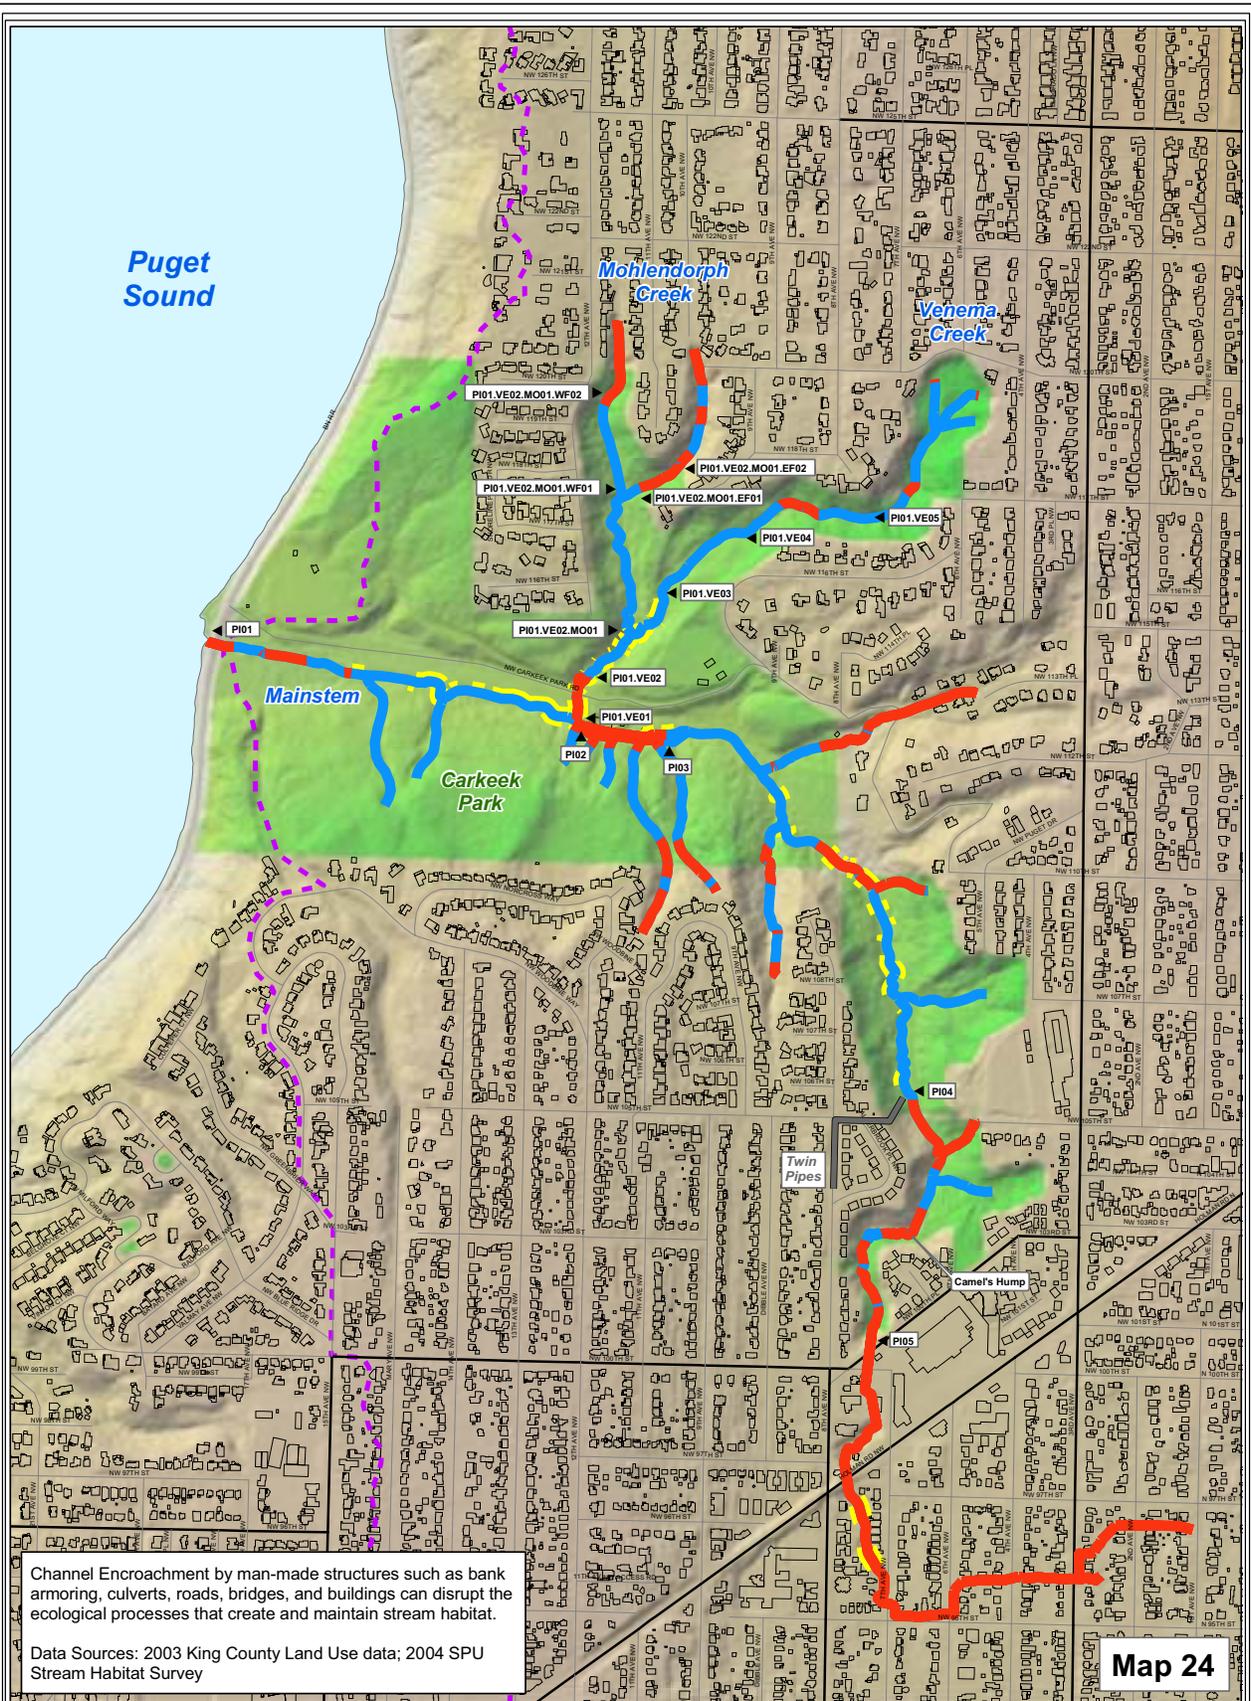
Channel Encroachment by man-made structures such as bank armoring, culverts, roads, bridges, and buildings can disrupt the ecological processes that create and maintain stream habitat.

Data Sources: 2003 King County Land Use data; 2004 SPU Stream Habitat Survey
