**Subject: Phase I Environmental Site Assessment  
South Magnolia CSO Control Project  
Near 2001 West Garfield Street,  
Seattle, WA 98199**

**Phase I Environmental Site Assessment  
South Magnolia CSO Control Project  
Vicinity of 2001 West Garfield Street,  
Seattle, WA 98199**

May 27, 2011  
Kleinfelder Project No.: 119103

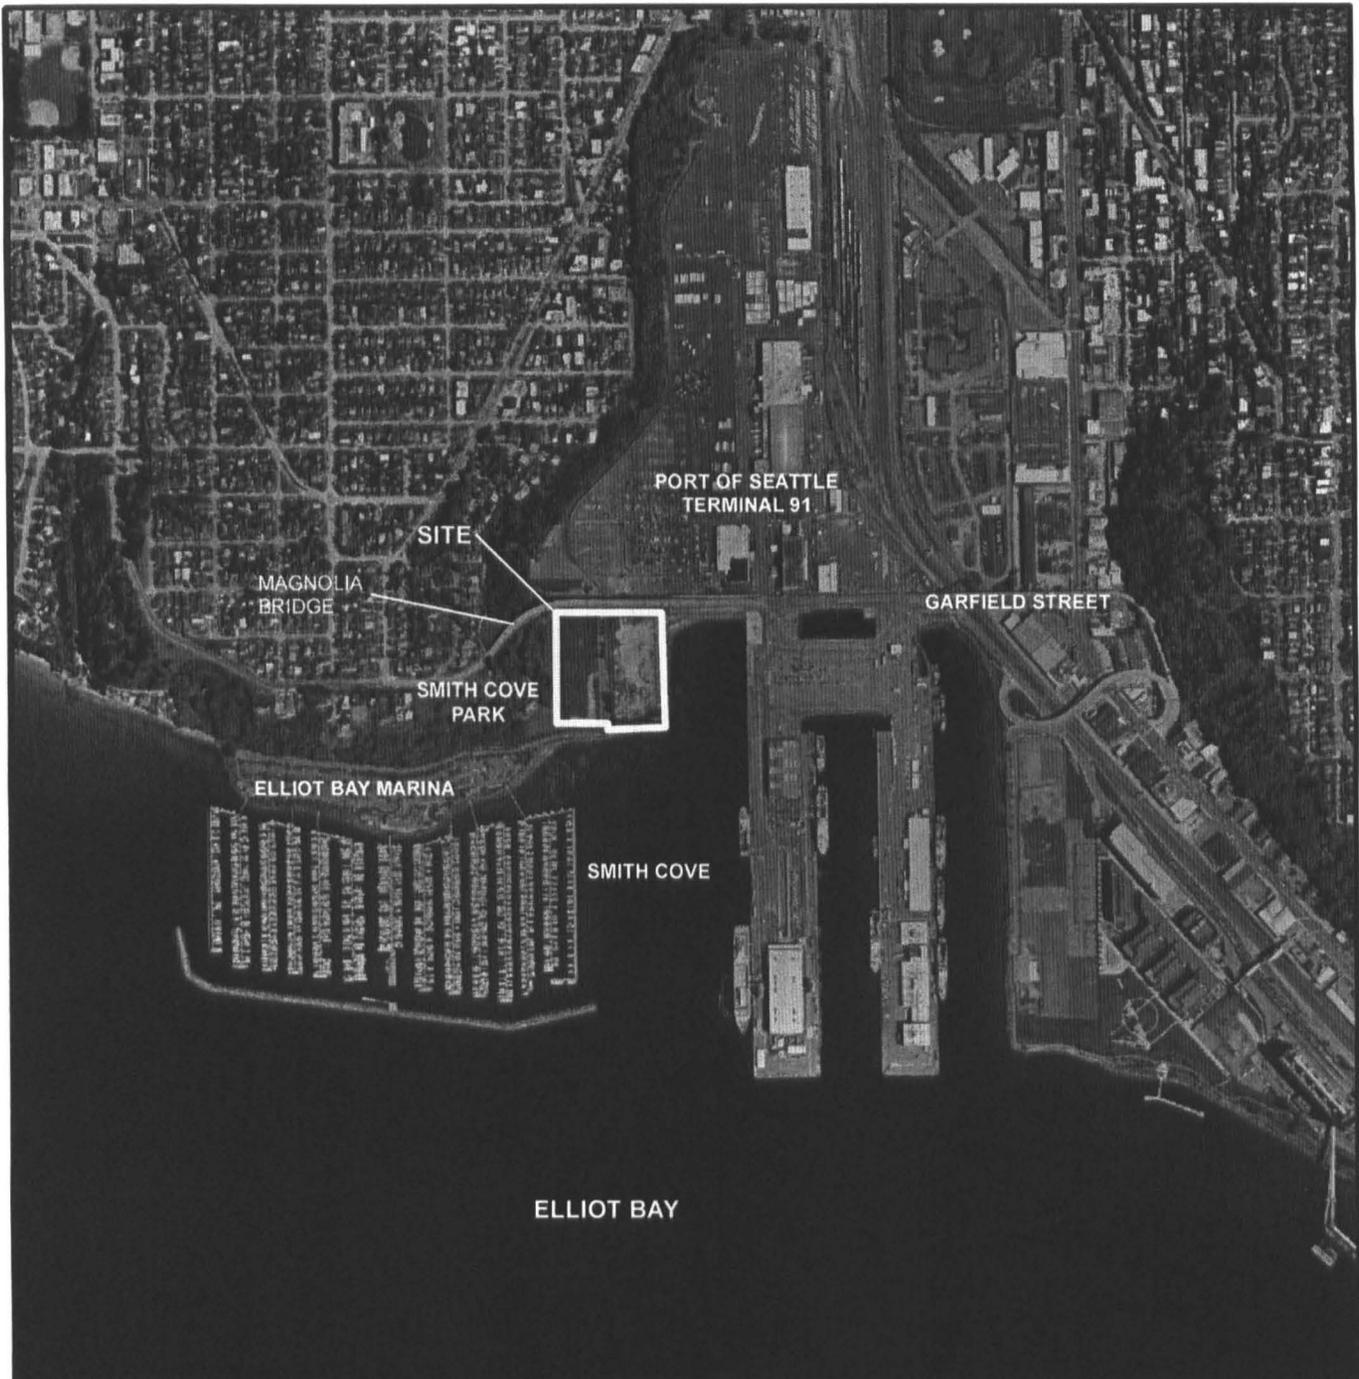
**SITE MAP WITH SURROUNDING PROPERTIES**

PHASE I ENVIRONMENTAL SITE ASSESSMENT  
S. MAGNOLIA CSO CONTROL PROJECT PROPOSED TANK LOCATION  
APPROXIMATELY 2001 WEST GARFIELD  
SEATTLE, WASHINGTON 98199

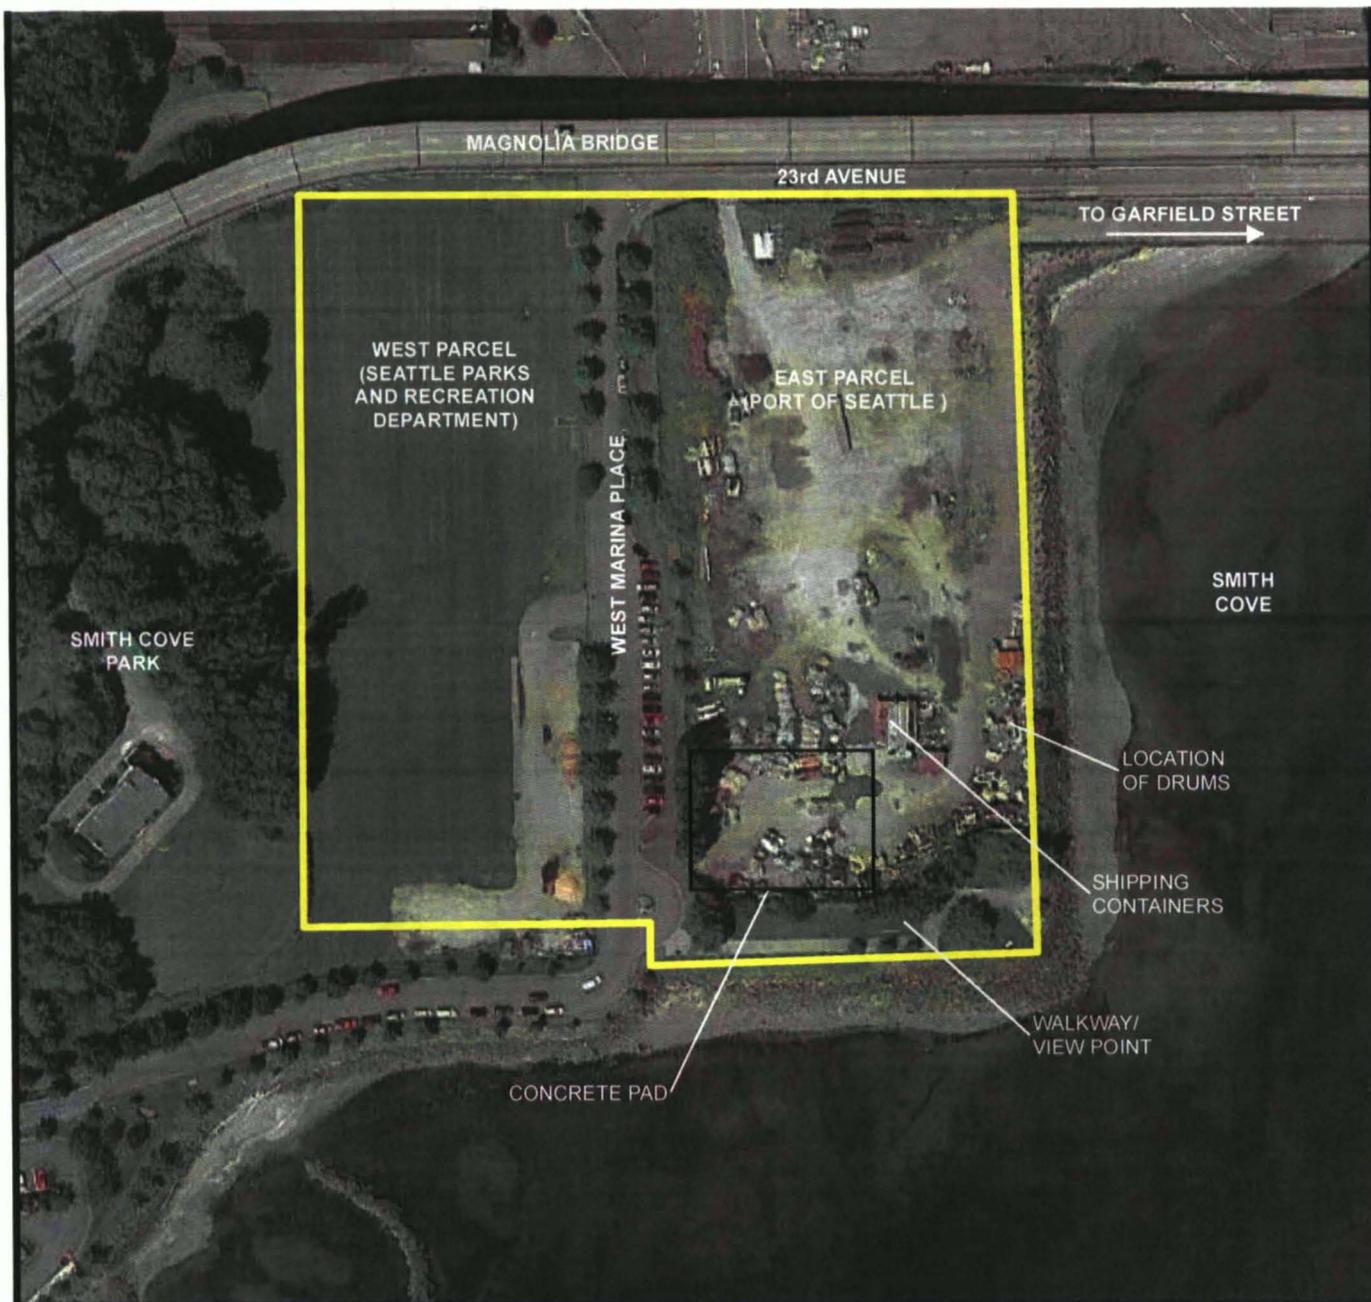
The east parcel of the Subject site consists of a fenced lot and an approximately 0.5-acre landscaped walkway/viewpoint area at the southern end of the property, which is open to the public. The fenced lot is currently utilized for miscellaneous storage. Several large shipping containers, miscellaneous equipment including an air compressor, fishing nets, small boats, metal parts, etc., one small propane tank, and some 55-gallon drums (see paragraphs below) were observed in the eastern portion of the subject site. A soil pile of about 2,000 cubic yards is located in the northwest corner of the parcel. The lot is a combination of paved areas, gravel areas, and a concrete section. No buildings were observed on the east parcel.

Several 55-gallon drums were observed at the east parcel. One 55-gallon drum was labeled as "DTE 797 Oil" (equipment lubricant oil) and one 55-gallon drum was labeled as "Beilge Water." These drums were steel and stored on wooden pallets. The "DTE 797 Oil" drum was rusted around the bottom, however, no readily observable staining or leaking was observed. Six additional plastic 55-gallon drums with "Dimethylpolysiloxane Defoamer" were also apparent. One small propane tank was also observed. No spills, staining, or other visible signs of hazardous materials release were noted at the Subject site.

- Poor housekeeping combined with the presence of several 55-gallon drums labeled as containing potentially hazardous material and stock piled soil impacted our ability to visually assess portions of the Subject site. Once the stored materials, equipment and supplies are removed from the subject site, the Subject site should be visually assessed for staining, distressed vegetation and other indicators of the release of hazardous substances.
