CITY OF SEATTLE

JANUARY 2010

# Shoreline Characterization Report

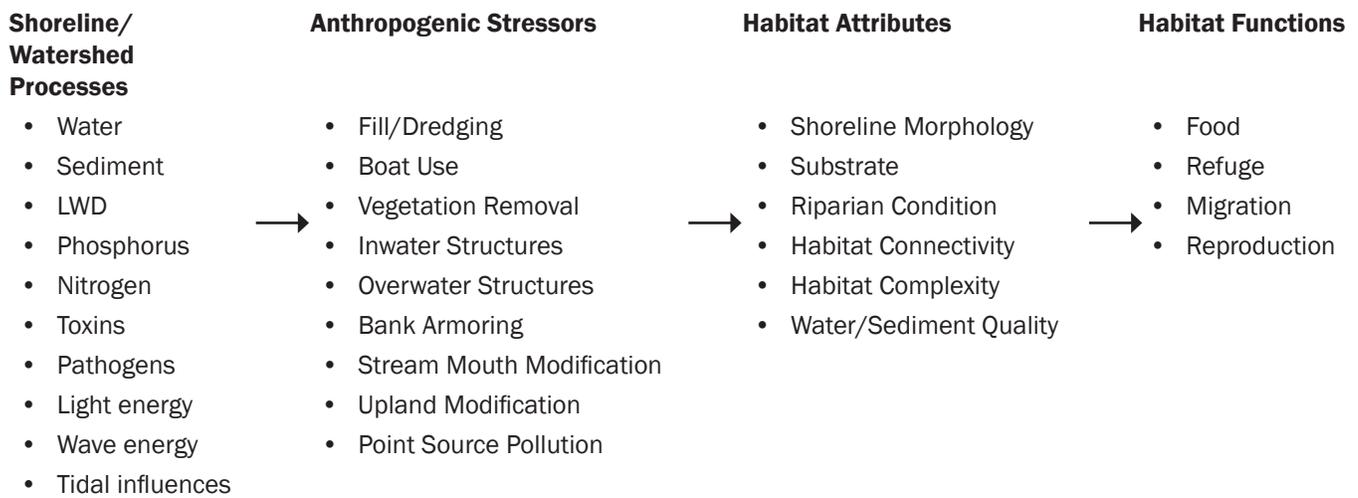
Figure 2-1: Conceptual Model of Watershed Processes, Stressors, and Habitat

The type and functional quality of aquatic habitats result from the interaction of physical, chemical, and biological processes that occur in both the aquatic system and adjacent watershed (Naiman et al. 1995). In the Washington State Department of Ecology’s (Ecology’s) Guide to Watershed Planners to Understand Watershed Processes (Stanley et al. 2005), the authors use the term watershed processes to refer to “the dynamic physical and chemical interactions that form and maintain the landscape at the geographic scales of watersheds to basins (hundreds to thousands of square miles).” These processes and their natural controls and human-caused (anthropogenic) stressors combine to create, maintain, or destroy habitat. The resulting changes in habitat attributes also impact the functions that the habitat supports for organisms. Therefore, the distribution and behavior of plants and animals are a response to the watershed processes that occur and the structure of habitat that is created. This is illustrated in a simple conceptual model as shown in Figure 2-1.

There are numerous human-caused stressors that impact these watershed processes. These can range from stressors with a site-specific effect, such as overwater structures, to those that cover a large area, such as irrigation water withdrawals. In addition, the impacts of various stressors depend on which stressor it is; for example, overwater structures have impacts to water and sediment quality as well as sediment delivery and wave energy. Table 2-1 provides an overview of human-caused stressors that may occur in lake, marine, and estuarine watersheds, and summarizes (by watershed process) the mechanisms by which stressors act on processes.

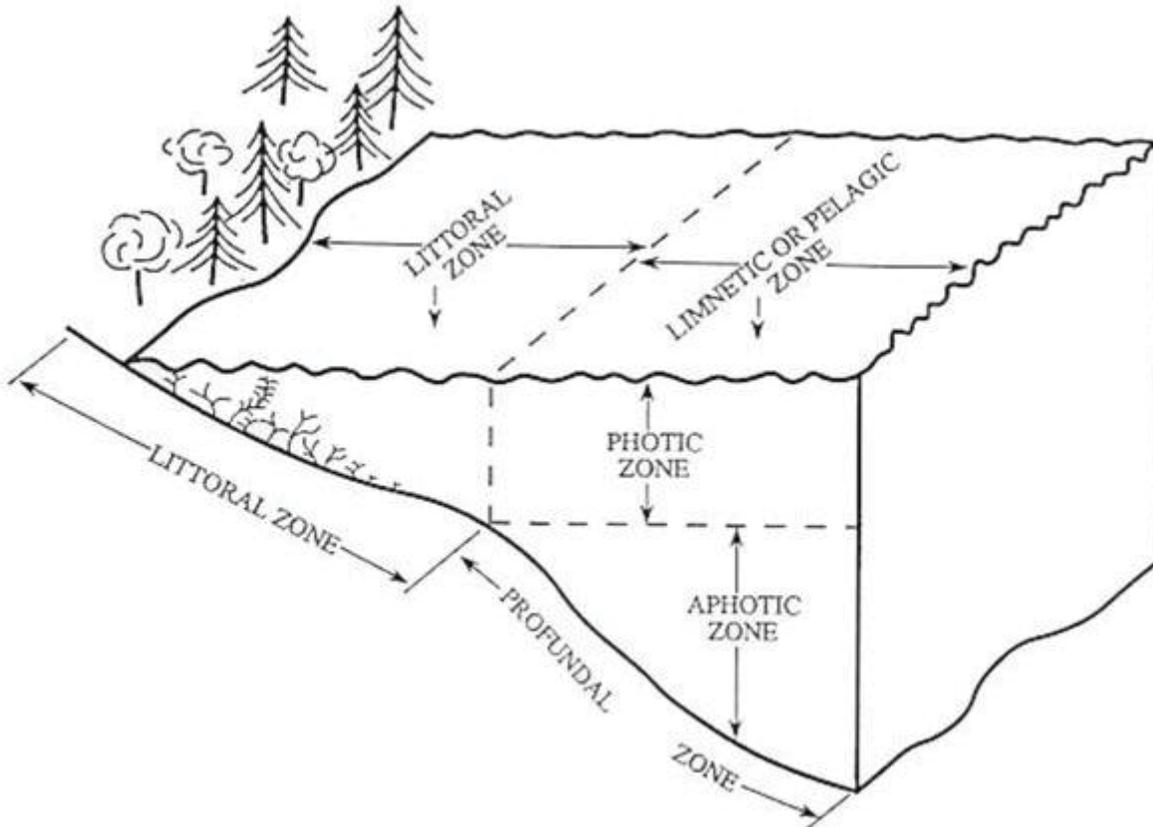
Figure 2-2: Lake Structure Zones

Aquatic scientists divide lake habitat into several zones, each with unique features: littoral, benthic, and pelagic (also called limonitic) zones (Figure 2-2). Littoral zones are those within the shallow area of the lake, adjacent to and associated with the lake shoreline. The littoral zone extends out from the shoreline and encompasses the shoreline region between the highest seasonal water level and the lowest elevation of submerged rooted or attached aquatic plants (Wetzel 1983). The lowest extent of growth by submerged aquatic plants typically occurs at a depth where light is low enough to dramatically reduce photosynthesis (Wetzel 1983; Schindler and Schuerell 2002), but it is important to note that the depth at which light penetrates water is variable depending on several factors (e.g., turbidity and phytoplankton densities).

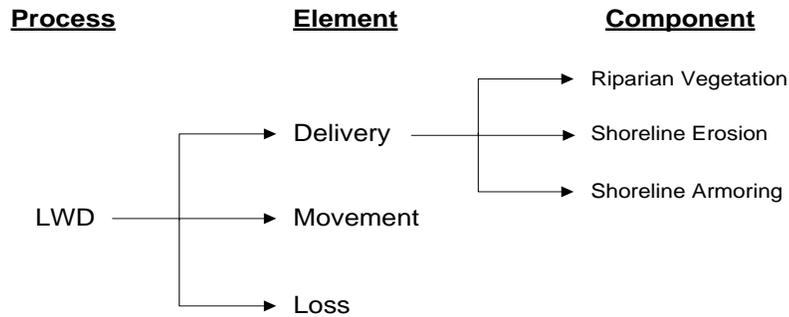
Figure 3-1: Example of the Relationship Between Processes, Elements, and Components

The second step of the analysis was to score processes within each pixel using indicators of the degree and effect of change from an undeveloped condition. Using information from the scientific literature and professional judgment, and following the approach of Stanley et al (2005), a scoring system was developed to assess the condition of each process based on the presence or absence of shoreline alterations known to impair the process. The scoring system included scoring up to three elements (delivery, movement, and loss) of each process, with each element typically separated into multiple components (Figure 3-1). Pixels were initially rated independently, and then combined to form a shoreline reach. The model scoring system is described below and more detailed information on the ecosystem processes, elements, and component scoring is provided in Appendix B.

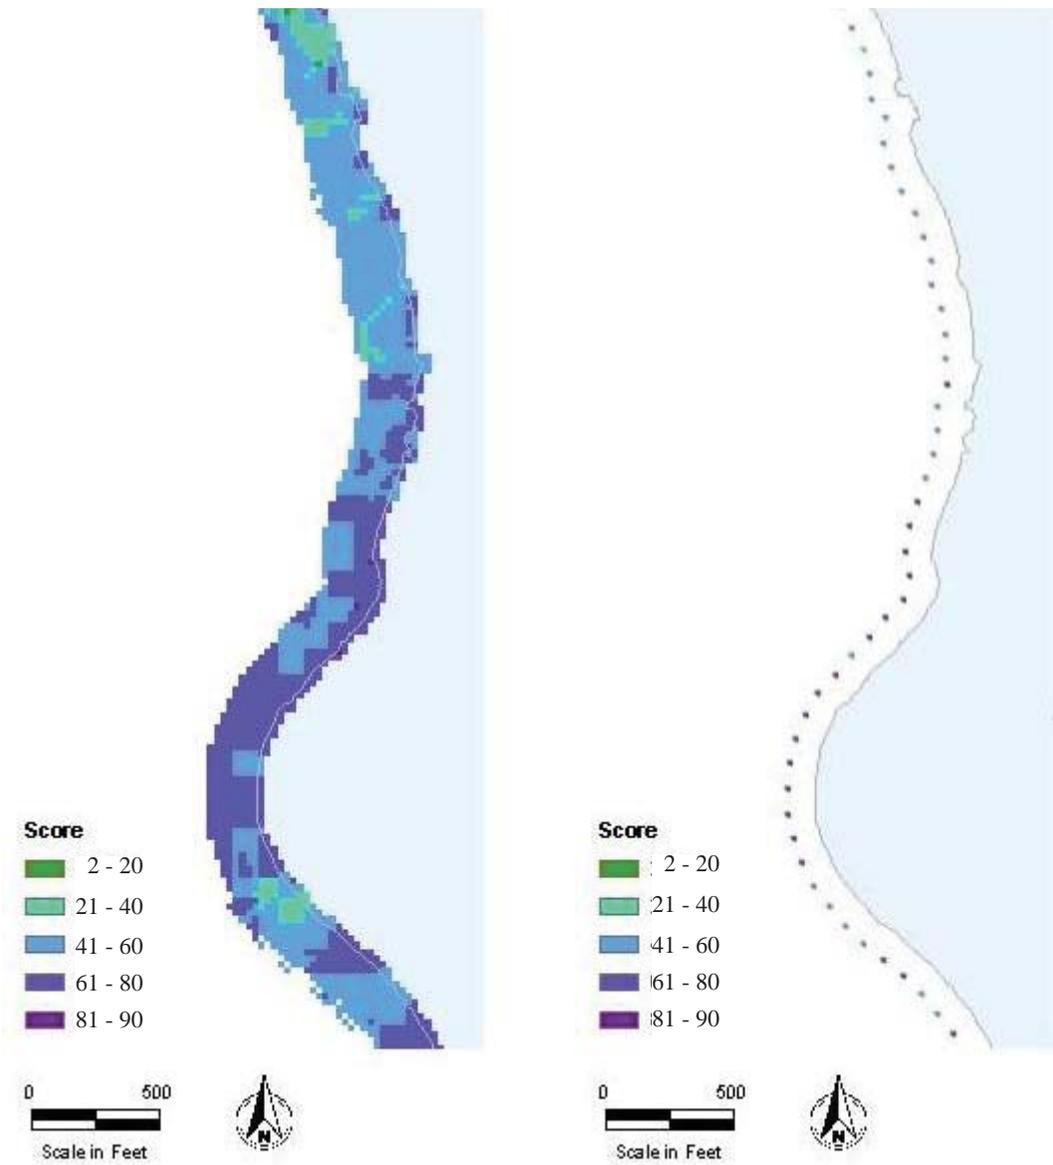
Figure 3-2: Original Gridded Data (left) and Simplified Point Data at 100-foot Intervals Along the Shoreline (right)

were also given a distance (station) along the shoreline from an arbitrary start point. The data were then plotted on a graph with distance on the x-axis and the aggregated score on the y-axis. From this graph, sub-reach break points were manually determined using the criteria described above and based on best professional judgment (Figure 3-3). For presentation in the results chapter, sub-reaches were grouped together to form reaches. Reach breaks were determined based on a transition in shoreline habitat condition or a change based on land use (e.g., include a park in one reach) or ecosystem (e.g., separate freshwater from marine).

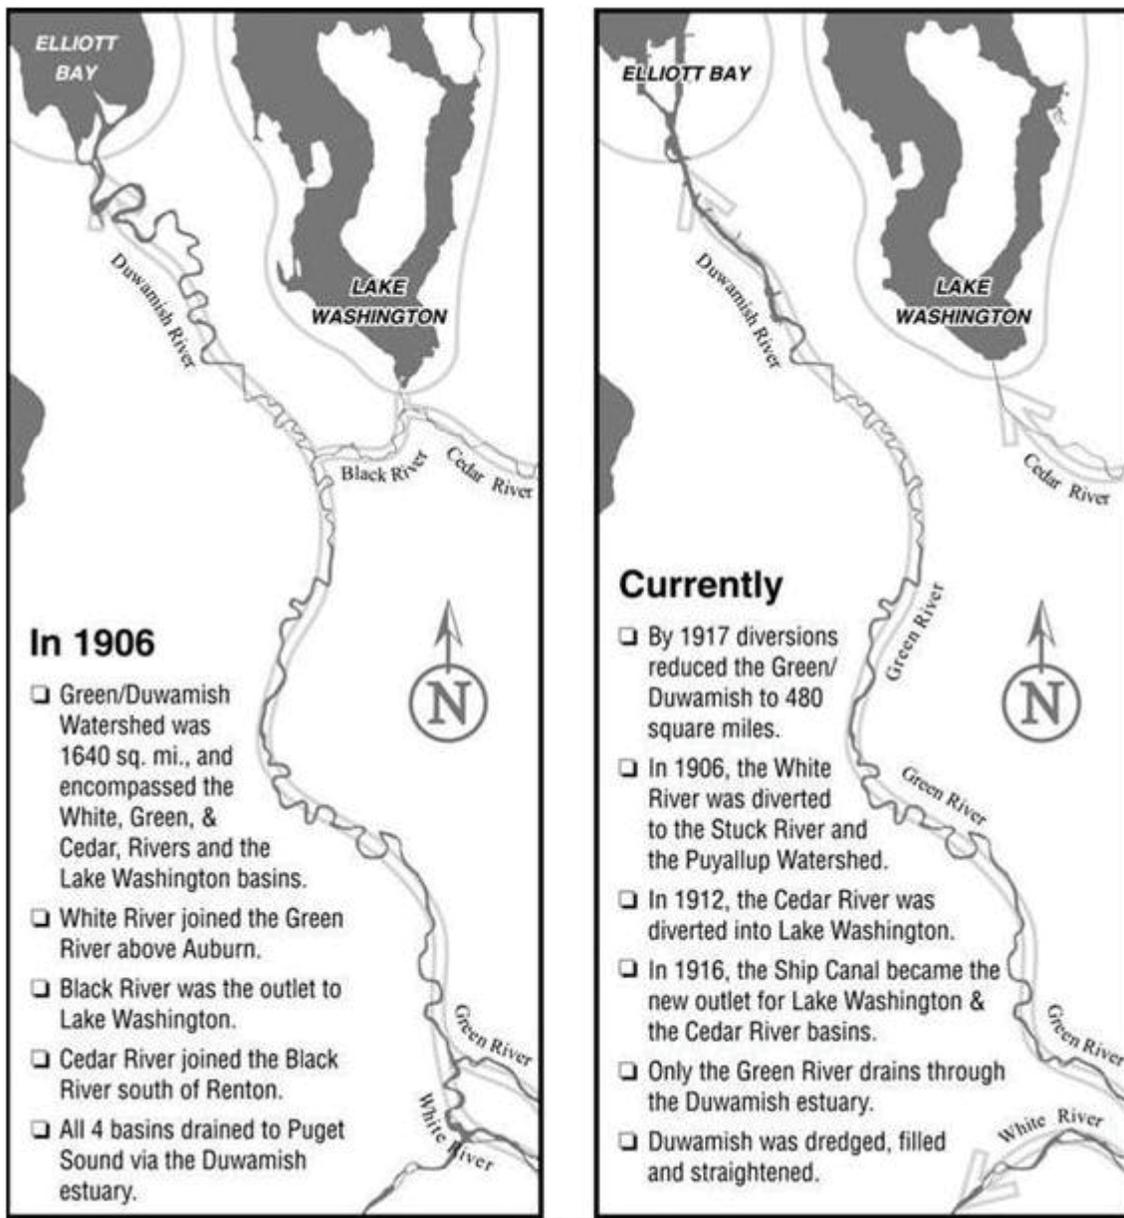
Figure 4-1: Lake Washington Drainage Basin Before and After 1917

As the Ship Canal was built, the Cedar River was diverted into southern Lake Washington (Figure 4-1). This aided in flood reduction in the City of Renton at the south end of the lake, but the historical outlet of the lake, the Black River, effectively dried up. When lock construction was completed, the water level in Lake Washington dropped about 10 feet, resulting in the exposure of 1,330 acres of previous shallow water habitat, a 7 percent reduction in the lake's surface area, a 12.8 percent reduction in the lake shoreline length, and the elimination of most of the shoreline wetlands (Chrzastowski 1983). This rerouting also changed the configuration of tributary confluences with the lake. Other associated marsh habitats, such as those of the Black River in the south and the Sammamish River in the north, were also eliminated.

Changes to the Lake Washington basin substantially altered the frequency and size of floods. Historically, lake elevations peaked in winter and declined in summer. In 1903, the average lake elevation was about 32 feet. Today, lake elevation peaks at 22 feet in May and reaches its lowest level, 20 feet, in December. Water is regulated at the Ballard Locks to keep seasonal fluctuations to within 2 feet annually (SPU and USACE 2008). The U.S. Army Corps of Engineers (USACE) regulates the lake level based on lake level forecasts and measurement and projected demand for its operations.

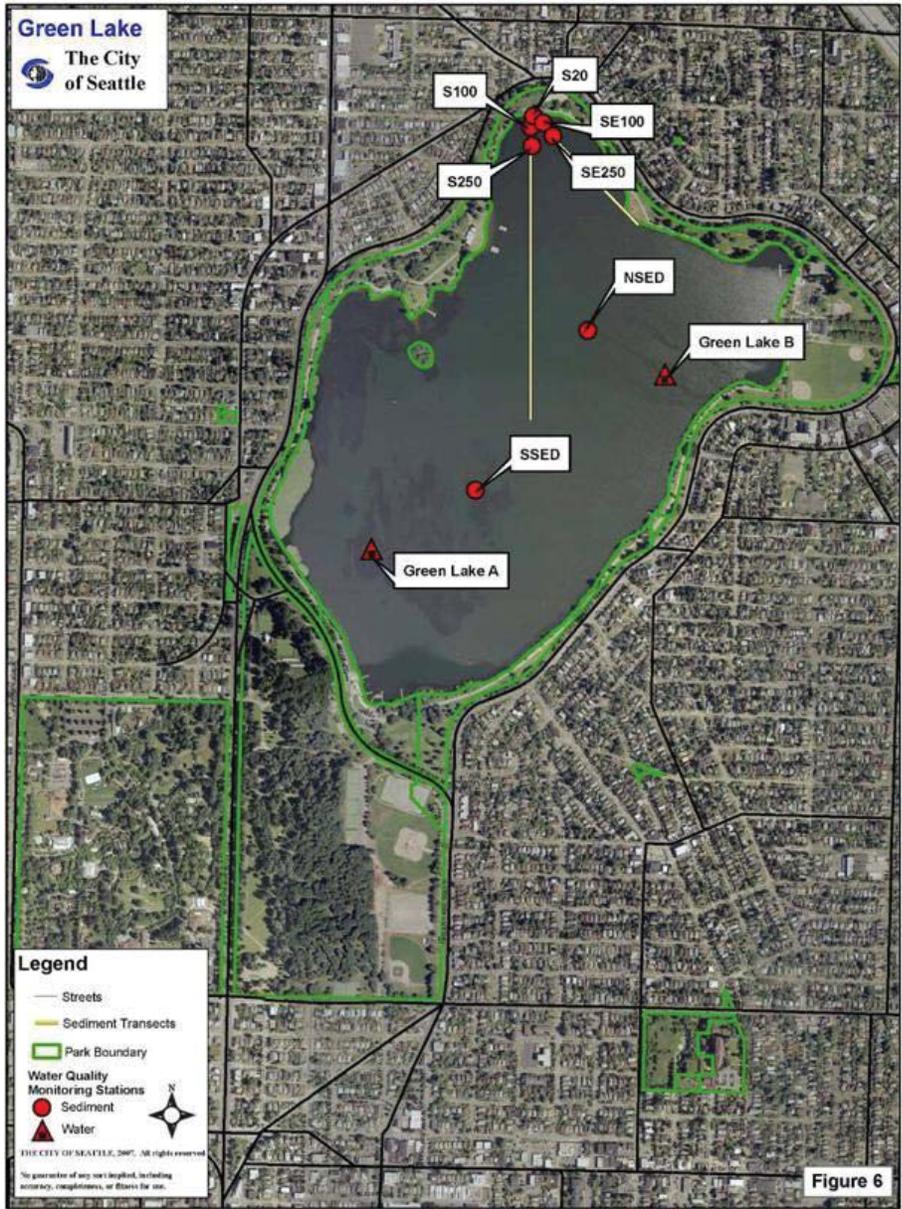
Figure 4-5: Green Lake Sediment Sampling Stations

In 2004, SPU collected sediment samples from seven locations offshore of the Densmore Avenue North storm drain outfall in Green Lake to evaluate possible impacts on the sediment quality resulting from stormwater discharges (Figure 4-5). Samples were analyzed for metals, semivolatile organic compounds, total petroleum hydrocarbons, and PCBs.

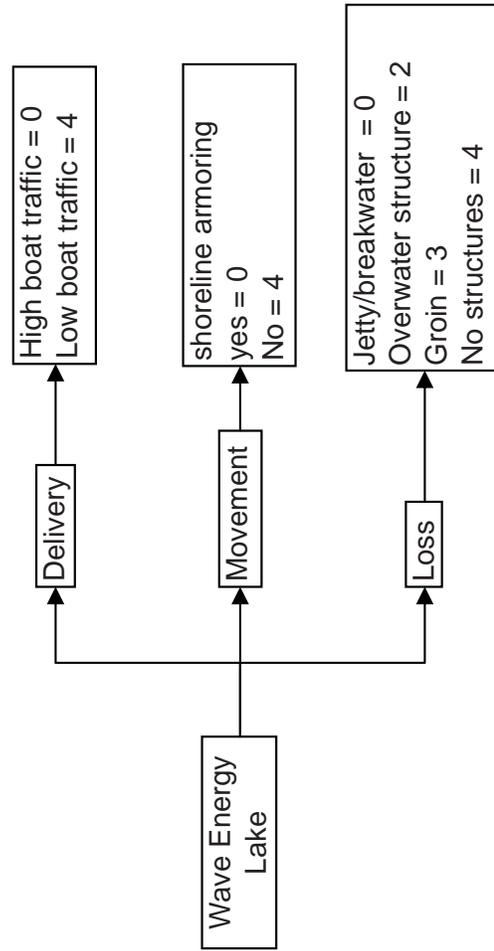
# Wave Energy Flowchart, Lake

Analysis is for the first pixel along the shoreline only

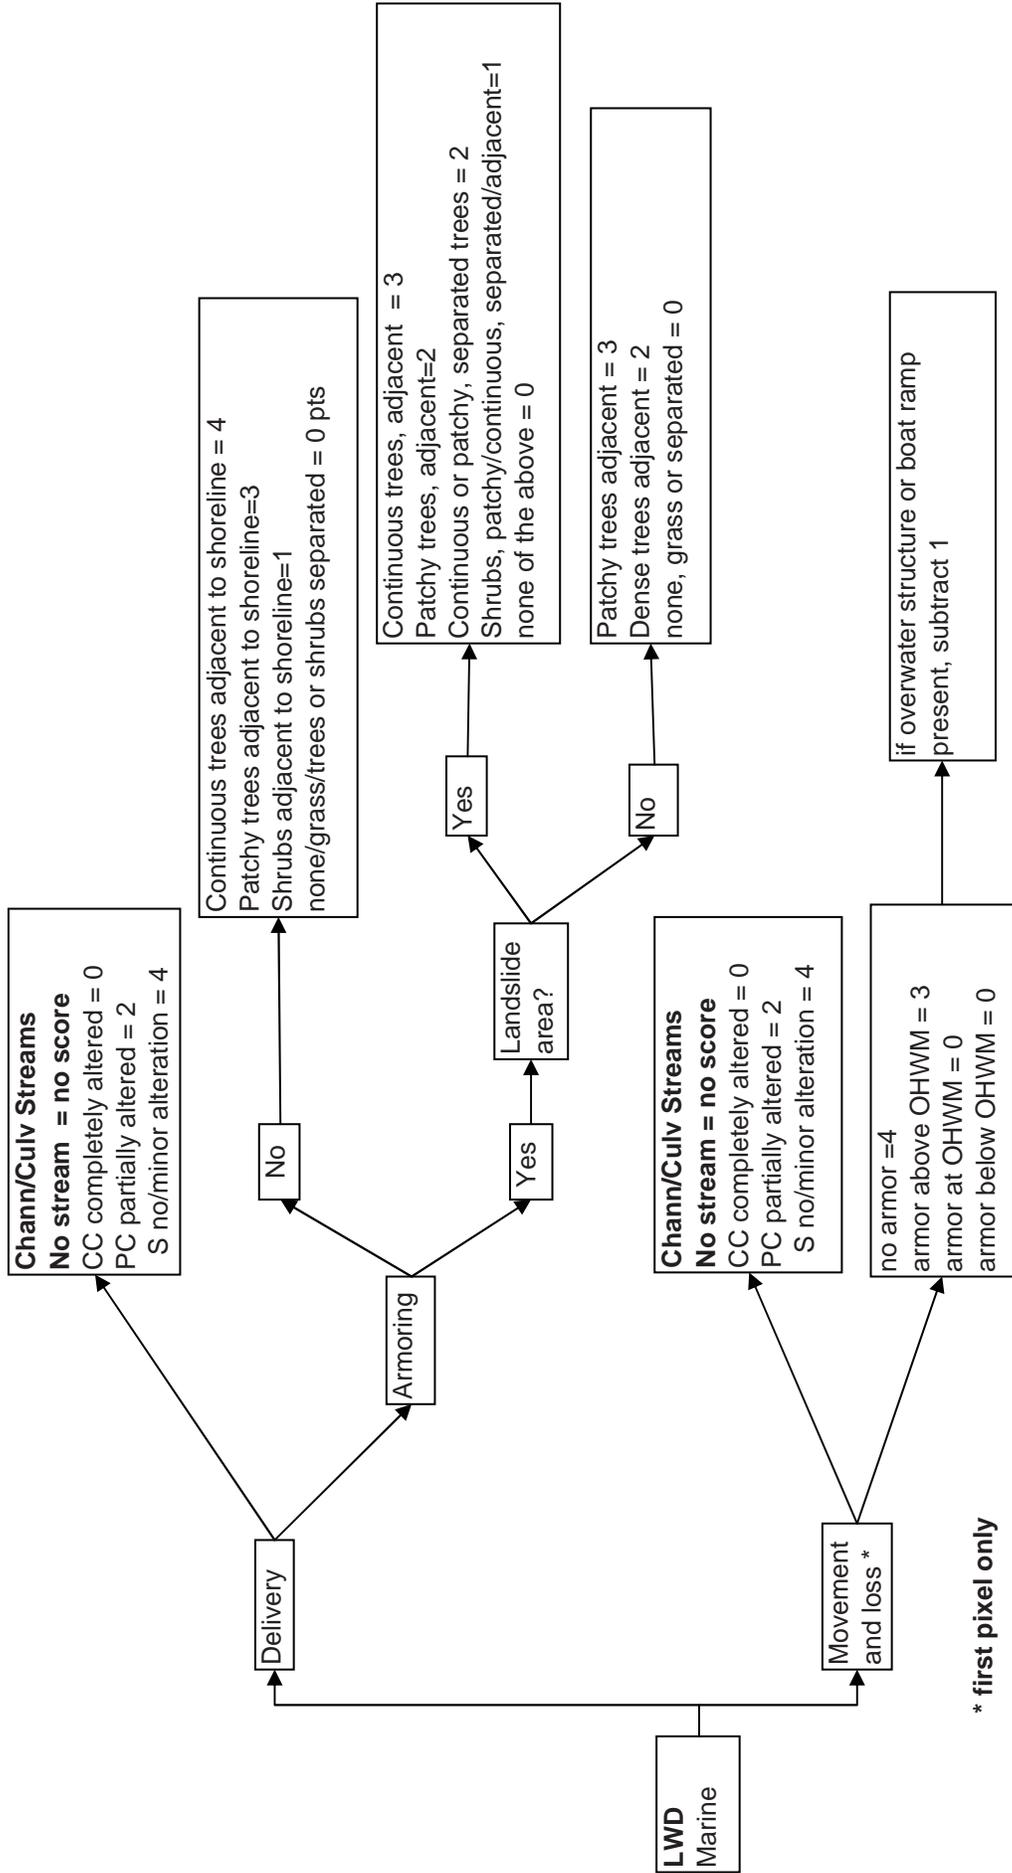
# LWD Flowchart, Marine

\* first pixel only
