# SHOWBOX

1426 First Avenue  
SEPTEMBER 10, 2018

The City of Seattle  
**Landmarks Preservation Board**

**Name:** Show Box, Showbox, Showbox Ballroom, Showbox at the Market      **Year Built:** 1917

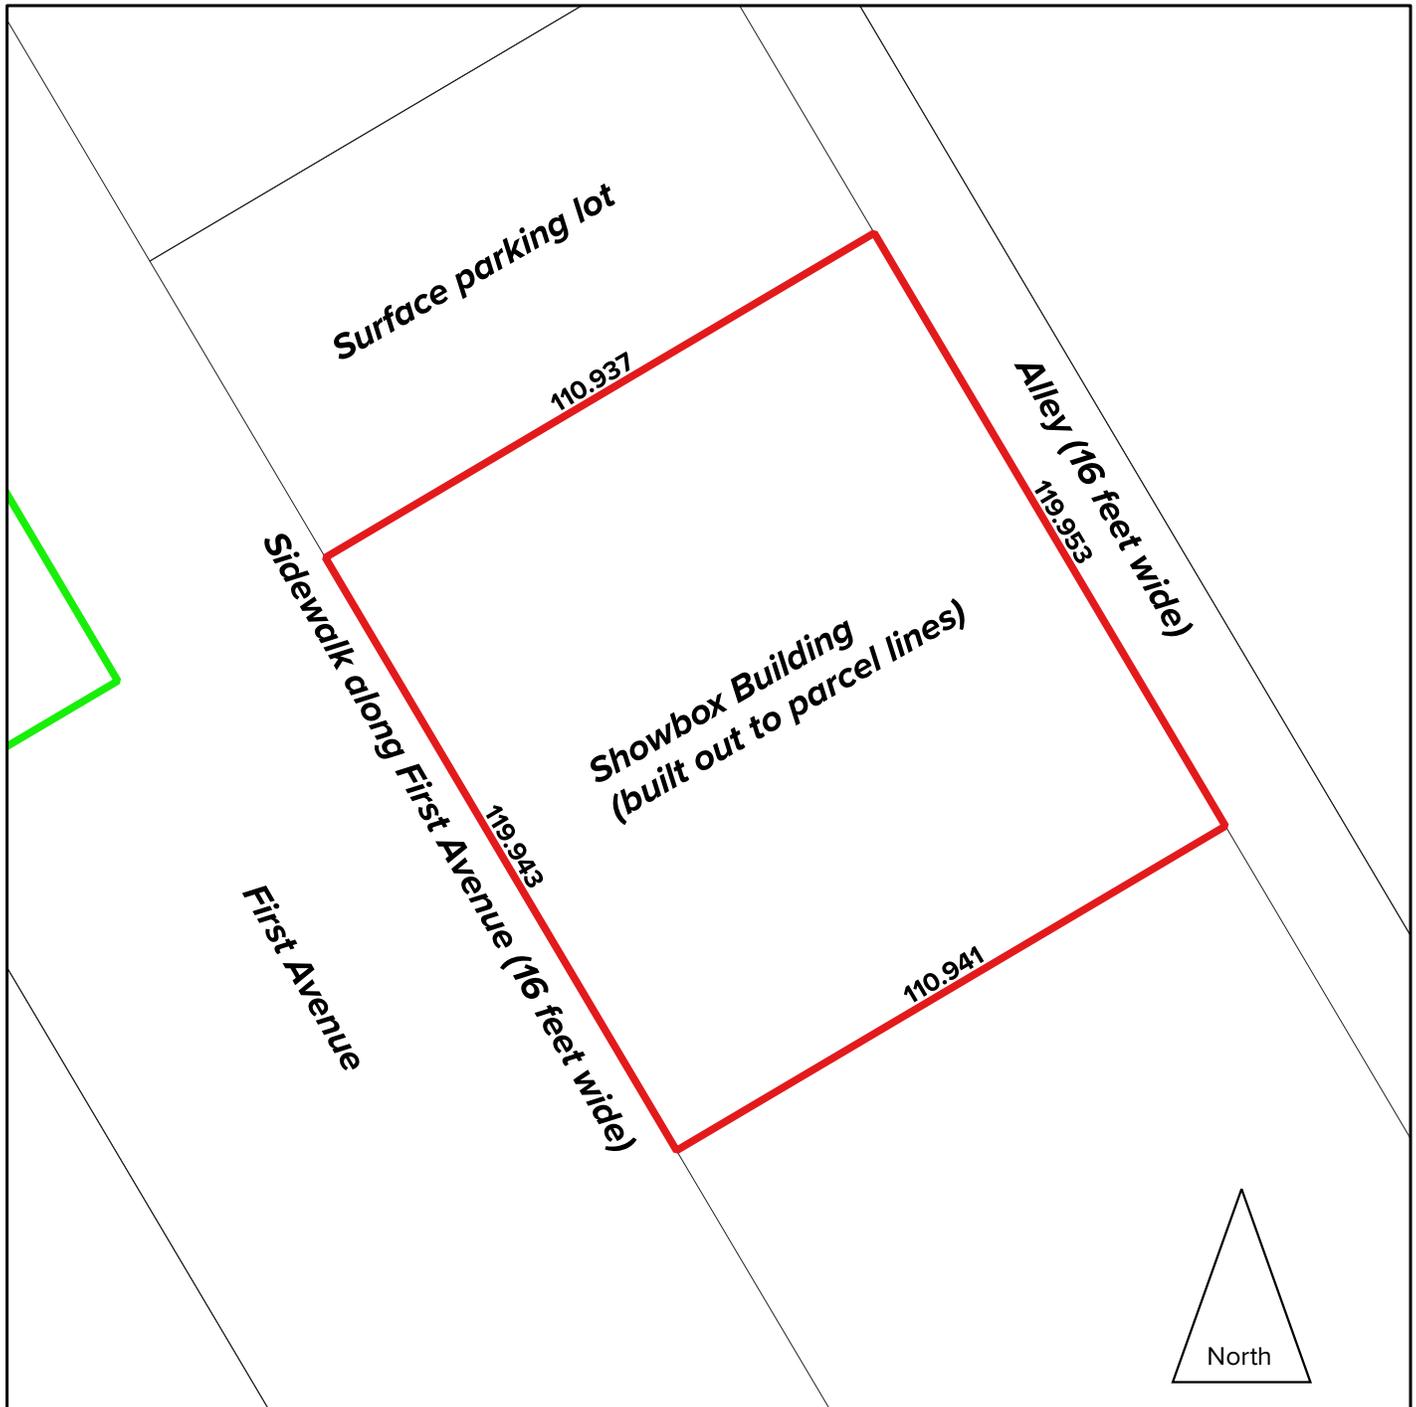
**Figure 2.** Site plan. The footprint of the Showbox is outlined in red. The building is built out to the parcel lines.

C. Penney department store location) fills the east half of the block with the retailer Target in the ground floor. **See Figures 1-3, and 69-73.**

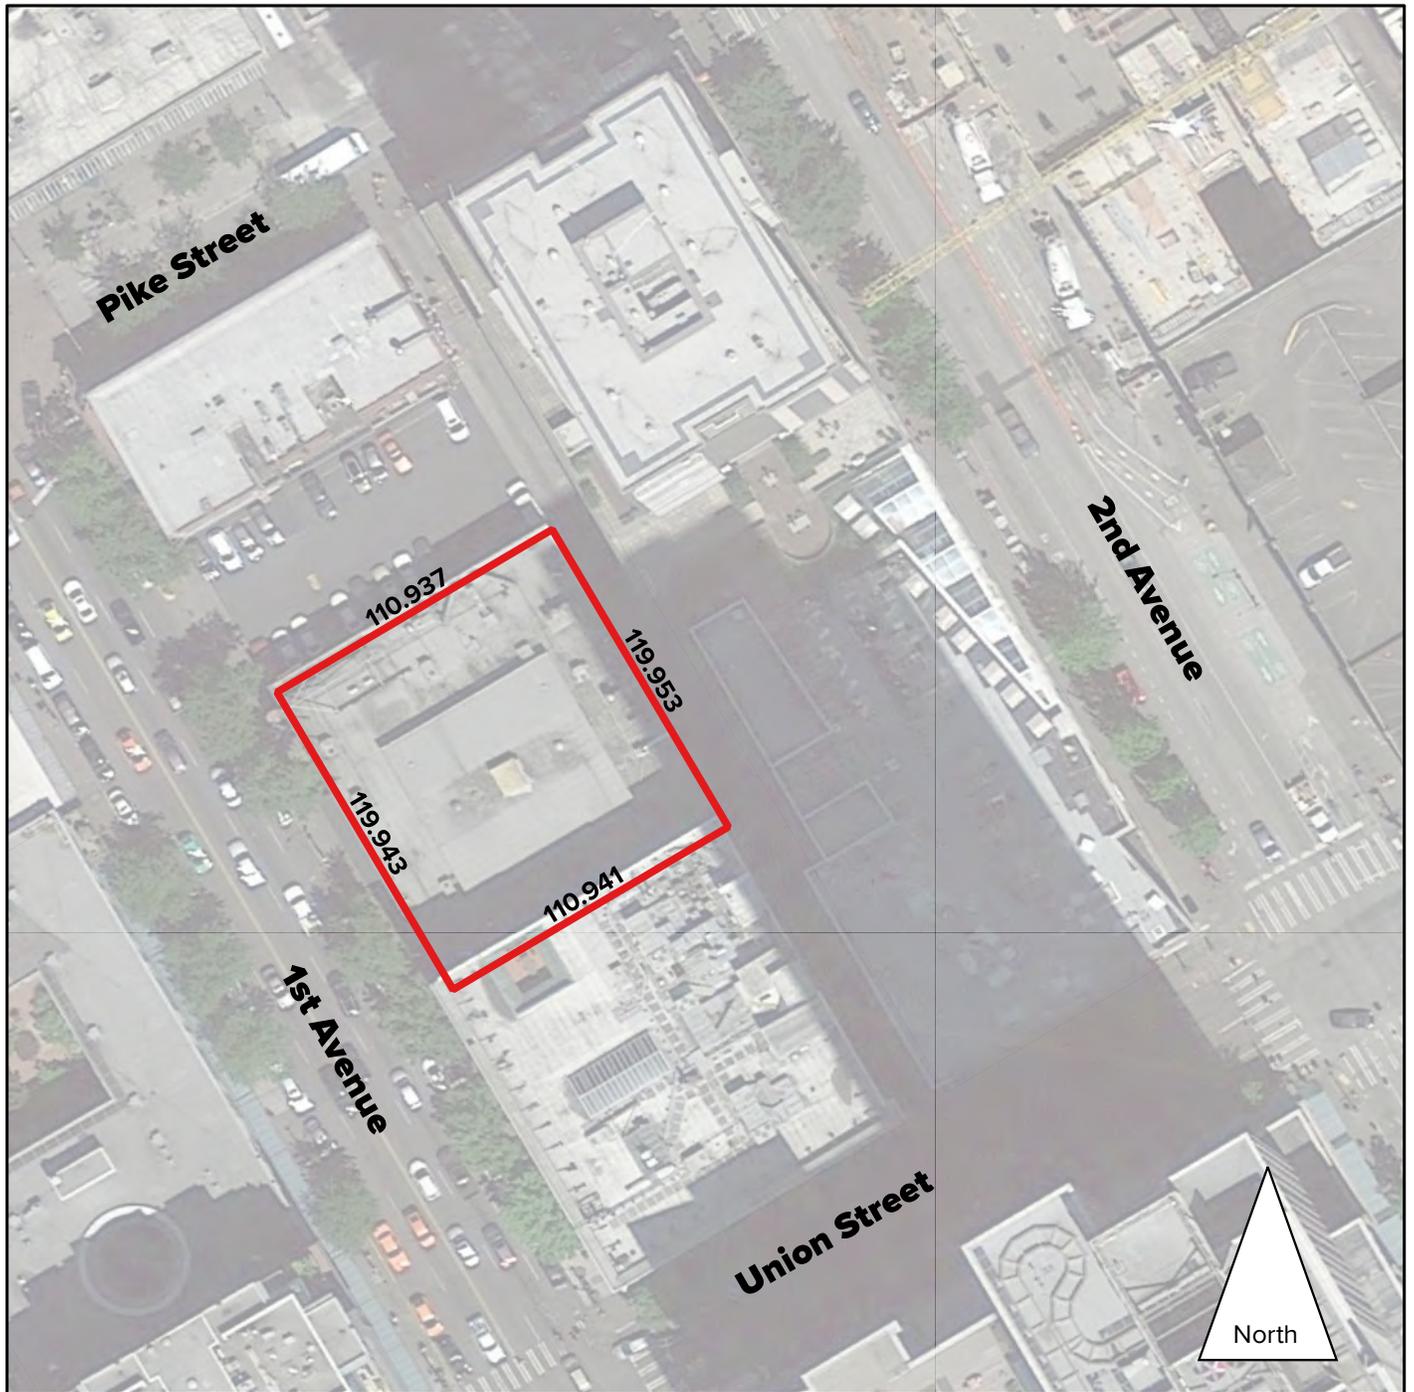
**Figure 3.** Nominated property map. Note that although the red line appears to be offset slightly, this is due to the angle of the satellite imagery. The red line actually follows the footprint of the building and the parcel boundary.

A flat roof with composition roofing clads the building. A central low-pitched gable roof portion projects up from the main roof over the second-floor trusses and the domed ceiling. Parapets extend along the west, north, and east sides of the roof with a thin ledge (coping) along the front facade to visually accent the parapet edge and provide a horizontal emphasis to the facade. This ledge is repeated at a step in the parapet height. Sheet metal flashing caps the parapet. A steel armature mounted to the roof framing and supporting the front marquee occupies the northwest corner of the roof behind the parapet. Rooftop mechanical equipment is located around the roof perimeter behind the parapet. Sheet metal ducting and steel enclosed conduit (related to restaurant and performance venue functions) extend up to this equipment along the outer face of the east facade to avoid disrupting the interior performance volume. Metal downspouts extend down from the roof along the east facade, discharging at the alley. An internal brick chimney is in the northeast corner of the building. **See Figures 3, 74.**

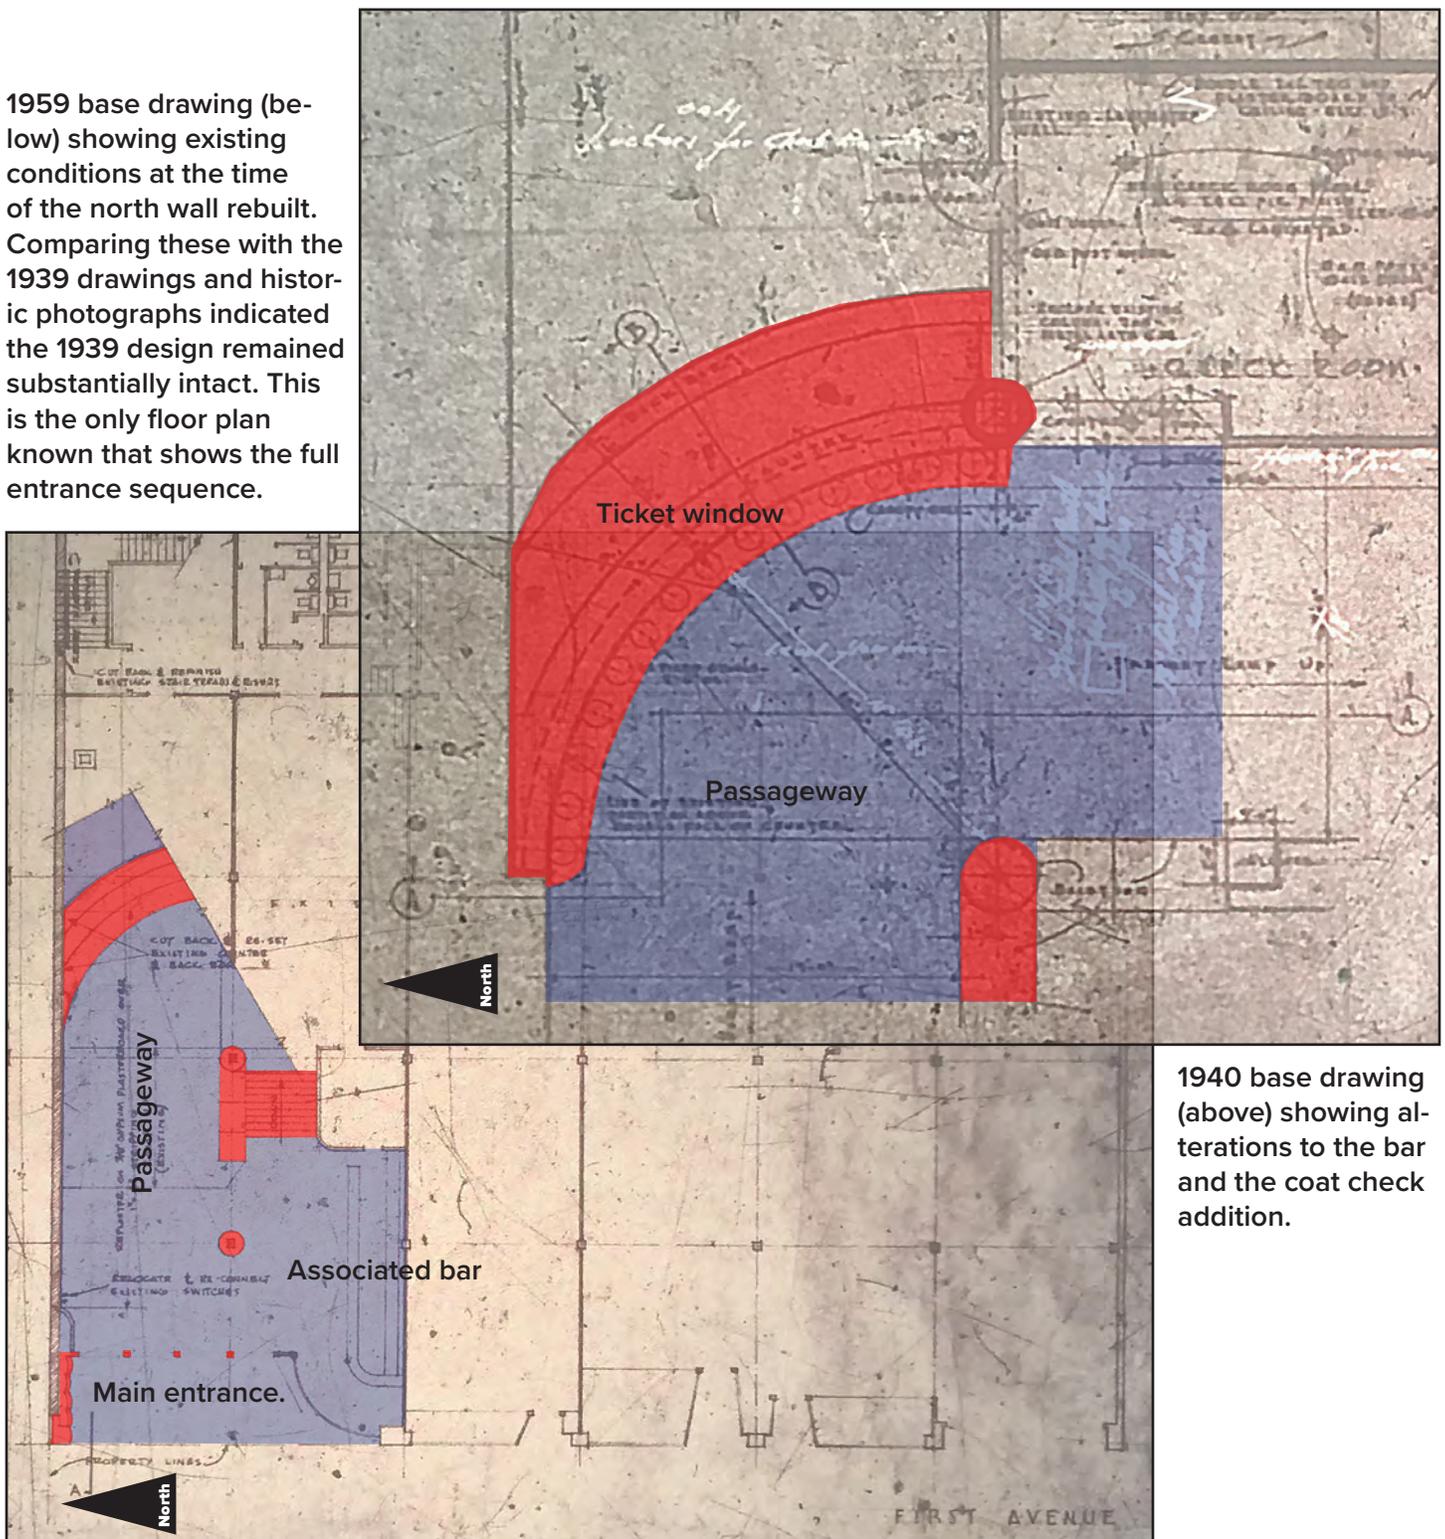
1959 base drawing (below) showing existing conditions at the time of the north wall rebuilt. Comparing these with the 1939 drawings and historic photographs indicated the 1939 design remained substantially intact. This is the only floor plan known that shows the full entrance sequence.

1940 base drawing (above) showing alterations to the bar and the coat check addition.

**Figure 5.** First floor entrance and passageway analysis plan. The 1959 north wall rebuilt and the 1940 alterations plans are the base drawings with overlaid color coding to show what remains today from the original design. The core volume, exterior engaged columns, door mullions (reeded surrounds, transom), large columns, stairs down to the 1424 lower level, stepped cheek wall, ticket counter (former bar), and the original ramp structure of the passageway all remain. Inspection in the crawl space and lower level confirmed the ramping remains intact below added stairs. Refer to the character defining features and spaces section in the description for a full list of the features.

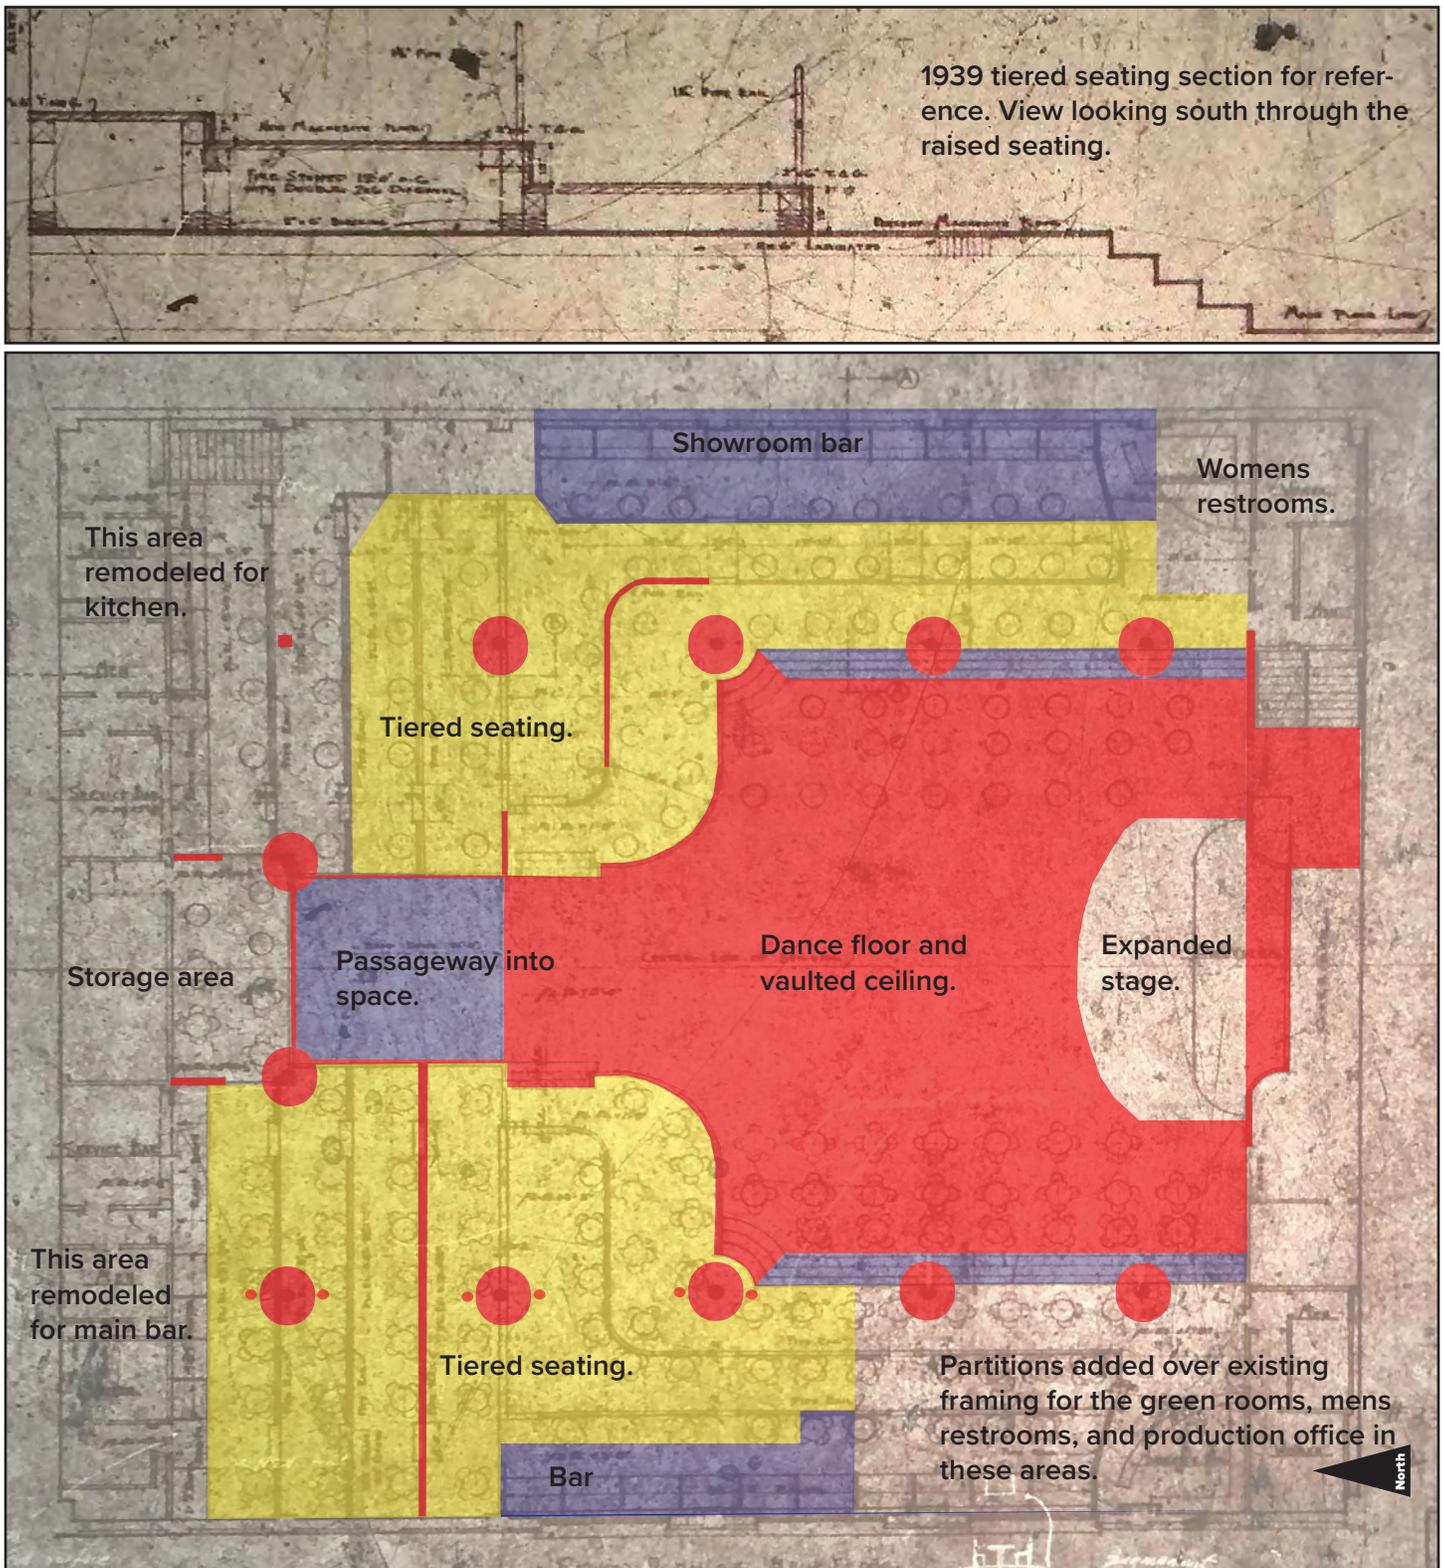
**Figure 6.** Second floor analysis plan. The 1939 remodel plan is the base drawing with overlaid color coding to show what remains today from the original design. The core volume, dance floor, raised seating, columns, proscenium, and fly loft all remain. Refer to the character defining features and spaces section in the description for a full list of the features.

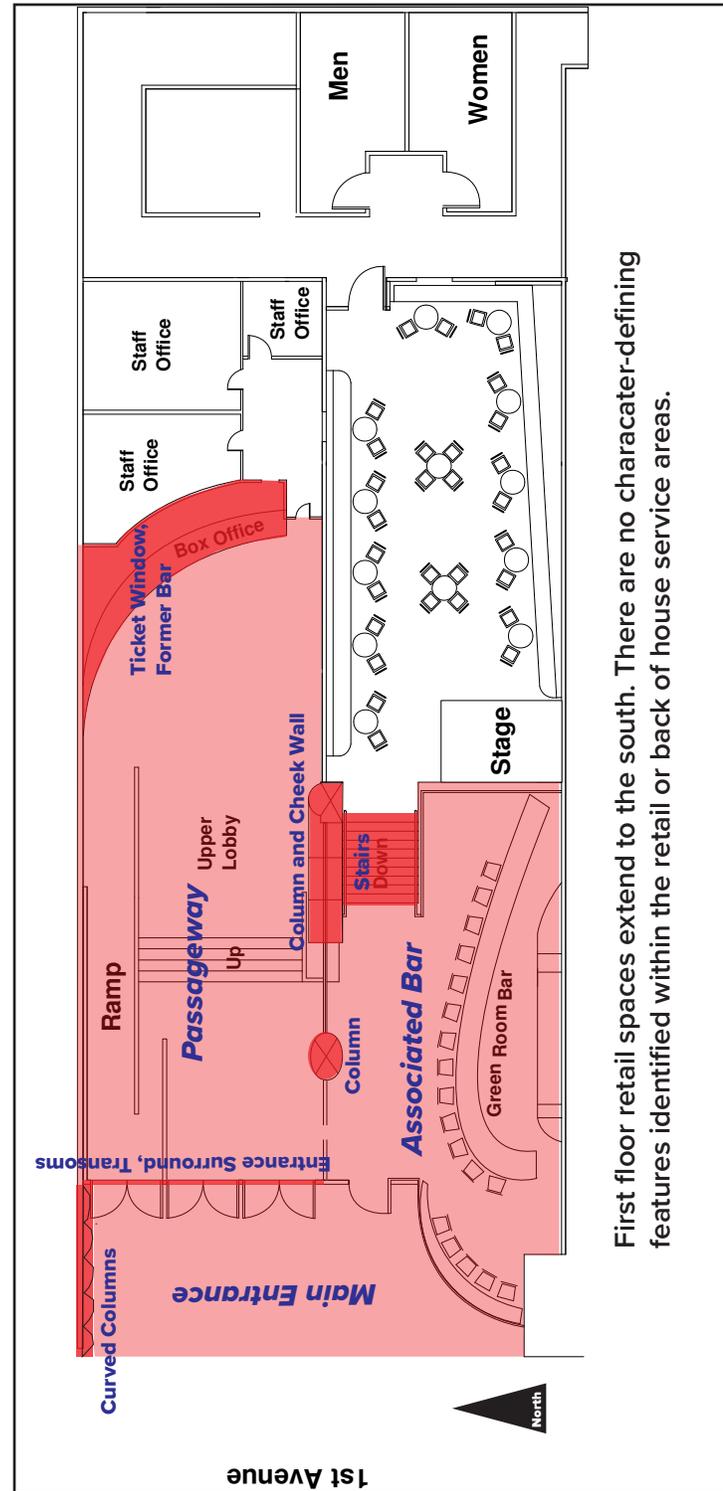
First floor retail spaces extend to the south. There are no character-defining features identified within the retail or back of house service areas.

**Figure 7.** First floor character defining features and spaces plan. This plan identifies by color coding the character defining features and spaces. Refer to the character defining features and spaces section in the description for a full list of the features.

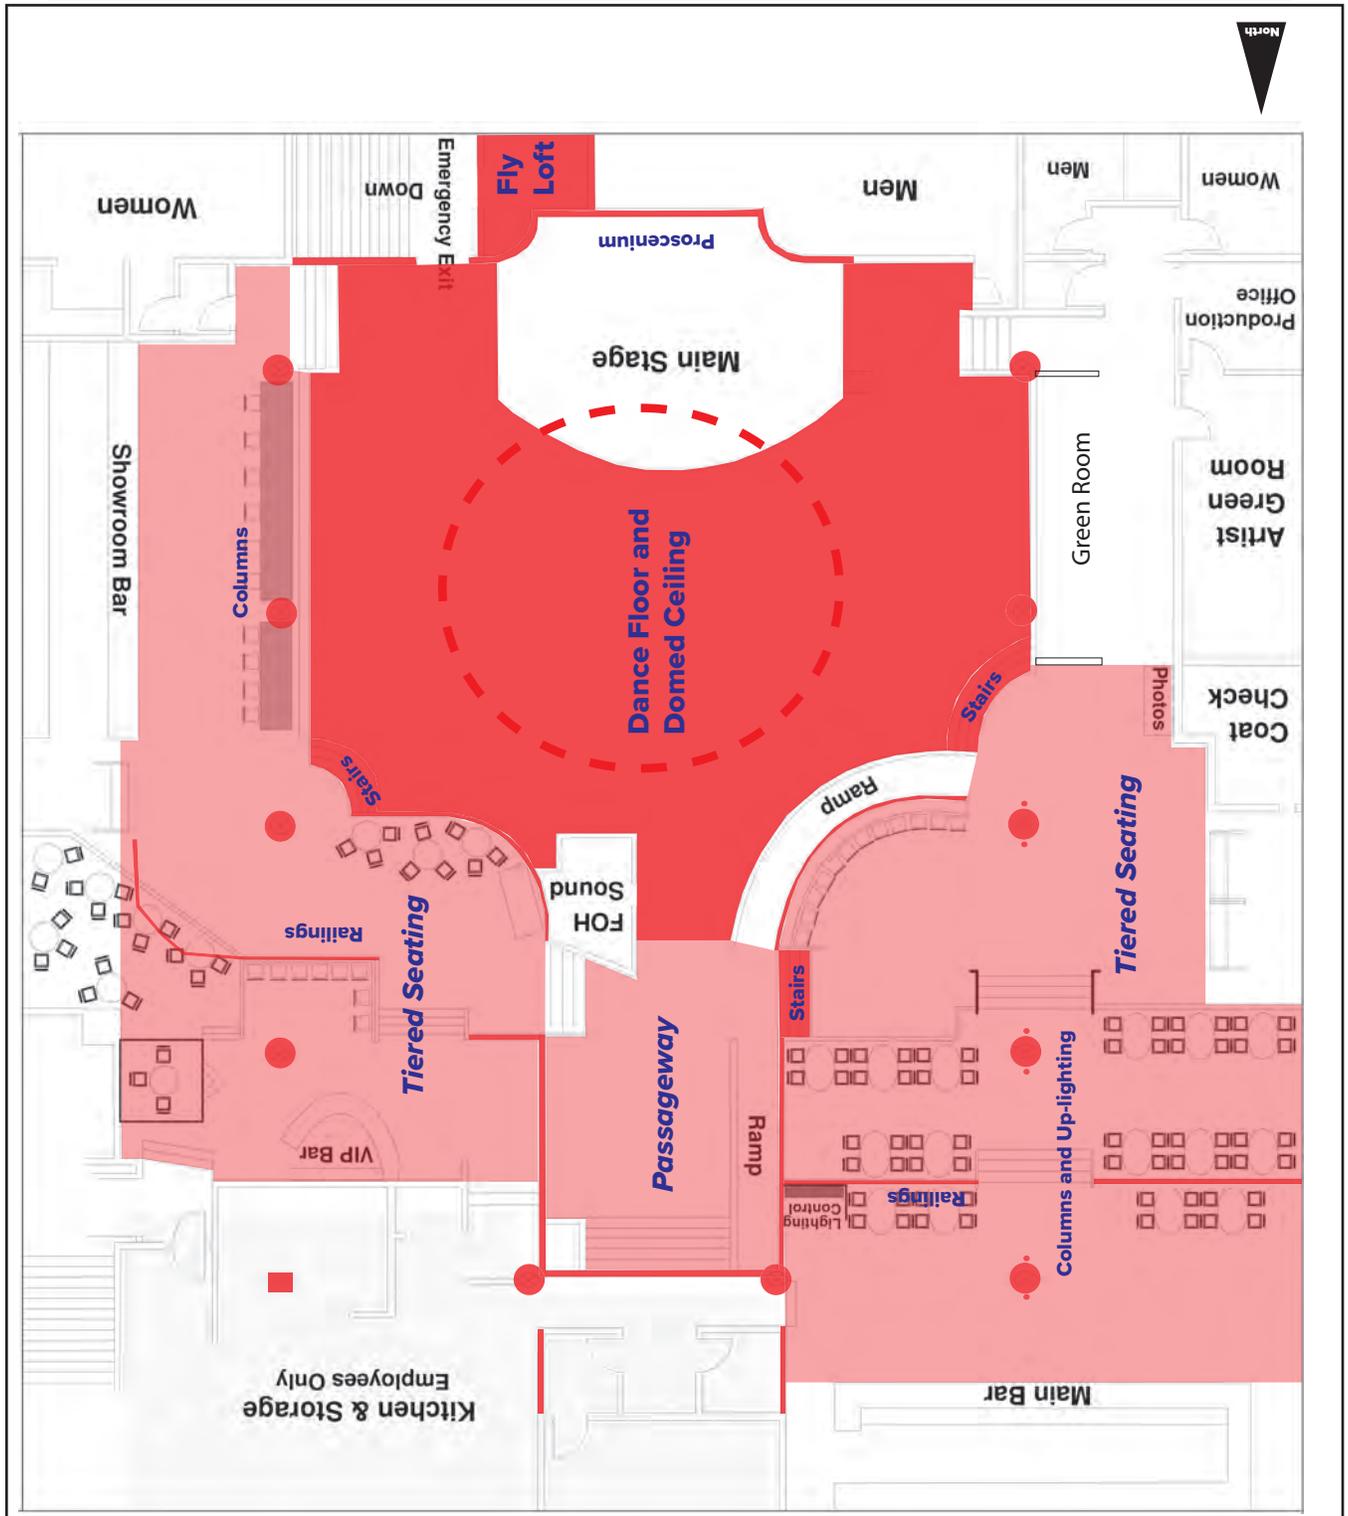
**Figure 8.** Second floor character defining features and spaces plan. This plan identifies by color coding the character defining features and spaces. Refer to the character defining features and spaces section in the description for a full list of the features.

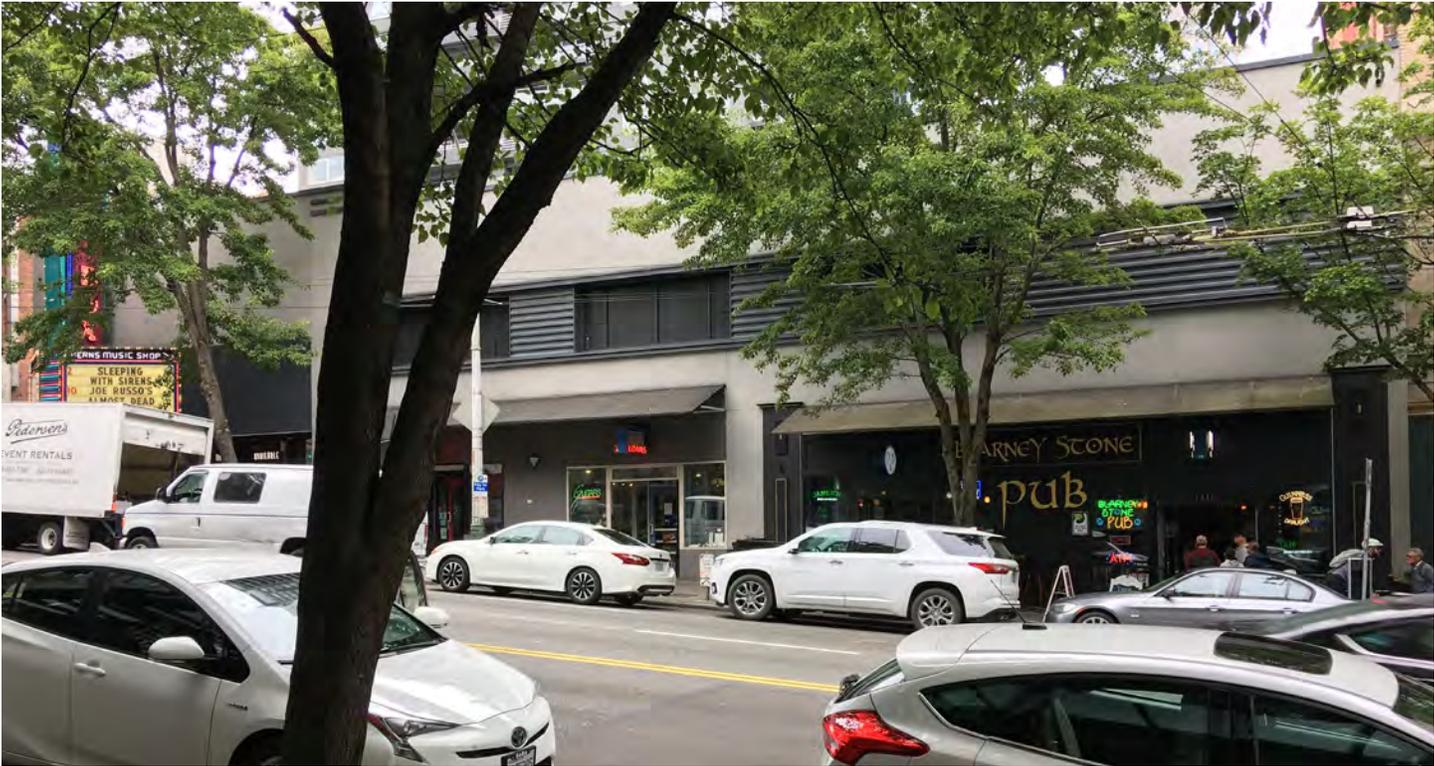
Figure 11. Front, west facade along 1st Avenue.

A masonry foundation supports the building structure with footings below the wood posts. There are no known basement areaways extending below the sidewalk along First Avenue. The building's east and west walls consist of unreinforced, load bearing common bond brick walls with headers every sixth course. These walls are three to four wythes thick for an approximate wall thickness of 12- to 16-inches. Brick piers step out on the interior face of the wall to carry beams supporting the floor framing. The southern third of the east wall at the second story level consists of stacked hollow clay tile, with a brick parapet above. Multiple steel louvers at through-wall openings along the first story level support building mechanical functions. **See Figures 11, 18-20.**

Windows occur on the front west and rear east facades. West facade windows consist of three window openings set in a horizontal band characteristic of the Streamline Moderne style. Each opening consists of two fixed sash flanked by narrow sash having a larger fixed upper and smaller operable lower sash. Window frames are anodized aluminum. The window band is framed by a projecting modernistic border emphasizing the horizontal character of the facade, with painted corrugated metal panels between the windows and at the south end. The border consists of raised outer edges with a central recessed channel. **See Figures 11, 13, 59-60.**

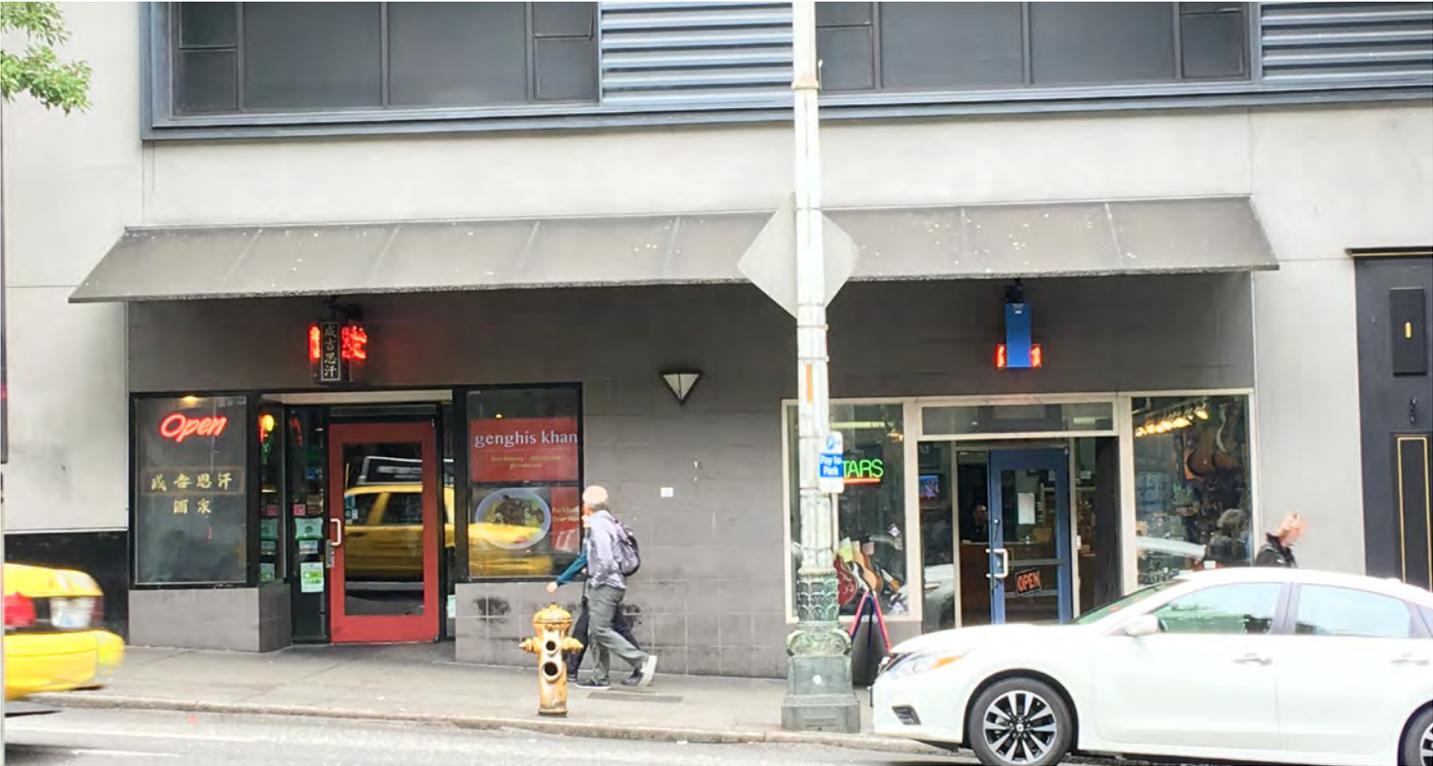
**Figure 13.** The 1420 and 1422 1st Avenue storefronts on the west facade.

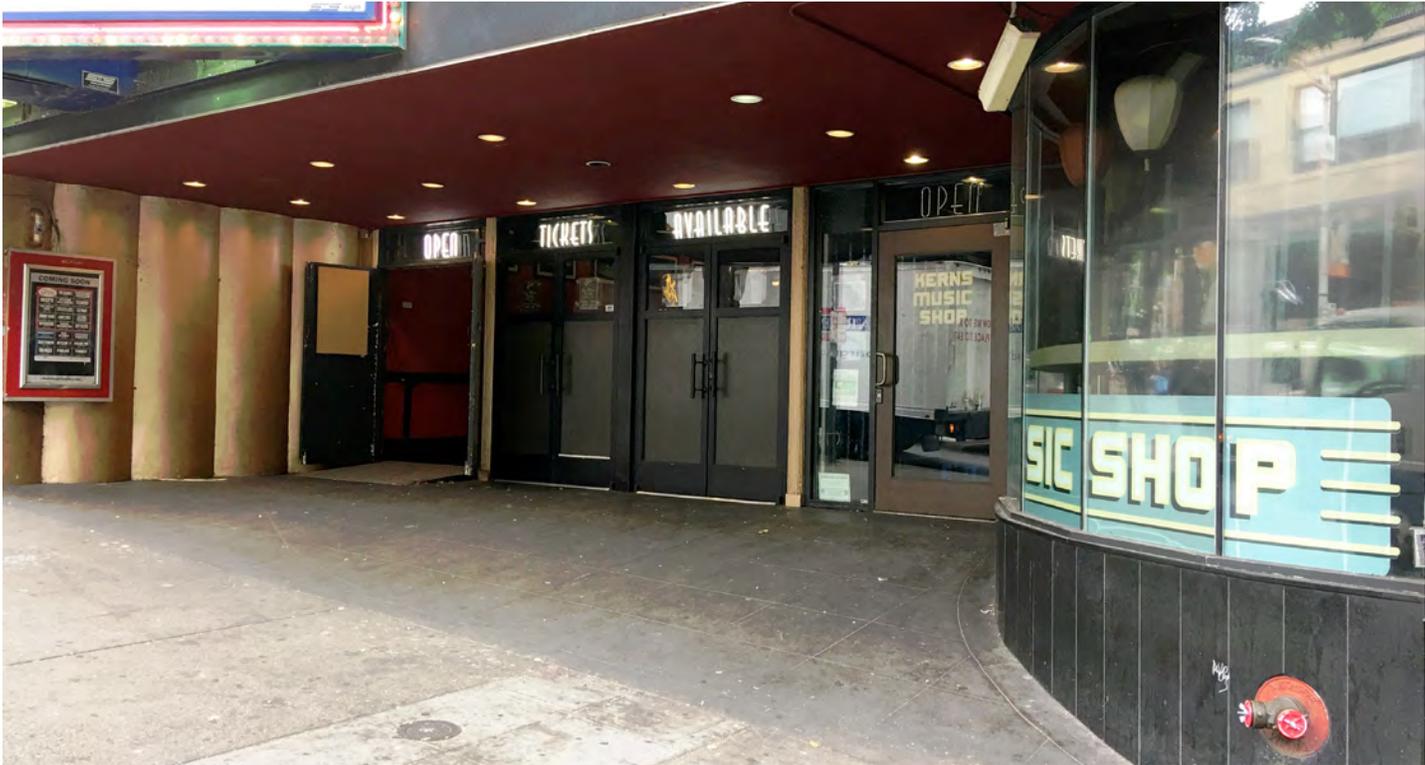
**Figure 14.** The Showbox entrance at 1426 and the associated curved storefront at 1424 1st Avenue on the west facade.

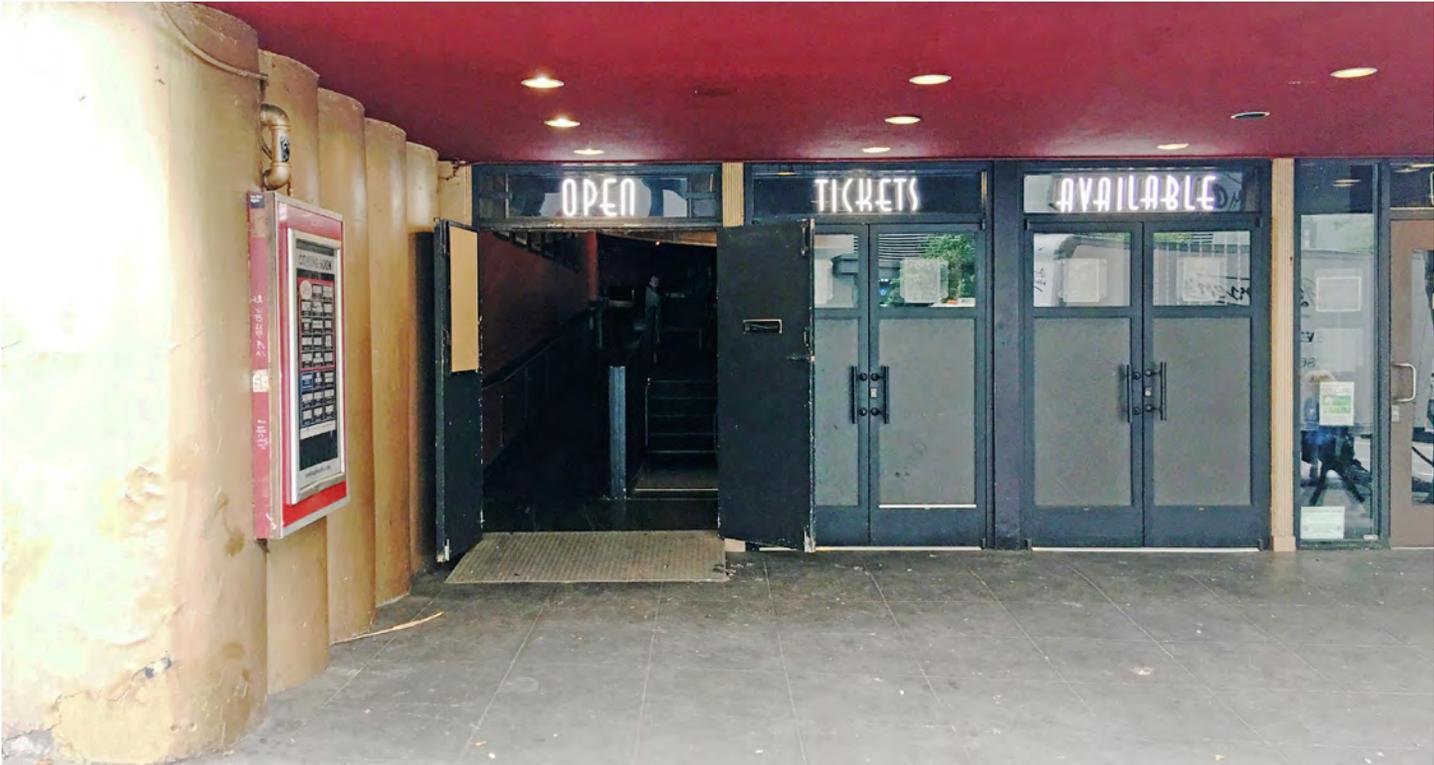
**Figure 16.** Showbox entrance with the original columns and entrance configuration stemming from the 1939 remodel that created the Showbox.

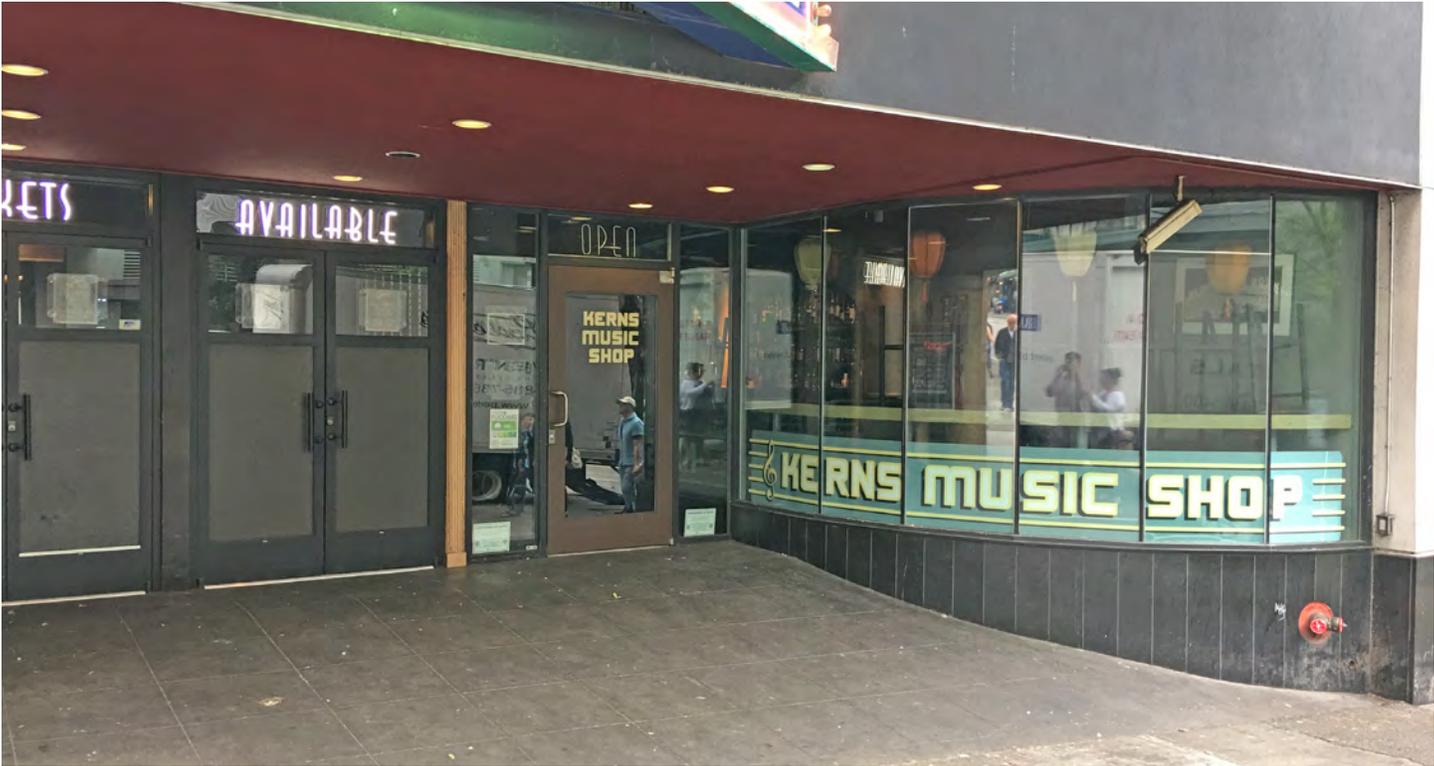
Figure 17. Curved storefront and bar entrance that function as part of the Showbox entrance.

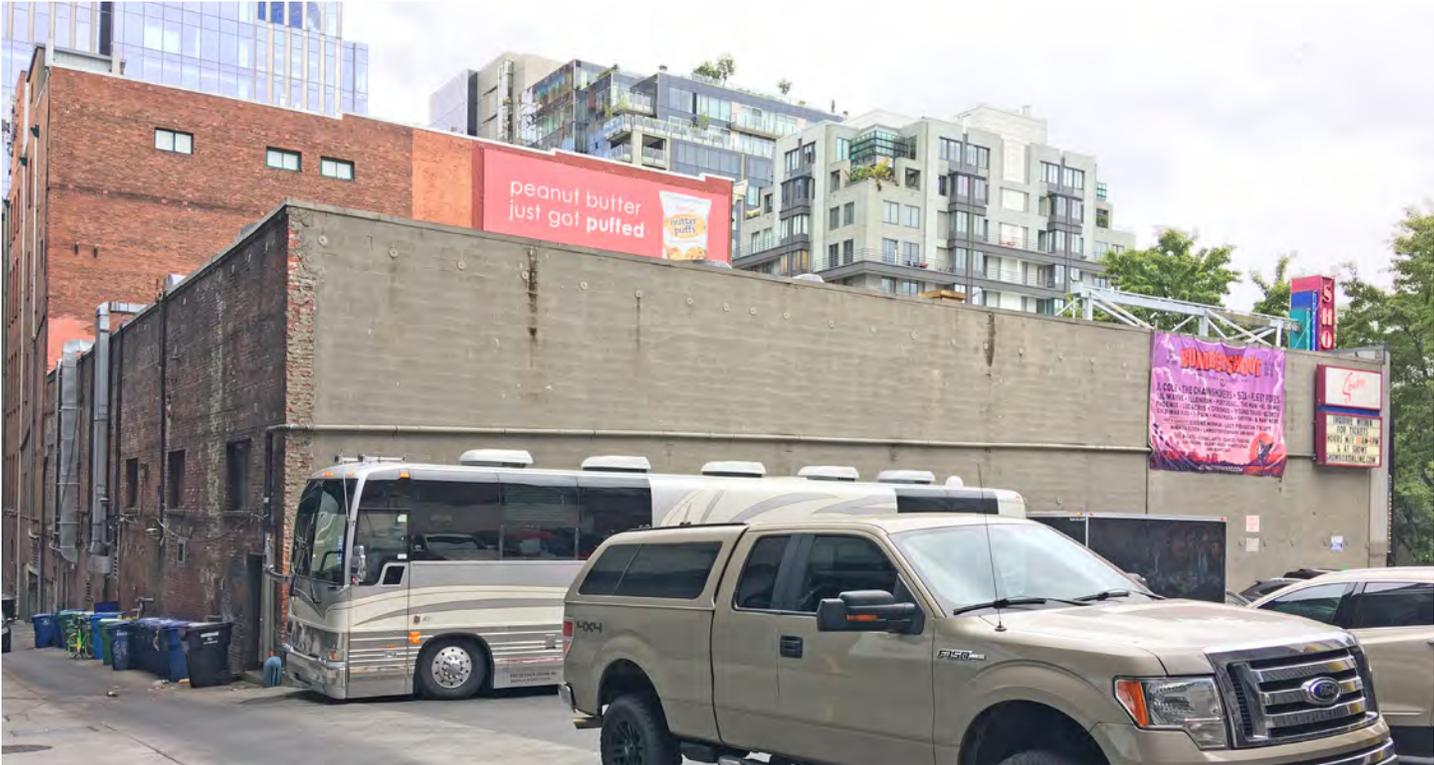
Figure 18. Northeast corner, looking southwest along the alley. The reconstructed north wall is visible.

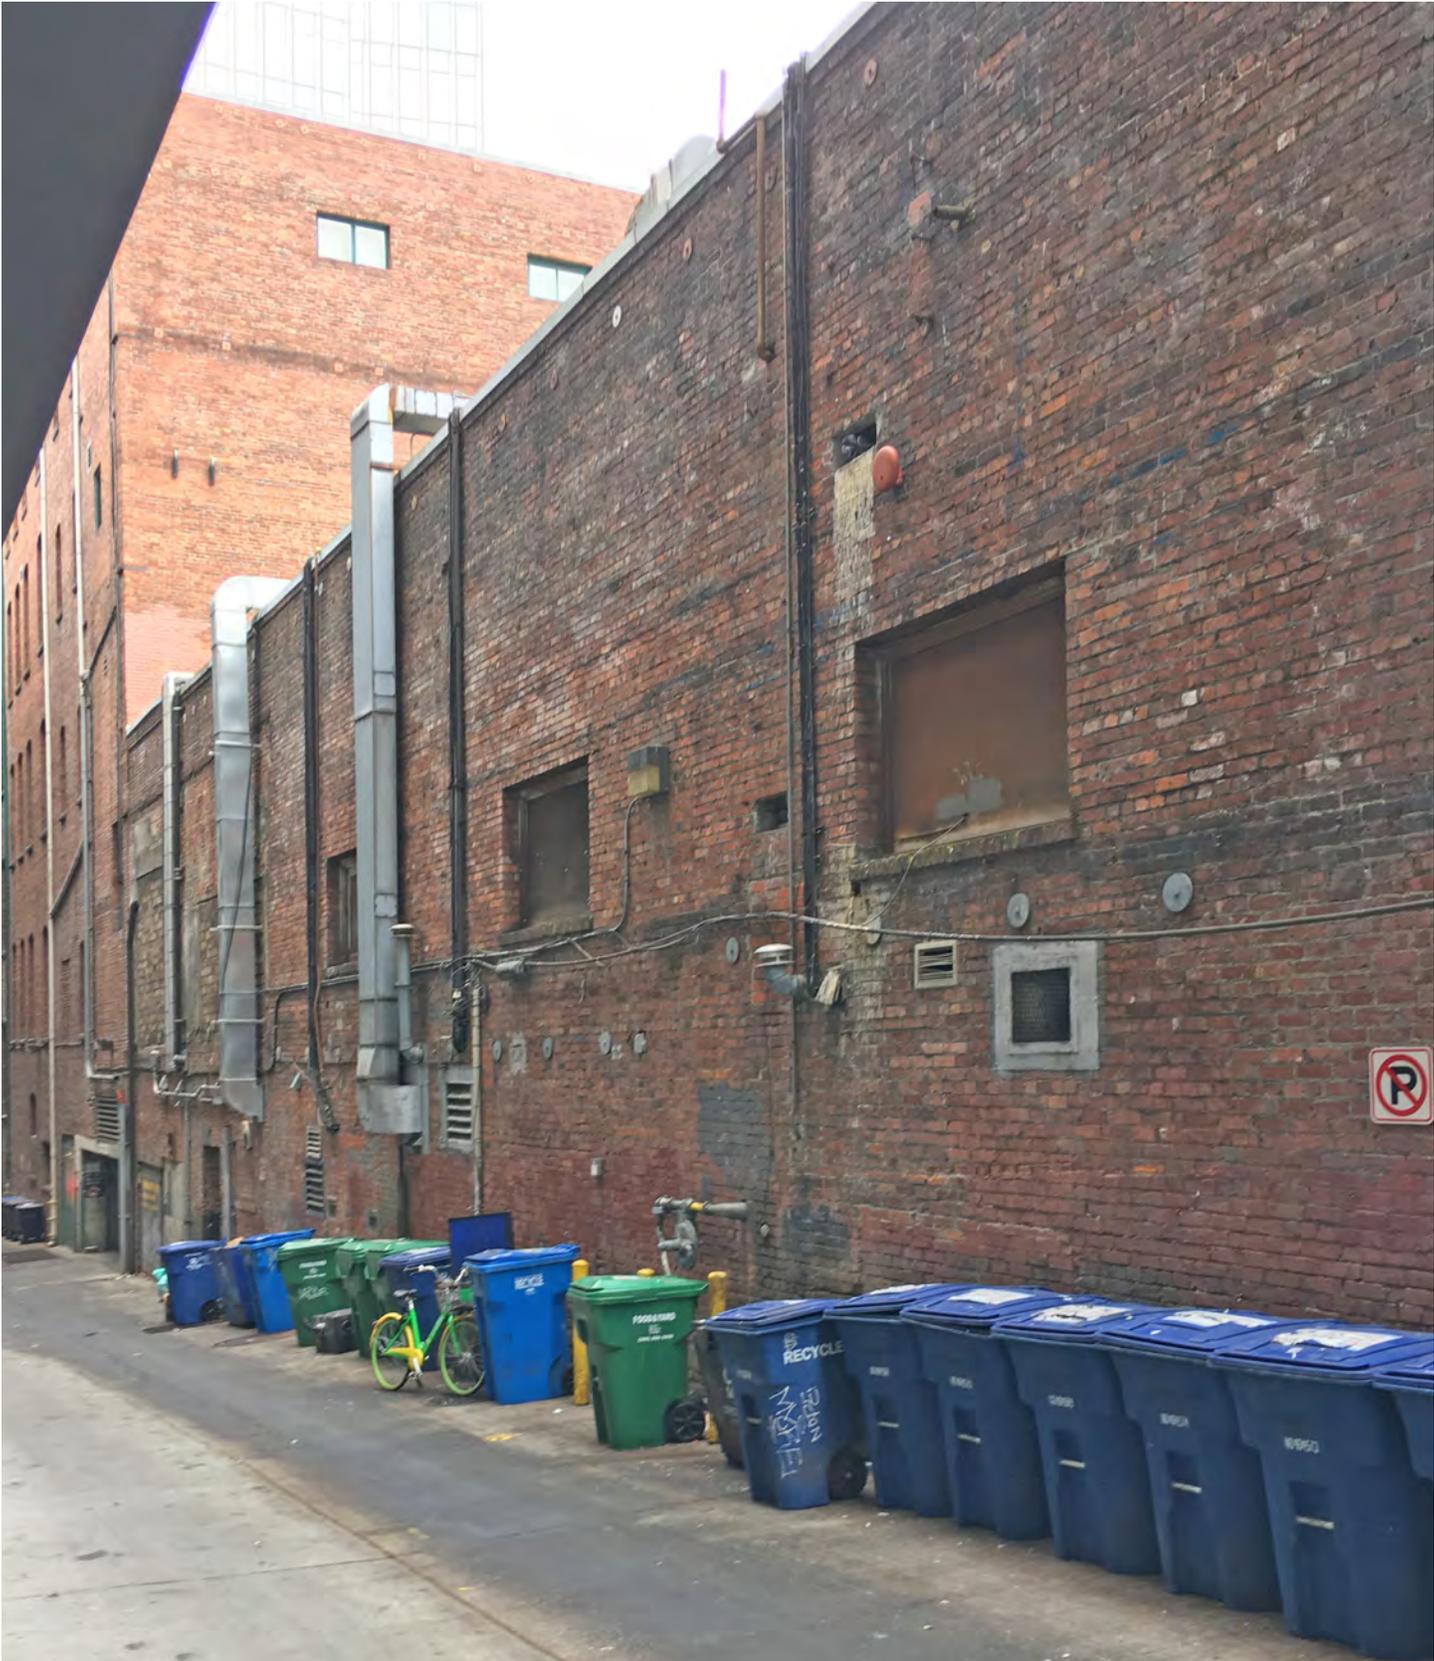
**Figure 19.** East alley facade looking south. The load bearing brick construction stems from the building's 1916 construction.
