# SHOWBOX

1426 First Avenue  
SEPTEMBER 10, 2018

The City of Seattle  
**Landmarks Preservation Board**

**Name:** Show Box, Showbox, Showbox Ballroom, Showbox at the Market      **Year Built:** 1917

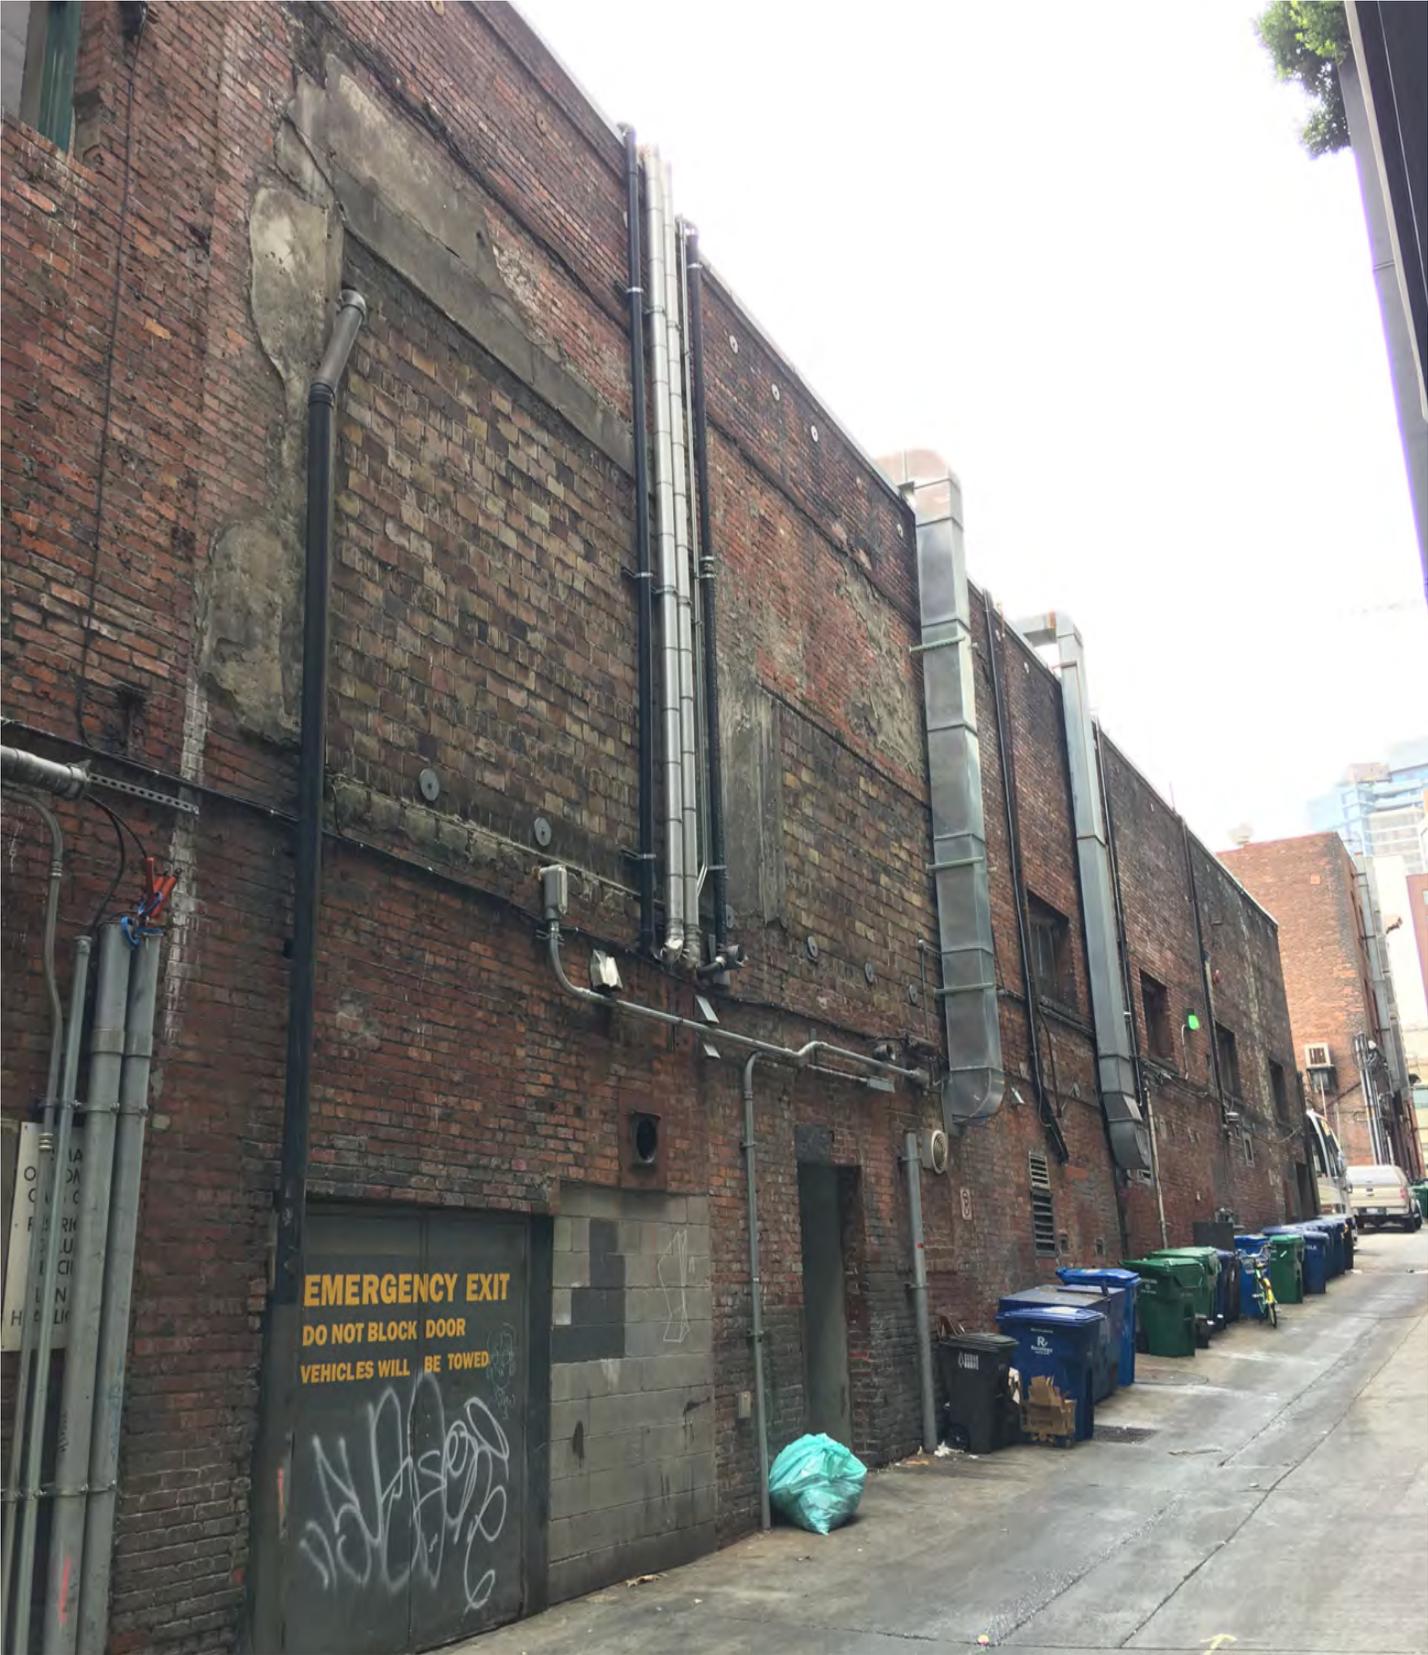
**Figure 20.** East alley facade, looking north.

A masonry foundation supports the building structure with footings below the wood posts. There are no known basement areaways extending below the sidewalk along First Avenue. The building's east and west walls consist of unreinforced, load bearing common bond brick walls with headers every sixth course. These walls are three to four wythes thick for an approximate wall thickness of 12- to 16-inches. Brick piers step out on the interior face of the wall to carry beams supporting the floor framing. The southern third of the east wall at the second story level consists of stacked hollow clay tile, with a brick parapet above. Multiple steel louvers at through-wall openings along the first story level support building mechanical functions. **See Figures 11, 18-20.**

The rear alley facade generally retains its original form with some infill of former windows, a doorway in the southeast corner, and the replacement of brick with hollow clay tile in a section of the second story wall at the south end of the facade. The hollow clay tile infills a

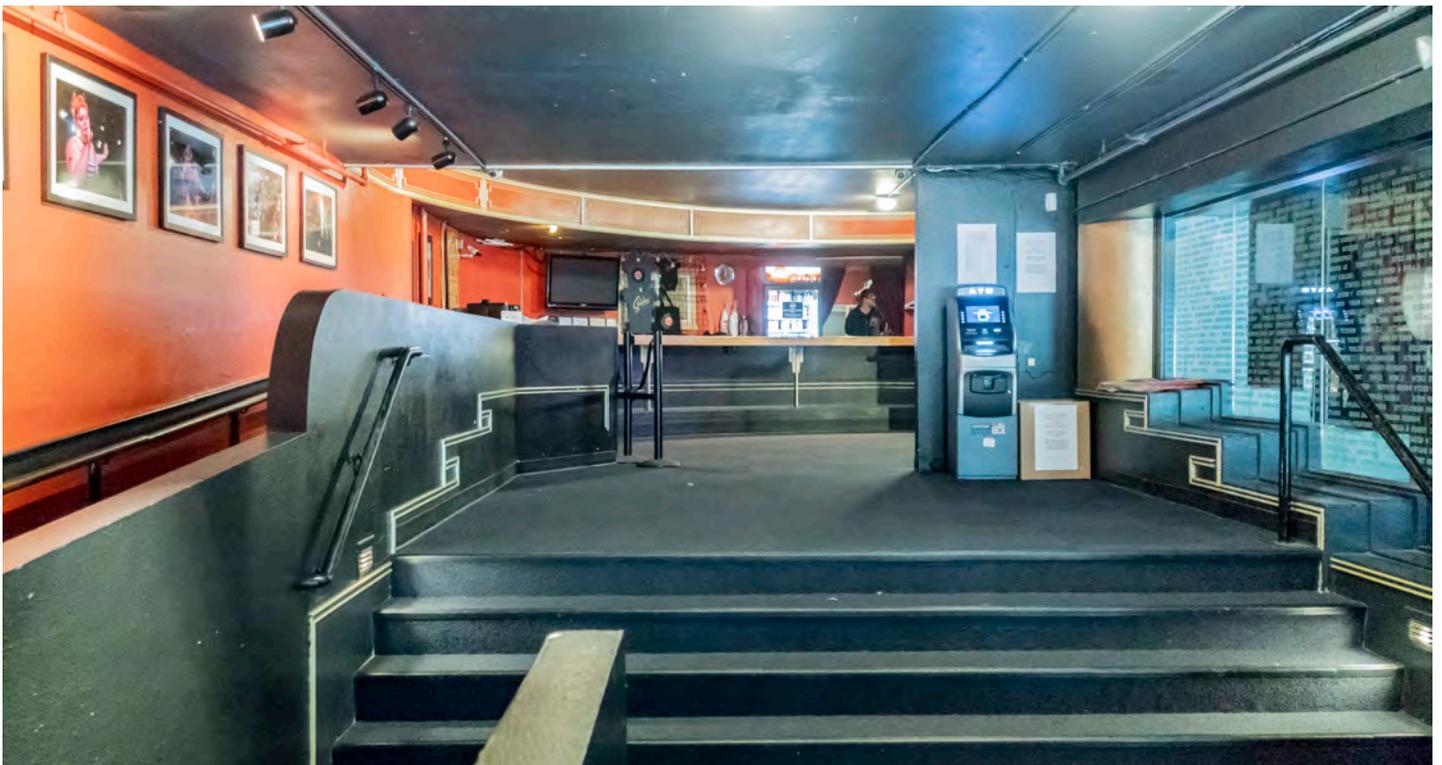
**Figure 24.** Showbox, entrance passageway showing the stairs, original south cheek wall and column, intermediate landing, and the original ticket window (originally a bar).

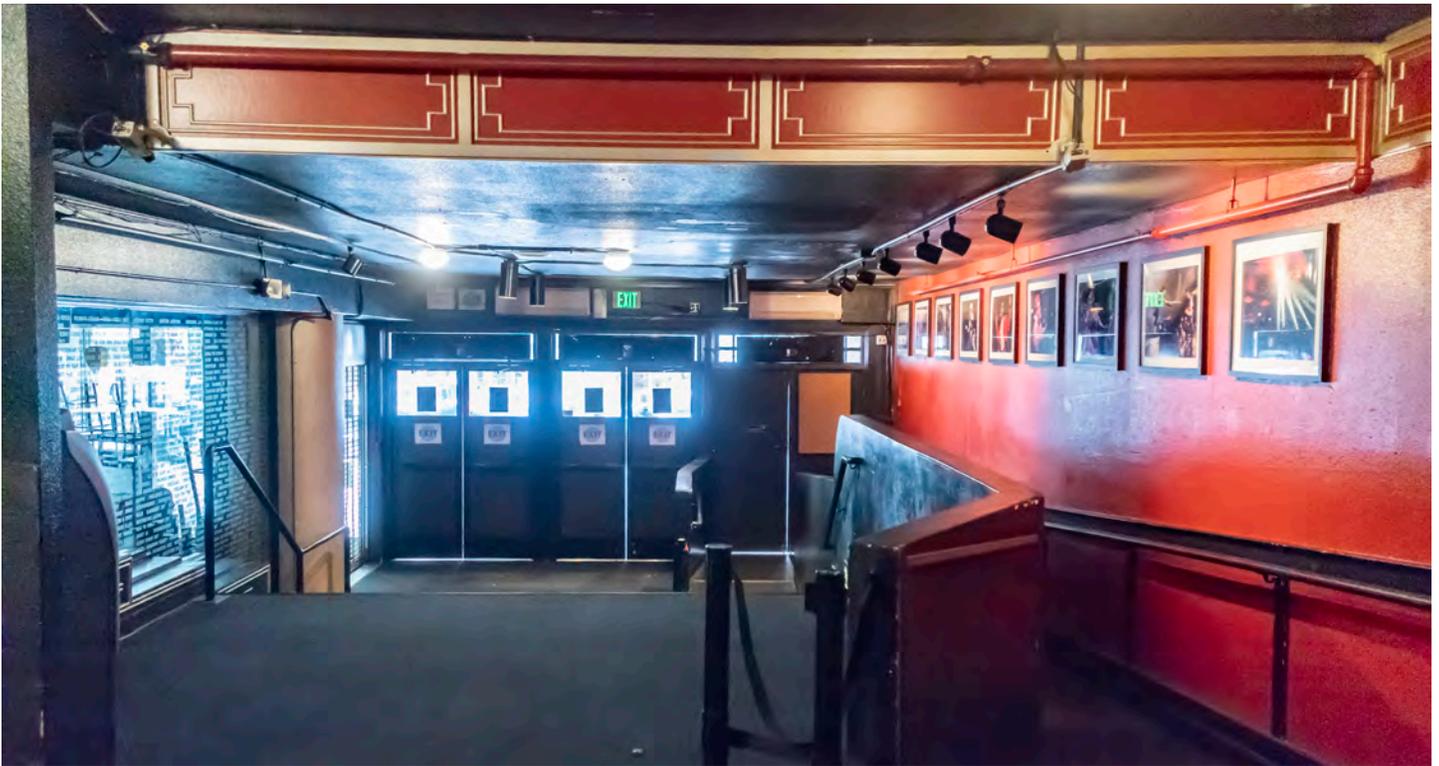
**Figure 25.** Showbox, looking west along the passageway at the three doorways providing access. The soffit above marks the line of the second floor framing. The volume of this passageway, door surrounds, and the large column at left are original to the 1939 remodel creating the Showbox.

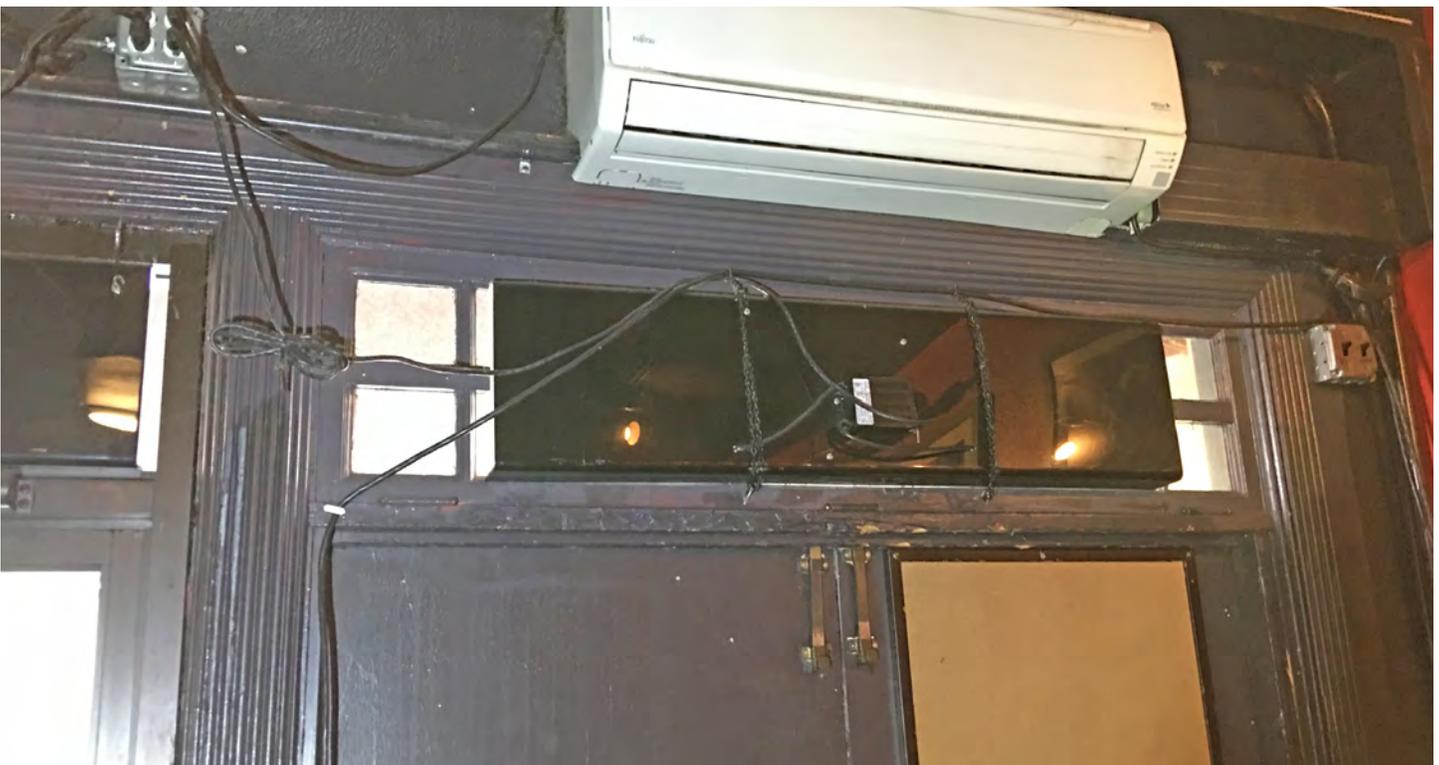
**Figure 26.** Showbox, detail view of the interior face of the doors showing the reeded detailing original to the 1939 remodel that is replicated on the exterior side of the doorways as well. The wood sash transom is also visible.

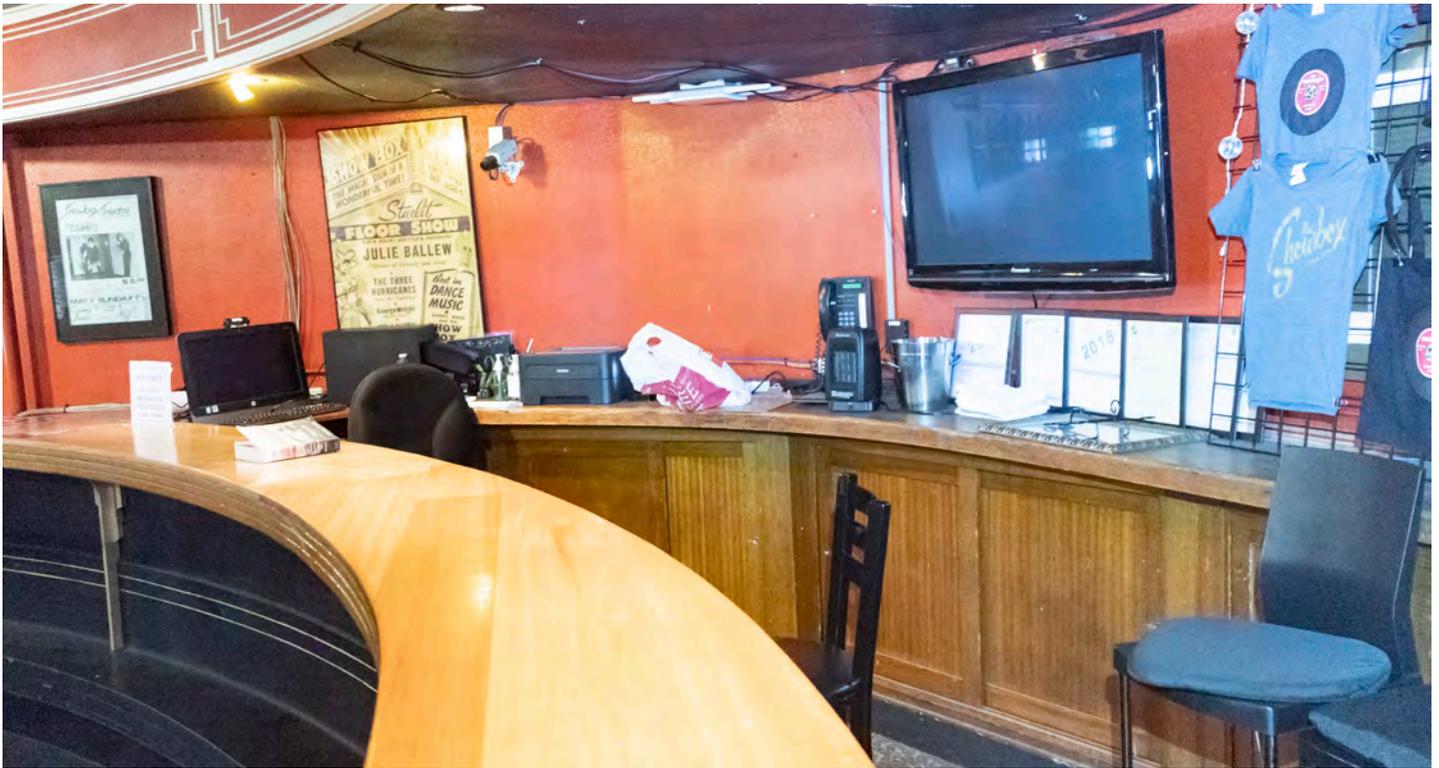
**Figure 27.** Showbox, looking north at the ticket window. The counter and back cabinets and overall opening are original to the 1939 remodel and 1940 modifications creating the Showbox. This space originally functioned as a bar for guests on their way to the performance volume.

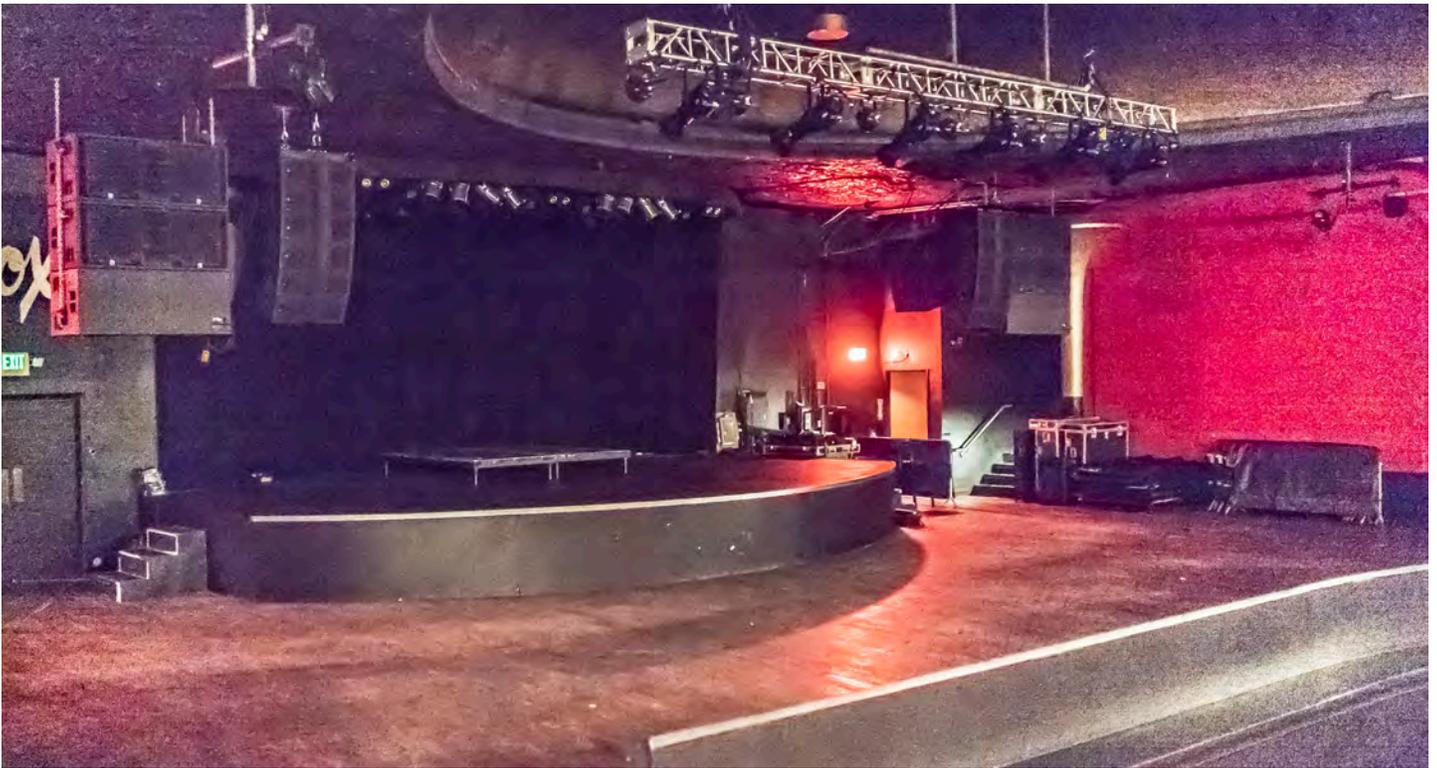
**Figure 29.** Showbox, looking south at the stage. The proscenium consisting of large rounded corners leading back to a flat back wall are original to the 1939 remodel and remain behind the curtains.

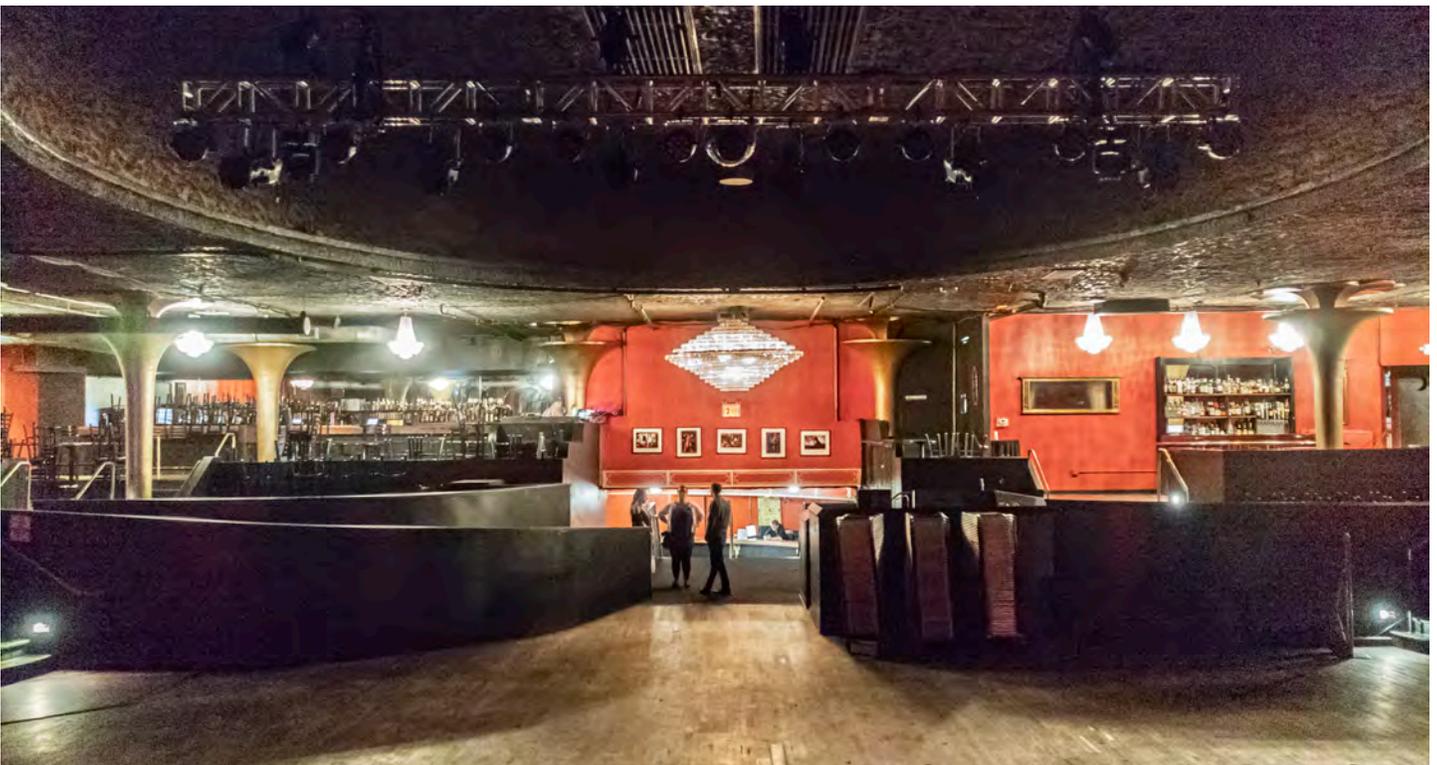
**Figure 30.** Showbox, looking north from the stage at the passageway entrance to the space. The vaulted ceiling is original to the 1939 remodel.

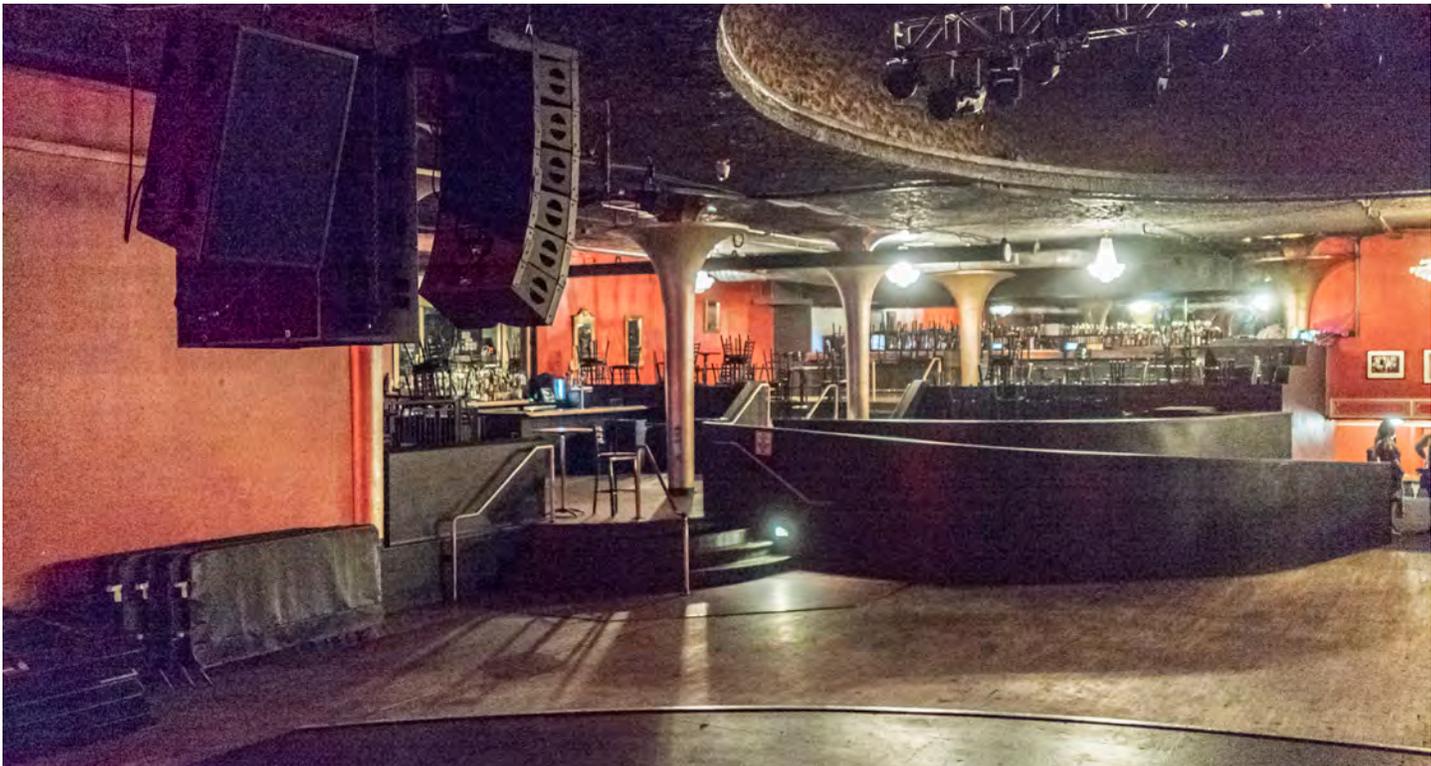
**Figure 31.** Showbox, looking west from the stage. The columns and parts of the tiered seating are original to the 1939 remodel.

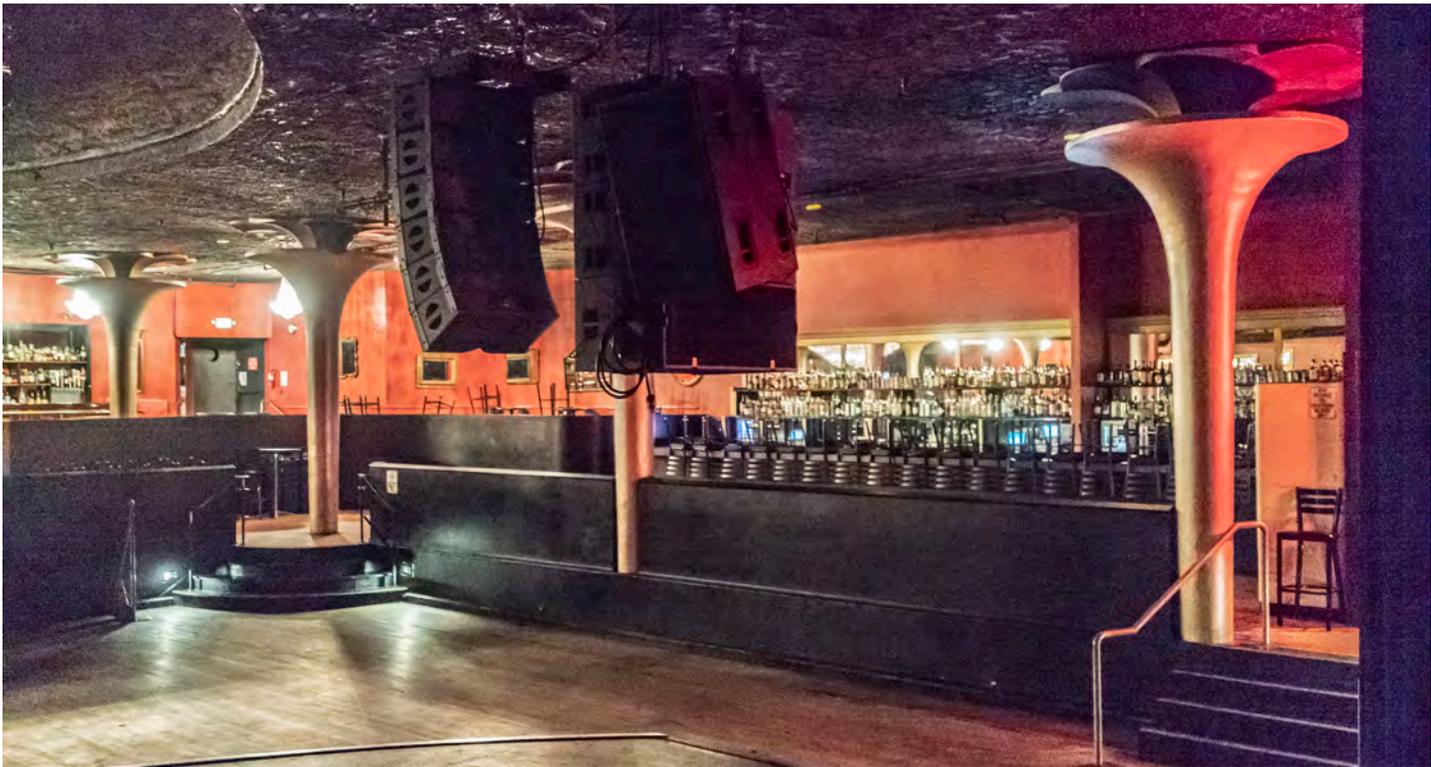
**Figure 32.** Showbox, looking east from the stage. The columns and parts of the tiered seating are original to the 1939 remodel.

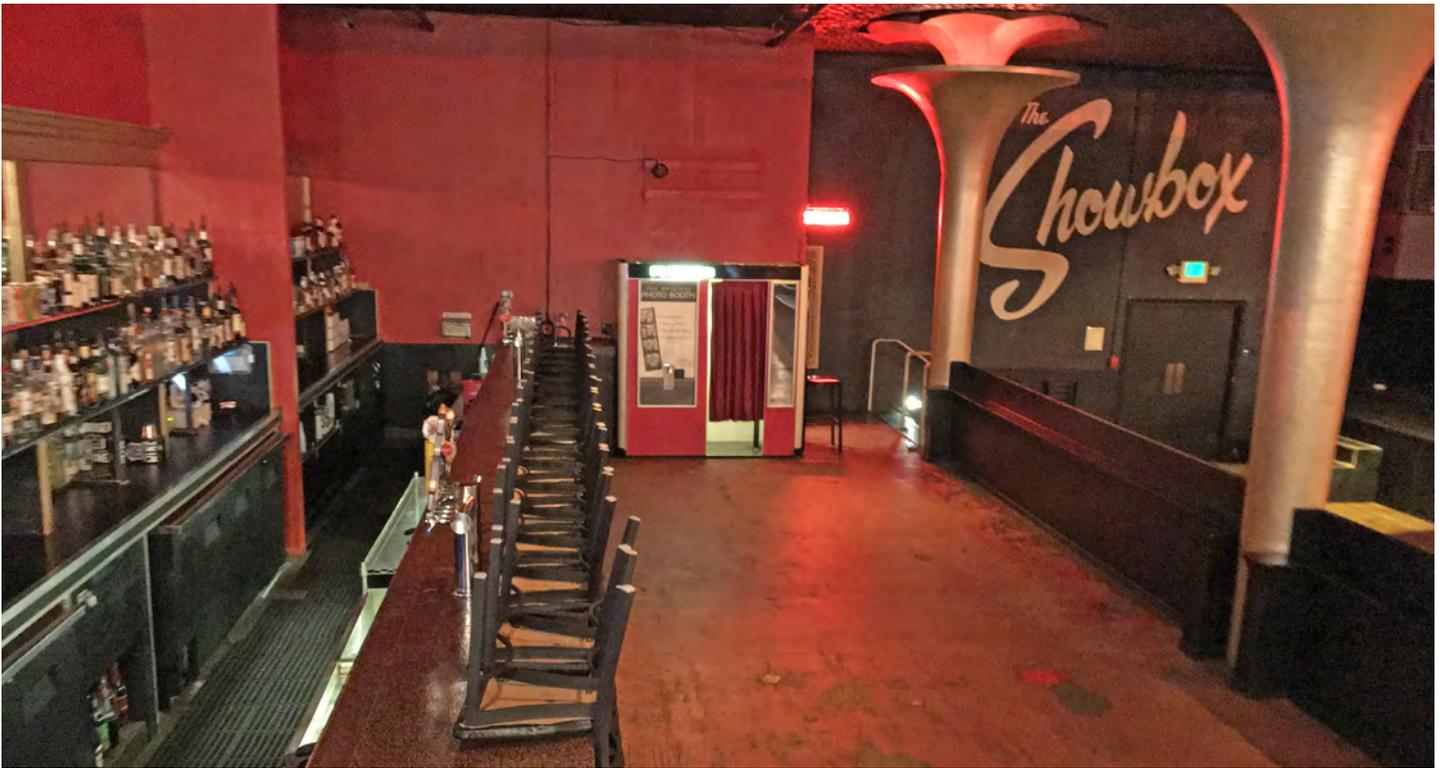
**Figure 35.** Showbox, east bar, looking south.

- 2000s: This work added a rounded front to the main stage, installed a full bar along the east side of the room, and constructed the inner and outer artist green rooms. The small stage that had been added on the west side of the floor was replaced with the existing bar.

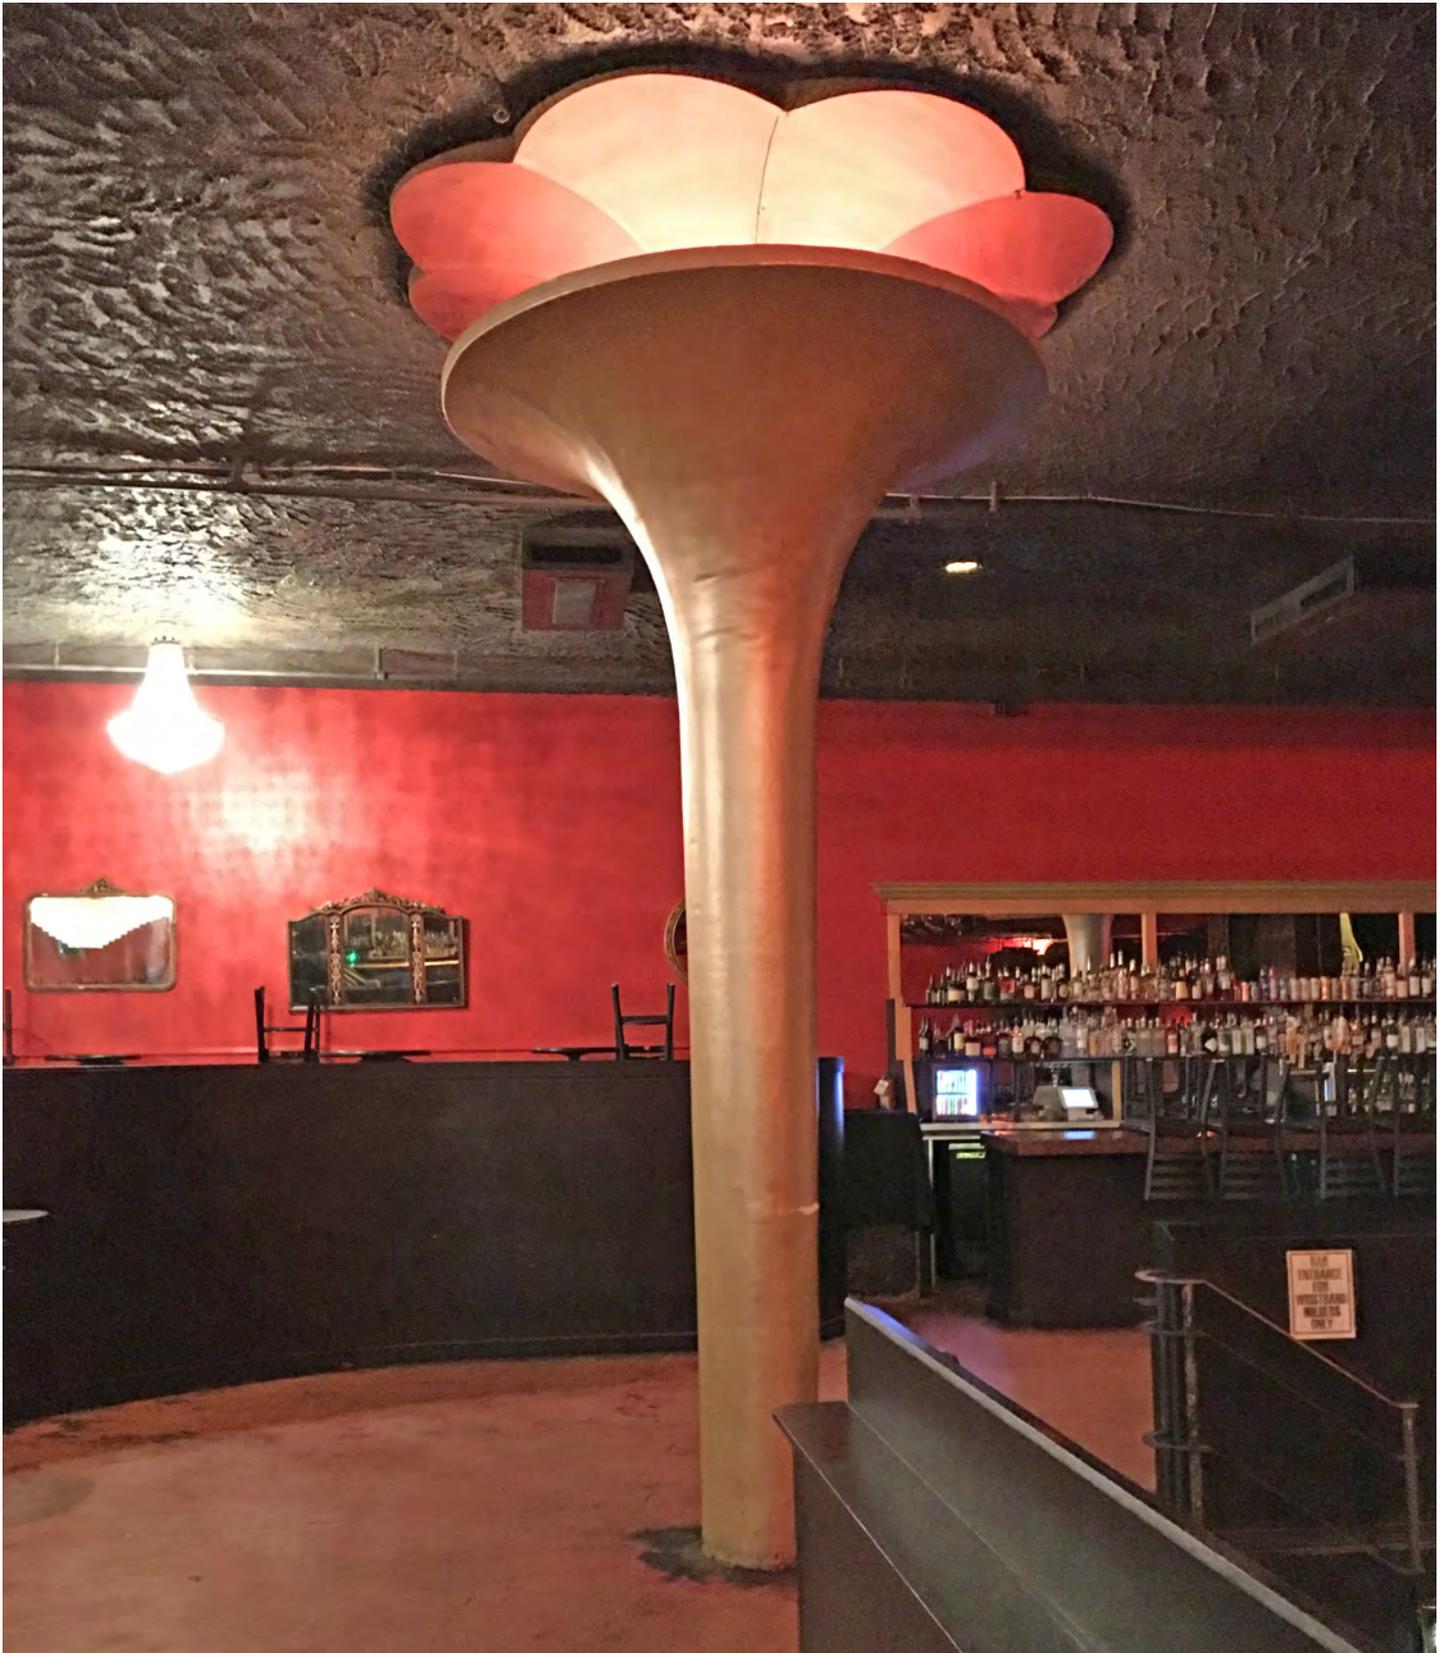
**Figure 37.** Showbox, detail of column original to the 1939 remodel. The core is a wood post with an outer plaster and wood form.

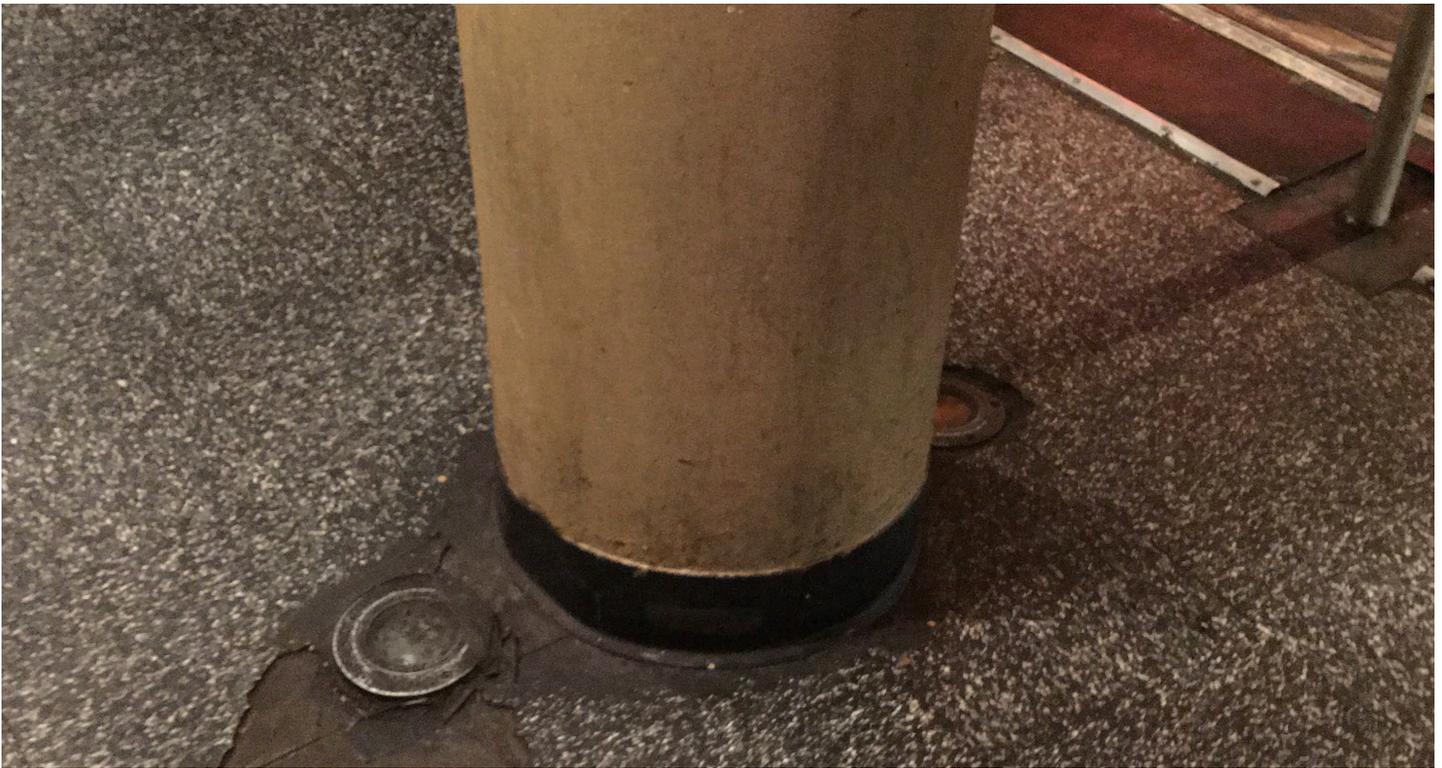
**Figure 38.** Showbox, detail of the floor lights original to the 1939 remodel that provided a light wash up the column.

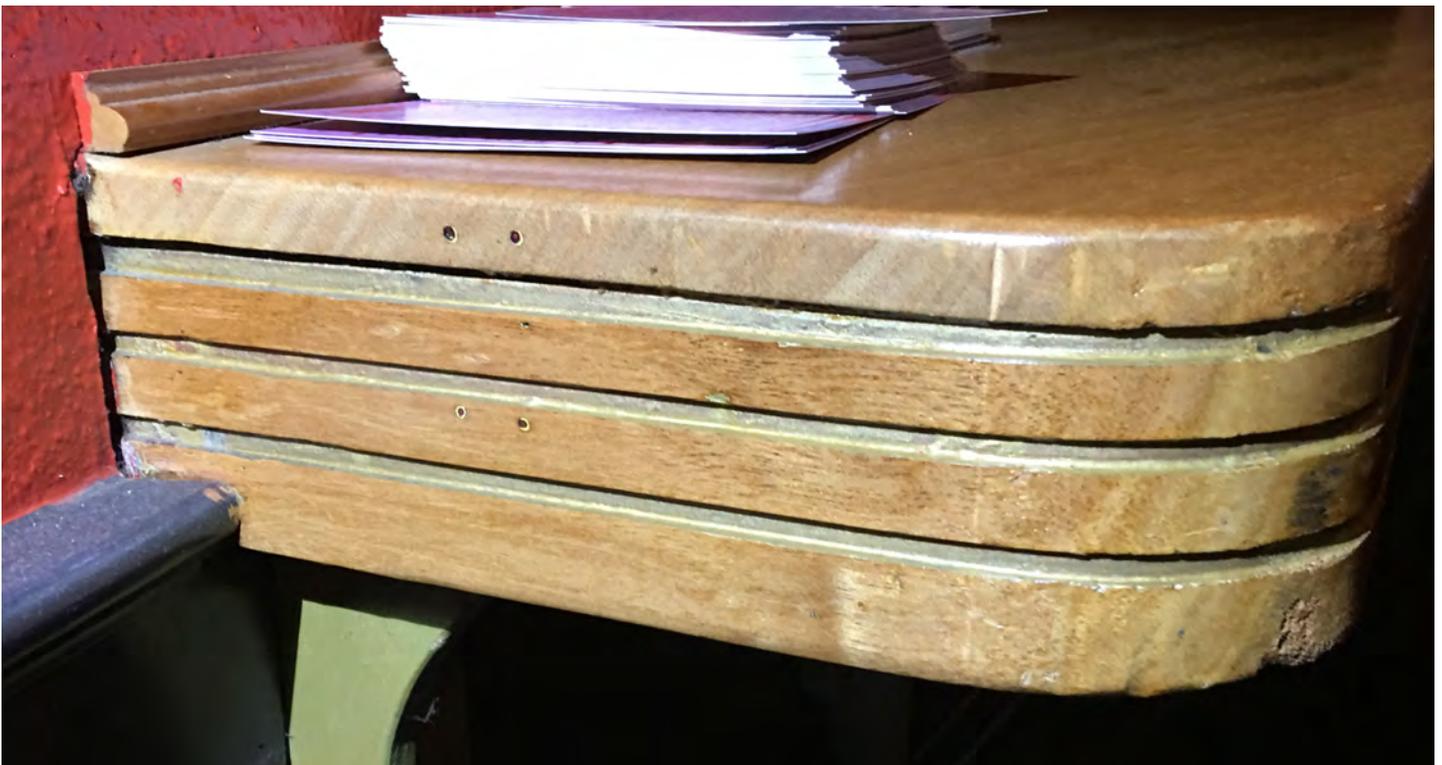
**Figure 39.** Showbox, detail of the ticket counter that is original to the 1939 remodel.

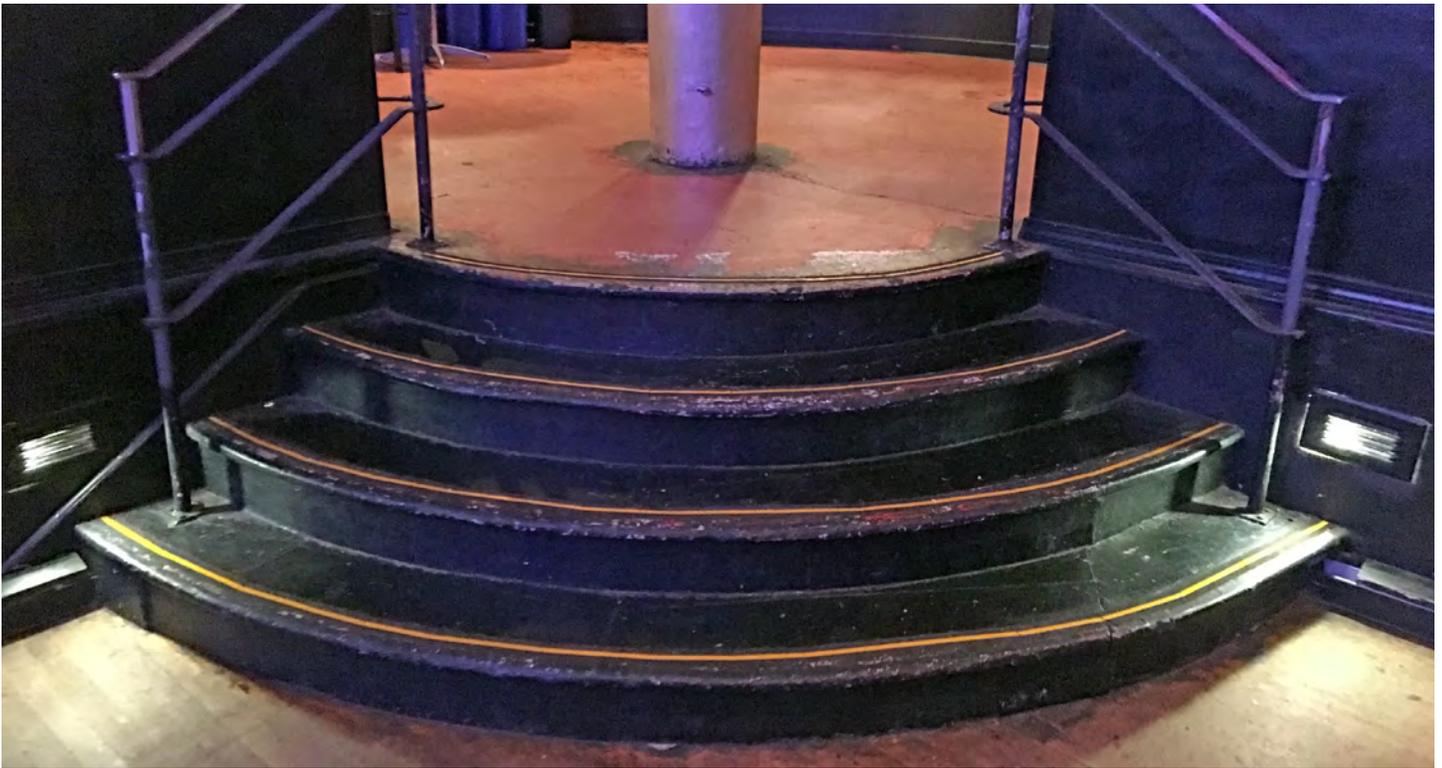
**Figure 40.** Showbox, detail of curved stairs and metal railings up from the dance floor to the terraced seating that are original to the 1939 remodel.

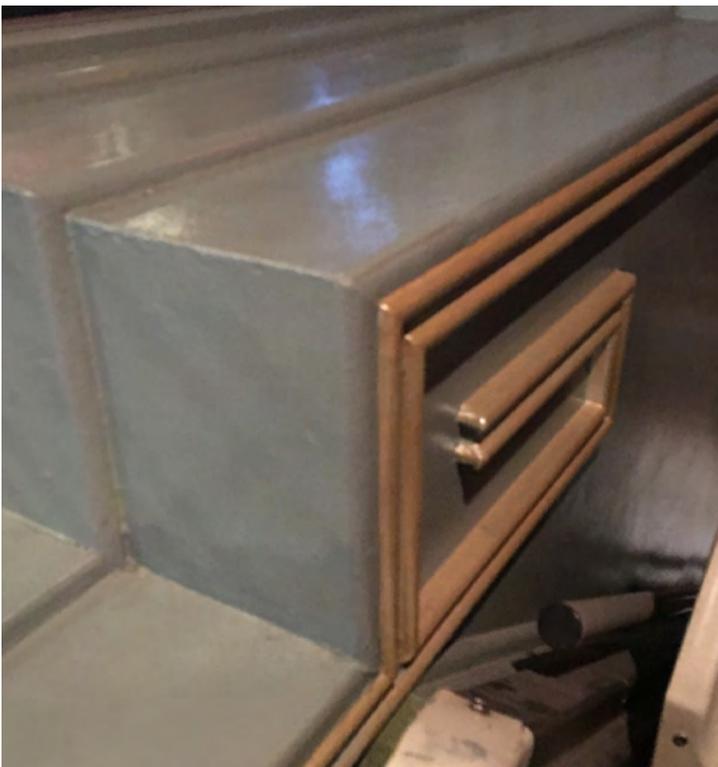
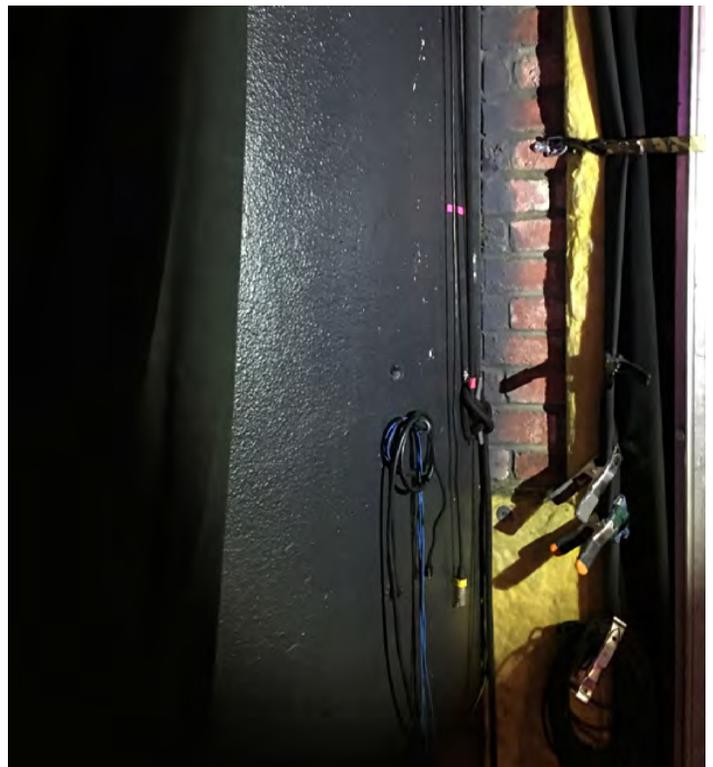
**Figure 41.** Showbox, detail (above left) of the stepped cheek walls and detailing that are original to the 1939 remodel. Detail (above right) of the curved proscenium edges that are original to the 1939 remodel.

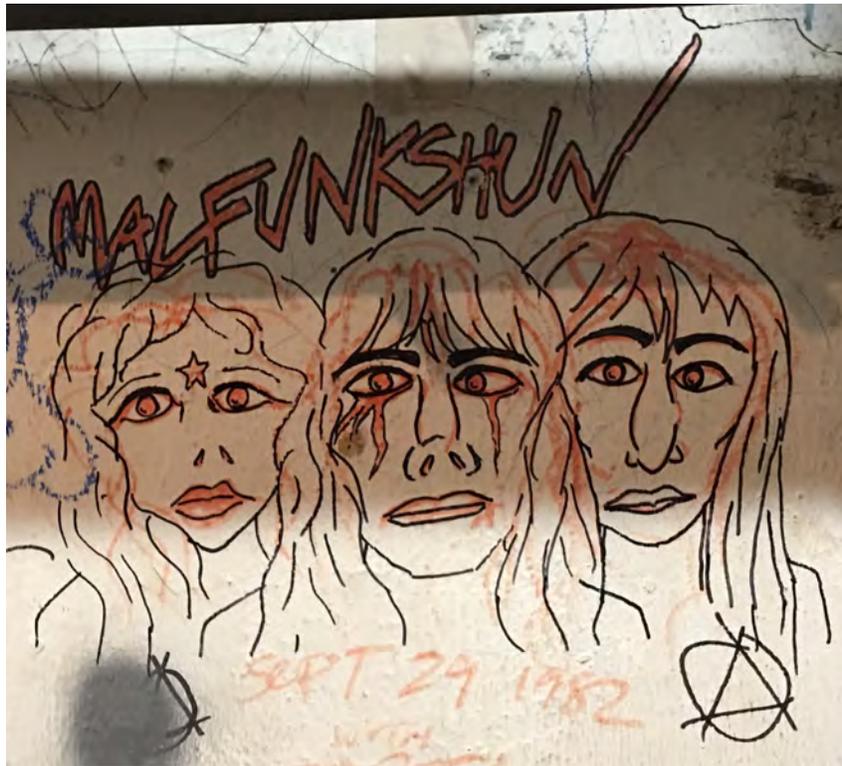
**Figure 42.** Showbox, example of the unique graffiti in the fly loft space above and behind the stage that relate to the Seattle's music history and to local and Washington state bands that were key in the early development of grunge.

The fly loft is located behind the stage and extends to the southeast over the egress stairway. Douglas fir flooring extends throughout the space, with plaster walls. A wood frame ladder provides access to the upper level. The space provides storage for cabling and performance related equipment. The upper portion features graffiti from the multiple bands that played at the venue, including Neil Young and Malfunkshun (one of the forerunners of the grunge scene in the early 1980s and founded by brothers from Bainbridge Island).

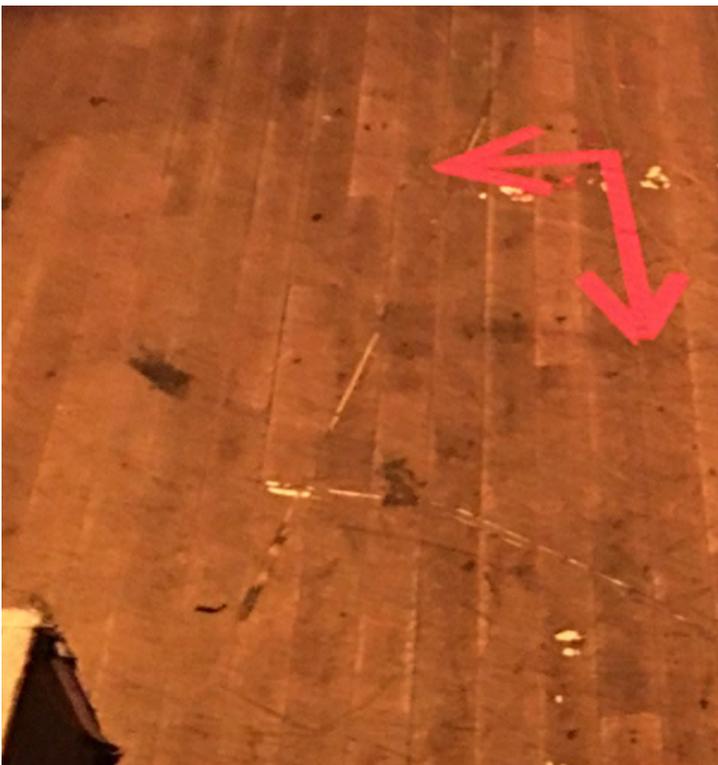
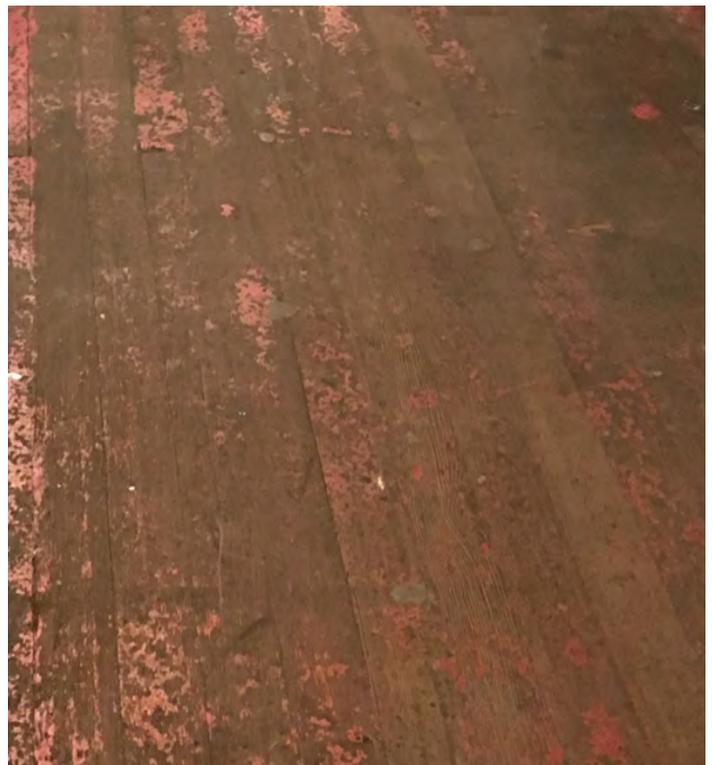
**Figure 43.** Showbox, detail (above left) of the maple dance floor original to the 1939 remodel. Detail (above right) of the Douglas fir flooring at sections of the raised seating area and behind the stage and at the ticket counter that are original to the 1939 remodel.
