# SHOWBOX

1426 First Avenue  
SEPTEMBER 10, 2018

The City of Seattle  
**Landmarks Preservation Board**

**Name:** Show Box, Showbox, Showbox Ballroom, Showbox at the Market      **Year Built:** 1917

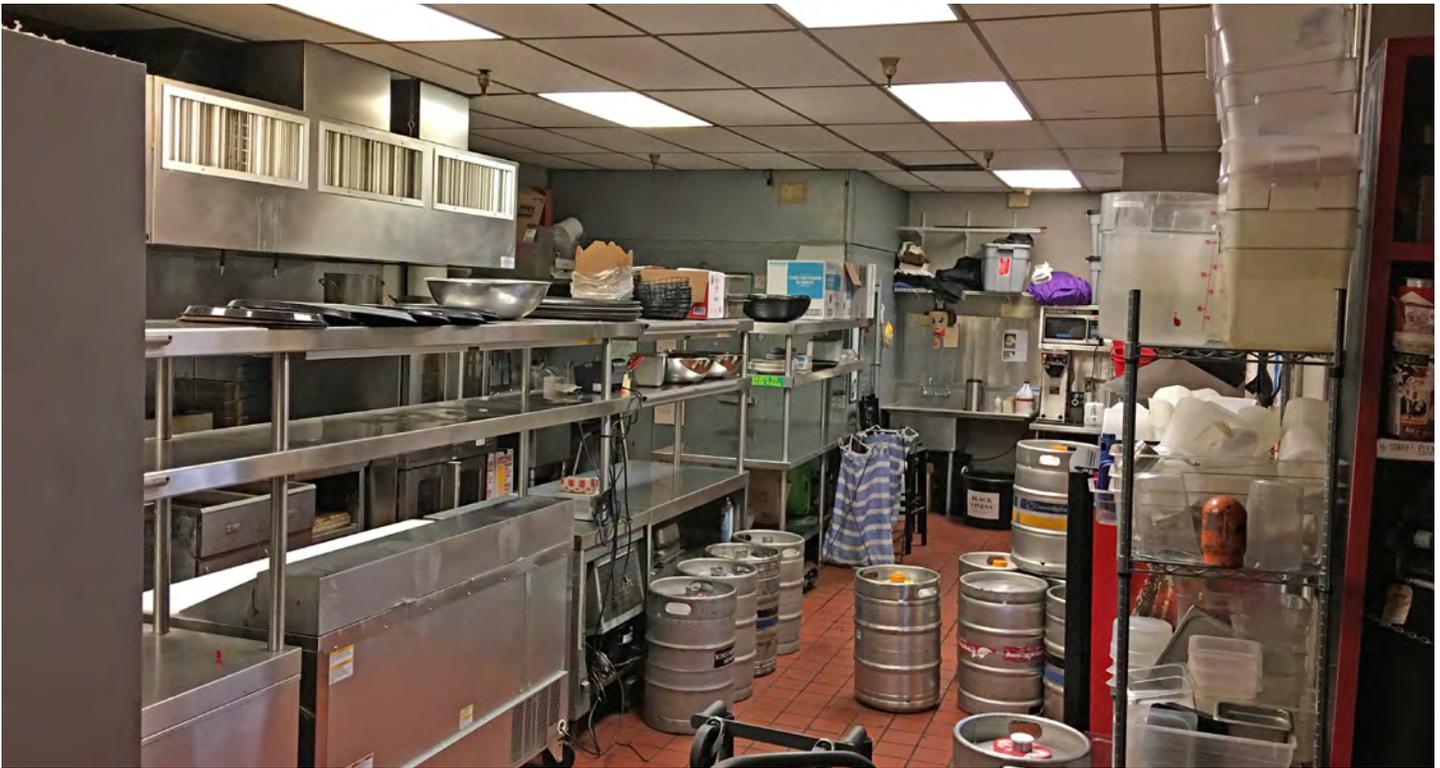
Figure 44. Showbox, view of the kitchen looking northeast.

The kitchen is narrow galley style with quarry tile flooring, T-bar drop ceiling, and painted sheet rock walls. Stoves, ovens, and stainless-steel food preparation spaces are built-out within the kitchen volume in the northeast corner of the floor. A hallway extends west through a former seating area above the entrance passageway, since enclosed, to the west seating area for service. Two doors off the south side of the kitchen area access the east seating area.

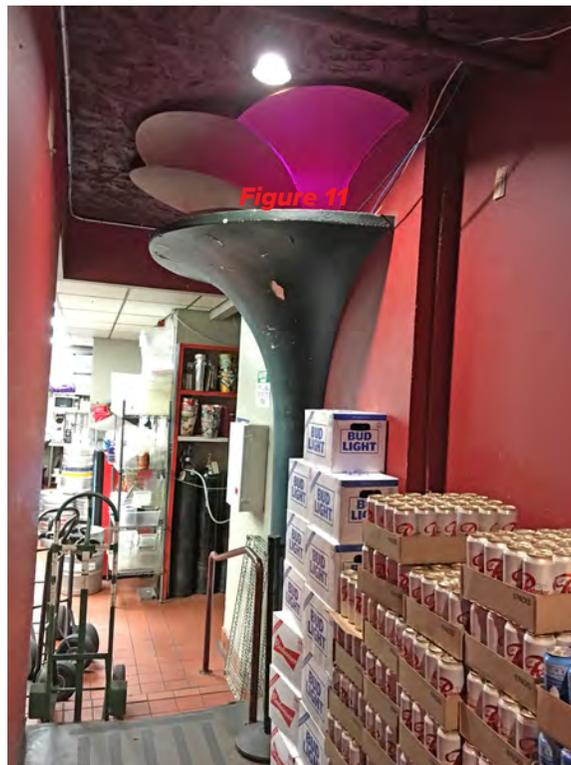
Figure 45. Showbox, detail of the walkway above the passageway from the west seating area into the kitchen. Note how later partitions were abutted up to the column elements leaving them intact.

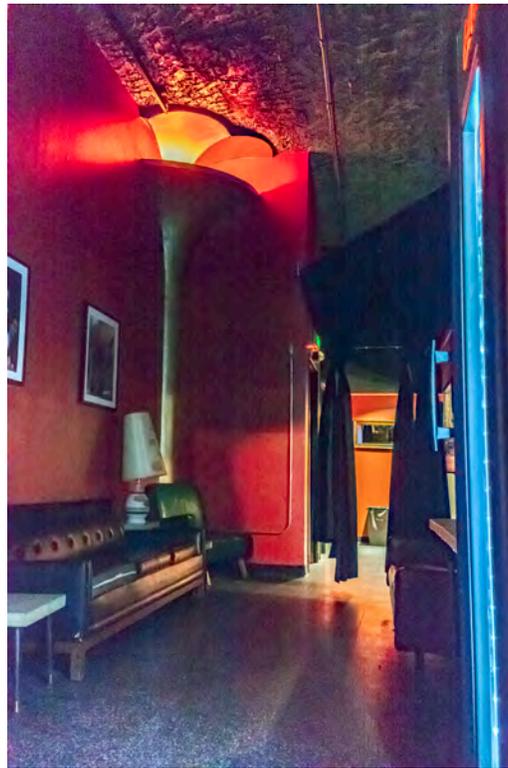
**Figure 46.** Showbox, outer green room looking south. Note how later partitions were abutted up to the column elements leaving them intact.

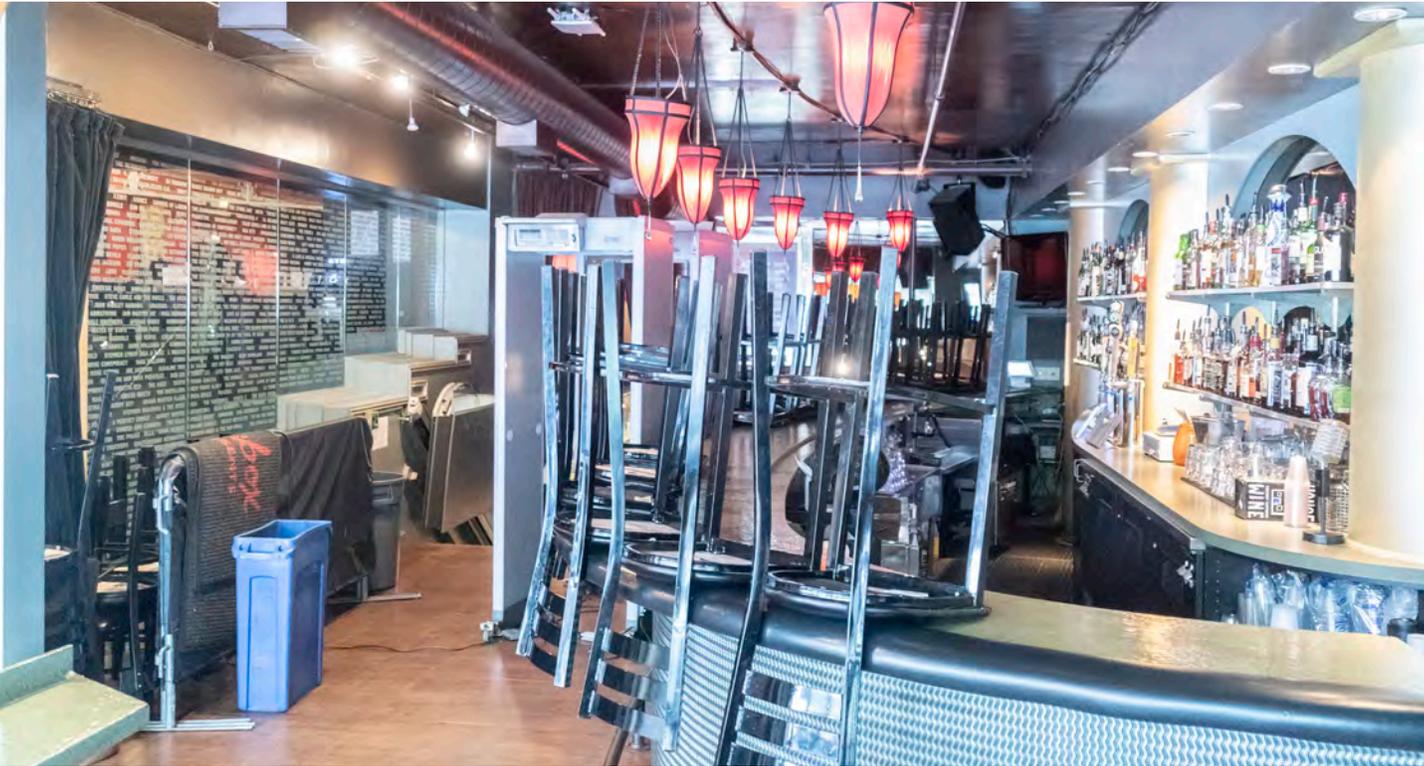
Figure 51. Showbox, fly loft showing the building framing and the graffiti within the space.

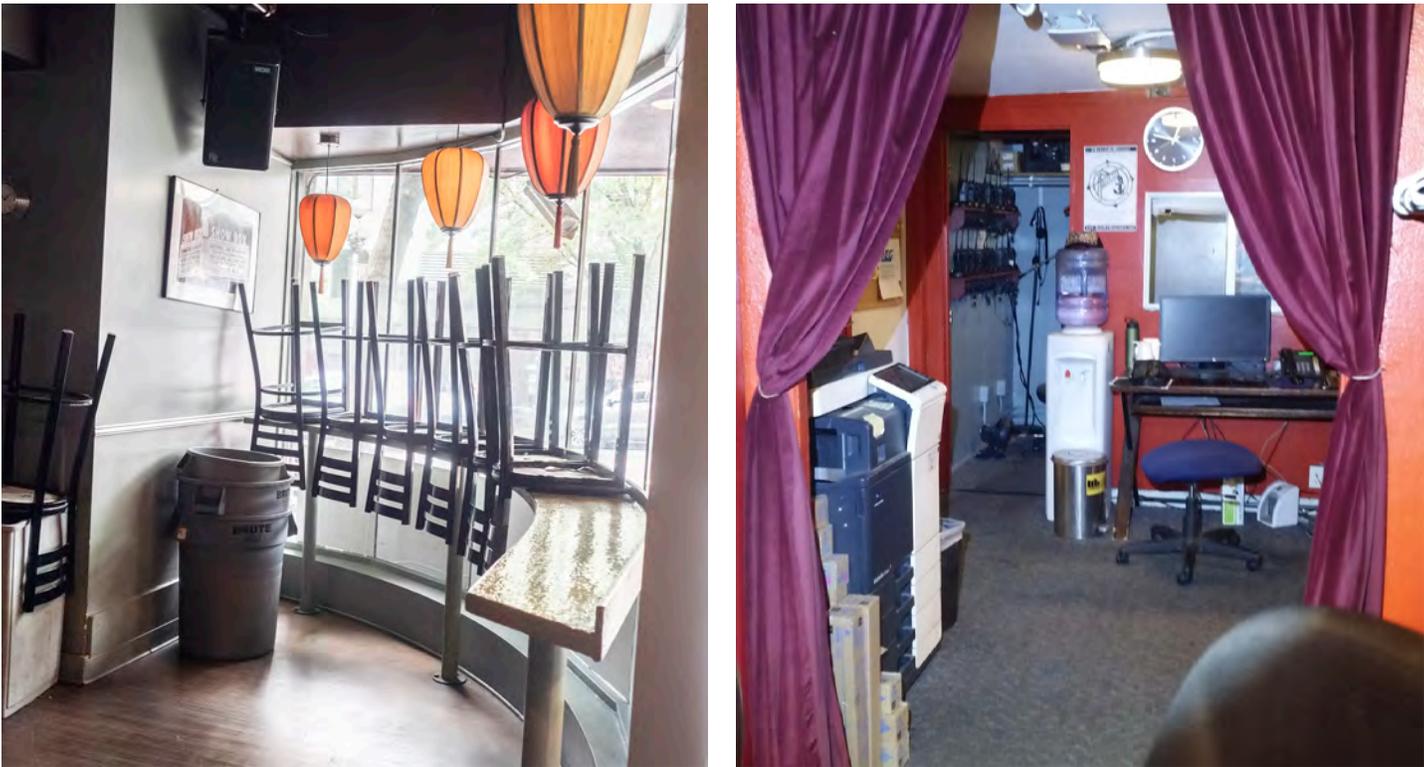
**Figure 52.** Showbox, associated bar in the 1424 1st Avenue curved storefront space, looking east. Note the stepped cheek wall at left that is original to the 1939 remodel.

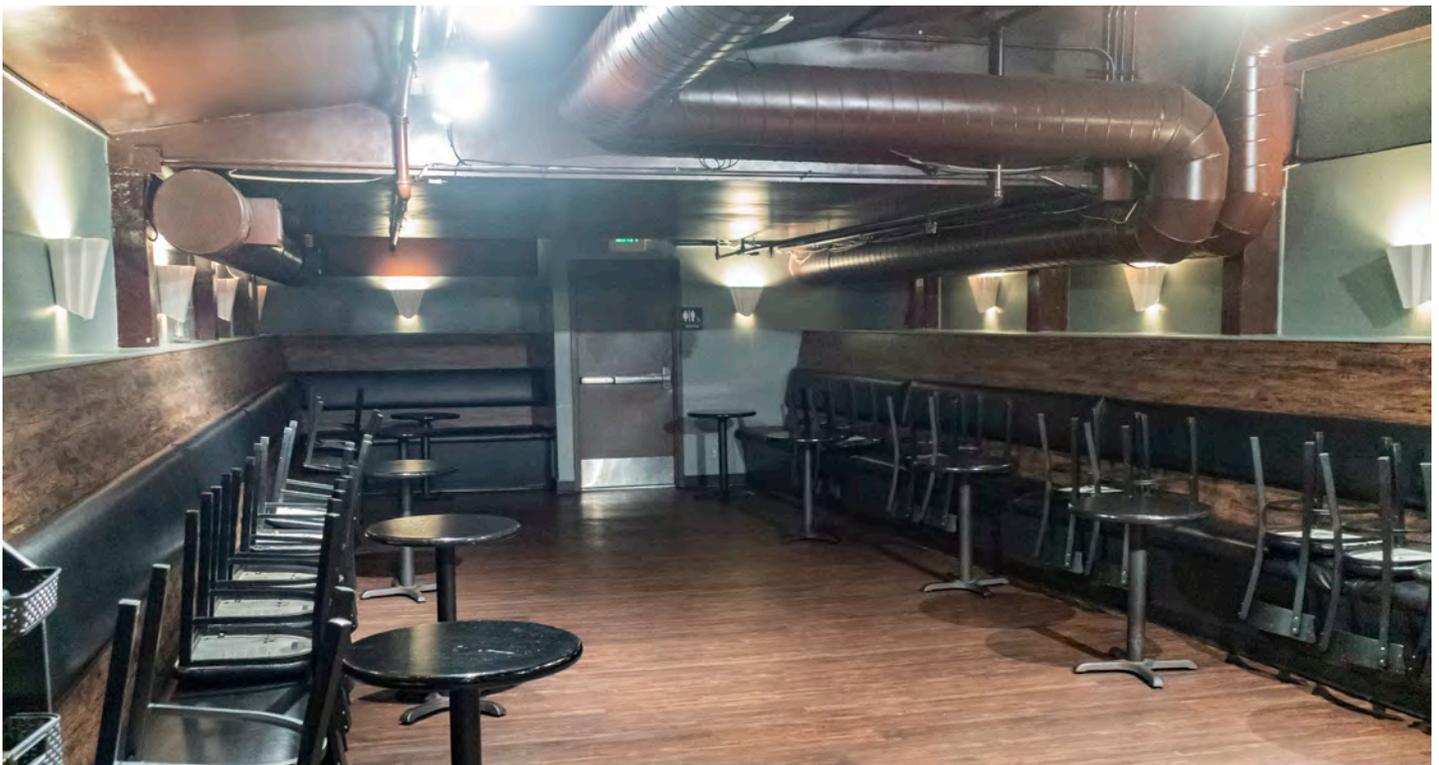
**Figure 55.** Showbox, looking east through the lower level. Note the sloped ceiling which is original to the 1939 remodel and is the underside of the original ramp up to the performance hall from the ticket counter.

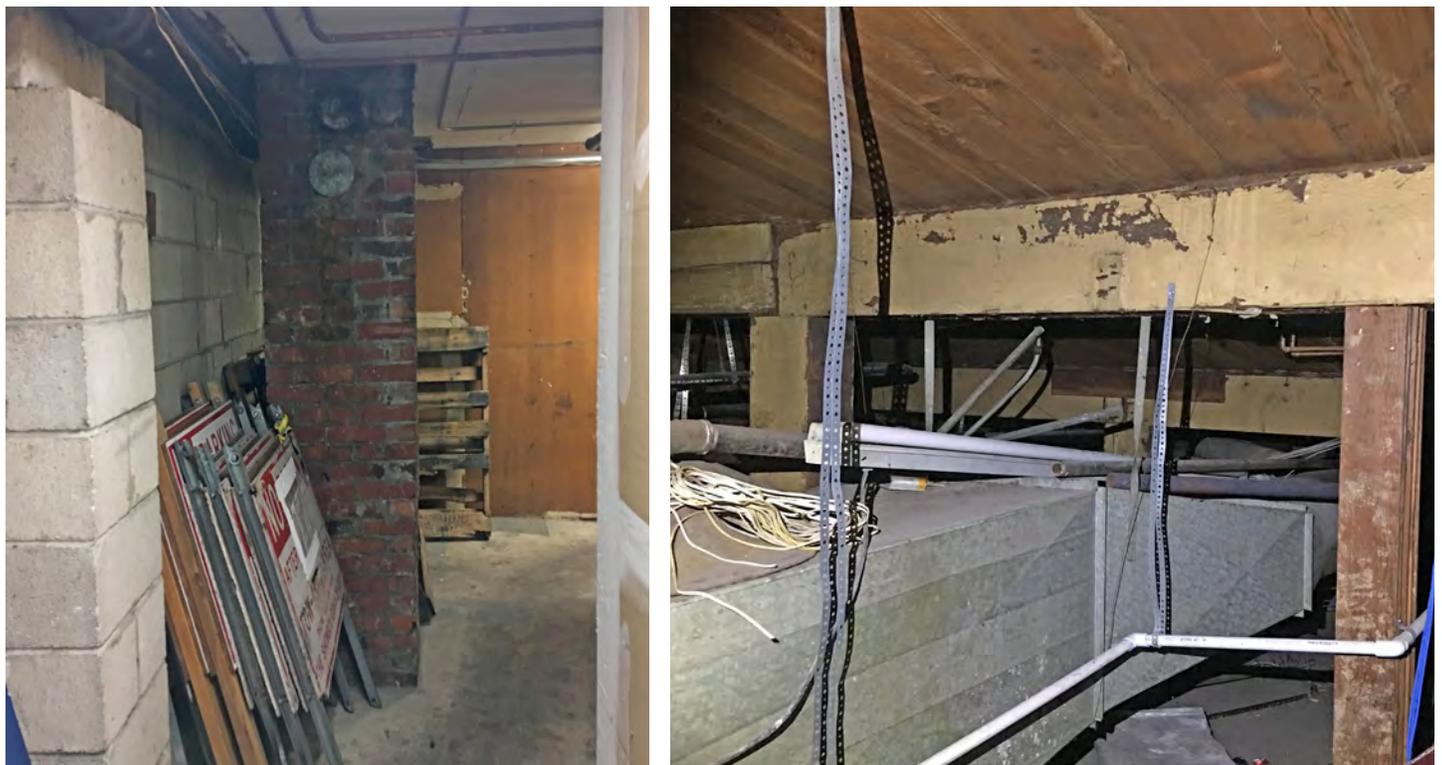
**Figure 57.** Service area, looking east along the rebuilt north facade. The brick chimney is original to the 1916 construction of the building (above left). A view looking west (above right) below the Showbox passageway showing the framing and ramp that are original to the 1939 remodel.

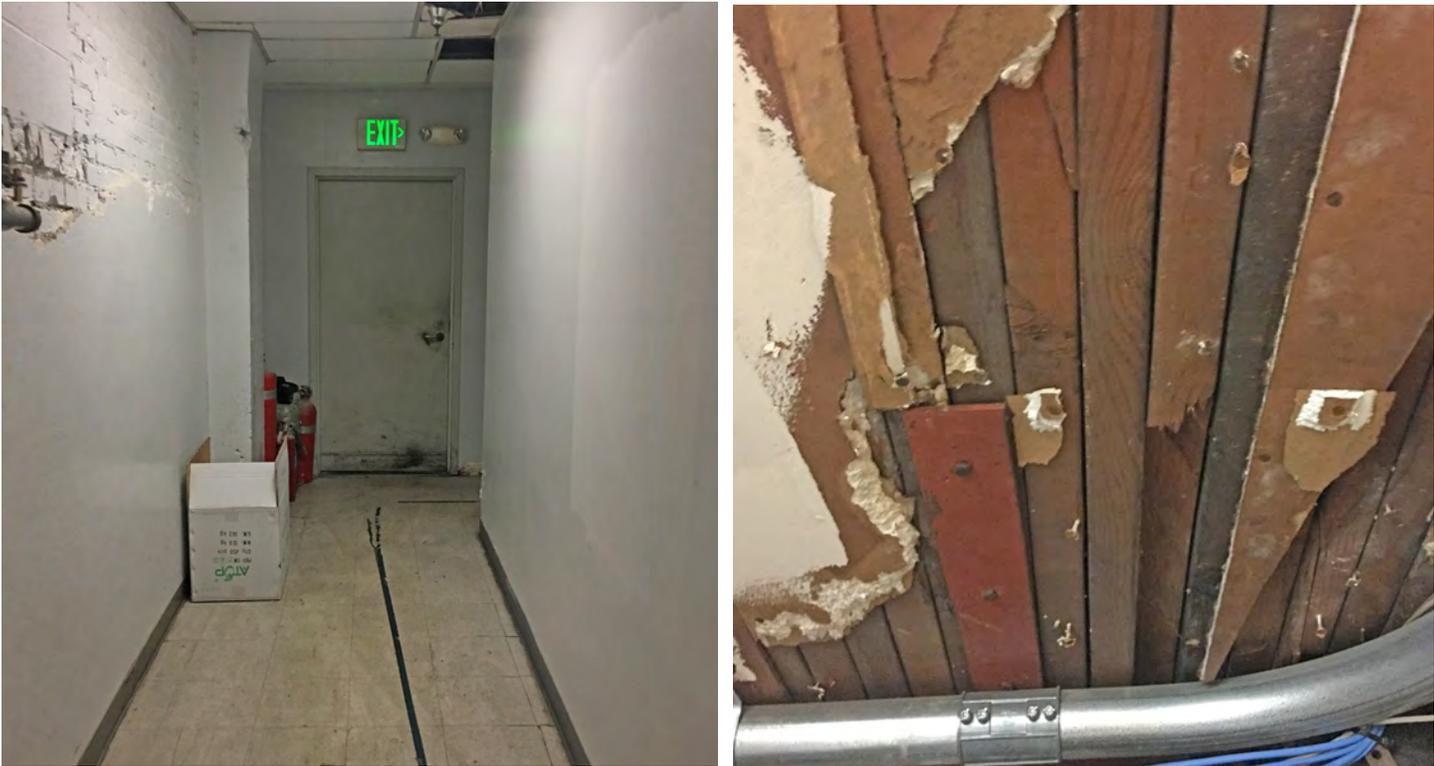
**Figure 58.** Service area, looking east and showing typical wall finishes (above left). The wall along the left side is the outer brick masonry wall. Note the brick pier that steps out to support the massive east to west beams carrying the second floor. A detail (above right) of the crib construction (2x boards on edge) comprising the floor structure for the second floor.

Interior framing consists of ten- by ten-inch posts set on 22-foot centers that support the floor framing. These wood posts occur at each floor. The posts have chamfered corners and carry massive timber beams (approximately 14- by 14-inches in section) that run east to west. Steel strap ties anchor the beam ends to the outer walls. The first floor consists of a concrete slab with some wood floor sections along First Avenue. The second floor and roof deck consist of nominally two-inch-thick boards set on edge and butted one next to the other. This construction method provides a high load capacity for the flooring system. Steel brackets anchor the posts to the beams. Through-wall steel ties connect the second floor and roof framing to the exterior walls. **See Figure 58, upper right image.**

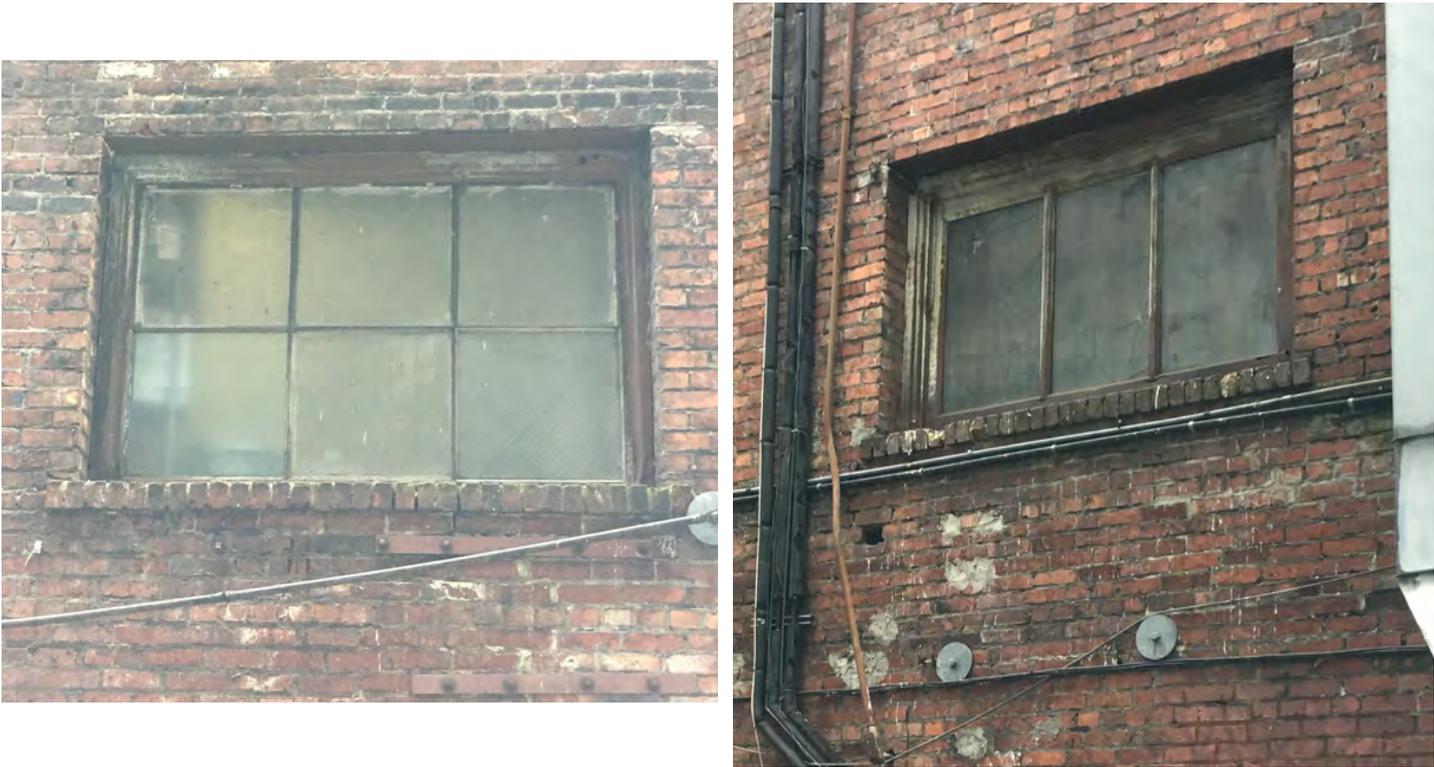
**Figure 59.** Alley facade, detail of the 6-lite (above left) and 3-lite (above right) sash along this facade.

Windows occur on the front west and rear east facades. West facade windows consist of three window openings set in a horizontal band characteristic of the Streamline Moderne style. Each opening consists of two fixed sash flanked by narrow sash having a larger fixed upper and smaller operable lower sash. Window frames are anodized aluminum. The window band is framed by a projecting modernistic border emphasizing the horizontal character of the facade, with painted corrugated metal panels between the windows and at the south end. The border consists of raised outer edges with a central recessed channel. **See Figures 11, 13, 59-60.**

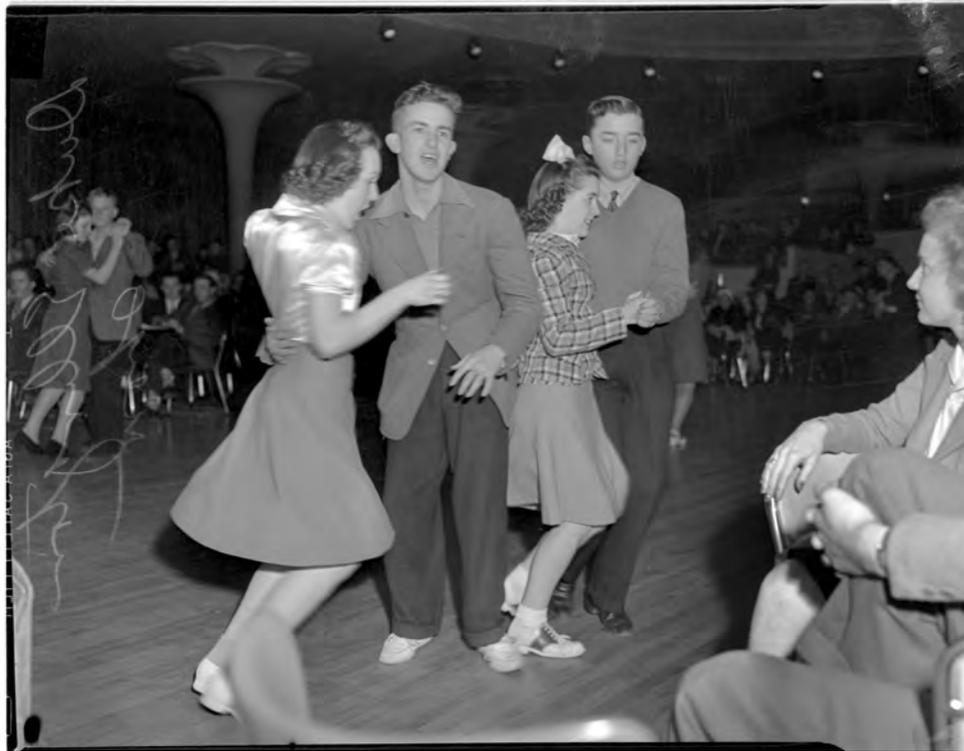
**Figure 62.** Ca. 1940s to 1950s view showing the front entrance to the Showbox, the underside of the original marquee, and the curved storefront of the associated bar. The glass panes in the storefront replicated the original glazing pattern in the west facade upper story windows. Image courtesy Lyons Family Archive.

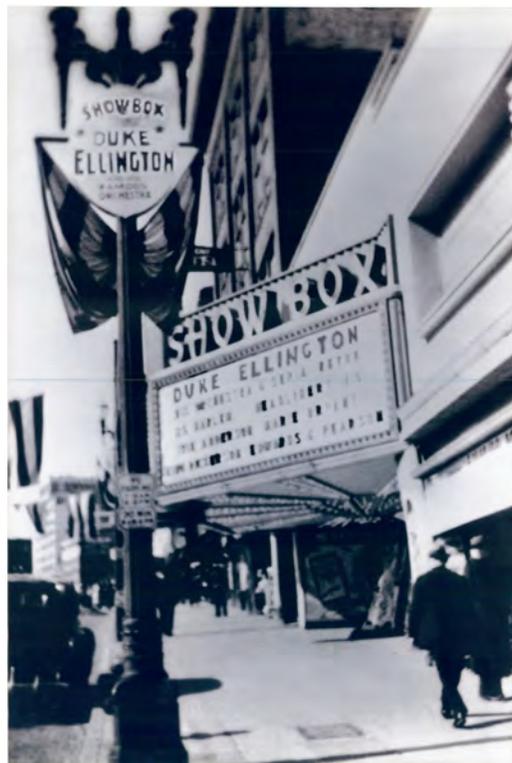
**Figure 63.** 1940 image showing dancers at the Duke Ellington performance. The existing original dance floor, columns, and vaulted ceiling are visible in the photograph. Image courtesy Lyons Family Archive.

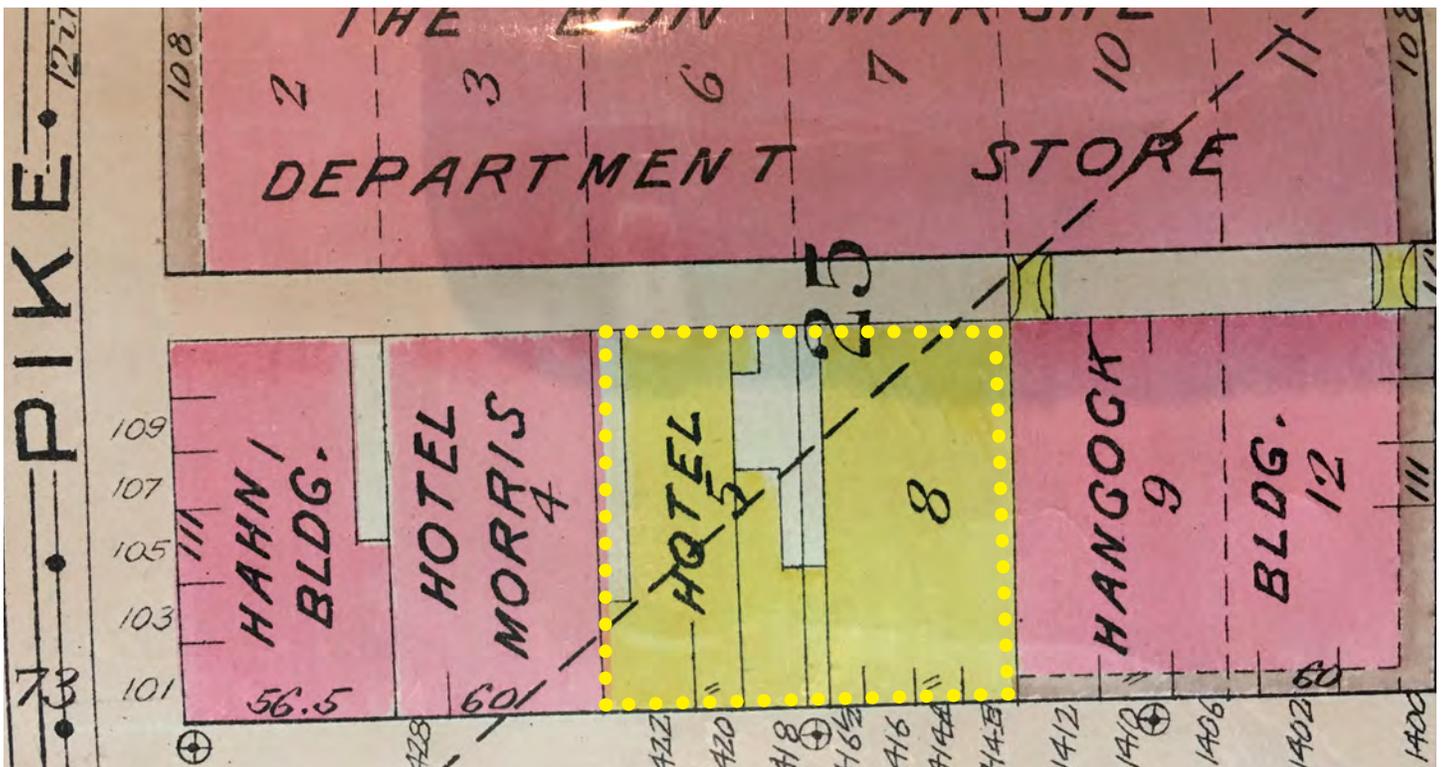
**Figure 69.** 1908 Baist's Real Estate Atlas Map. Courtesy of Seattle Public Library, Seattle Room. This map shows the buildings at the site (outlined in yellow dots) prior to construction of the Central Market Building in 1916, which would become the Showbox. Note the Great Northern Railroad tunnel passing below the building site.

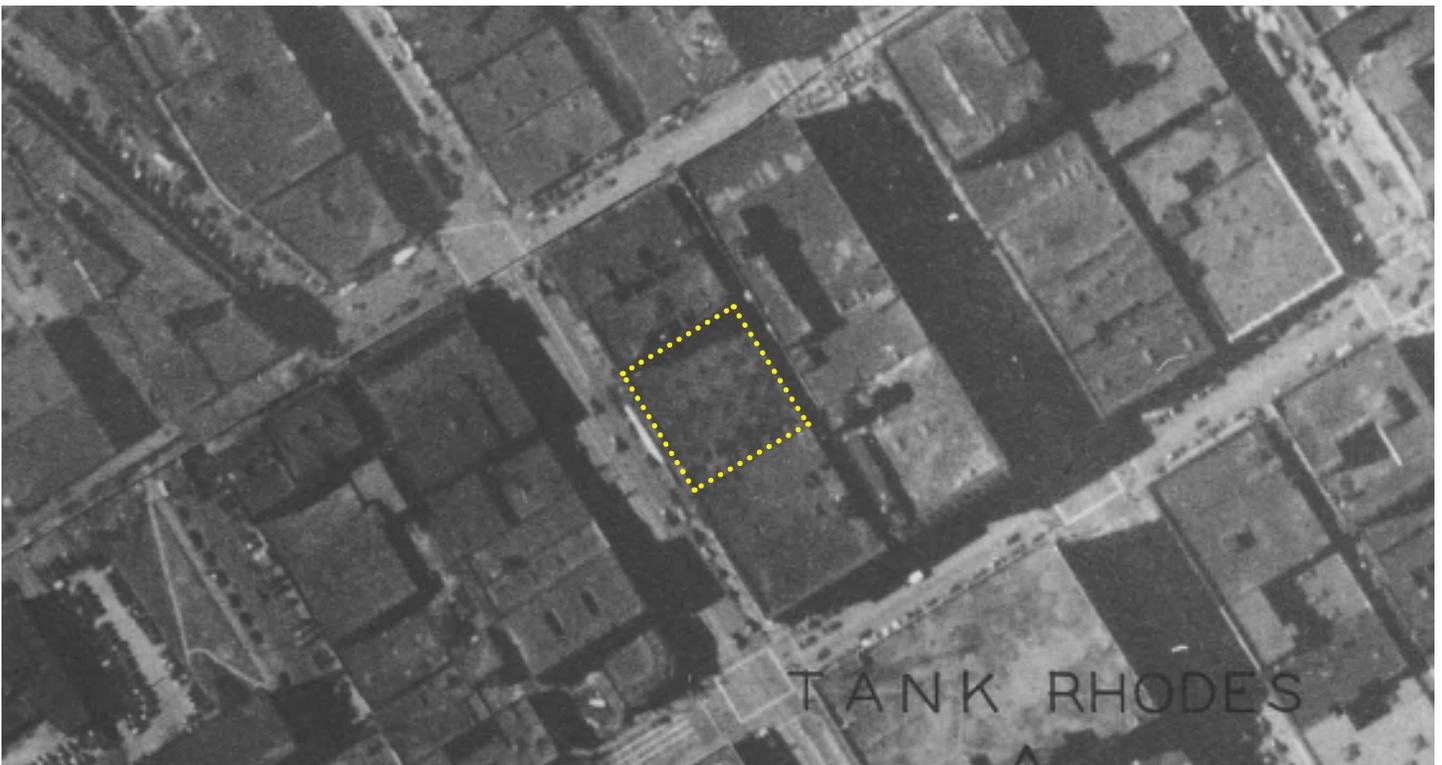
**Figure 74.** 1937 King County aerial showing the building (outlined in yellow dots) prior to the 1939 remodel. Note the elevated central truss roof portion for the vaulted ceiling at the second floor was part of the 1939 remodel.

A flat roof with composition roofing clads the building. A central low-pitched gable roof portion projects up from the main roof over the second-floor trusses and the domed ceiling. Parapets extend along the west, north, and east sides of the roof with a thin ledge (coping) along the front facade to visually accent the parapet edge and provide a horizontal emphasis to the facade. This ledge is repeated at a step in the parapet height. Sheet metal flashing caps the parapet. A steel armature mounted to the roof framing and supporting the front marquee occupies the northwest corner of the roof behind the parapet. Rooftop mechanical equipment is located around the roof perimeter behind the parapet. Sheet metal ducting and steel enclosed conduit (related to restaurant and performance venue functions) extend up to this equipment along the outer face of the east facade to avoid disrupting the interior performance volume. Metal downspouts extend down from the roof along the east facade, discharging at the alley. An internal brick chimney is in the northeast corner of the building. **See Figures 3, 74.**

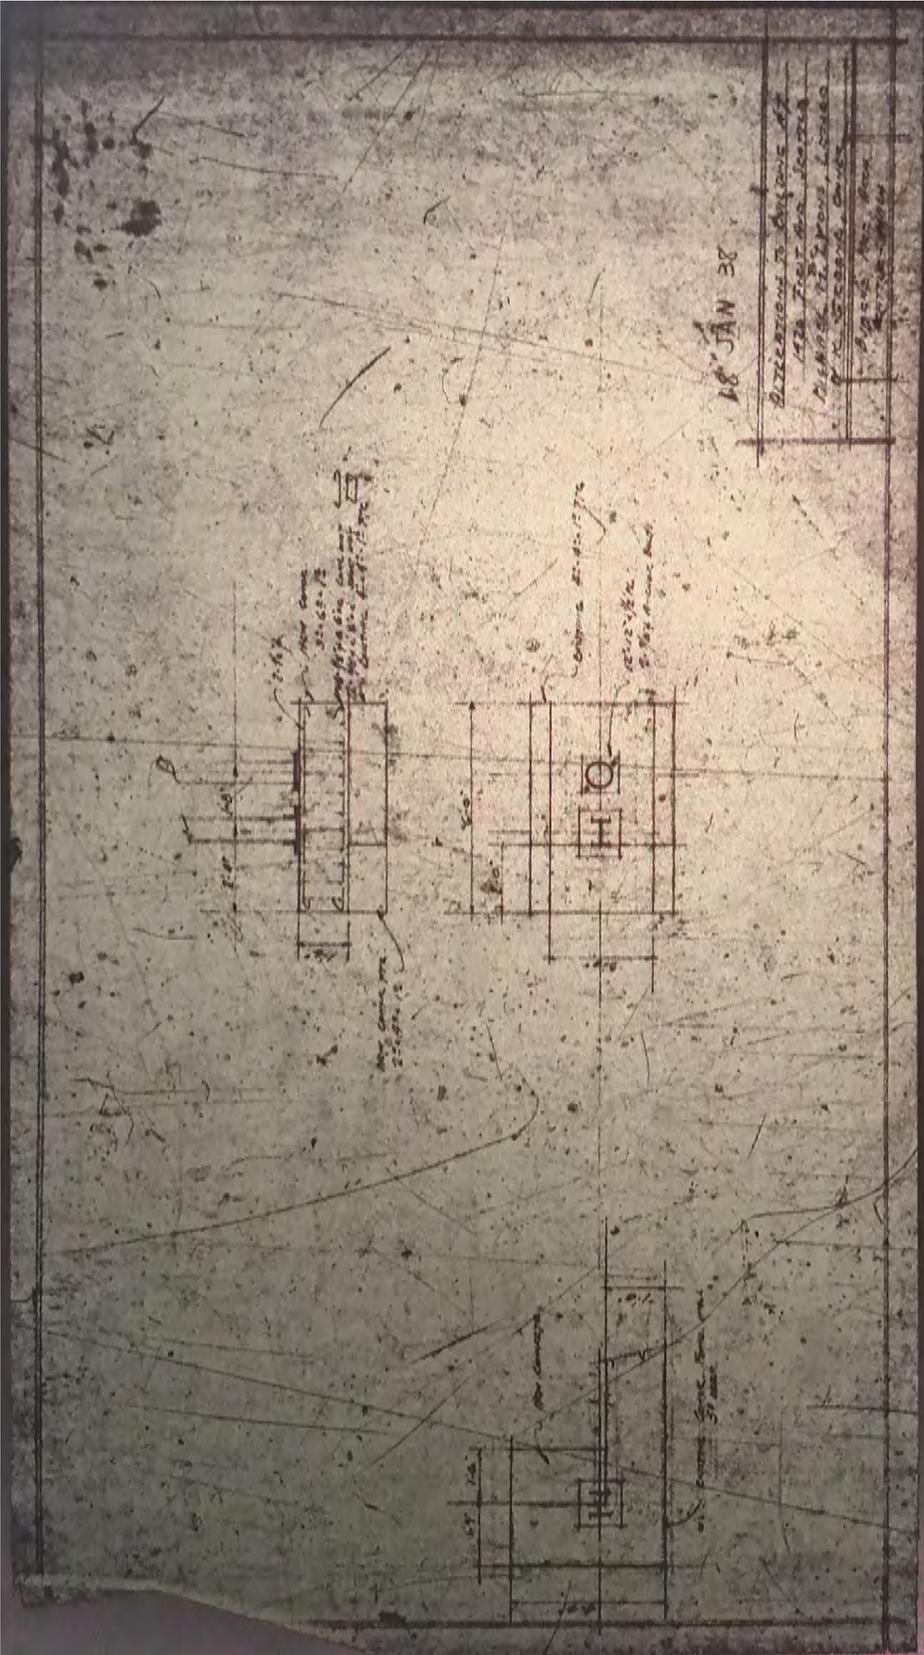
**Figure 75.** 1938 (January 18) drawing showing foundation upgrades for Michael Lyons (leasing space) and K. Greene (owner) by architect Bjarne Moe. Courtesy Seattle Department of Construction and Inspections microfilm library.

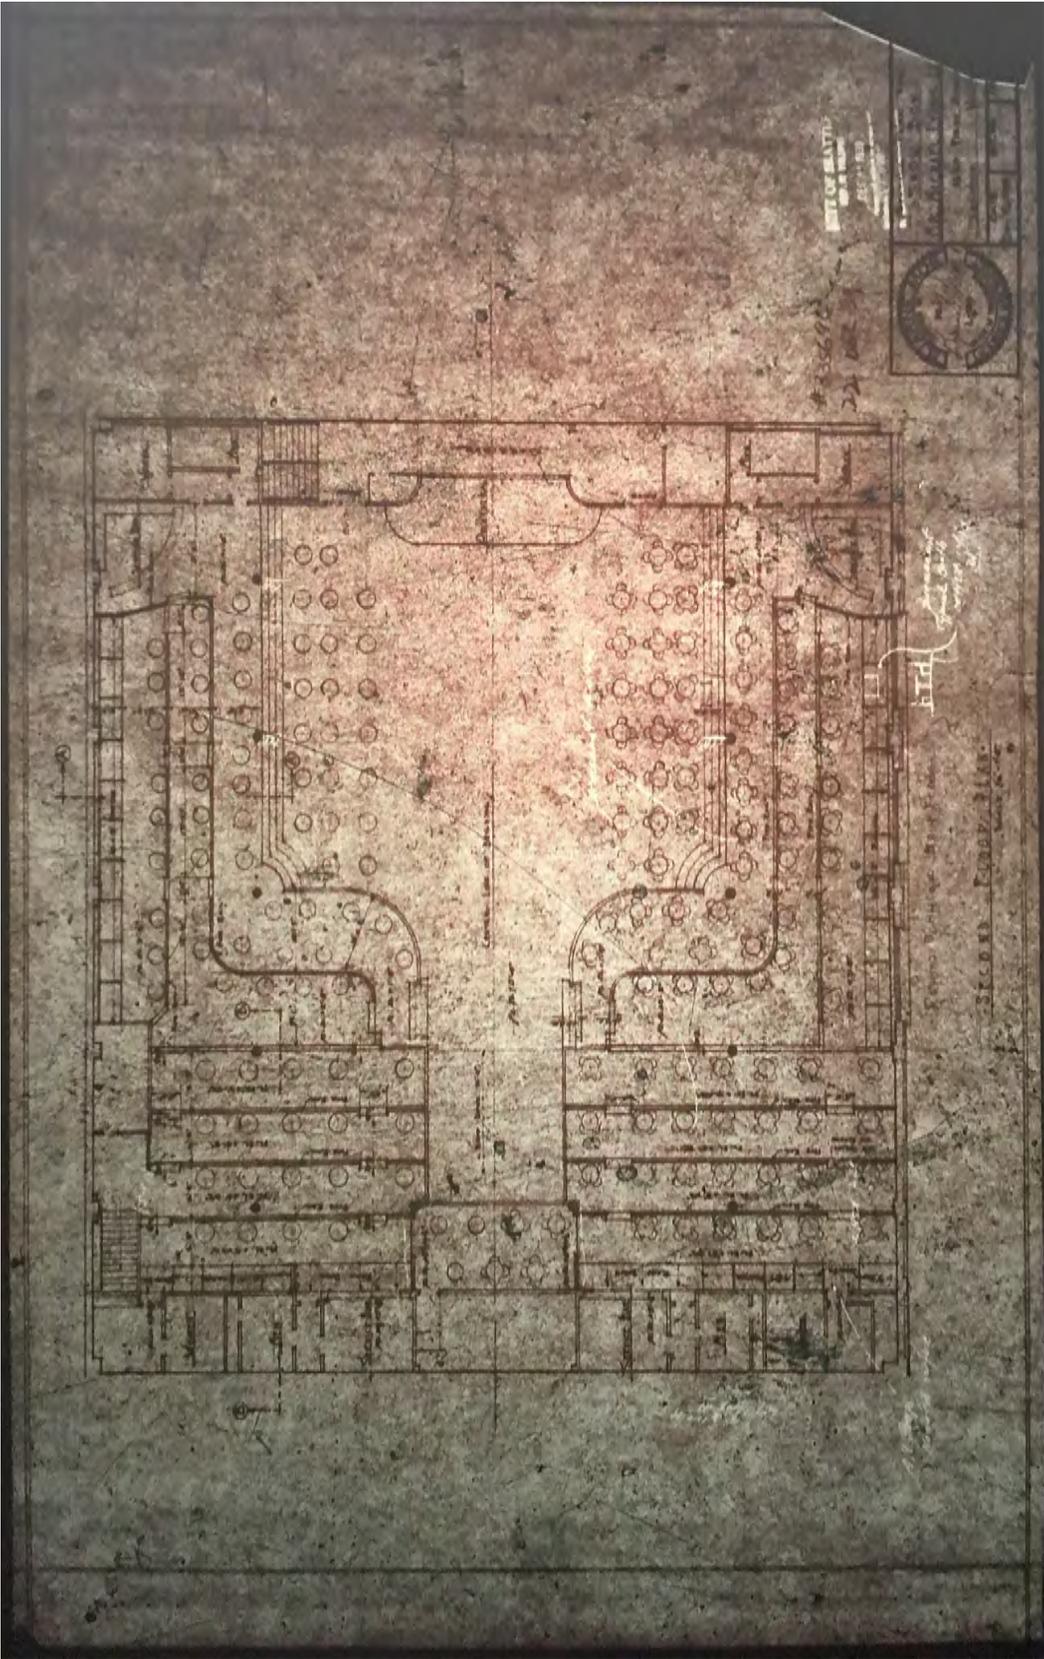
**Figure 76.** 1939 (December 15) drawing showing the second floor plan for the Showbox remodel for Michael Lyons prepared by architect Bjarne Moe. Courtesy Seattle Department of Construction and Inspections microfilm library.

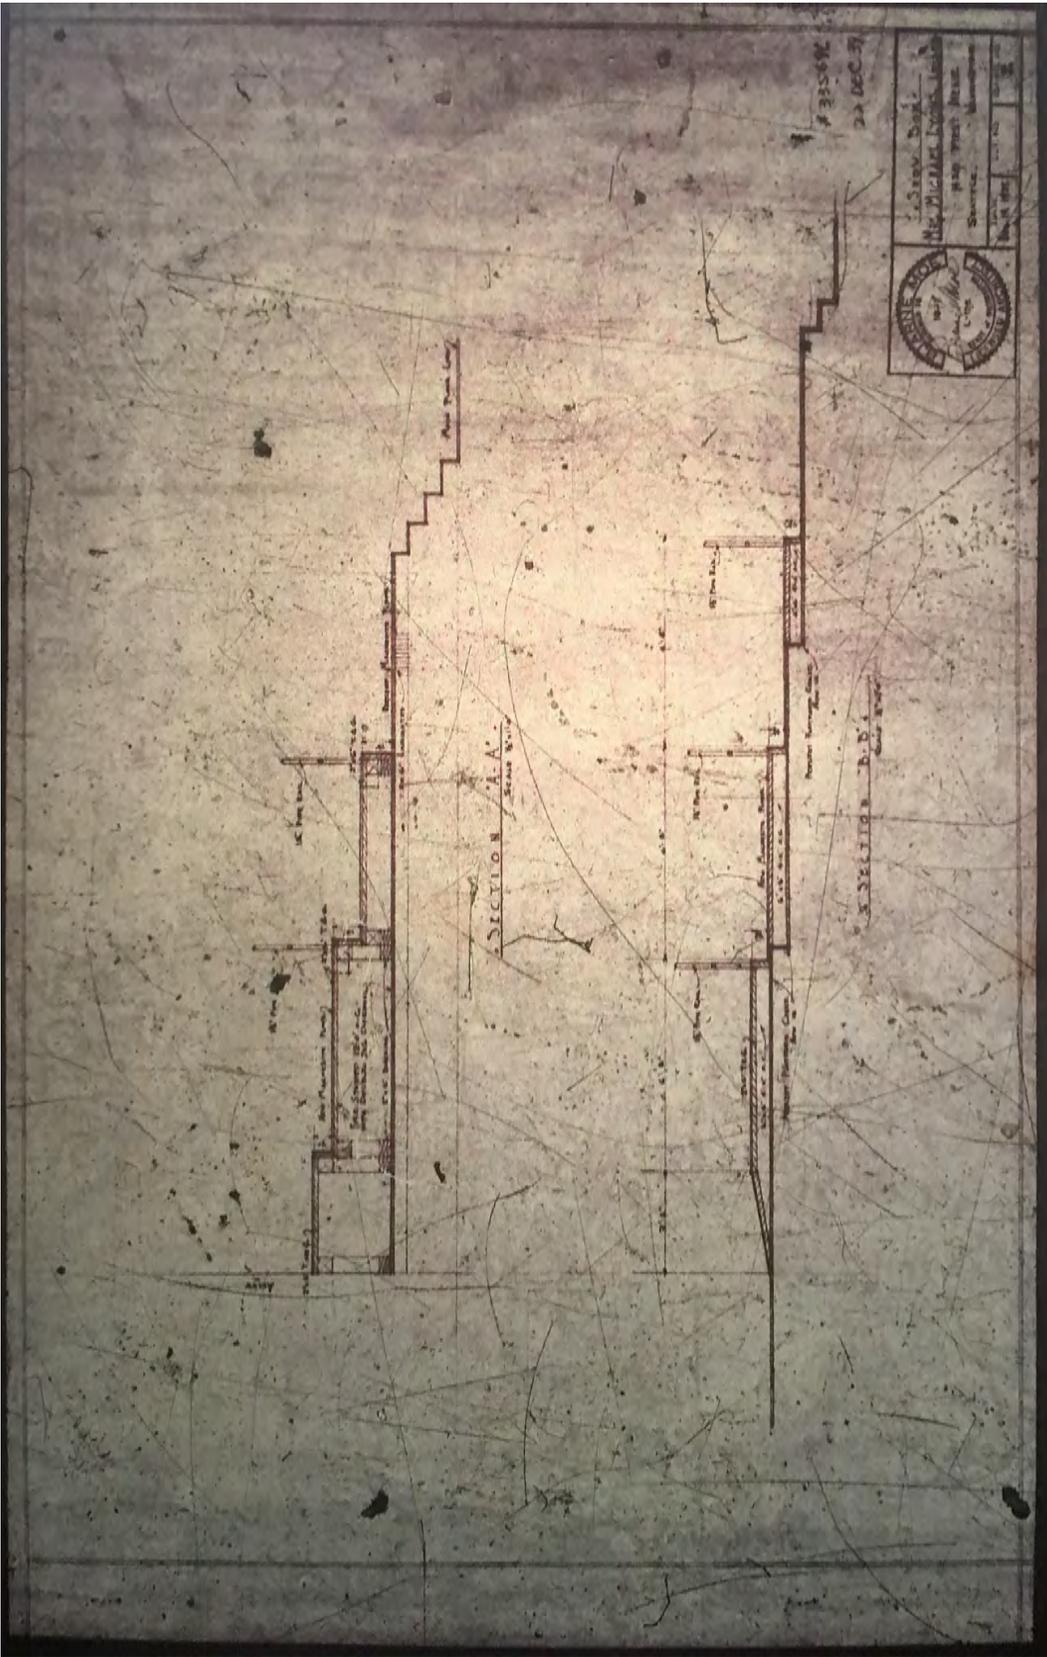
**Figure 77.** 1939 (December 19) drawing showing the second floor tiered seating design for the Showbox remodel for Michael Lyons prepared by architect Bjarne Moe. Courtesy Seattle Department of Construction and Inspections microfilm library.

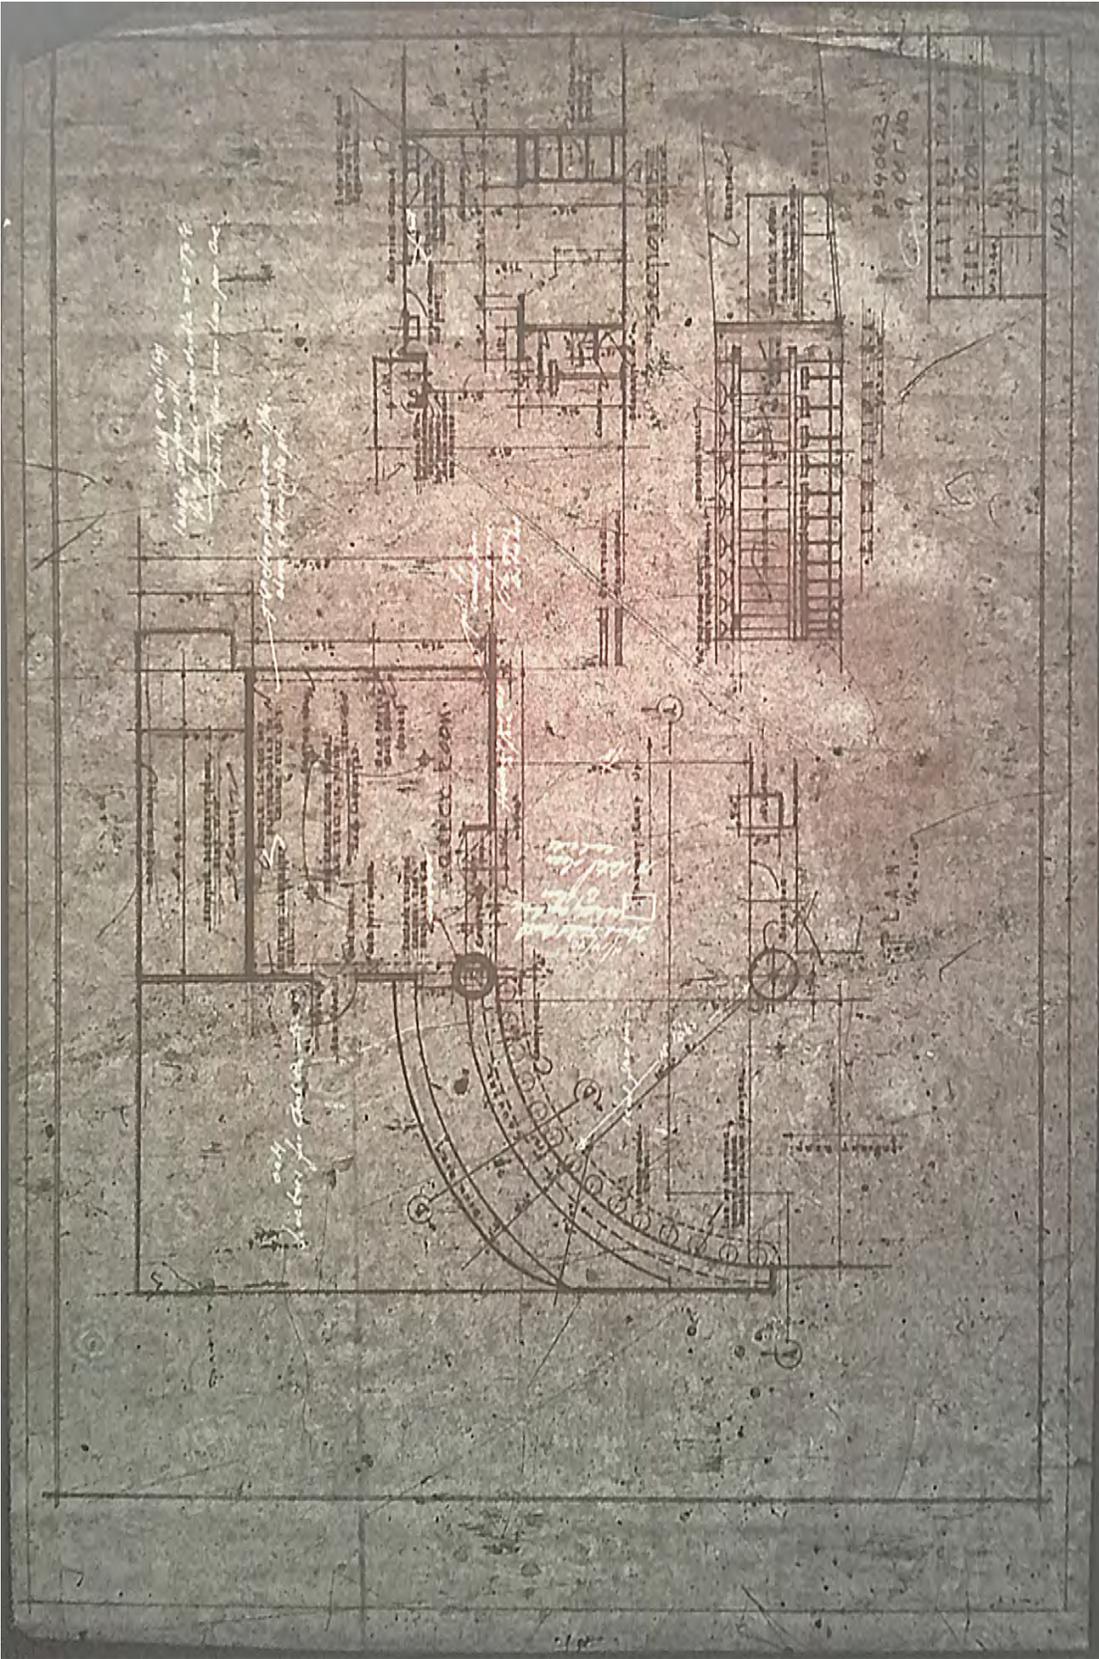
**Figure 78.** 1940 (October 3) drawing showing alterations to the passageway for the Showbox adding a coat check room and work at the bar for Michael Lyons. Courtesy Seattle Department of Construction and Inspections microfilm library.

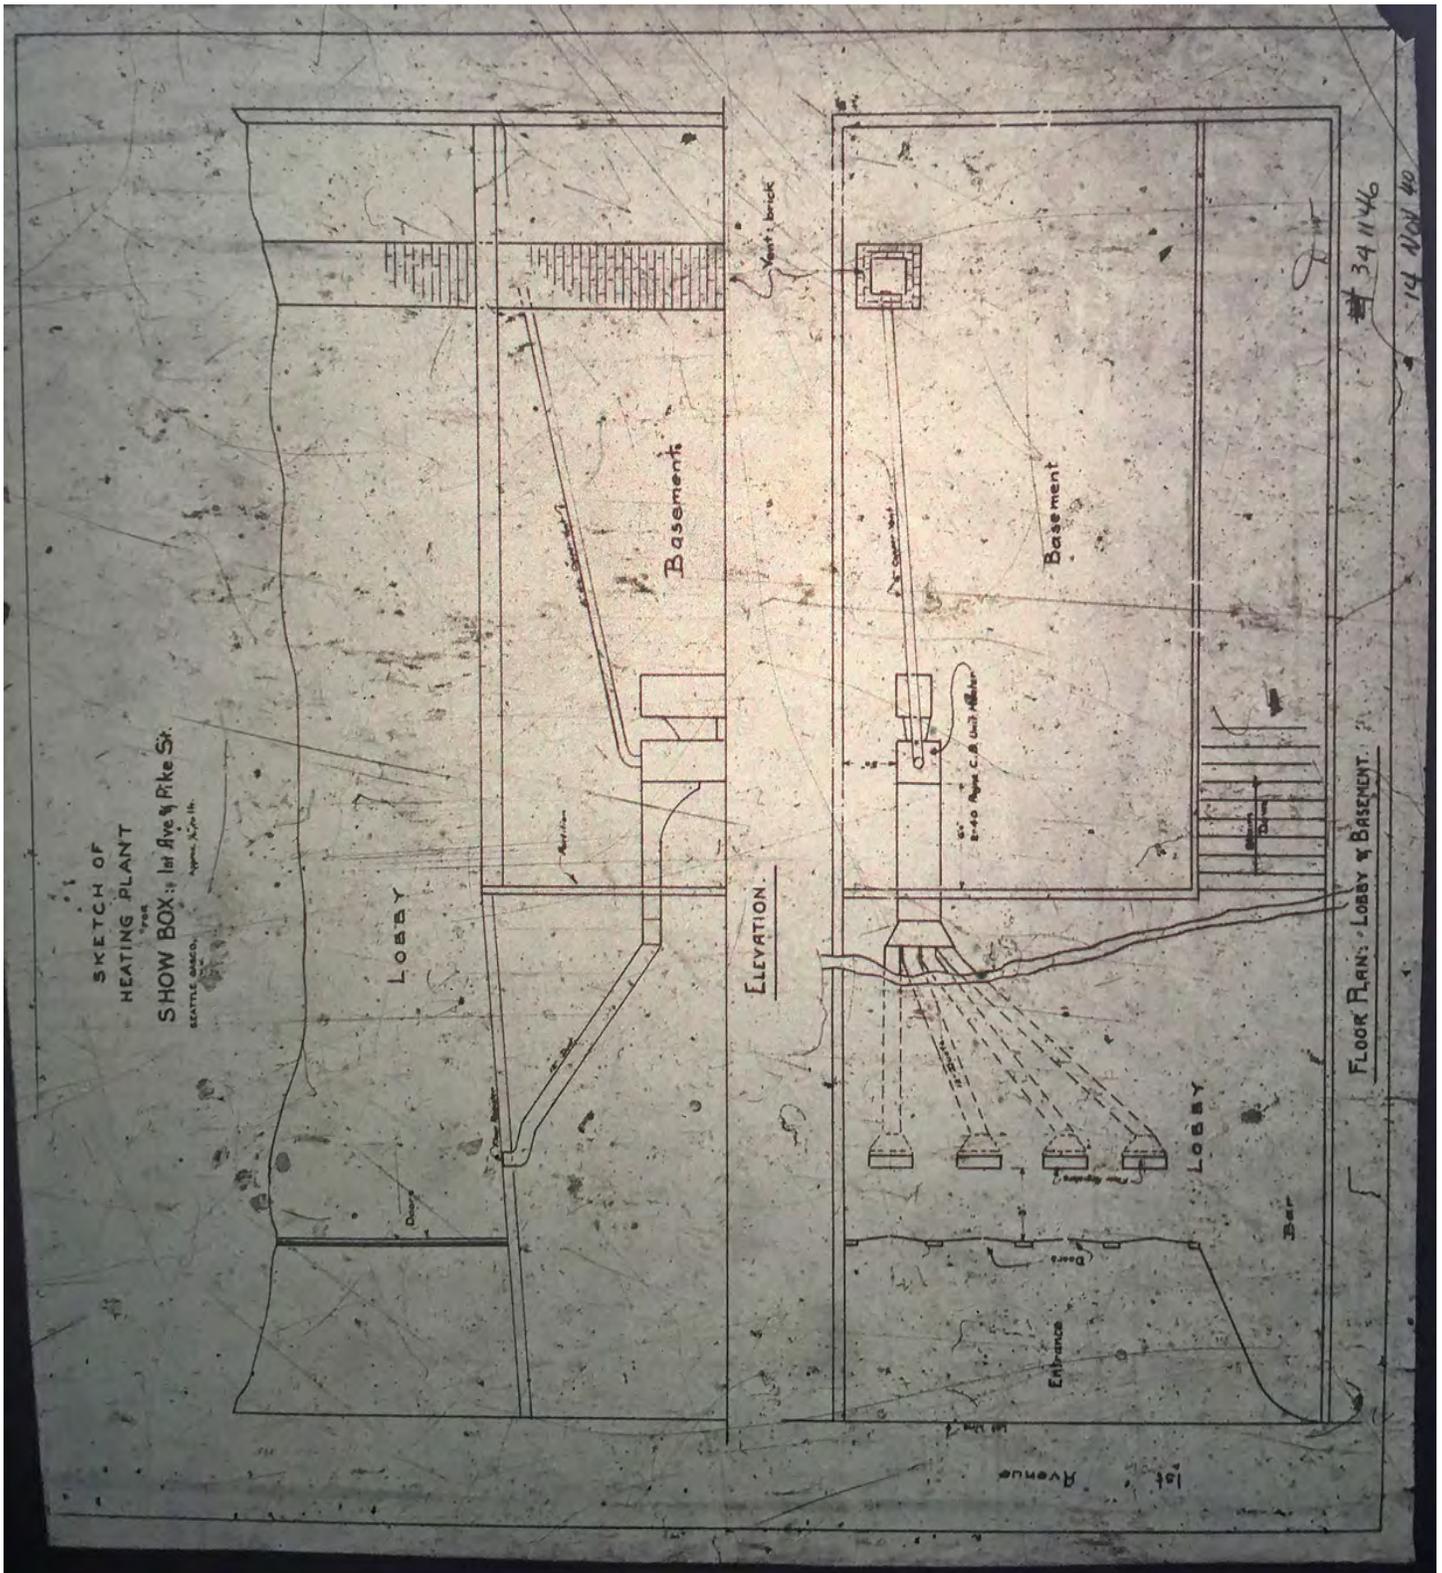
**Figure 79.** 1940 (November 14) drawing showing the mechanical system and heating provisions for the Showbox passageway. Courtesy Seattle Department of Construction and Inspections microfilm library.
