# SHOWBOX

1426 First Avenue  
SEPTEMBER 10, 2018

The City of Seattle  
**Landmarks Preservation Board**

**Name:** Show Box, Showbox, Showbox Ballroom, Showbox at the Market      **Year Built:** 1917

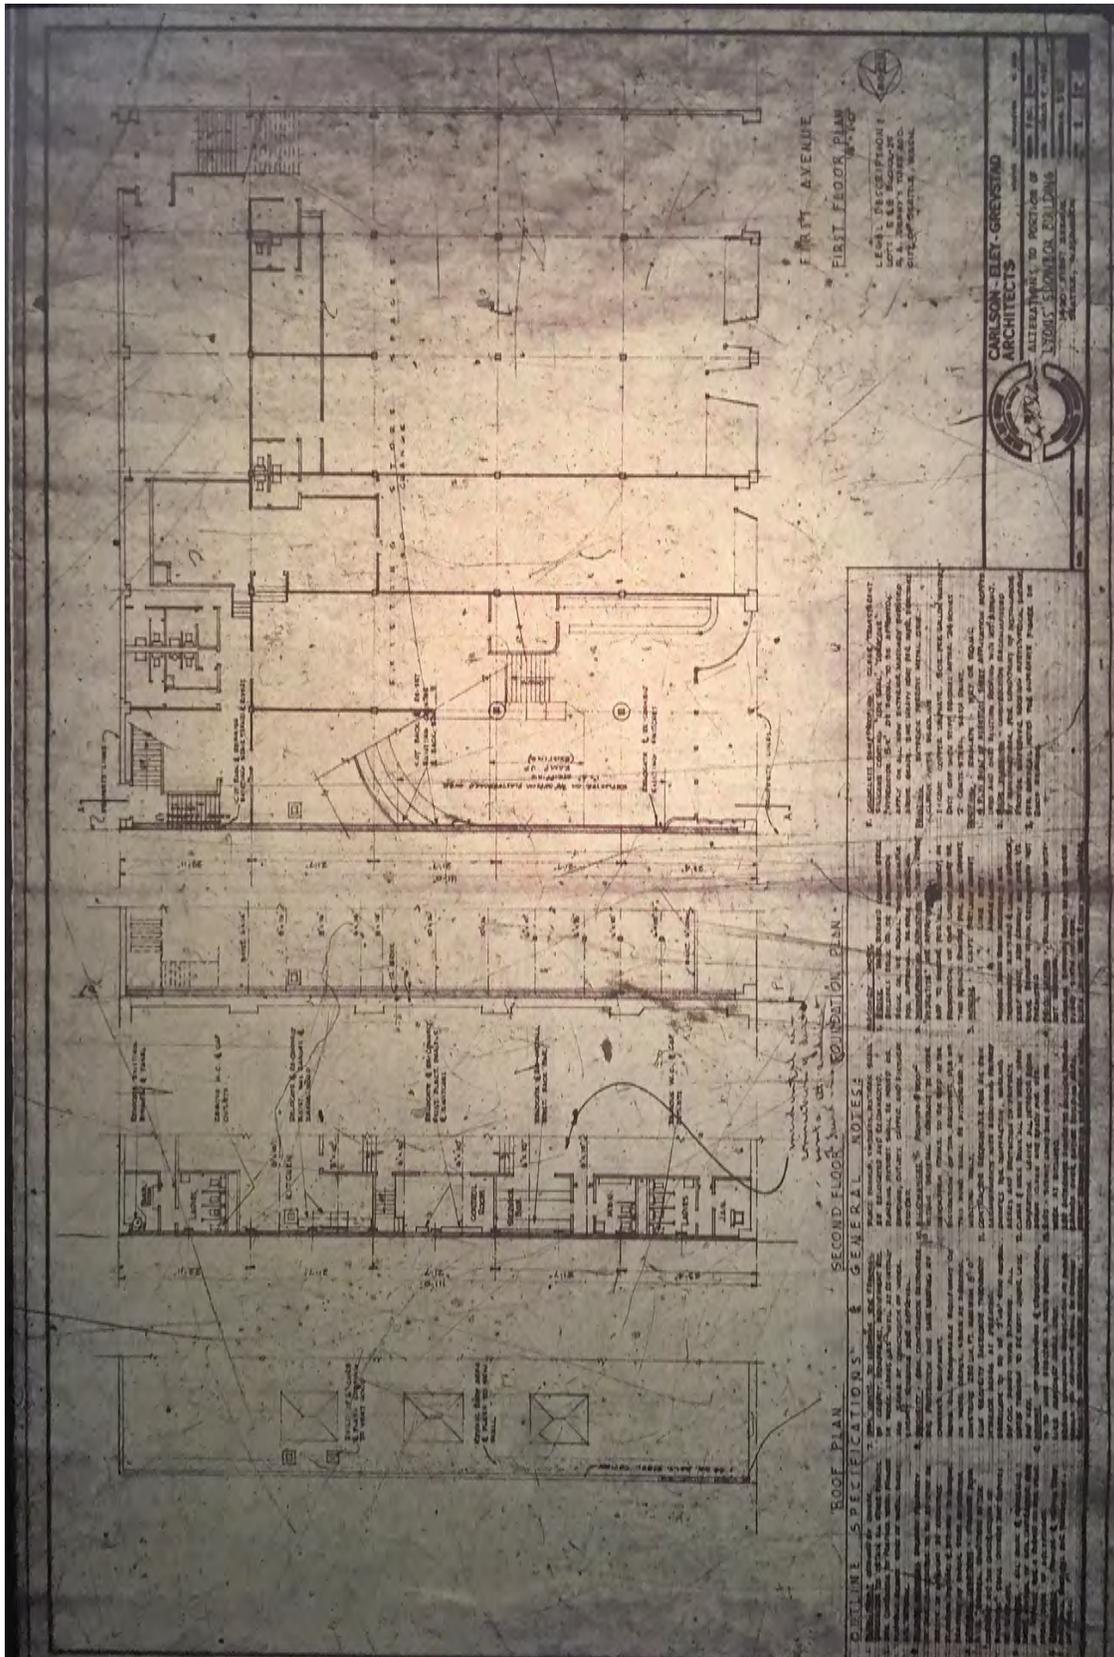
Figure 80. 1959 plans prepared by architects Carlson Eley Greystad as part of the north wall rebuilt following the demolition of the Regent Hotel in 1958.

- 1959: Architects Carlson, Eley, Grevstad designed the construction of a new north wall for the building. The building had originally used the south wall of the former building to the north. When that building was demolished, its south wall was left standing, but in an unusable condition. This required the construction of the

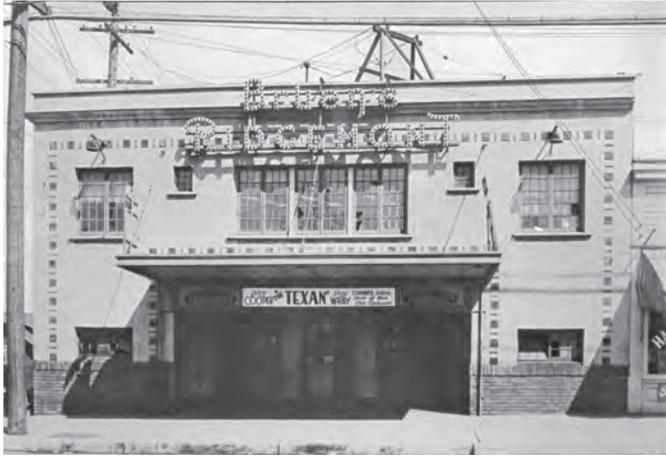
**Figure 103.** 1939 post card of the "Riviera" in Fort Lee, New Jersey that inspired Lyon's development of the Showbox.

While planning his new and larger venue, Lyons traveled back east to New York and New Jersey to tour popular nightclubs, theaters, and ballrooms. The Riviera nightclub in Fort Lee, New Jersey, caught Lyons' eye and was cited as the inspiration for his new venue.<sup>22</sup> **See Figure 103.** Lyons hired architect Bjarne H. Moe (1904–1980), who was establishing his reputation as a theater designer in Seattle and the greater Pacific Northwest with his design for the Green Lake Theater (1937).<sup>23</sup> Moe also had a reputation for helping clients modernize their properties, with evidence of this skill mentioned in a 1932 article in *The Seattle Daily Times*.<sup>24</sup> In the article, Moe provided two different mock-ups of a simple wood-clad bungalow refaced with brick to completely modernize and refine the property. His eye for updating buildings continued with many of his theater remodels, including the Roman Theater in Red Lodge, Montana, the Capitol Theater in Walla Walla, and the Varsity Theatre and Show Box remodels in Seattle.

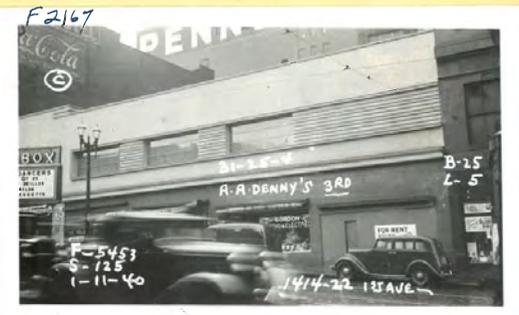
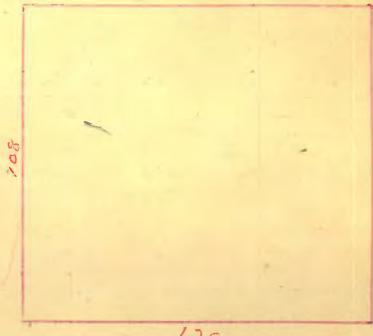
Figure 113. Pre 1973 property record card. Courtesy Puget Sound Regional Archives.

ORIG. COST \$  
 6 BUILDING **Store & Loft**  
**2 Story**  
**2 Stores**

EXTRA FEATURES **380 Sprinklers**  
 CONSTRUCTION **Ord. Masonry, Mill P&B, medium**  
 REFRIGERATION  
 7 CONDITION: EXTERIOR **Good** INTERIOR **Good** FOUND. **Good**  
 8 MAIN SUPPORT COLUMN **X** FOOTING **SPAN** FT.  
 9 FIRST FLOOR JOIST **INCH CENTER BRIDGED**  
 10 **BUILDING Finished**

WIRING **Knob & tube.**  
 HEATING **Central, steam**  
**P S L & P service.**  
 ELEVATORS **None**  
 ENTRANCE **Conc.**  
 CEILING - STORY HEIGHT  
**1st flr-12'**  
**2nd flr-20'**

REMARKS  
*Also 8*  
*Part of 2 bldg Bldg formerly A.V. to 25*  
*A.A. Denny's 3rd*  
 Permit #333832, 8-23-39; Permit #332356, 5-27-39;  
 Permit #332400, 6-2-39; alterations and installation of fixtures.

*1966-1970 - 2 bldg - 25,400*  
**5040' FLOOR PLAN**
