TAYLOR CREEK SEDIMENT CONTROL OPPORTUNITY STUDY

Prepared for:
Seattle Public Utilities
December 13, 2012

Taylor Creek Sediment Control Opportunity Study

REPORT

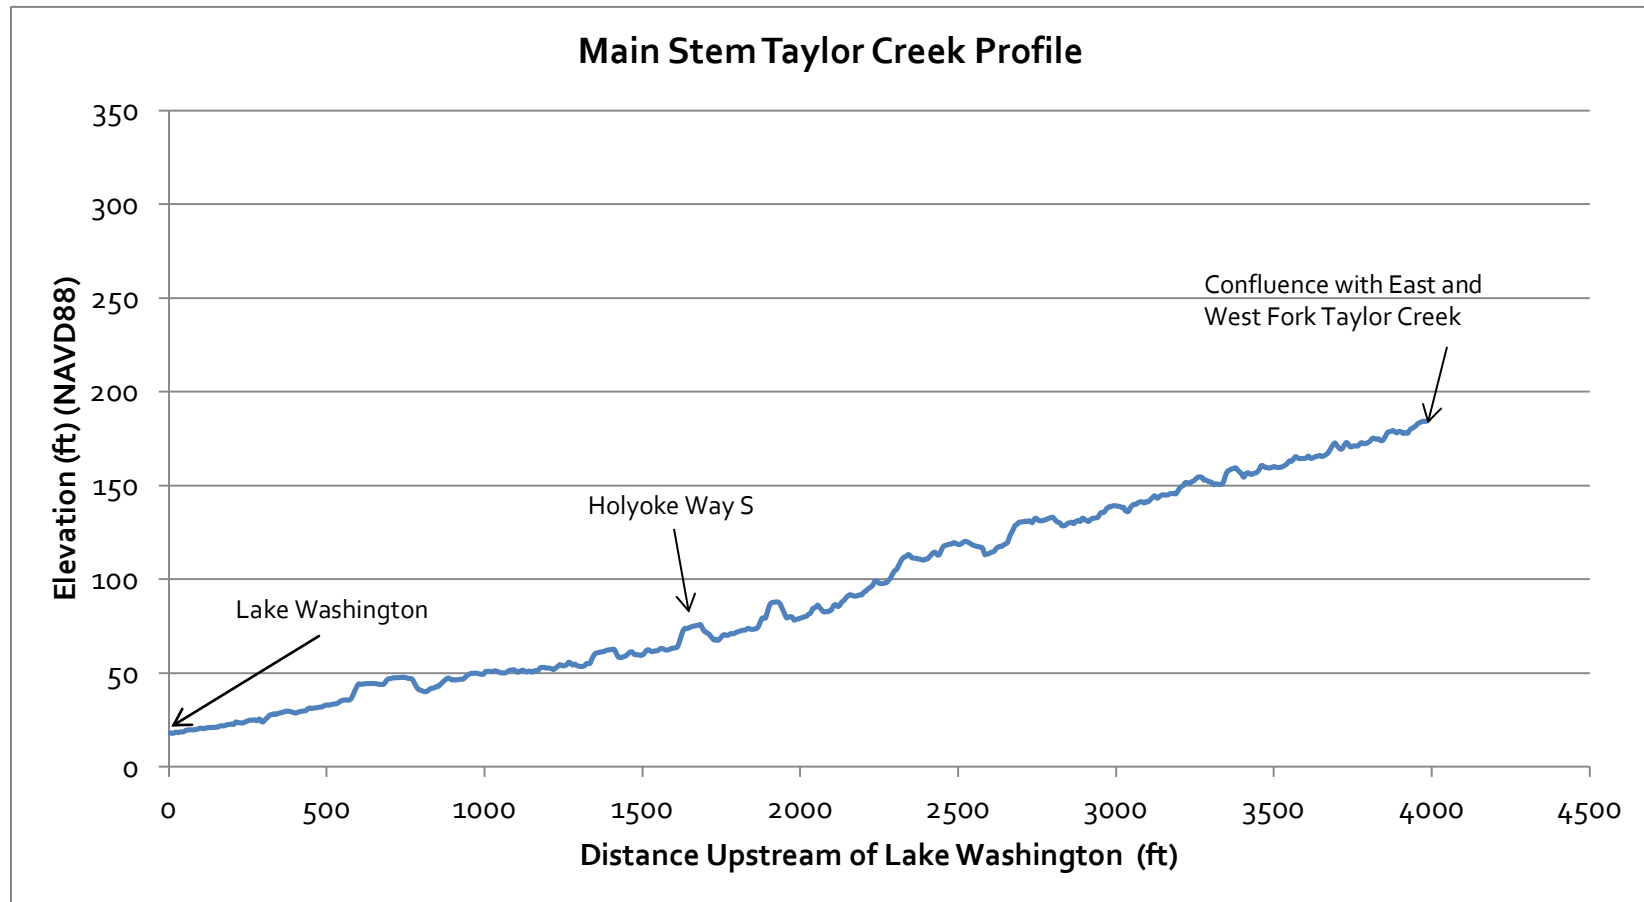
FIGURE 7
Main Stem Taylor Creek Profile LIDAR Elevations

Notes: LIDAR may provide artificial elevation where large logs or culverts span the channel.

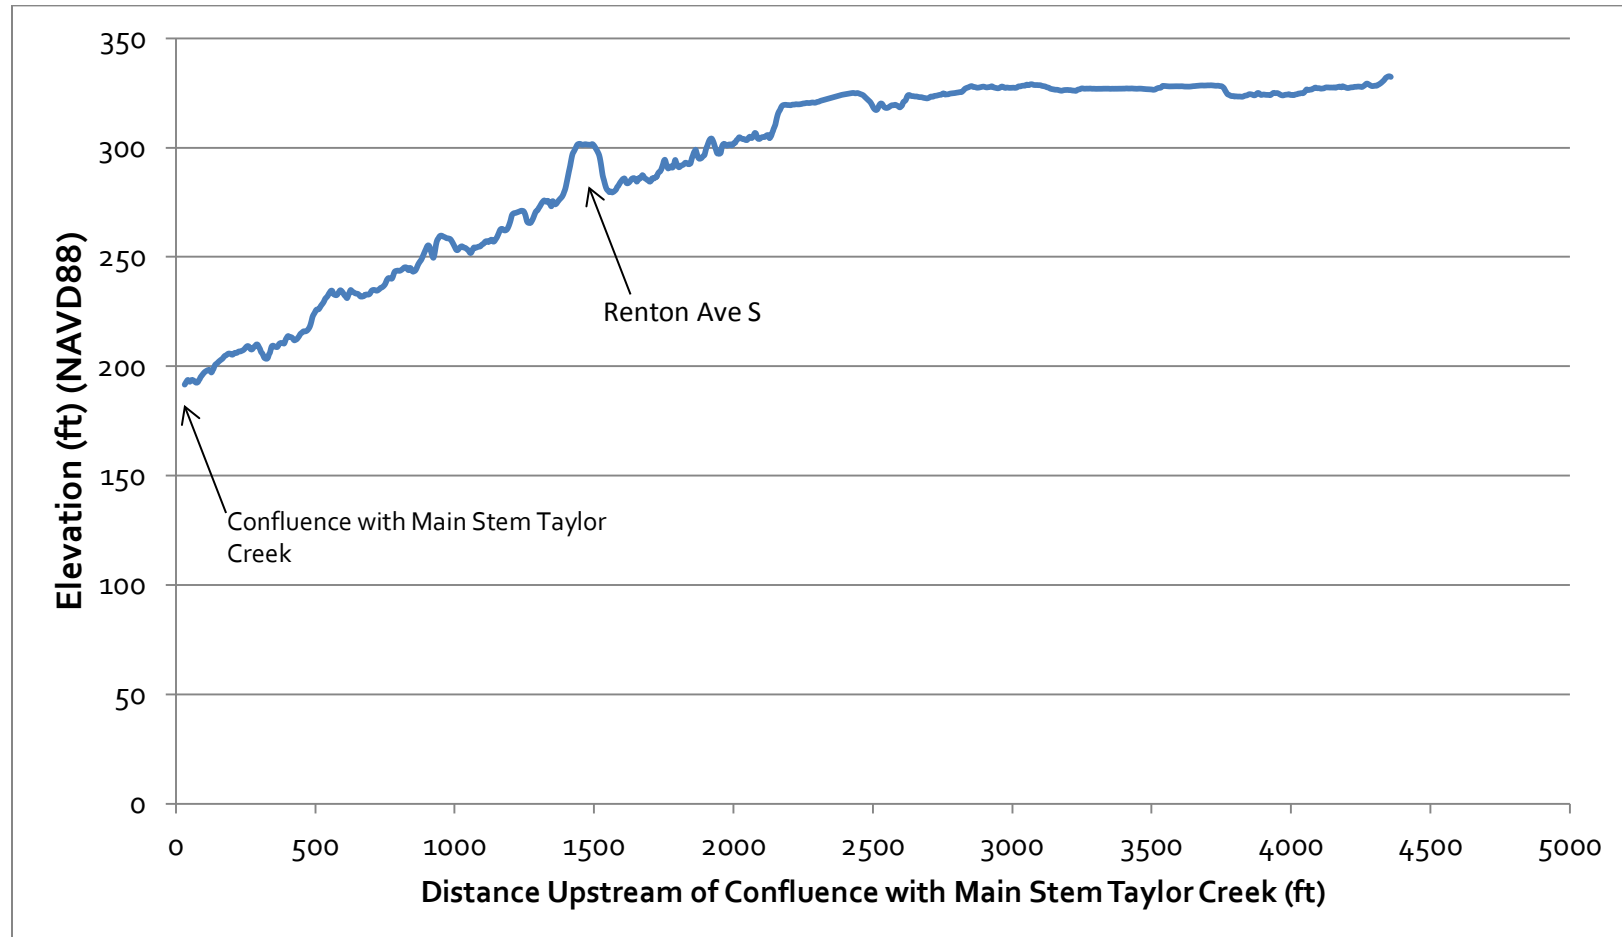
FIGURE 9
East Fork Taylor Creek Profile

Notes: LIDAR may provide artificial elevation where large logs or culverts span the channel.
Source: LIDAR 2000

- Surveyed channel gradient within the East Fork within Lakeridge Park was approximately 5%. The gradient varied locally with the presence of a 3 feet high vertical step just upstream of the confluence and with the two concrete weirs observed within the channel. The overall approximate longitudinal profile of the East Fork of Taylor Creek is plotted using LIDAR data on **Figure 9**.

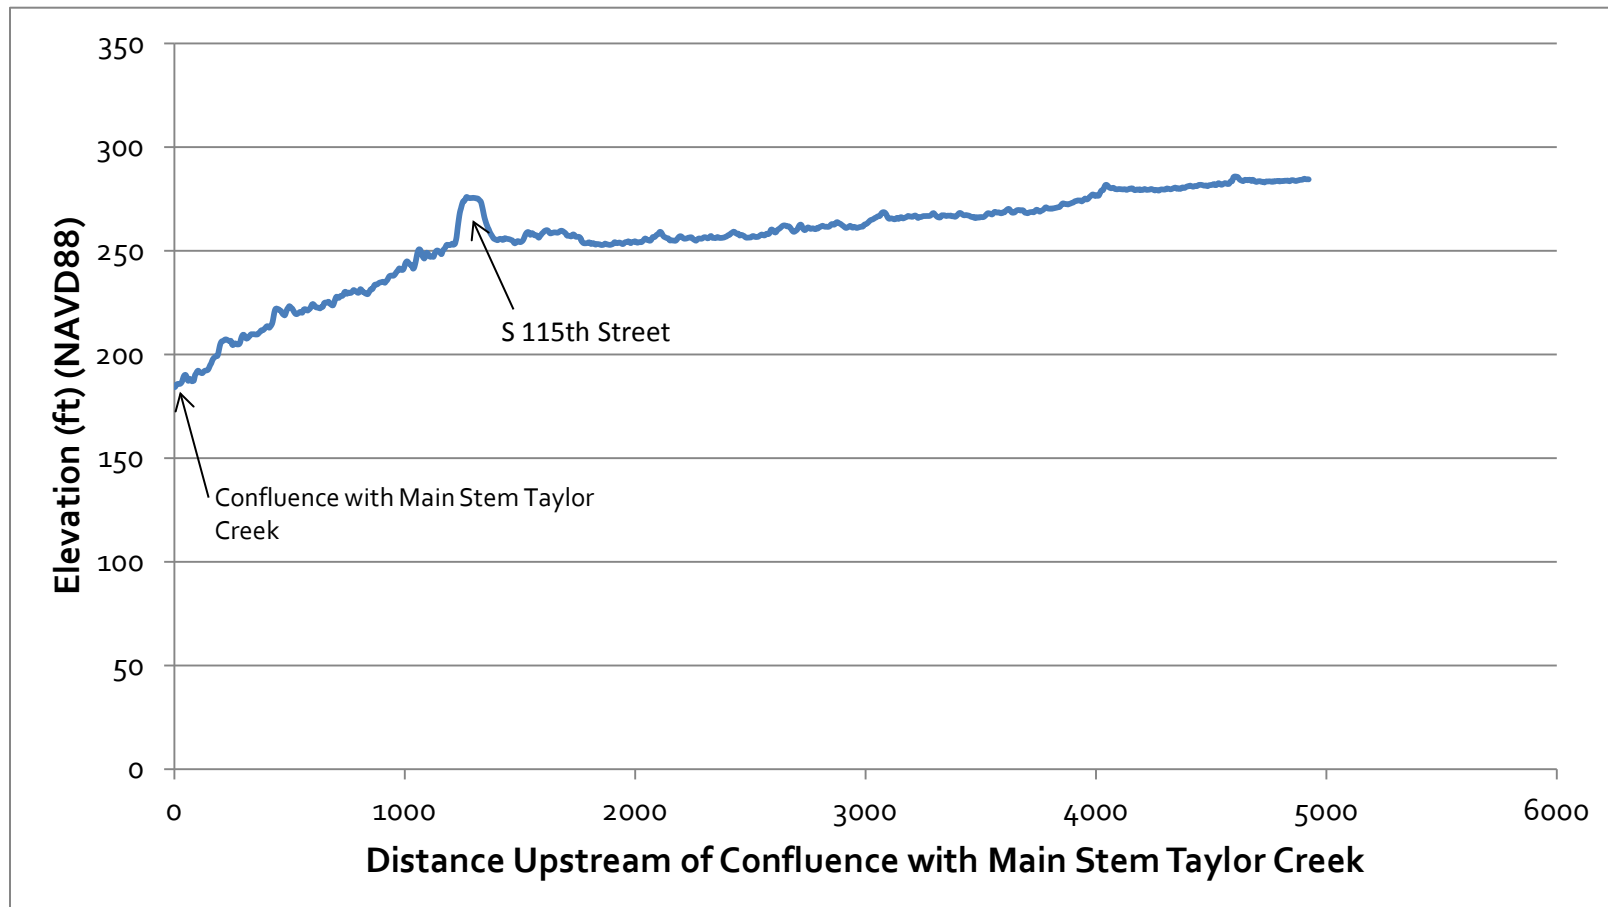
FIGURE 10
West Fork Taylor Creek Profile

Notes: LIDAR may provide artificial elevation where large logs or culverts span the channel.
Source: LIDAR 2000

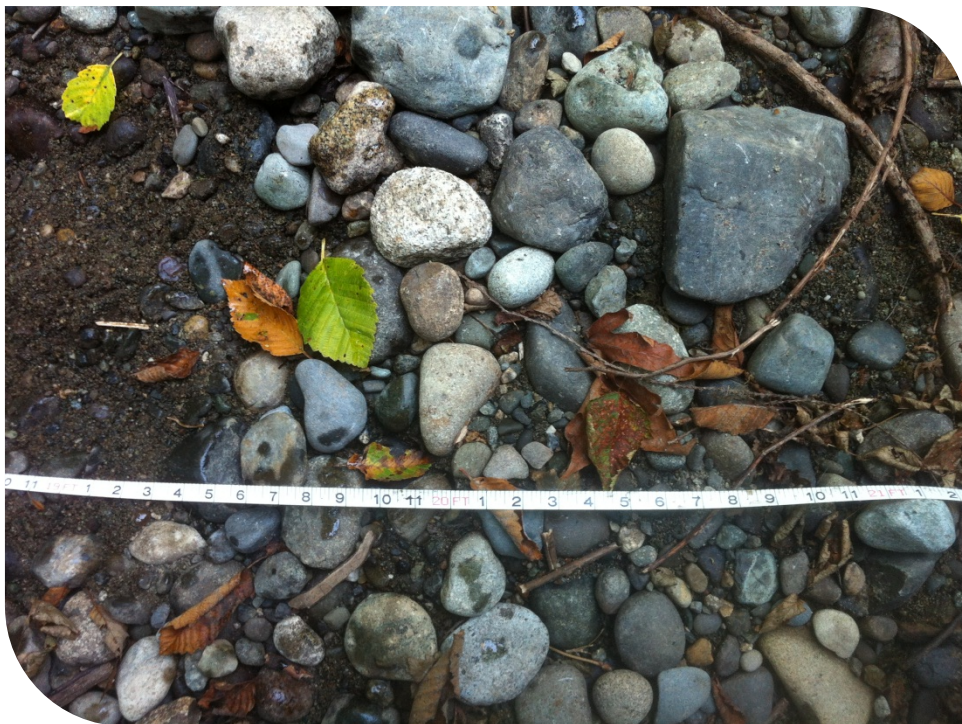
Photo 2— Streambed gravel at XS1 *(taken by CEC on 9/20/12).*

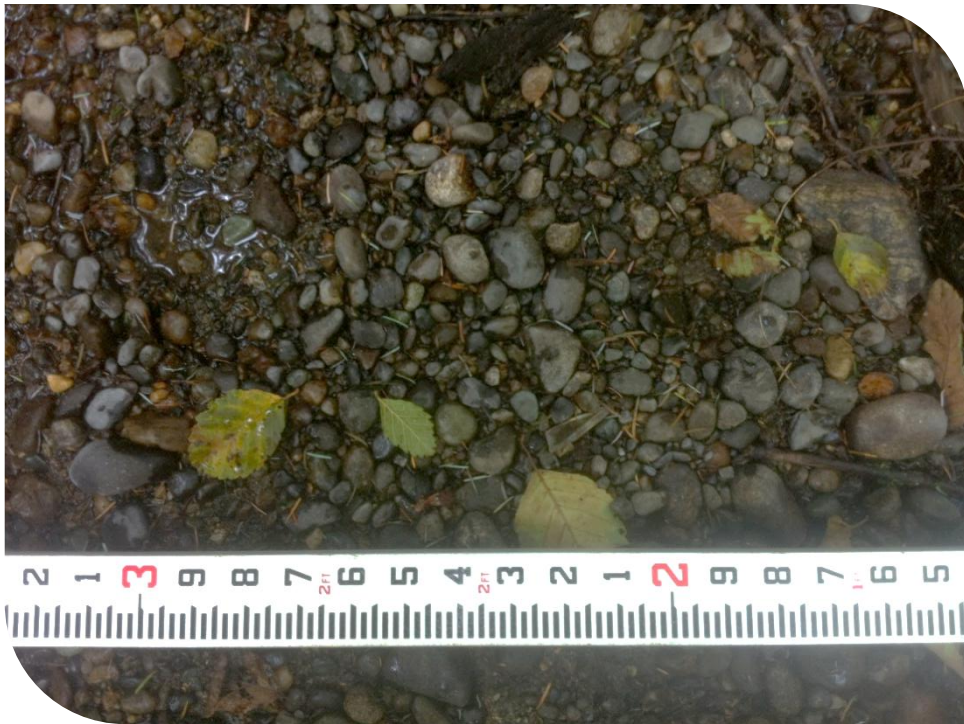
Photo 4— Streambed gravel at XS2 *(taken by CEC on 9/20/12).*

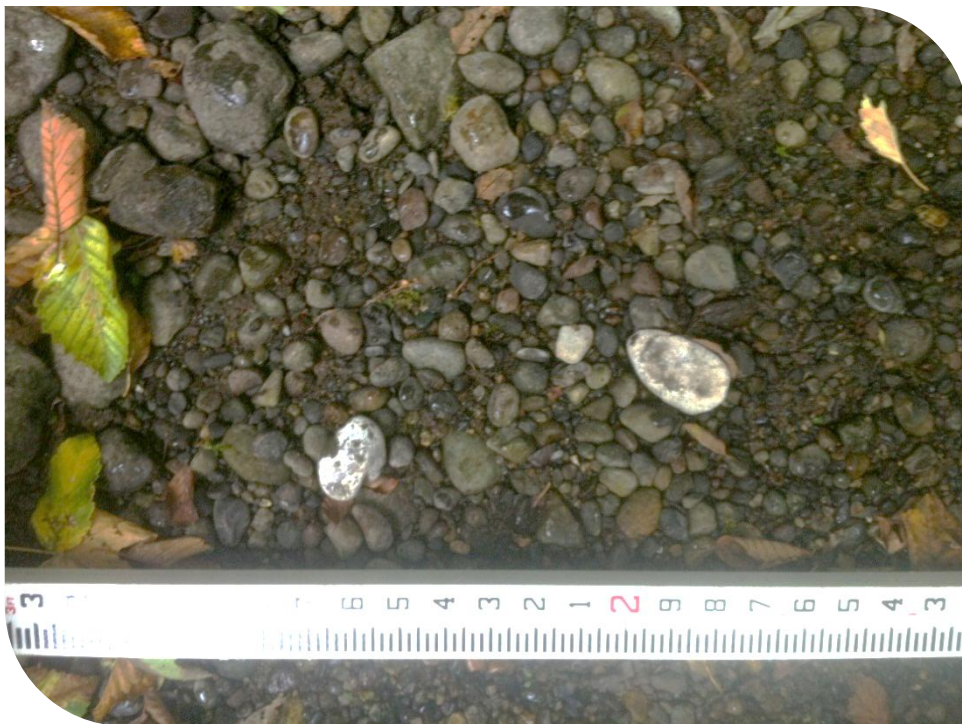
Photo 6 – Streambed gravel at XS₃ (taken by CEC on 9/20/12).

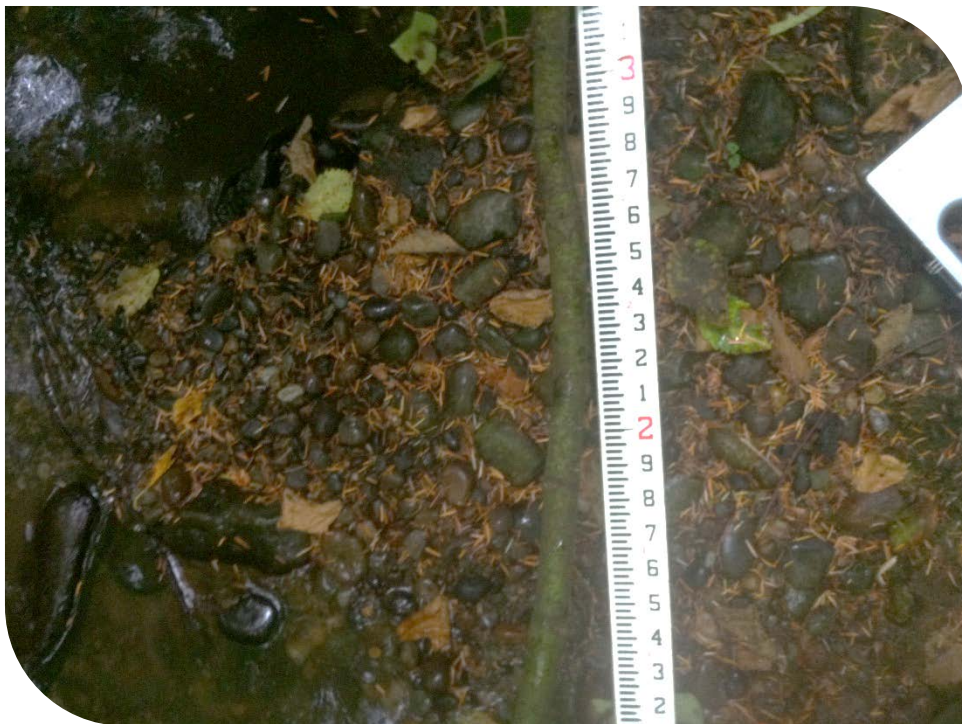
Photo 8— Streambed gravel at XS₄ (taken by CEC on 9/21/12).

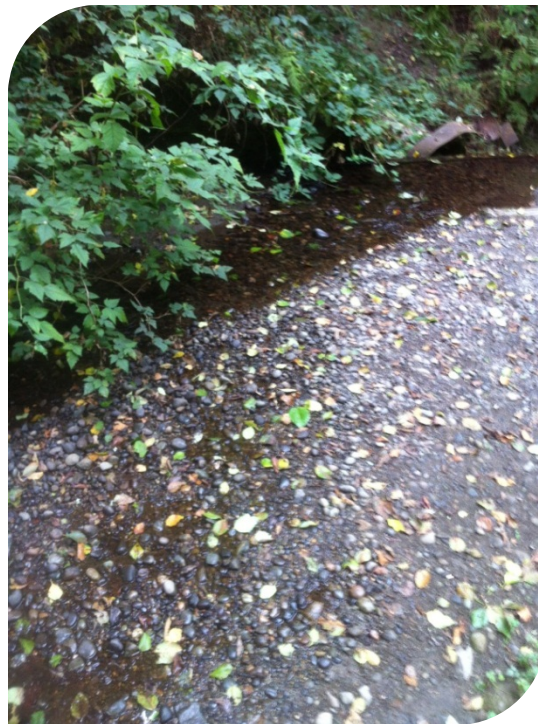
Photo 10— Streambed gravel at XS5 (taken by CEC on 9/21/12).

- Streambed composition in the East Fork is primarily gravel with occasional cobbles. The large boulders observed in the main stem are absent from the East Fork.

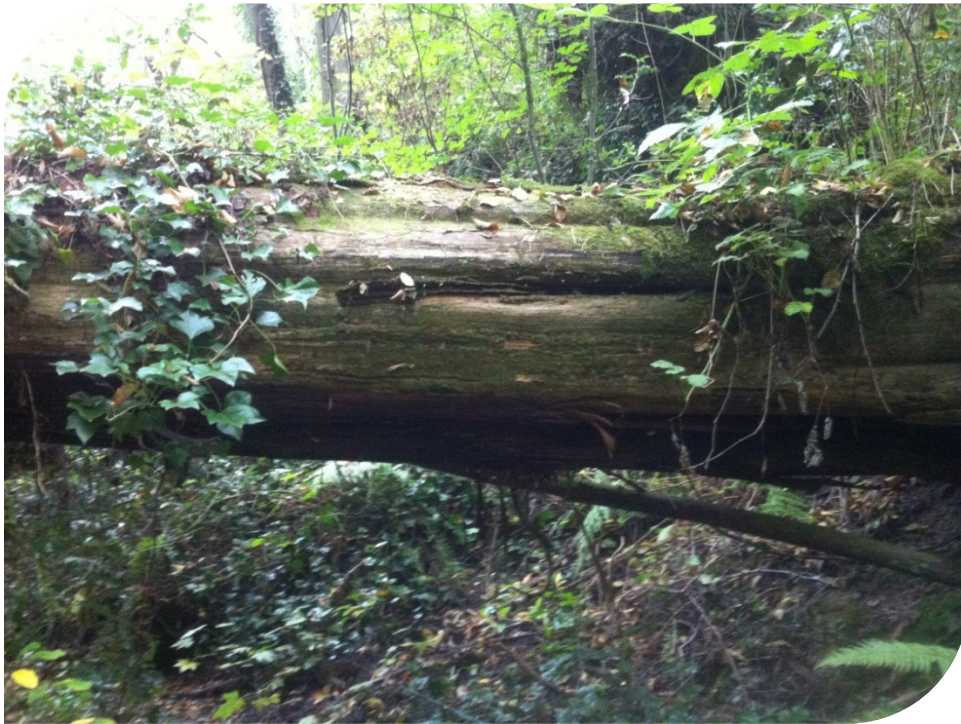
Photo 12— Typical cedar spanner log *(taken by CEC on 9/20/12).*

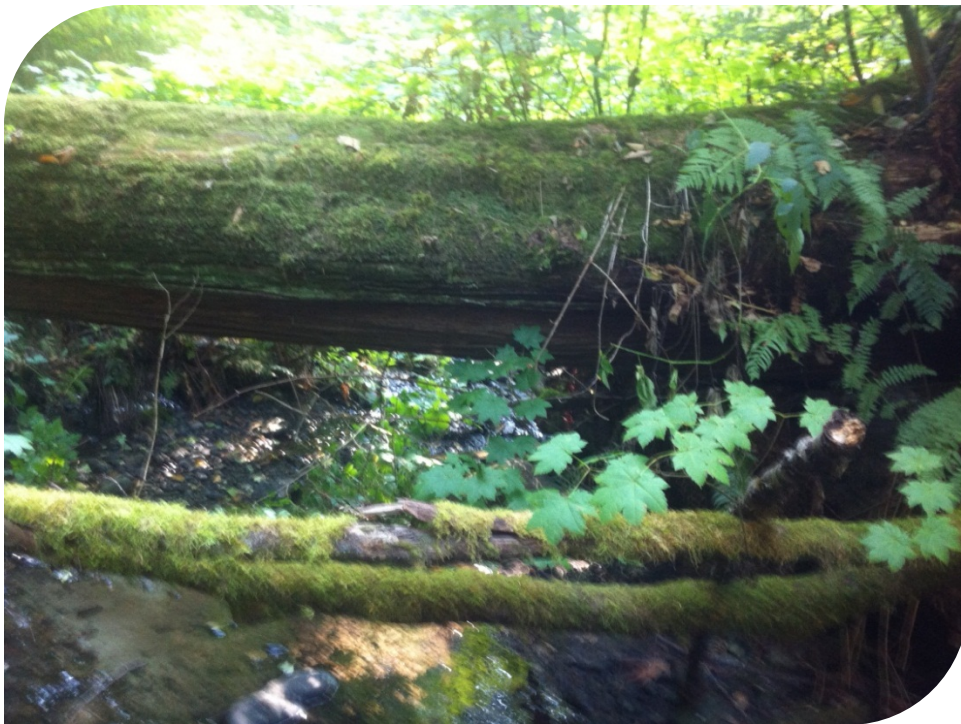
Photo 13— Typical cedar spanner log *(taken by CEC on 9/20/12).*

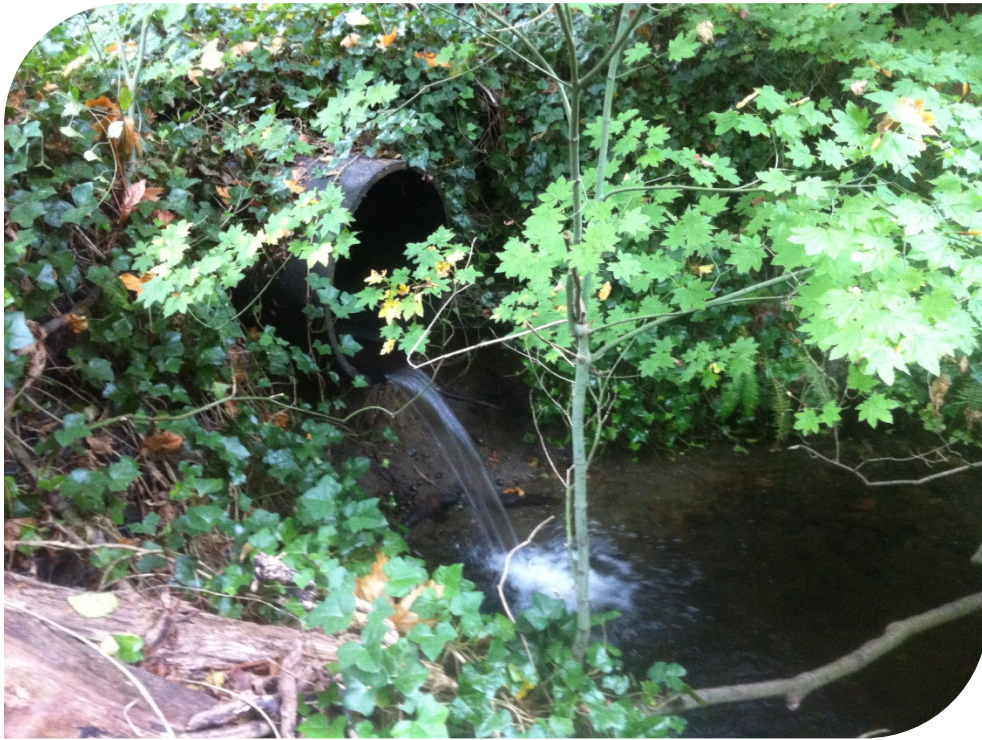
Photo 14— Looking upstream at perched culvert (*taken by CEC on 9/21/12*).

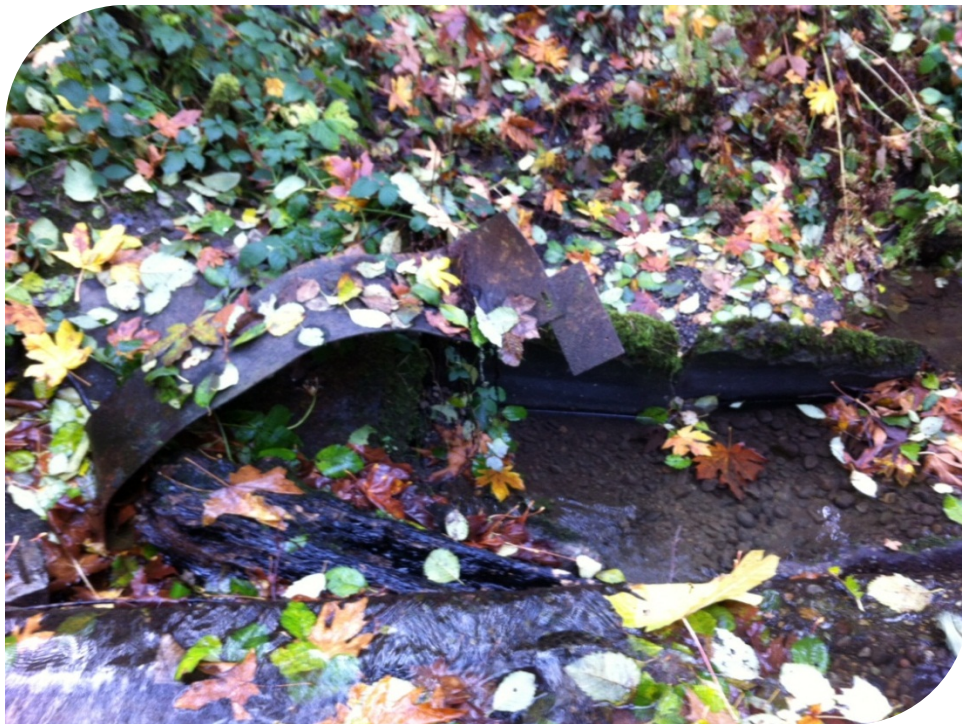
Photo 15— Looking upstream at culvert upstream of XS₅ (*taken by CEC on 11/6/12*).

- Within Lakeridge Park, the East Fork channel flows over two concrete weirs that appear to be components of a defunct instream facility. There is a broken culvert no longer conveying flow that formerly bypassed the relict structure. SPU staff indicated that within recent years the stream flowed through the culvert that is now abandoned, and the observed stream alignment flowing over the two concrete weirs represents a channel relocation that may have occurred on its own when the broken culvert failed.

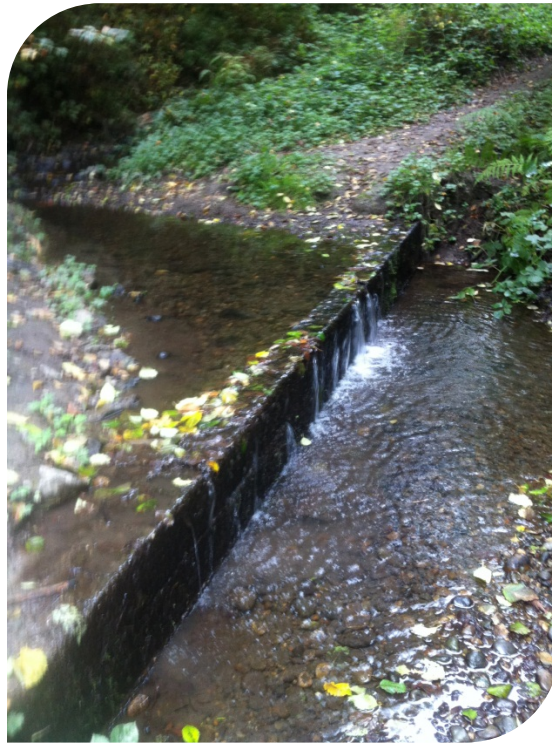
Photo 16— Looking across channel at weir upstream of XS5 (*taken by CEC on 9/21/12*).

In addition to the other planned or pending options, we recommend that SPU evaluate and consider installing another in-line sediment trap on the east fork just upstream of the forks confluence (100 ft upstream of XS5. This zone is relatively broad and locally flat with a defunct access road and relict concrete structures in the East Fork channel. Utility conflicts with the sanitary sewer line and the overhead power lines may preclude or at least limit the scale and potential configuration of a sediment trapping facility. We recommend that SPU consider as another option configuring this zone as another temporary sediment storage zone through the placement of LWD or modification of the existing concrete weirs.

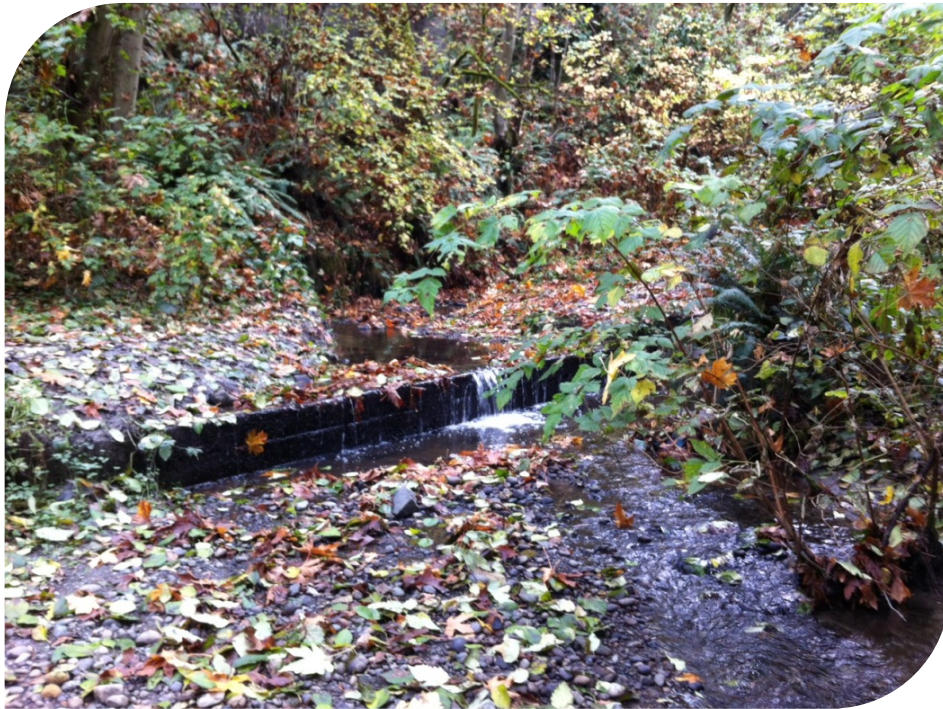
Photo 17— Looking upstream at weir upstream of XS5 (*taken by CEC on 11/6/12*).

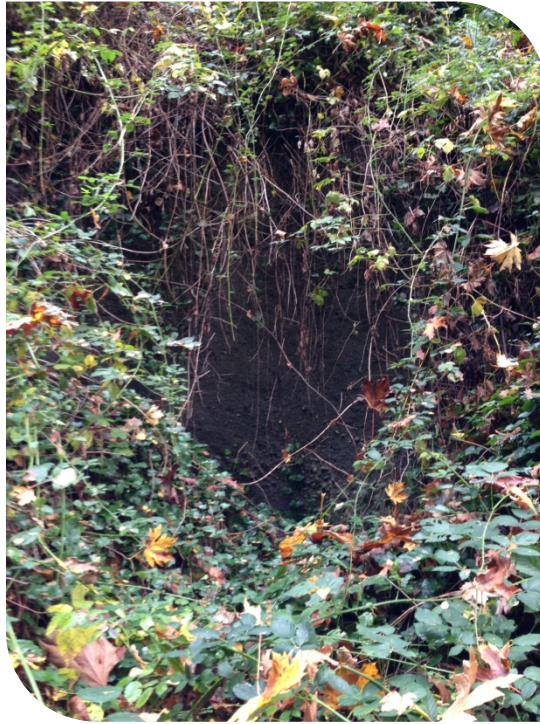
Photo 18— Looking at landslide on east slope of Main Stem Taylor Creek (*taken by CEC on 11/6/12*).

- Confluence observed 5 landslides, during the September stream survey work, on the east slope that intersect with the stream bank of Taylor Creek and deliver sediment to the system. During the November 6, 2012 reconnaissance, Confluence observed an additional landslide from the top of slope that was not visible from the channel. The landslide locations are shown on **Figure 6** and stations are identified on **Table 3**.

Opportunities to directly stabilize the slopes on the east side of the ravine are limited. Observations of the landslide initiation points high on the slopes illustrate that landslide initiation occurs in response to subsurface conditions including geology and seepage that seasonally saturates potential slope failure zones. Slope stabilization activities using equipment would create large disruptions that would be counterproductive to promoting slope stability. Surface treatments implemented with laborers without large mechanical equipment would provide the equivalent of temporary erosion control, but such actions would have little if any effect on the initiation of deeper slope failures. We recommend that SPU does not engage in slope stabilization efforts as part of this effort.
