**Presentation outline:**

Observations and Recommendations for Sound Transit Mercer Island P&R

John Easley  
2014

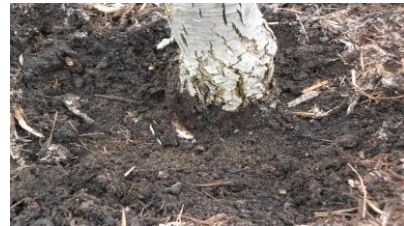
Several trees were flagging and clearly in a stressed condition.

### Trees planted too deep

- Recommended getting a tree assessment from a certified arborist to determine hazards, remedies, and survivability of the trees on site.

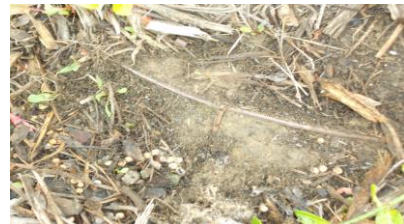
### Trees planted in wire baskets

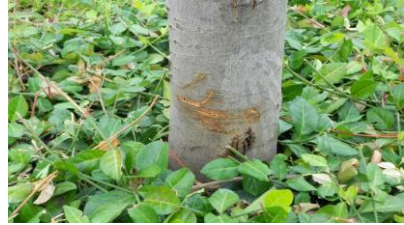
Mower/weed eater damage to trunks

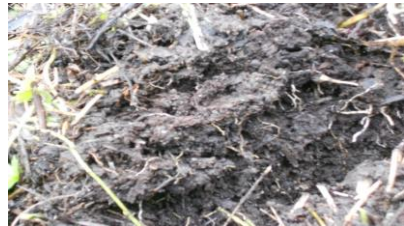
Overwatering

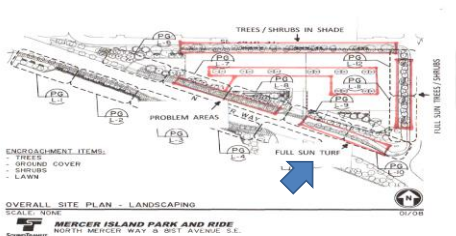
## FULL SUN TURF

The turf is parking strip approximately 172' X 12' tapering on one end. The irrigation system used Rainbird 1800 spray heads only on the street-side curb spraying toward the sidewalk. This causes dry spots behind trees, traffic signs and other obstructions.

- Use 4" heads and cut sod away
- Adjust flow control handle at the valve
- Change nozzles on tapered end of turf to prevent overspray
- If hydraulically possible, install a lateral and heads on the sidewalk-side of the area and change all spray nozzles in the zone to high DU rotary nozzles
- Layout heads to minimize spraying the tree trunks

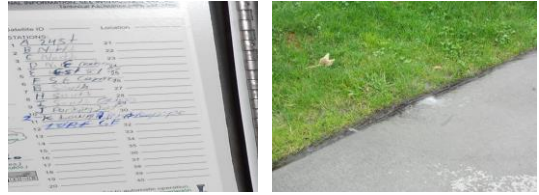
There was one bad nozzle and a lateral break causing wash-out and water waste.

**Timely maintenance needed**

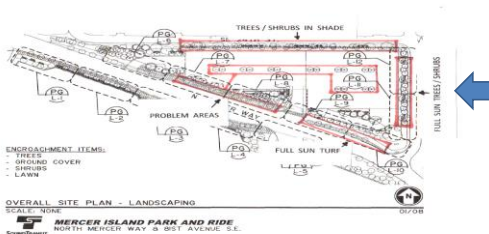
**FULL SUN TREES & SHRUBS**

The bed area is a mixed planting of trees, shrubs and ground covers in a full sun exposure. Area had about 1" of mulch covering the bare areas of the bed while the ground covers are still establishing. The irrigation covered the area well with Rainbird spray heads. One nozzle was broken and in need of replacement.

Maintain tree wells and mulch rings around trees and woody shrubs even in ground covers to reduce competition for nutrients and water.

Decrease water usage by developing a proper ET-based watering schedule that considers climatic conditions, plant material, and soil.

Consider replacing spray nozzles with High DU rotary nozzles.

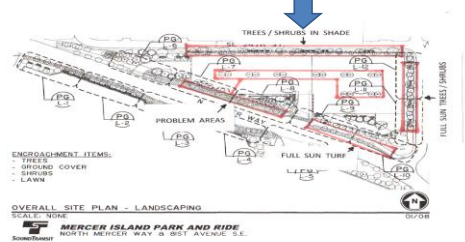
**TREES & SHRUBS IN SHADE**

Area consisted of a mixed planting of trees, shrubs, vines, and ground covers.

It's located on the north side of the garage structure and only receives direct sun a few hours a day.

The soil is a sandy loam and wet almost to the point of saturation.

Maintain tree wells and mulch rings around trees and woody shrubs even in ground covers to reduce competition for nutrients and water.

Decrease water usage by developing a proper ET-based watering schedule that considers climatic conditions, plant material, and soil.

Consider replacing spray nozzles with High DU rotary nozzles.

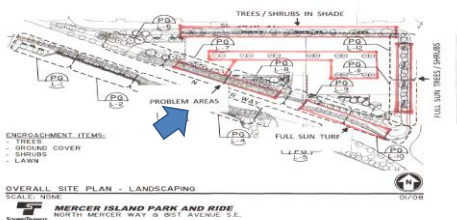
**CLIENT SELECTED PROBLEM AREA**

The problem areas examined were elevated planters and tree pits in the sidewalk.

Several trees in the planters were visibly stressed and there were several stumps where the trees had failed and been removed.  
 The soil in the planters and pits was a sandy loam and wet almost to the point of saturation.  
 The area around the bottoms of the elevated planters had accumulations of mud, water, and moss, evidence of either excessive amounts of drainage or overspray outside the target area.

- Repair stuck heads in elevated planters and bubblers in tree pits
- Decrease water usage by developing a proper ET-based watering schedule that considers climatic conditions, plant material, soil types, and irrigation system efficiency
- Change either the bubblers to spray nozzles or spray nozzles to bubblers to achieve matched precipitation or use 2 valves, one for bubblers and one for spray nozzles
- Consider using drip irrigation in the elevated planters for additional water savings
