# **Geotechnical Investigation Report**

**Property: PMA #1594**

**City of Seattle, Washington**

**April 2017**

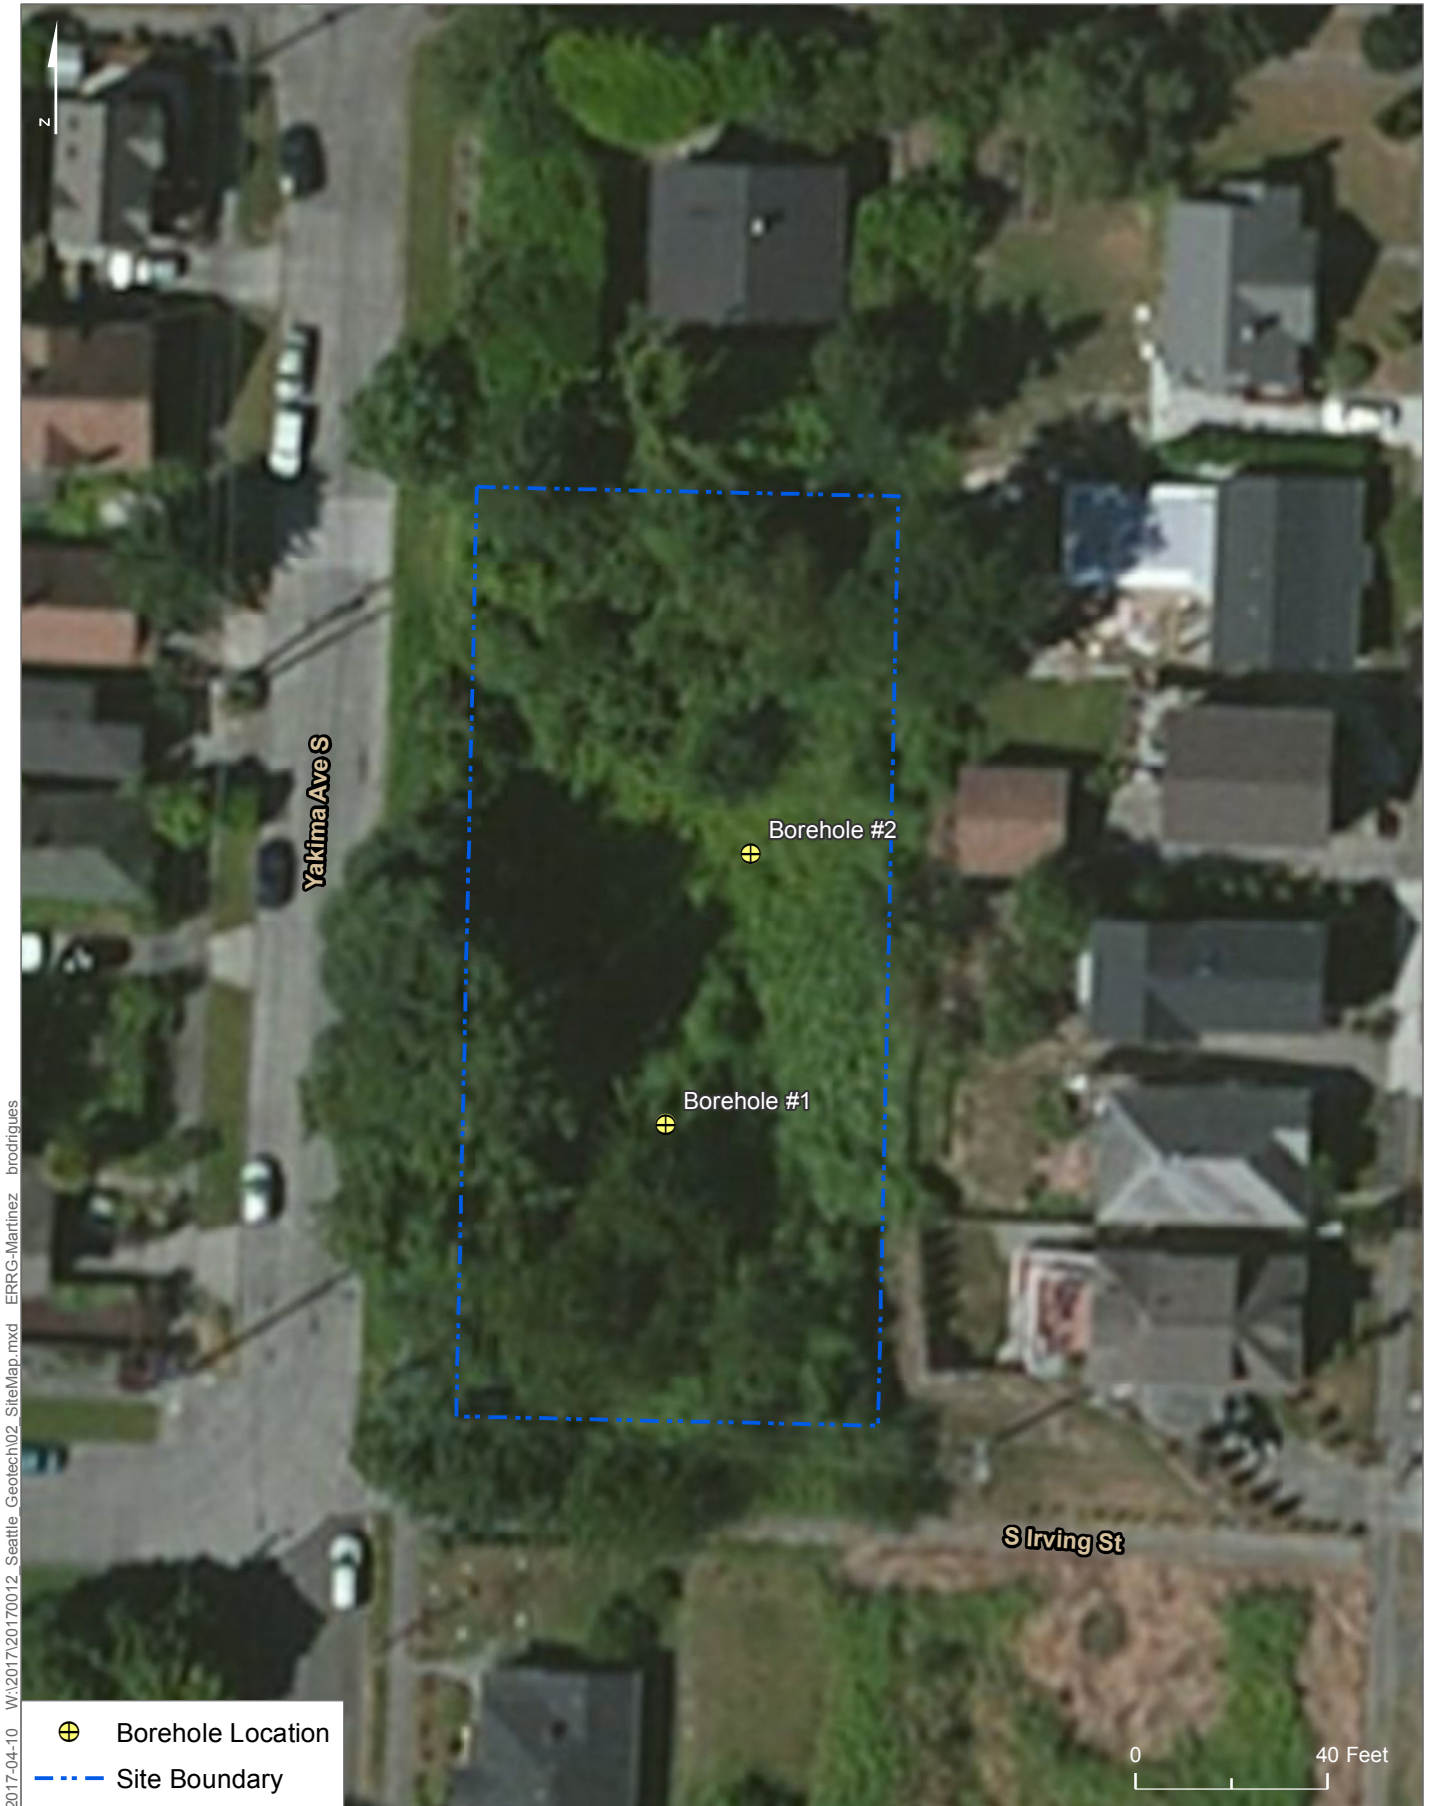
**Figure 2. Site Map and Subsurface Exploration Locations**  
 City of Seattle, Washington

Prior to drilling activities ERRG cleared the eastern edge of the property to allow the drill rig to access the site. ERRG then used a hollow-stem auger to advance two borings to a maximum depth of 50 feet below ground surface (bgs), collected continuous cores to log the soil lithology, and collected and submitted two soil samples to HWA Geosciences, Inc. in Bothell, Washington, for geotechnical analysis. The soil samples were collected from a Dames and Moore standard penetration test (SPT) sampler driven at 5-foot intervals. [Appendix A](#) contains the boring logs describing the lithology. [Figure 2](#) shows the boring locations. [Appendix B](#) includes the analytical laboratory report.

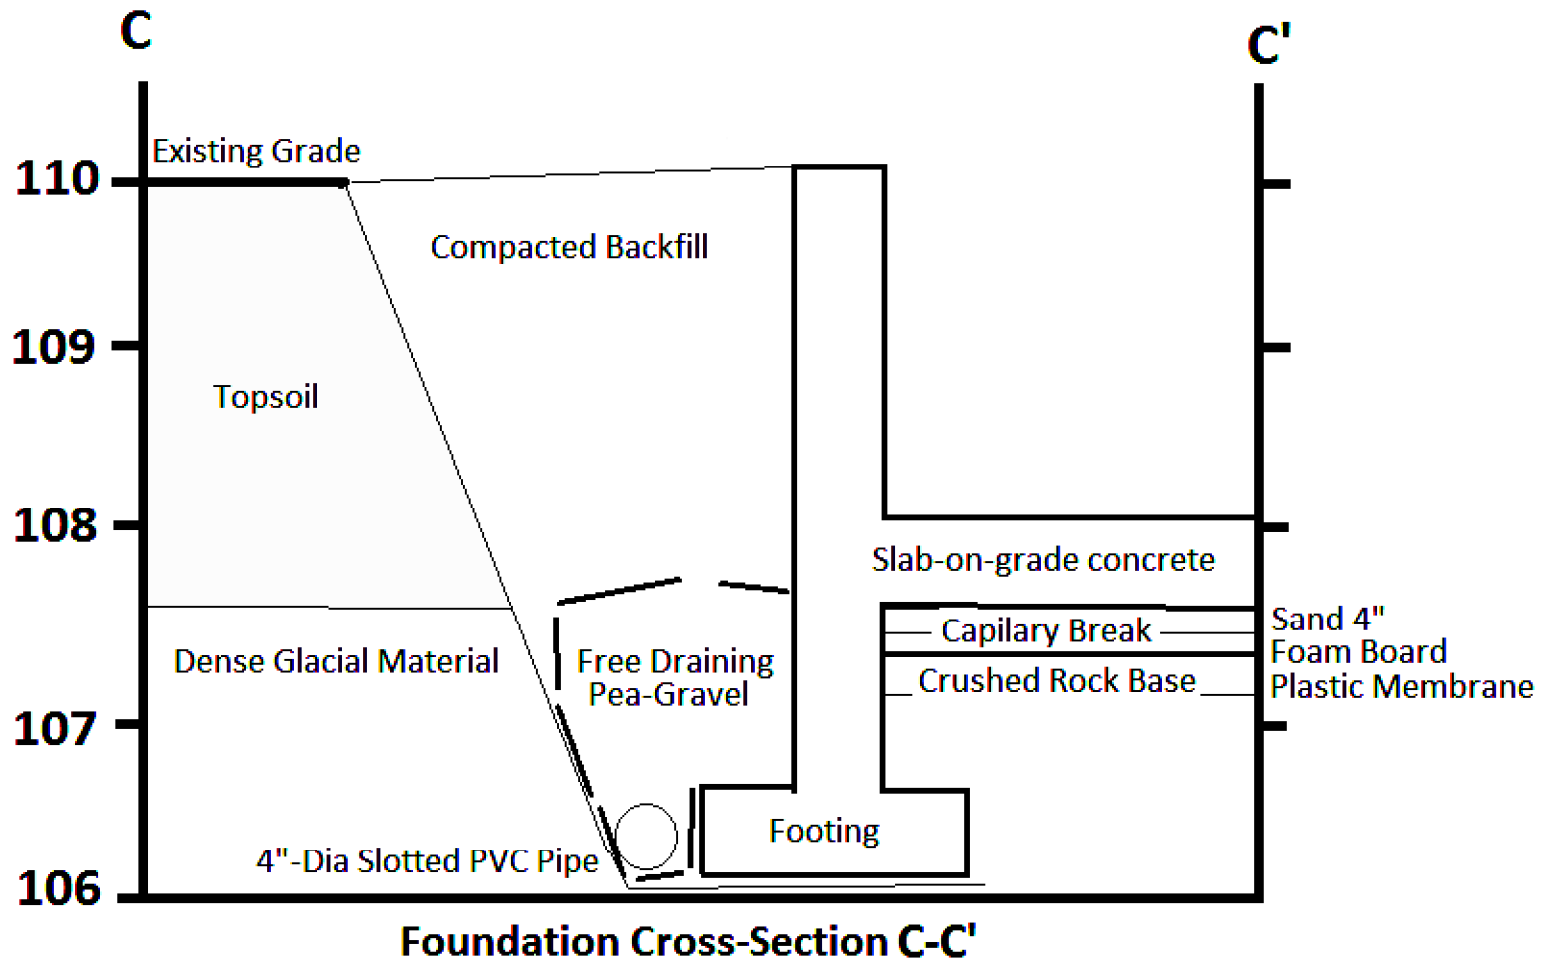
**Figure 3. Foundation Cross Section C-C**

**Figure 3. Foundation Cross Section C-C'**  
City of Seattle, Washington

a minimum of 1 foot below the pad grade and be supported on the dense native soil, or on structural fill that extends down to the dense soil, as shown on [Figure 3](#). The structural fill prism below the footings should be as wide as it is deep, plus the width of the footing, to adequately transfer the loads to the underlying dense soil, or as recommended by the geotechnical engineer. Individual spread footings may be used for supporting columns, and strip footings may be used for bearing walls. ERRG's recommended design criteria for the foundations are as follows:

Anticipated settlement of footings founded on the medium dense to dense outwash soil should be on the order of 1 inch. A geotechnical engineer should inspect all footing areas prior to placement of concrete to verify the design-bearing capacity of the soil has been attained, and that construction conforms to the recommendations contained in this report. Such inspections may be required by the City of Seattle. Footing drains should be placed around all perimeter footings, as shown on [Figure 3](#) and described in [Section 5.4](#).

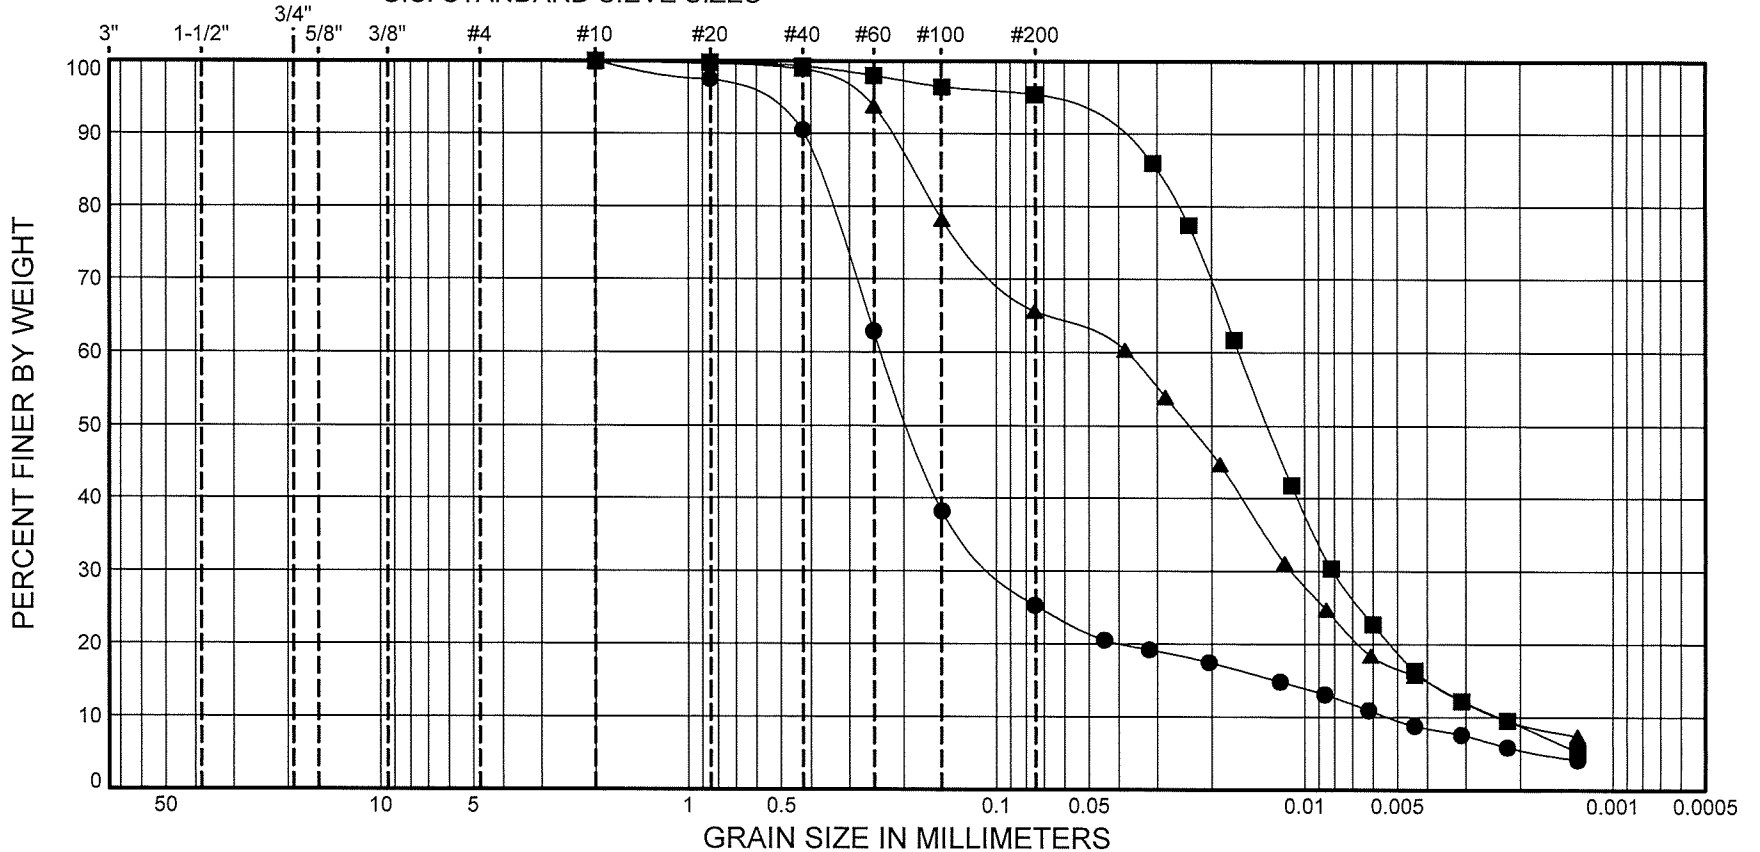
SYMBOL	SAMPLE	DEPTH (ft)	CLASSIFICATION OF SOIL- ASTM D2487 Group Symbol and Name	% MC	LL	PL	PI	Gravel %	Sand %	Fines %
●	BH-1	5.0 - 6.5	(SM) Dark grayish brown, silty SAND	14					74.7	25.3
■	BH-1	10.0 - 11.5	(ML) Olive brown, SILT	24	NP	NP	NP		4.6	95.4
▲	BH-1	15.0 - 16.5	(ML) Grayish brown, sandy SILT	23	18	15	3		34.4	65.6

**PARTICLE SIZE ANALYSIS OF SOILS:** The samples were tested to determine the particle size distribution in general accordance with ASTM D422, using both sieve and hydrometer analysis. As requested by the client only the portion of the sample passing the 2.0 mm sieve was tested, the amount of material retained on the 2.0 mm sieve is shown the table below. The results are plotted on the attached Particle Size Analysis of Soil Report, Figure 1 which also indicates the moisture content of the soil samples at the time of testing.

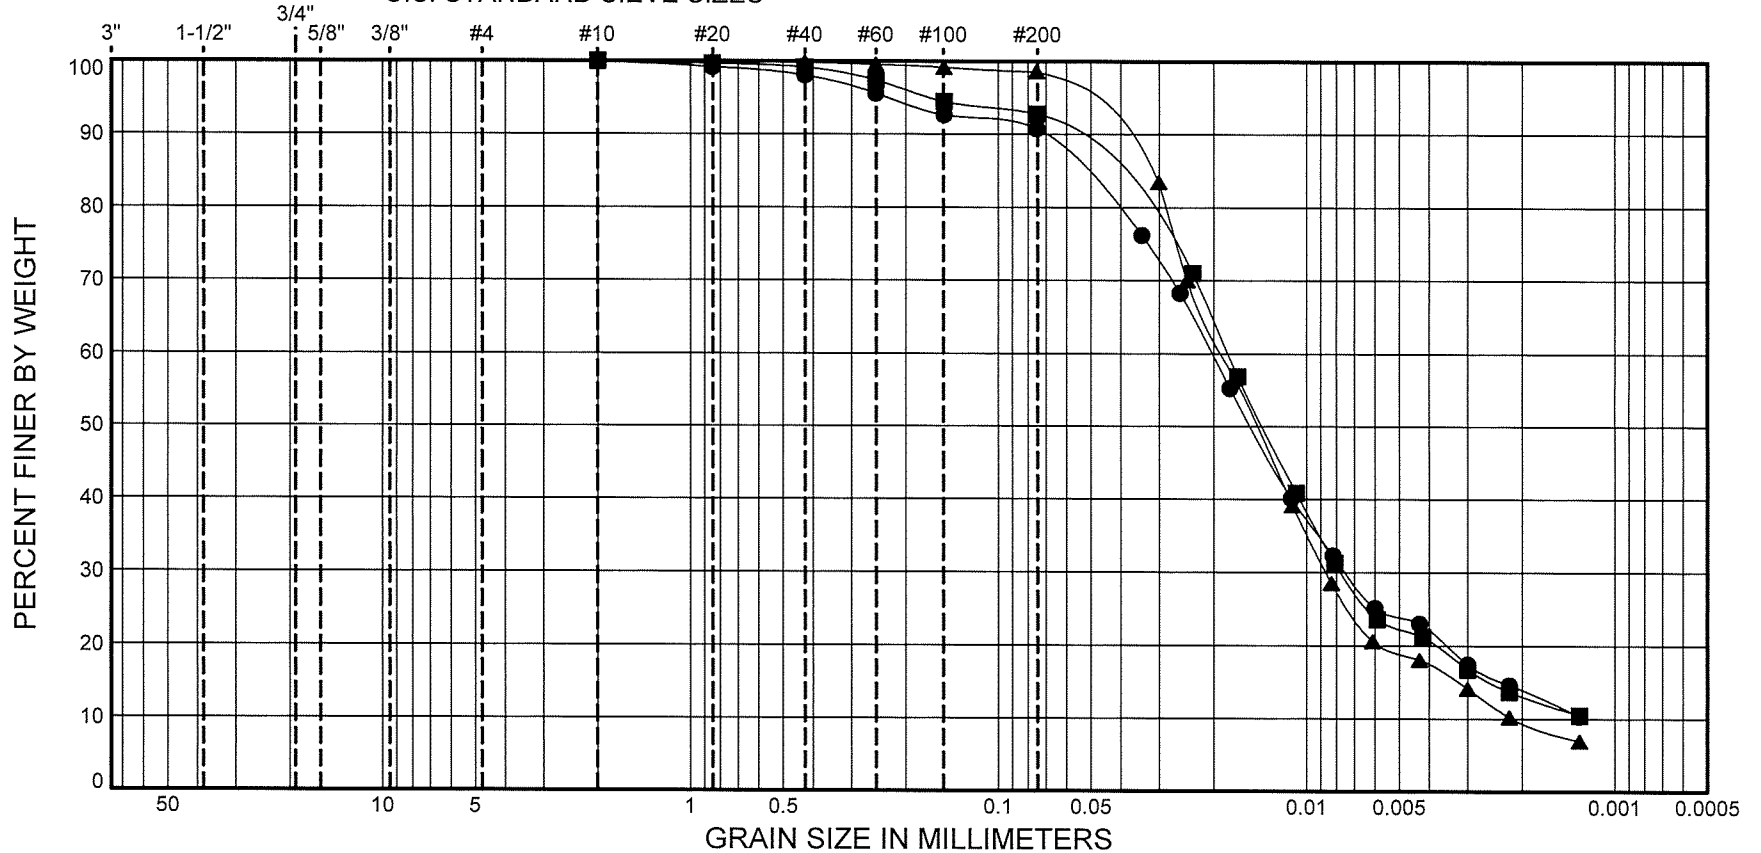
SYMBOL	SAMPLE	DEPTH (ft)	CLASSIFICATION OF SOIL- ASTM D2487 Group Symbol and Name	% MC	LL	PL	PI	Gravel %	Sand %	Fines %
●	BH-2	5.0 - 6.5	(CL) Olive brown, Lean CLAY	25					9.3	90.7
■	BH-2	10.0 - 11.5	(CL) Gray, Lean CLAY	26	32	23	9		7.2	92.8
▲	BH-2	15.0 - 16.5	(CL) Gray, Lean CLAY	24	49	26	23		1.4	98.6

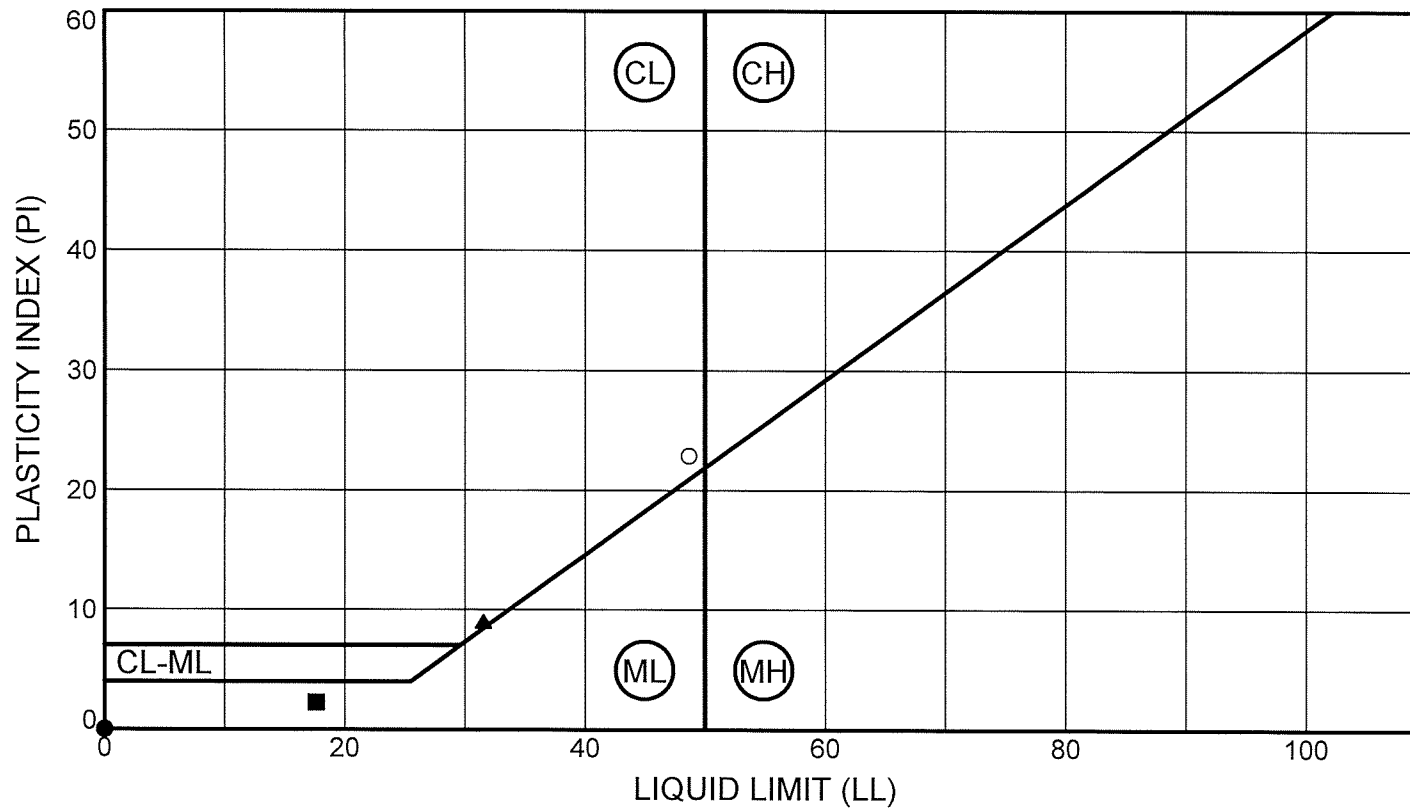
SYMBOL	SAMPLE	DEPTH (ft)	CLASSIFICATION	% MC	LL	PL	PI	% Fines
●	BH-1	10.0 - 11.5	(ML) Olive brown, SILT	24	NP	NP	NP	95.3
■	BH-1	15.0 - 16.5	(ML) Grayish brown, sandy SILT	23	18	15	3	65.1
▲	BH-2	10.0 - 11.5	(CL) Gray, Lean CLAY	26	32	23	9	92.5
○	BH-2	15.0 - 16.5	(CL) Gray, Lean CLAY	24	49	26	23	98.6

**LIQUID LIMIT, PLASTIC LIMIT, AND PLASTICITY INDEX OF SOILS (ATTERBERG LIMITS):** Selected samples were tested using method ASTM D 4318, one-point method. The results are reported on the attached Liquid Limit, Plastic Limit, and Plasticity Index report, Figure 2.
