## GEOTECHNICAL FEASBILITY REPORT PROPOSED AFFORDABLE HOUSING DEVELOPMENT 2901 27<sup>th</sup> Avenue South Seattle, Washington

PROJECT NO. 19-311.100 December 2019

Subject: Geotechnical Feasibility Study Proposed Affordable Housing Development 2901 27<sup>th</sup> Avenue South, Seattle, Washington

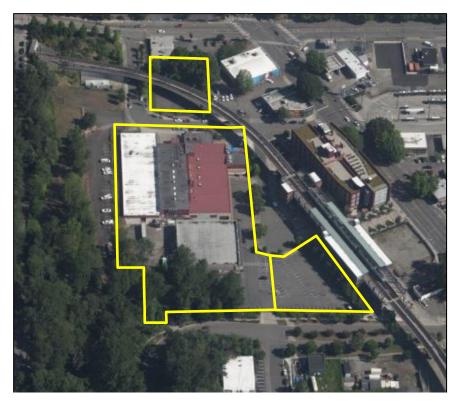
North is toward the top of the image.

A topographic survey was not available at the time of this study. Based on our review of the Seattle Department of Construction and Inspection (SDCI) GIS website 2-foot contours, and our on-site observations, the site slopes down from the west to the east, with about 20 to 25 feet of elevation change across the site. Most of the elevation change occurs in the western portion of the site where the existing improvements have been benched into the slope with a series of retaining walls ranging from four to 15 feet high, and graded slopes and ramps have been constructed to provide access around the west side of the site.

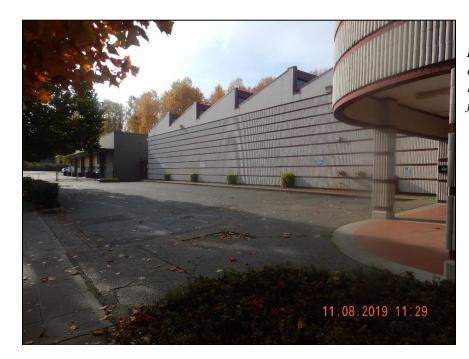
**Plate 2:** View of the east side of the UW Laundry site. Looking from north to south.

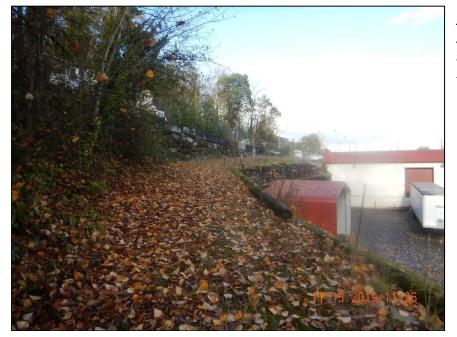
Plate 3: View of slope/access ramp on the west side of the UW Laundry site.

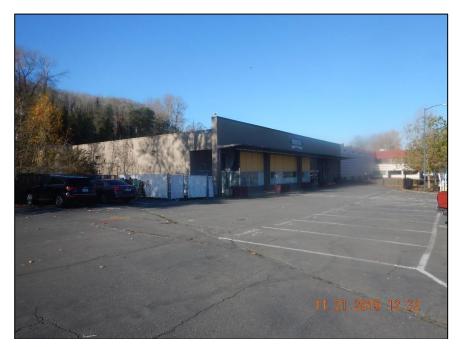
**Plate 4:** View of the former grocery store building in the south portion of the central parcel.

Looking from south to north.

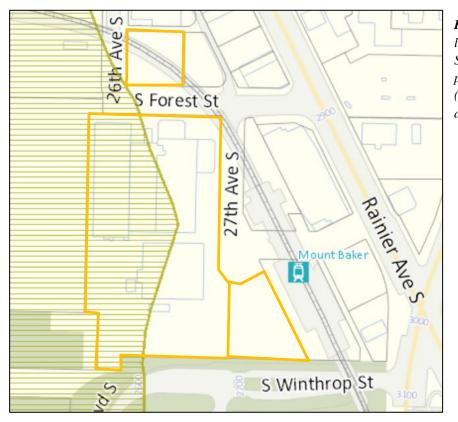
Plate 6: Approximate lateral extent of SDCI mapped potential slide ECA (yellow hatched area).

The west portion of the central parcel is mapped as a potential landslide hazard ECA due to geologic conditions. The area to the west of the site is mapped as an Uncertain Landslide Area in Landslides Mapped using LIDAR Imagery, Seattle, Washington, USGS OFR-2004-1396 (Schulz, 2004) and as a Zone 2 Landslide in Map Showing Susceptibility Estimated from LIDAR Mapping and Historical Landslide Records, Seattle, Washington, USGS OFR-2005-1405 (Schulz, 2005). The approximate extent of the potential landslide hazard ECA is shown on Plate 6, below.

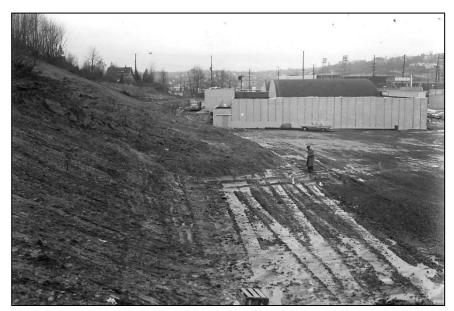
**Plate 8:** View of 1958 slide looking from South Winthrop Street to the north.

The Rainier Bowl building is in upper right of photo.

In January and February of 1958 there was additional movement which expanded the slope failure and the slide eventually extended between South Stevens Street at the south and South McClellan Street to the north, damaging 25th Avenue South. Plate 8 below is a photo of the slope failure obtained by SDOT in January 1958.

The cause of the slide was excavation at the base of the slope, uncontrolled surface water drainage and groundwater seepage.

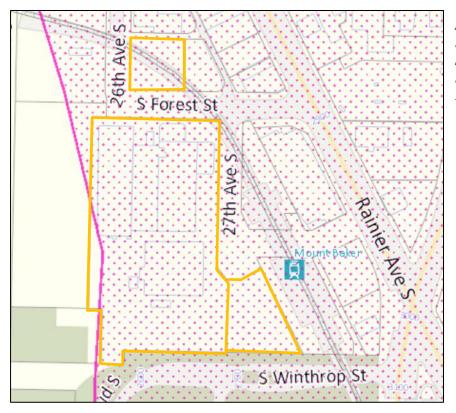
**Plate 9:** Approximate lateral extent of SDCI-defined liquefaction hazard ECA.

A seismic hazard ECA is defined by the City as an area that will be susceptible to liquefaction during a design level seismic event. The lateral extent of the seismic hazard ECA is shown on Plate 9, below. Soil liquefaction is a condition where saturated cohesionless soils undergo a substantial loss of strength due to the build-up of excess pore water pressures resulting from cyclic stress applications induced by earthquakes. Soils most susceptible to liquefaction are loose, uniformly graded sands and loose silts with little cohesion that are below the groundwater.
