701-711 South Jackson - Historic Evaluation

June 11, 2021, rev. July 25, 2021

1. INTRODUCTION

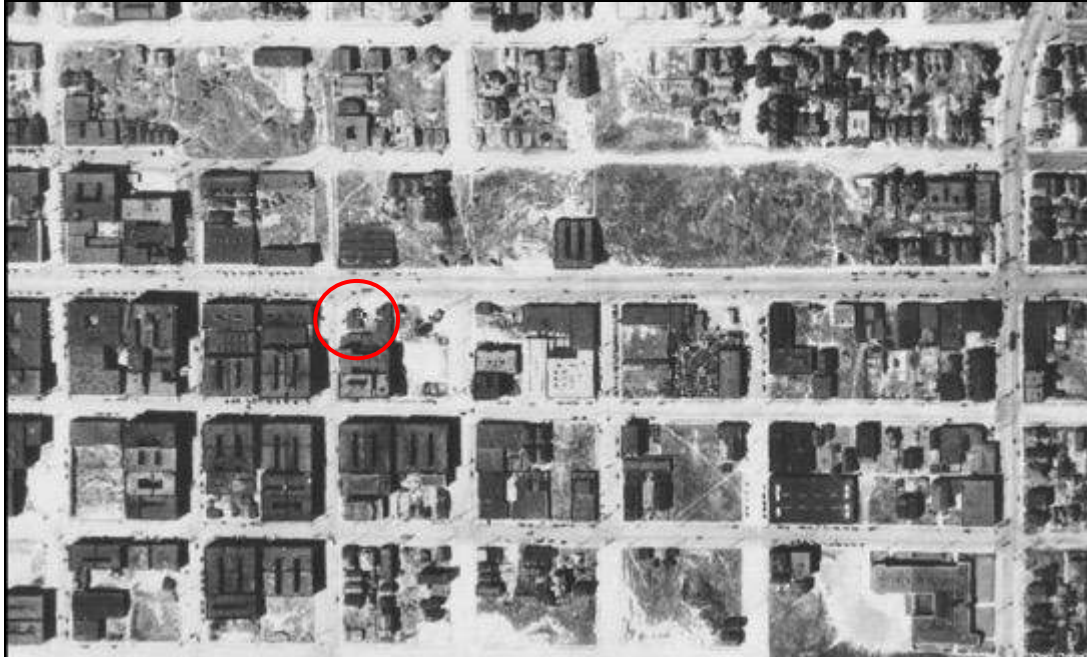
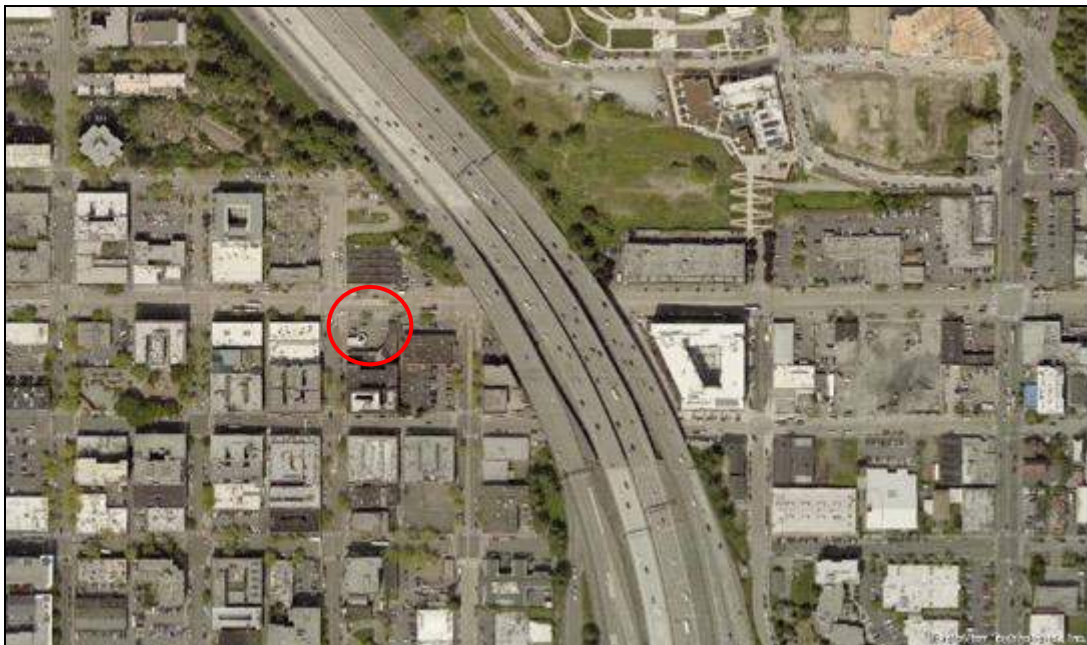
Below, two aerial photos show changes in the surrounding neighborhood between 1936 and 2019. The subject property is circled in red. (KCTA GIS, available through King County Parcel Viewer)

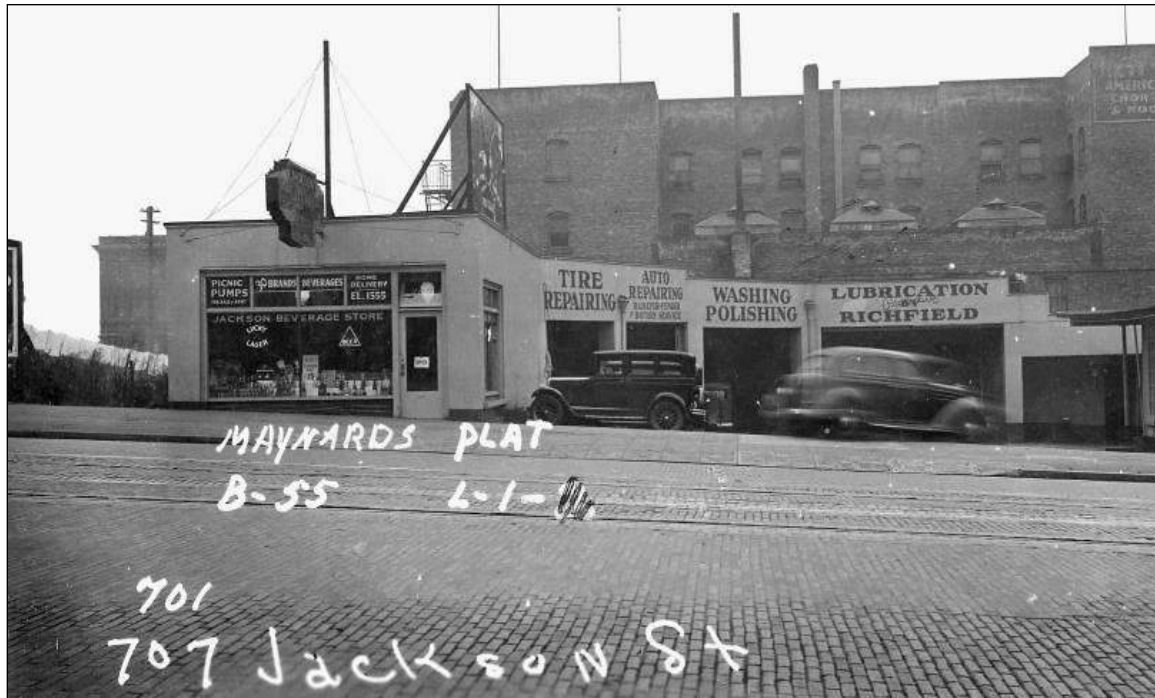
Above, the 1937 era tax assessor's photo of the Garage at 707-711 Jackson Street, looking south. Below the record photo from May 20, 1957. (King County Tax Assessor, Property Record Card)

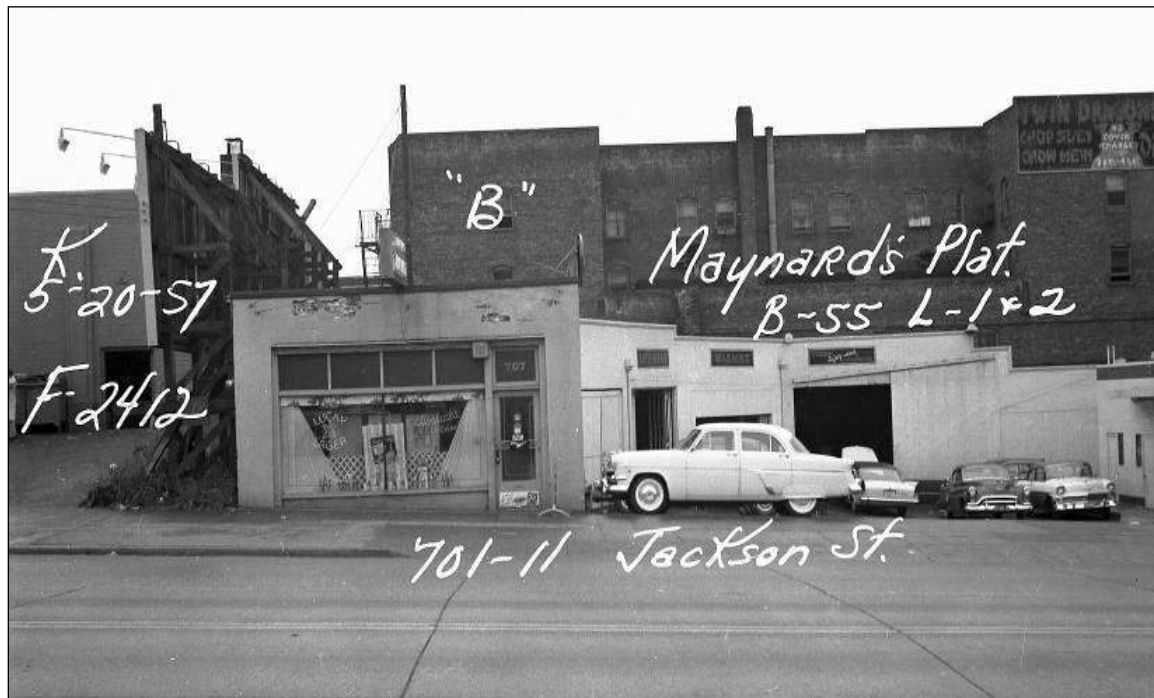
Above, a May 19, 1948, tax assessor's photo of the gas station at its original location at 520 Seneca Street, prior to its relocation to S Jackson Street. Below the record photo of the gas station on the present site from May 20, 1957. (King County Tax Assessor, Property Record Card)

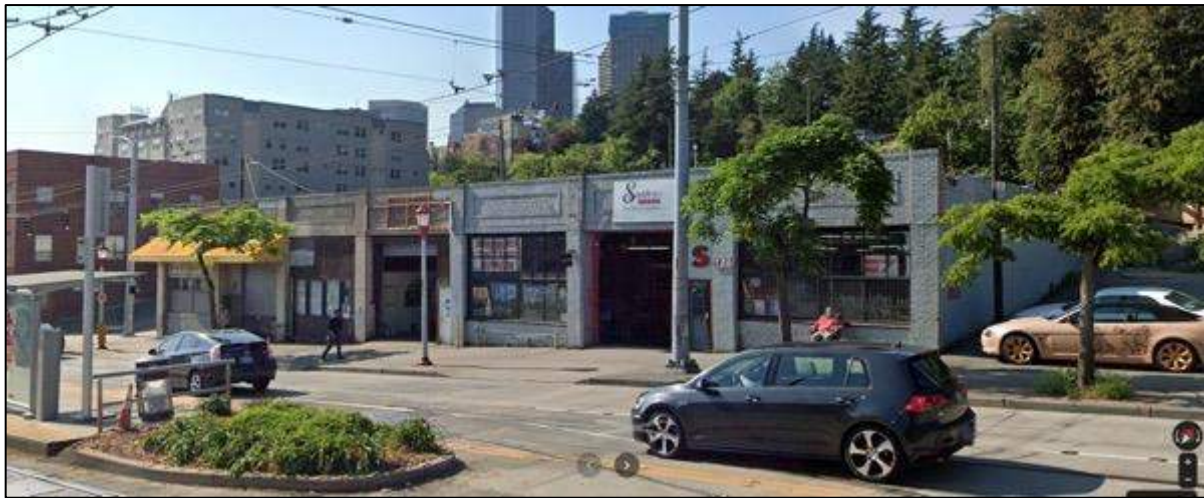
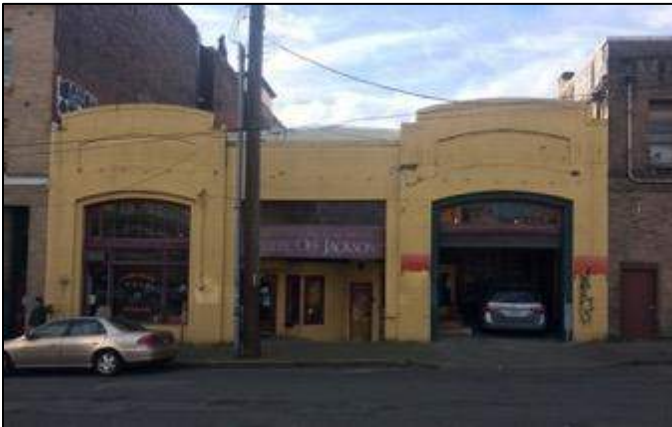
Above and left, views of two other garages in the Chinatown-International District and in the immediate vicinity: The 7th Avenue Garage/7th Avenue Auto Rebuild at 710-720 S Jackson Street, and the former China Garage and Wing Luke Museum / current Theater Off Jackson, at 407-413 7th Avenue S. (Upper photo, 2019, Google Earth. Left photo, 2021)

A number of older garage buildings survive throughout the city. Some have been adapted for other use, such as the former Wing Luke Museum and currently the Theater off Jackson, at 407 7th Avenue S. Others, such as the garage across the street, at 710-720 S Jackson, are still used for vehicle repair work.

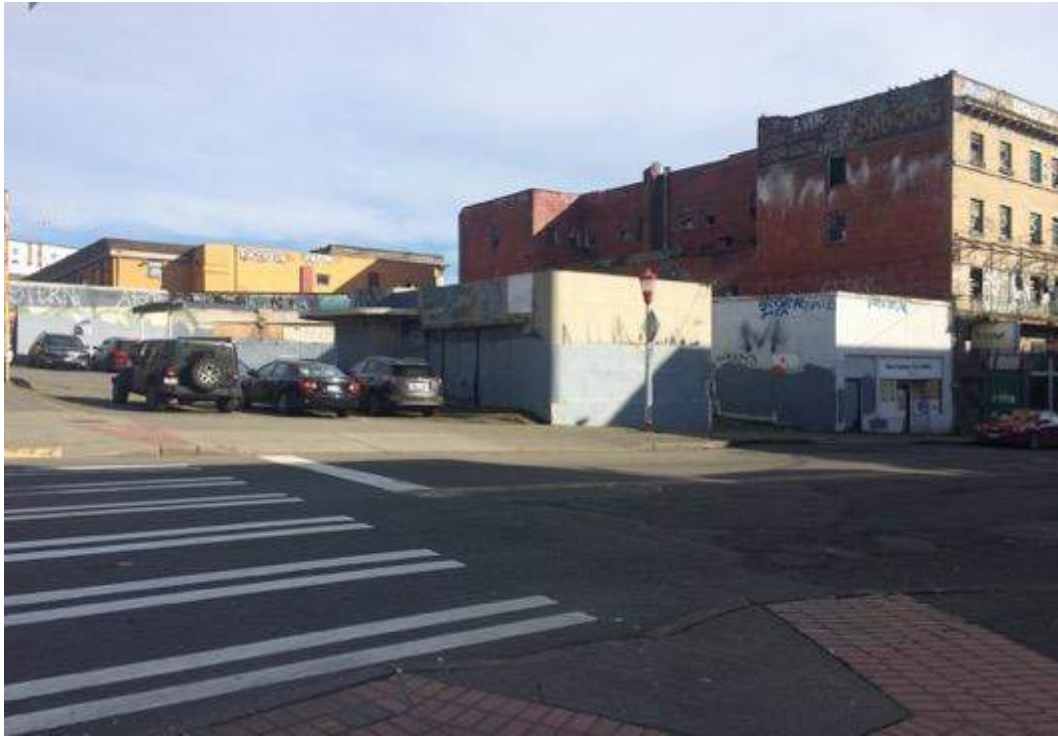
Above a 2021 view looking southeast at the site, with the adjacent House of Hong Building in the background (to the east), and the adjacent Republic Hotel on the right (to the south).

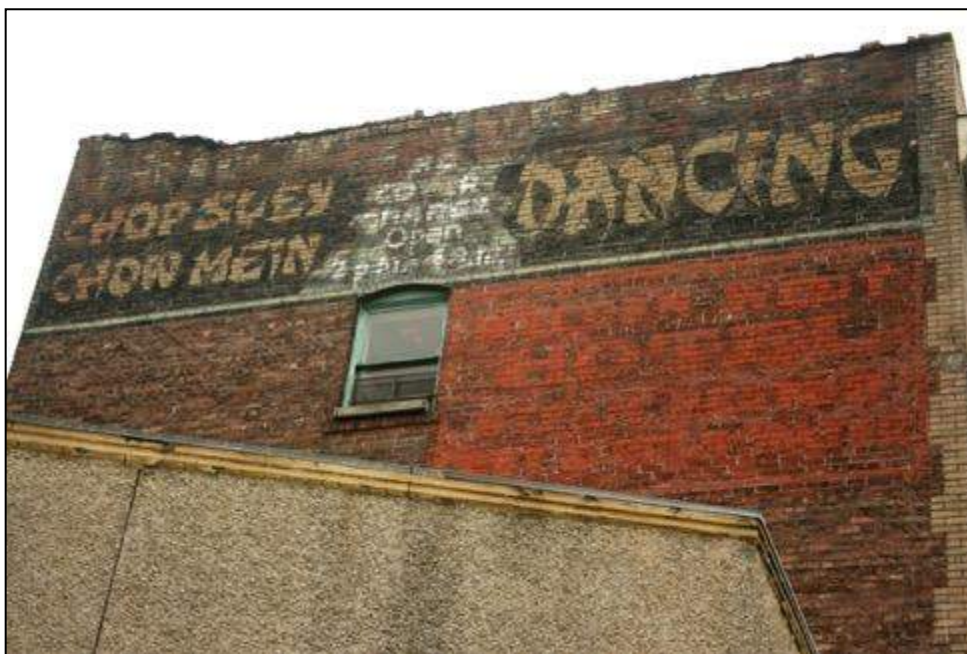
Below, a 2008 photo of painted signage on the upper north façade of the Republic Hotel, showing and the condition of the masonry and parapet. The stucco clad walls in the foreground are part of the subject garage.

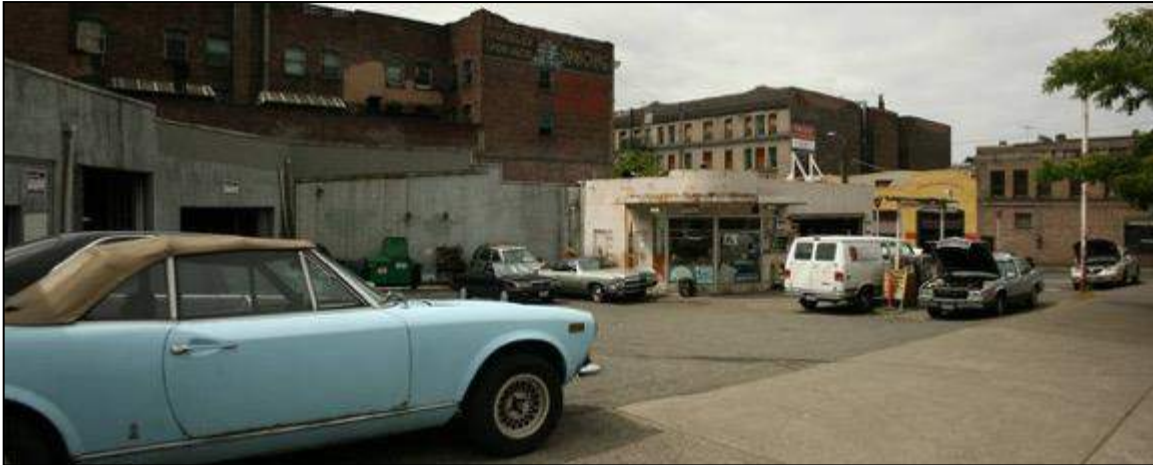
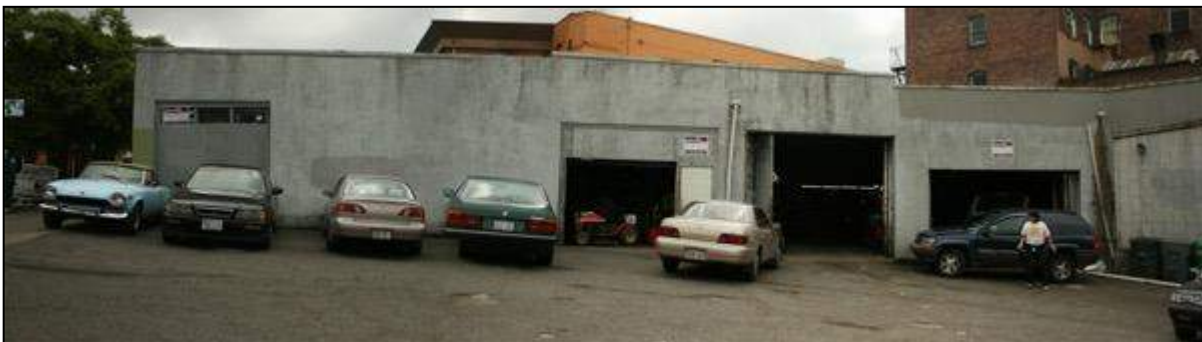
Views of the property in 2008 when it was still operating as a repair garage and service station. Above, looking southwest at the site from S Jackson Street. Below a composite photo of west and northwest facades of the Garage (Building B in the King County Assessor’s records).

Below, views in 2008 of the Service Station (Building A in the King County Assessor’s records). Some of the steel framing, cladding and steel framed windows were visible at that time, along with the “top-hat” style overhang.

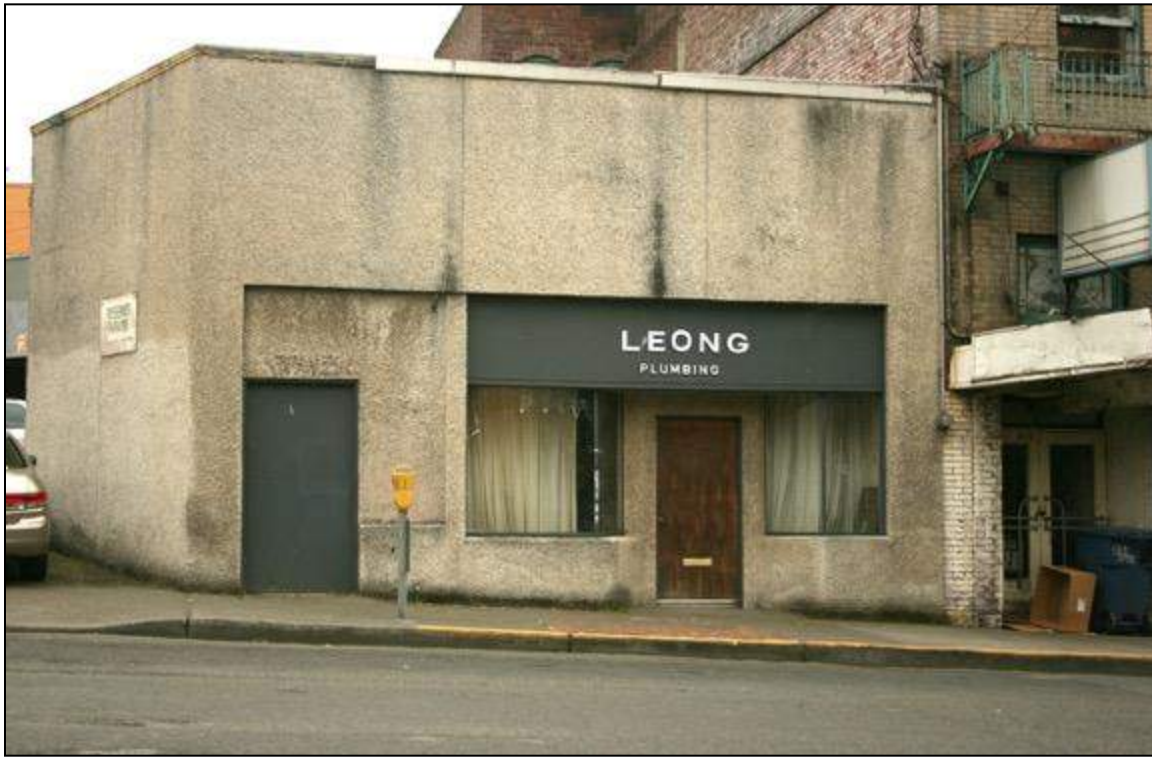
Above, the retail space at the southwest end of the Garage in 2008 when Leong Plumbing was the tenant of 408 7th Avenue S. By that date the historic storefront had been replaced by a Modern style one. Below, the Gas Station and remnants of the pump island in 2008.

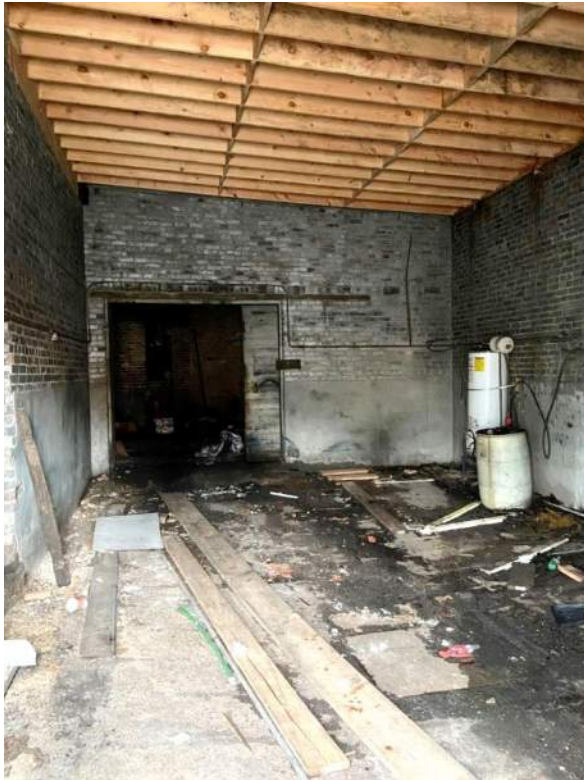
Left, an interior view of one of the service bays in the Garage in 2021 (photograph by Anton Dekom, Neiman Taber Architects).

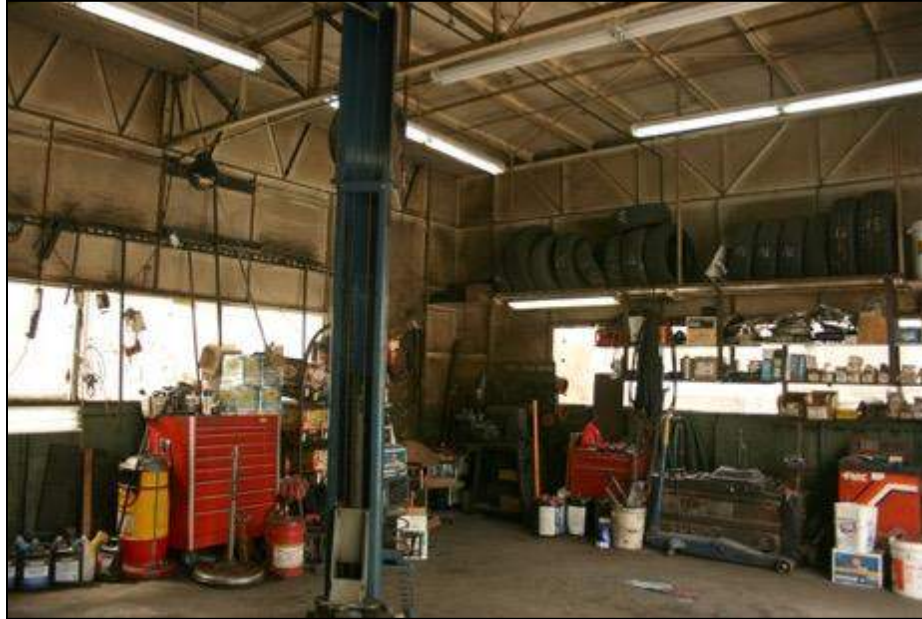
Below, the steel-framed structure and two-bay service space of the Gas Station in 2008. (This interior space was not accessed in 2021.)

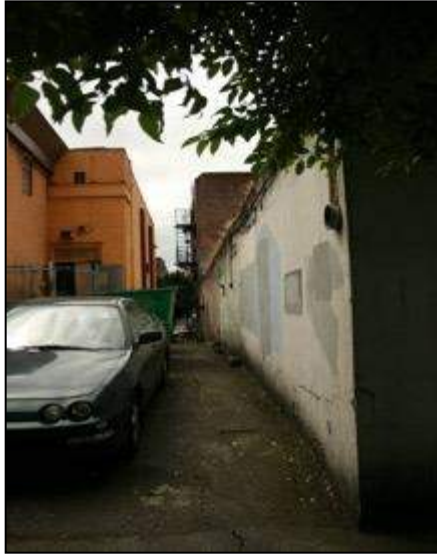
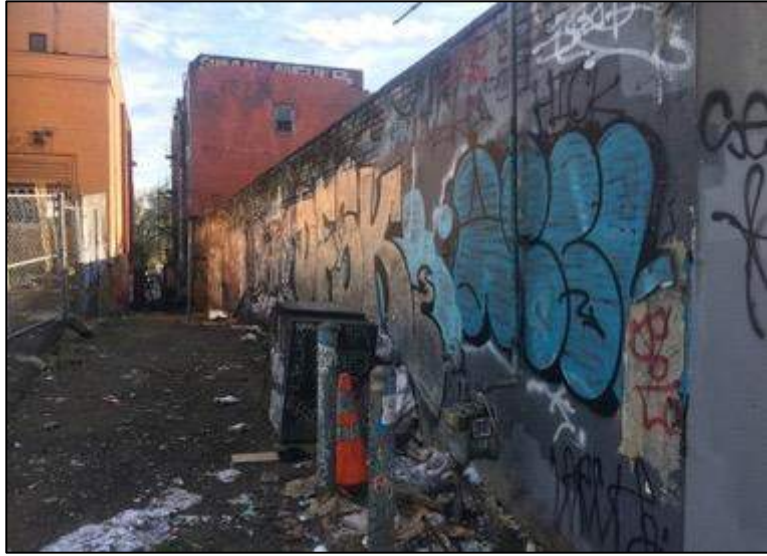
Above, looking south along vacated alley and the east facade of the Garage in 2008 (left) and 2021 (right). Directly below, looking southeast at the former retail space and storefront at 707 S Jackson Street, and the northernmost part of the Garage in 2008. Lower photo, a similar view in 2021. The space is vacant.

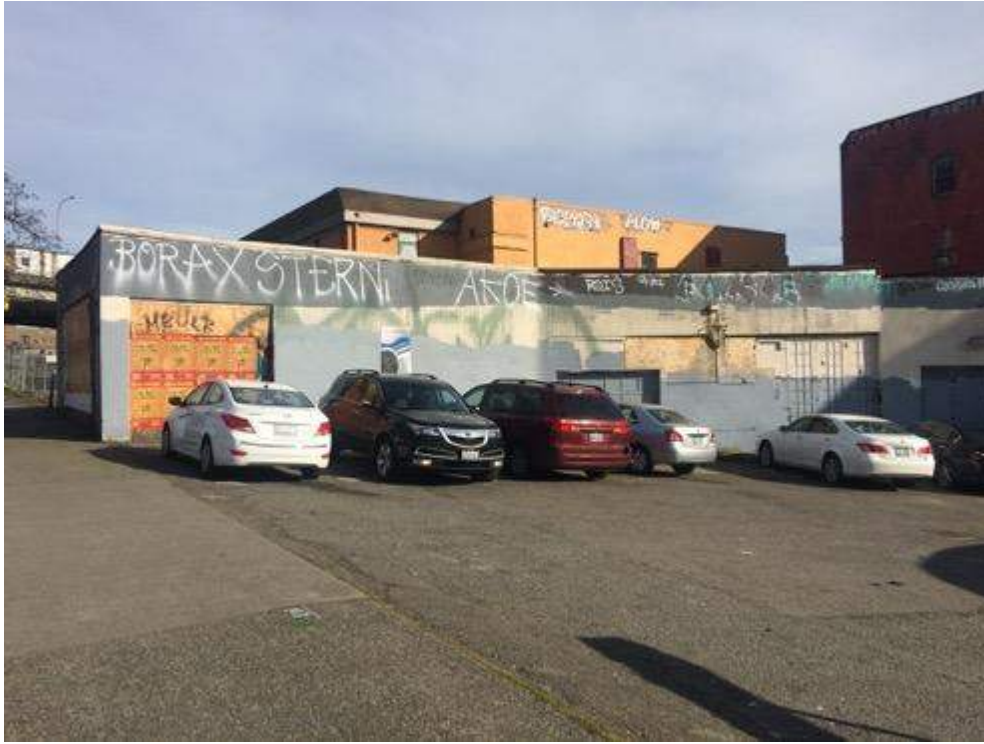
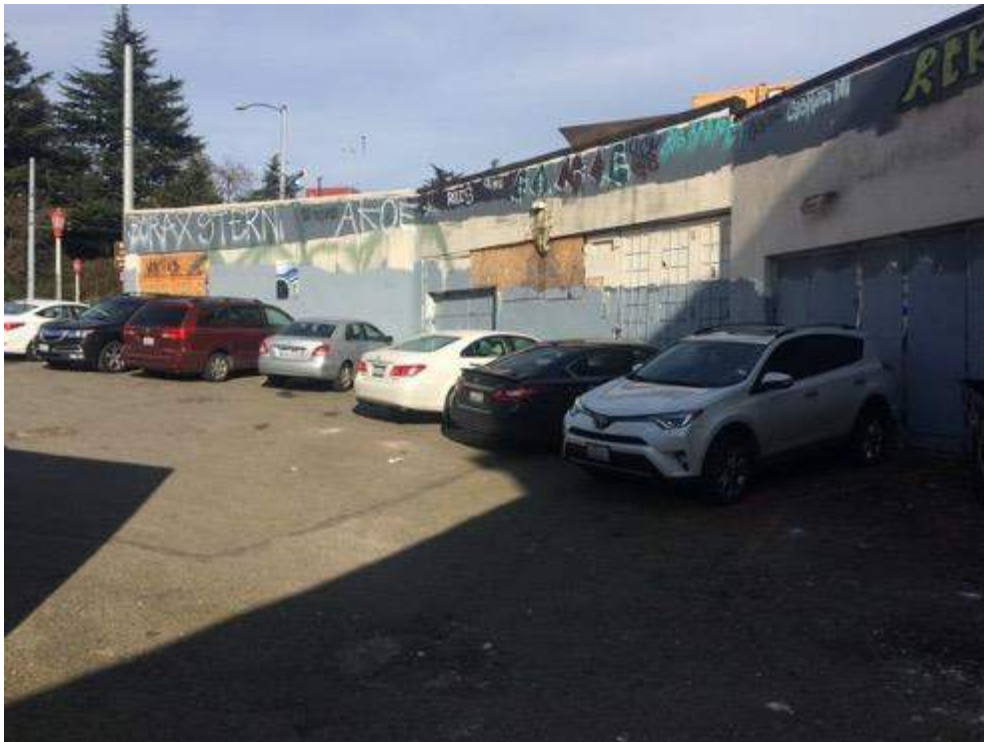
Above, looking east and south at the Garage facades and parking area in front of it in 2021.

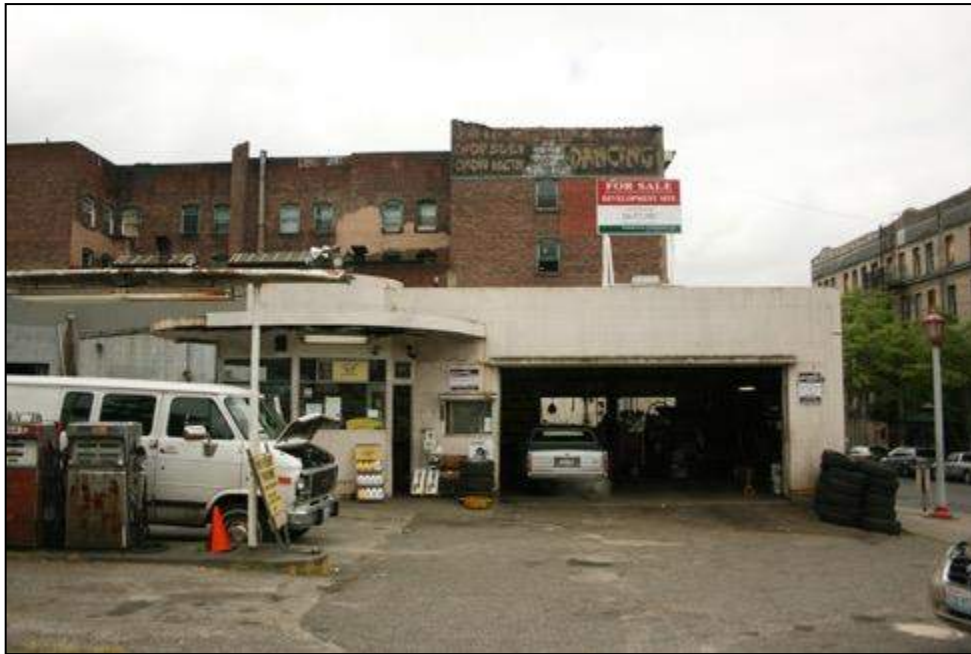
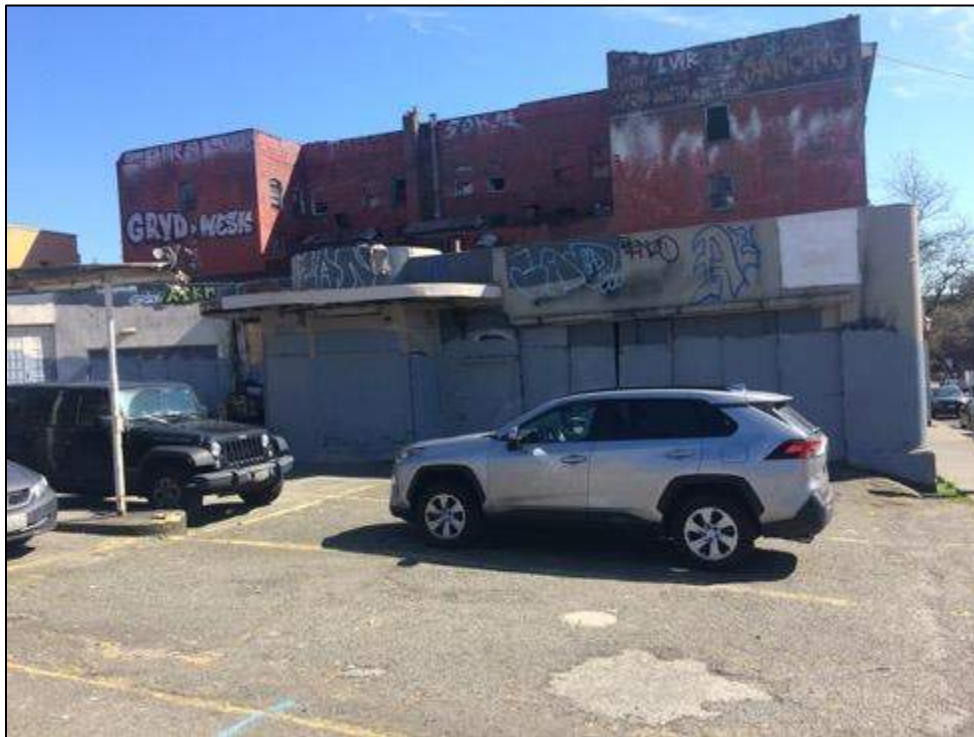
The gas pumps have been inoperative for nearly two decades, and the station's service bays have been closed for over five years. All of the original glazed windows and personnel door openings have been infilled with solid panels. Parts of the steel vehicle garage doors, roofing and framework show evidence of rust and deterioration. In its current condition, it has lost much of its architectural integrity.

Above, looking south at the primary (north) facade of Gas Station in 2008 (above).
Below, a similar view in 2021.

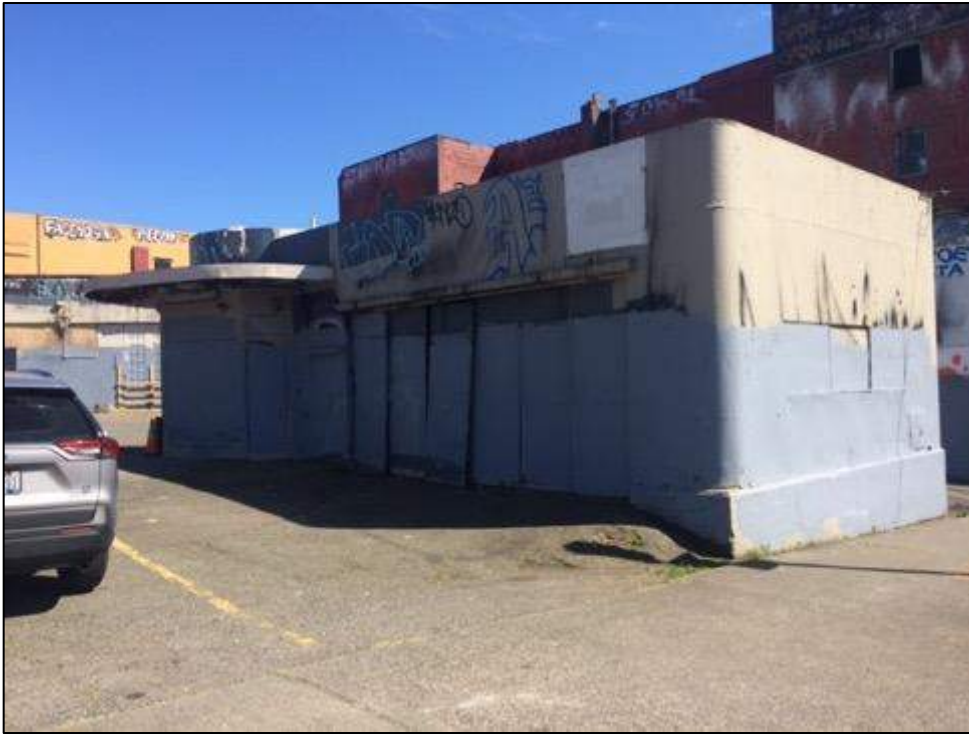
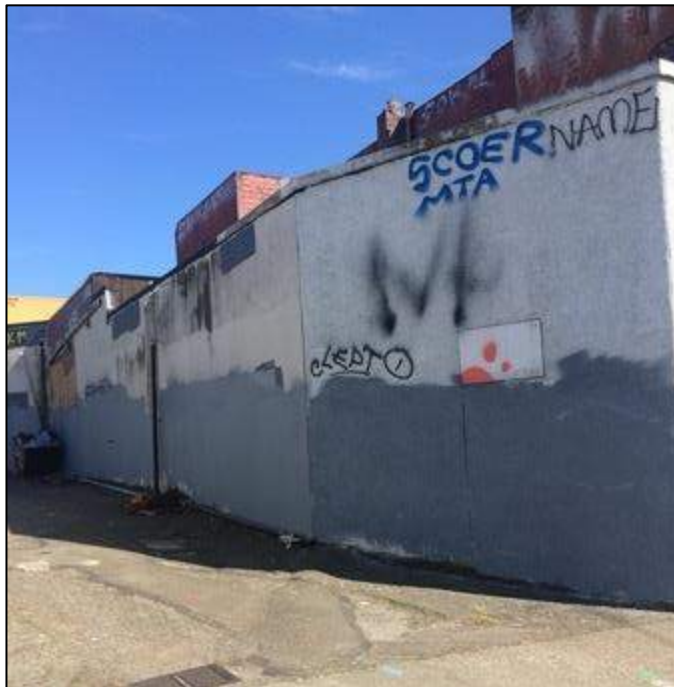
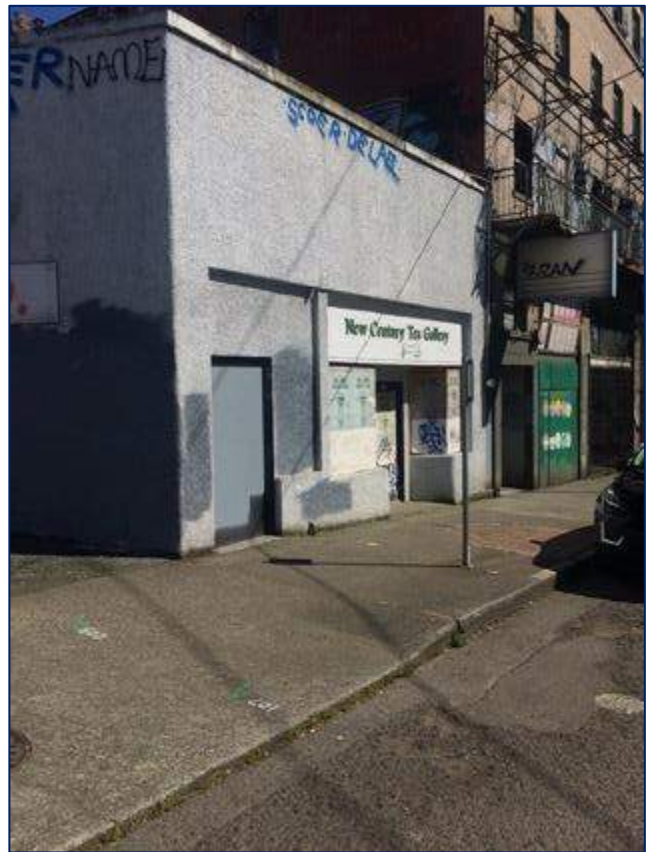
Above, the north and west facades of the Gas Station in 2021. Below, looking east along the inner north façade of the Garage, and left, the retail space at the southwest end, which faces onto 7th Avenue S. This space is used currently as a storage facility.

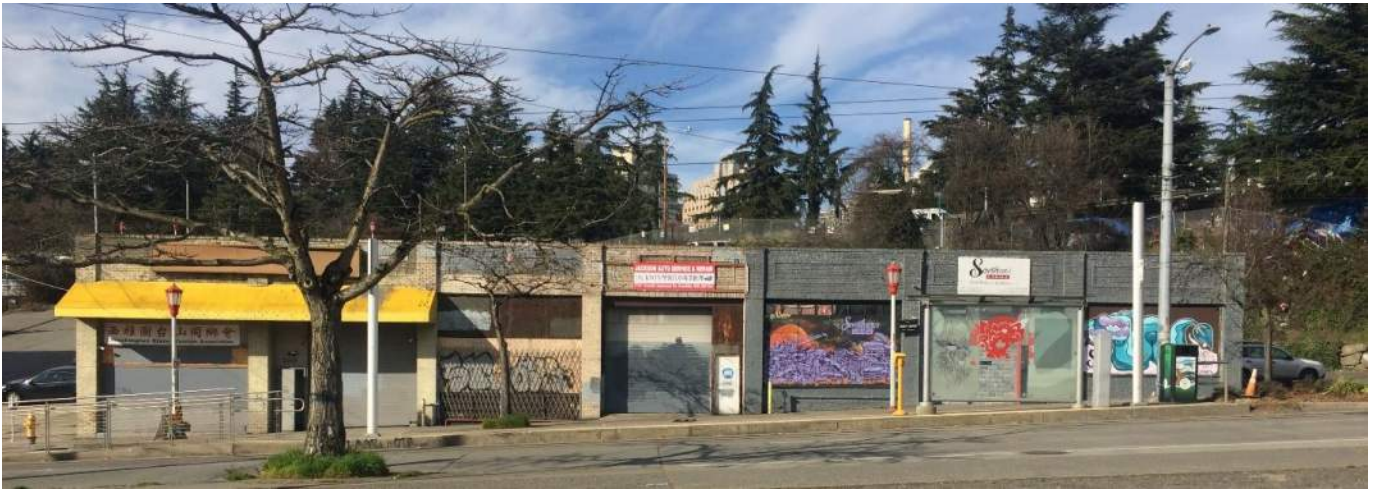
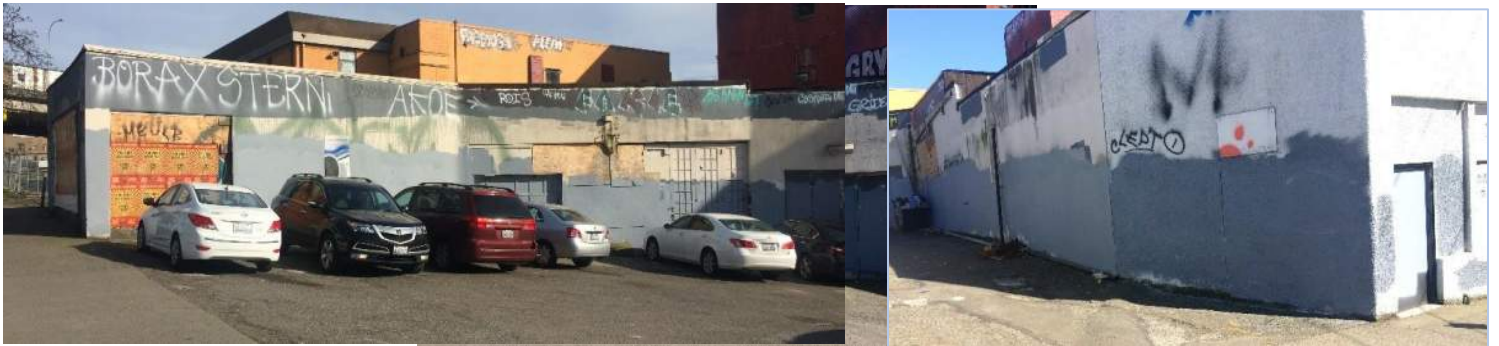
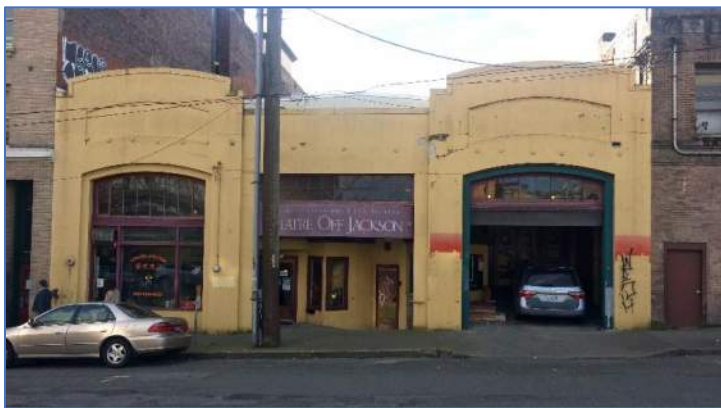
Comparable views of service garages in the historic district. Above, the active garage at 710-720 S Jackson Street, and below a composite photo of the subject garage at 711 S Jackson Street. Lower image, a comparable scale photo of the former garage across 7th Avenue S., which was transformed into the Wing Luke Museum and has served since 2005 as the Theater Off Jackson.
