The City of Seattle

## Landmarks Preservation Board

# Bressi Garage

## City of Seattle Historic Landmark Nomination

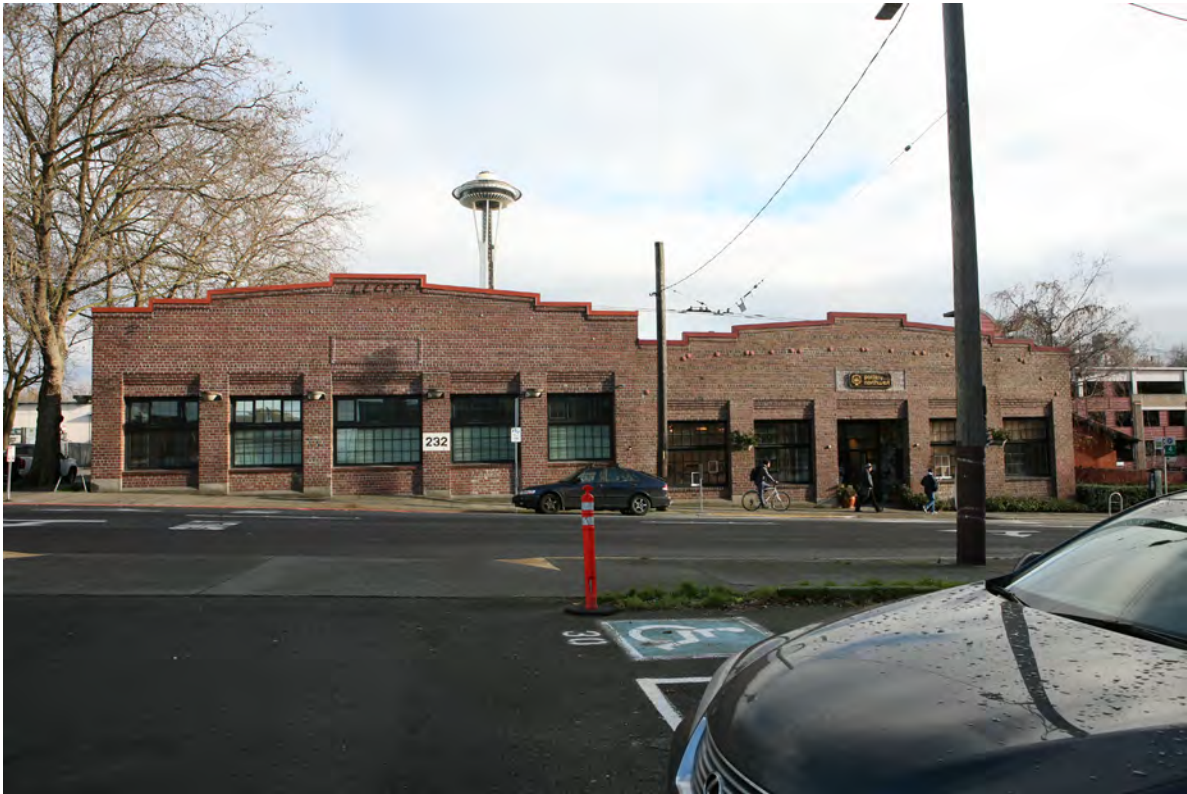
Photograph 1: 2017 view of Bressi Garage west elevation. Courtesy Artifacts Consulting, Inc.

The west elevation, fronting First Avenue N., is the building's primary elevation (see Photograph 1). The west elevation is divided into two storefronts with stepped parapet walls highlighting each half. Each storefront

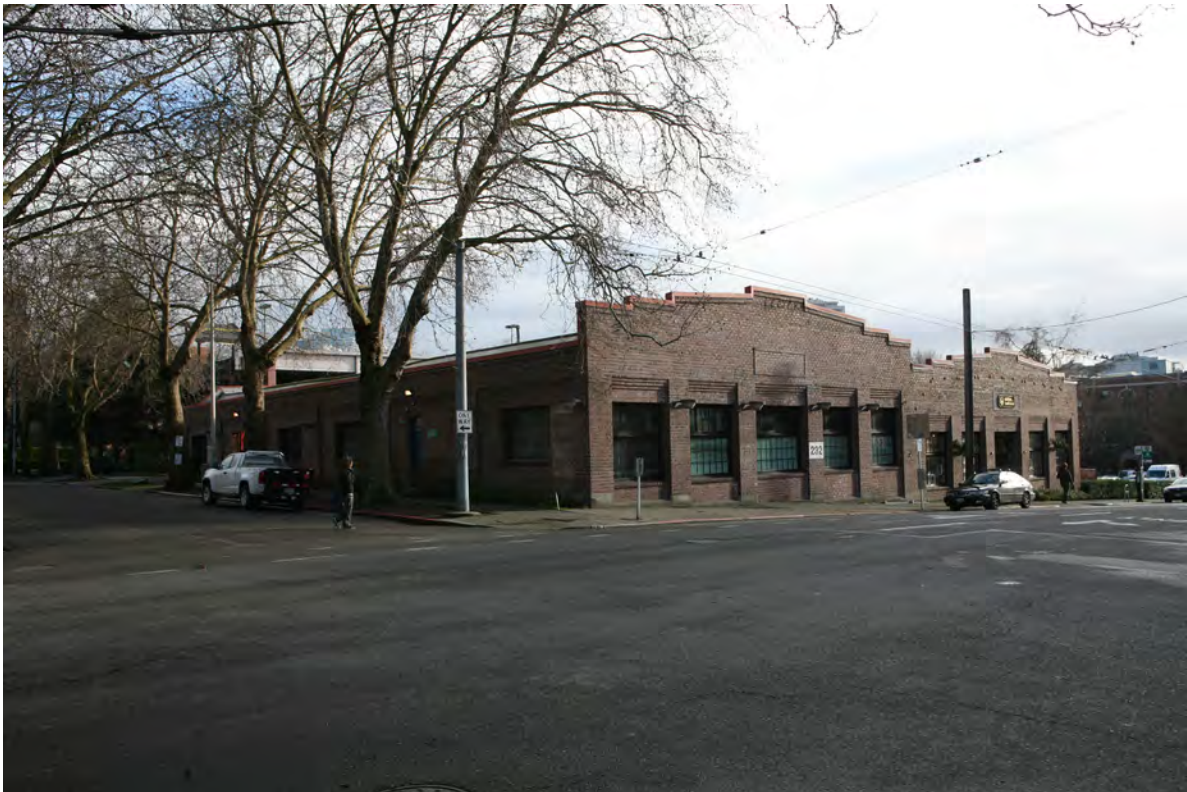
Photograph 2: 2017 view of Bressi Garage west and north elevations. Courtesy Artifacts Consulting, Inc.

The north elevation is divided into six bays, wider than those on the west elevation (see Photographs 2, 3, and 8 and Figure 16). Wide brick pilasters separate each bay. Brick corbelling highlights the lintel. Windows, a roll-up garage door, and a metal personnel door with a transom punctuate this elevation's bays.

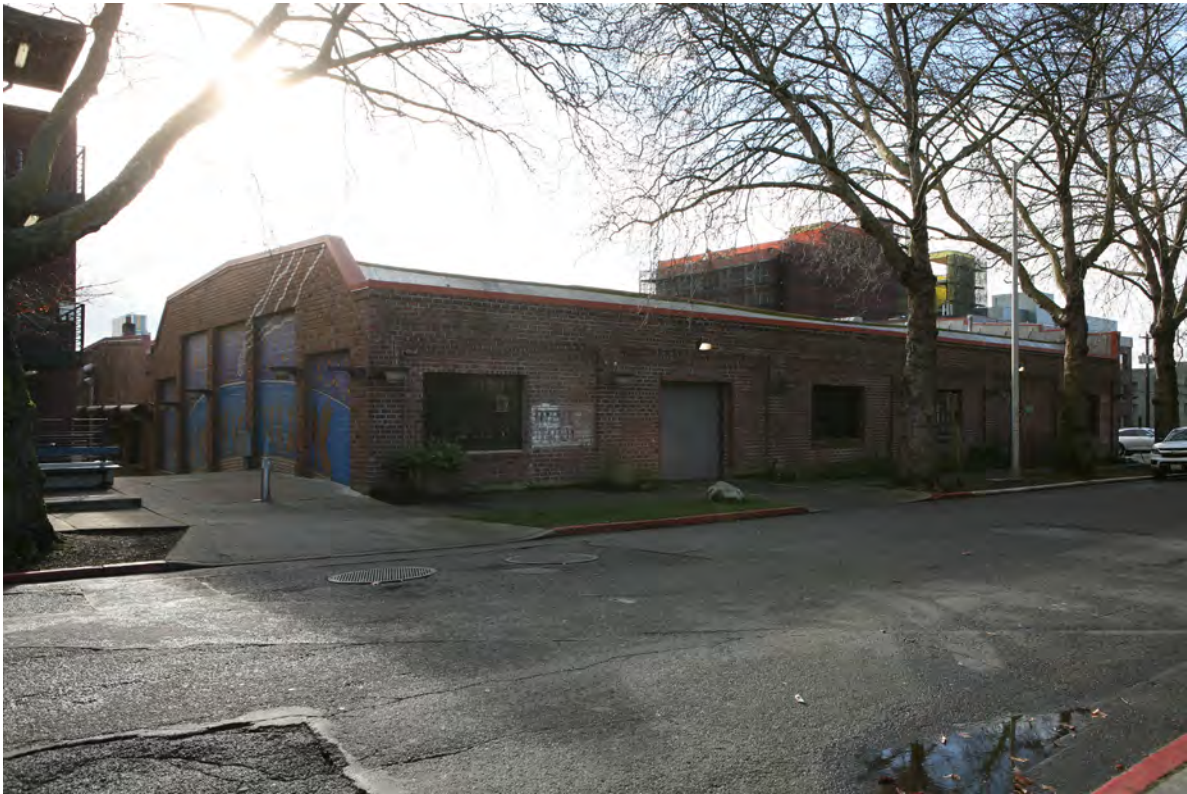
Photograph 3: 2017 view of Bressi Garage north and east elevations. Courtesy Artifacts Consulting, Inc.

The east elevation, like the west, is divided in two with five bays each (see Photographs 3, 4, and 9). Angled parapet walls provide definition for the north and south half of the elevation. Each bay features a recessed opening, marked by a sailor header course. The recessed openings in the northern five bays of the east elevation have been infilled with concrete block. A painted mural covers the concrete blocks and partially extends onto the brick. The recessed openings in the southern five bays of the east elevation retain their original windows and door. This half of the elevation features a central door flanked by two bays of windows; roll up metal security doors are located above all five openings (see Photograph 15 and Figure 15).

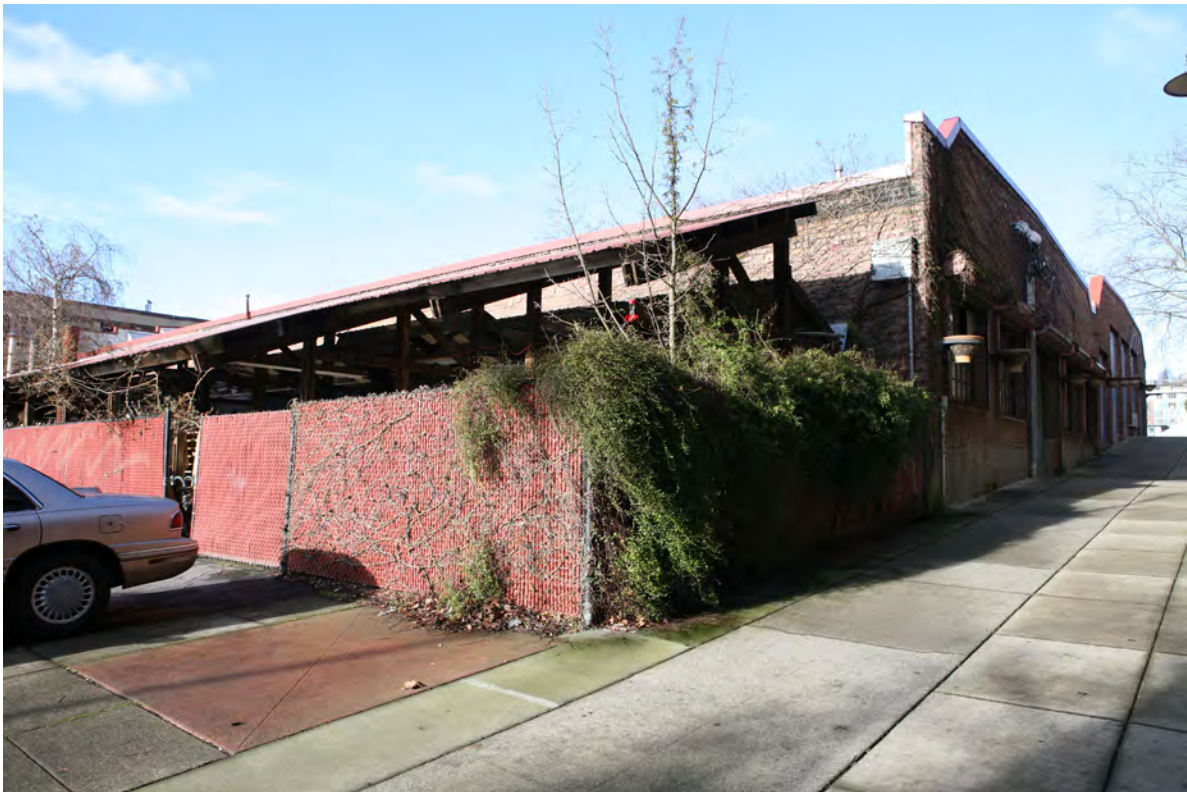
Photograph 4: 2017 view of Bressi Garage south and east elevations. Courtesy Artifacts Consulting, Inc.

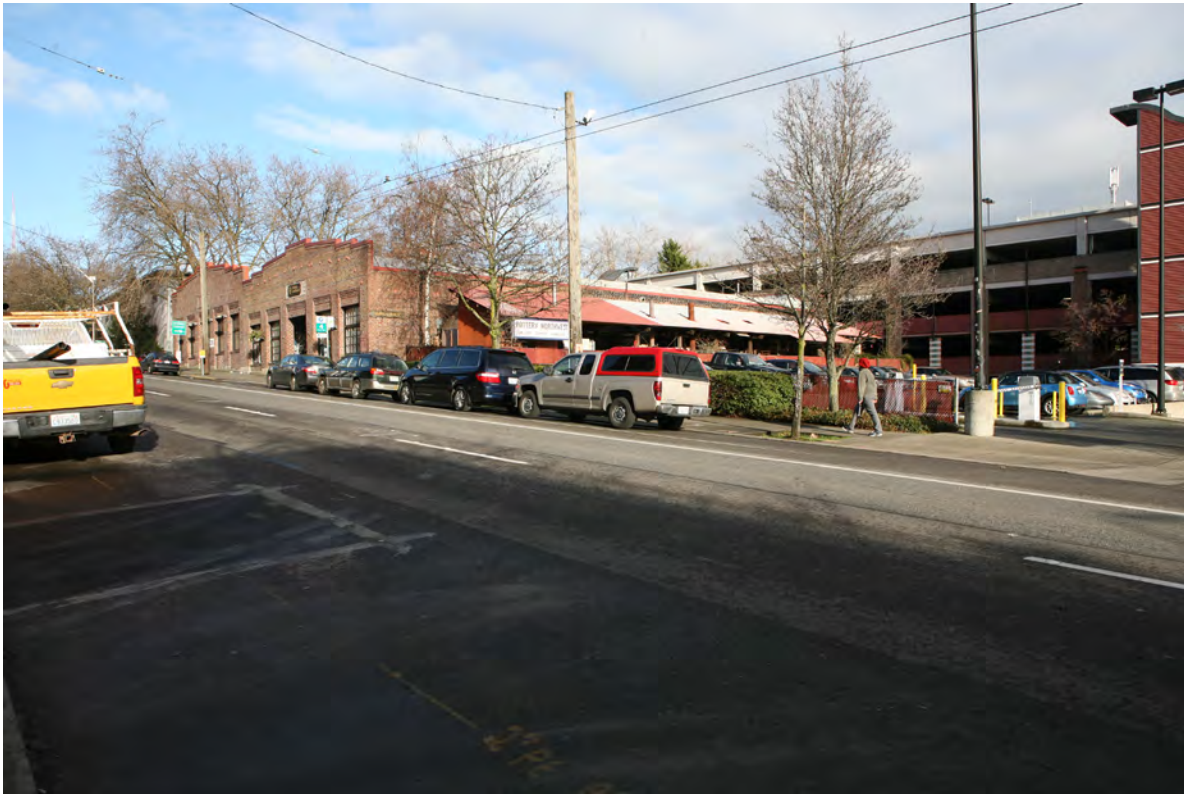
Photograph 5: 2017 view of Bressi Garage west and south elevations. Courtesy Artifacts Consulting, Inc.

The south elevation, like the north, is divided into six bays (see Photograph 10 and Figure 16). A shed roof lean-to obscures much of the south elevation, providing outdoor workspace as a kiln shed for the current tenant, Pottery Northwest. Drawings for the kiln shed were received by the City of Seattle in 1974. A door located in the second bay from the east provides access from the interior of the building out to the shed. The shed extends 25-feet to the south and runs along the south elevation (see Photograph 5).

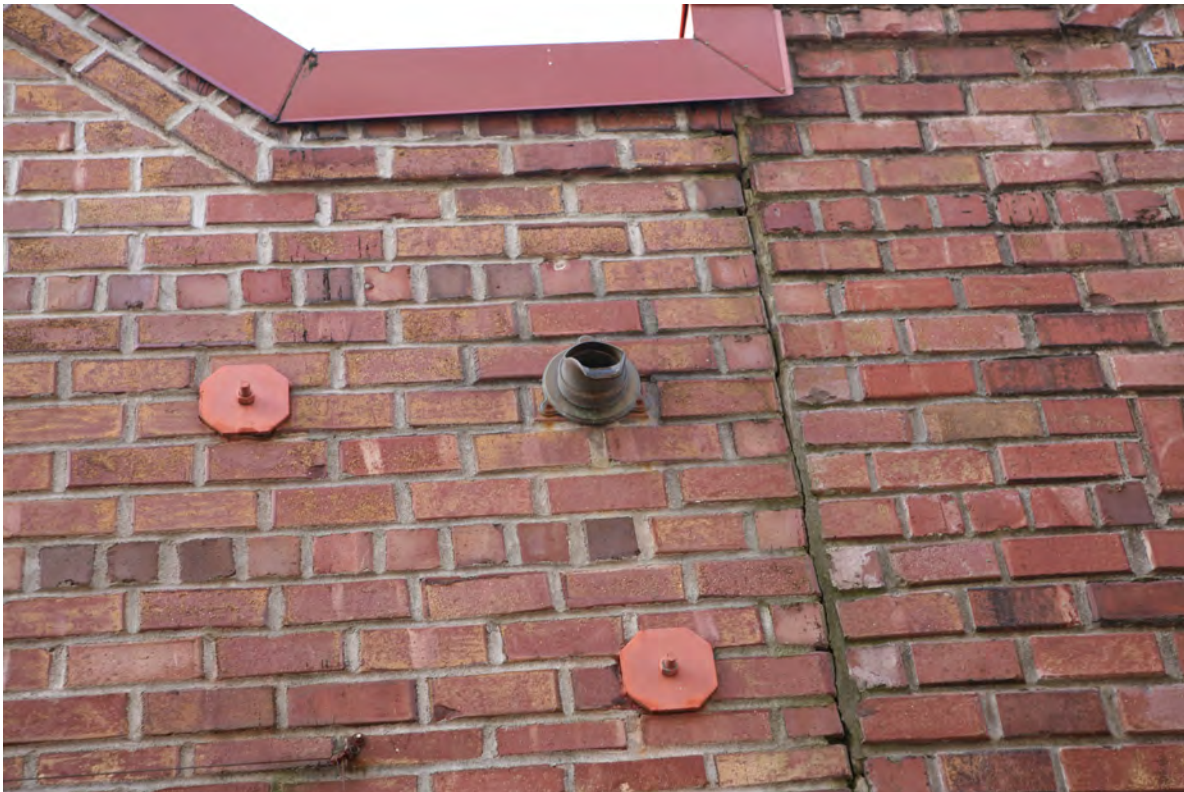
Photograph 6: 2017 detail view of Bressi Garage brick and parapet on east elevation. Courtesy Artifacts Consulting, Inc.

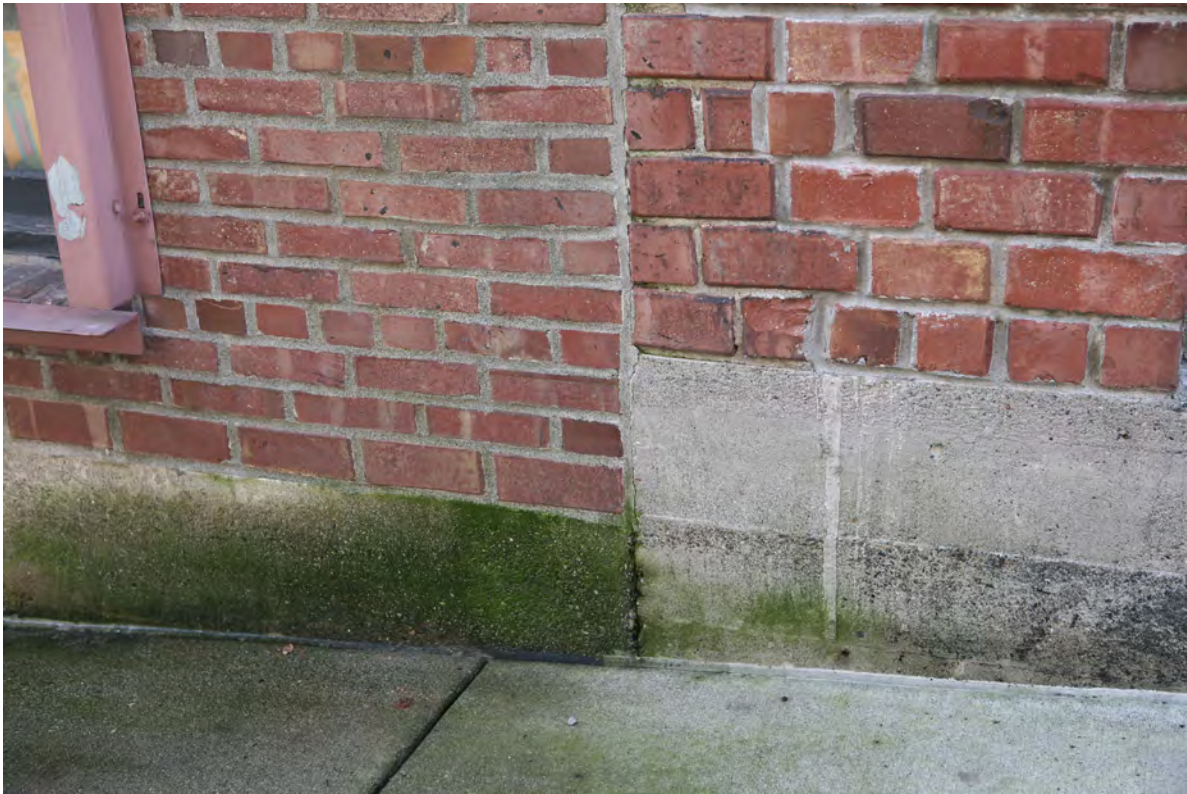
Photograph 7: 2017 detail view of foundation and structure on Bressi Garage east elevation. Courtesy Artifacts Consulting, Inc.

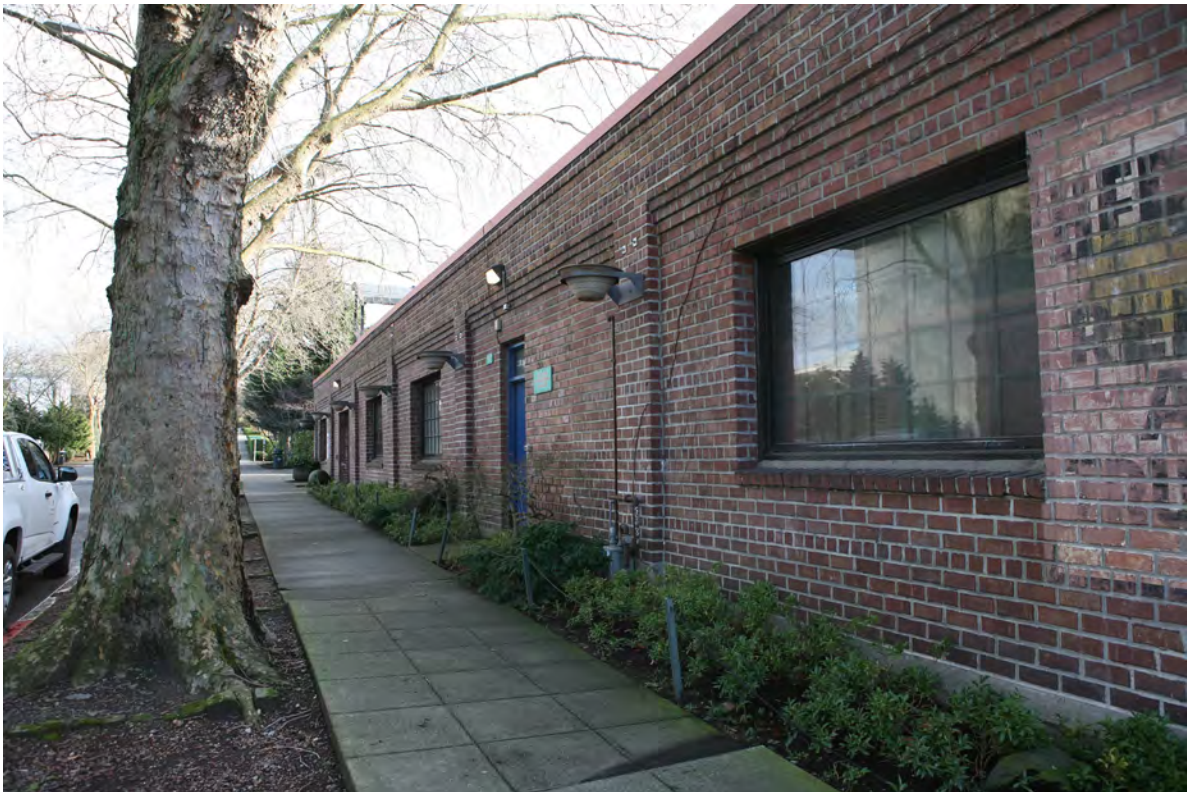
Photograph 8: 2017 view looking east along north elevation of Bressi Garage. Courtesy Artifacts Consulting, Inc.

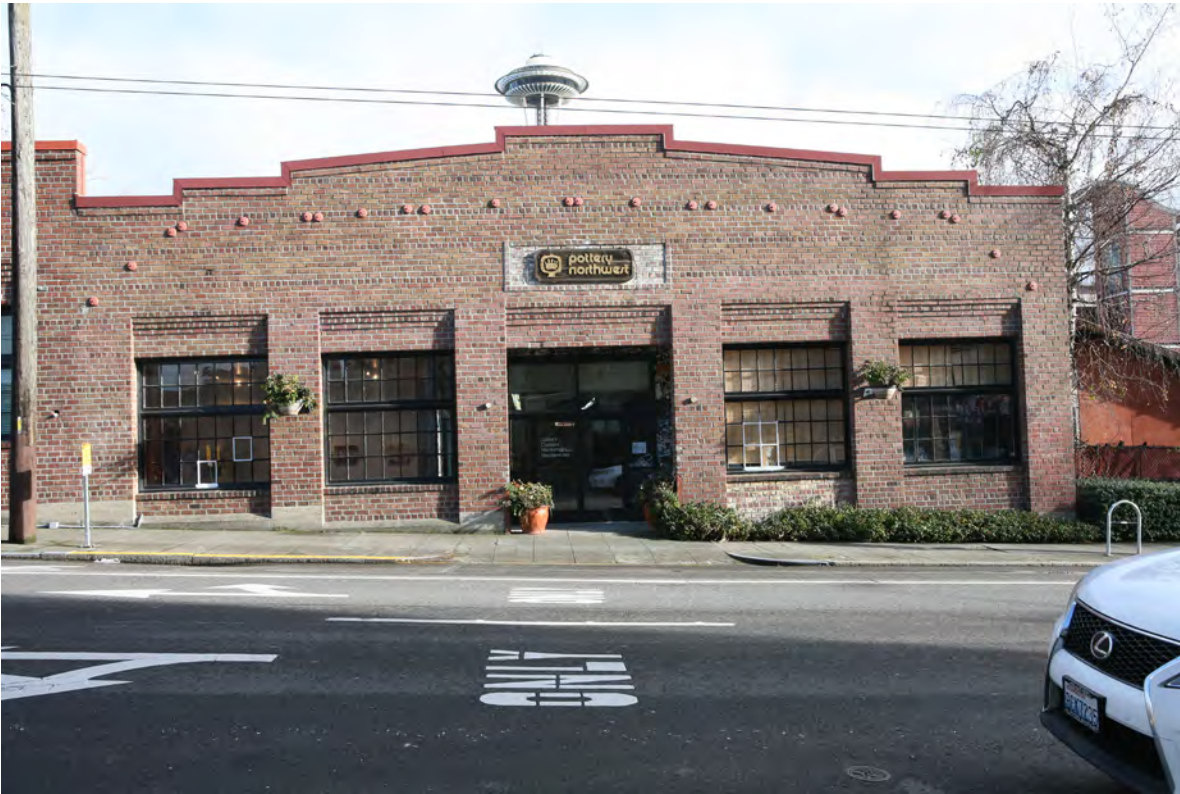
Photograph 11: 2017 view of Bressi Garage west elevation, south storefront. Courtesy Artifacts Consulting, Inc.

features five bays, separated by wide brick pilasters (see Figure 14). The southern storefront features a central entrance flanked by two bays of windows (see Photograph 11). The northern storefront features five bays of windows (see Photograph 13). The windows are deeply recessed with brick corbelling highlighting the lintels above the windows (see Photograph 12). A brick bulkhead runs beneath the windows, capped by bricks forming a sloped sill for the windows. The bulkhead height follows the slope of the site. According to historic photographs (see Photograph 16), each storefront featured a central entrance with a door to accommodate automobiles entering the building. Simple wall sconces with white glass globes flanked these central entrances and a "Bressi Garage" sign existed above each entrance.

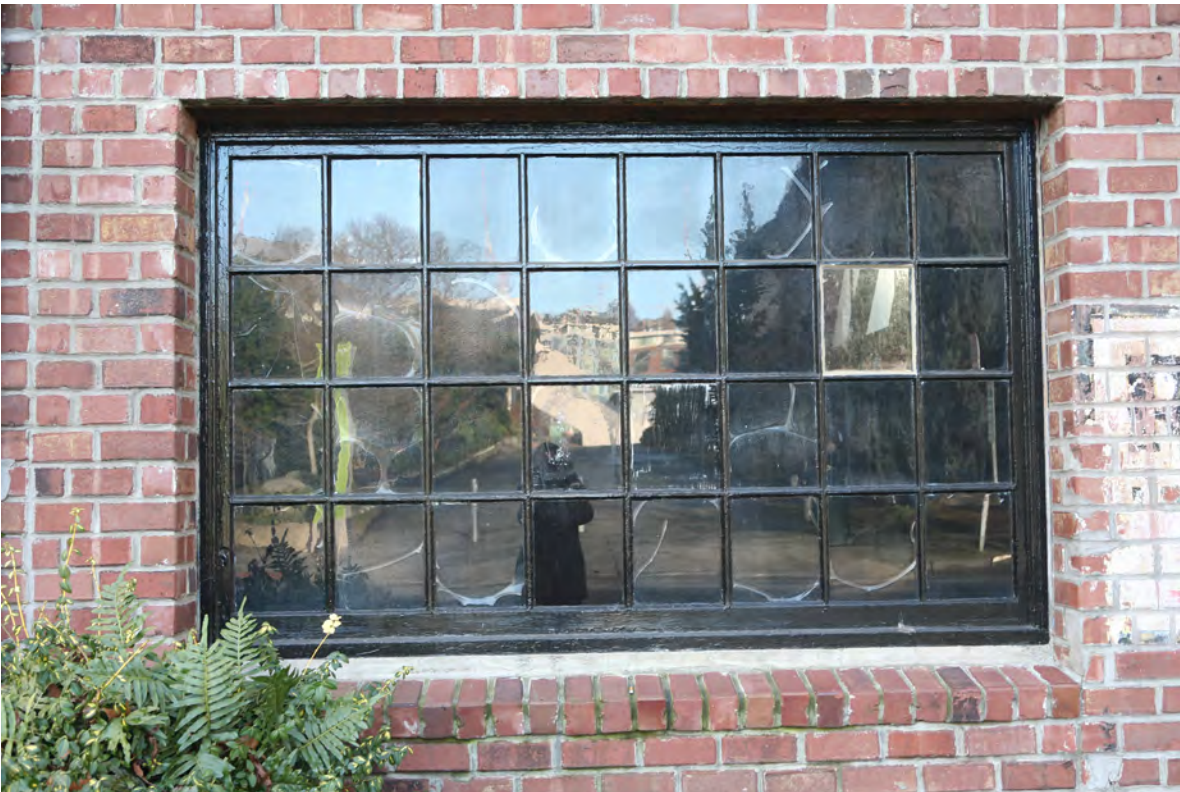
Photograph 12: 2017 view of extant original window on the Bressi Garage. Courtesy Artifacts Consulting, Inc.

Most of the bays retain the original wood, multi-lite fixed sash windows. Slender wood muntins separate the panes of glass. Wood brick molding and a wood sill frame the windows within their recessed openings. The west elevation original windows consist of sets of 28-lite fixed sash windows with 14-lite fixed transoms. The north elevation original windows consist of 32-lite fixed sash windows. The east elevation original windows consist of 35-lite fixed sash windows. Replacement windows, including the five northernmost windows on the west elevation and the westernmost window on the north elevation, are a set of double-paned fiberglass fixed sash windows with transoms. The replacement windows and transoms feature muntin grids sandwiched

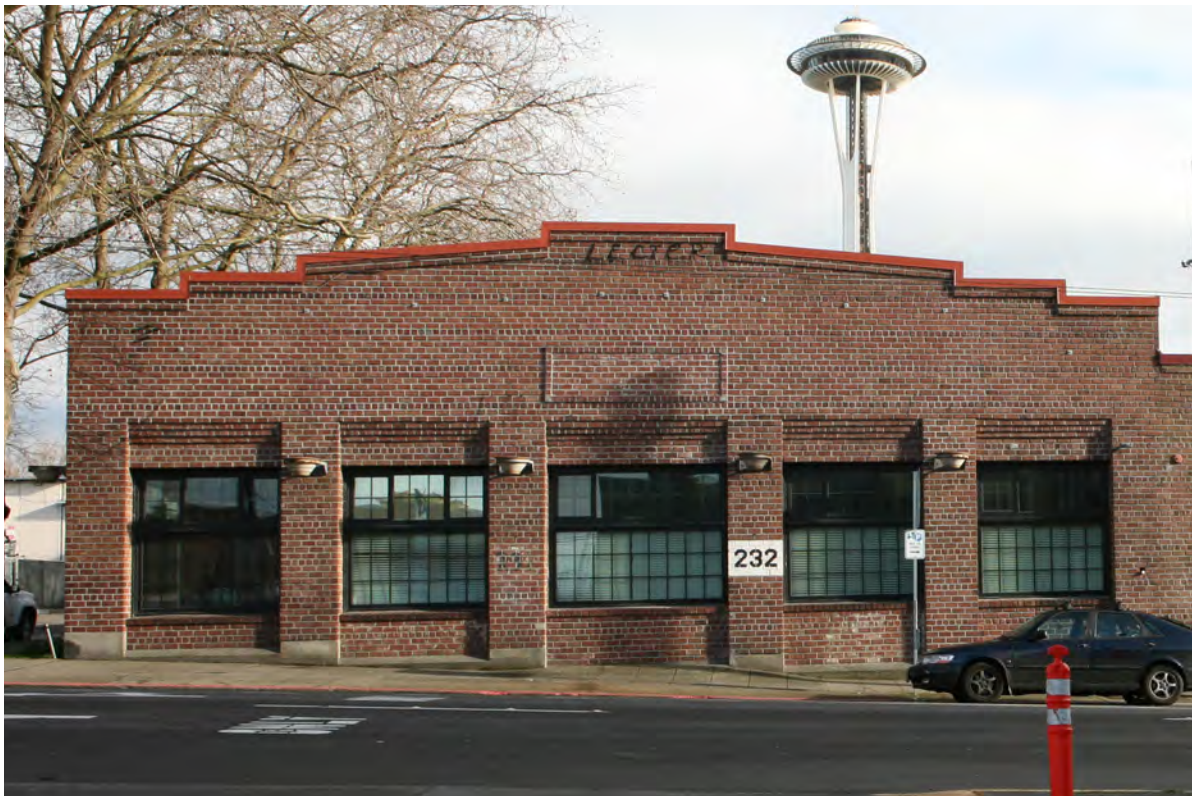
Photograph 13: 2017 view of Bressi Garage west elevation, north storefront. Courtesy Artifacts Consulting, Inc.

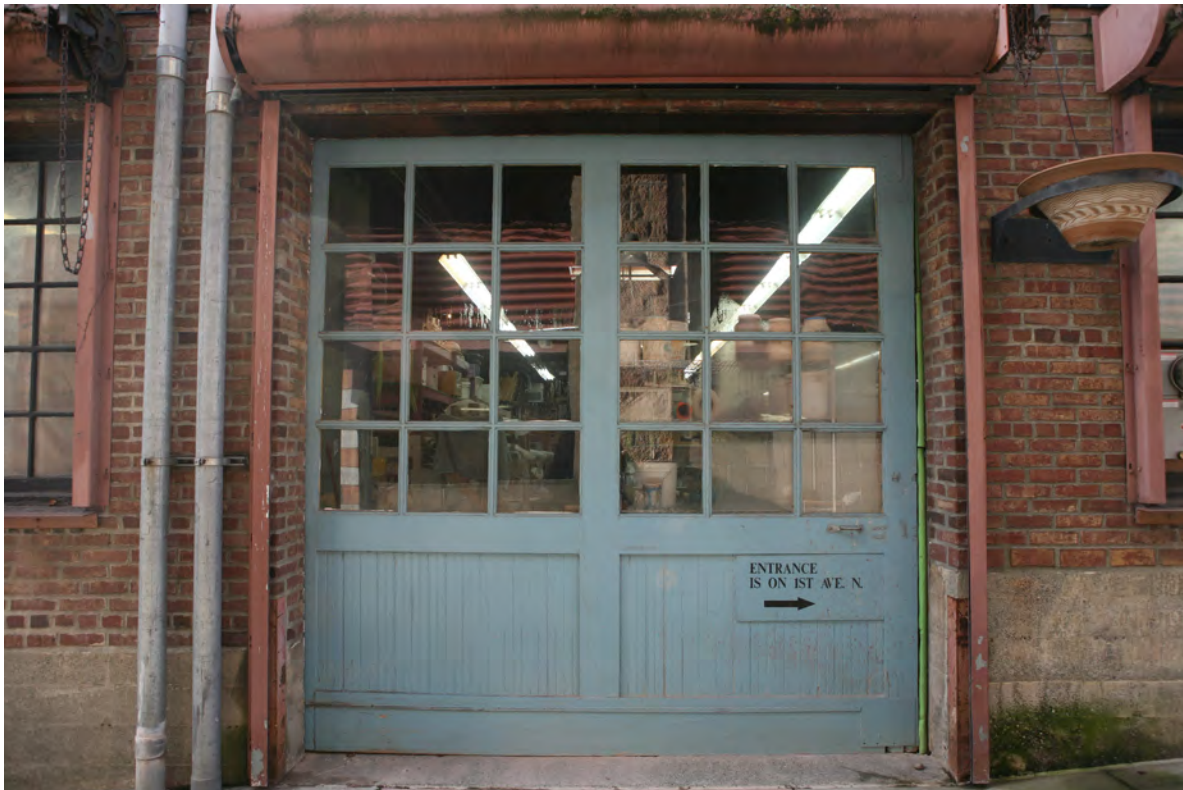
Photograph 14: 2017 view of extant original garage door on east elevation. Courtesy Artifacts Consulting, Inc.

The building retains one original door, a large wood sliding door on the east elevation (see Photograph 14). The door features a pair of 12 lites over a beadboard recessed panel, separated by a wood mullion. Slender wood muntins and putty hold the panes of glass in place. A simple metal replacement handle operates the door.

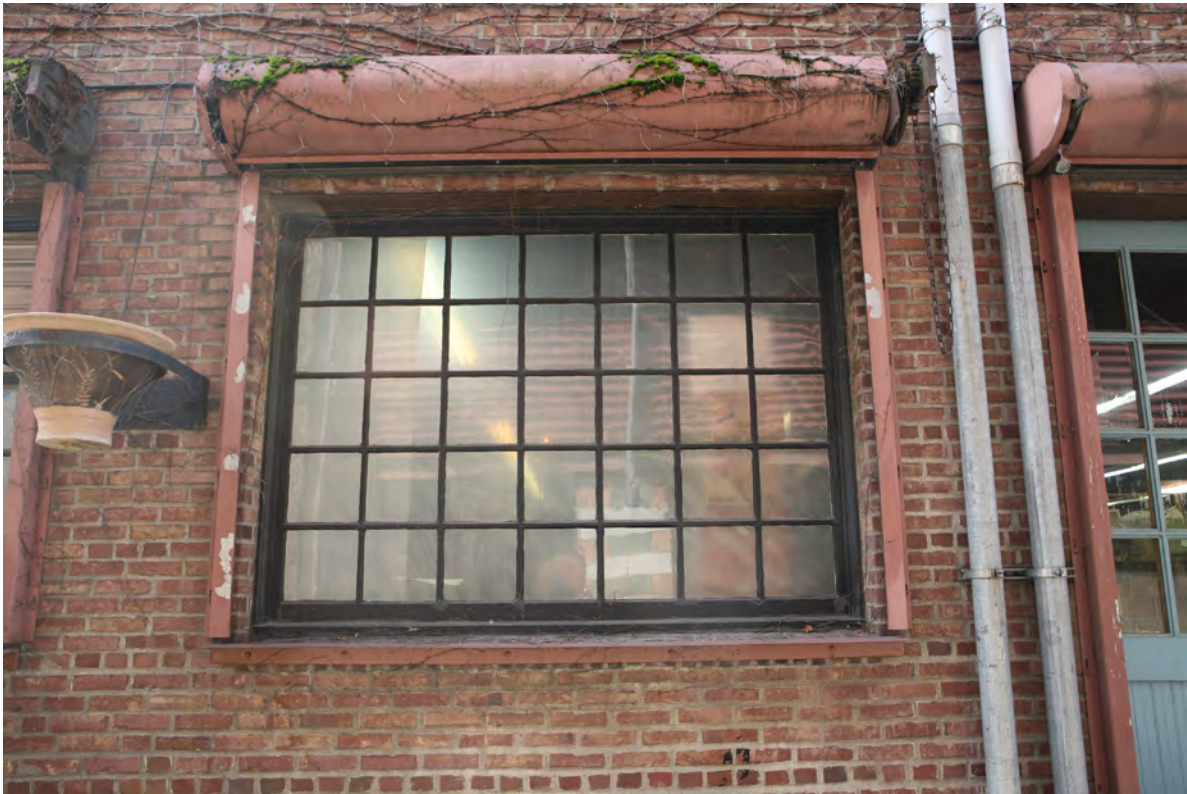
Photograph 15: 2017 view of extant original window on east elevation of the Bressi Garage. Courtesy Artifacts Consulting, Inc.

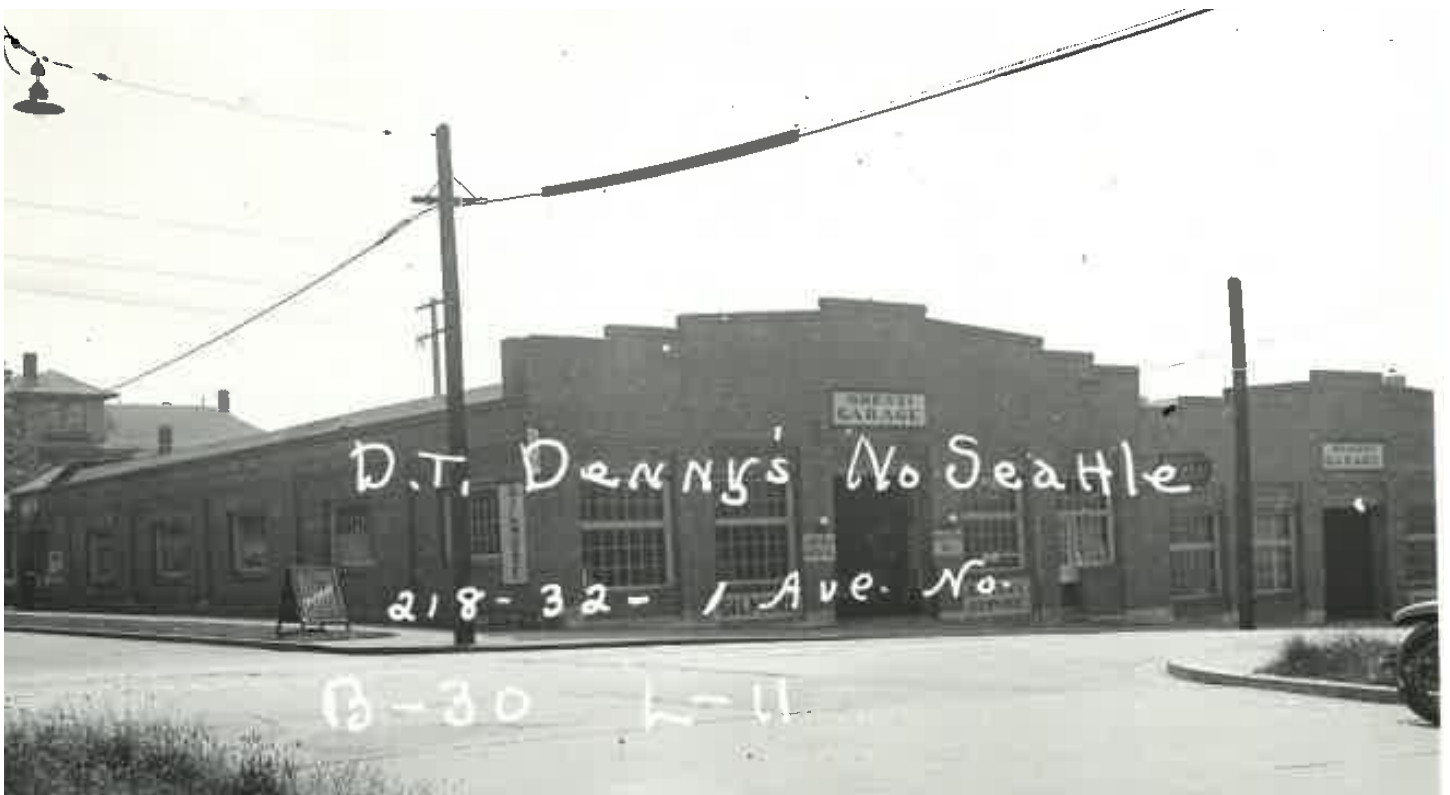
Photograph 16: View of west and north elevations of the Bressi Garage, ca. 1936. Courtesy King County Property Record Card, Puget Sound Regional Archives.

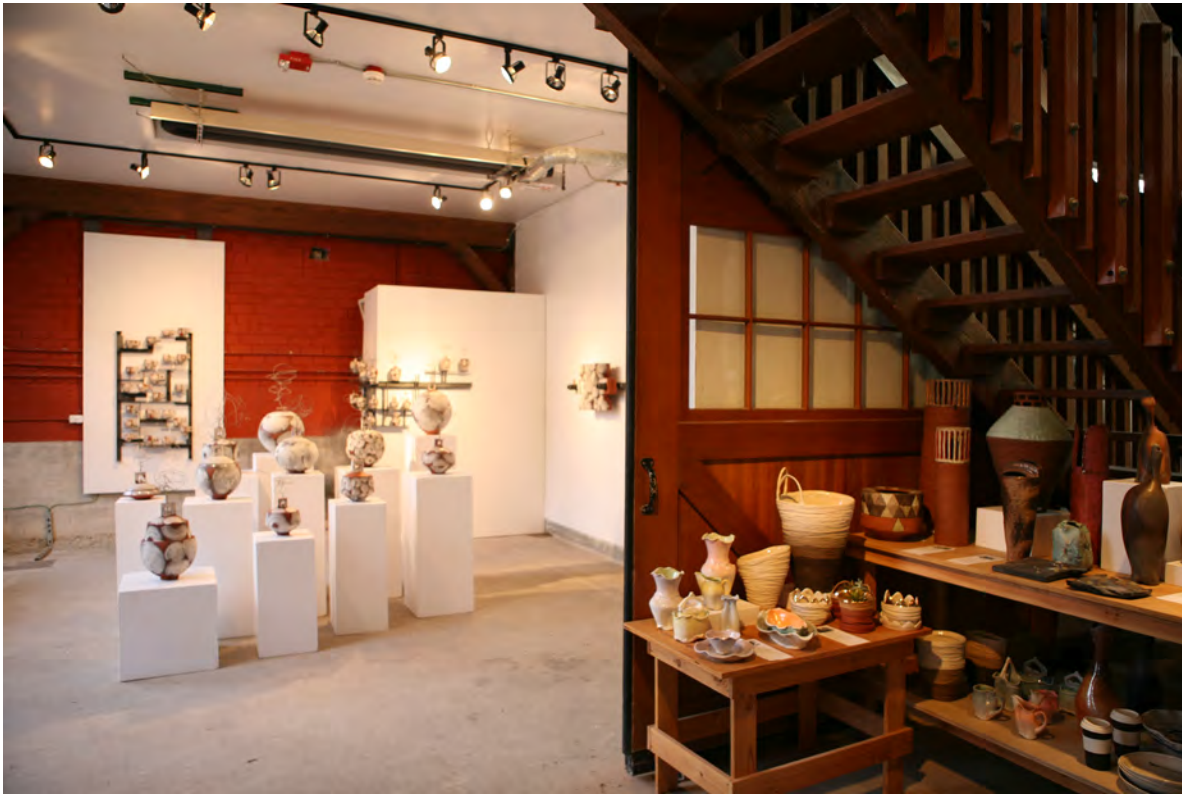
Photograph 21: Exhibit space in south storefront (Pottery Northwest). Courtesy Artifacts Consulting, Inc.

Concrete floors are present throughout the space. Vinyl composition tiles cover the concrete in the western portion of the north half of the building where offices now exist. Perimeter walls are exposed brick, painted in some locations. The northern half of the building, which currently functions as the Gardener's Complex for Seattle Center, has been subdivided to create office spaces in the west (see Photograph 17), break and locker rooms in the middle (see Photograph 18), and an open-air garage in the east (see Photograph 19). Partition walls separate these reconfigured spaces. An attic level mezzanine was added above the offices to house mechanical items. The southern half of the building, which currently houses Pottery Northwest, remains largely open with clear sightlines from west to east within the interior (see Photograph 20). Partition walls create a gallery space for pottery in the northwest corner (see Photograph 21) and an office in the southwest

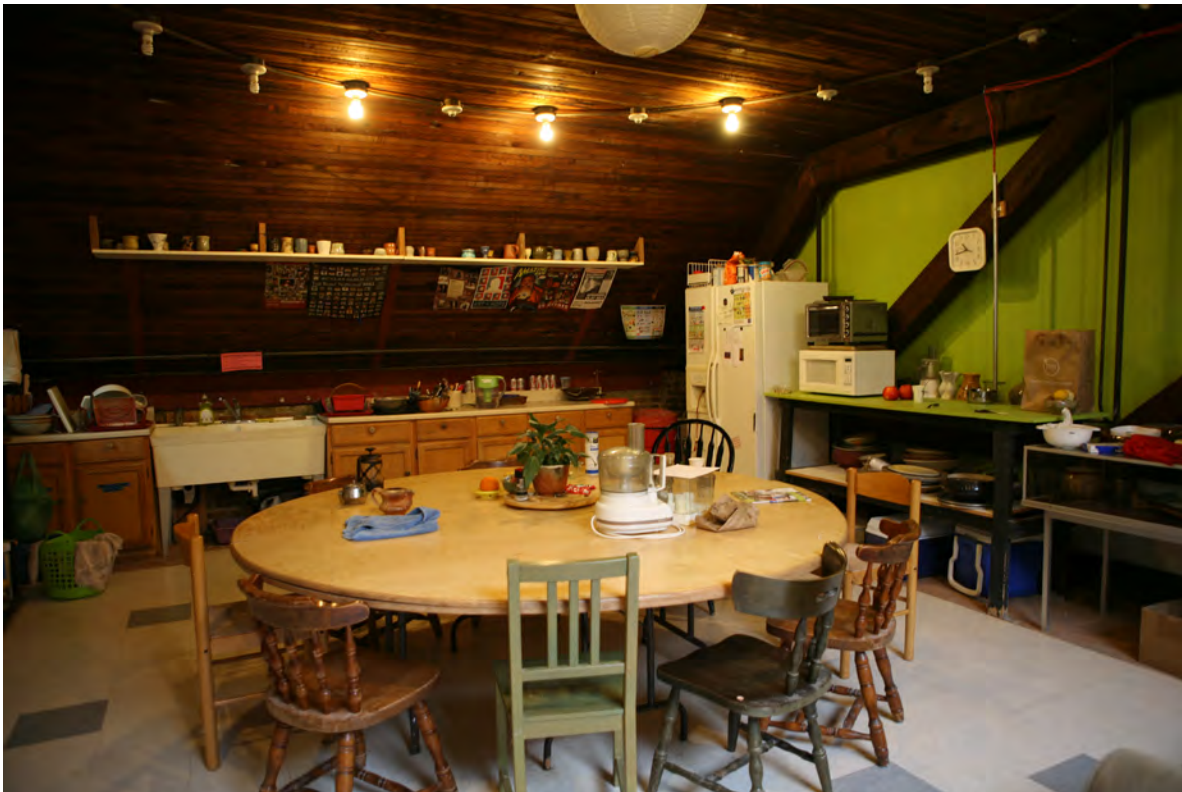
Photograph 22: Mezzanine addition in south storefront (Pottery Northwest). Courtesy Artifacts Consulting, Inc.

corner, but the partition walls stop short of the windows. A mezzanine added in the attic space runs along the west and south end of this space (see Photograph 22).

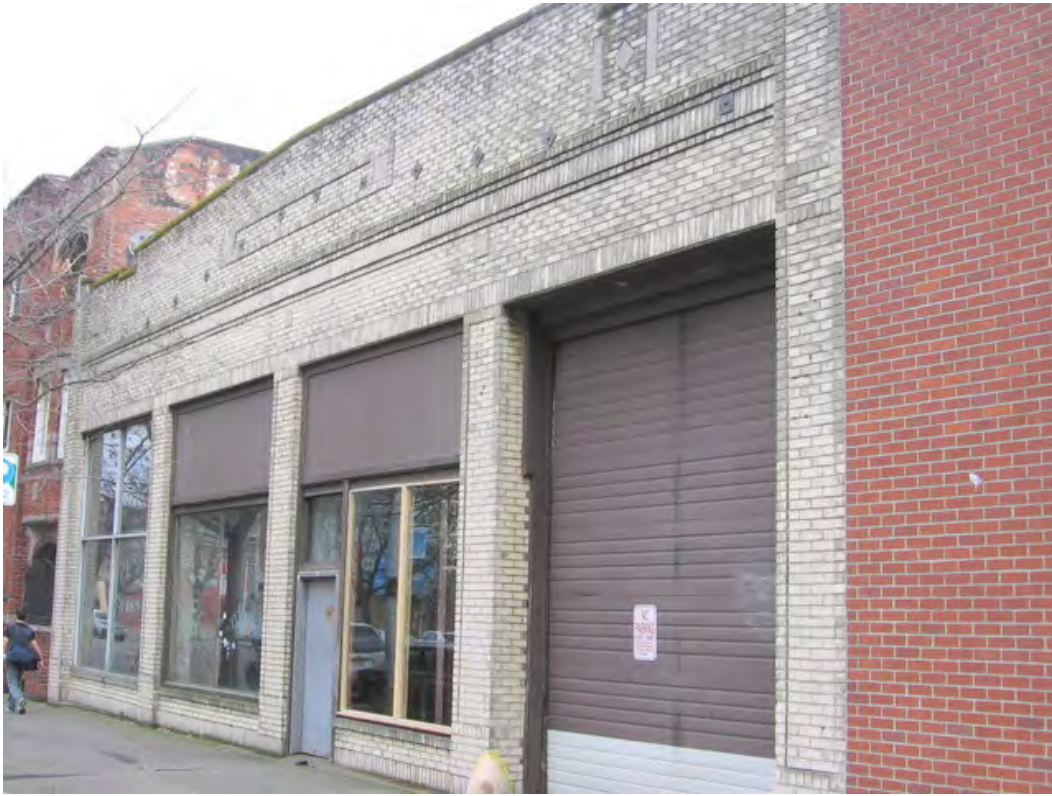
Photograph 24: Example of a garage building of a similar style and age as the Bressi Garage. The Automotive Service Co. (1924) at 2218 4th Avenue. Courtesy Seattle Historical Sites Database.

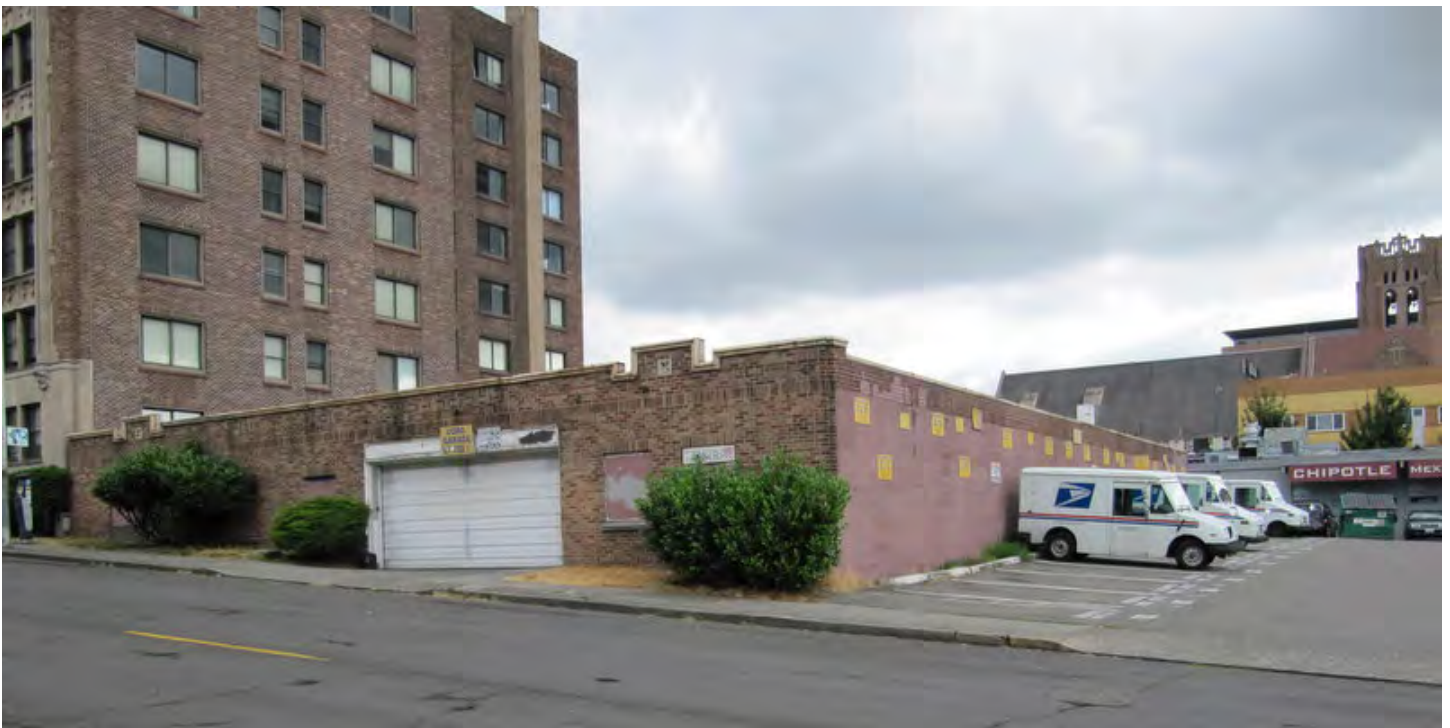
Photograph 23: Example of a garage building of a similar style and age as the Bressi Garage. The University Manor Garage (1928) at 4236 Brooklyn Ave NE. Courtesy Seattle Historical Sites Database.

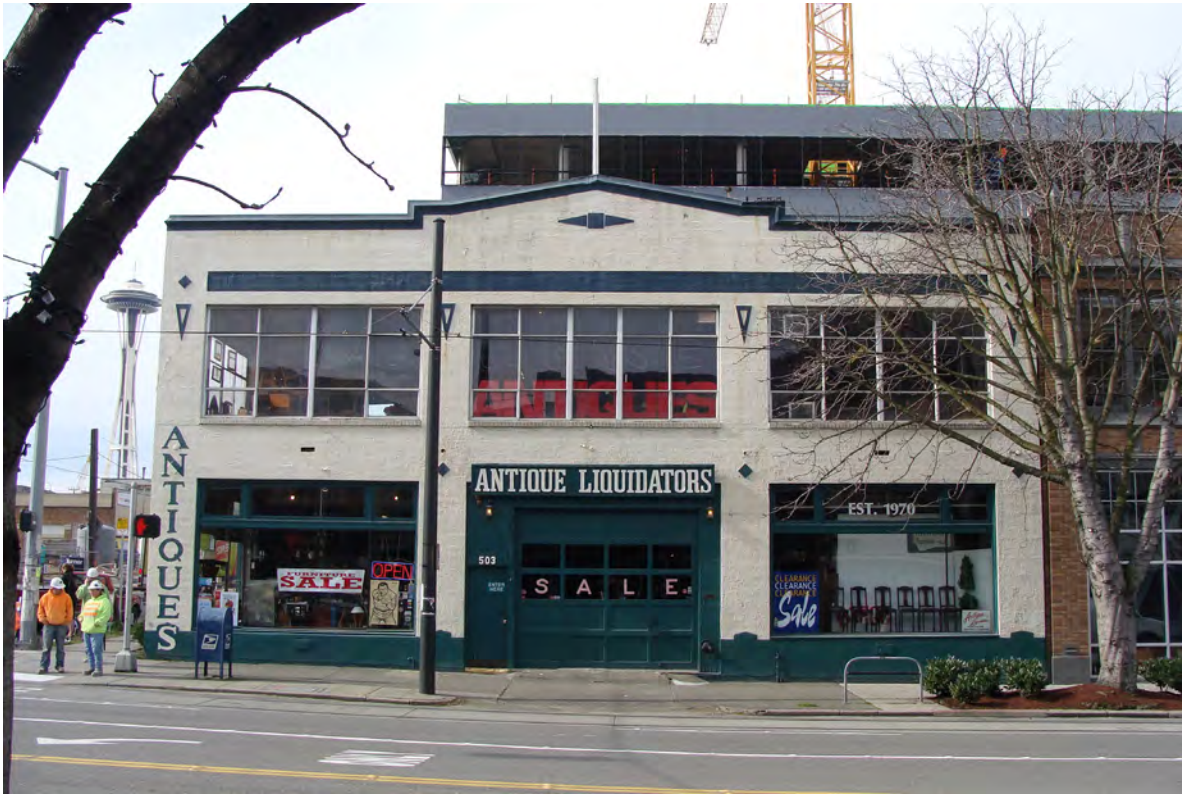
Photograph 27: An example of a similarly styled, albeit larger auto garage building. A. J. Eberharter Garage (1919) at Westlake Avenue and Republican Street. Courtesy Seattle Historical Sites Database.

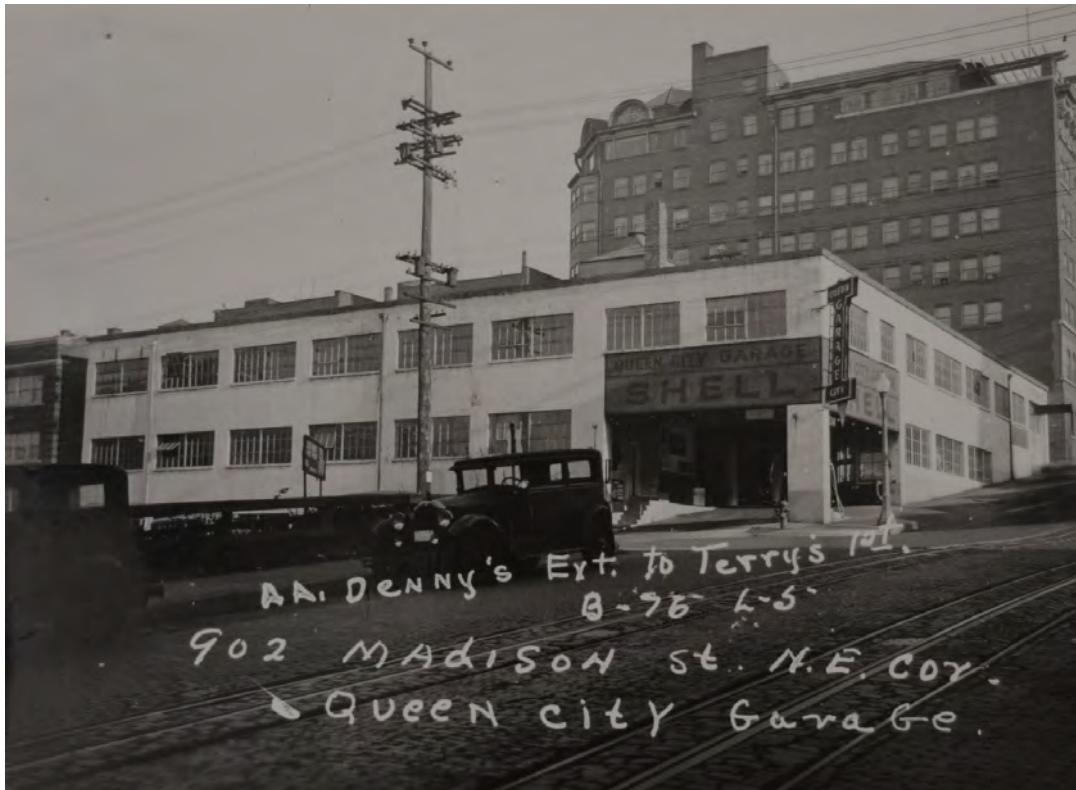
Photograph 28: An example of a garage of a similar style and age as the Bressi Garage. The President Garage (1924) at 2014 2nd Avenue. Courtesy DAHP.

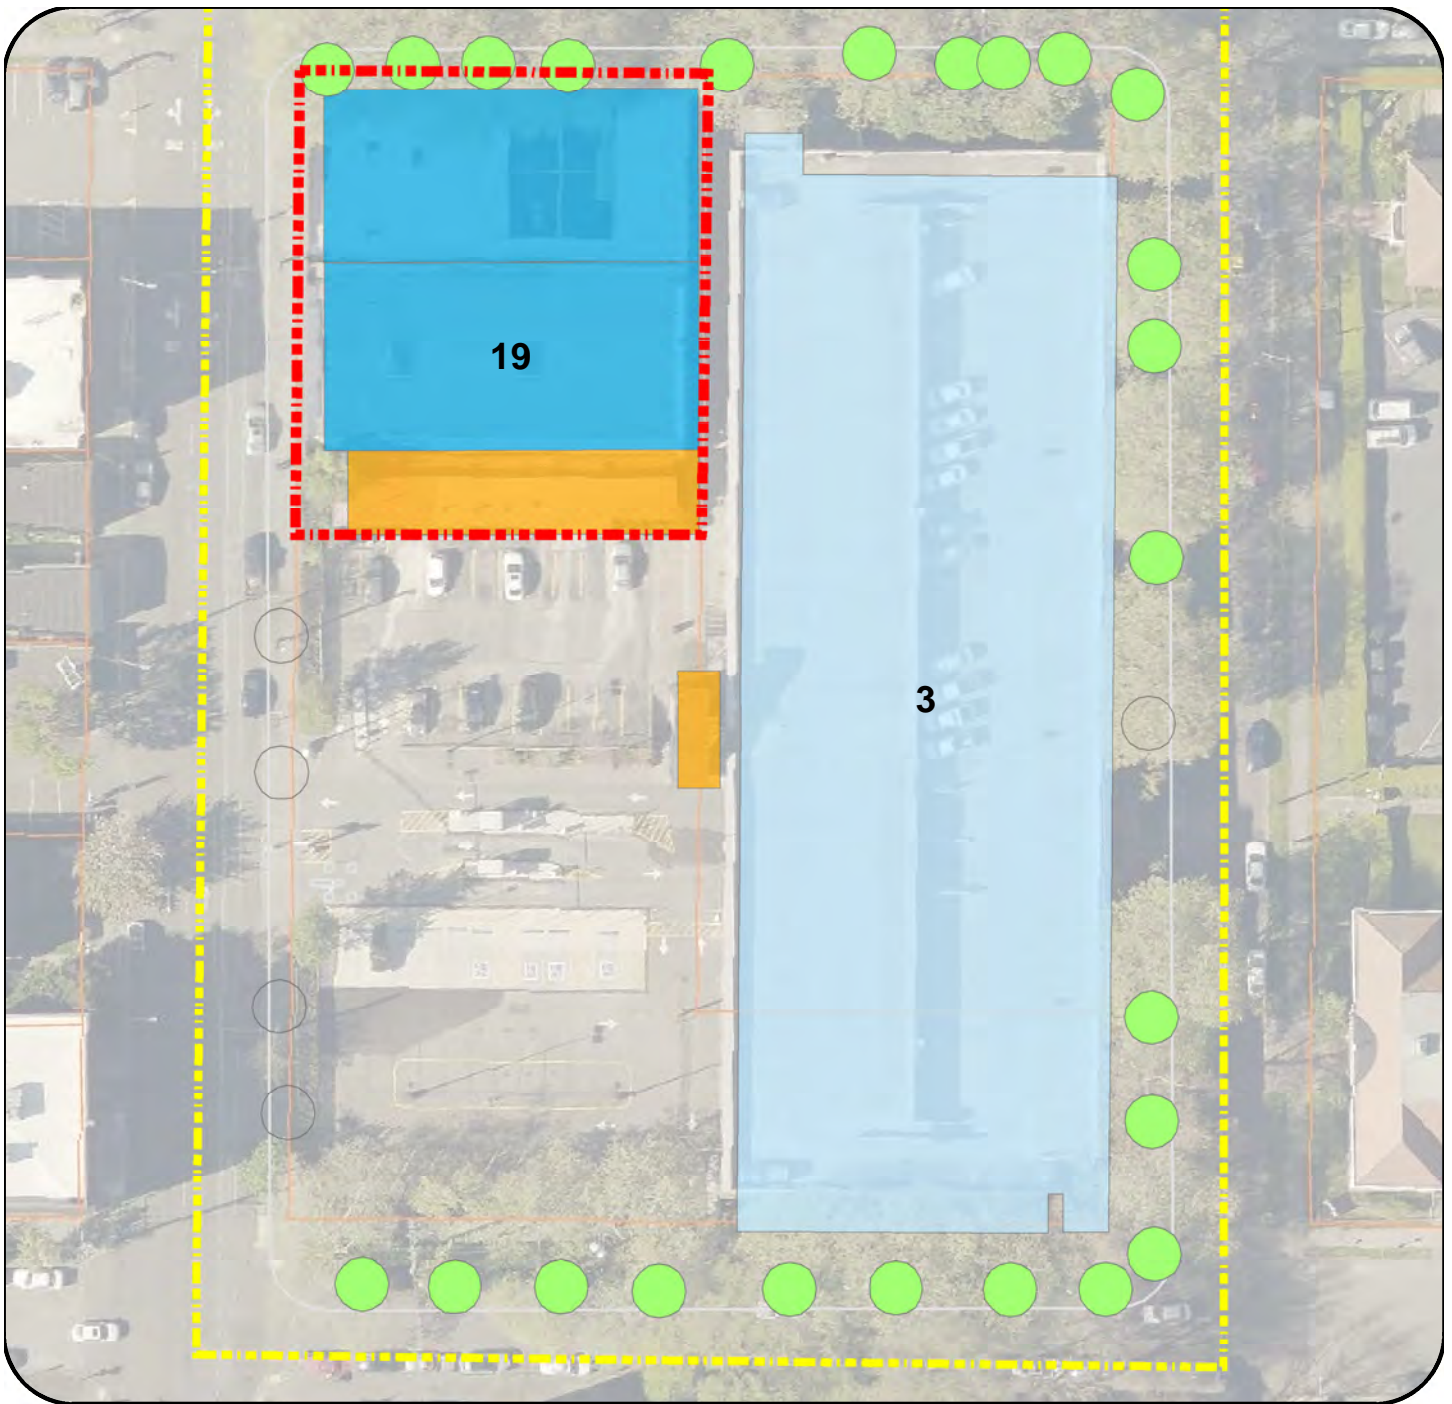
Figure 3: View of nominated property and surrounding buildings, circulation and trees with relevant status on the Seattle Center Campus.
