The City of Seattle

## Landmarks Preservation Board

# Bressi Garage

## City of Seattle Historic Landmark Nomination

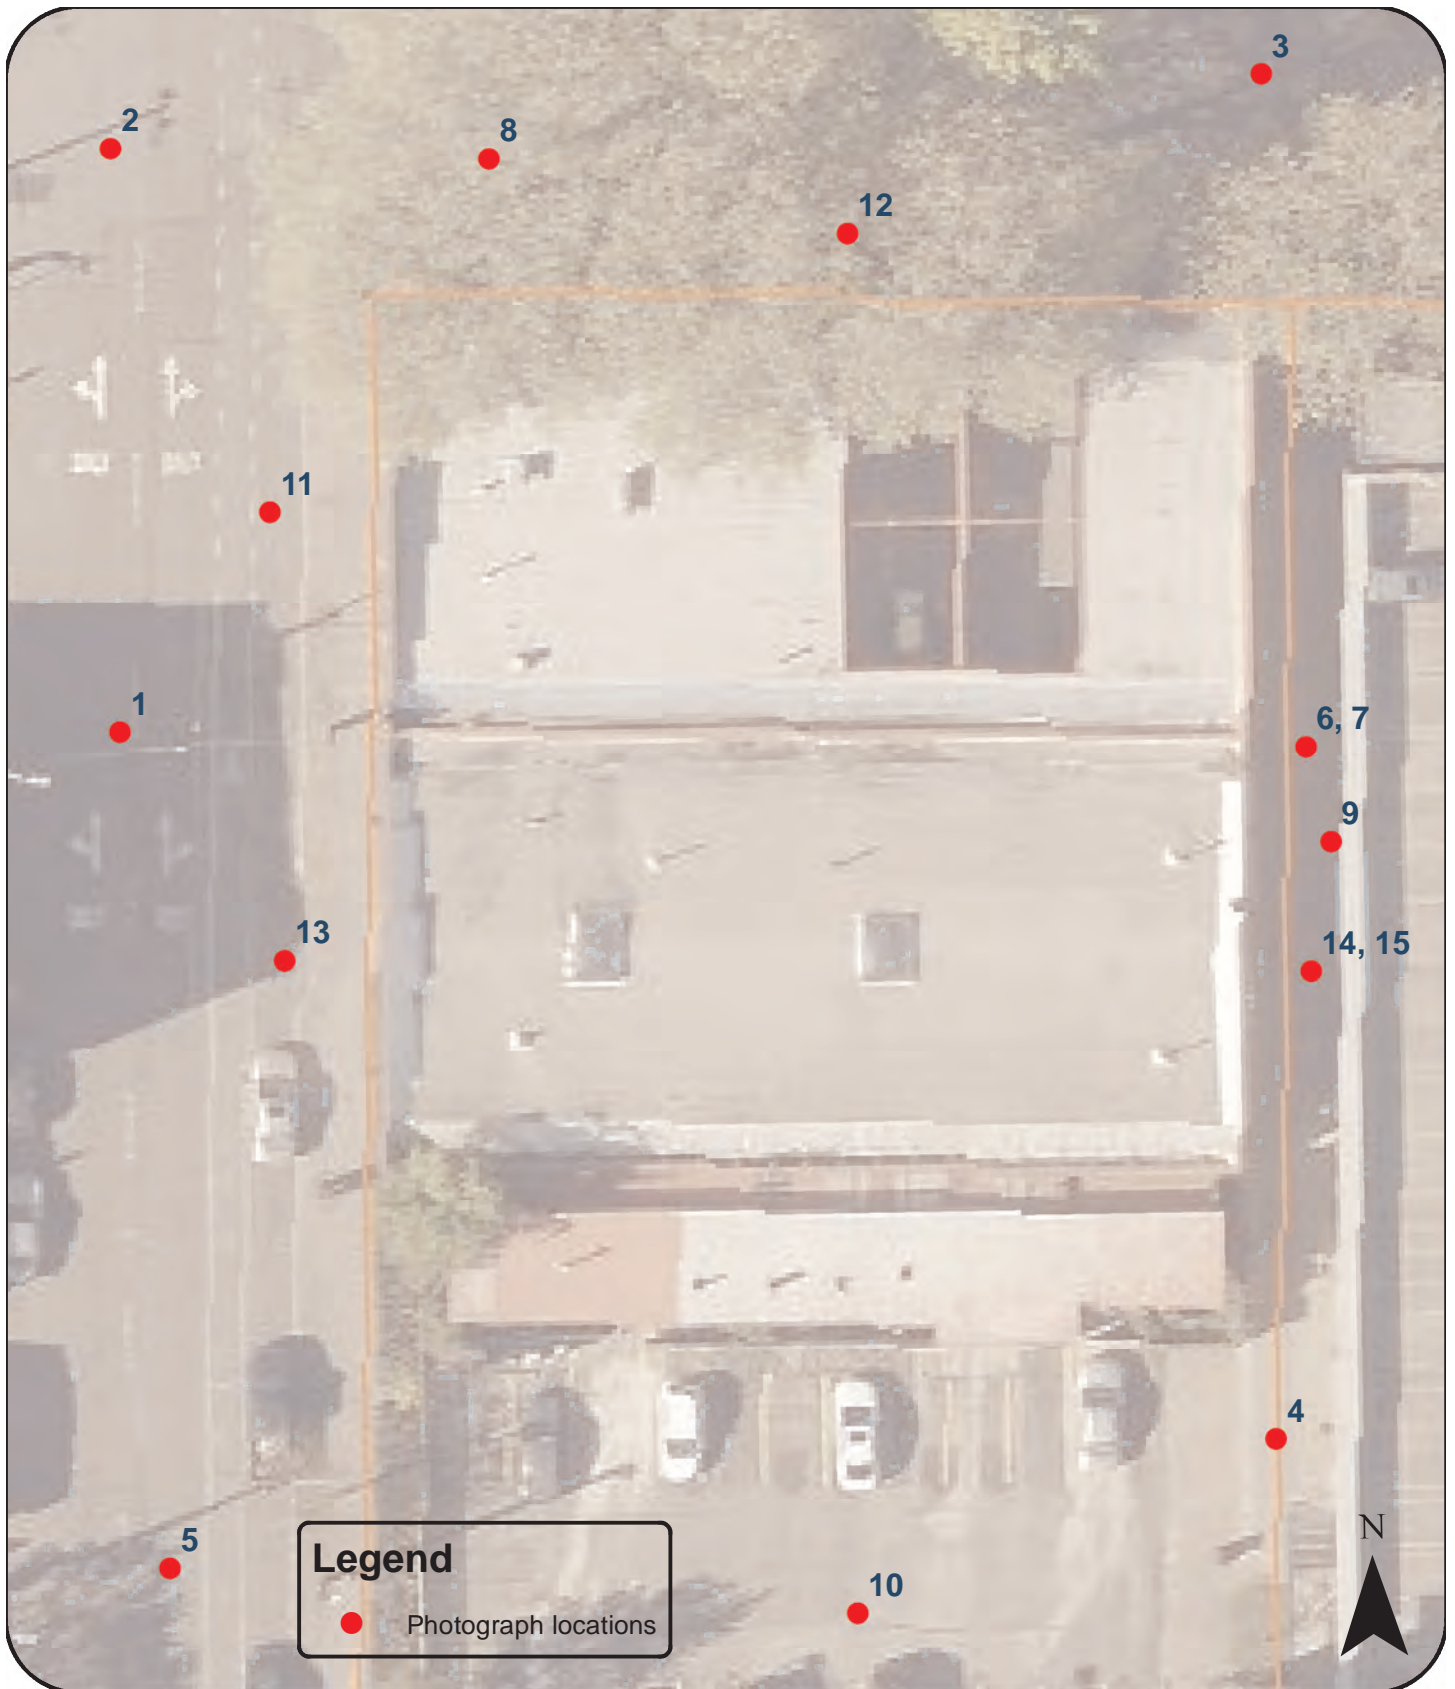
Figure 4: Photograph key map showing point from which the following photographs were taken (see Photographs 1 - 15).

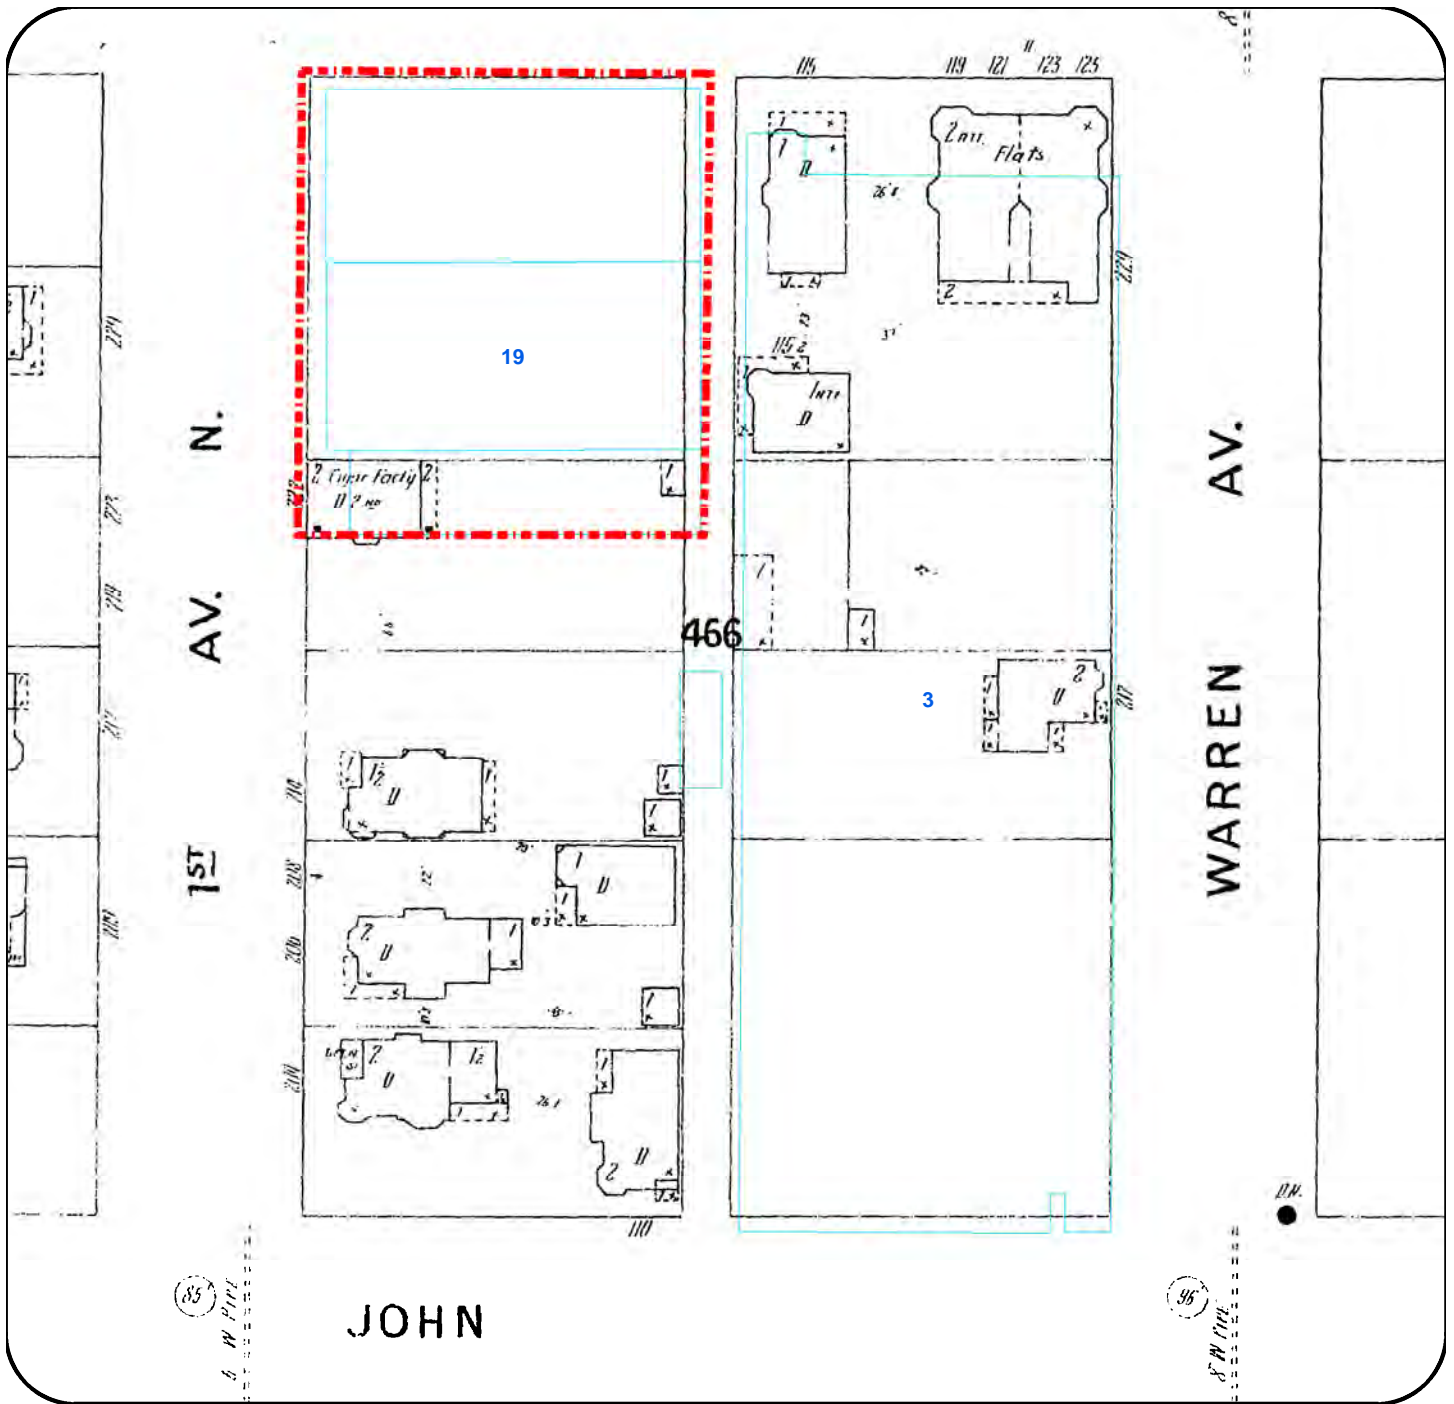
**1904-1905 Sanborn  
Vol 3 Sheets 276, 253**

Figure 5: 1904-1905 Sanborn map with an overlay of the existing buildings.

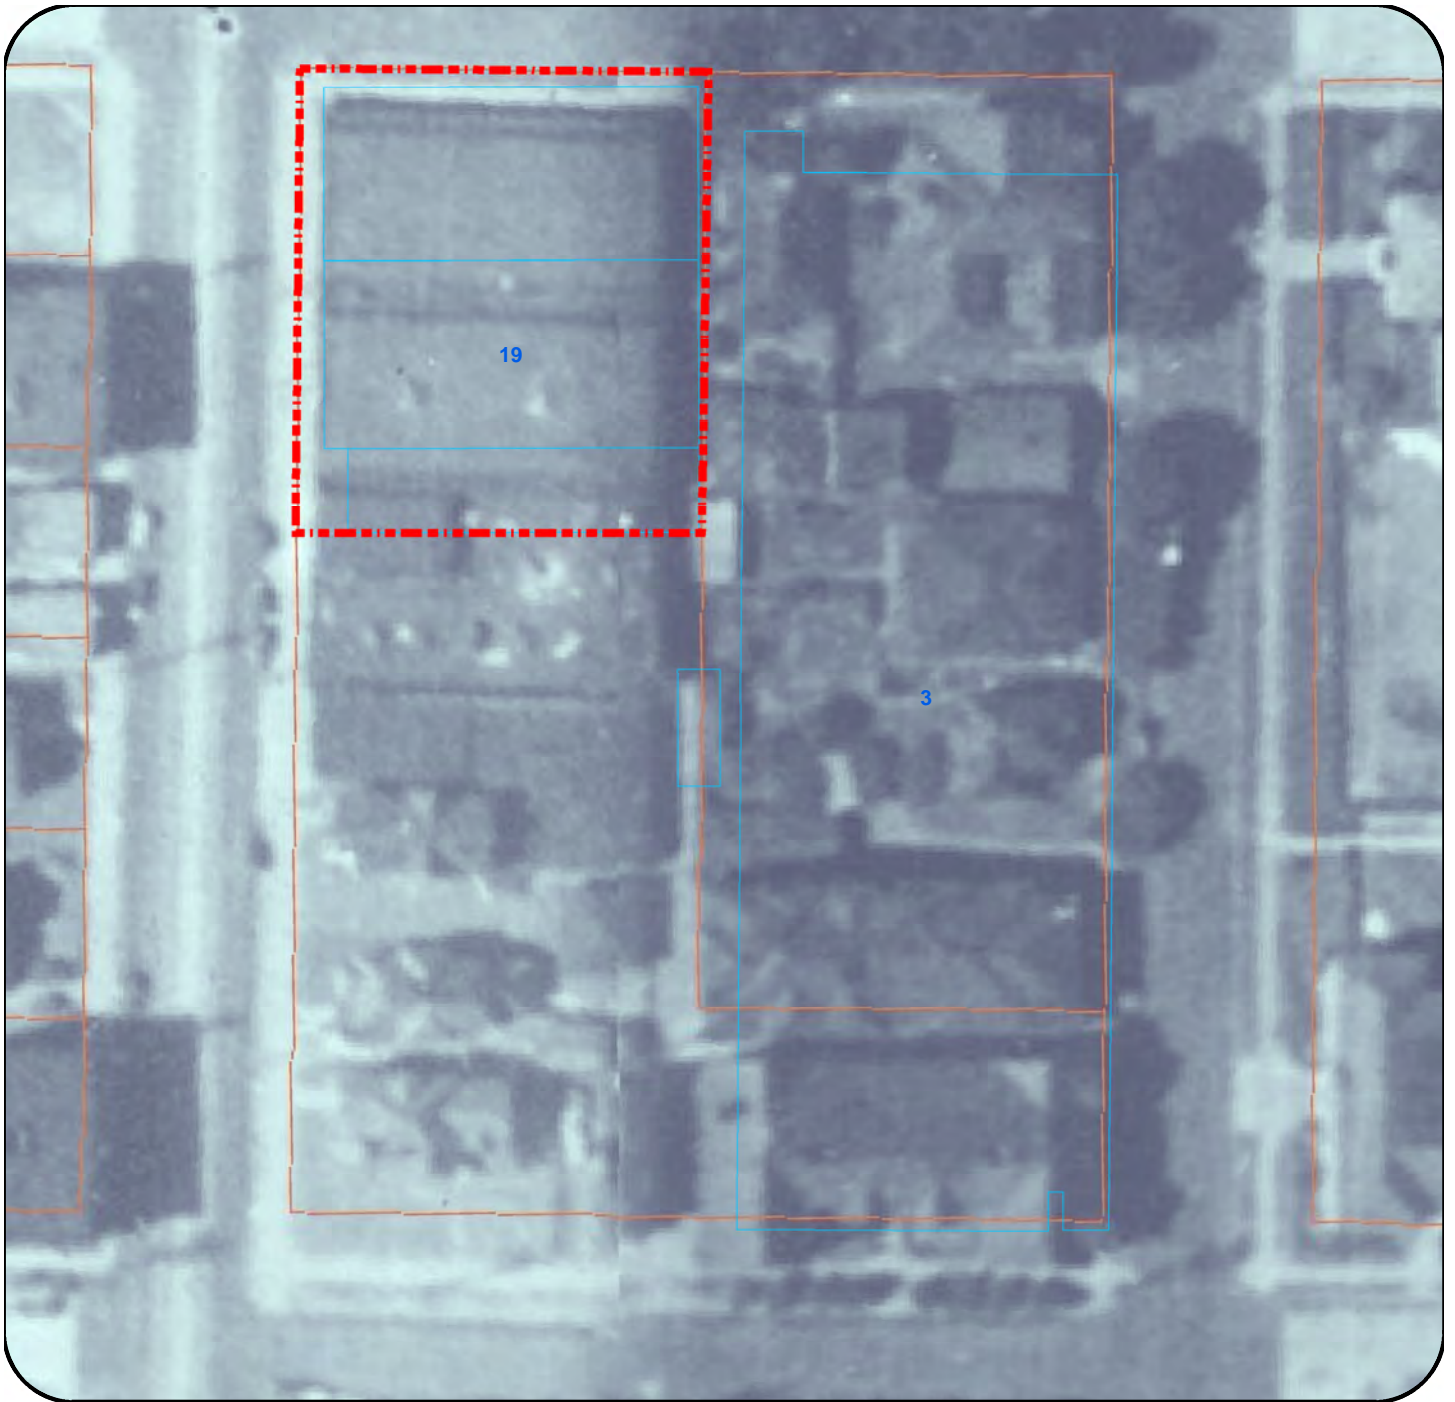
### 1937 Aerial Courtesy King County

Figure 6: 1936 aerial photograph of the site with an overlay of the current buildings. Courtesy King County.

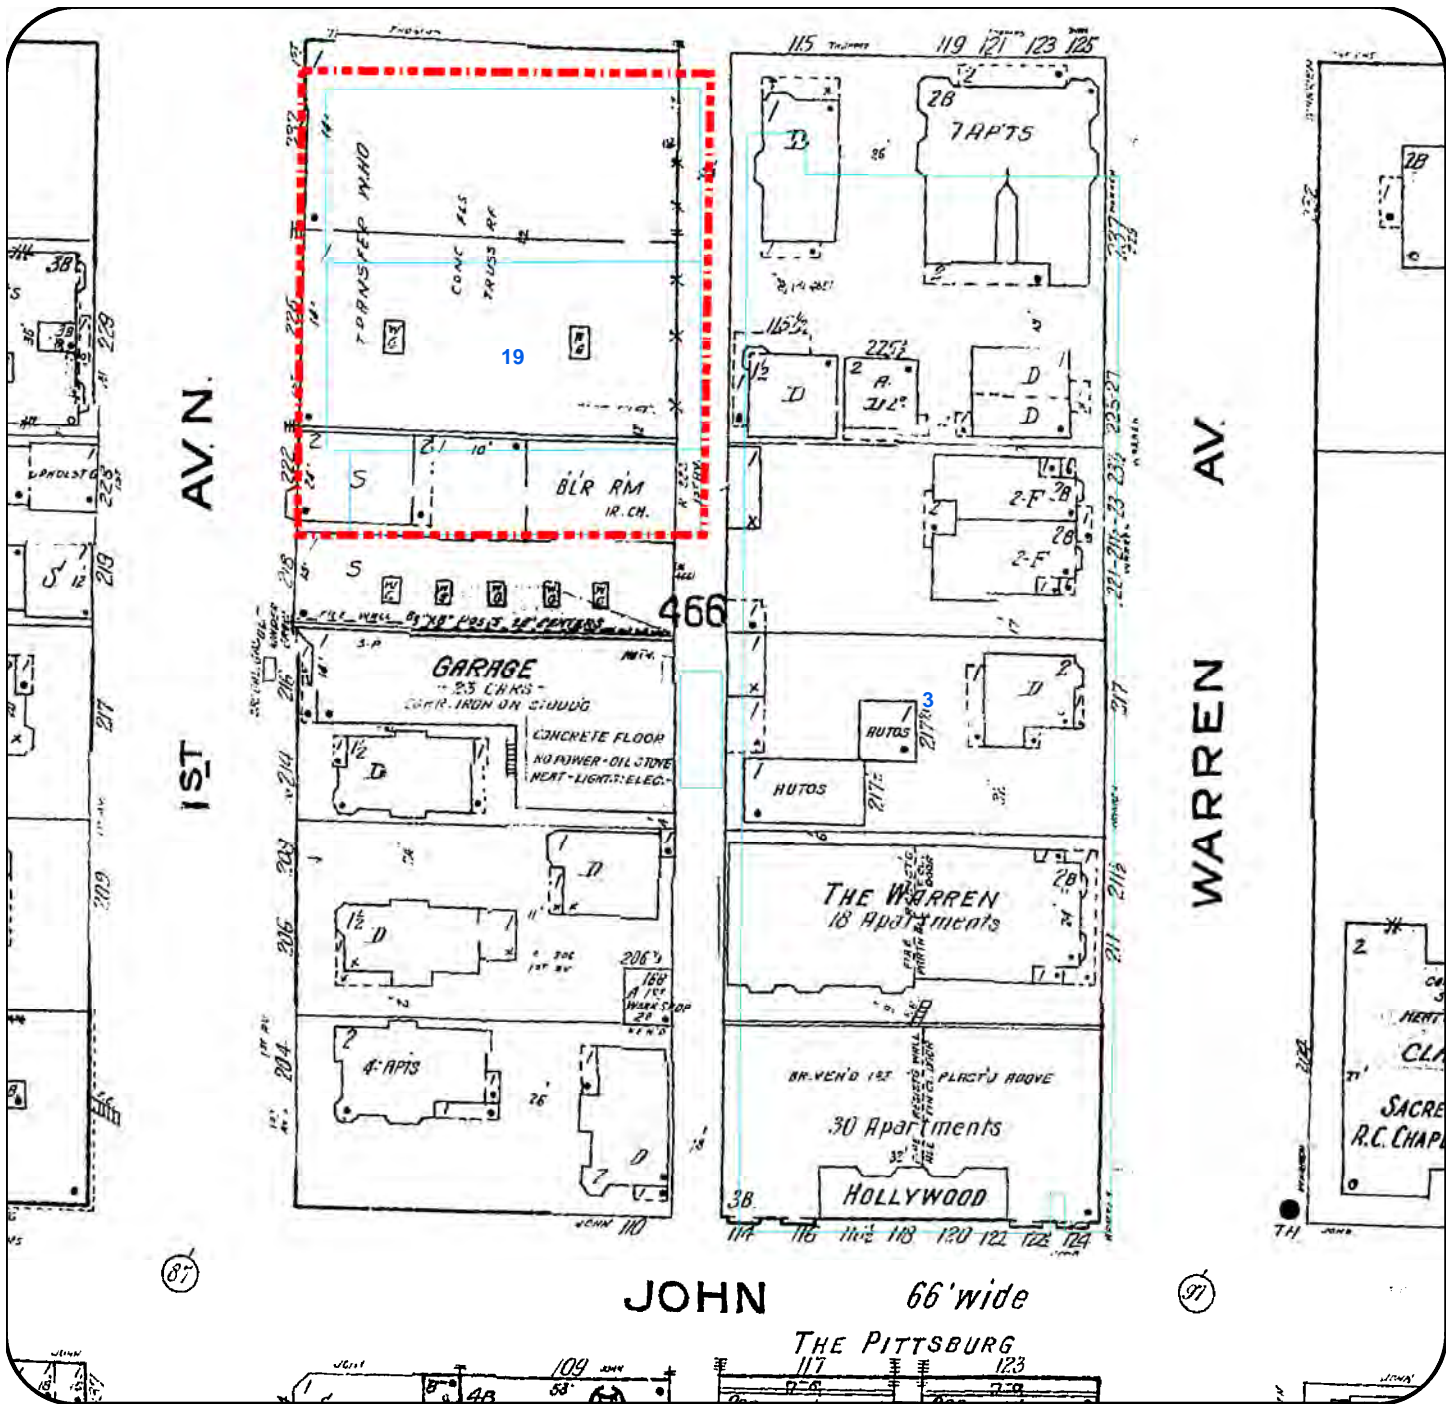
1905-1951 Sanborn  
Vol 4 Sheets 438, 479

Figure 7: 1905-1951 Sanborn map of the site with an overlay of the current buildings.

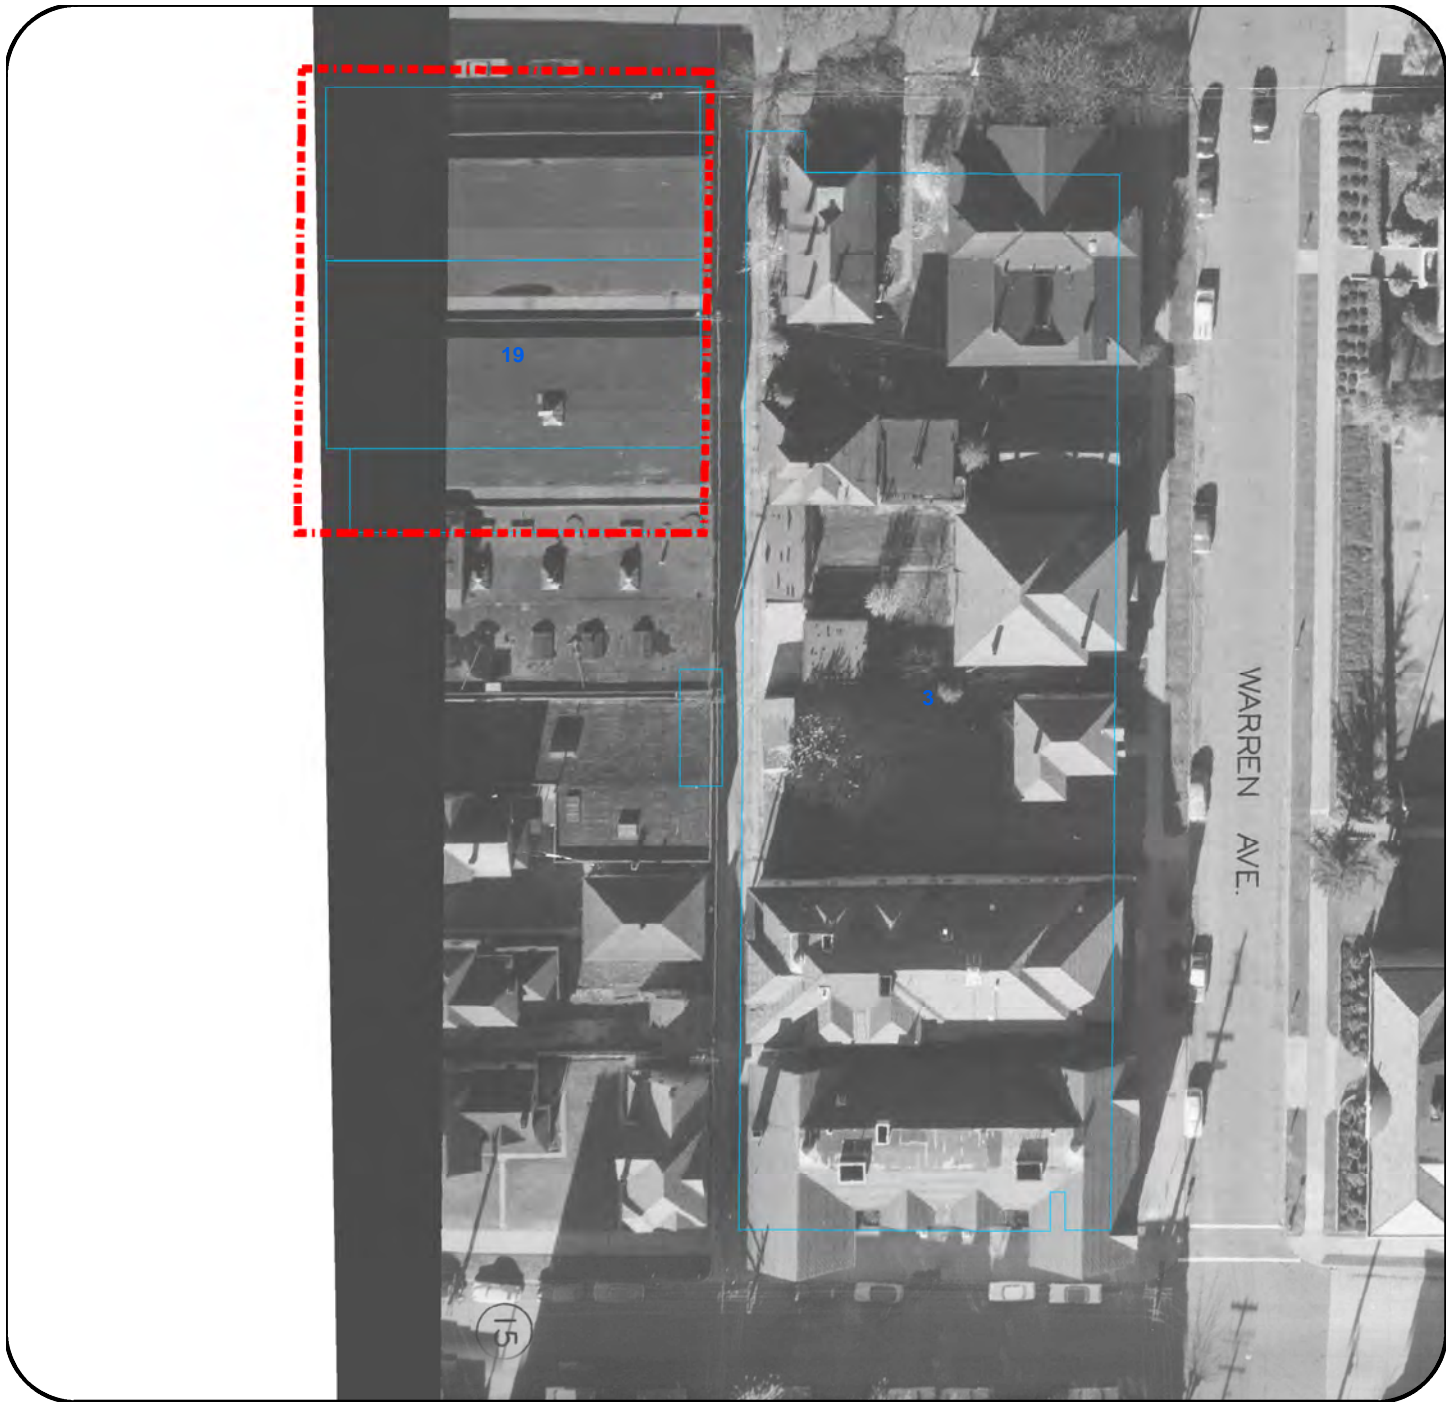
### 1957 Aerial Courtesy Seattle Center

Figure 8: 1957 aerial photograph of the site with an overlay of the current buildings. Courtesy Seattle Center.

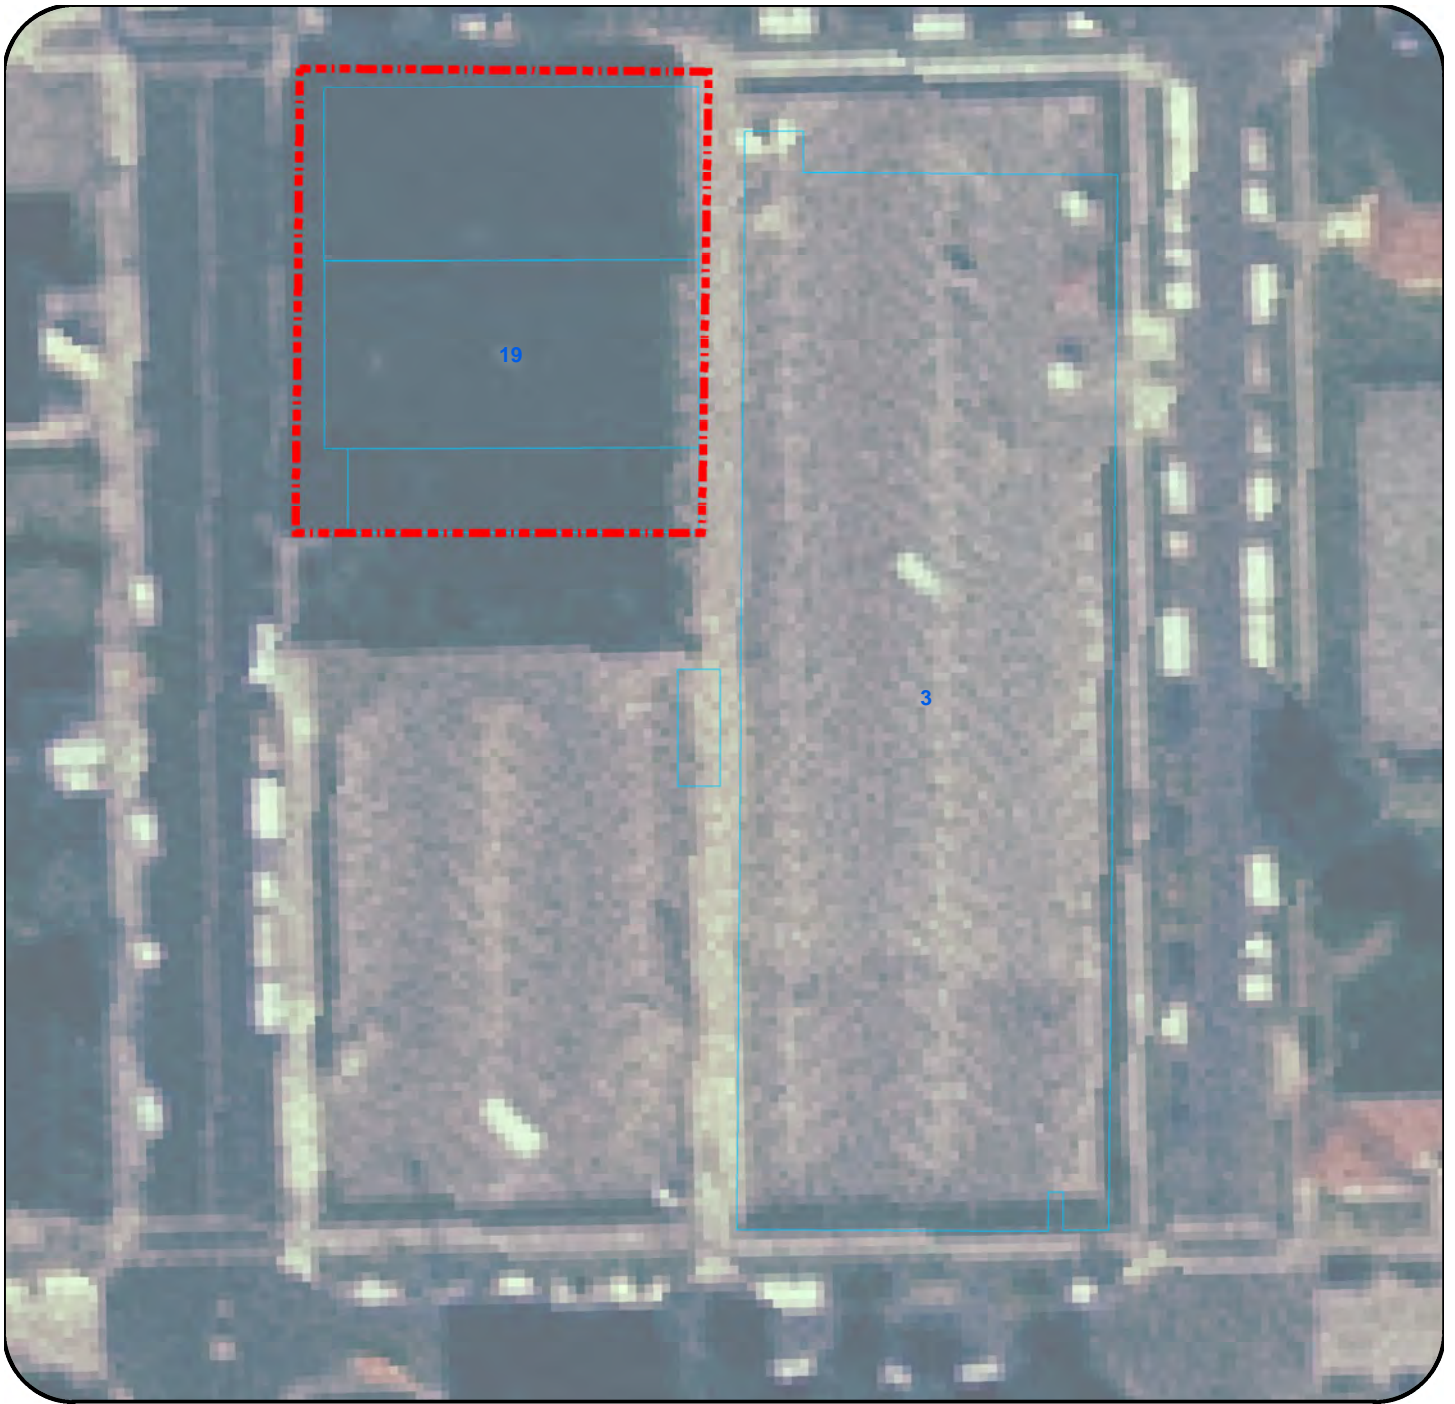
**1968 Aerial  
Courtesy USGS**

Figure 9: 1968 aerial with an overlay of the current buildings. Courtesy USGS.

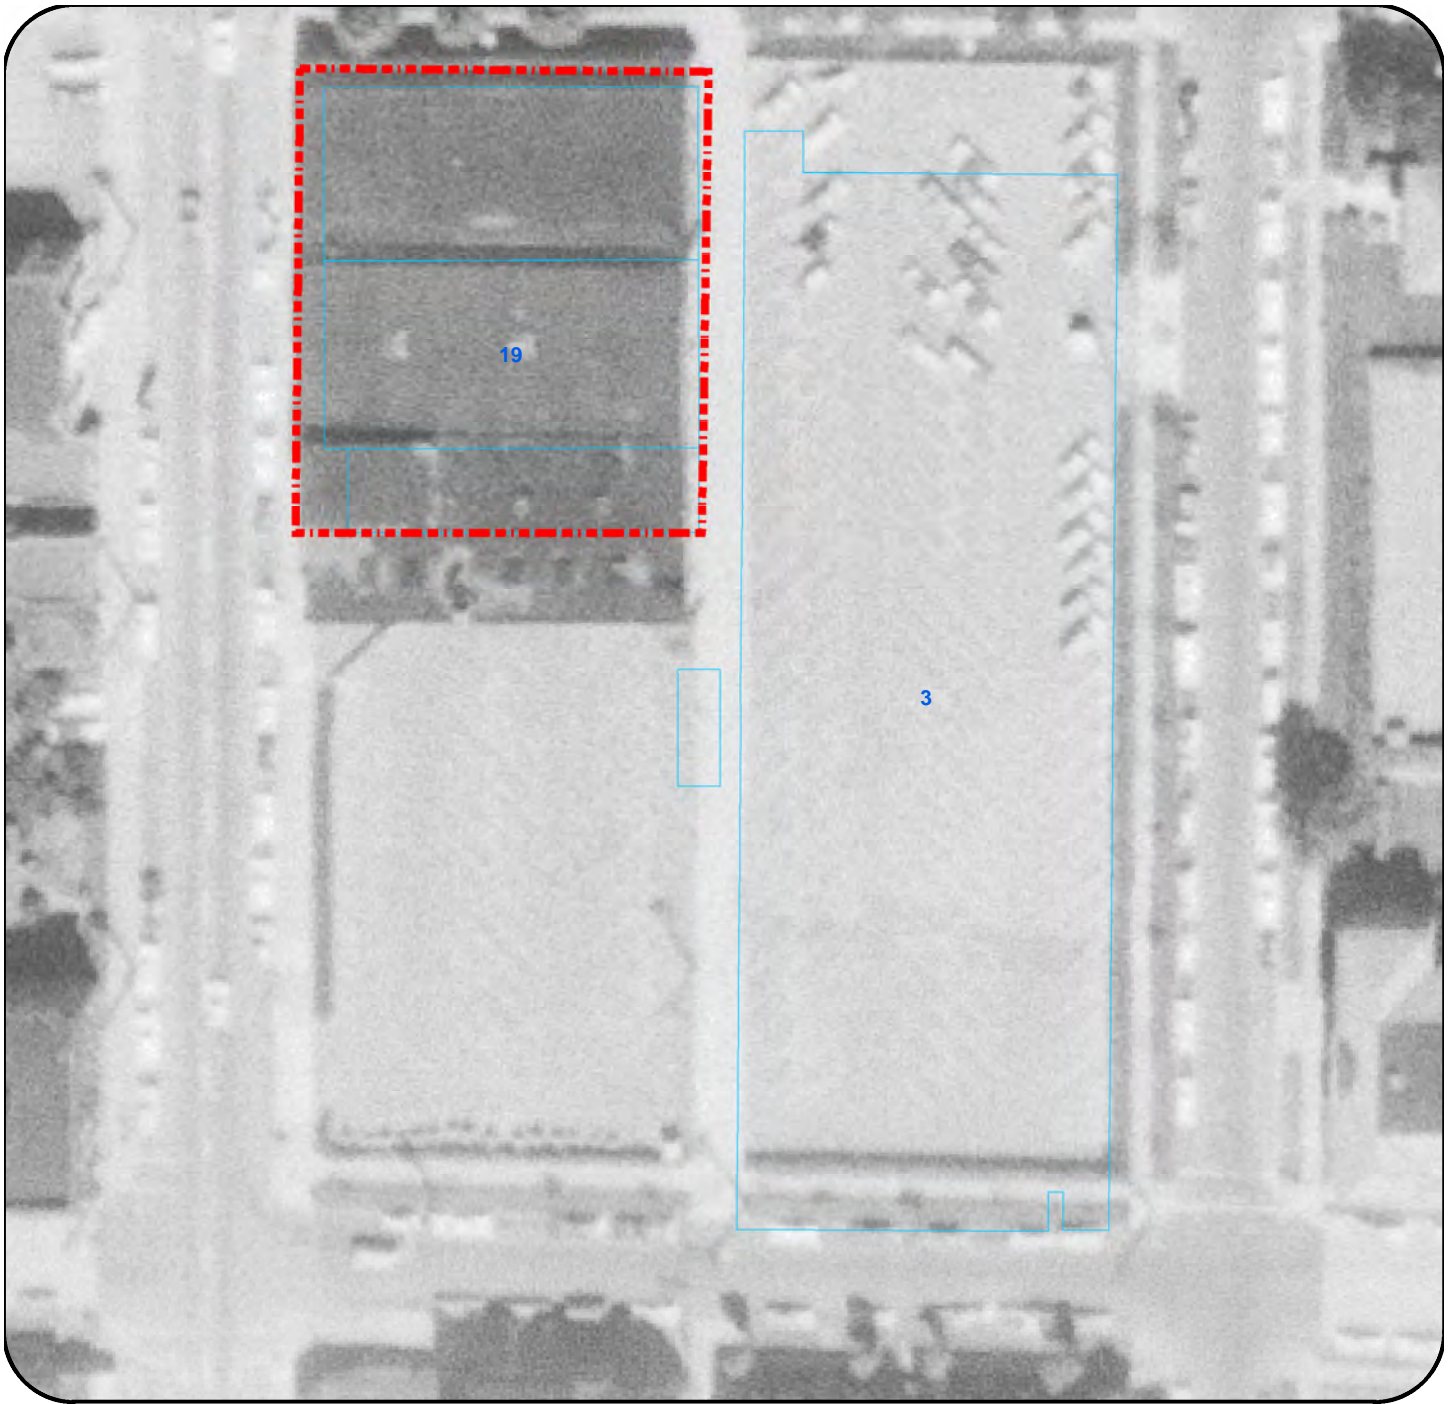
**1969 Aerial  
Courtesy USGS**

Figure 10: 1969 aerial with an overlay of the current buildings. Courtesy USGS.

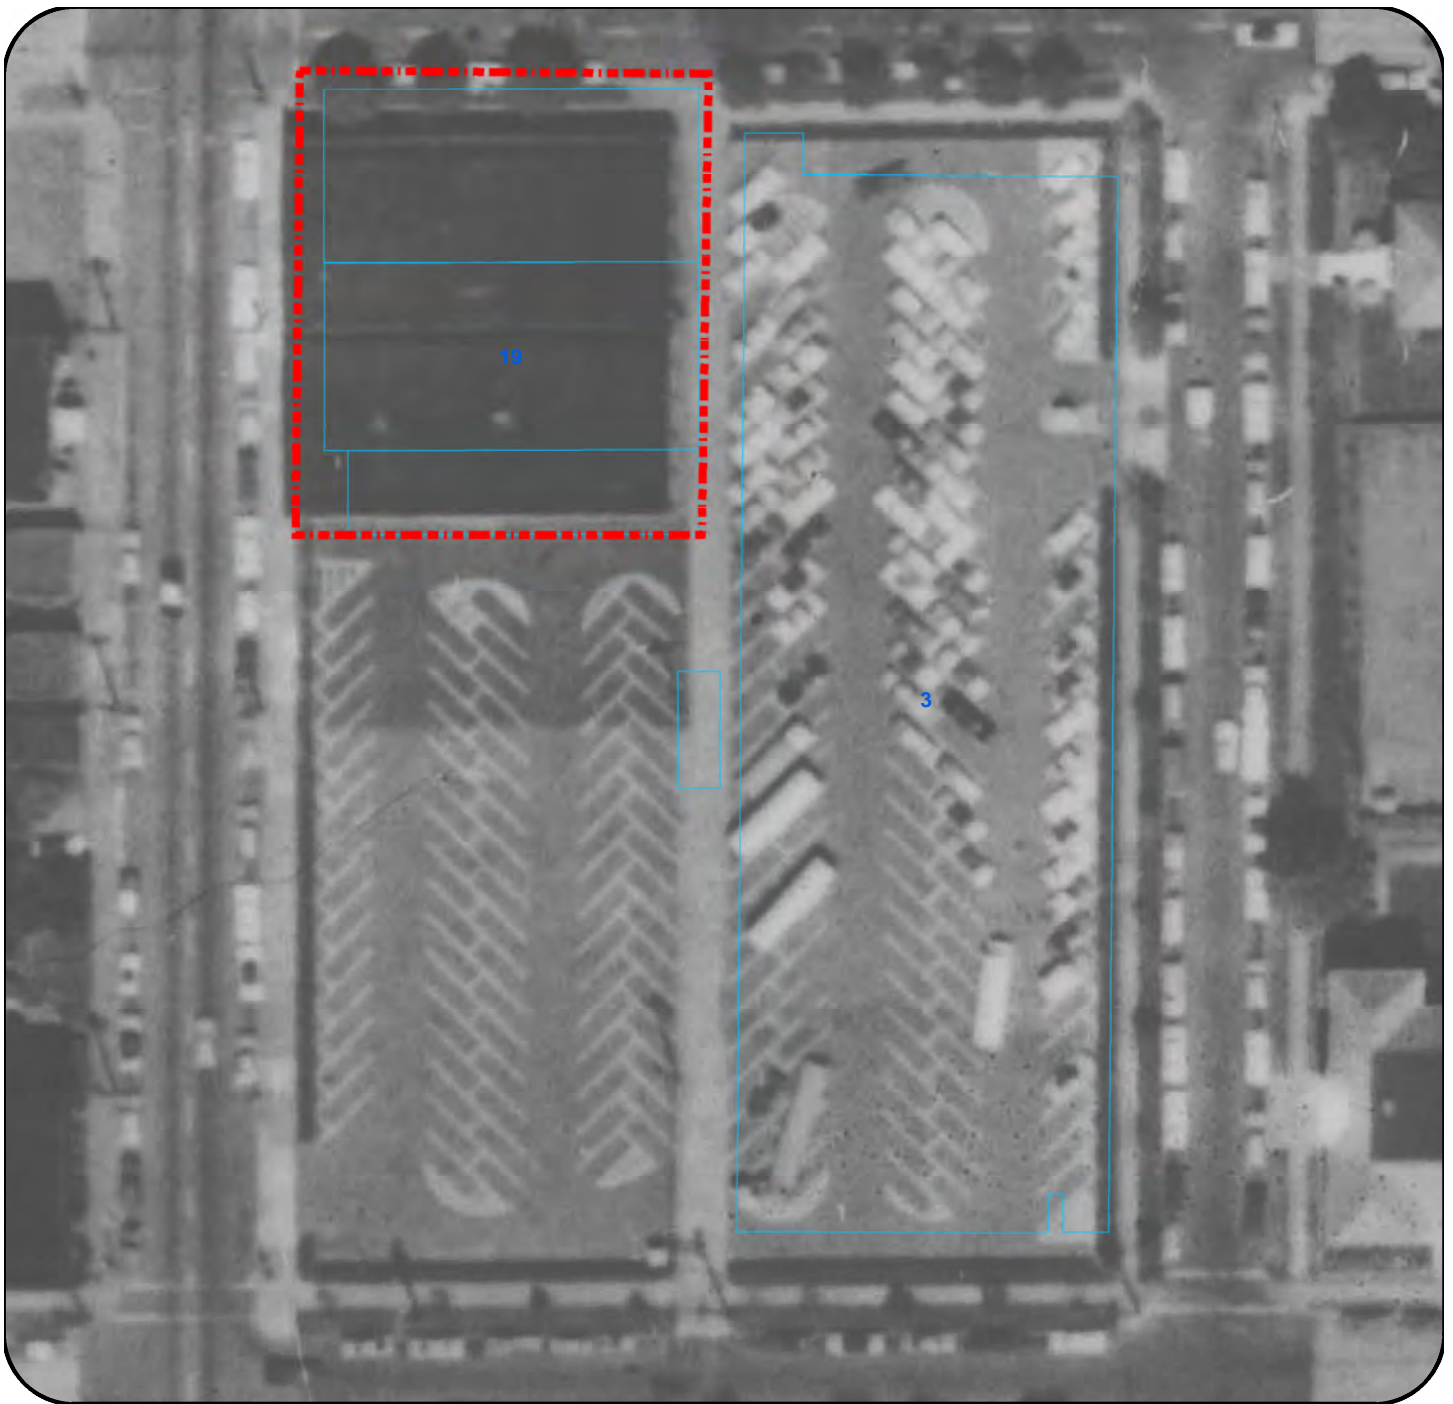
### 1970 Aerial Courtesy Seattle Center

Figure 11: 1970 aerial with an overlay of the current buildings. Courtesy Seattle Center.

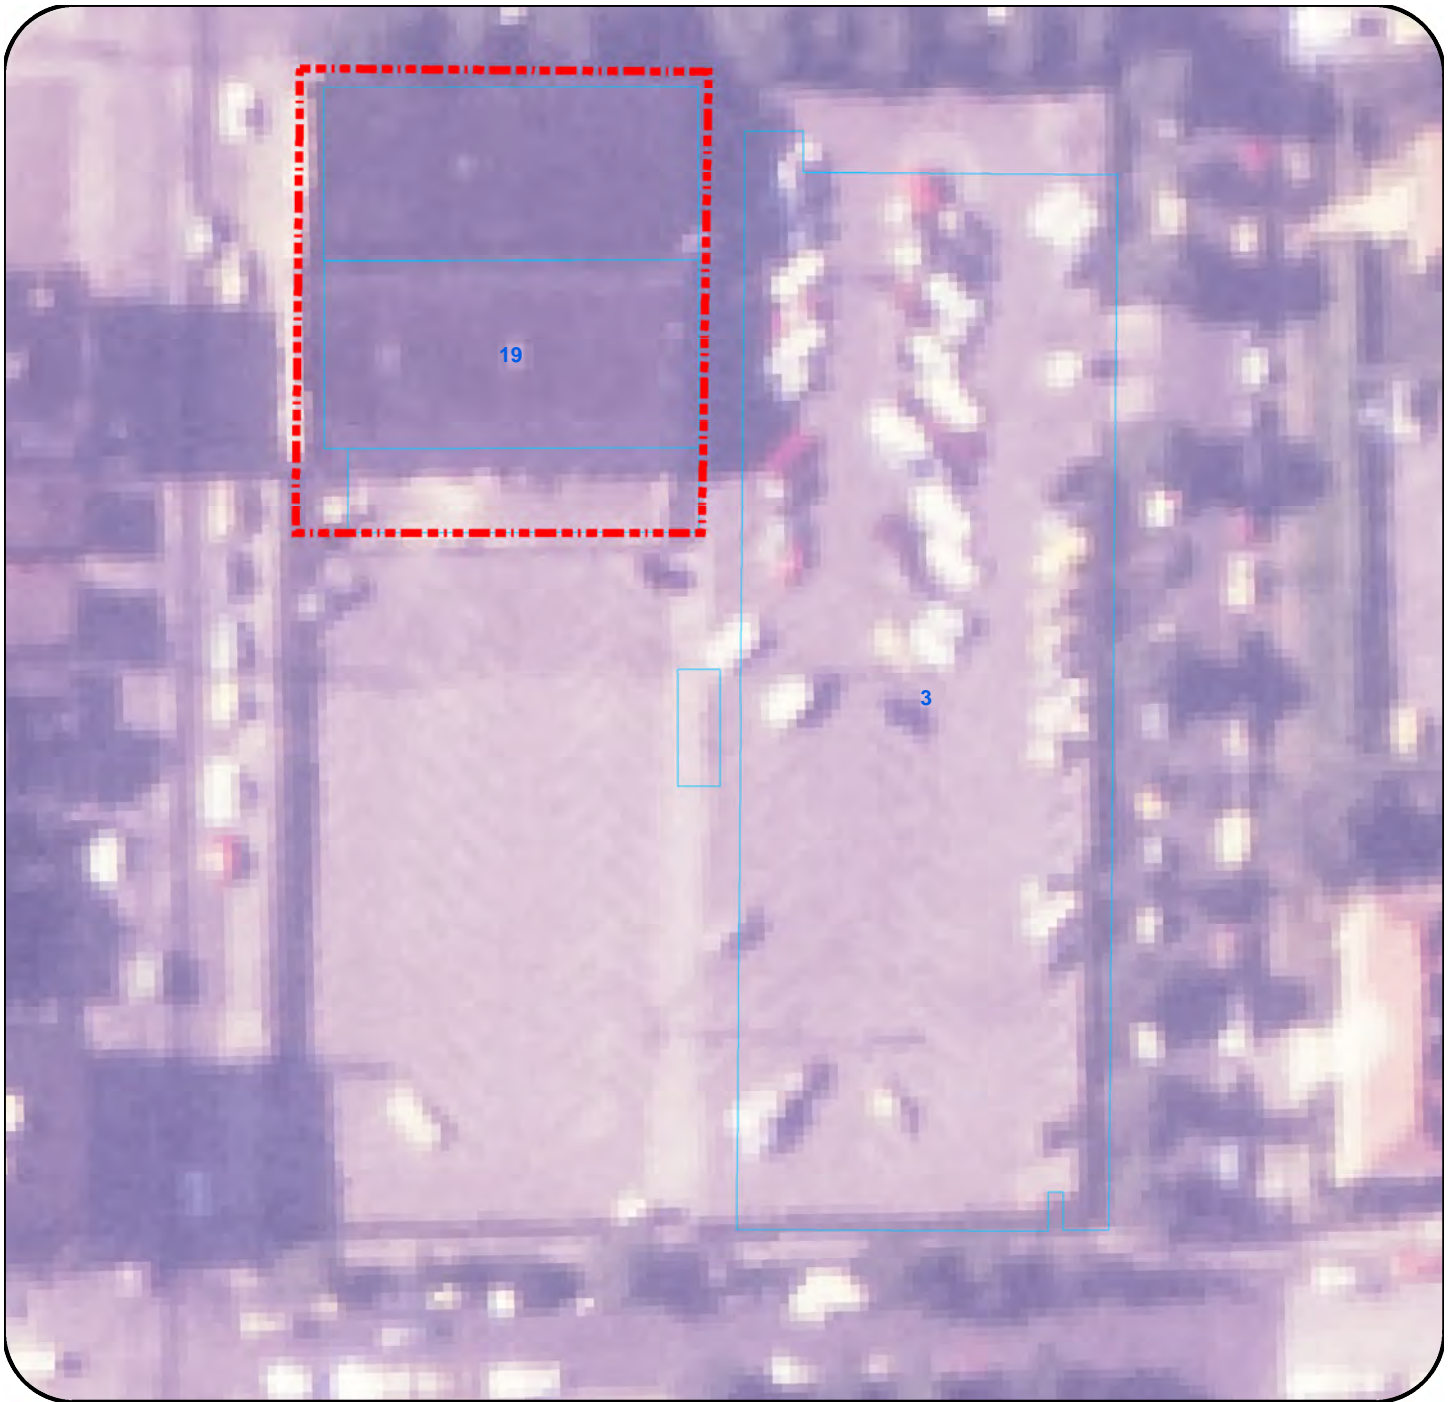
**1974 Aerial  
Courtesy USGS**

Figure 12: 1974 aerial with an overlay of the current buildings. Courtesy USGS.

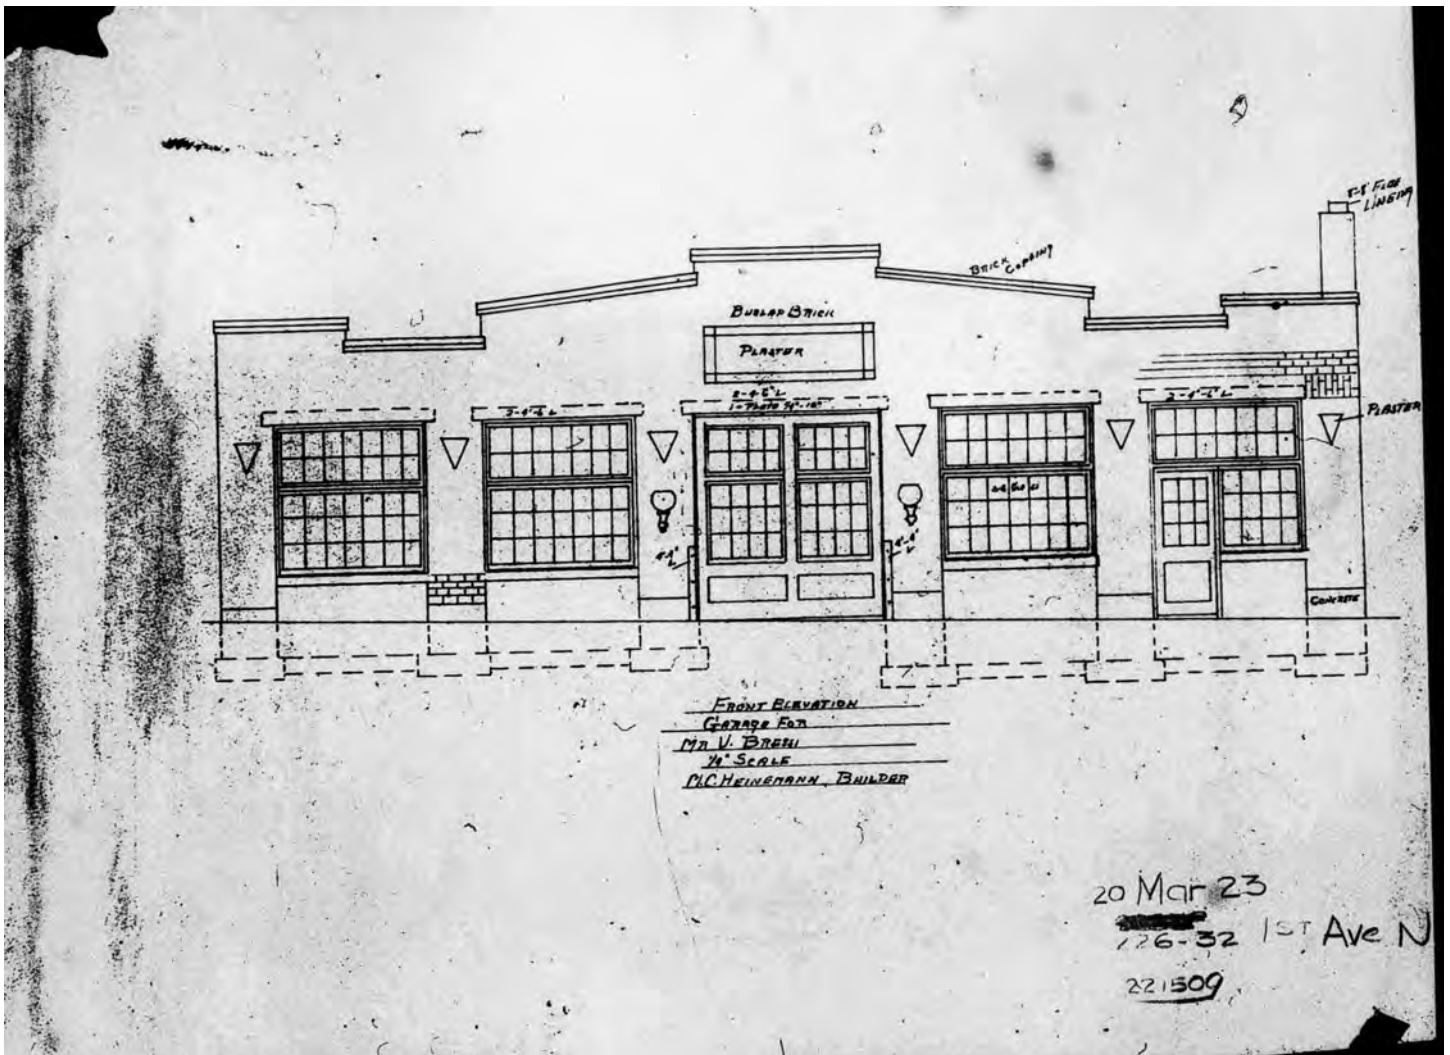
Figure 14: Front elevation, Bressi Garage. March 1923. M.C. Heinemann, Builder. Courtesy Seattle Department of Planning and Development Microfilm Library.

features five bays, separated by wide brick pilasters (see Figure 14). The southern storefront features a central entrance flanked by two bays of windows (see Photograph 11). The northern storefront features five bays of windows (see Photograph 13). The windows are deeply recessed with brick corbelling highlighting the lintels above the windows (see Photograph 12). A brick bulkhead runs beneath the windows, capped by bricks forming a sloped sill for the windows. The bulkhead height follows the slope of the site. According to historic photographs (see Photograph 16), each storefront featured a central entrance with a door to accommodate automobiles entering the building. Simple wall sconces with white glass globes flanked these central entrances and a "Bressi Garage" sign existed above each entrance.

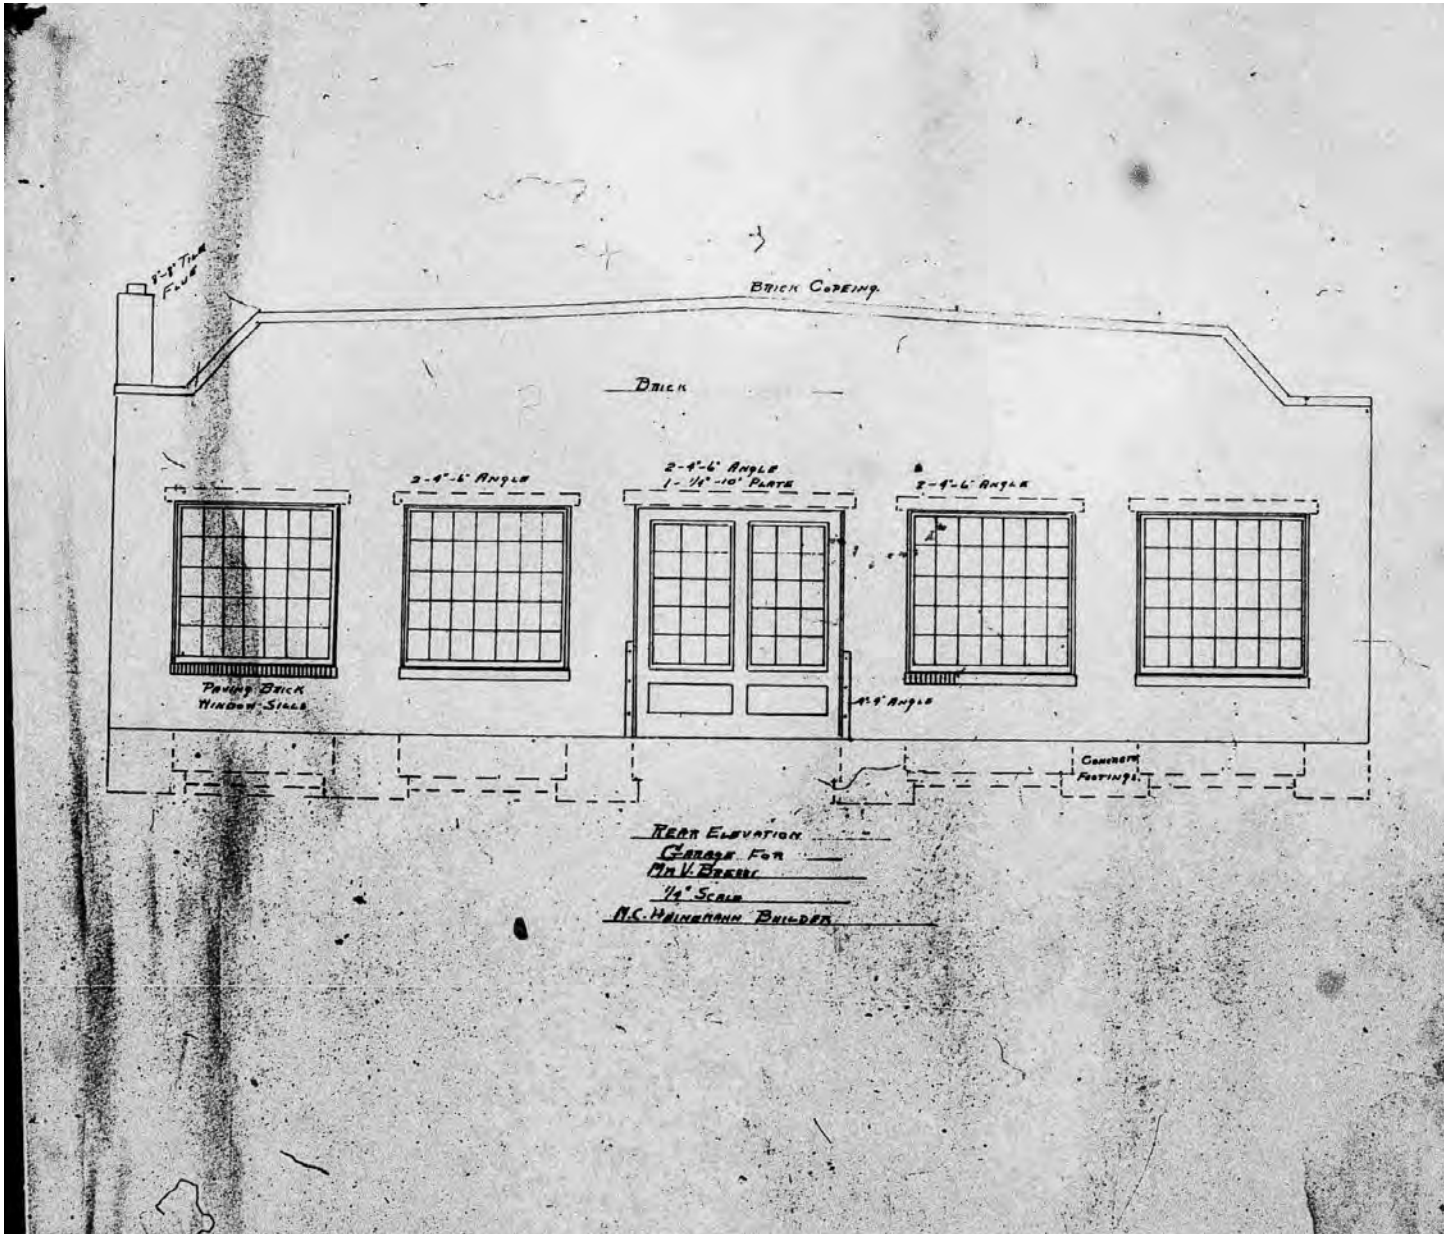
Figure 15: Rear elevation, Bressi Garage. March 1923. M.C. Heinemann, Builder. Courtesy Seattle Department of Planning and Development Microfilm Library.

The east elevation, like the west, is divided in two with five bays each (see Photographs 3, 4, and 9). Angled parapet walls provide definition for the north and south half of the elevation. Each bay features a recessed opening, marked by a sailor header course. The recessed openings in the northern five bays of the east elevation have been infilled with concrete block. A painted mural covers the concrete blocks and partially extends onto the brick. The recessed openings in the southern five bays of the east elevation retain their original windows and door. This half of the elevation features a central door flanked by two bays of windows; roll up metal security doors are located above all five openings (see Photograph 15 and Figure 15).
