The City of Seattle

## Landmarks Preservation Board

# Bressi Garage

## City of Seattle Historic Landmark Nomination

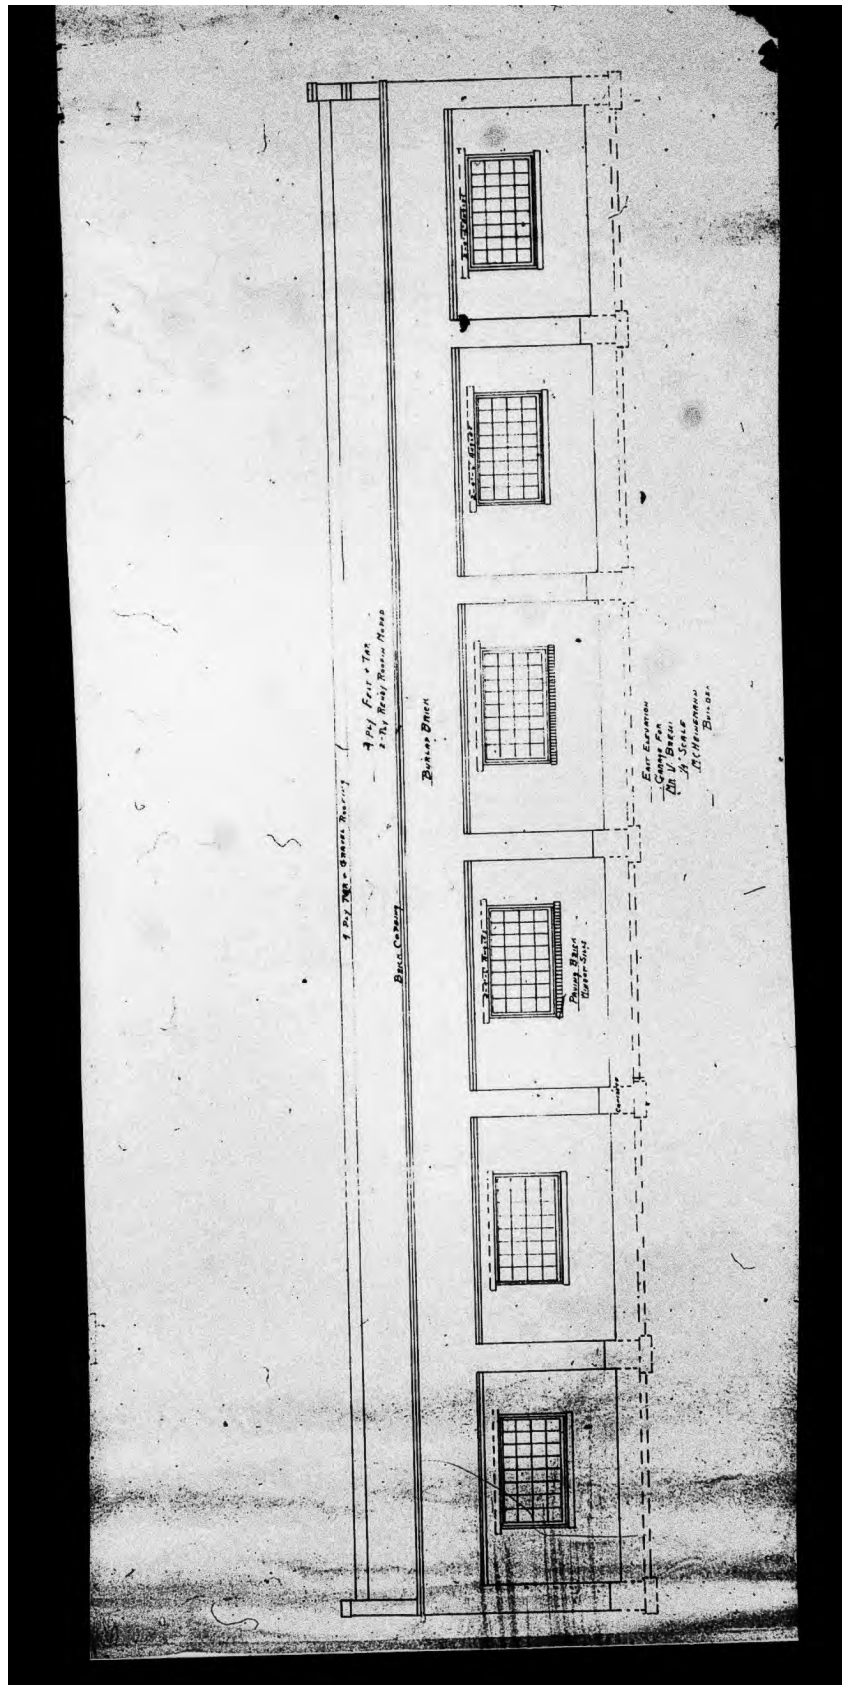
Figure 16: Side elevation, Bressi Garage. March 1923. M.C. Heinemann, Builder. Courtesy Seattle Department of Planning and Development Microfilm Library.

The north elevation is divided into six bays, wider than those on the west elevation (see Photographs 2, 3, and 8 and Figure 16). Wide brick pilasters separate each bay. Brick corbelling highlights the lintel. Windows, a roll-up garage door, and a metal personnel door with a transom punctuate this elevation's bays.

The south elevation, like the north, is divided into six bays (see Photograph 10 and Figure 16). A shed roof lean-to obscures much of the south elevation, providing outdoor workspace as a kiln shed for the current tenant, Pottery Northwest. Drawings for the kiln shed were received by the City of Seattle in 1974. A door located in the second bay from the east provides access from the interior of the building out to the shed. The shed extends 25-feet to the south and runs along the south elevation (see Photograph 5).

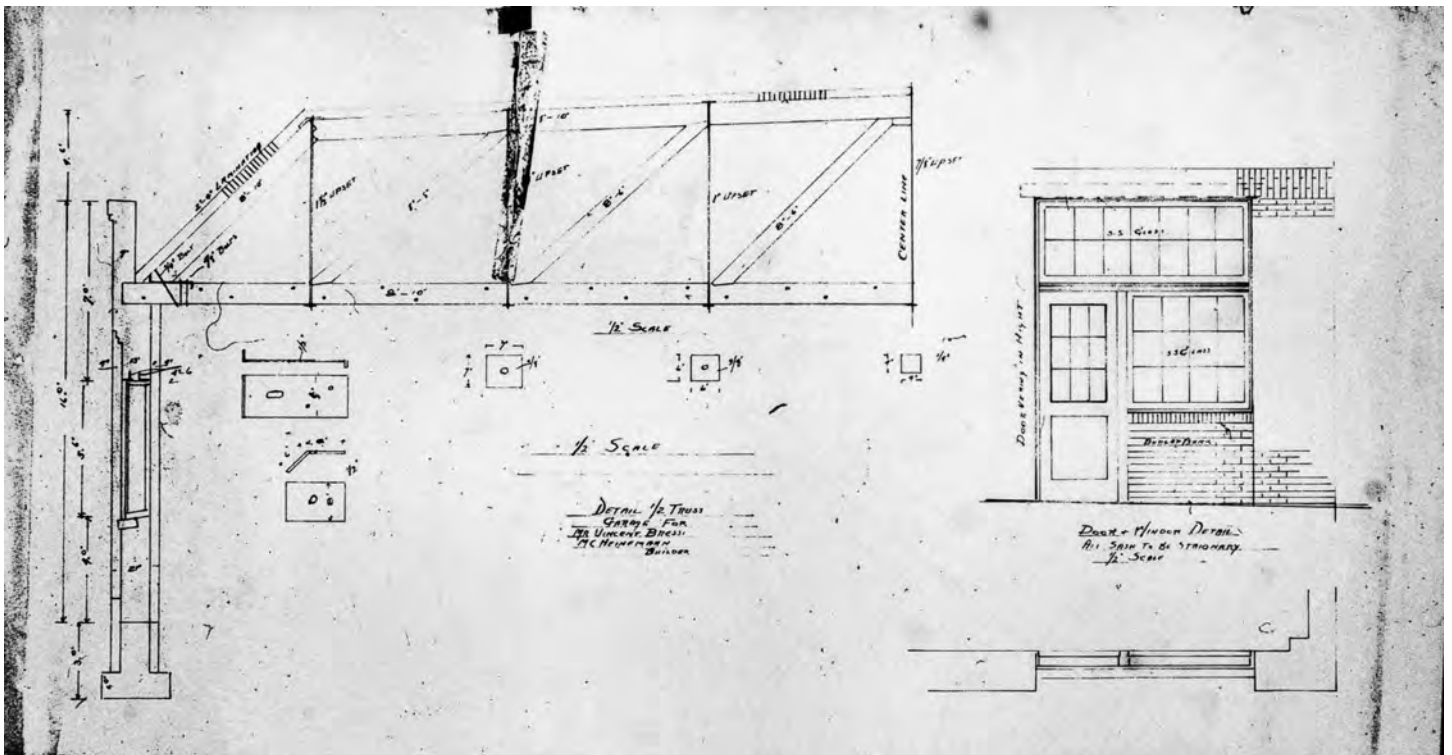
Figure 17: Truss and door detail, Bressi Garage. March 1923. M.C. Heinemann, Builder. Courtesy Seattle Department of Planning and Development Microfilm Library.

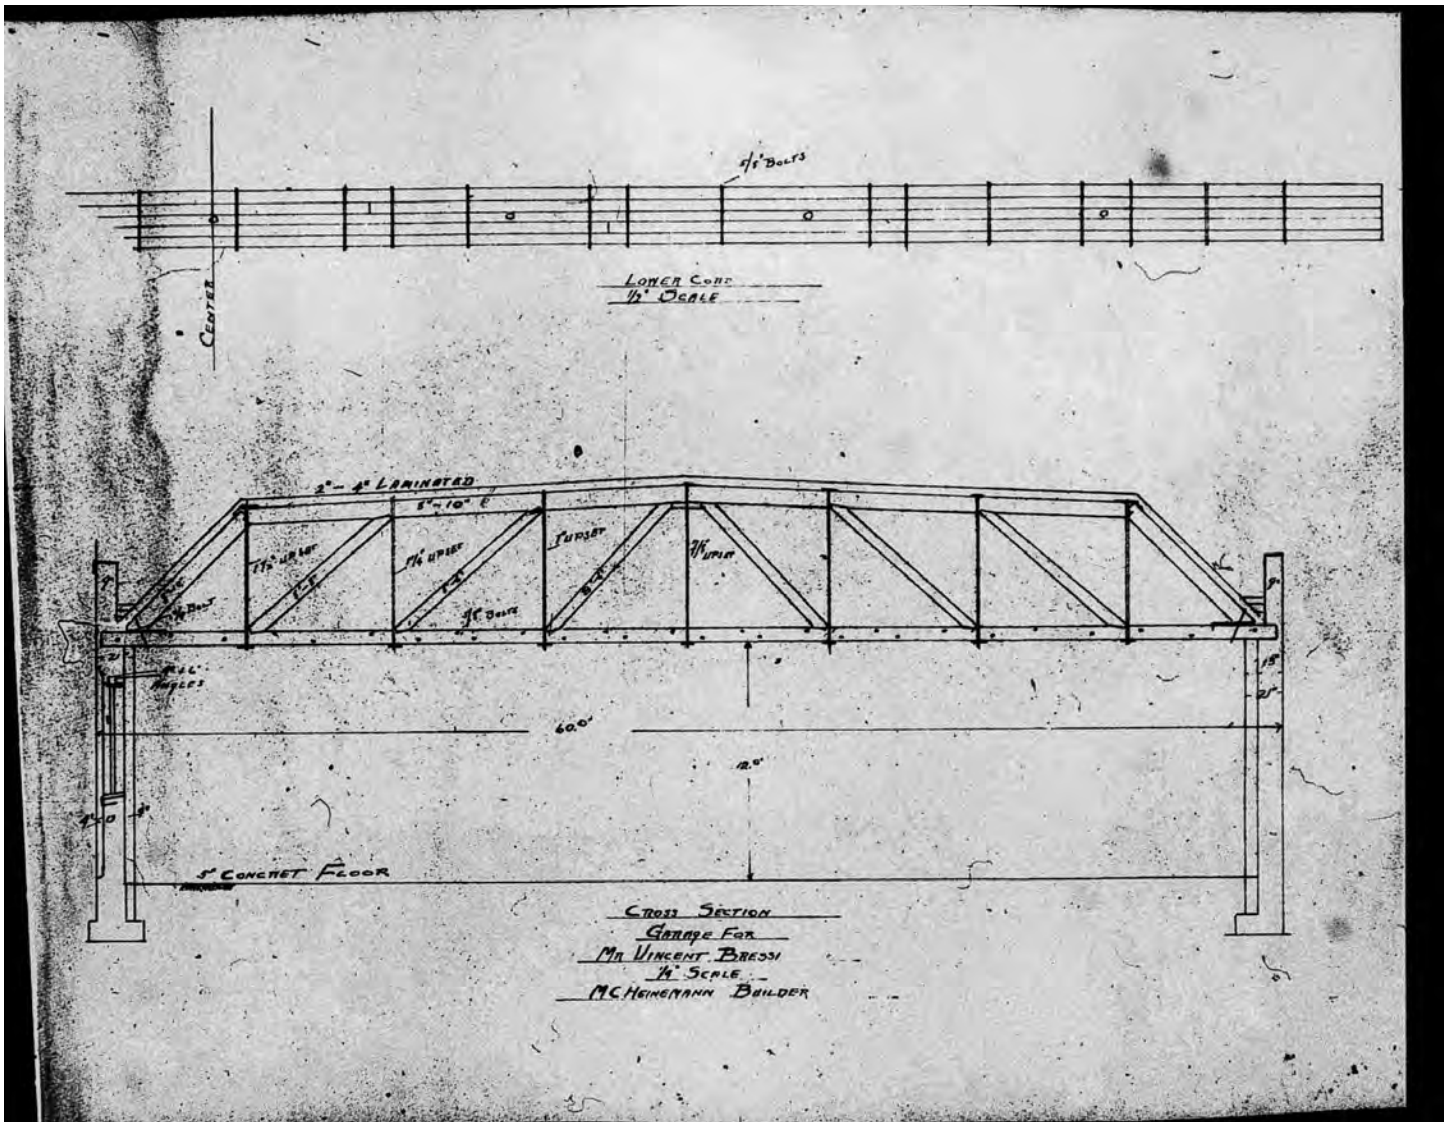
Figure 18: Cross section, Bressi Garage. March 1923. M.C. Heinemann, Builder. Courtesy Seattle Department of Planning and Development Microfilm Library.

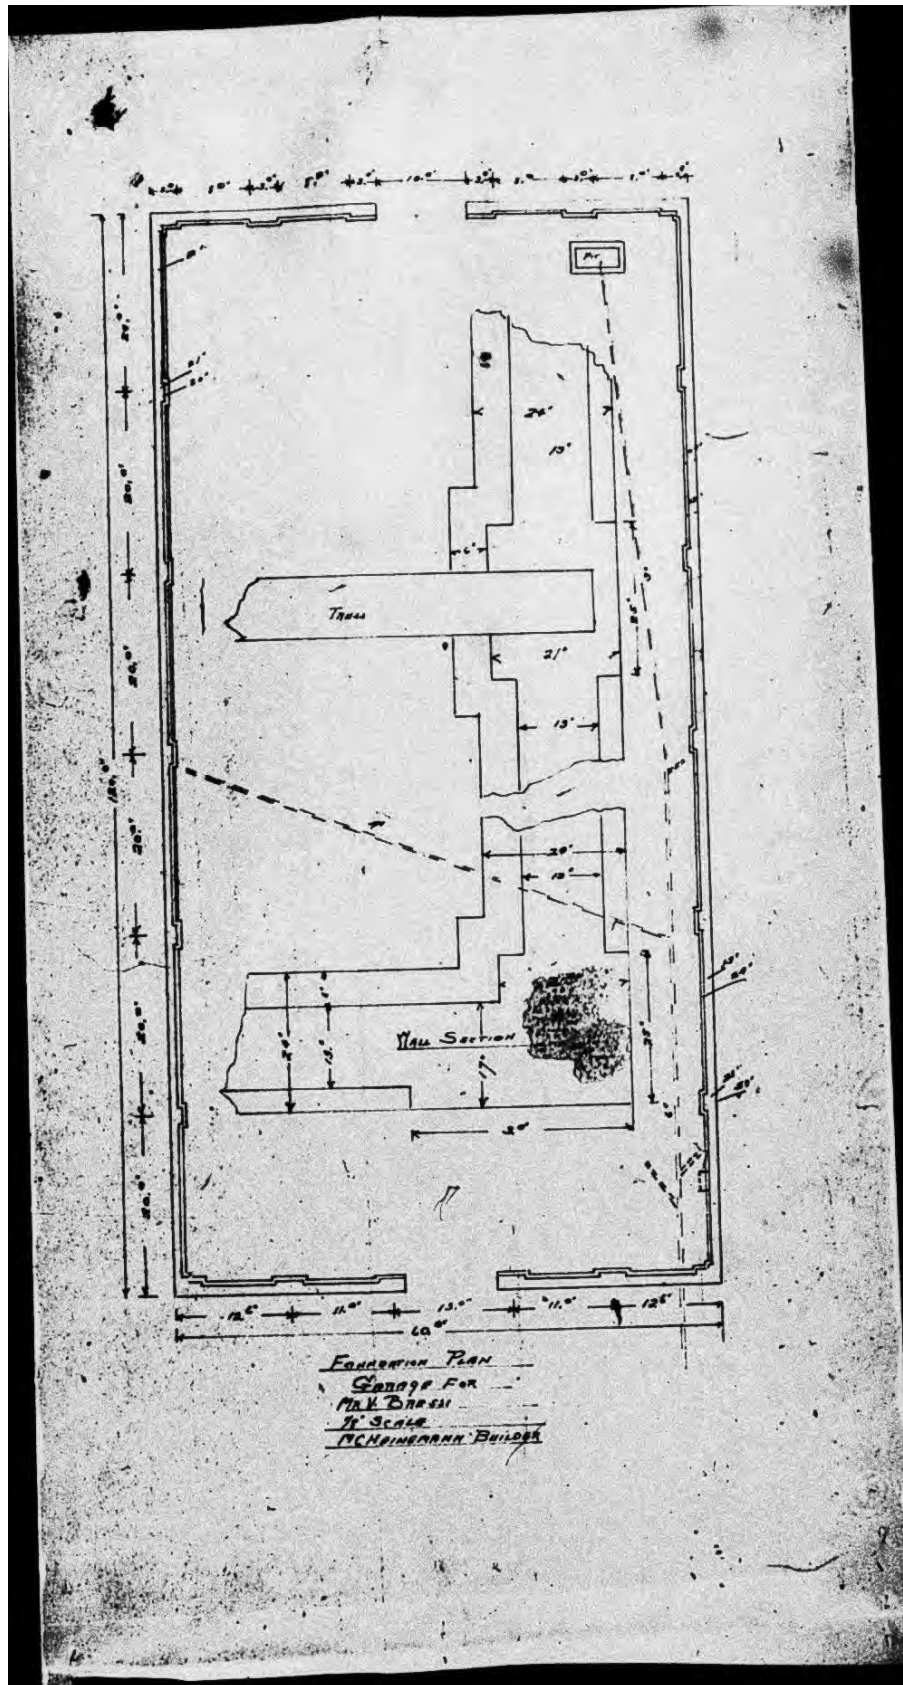
Figure 19: Foundation plan, Bressi Garage. March 1923. M.C. Heinemann, Builder. Courtesy Seattle Department of Planning and Development Microfilm Library.

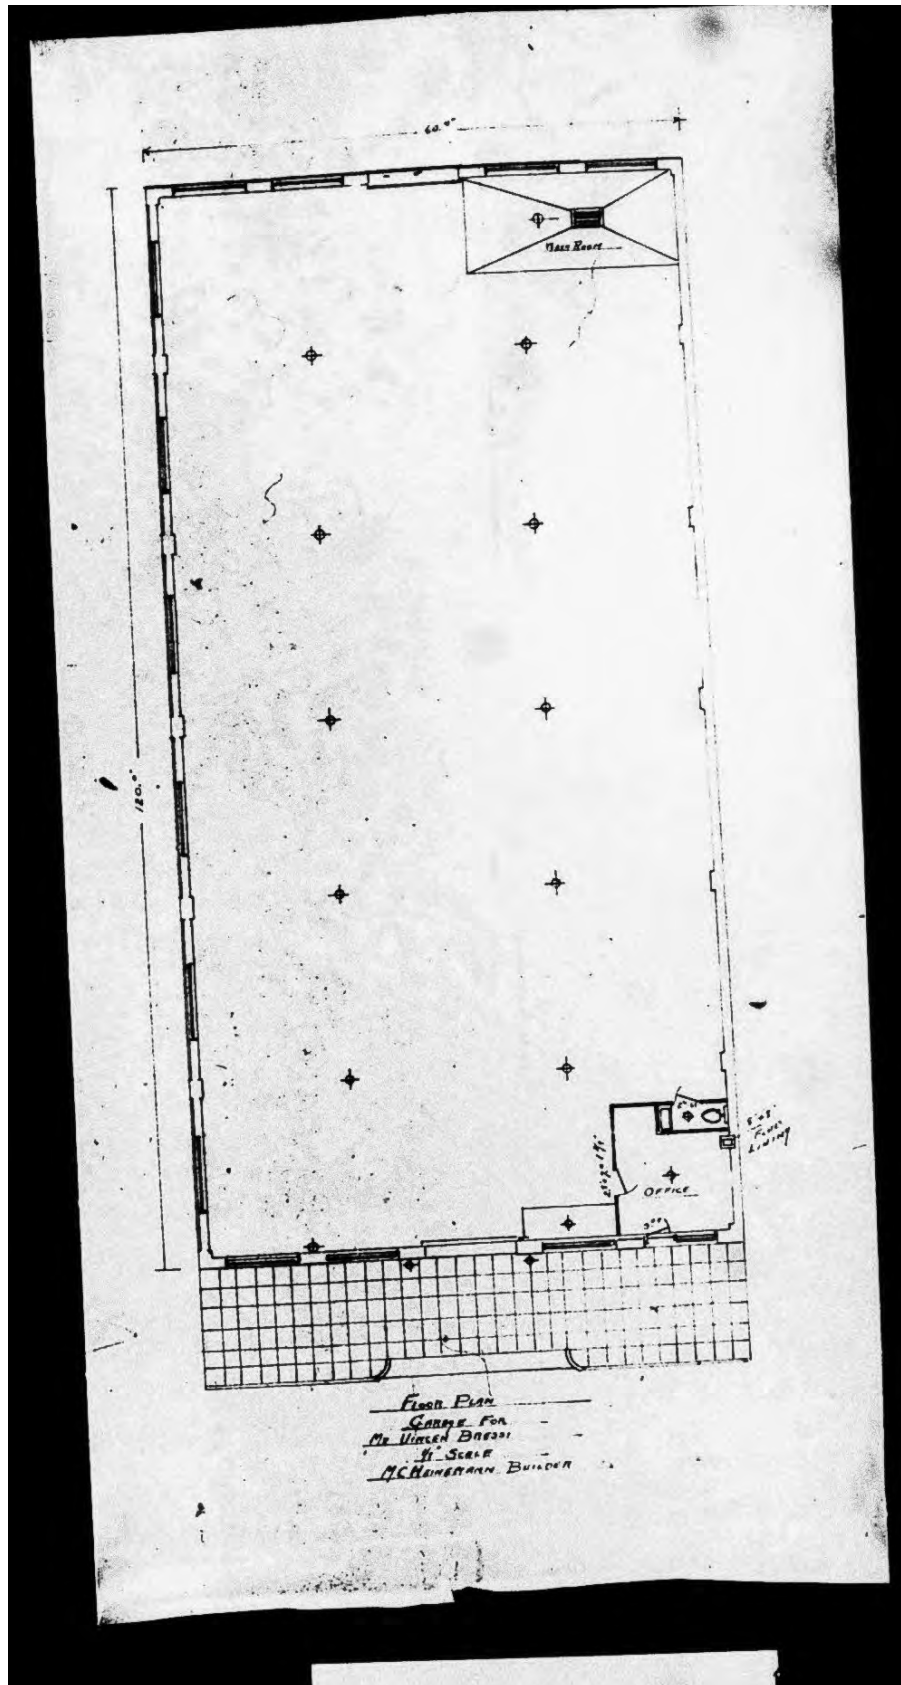
Figure 20: Floor plan, Bressi Garage. March 1923. M.C. Heinemann, Builder. Courtesy Seattle Department of Planning and Development Microfilm Library.

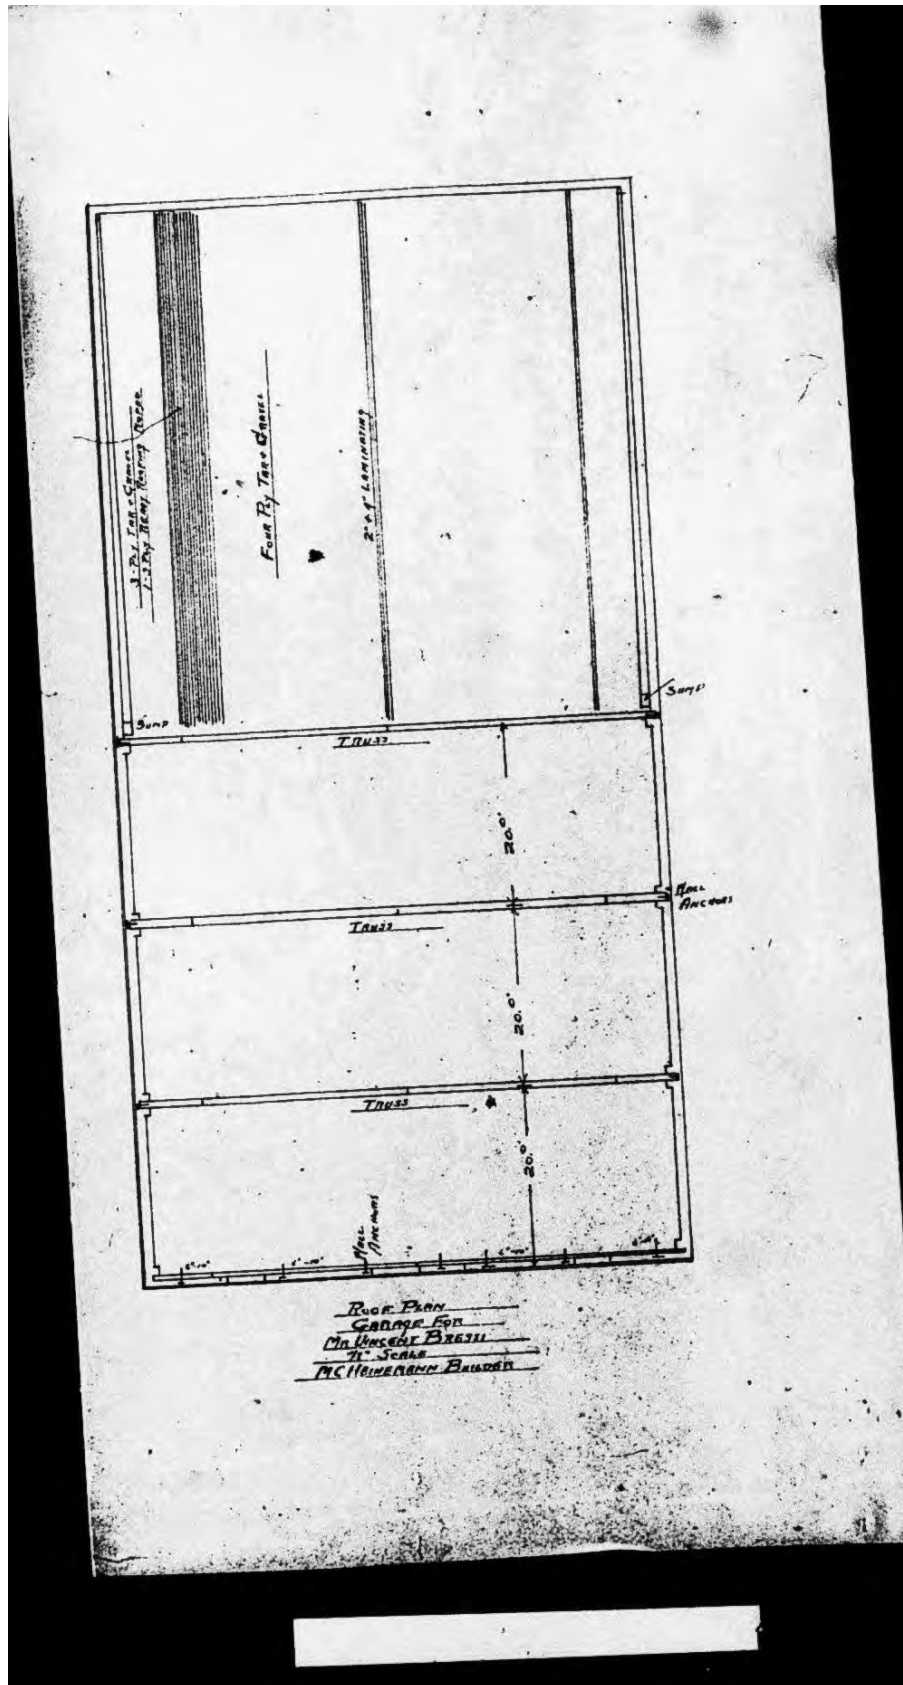
Figure 21: Roof plan, Bressi Garage. March 1923. M.C. Heinemann, Builder. Courtesy Seattle Department of Planning and Development Microfilm Library.
