Landmark NOMINATION Application

Name: Benjamin S. Anderson House

Street and Number: 4211 Brooklyn Avenue NE

Submitted by: David Peterson / Historic Resource Consulting **Date:** January 25, 2019
301 Union Street #115
Seattle WA 98111
Ph: 206-376-7761 / david@dphrc.com

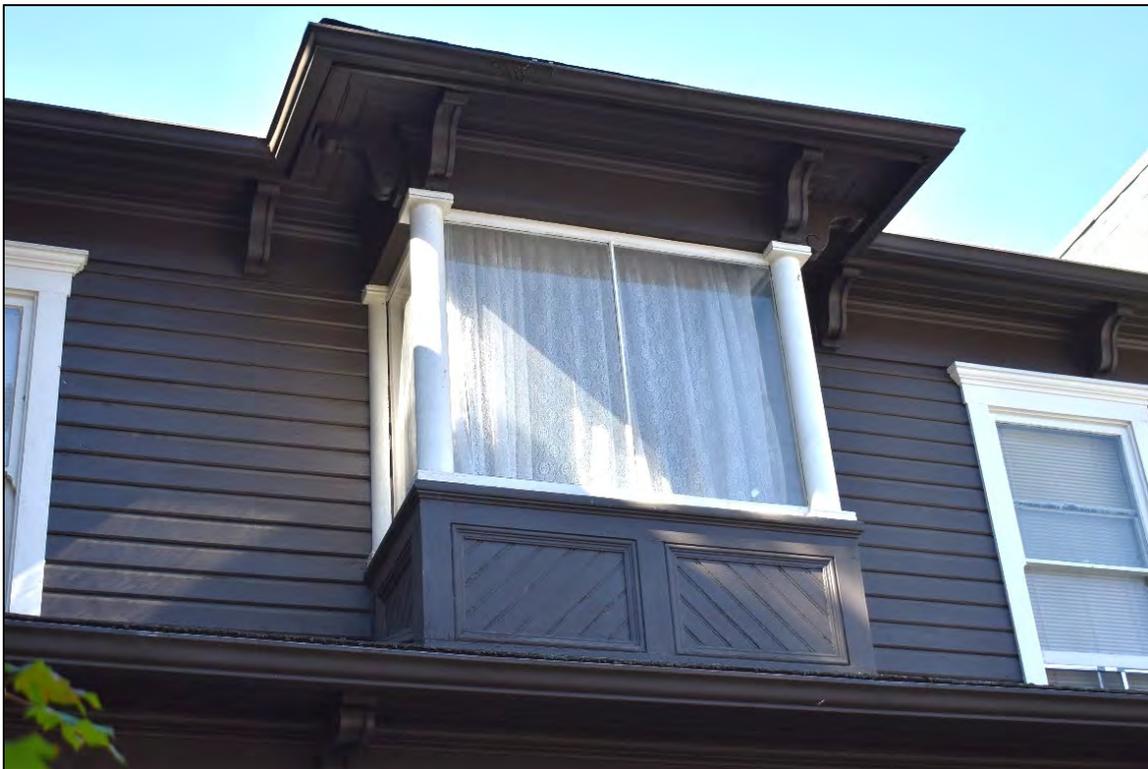
Fig. 10 – East elevation, upper floor, detail of bay window

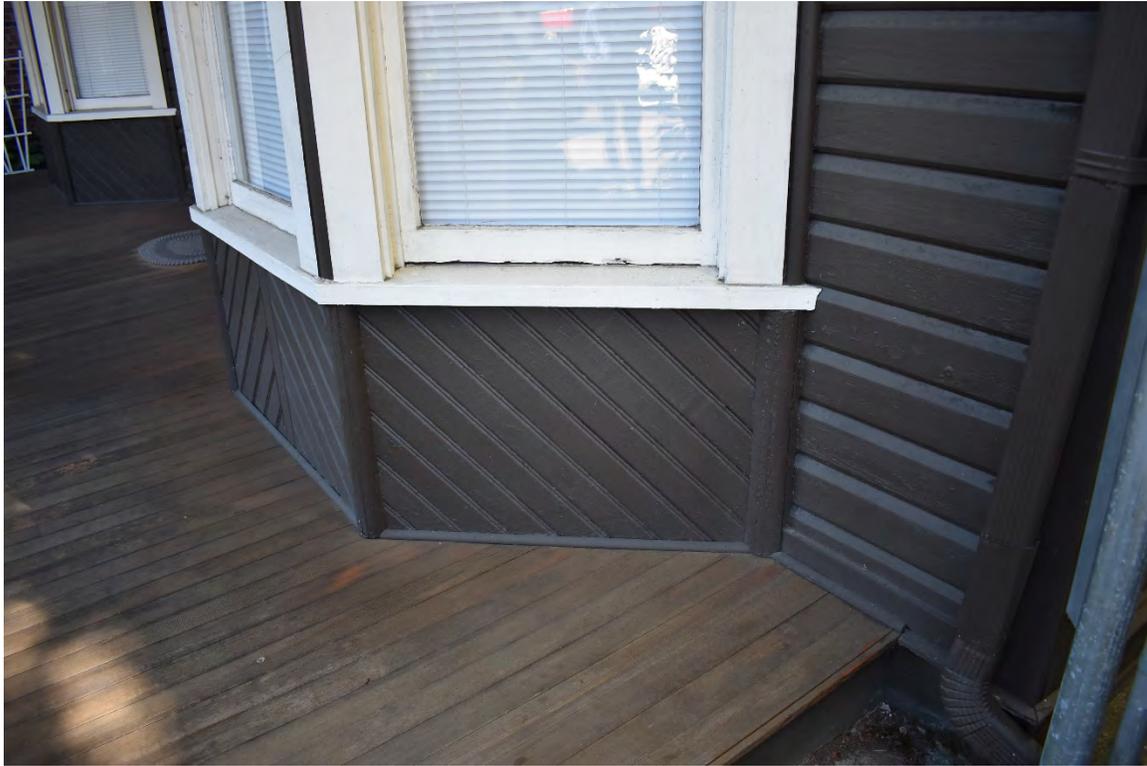
Fig. 14 – East elevation, detail of bay window and siding

The house is clad in painted drop siding (probably cedar) with a deep reveal. Windows are primarily original double-hung wood sash with 1-over-1 glazing. The second floor front box bay window has metal or aluminum sash which appears to date from the mid-20th century or later. At the rear basement level, and the first floor rear enclosed porch, are aluminum sash windows which date to c.1979-80 alterations. The rear elevation at the second floor also features two decorative lozenge-shaped windows at the building corners which date to the rear part second floor addition that occurred by 1919.

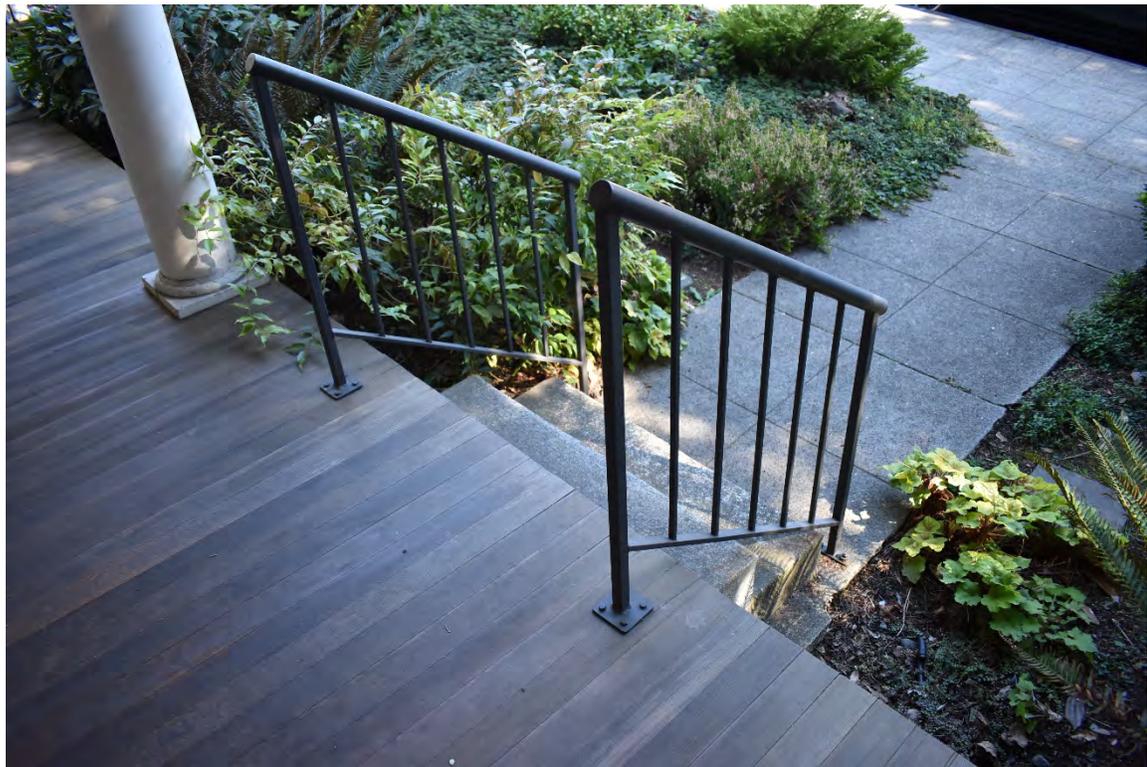
Fig. 15 – East elevation, detail of porch and porch stair handrail

On the front or east elevation, the first floor has a center entrance flanked by two angled bay windows, covered by a one-story full-width hip-roof porch. The porch is supported by four Tuscan posts, each punctuated at the crossbeam by shaped brackets, and its ceiling is finished with painted beadboard. The porch decking itself is wood but likely dates to recent decades, with modern concrete steps and metal handrails at the front walk. At the center of the second floor is a projecting square bay window topped by a hip roof; the bay corners feature peculiarly simple cylindrical wood posts supporting simple blocks, an apparently original condition that appears in the 1937 tax assessor photograph. All three bay windows feature decorative, angled wood slats in the bulkhead panels below the glazing.

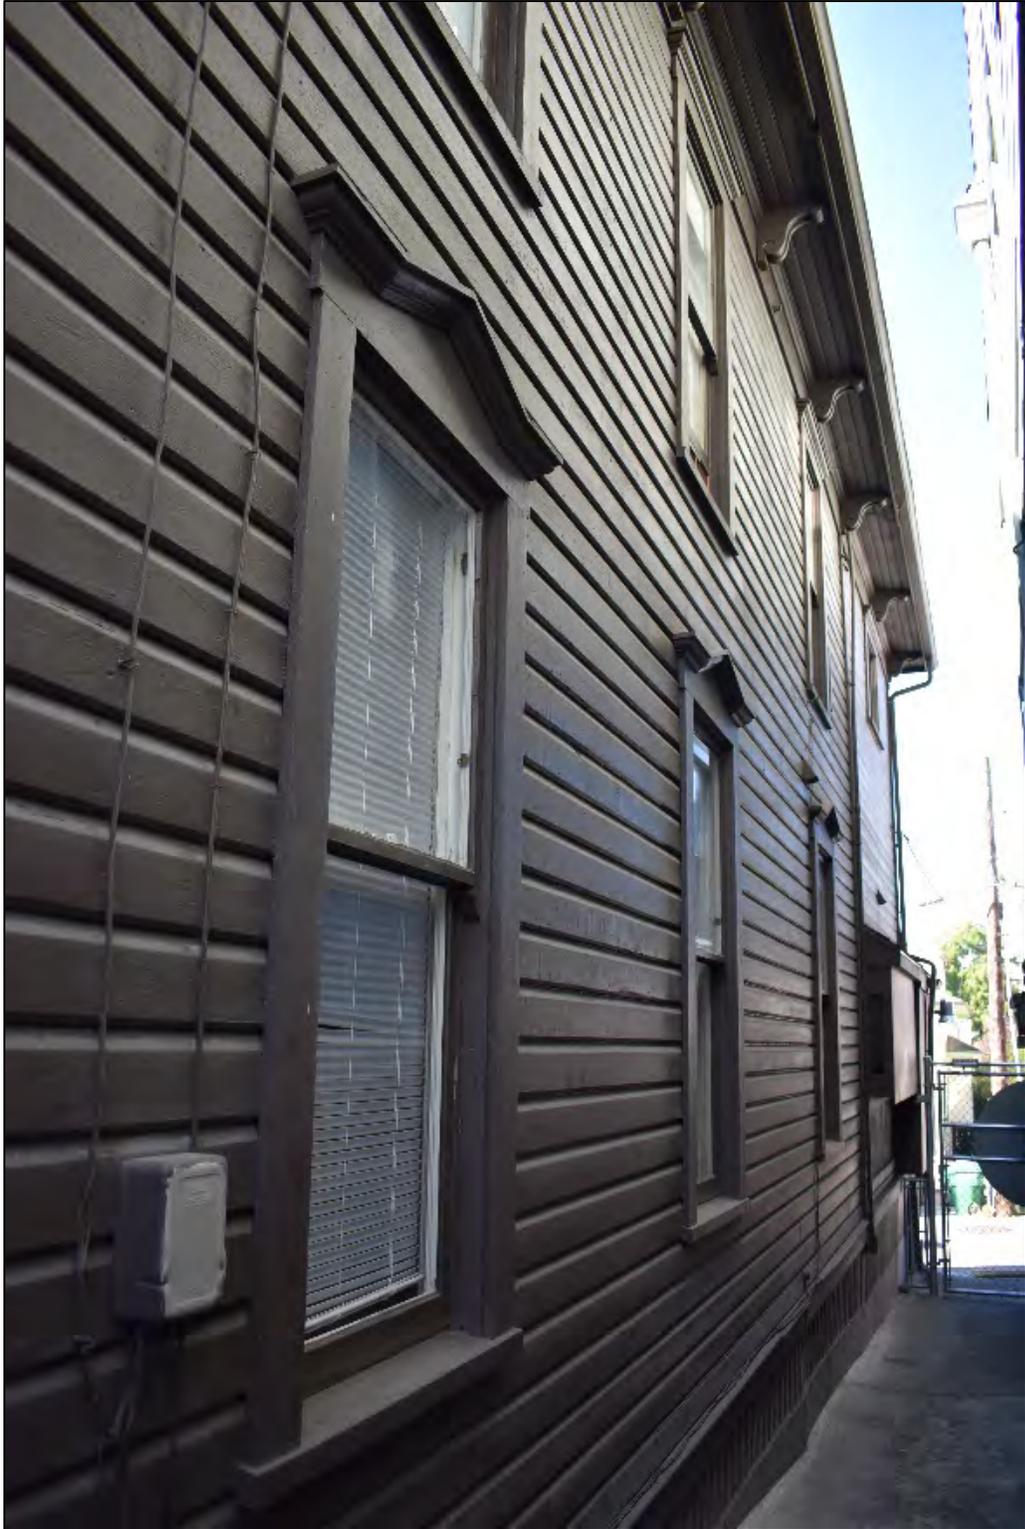
Fig. 16 – North elevation, view towards rear

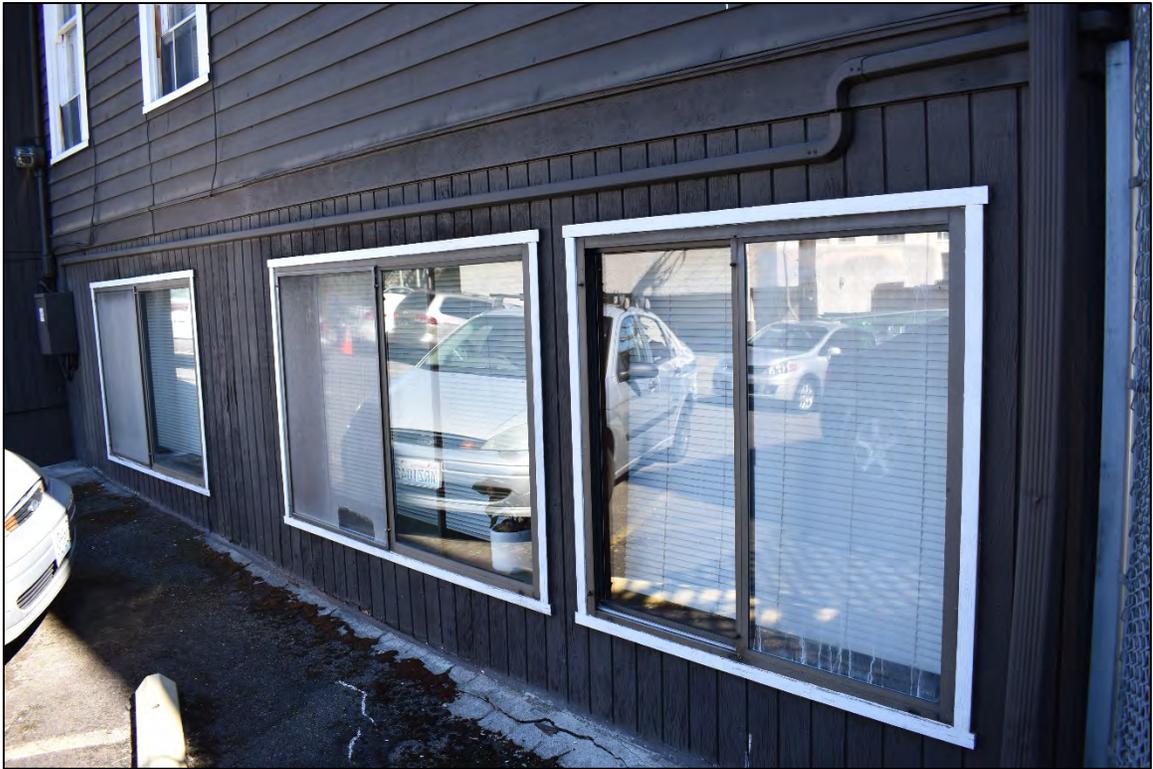
Fig. 19 – West elevation, basement level windows

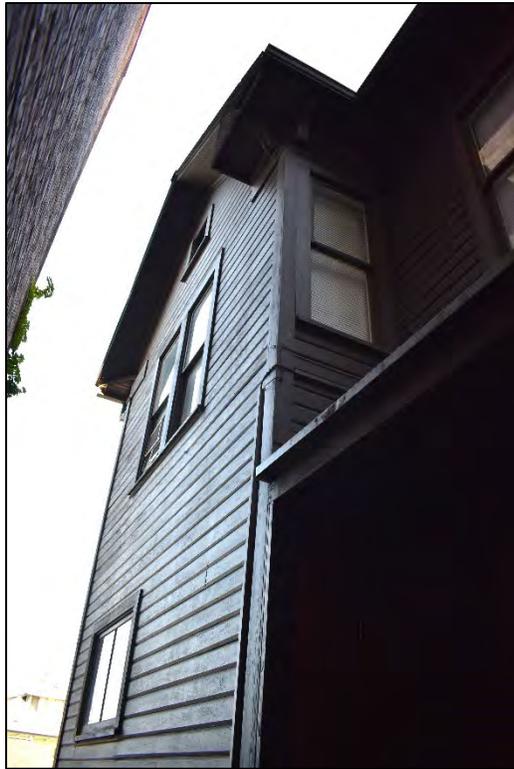
Fig. 21 – South elevation, rear part, showing gable roof at second floor

- Second story added to rear third of the building (between 1905 and 1915).
- Rear porch enclosed (1979-84).
- Interiors partitioned over time into separate apartments.

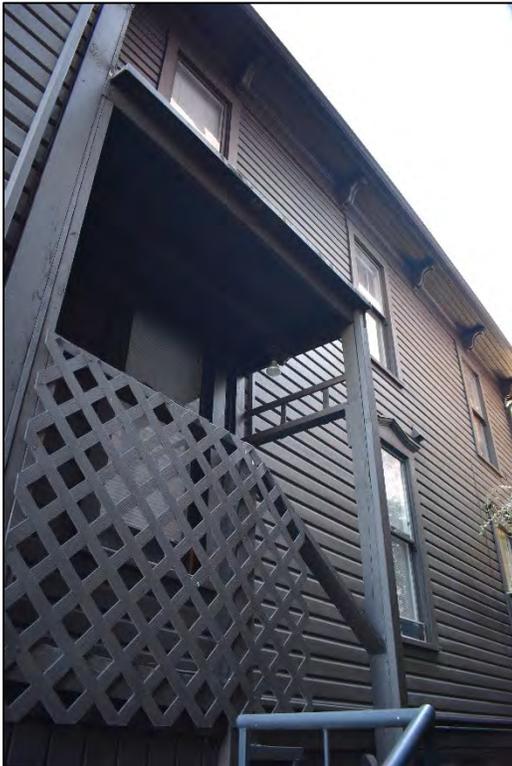
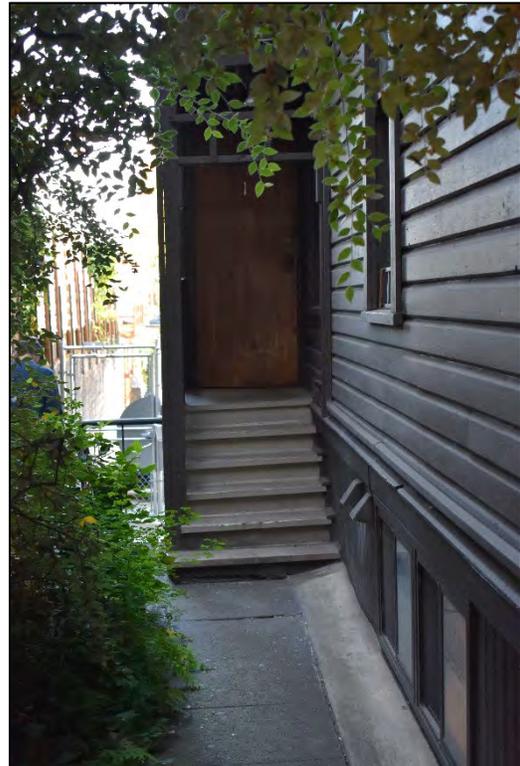
Fig. 22 – South elevation, rear part, showing side porch and stair at first floor

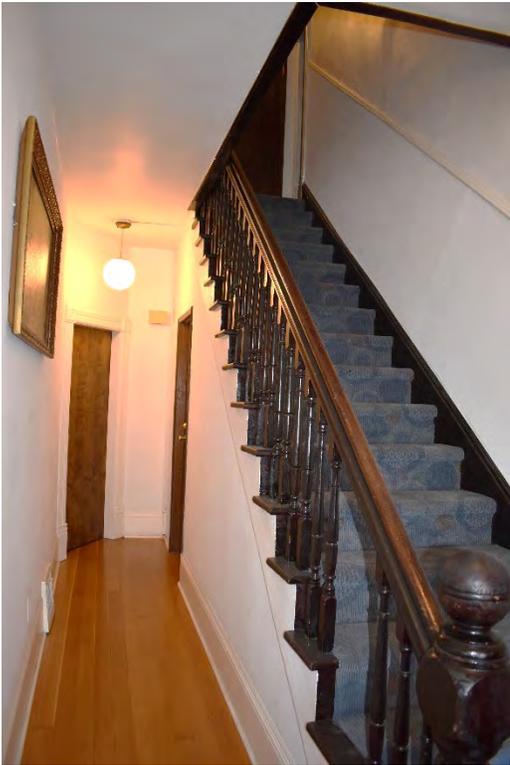
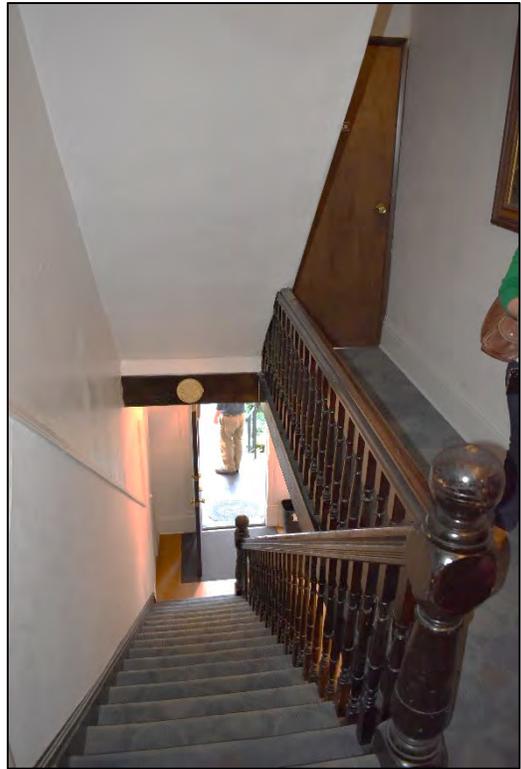
Fig. 23 – Interior, main entrance and stairway

The interior is organized around a central hall and straight-run stairway providing access to the second floor, which retains an original turned-wood balustrade and newel post. While the building was originally built as a single family residence with connecting interior spaces, the rooms for many years have been partitioned into separate apartments reached from the central hall, or directly from the outside (as is the case at the basement level). Tax records indicate that ceiling heights at the first floor are 9 feet at the first floor, 8 feet 6 inches at the second floor, and 7 feet at the basement. Tax records state that original interior finishes of the house included fir floors, plaster walls, fir trim, but no tilework or fireplace. One second-floor unit was available for inspection for this report; some original finishes may remain but there appear to be no significant interiors. Original or at least period casework at interior doors and windows is commonly seen at the perimeter walls.

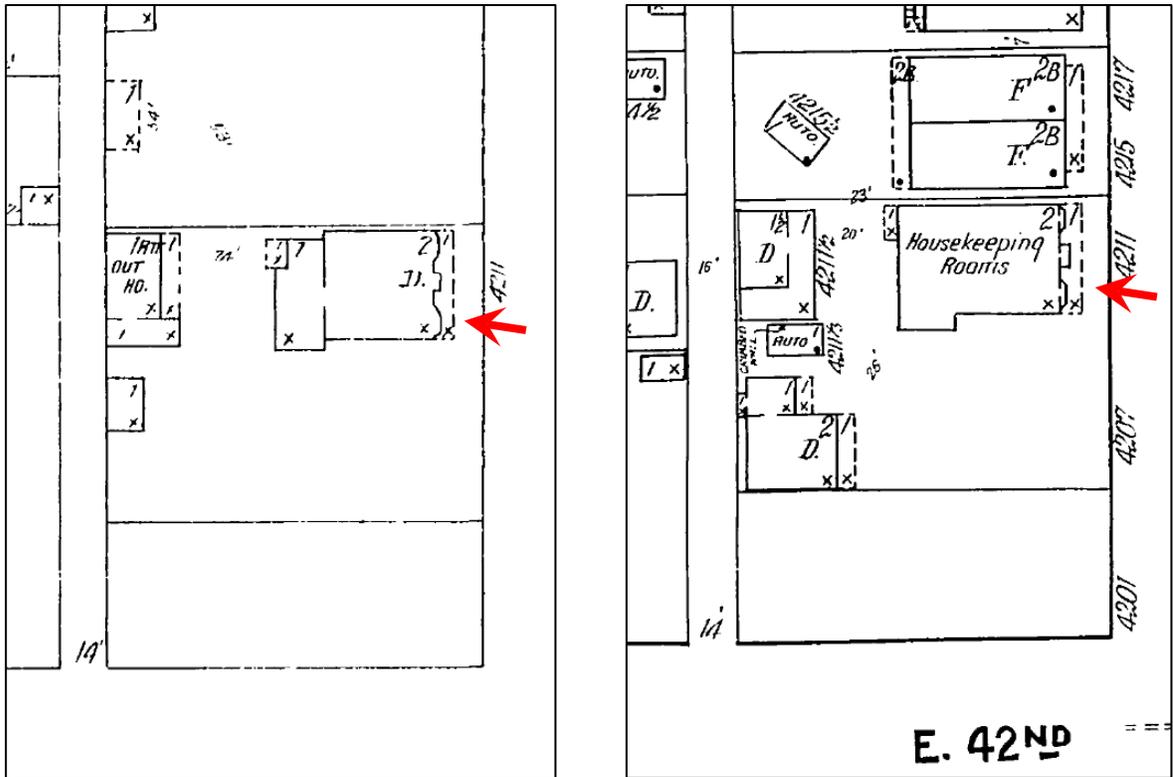
Fig. 29 – 1905 (left) and 1919 (right) Sanborn fire insurance maps of the subject building (b. 1901), indicated by arrow. By 1919, map notation indicates the rear portion has had a second story added.

Also by 1919 (as shown on the Sanborn map of that year), the outhouse at rear had been adapted into a one-and-a-half story dwelling, a small freestanding garage was added along the alley, and a two-story dwelling addressed as 4207 Brooklyn Avenue was constructed at the southwest property corner. The subject house was described as offering housekeeping rooms for rent, a condition which had likely been ongoing since about 1911, based a few classified ad listings in the Seattle Times. The building today remains a rooming house.

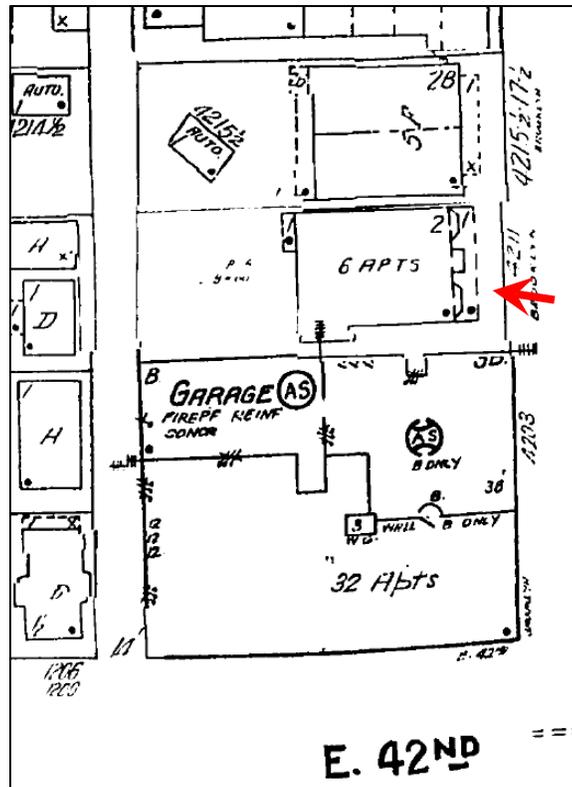
Fig. 30 – 1951 Sanborn fire insurance map of the subject property, indicated by arrow. North is up.

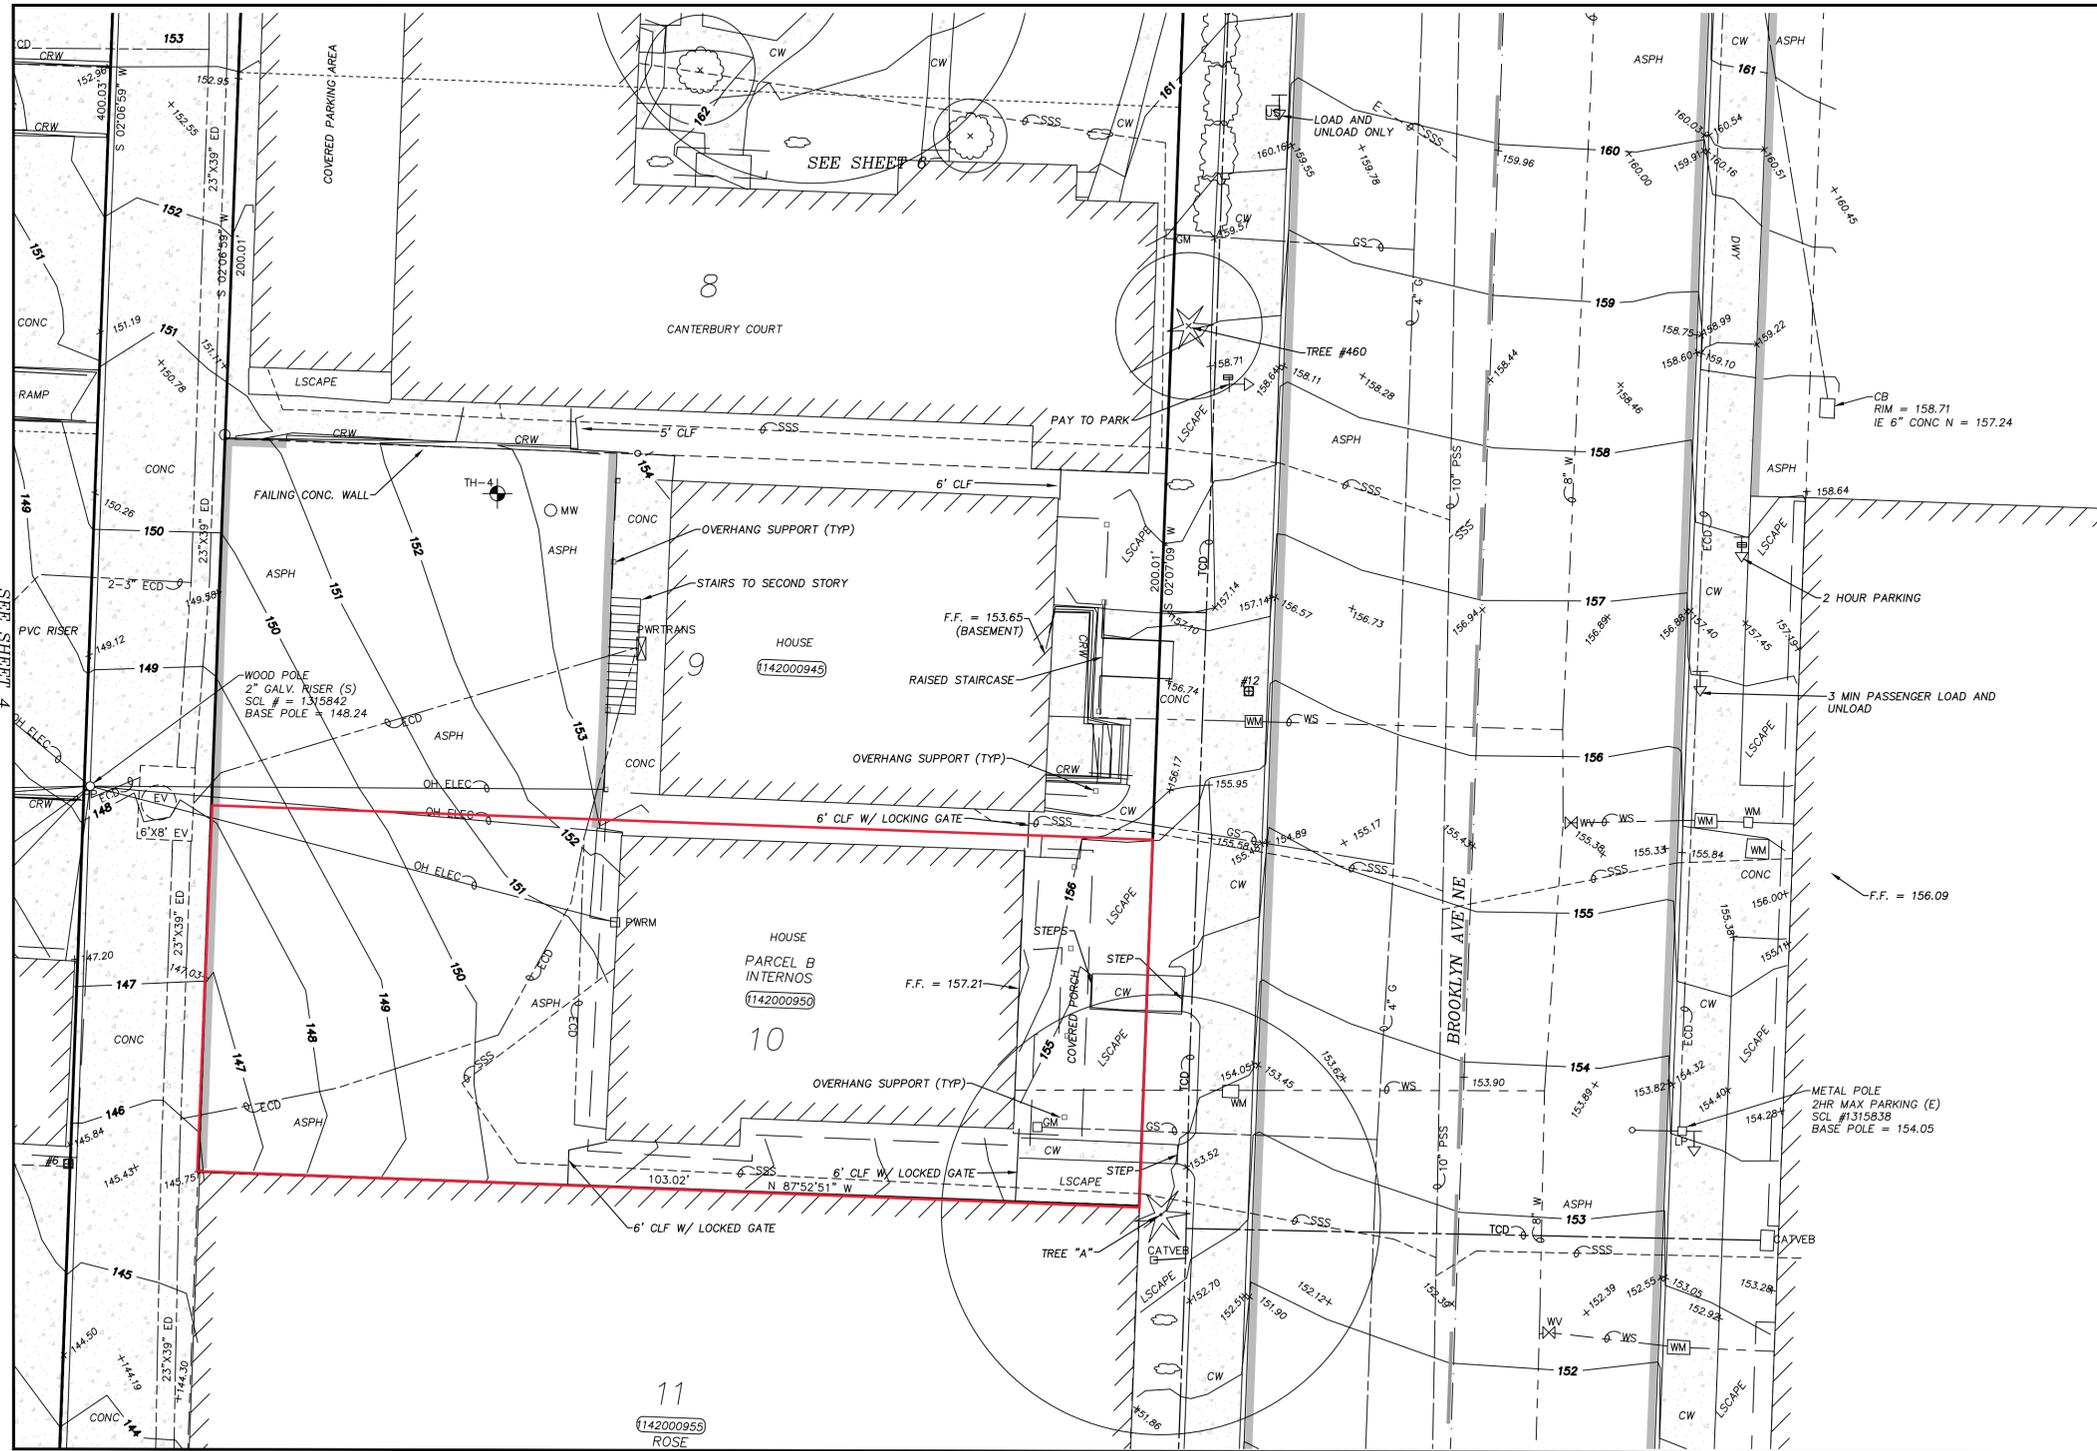
TOPOGRAPHIC SURVEY

NE 1/4 SECTION 17, TOWNSHIP 25N, RANGE 4E, W.M.
CITY OF SEATTLE, KING COUNTY, WASHINGTON
STANDARD AT SEATTLE
