The City of Seattle

Landmarks Preservation Board

Name: 1101 E Pike Street

1101 EAST PIKE STREET
SEATTLE LANDMARK NOMINATION

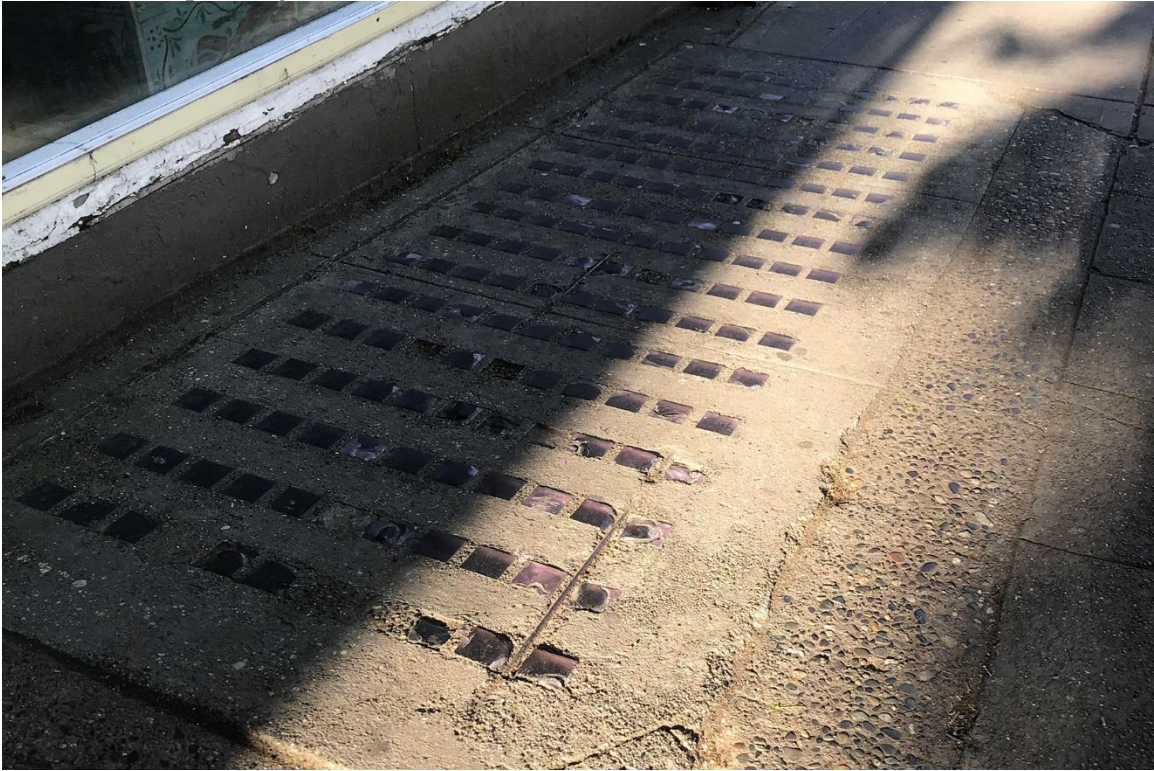
Figure 8) Sidewalk prism lights at areaway.

Concrete paved public sidewalks are located to the north and west of the subject building. The sidewalk on the north side of the building is approximately 10 feet wide. There is a section of glass areaway prisms along the north property line of the building that measures approximately ten feet by 4 feet. The condition of the areaway vault below is unknown. (Figure 8) There are two street trees located in tree wells at the north sidewalk. The easternmost street tree is a privately maintained Norway maple (*Acer platanoides*), and the westernmost street tree is an Armstrong Freeman (Red) maple (*Acer x Freemanii* ‘Armstrong’) maintained by the Seattle Department of Transportation (SDOT).⁴

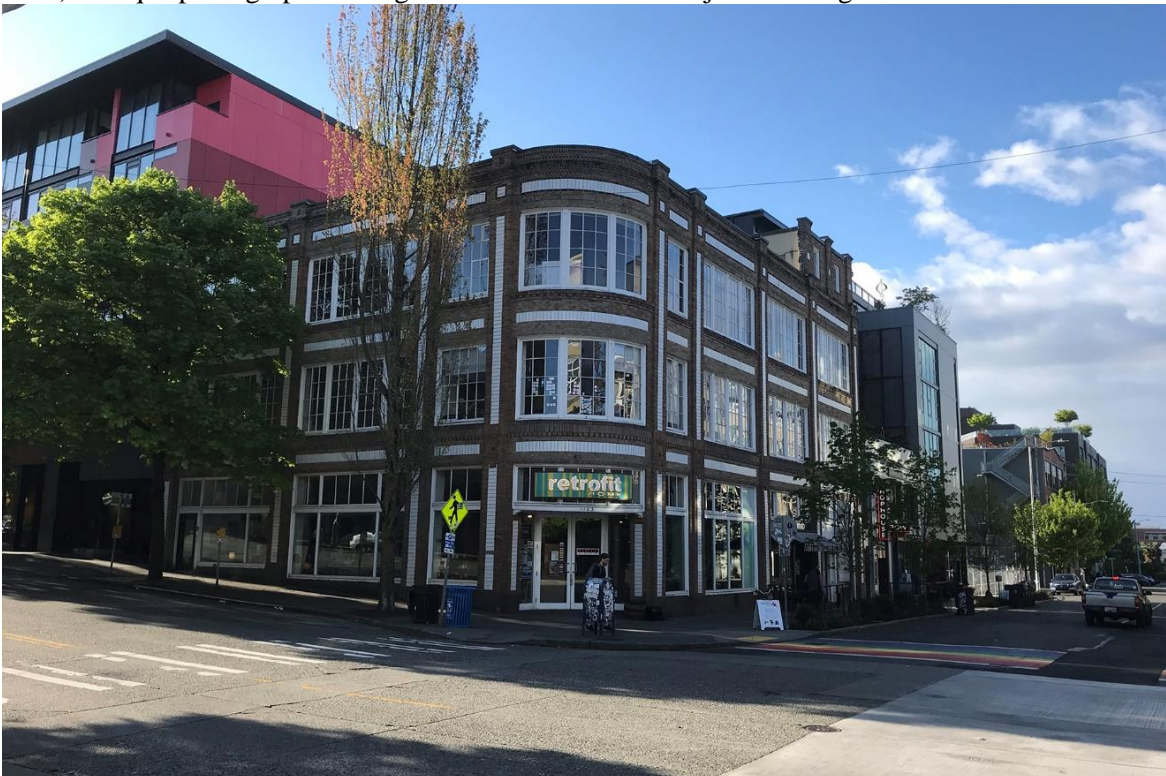
Figure 9) Oblique photograph looking southeast toward the subject building.

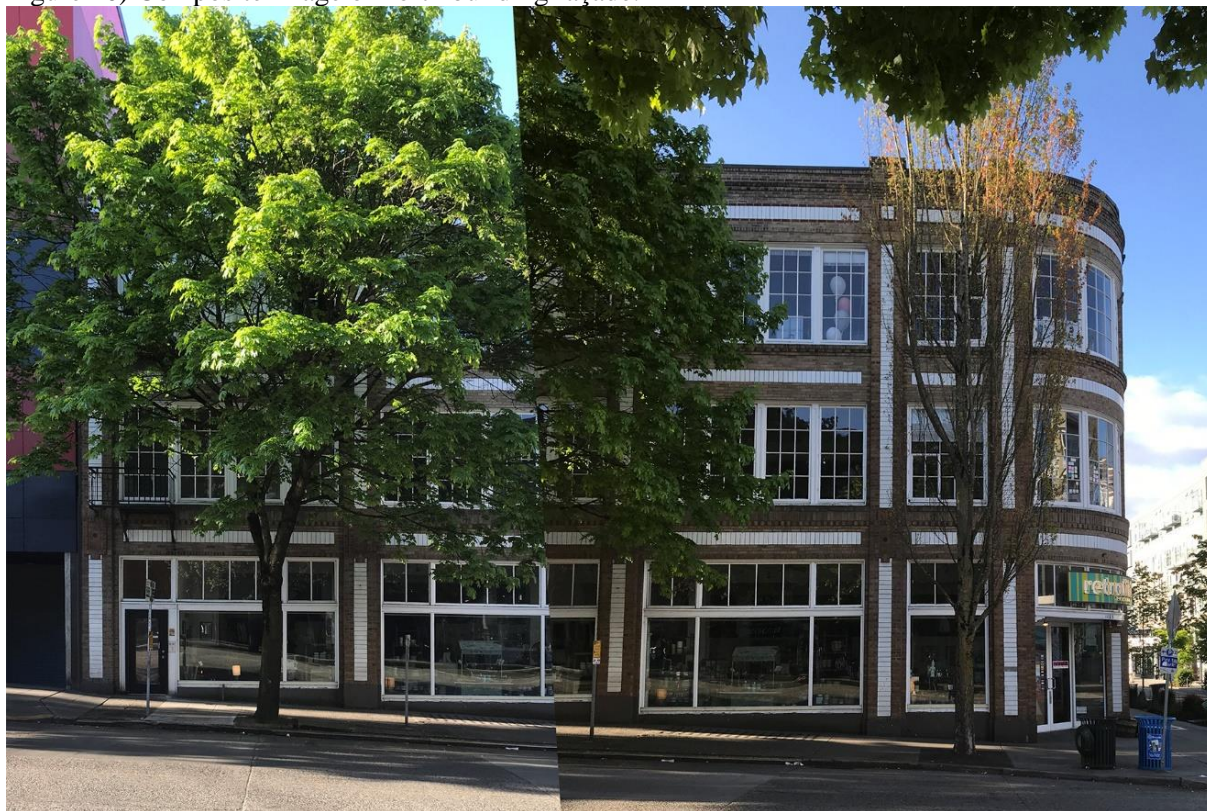
Figure 10) Composite image of north building façade.

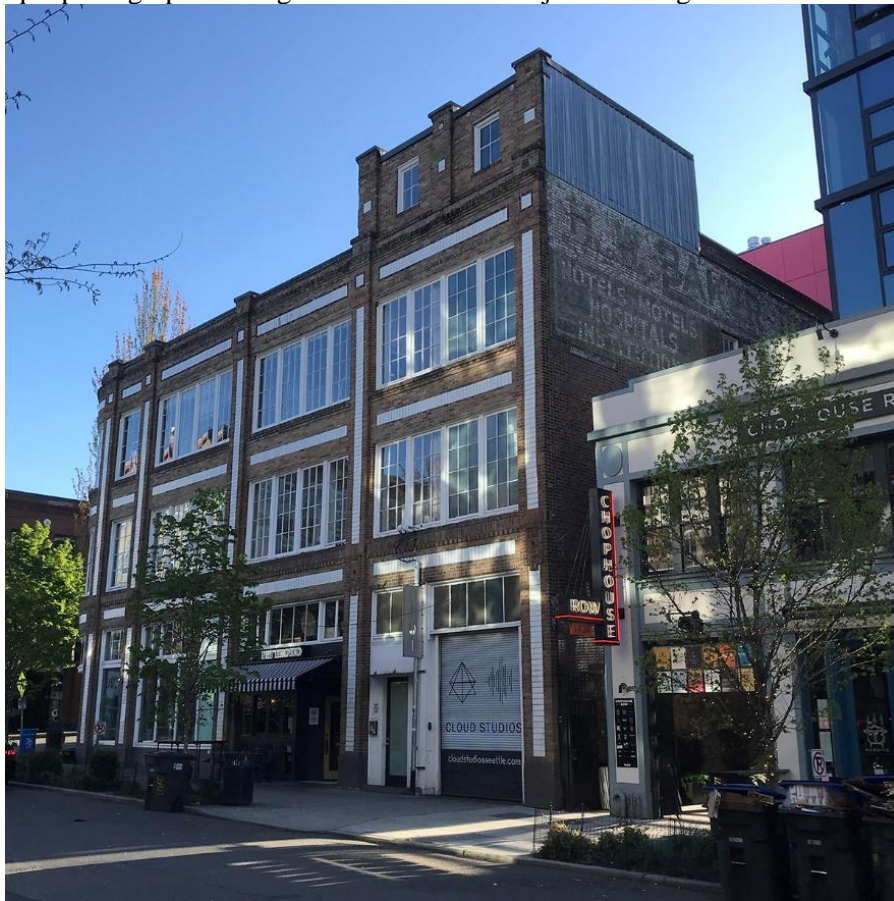
Figure 16) Oblique photograph looking northeast toward subject building.

Since the hoistway for the former car elevator is located at the southwest corner of the building, the westernmost bay of the south façade does not have any window or door openings. The brick masonry at the south wall of the penthouse at the roof level collapsed and fell off the building during the 2001 Nisqually earthquake. This area of missing masonry is currently covered with vertical seam galvanized metal siding. (Figure 16)

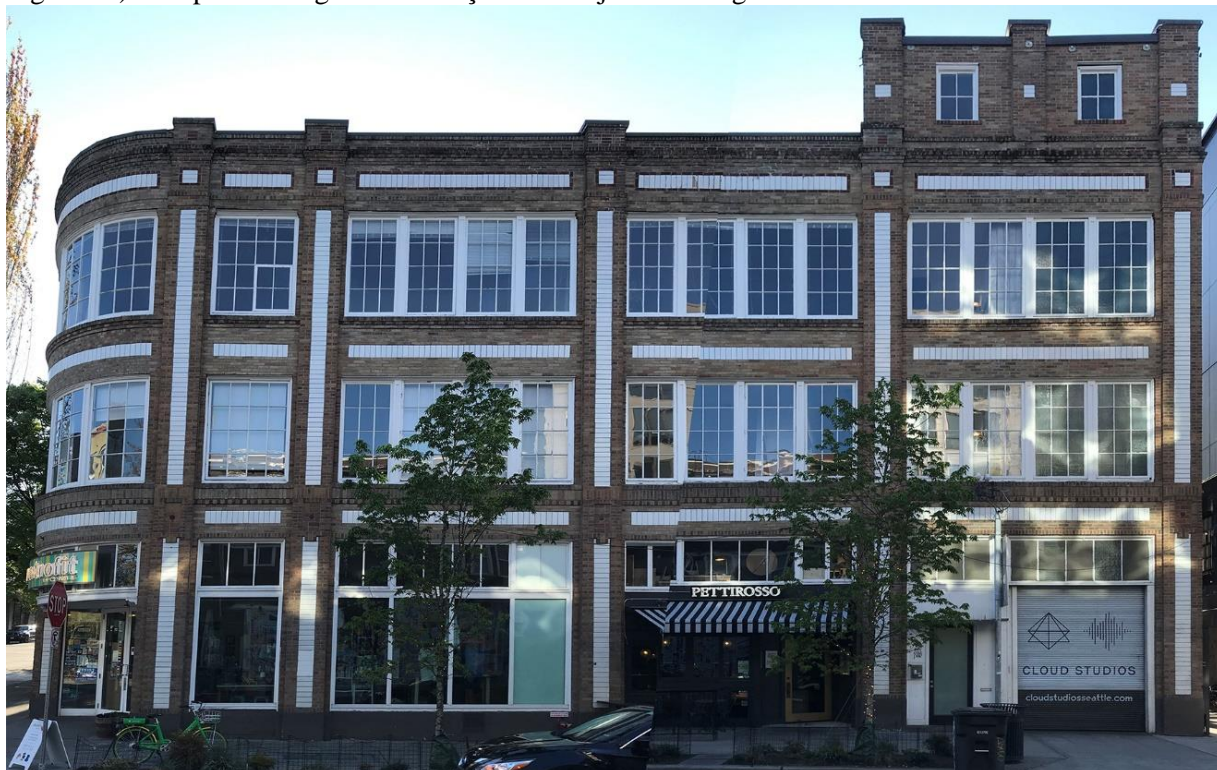
Figure 17) Composite image of west façade of subject building.

Like the primary corner entrance pavilion and north façade of the building, the west façade of the subject building is a primary façade and is clad with loadbearing rug face brick masonry laid in a regular, running-bond pattern, with additional brick details laid in header, rowlock, or soldier courses. (Figure 17) There are five brick masonry pilasters on the west façade, and each of these pilasters feature the rectangular white glazed ceramic tile noted above in the description of the north facade. The northernmost bay of the west façade measures approximately six feet between the pilasters, and the remaining three bays to the south each measure approximately sixteen feet between the pilasters. The bulkheads at the ground level storefront windows at the northernmost bay and the bay immediately to the south have been altered from their original condition, and are now painted stucco plaster. The storefront windows are plate glass with painted wood frames and transom windows above. The storefront in the next bay to the south has been altered from its original condition, but the painted wood transom windows are still located above the storefront. In the southernmost bay of the building, there is an entrance door with transom window above. Immediately to the south of this entrance door is a large painted metal roll-up door with a transom window above. This door was installed circa 2016 as a replacement for the previous roll-up door, which was also not original to the building. However, the transom window above the roll-up door is original to the building. This large opening in the façade allowed vehicles to access the car elevator located at the southwest interior corner of the building.

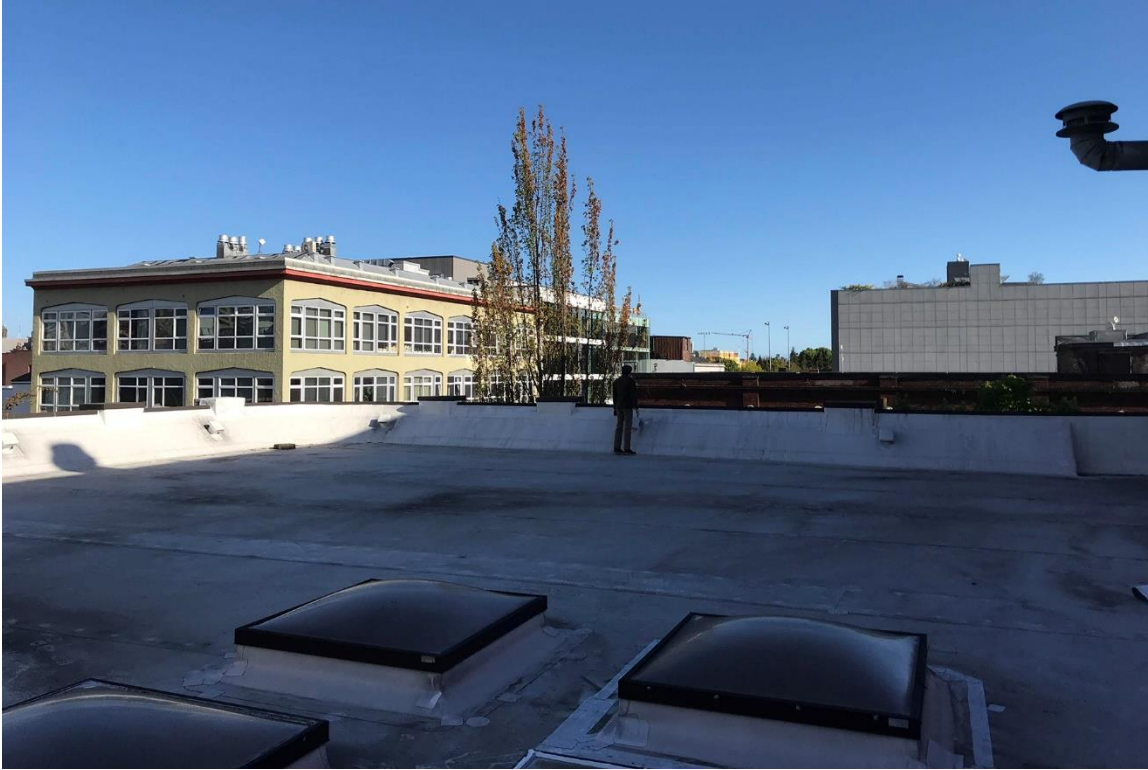
Figure 18) Photograph of roof of subject building looking northwest.

It appears that the roof was replaced in 2008 at the same time when the parapets on the north, west, and south sides of the building were seismically braced. The roof is generally flat and is sloped slightly to drains located at the northeast and southeast corners of the roof surface. The parapets extend above the roof surface by about four feet around the entire perimeter of the roof. The roof is clad with a modern plastic roofing material, such as a vinyl or thermoplastic polyolefin (TPO). (Figure 18) The parapets are capped with dark painted sheet metal flashing. There are four clear acrylic skylights mounted on curbs at roughly the center of the roof area. An air conditioning unit is mounted on wood skids at the east side of the roof next to the original brick masonry chimney. The brick masonry chimney has been wrapped in dark painted sheet metal

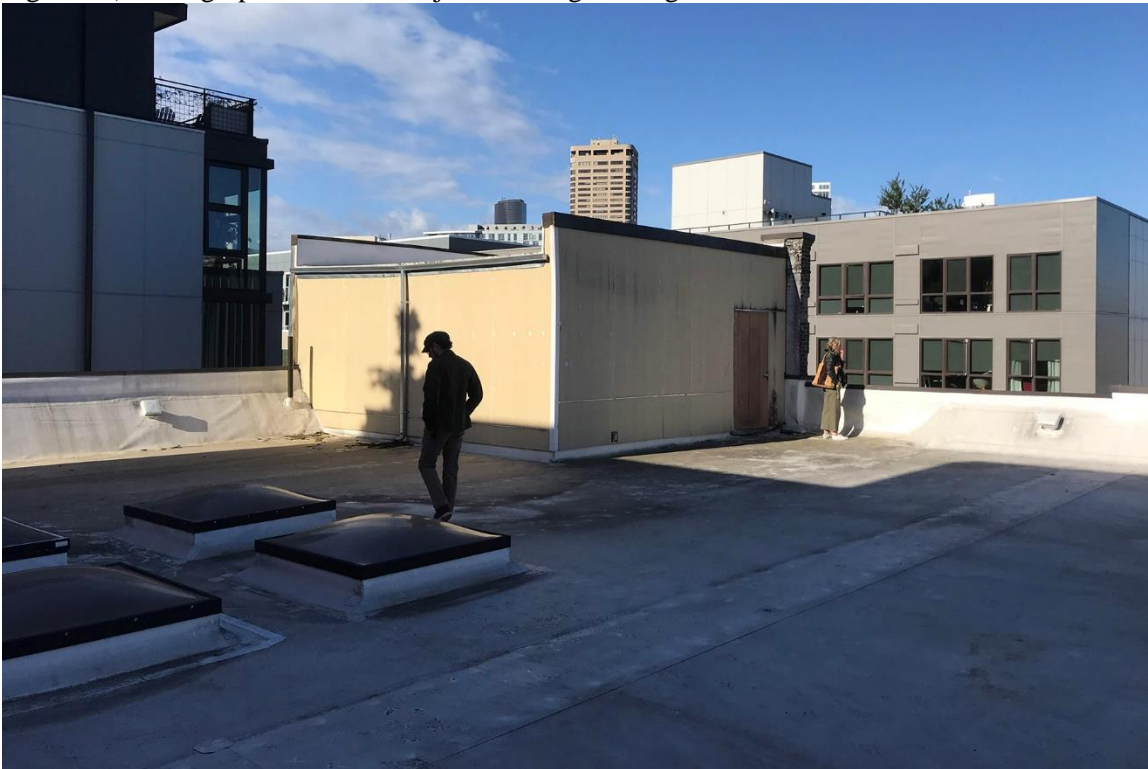
Figure 19) Photograph of roof of subject building looking southwest.

The brick masonry at the east and north walls of the rooftop penthouse appear to have been replaced with painted cement board siding. This work may have occurred after the 2001 Nisqually earthquake. The north, west, and south walls of the penthouse have short parapets that are about two feet high. The roof of the penthouse is clad in the same material as the rest of the main roof surface, and the parapets are capped with the same dark painted sheet metal flashings. A gutter and single downspout at the east wall of the penthouse drains water from the penthouse roof and discharges it onto the roof surface. (Figure 19)

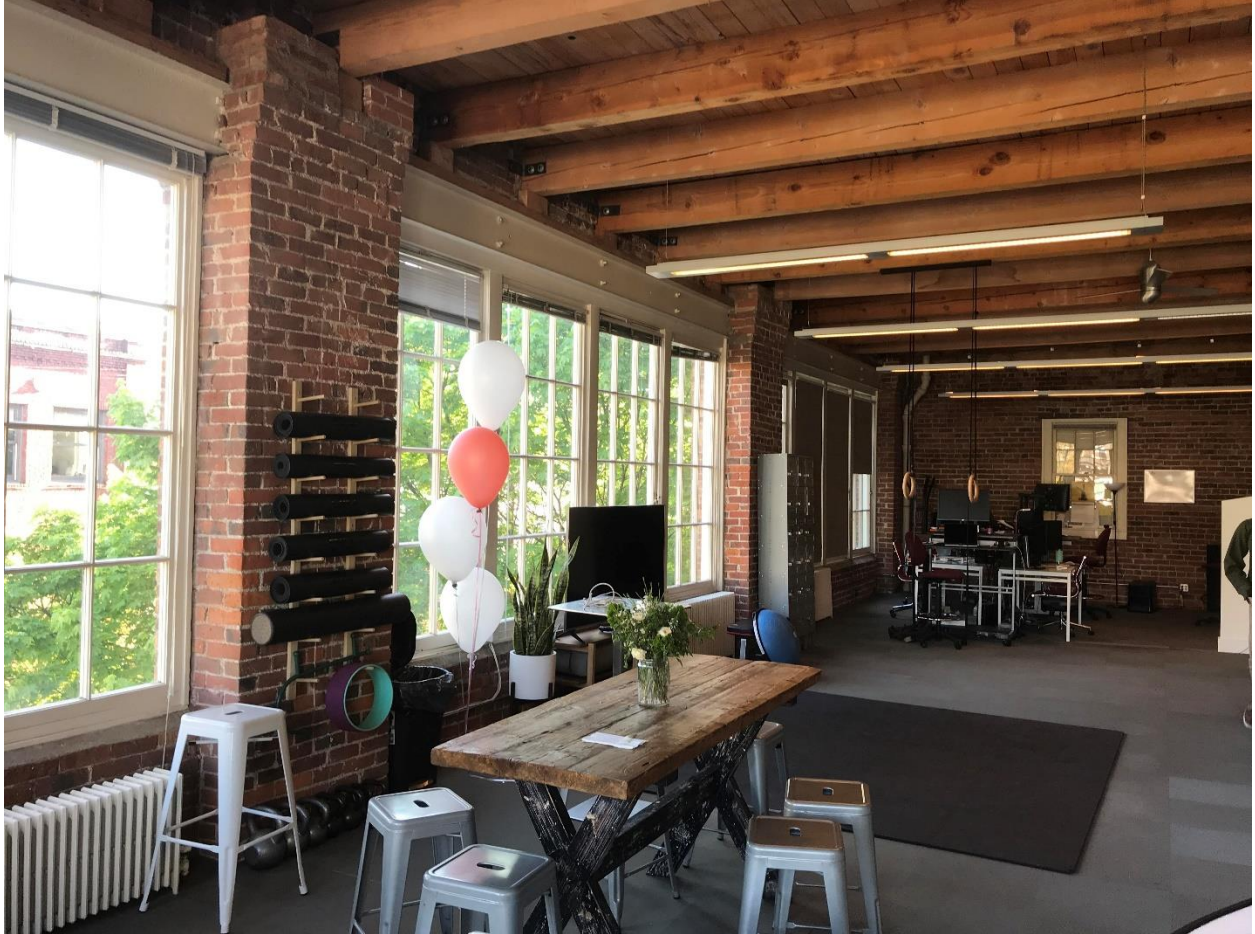
Figure 30) Photograph of exposed brick masonry exterior walls at north end of third floor level open office space.

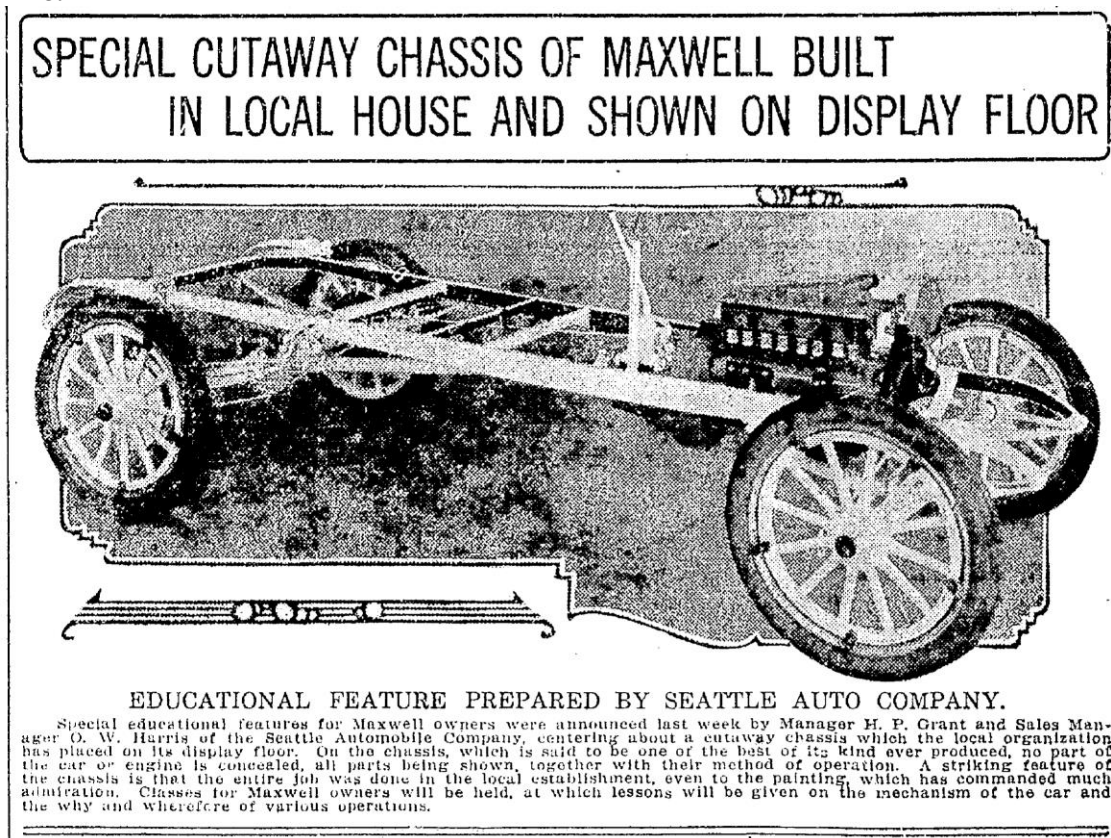
Figure 84) Seattle Automobile Company's cutaway Maxwell chassis, April 1, 1917. *Seattle Times* via Genealogybank.com.
