# PLAZAS FOR PEOPLE

Assessment of Privately Owned  
Public Spaces in Greater Downtown

NOVEMBER 2018

**Seattle Office of Planning and Community Development**

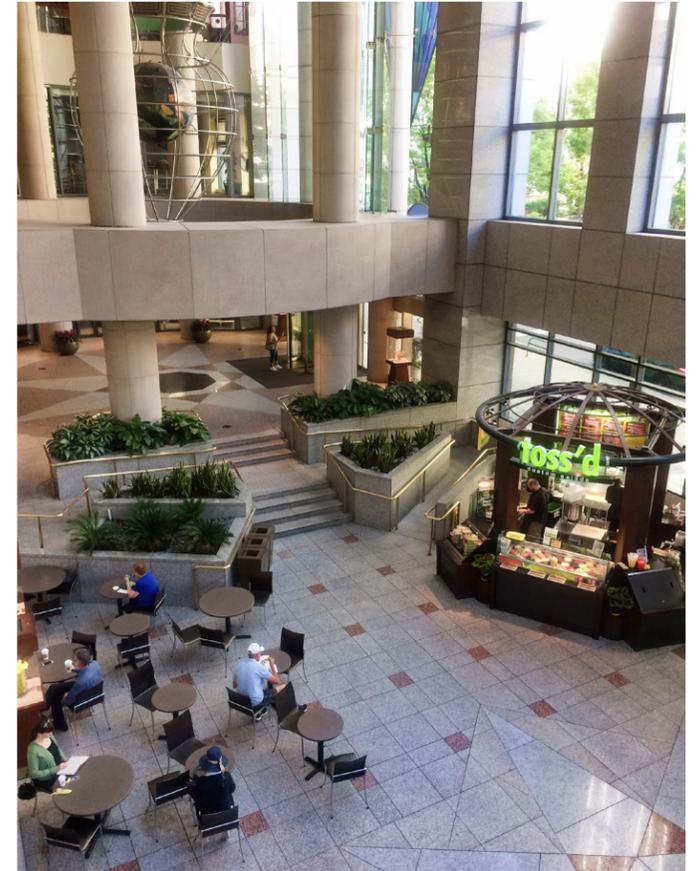
FIG 6: Indoor atrium of US Bank Centre, 1420 5th Avenue; Ref. #14

There are seven sites with an indoor component, either an arcade or an atrium (see TABLE 2). The US Bank Centre (FIG 6; Ref.# 14); Century Square (Ref.# 13); and 4th and Madison Building (Ref.# 27) are fully indoor spaces. Surprisingly, the seven sites are spread out in the rankings; a few are exemplary cases and others are average spaces. Expectedly, the visibility of these sites can be poor, and it can be unclear whether the space is public. This ultimately speaks to the biggest challenge for indoor public spaces: privatization.

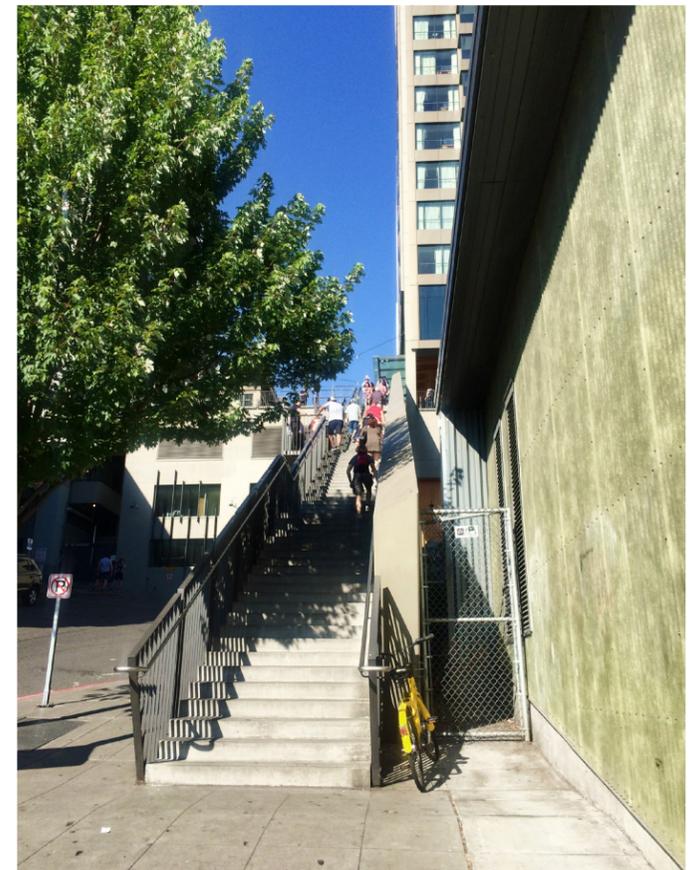
FIG 7: Hillclimb at Four Season Hotel, 99 Union Street; Ref. #19

The Four Seasons Hotel hosts the worst scoring POPS site. The hillclimb (FIG 7) fulfills its singular function of facilitating able-bodied pedestrian movement up a large elevation change. The landings along that long stair do not afford usable public space and the mini street end plaza at the top of the stair provides minimal amenities. The site contributes little public amenity beyond the 103 step stair function.

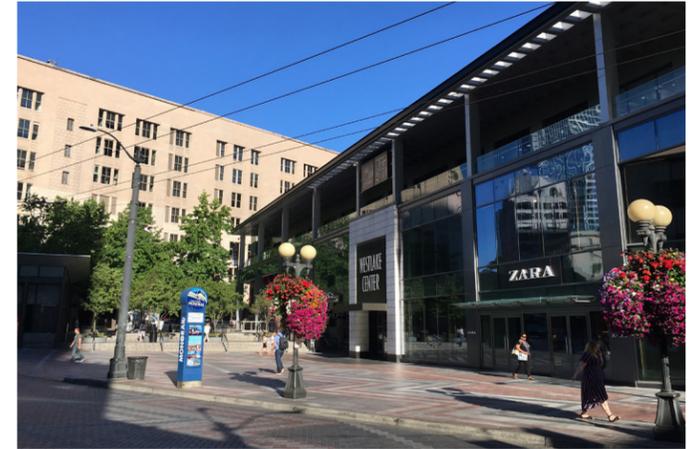
FIG 14: South facing plaza at Westlake Center Retail Mall

While the private plazas shown below were not a part of this assessment, they are examples of many privately owned public spaces in Seattle that could be improved through the recommendations found in this report.

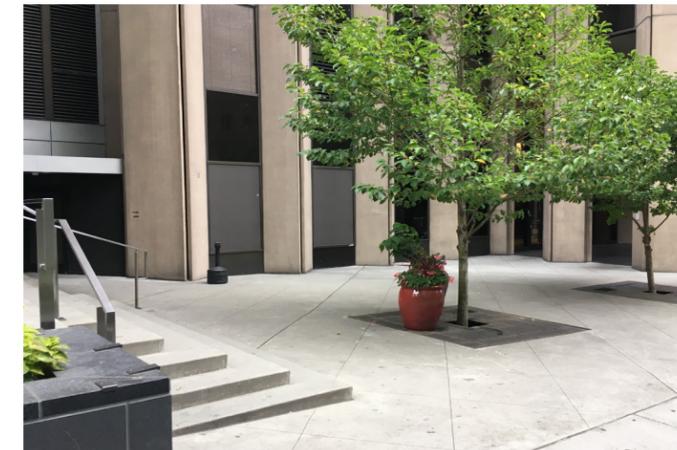
FIG 15: Sizable, non-amenable setback at 920 4th Avenue

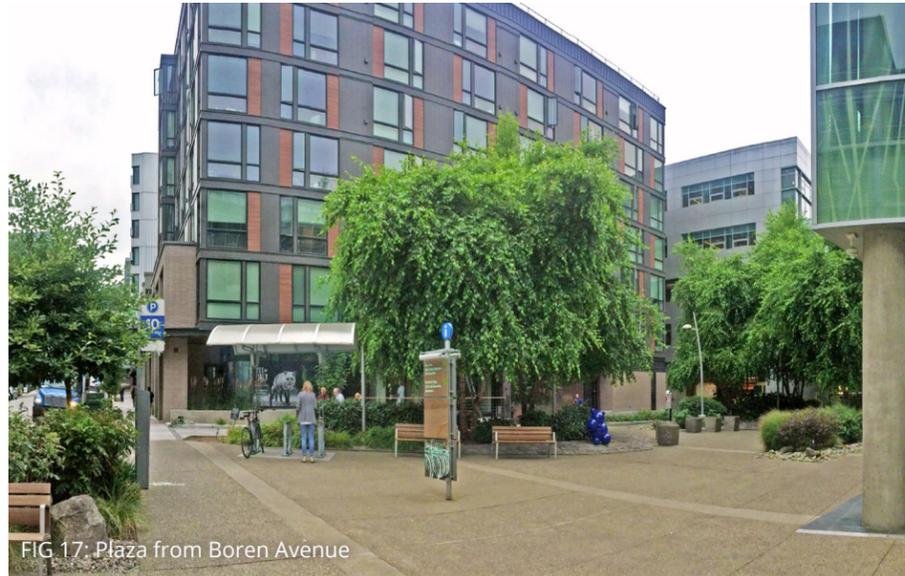
FIG 17: Plaza from Boren Avenue

The site is highly visible and accessible. There are no physical barriers impeding access to the site. On both Terry Avenue North and Boren Avenue, the sidewalk is flush with plaza (FIG 17, 18).

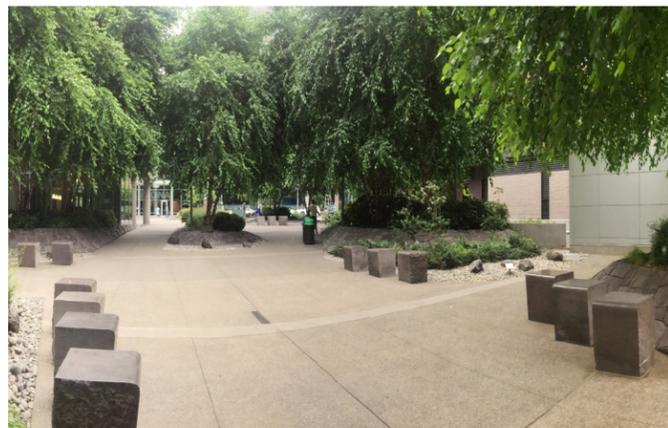
FIG 19: Seating and tree canopy

The plaza is easily seen from adjacent sidewalks and streets and visibility through the plaza is clear. In the space, navigation is easy. Users can walk from end to end to see the site amenities (FIG 20). During the summer, the tree canopy offers shade and shelter from the weather; the tree canopy also enhances the landscape to create a pleasant atmosphere. Fixed seating is found throughout the space (FIG 19).

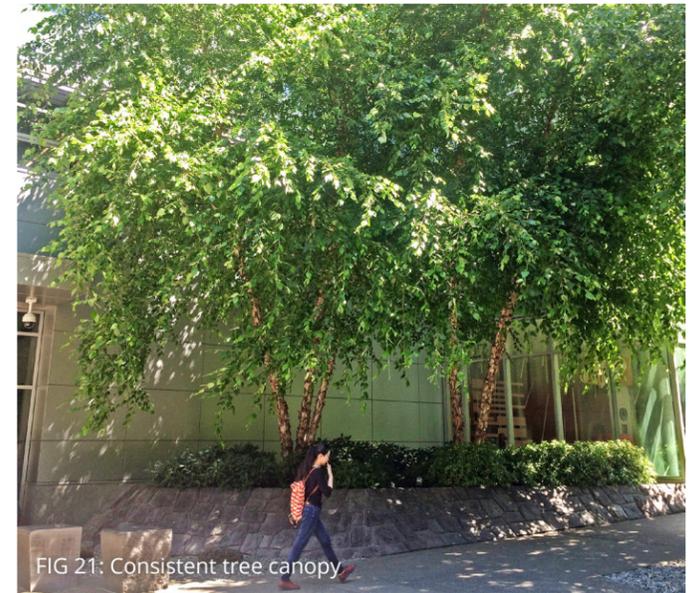
FIG 21: Consistent tree canopy

The site relies primarily on the tree canopy to provide weather protection (FIG 21). During the summertime, this works in the sites favor; however, protection during the wintertime is less because most of the trees will be leafless.

- Diversify landscaping
- Formalize smoking area
- Add movable seating

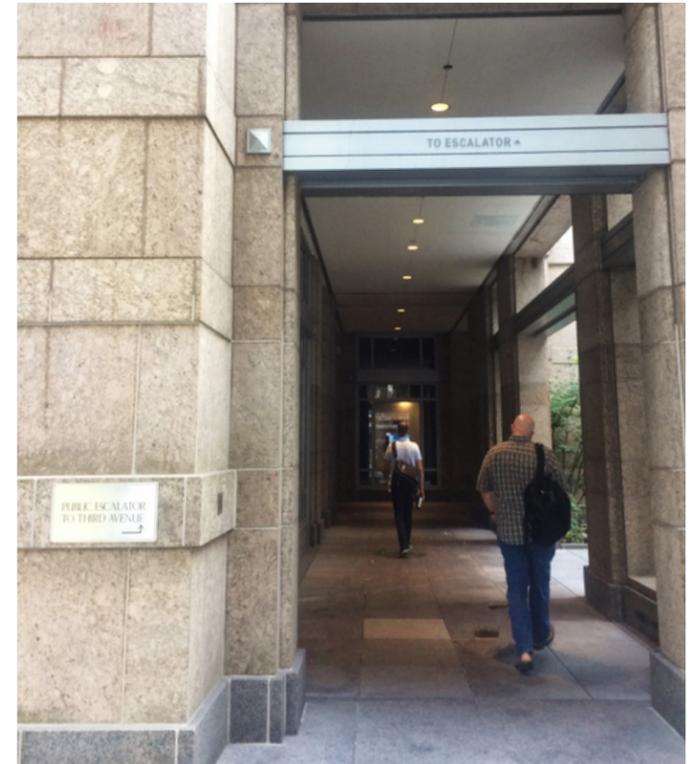
FIG 26: Signage for the hillclimb and ADA access to plaza

The site uses the official POPS sign issued through the City as well as signage specific to the building (FIG 26). However, there is no signage identifying the location of the rooftop garden, which cannot be seen from the plaza, despite the stair access in the space. Moreover, wheelchair users or parents using strollers cannot access the rooftop garden from the plaza space; instead they must travel to Seneca Street and locate the unmarked entry point at mid block.

While there are only one to three risers, the single steps along 2nd Avenue prevent physical access for wheelchairs, strollers, etc. The ADA access location is not easy to find or well signed.

- Increase signage informing public of the rooftop garden
- Enlarge legibility of signage for hillclimb assist escalator (FIG 26)
- Add ADA access signage at the steps along 2nd Avenue
- Retrofit the steps along 2nd Avenue into ramps, if possible

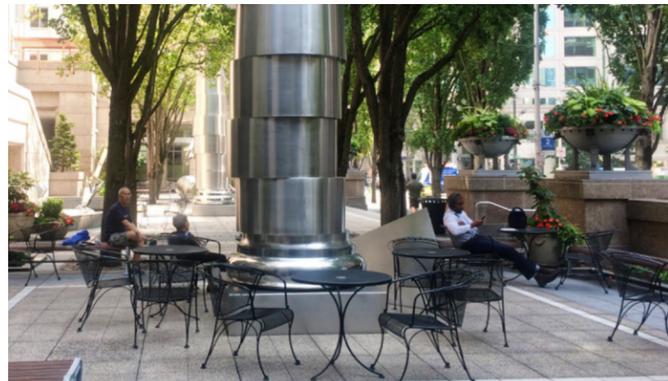
FIG 24: Moveable and fixed seating in the plaza

The plaza and rooftop garden provide ample outdoor seating. Large public art sculptures also add character to the space (FIG 25).

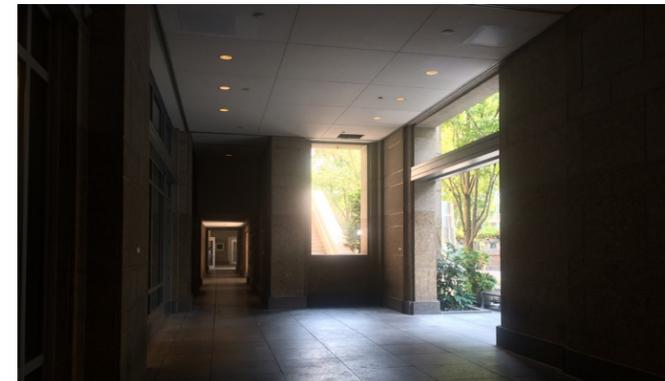
FIG 27: Weak lighting under arcade

The areas under the arcade are well lit at night; however, during the day, the lights are not as bright, making portions of the space darker than expected (FIG 27, FIG 28).

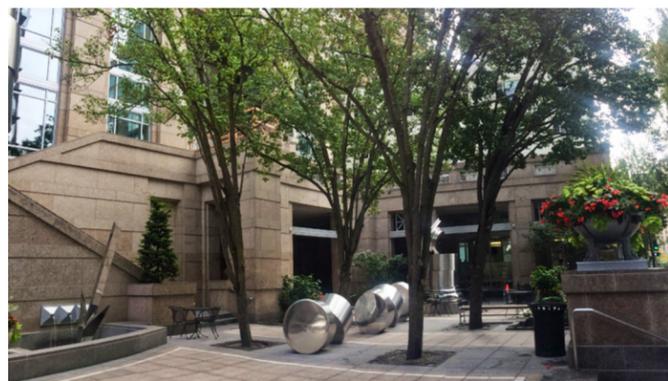
FIG 25: Tree canopy and arcade on site; stair access to rooftop garden

The plaza and rooftop garden include a variety of vegetation; however, only the tree canopy in the plaza provides shade. The public art and vegetation work together to create a pleasant environment for people to sit and interact. All materials are durable and high quality and the spaces are well maintained.

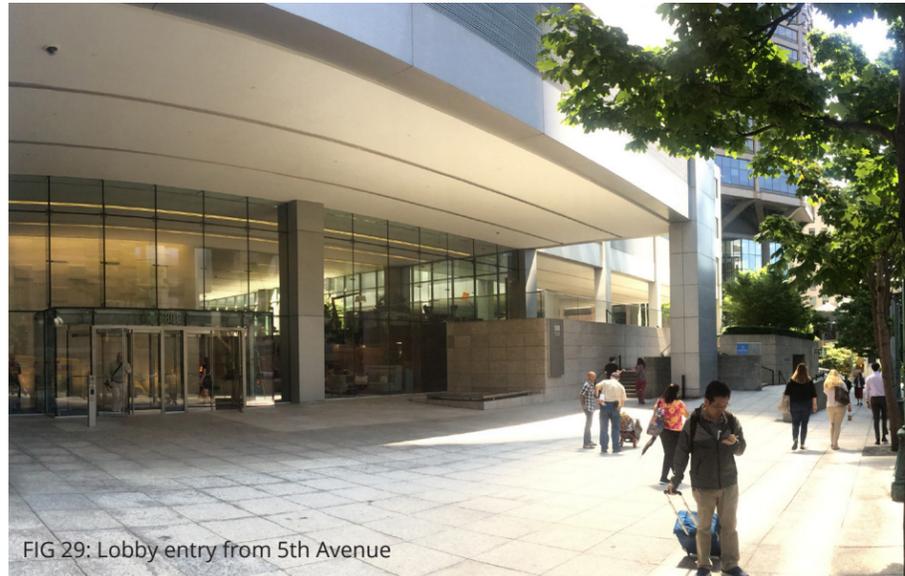
FIG 29: Lobby entry from 5th Avenue

**DESCRIPTION:**  
From the sidewalk on 5th Avenue there is a covered entry plaza to the building's main lobby. Adjacent to the entryway is an elevated and setback courtyard (FIG 30).

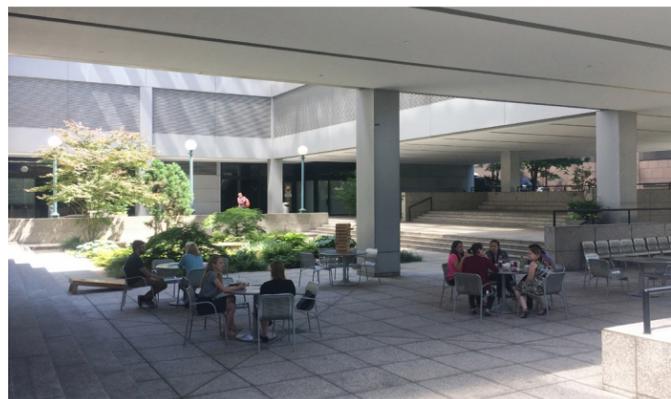
FIG 30: Seating in the elevated courtyard

The elevated courtyard has covered portions along its perimeter and plenty of seating options, both fixed and movable. There are opportunities to sit under shade and shelter as well as in the open where there is no weather protection. Additionally, the courtyard incorporates vegetation with a mini garden at the center (FIG 31). The courtyard is set back and elevated from the streets, which reduces traffic noise and other disturbances.

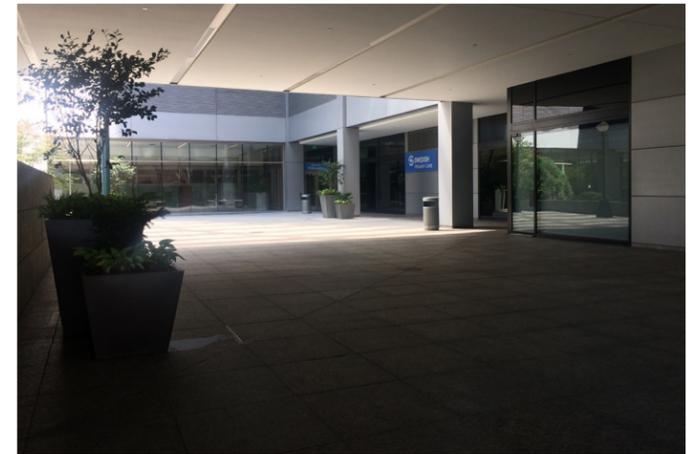
FIG 32: Empty space at southeast corner of elevated courtyard; non-activated storefronts

The entry plaza space on 5th Avenue lacks amenities; there is only one seating opportunity and there is no vegetation or art. There are no attempts to activate the space (FIG 33). Since there are few amenities, the vastness of the building entry creates a sterile and unwelcoming atmosphere. Additionally, this section of the site is not well lit at night and depends on the building's lobby to provide lighting.

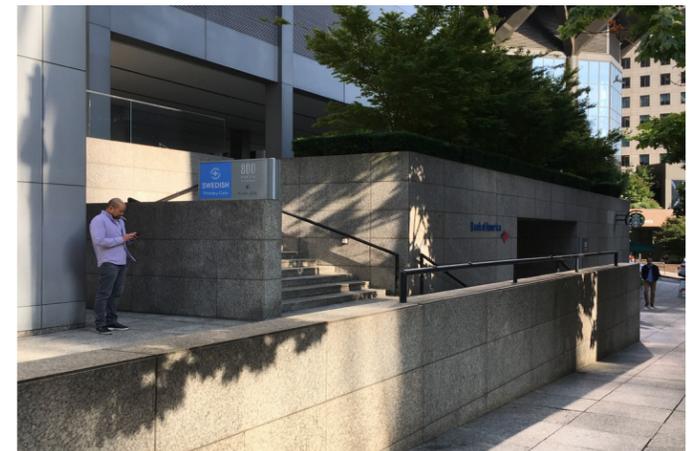
FIG 34: Barriers to access along 5th Avenue

While the elevated courtyard has better amenities, the space is not clearly visible to pedestrians and physical access is not intuitive (FIG 34), the site does not feel completely open to the public. Overall, the space feels privatized.

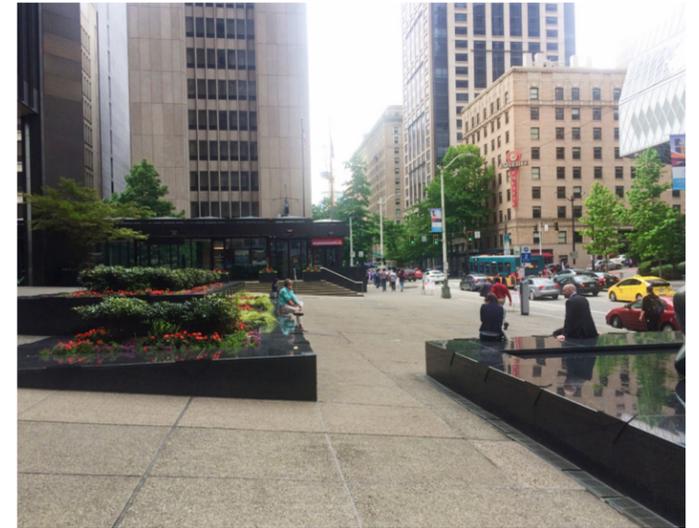
FIG 39: Incidental seating opportunities

The plaza space offers few amenities. While people sit around the large planter and public art base, the walls are not designed for comfortable seating (FIG 39). There are no benches or moveable chairs in this space. There is little protective cover; the building offers canopies only at the short edges of the space (FIG 39).

- Provide movable seating opportunities
- Increase activation beyond the edges; carts, kiosks, etc.
- Diversify landscaping; consider a tree canopy
- Increase the shade and shelter coverage to include the center
- Improve lighting

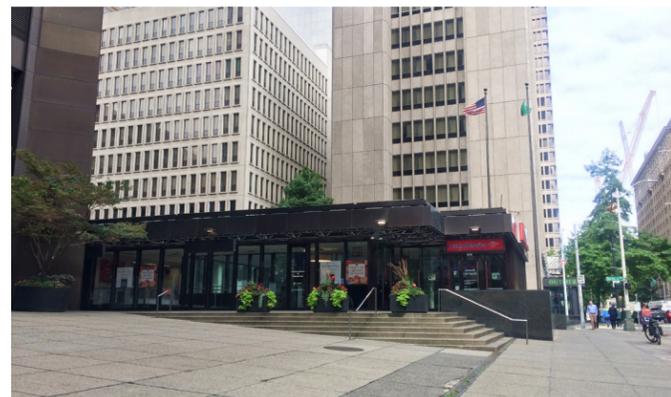
FIG 37: Activation at the short edge by bank

Activation is concentrated at the short edges of the space and not at the center of the site. Additionally, during a site visit, casual observations noted security asserting control of the space when a group of young people entered the plaza.

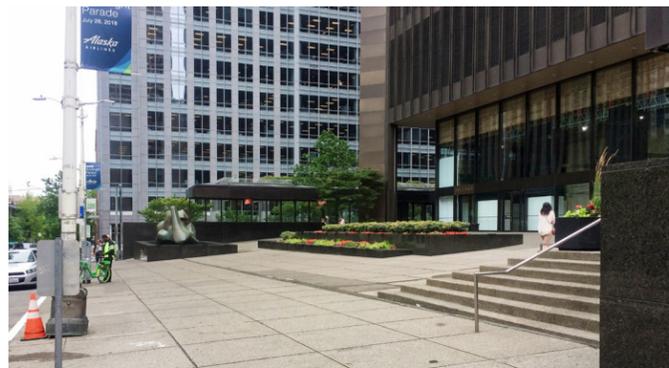
FIG 38: Sidewalk and plaza connection

The plaza is clearly visible from the sidewalk and the adjacent street. The plaza is mostly flush with the sidewalk, making access to the space easy; moreover, the site has smooth paving, which makes navigation easy (FIG 38).

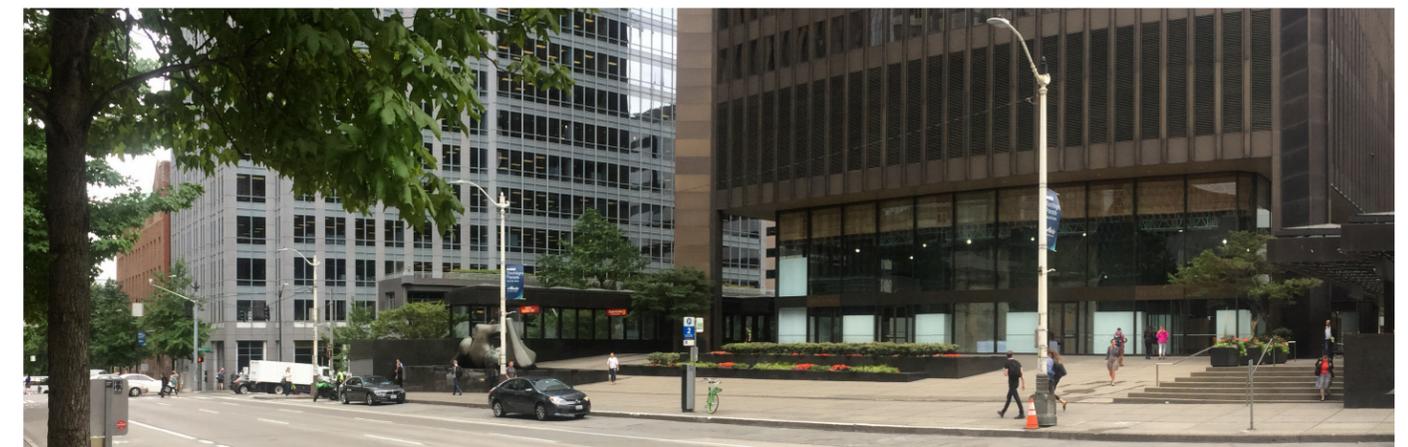
FIG 40: Full extent of the plaza, framed by short edges to left and right

With little activation in the center of the site, this plaza is essentially a giant forecourt to the building's lobby (FIG 40). Users are not invited to occupy the space; it is a space to quickly move through.
