Lowman Beach Feasibility Study

Public Meeting 05.31.2017

The following information was presented at a public meeting held on May 31, 2017, 6:30 PM at The Hall at Fautleroy. Information represents work-in-progress and does not indicate final findings or conclusions of the feasibility study.

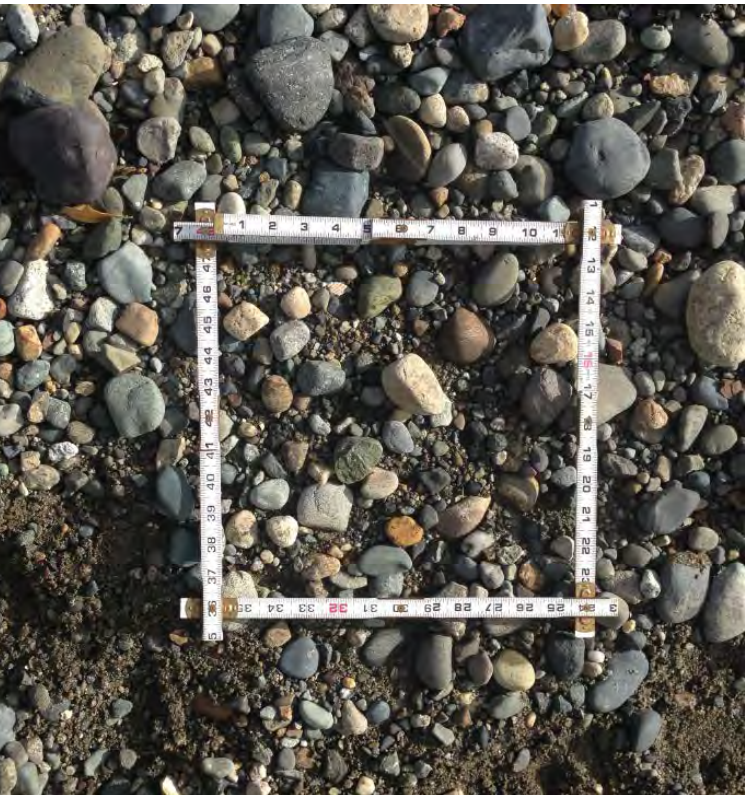
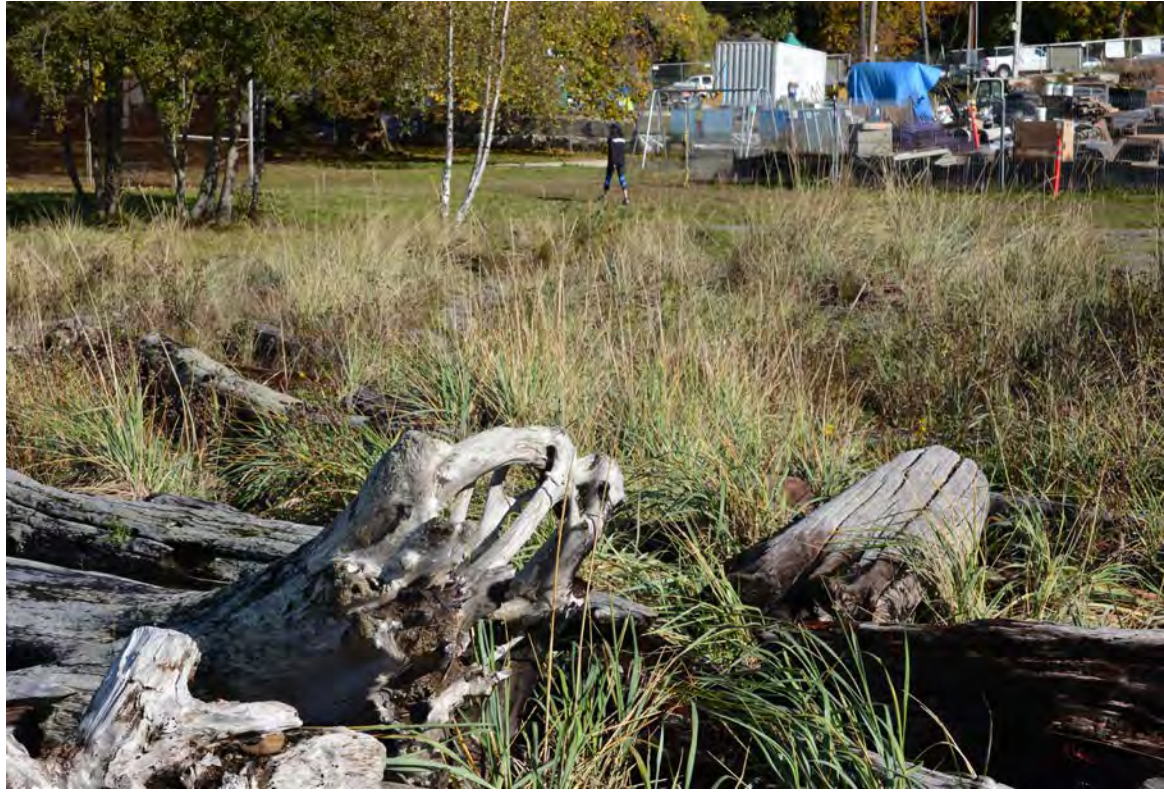
- No wetlands observed onsite from site recon.
- No surveyed forage fish spawning at this site
- Sediments are generally too large to support sand lance.
- Some lenses of sandy gravel may support surf smelt
- Shorebirds and waterfowl use the site (Killdeer, heron, ducks, etc.)
- Removal would require work above and below OHWM, and MHW, thus involving US Army Corps and WDFW

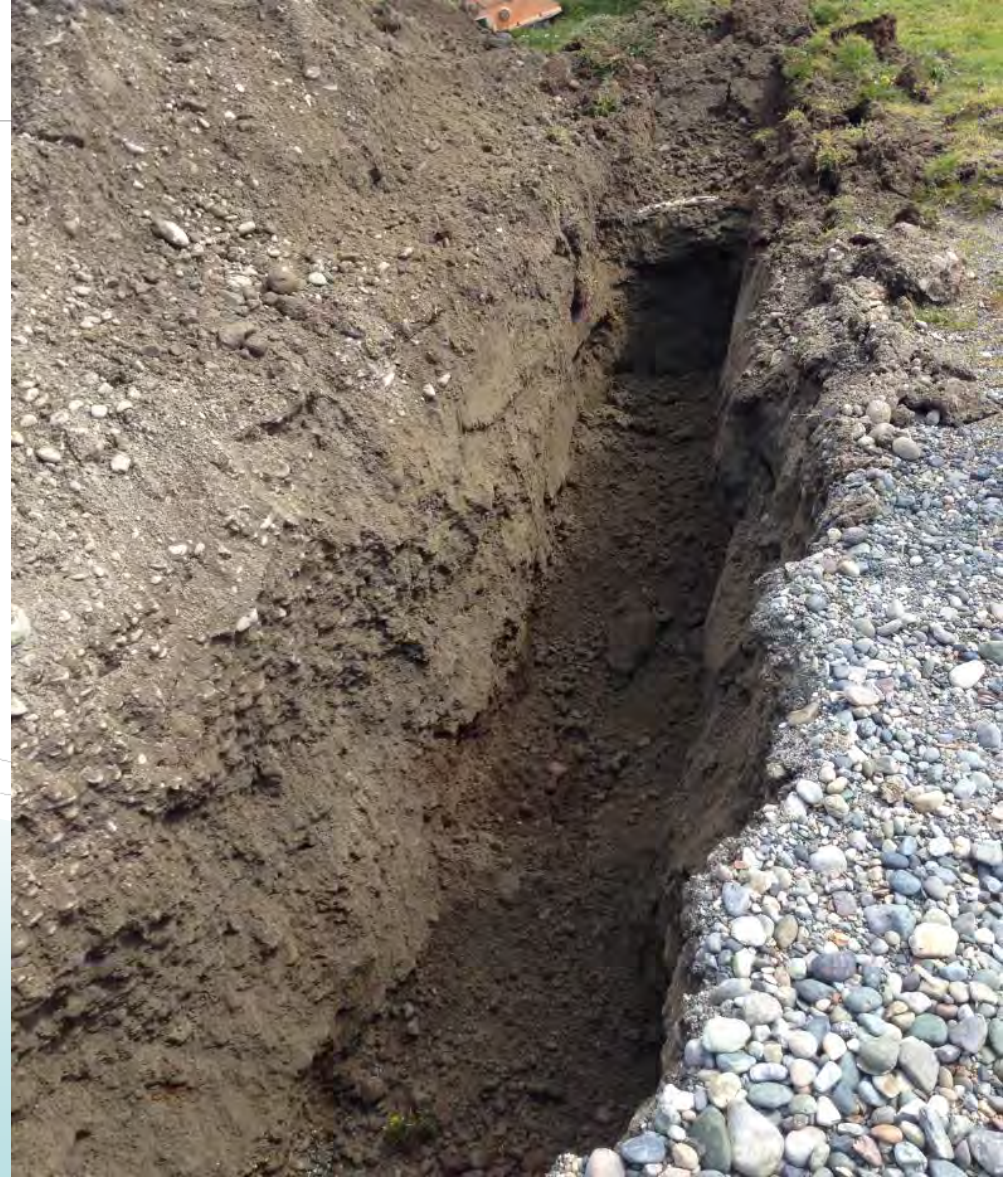
- Test pits performed 5/3/2017
- Encountered some rubble (mostly rock & sidewalk pieces)
- Observed 2 to 5 ft of fill over outwash and silty clay.
- Abundance sand and gravel beneath the surface, with some stiffer clay materials near the bottom of the wall elevation (+4) at Trench A & B.
- Materials behind wall can be eroded by waves/tide
- Potential to reuse some excavated materials for restored beach

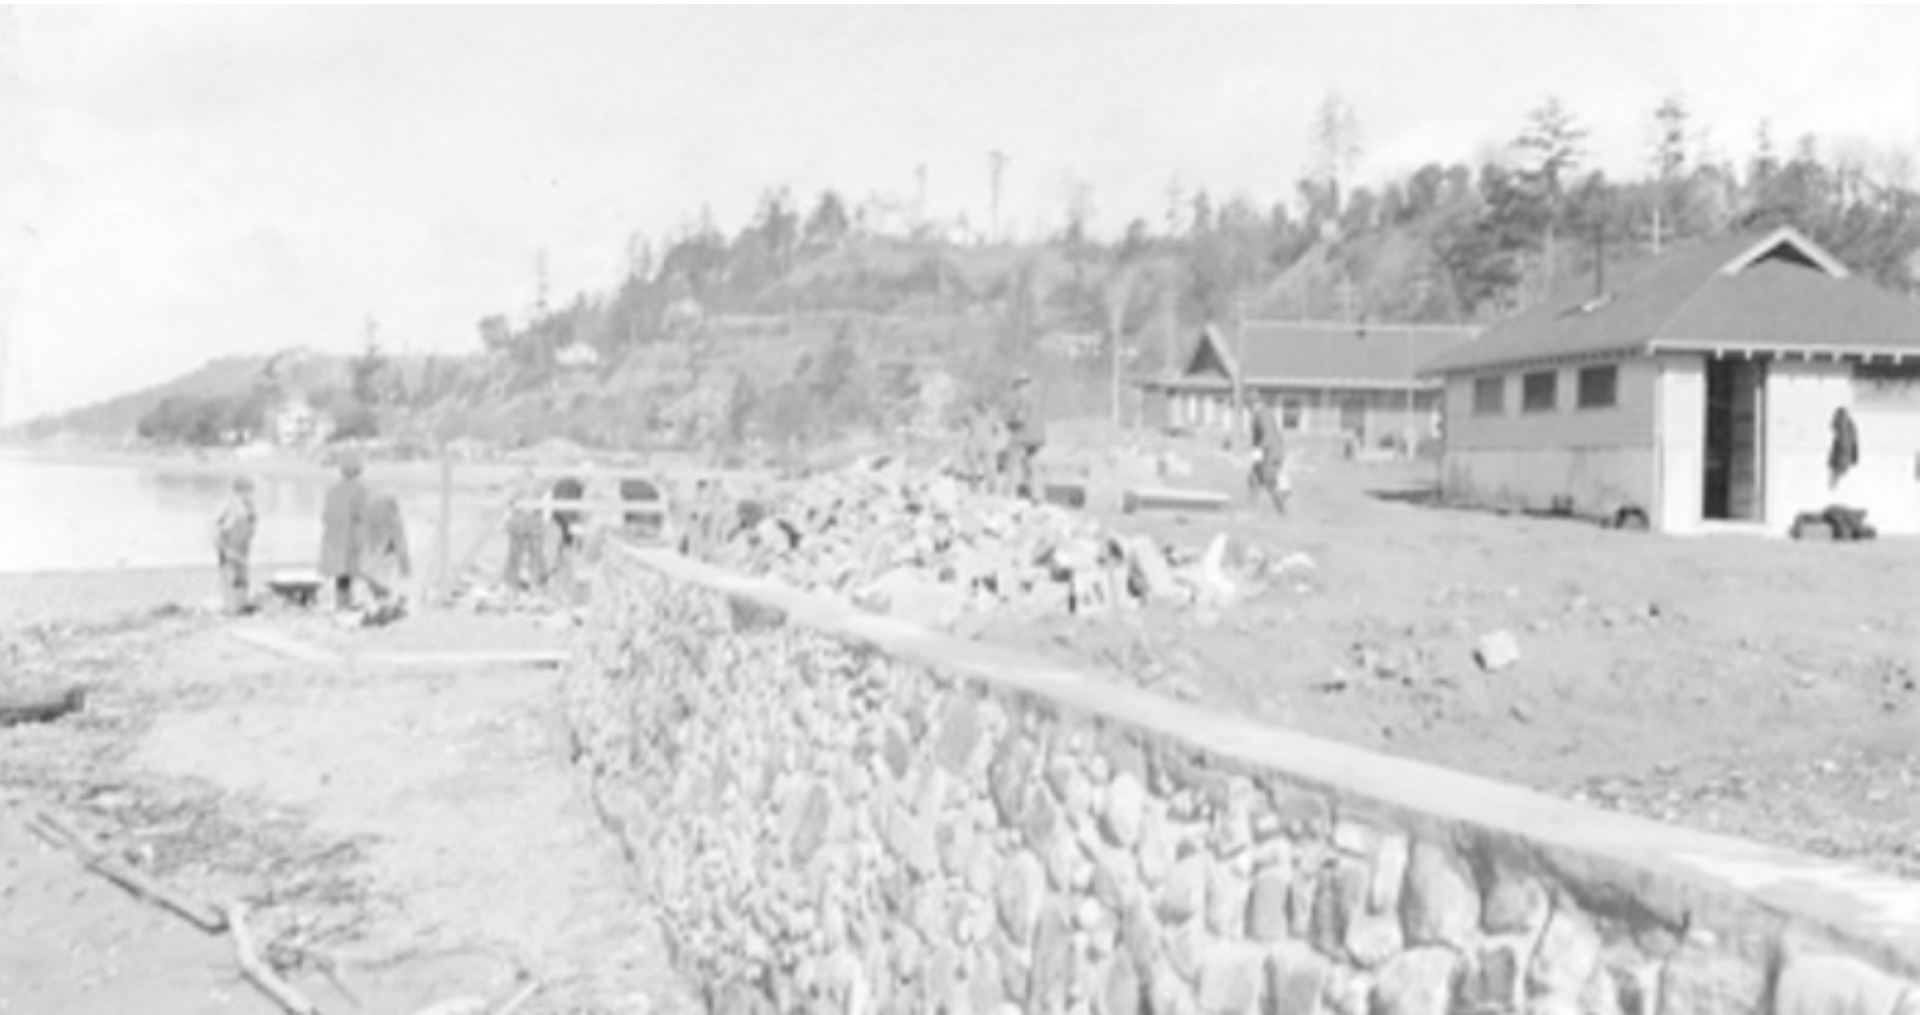
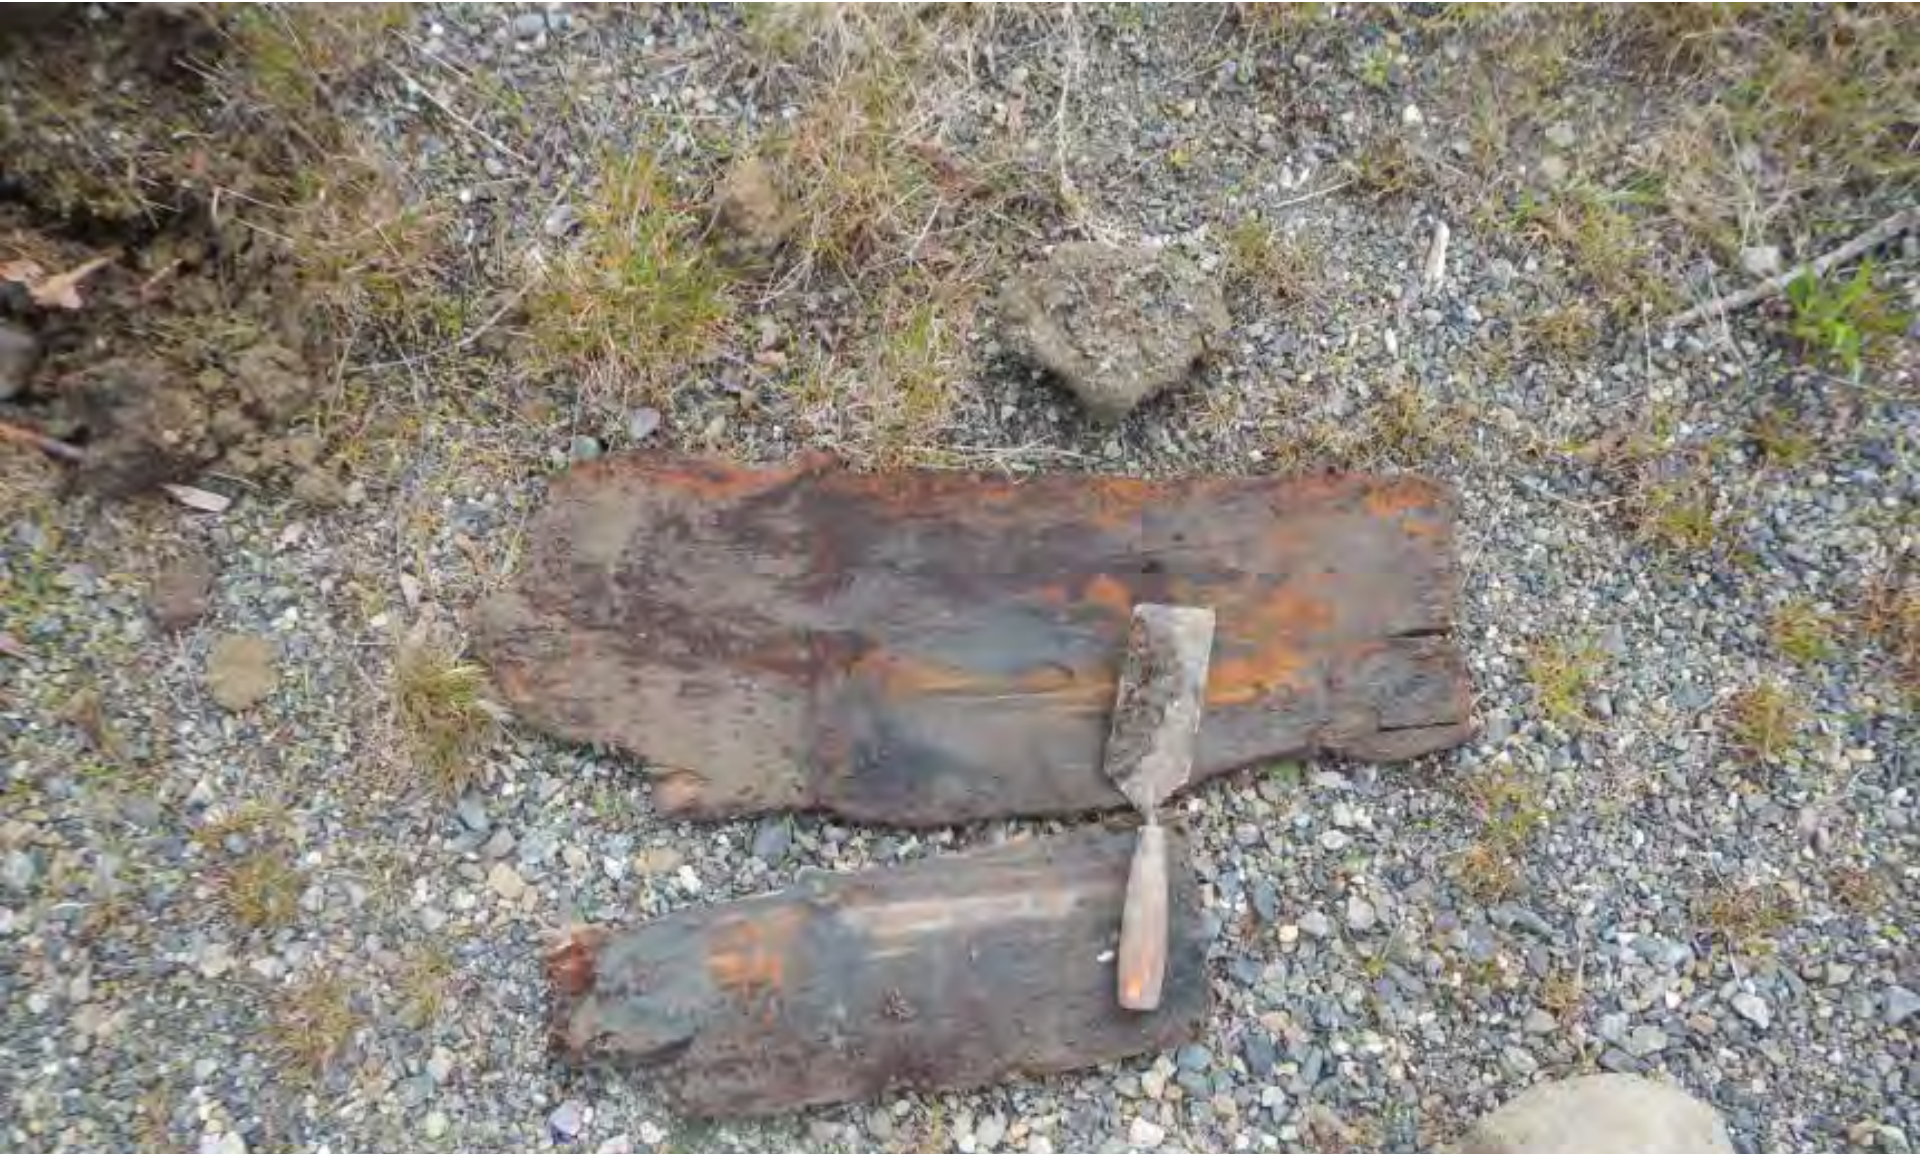
- Tennis court constructed by WPA in 1930's along with seawall
- Original seawall replaced in the 1950s
- No pre-contact artifacts were encountered during excavations and there were essentially no interesting cultural materials within the trenches
- Coordination with tribes and US Army Corps reporting still needed for permitting but additional field investigation not anticipated
- Unlikely that cultural or historical resources will dictate design alternatives or constructability.

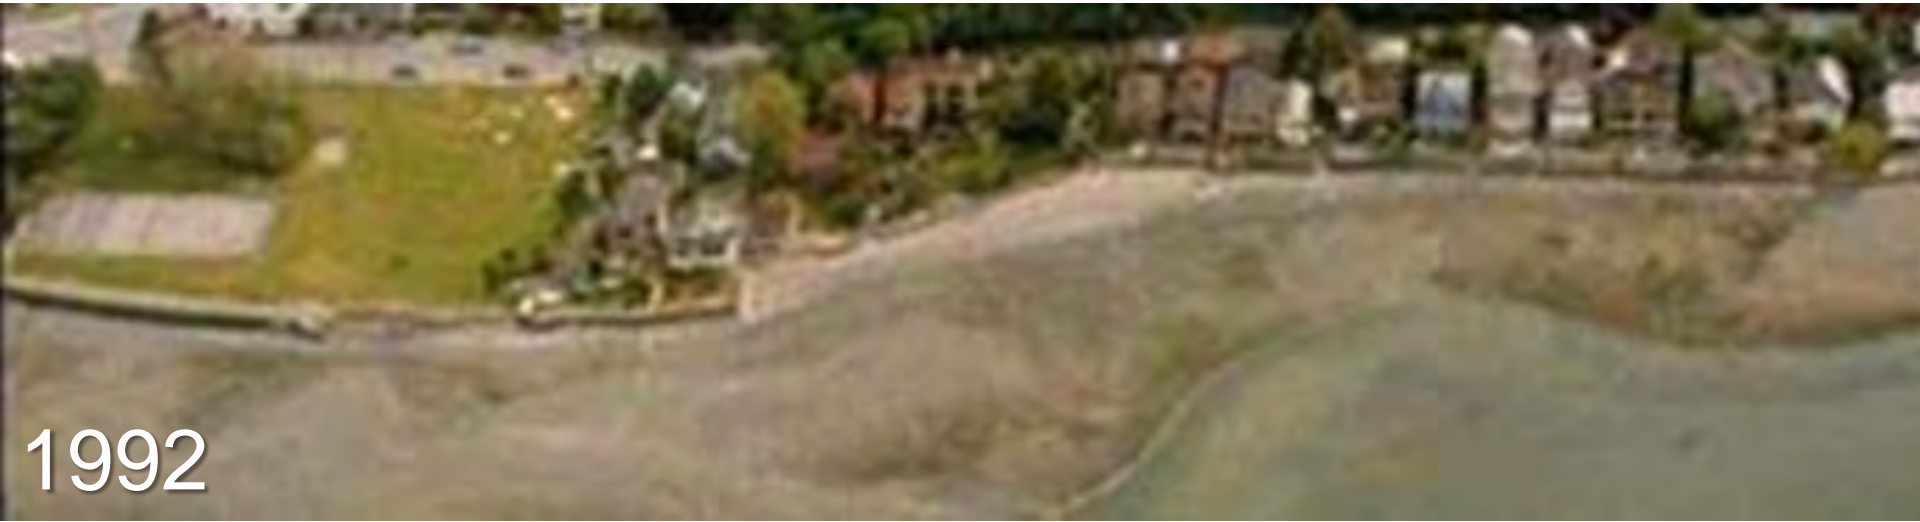
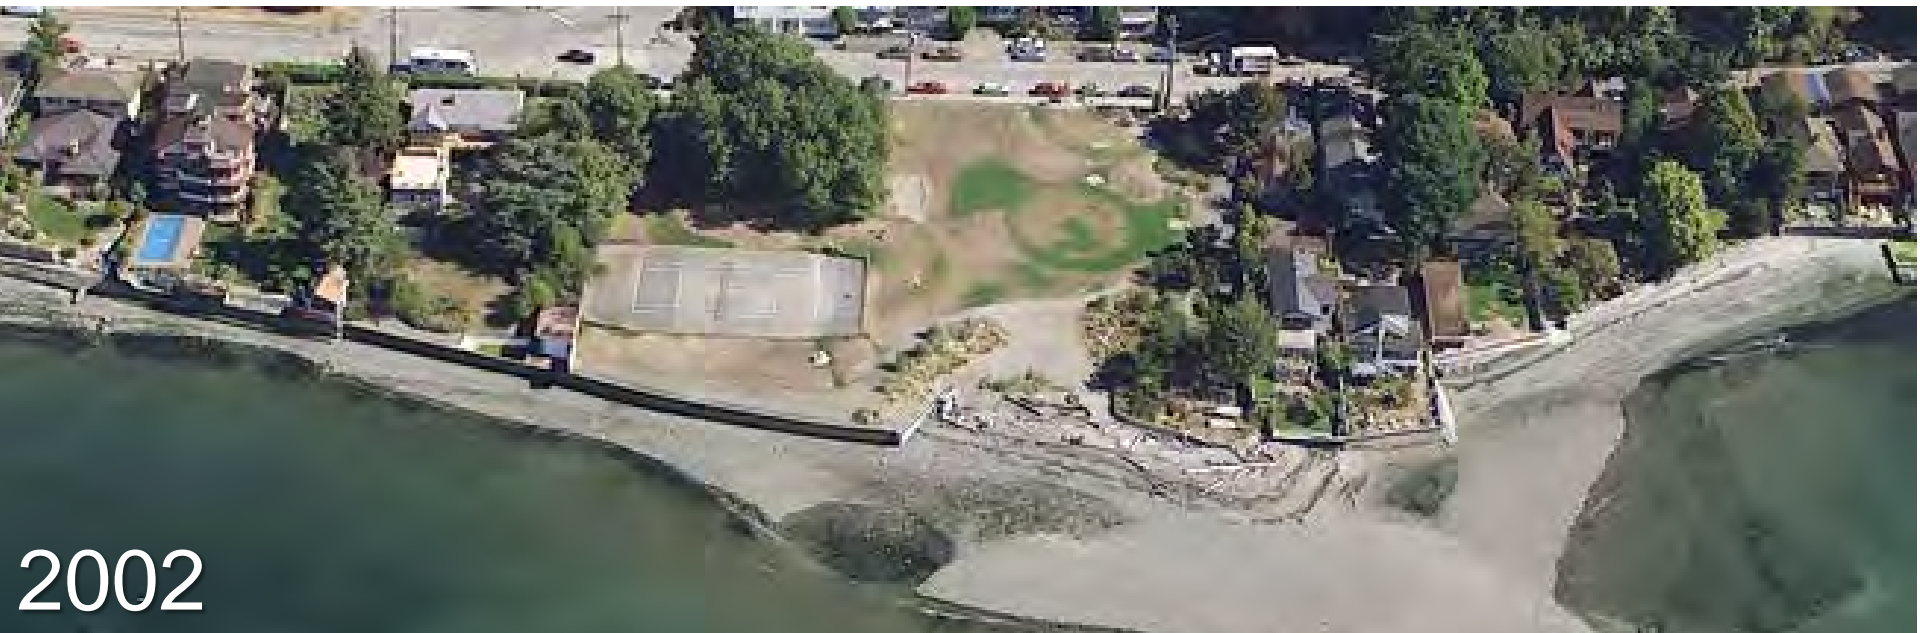
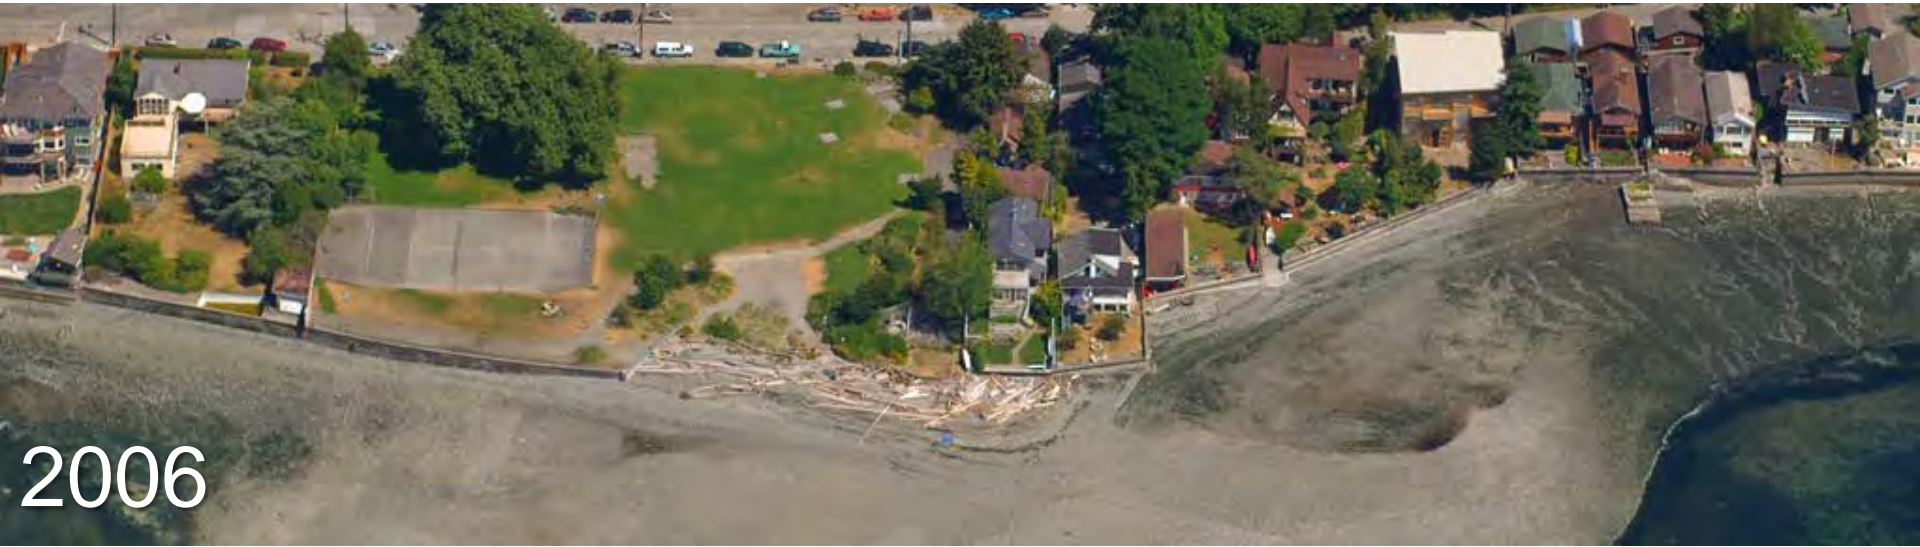
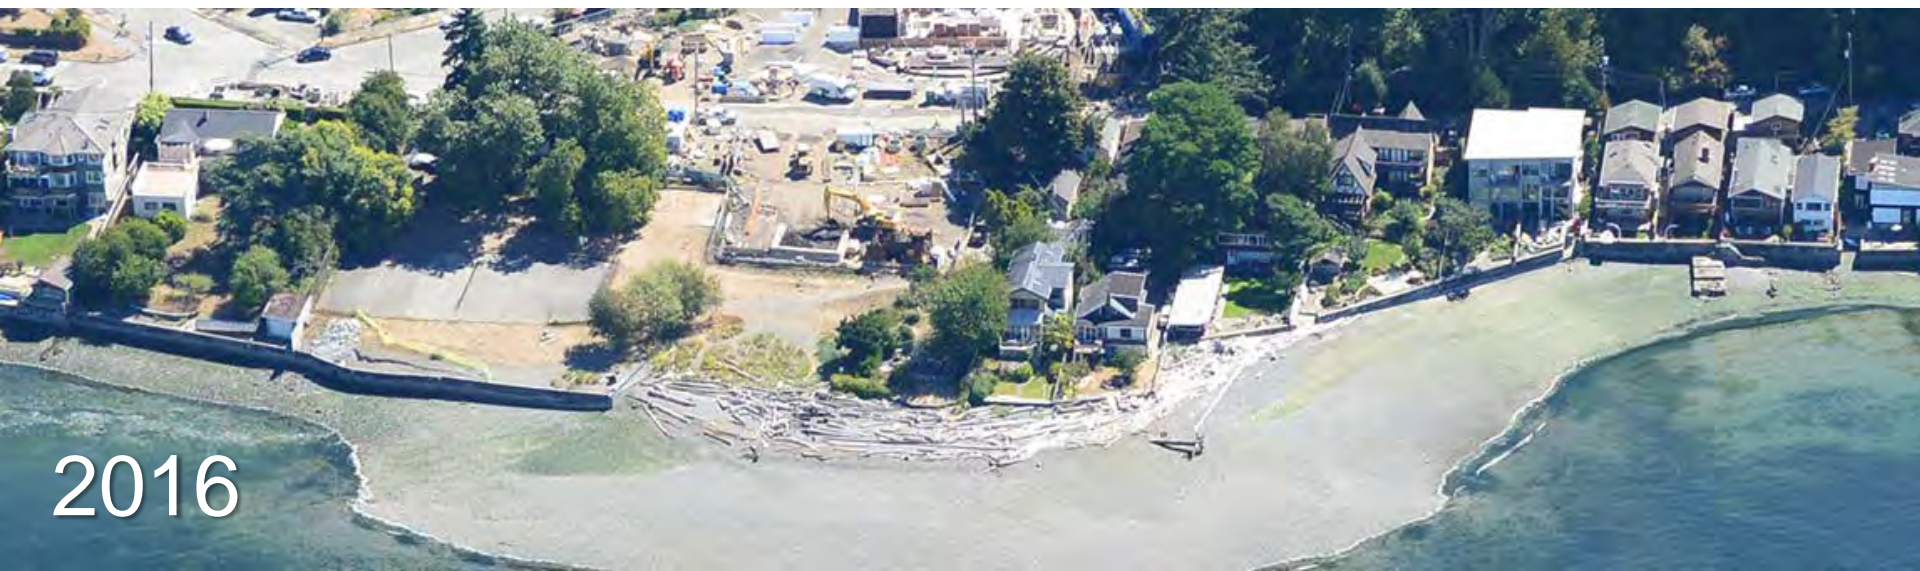
Technical Studies - Coastal

- Historically was low bluff-backed beach & creek mouth
- Accretion shore form evidenced by survey and photos
- 1920's shoreline was located landward of existing MHHW
- Since the 1990's material has accumulated on beaches to the south (approx. 3 ft higher along south property line)
- Net drift slightly to the north, but direction reverses and varies
- Beaches to the north have deficit of sediment and lack the capacity to accumulate and retain beach sediment due to structure position and exposure

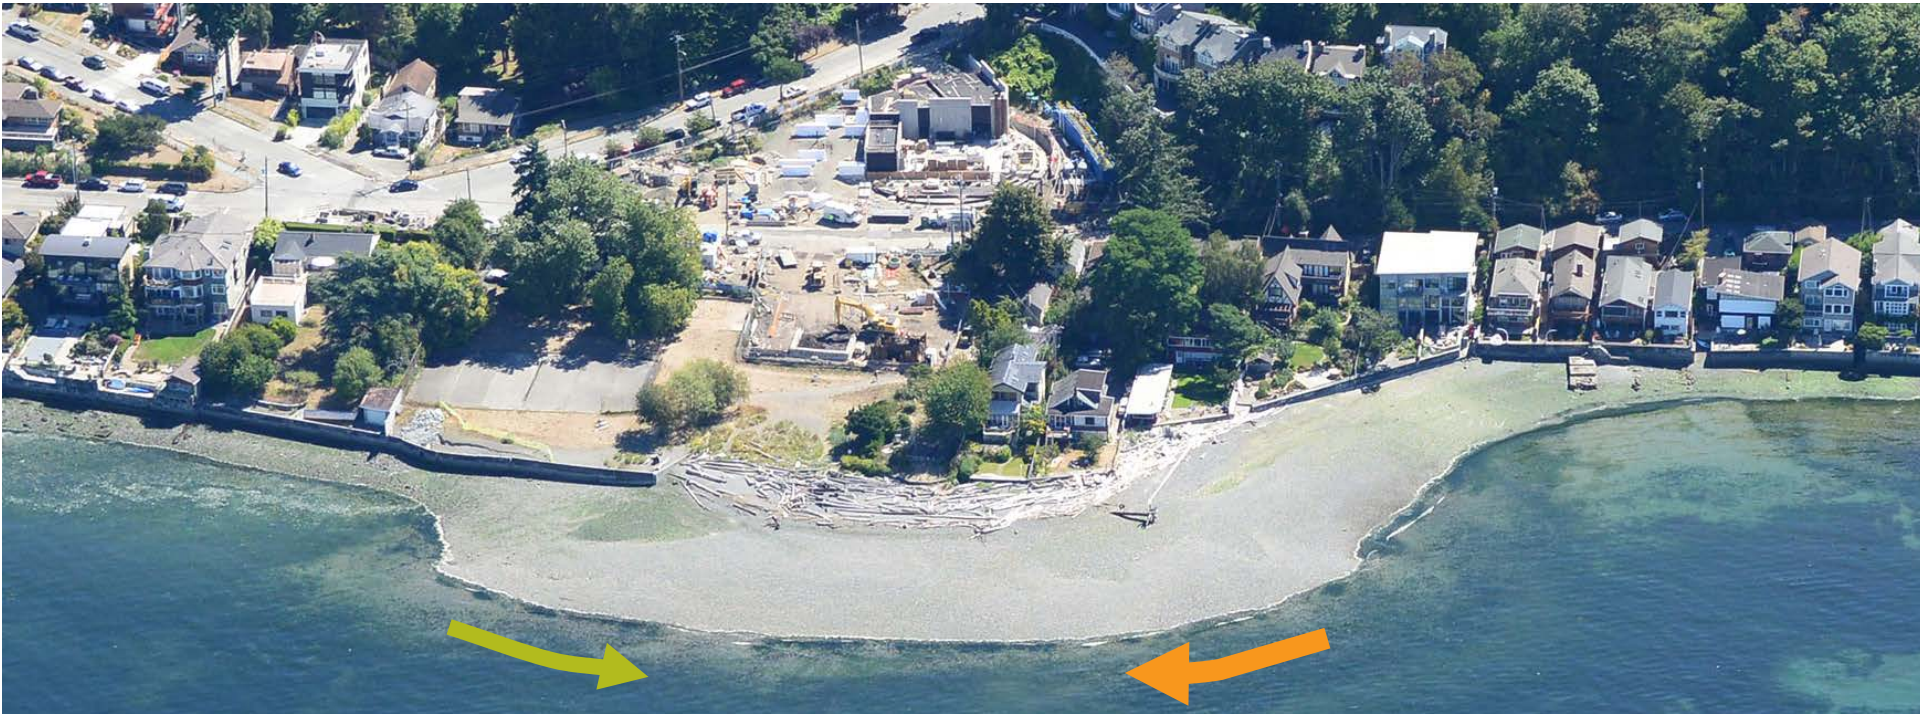
Net drift towards the north, however:

- Net drift is very slight and nearly in balance
- Net drift reverses from year to year
- Little material is available to be transported or retained to the north of park

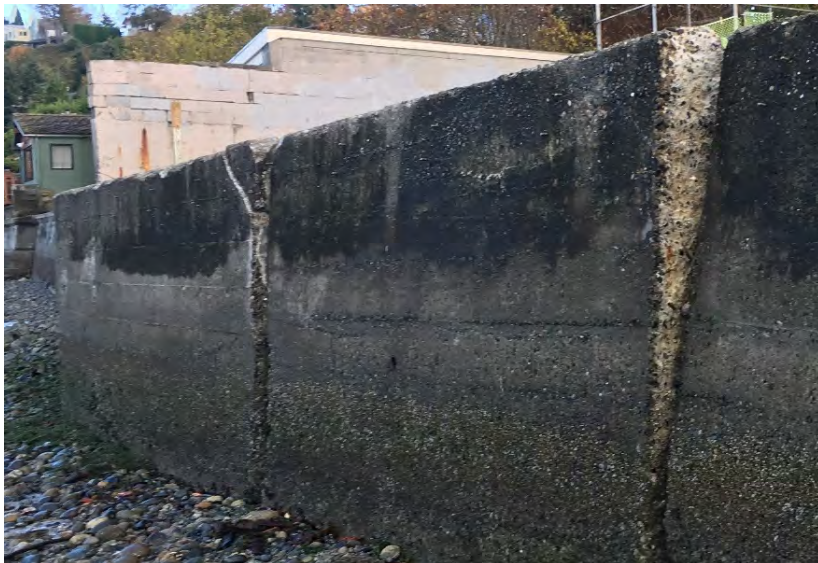
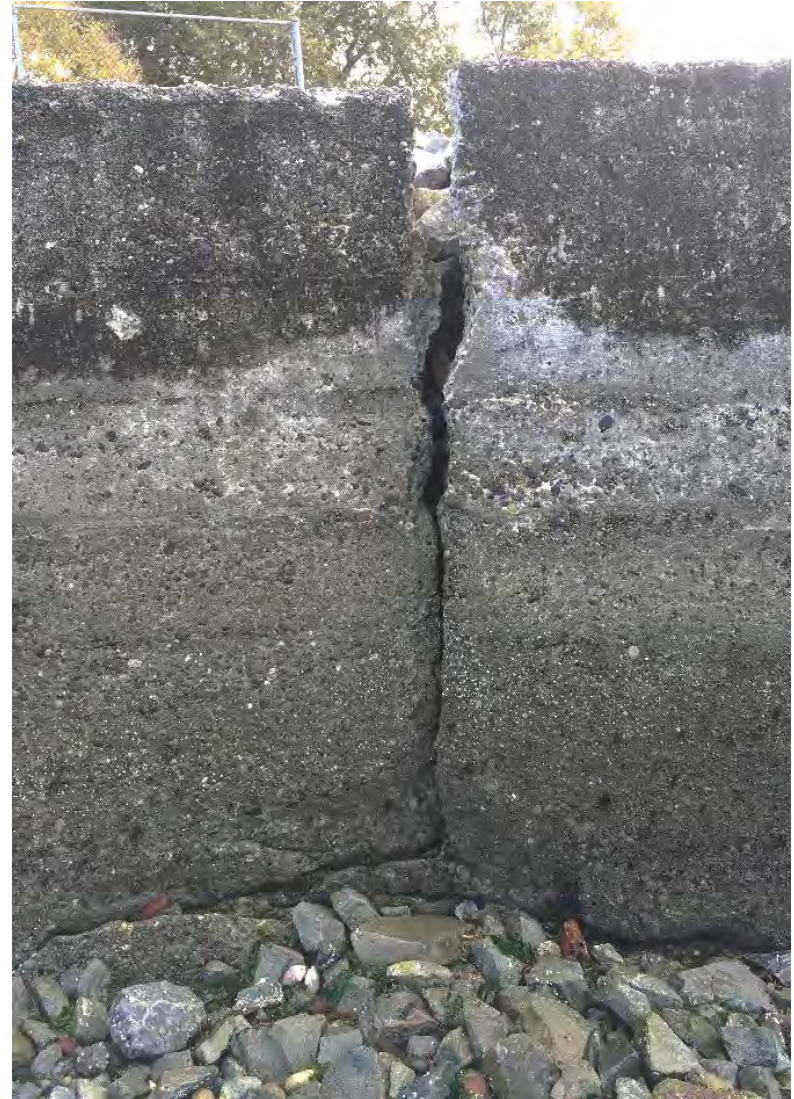
Failure of Existing Wall

- Undermined over time, toe exposed
- Settlement/rotation
- Outfall disconnected

Reuse of Portions of Existing Wall

- Susceptible to similar failure

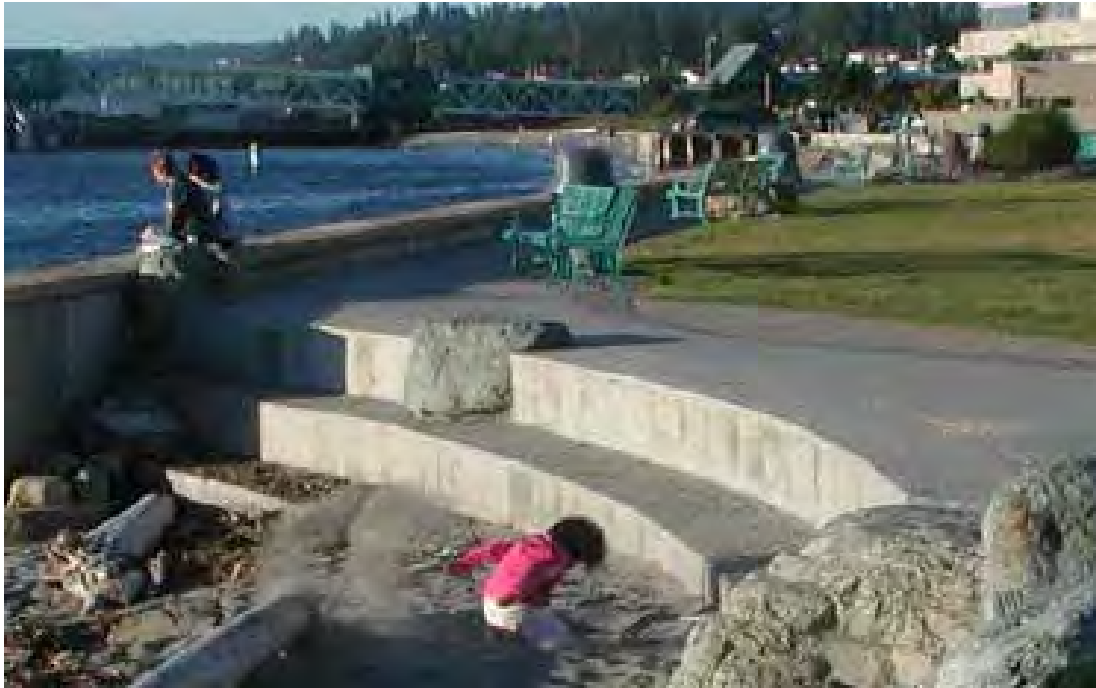
Seat Wall at Edmonds waterfront

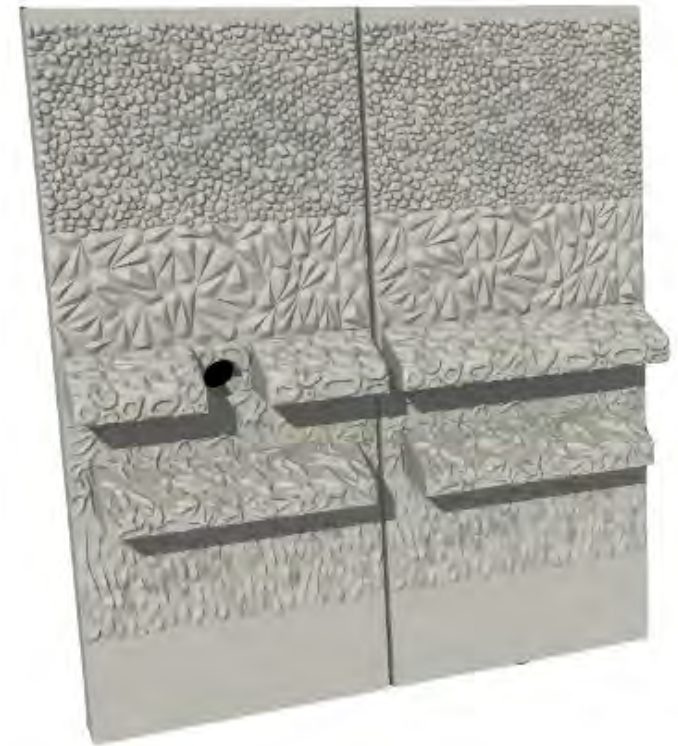
New Elliott Bay Seawall
