**Discipline Report**  
***Geology and Soils***

Prepared by:  
Shannon & Wilson, Inc.

Seattle Department of Transportation  
Agreement No. T01-34

**Magnolia Bridge Replacement**  
**City of Seattle**

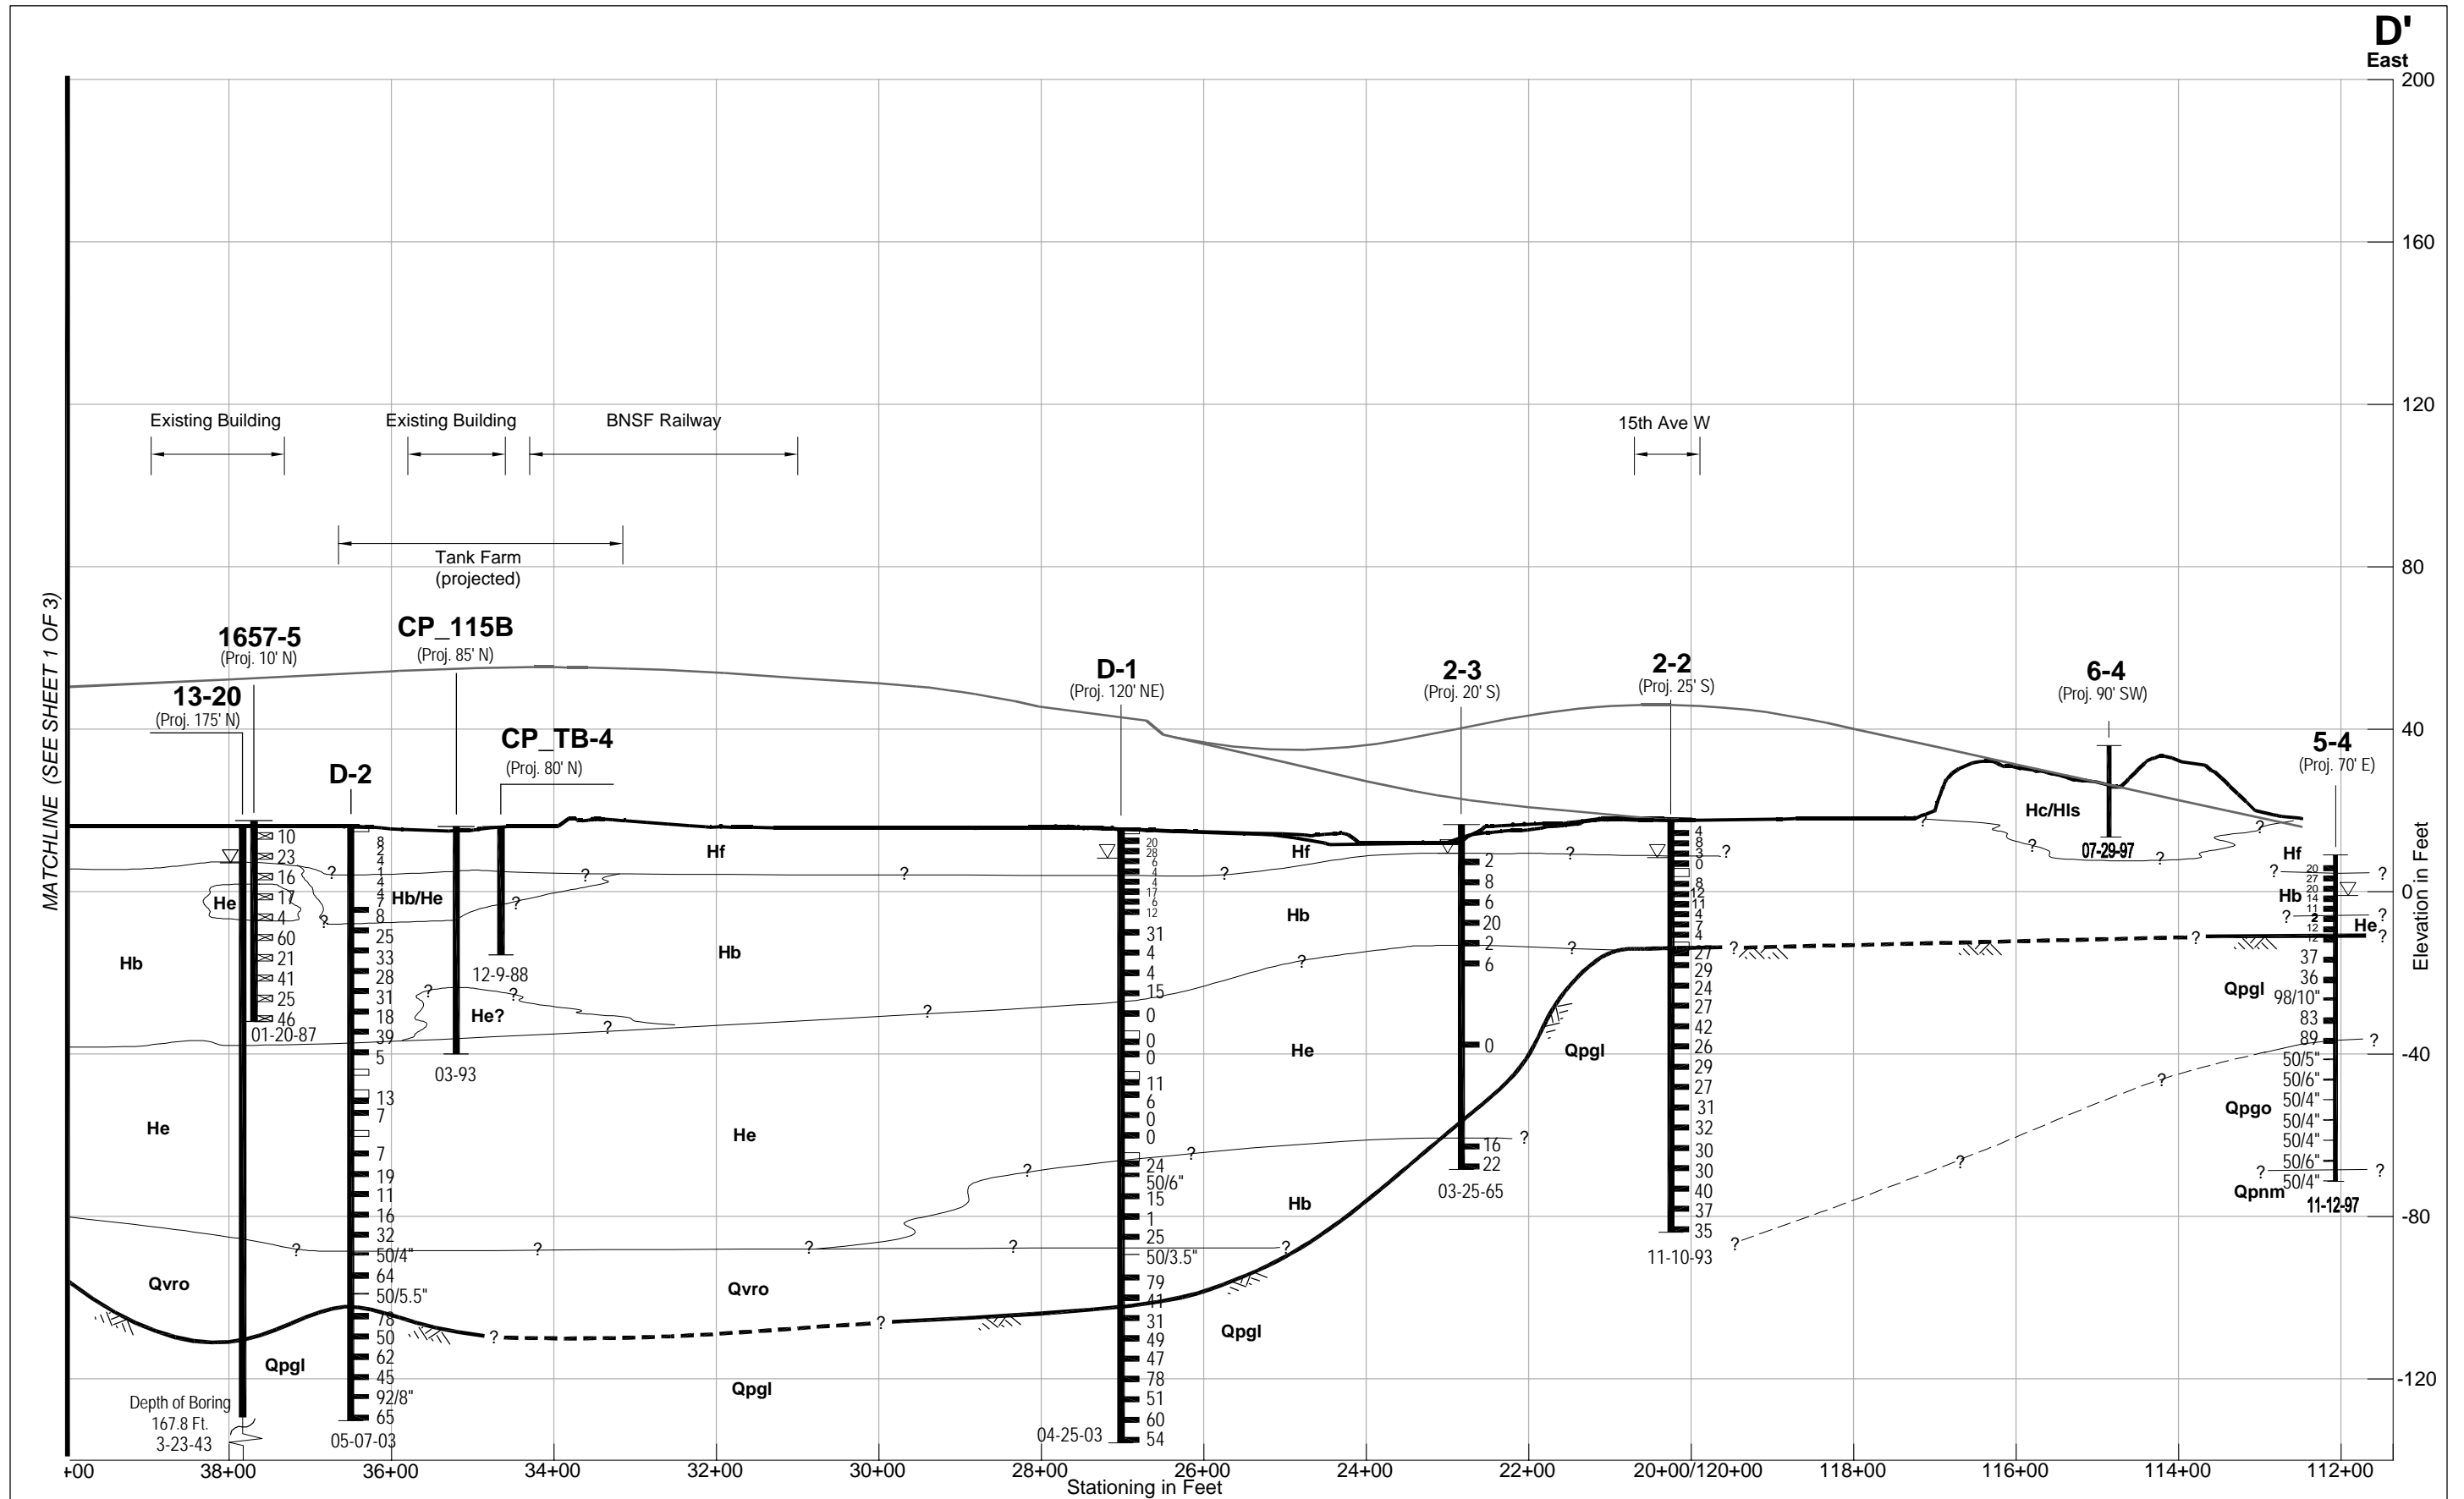
Figure 21, Sheet 2 of 3 - Generalized Subsurface Profile - Alternative D

1. This subsurface profile is generalized from materials observed in soil borings. Variations may exist between profile and actual conditions. Contact lines are dashed where questionable.
2. Figure adapted from electronic files provided by HNTB, received 10-31-03.
3. Datum: NAVD 88

The geologic conditions were interpreted from information obtained from the current and previous subsurface explorations, geologic maps of the area, and a geologic site reconnaissance, as described previously. A preliminary geologic map of each build alternative is presented in Figures 15, 16, and 17. A summary of the geologic units is presented in Figure 18. The following sections include a description of the regional and site geology, and the soil and groundwater conditions encountered along the alignments. The generalized subsurface conditions along Alternative Alignments A, C, and D are shown on the profiles presented on Figures 19, 20, and 21, respectively.

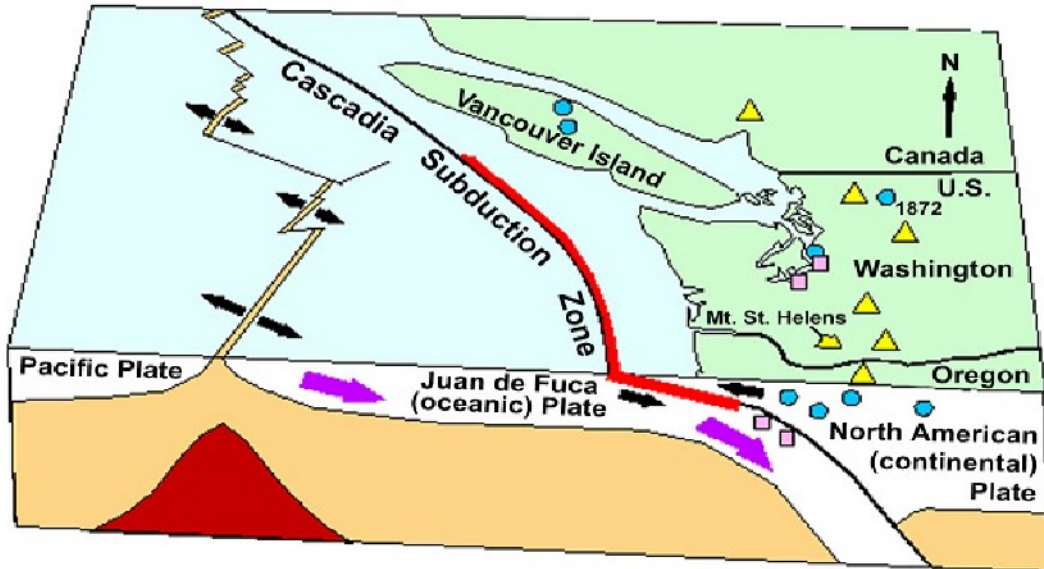
Within the present understanding of the regional tectonic framework and historical seismicity, three broad seismogenic zones have been identified. These include a shallow crustal source zone, a deep subcrustal (intraslab) source zone in the subducted Juan de Fuca Plate, and an interplate or subduction zone (Figure 22).

- Deep earthquakes (40 miles below the Earth's surface) are within the subducting oceanic plate as it bends beneath the continental plate. The largest deep Northwest earthquakes in the 20th century were in 1949 (M 7.1) and 1965 (M 6.5).
- Shallow earthquakes (less than 15 miles deep) are caused by faults in the North American Continent. The Seattle fault produced a shallow magnitude 7+ earthquake 1,100 years ago. Other magnitude 7+ earthquakes occurred in 1872, 1918, and 1946.
- Subduction earthquakes are huge quakes that result when the boundary between the oceanic and continental plates ruptures. In 1700, the most recent Cascadia Subduction Zone earthquake sent a tsunami as far as Japan.
- Mount Saint Helens / Other Cascade Volcanoes
