Northgate Pedestrian/Bicycle Bridge Project Hazardous Materials Technical Memorandum

Prepared for
**Seattle Department of Transportation
Washington State Department of Transportation**

Lead Author
Clearway Environmental

April 2018

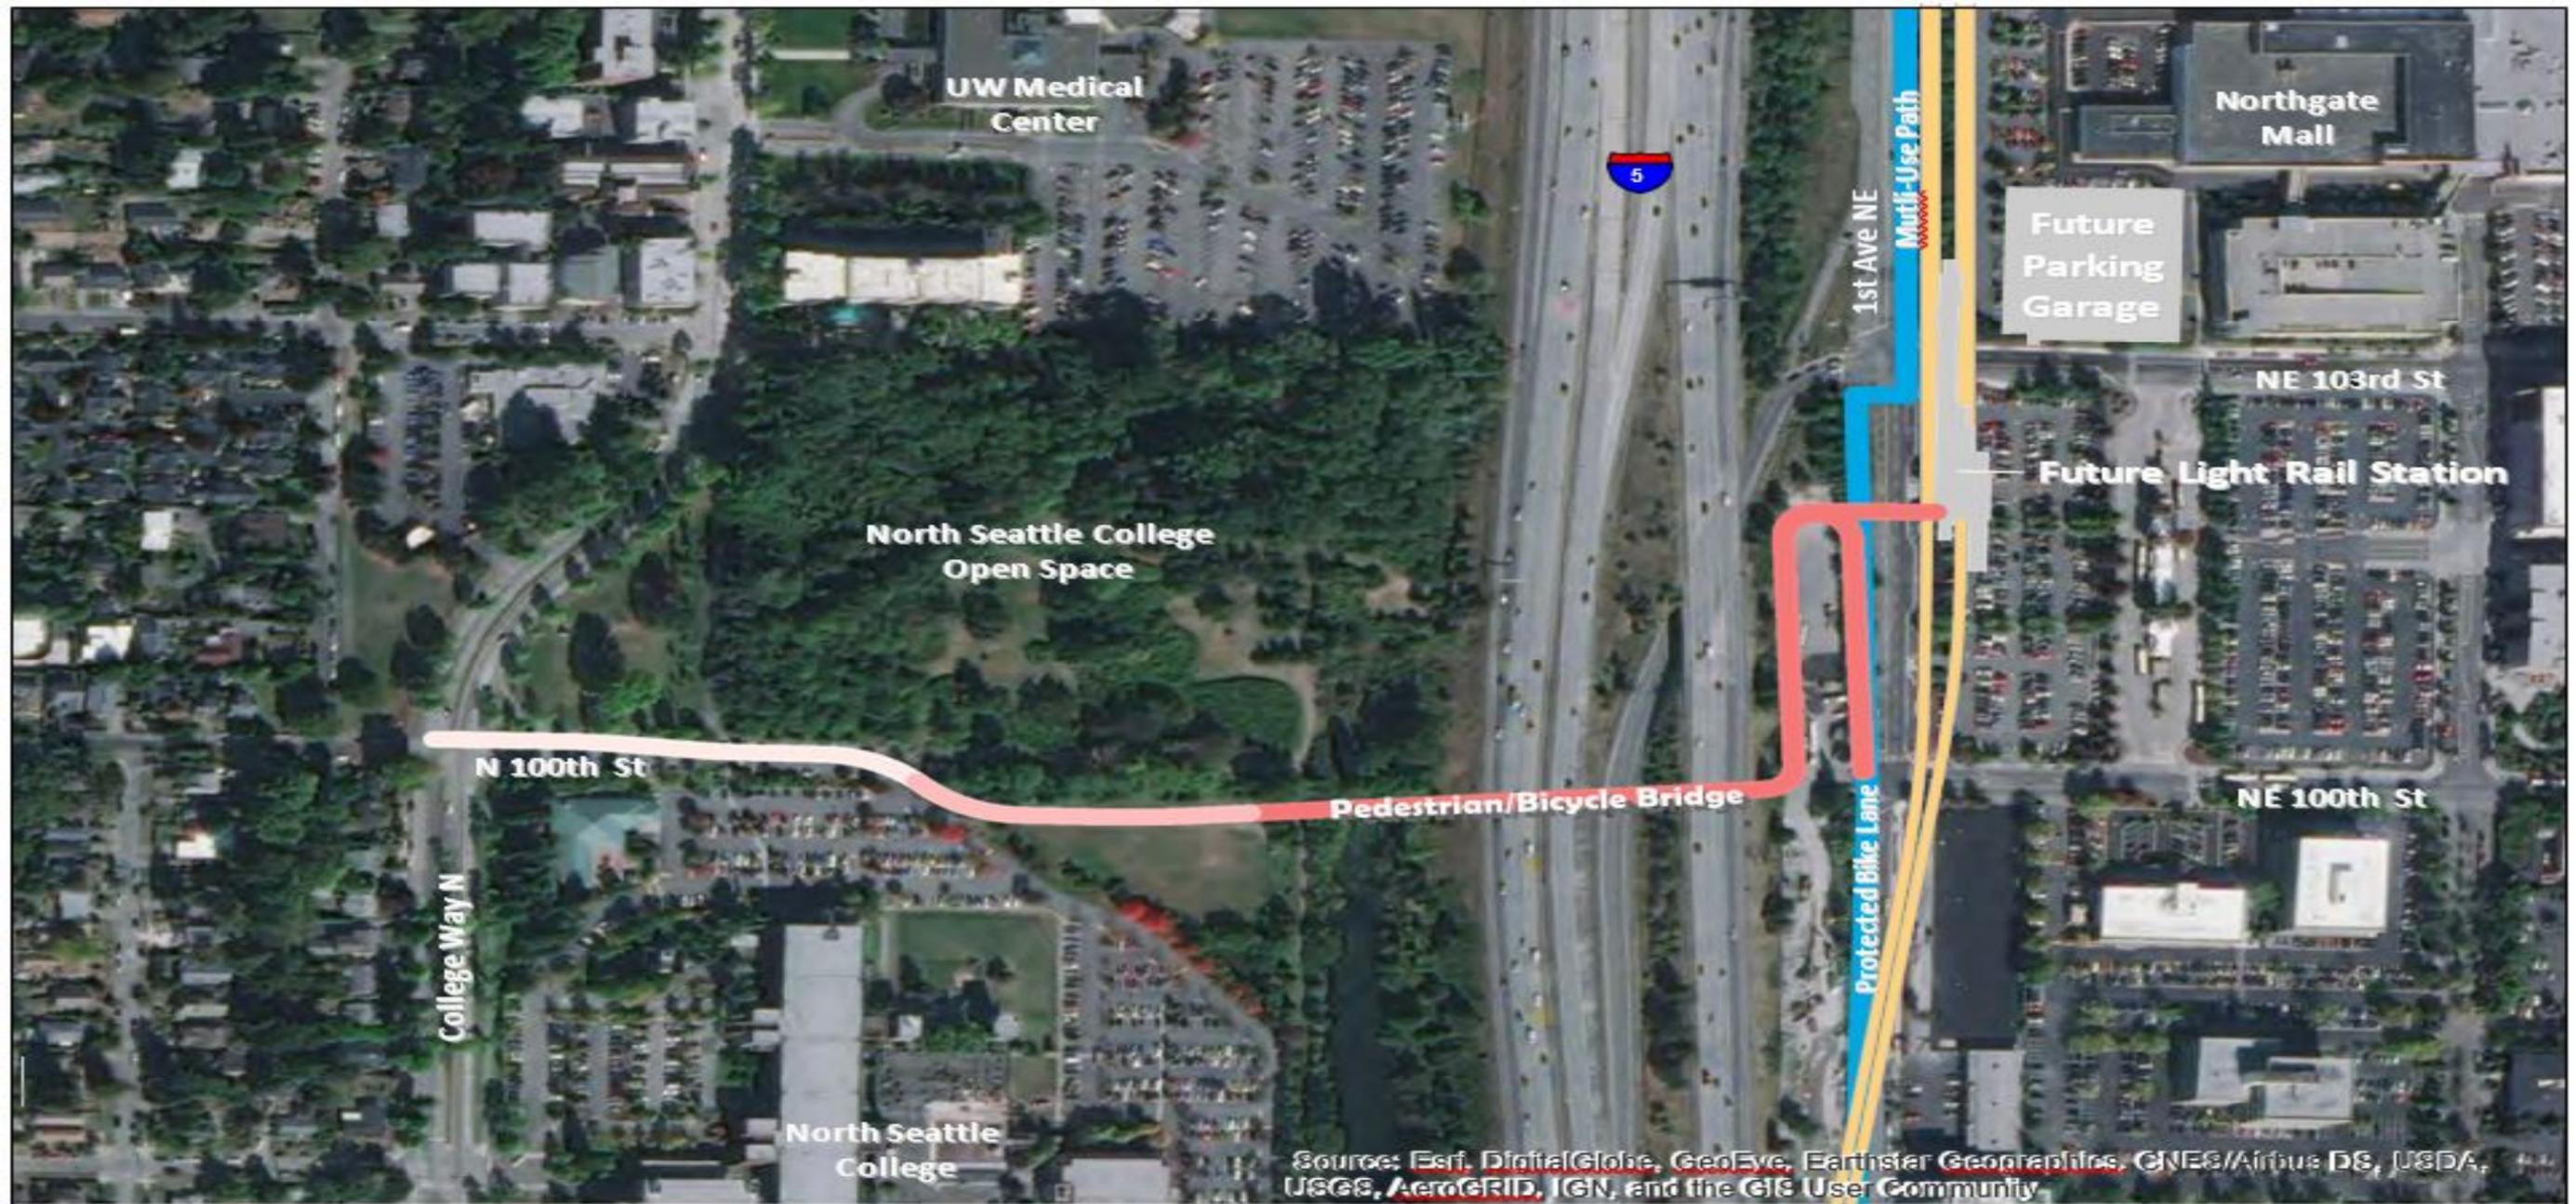
Figure 2: Project Site and Bridge Alignment

The Project is located in the Northgate area of Seattle, Washington (Figures 1 and 2). The project area is generally bounded by College Way N on the west, 1st Avenue NE on the east, Northgate Way on the north, and N 92nd Street on the south. This project area is bisected by

Bridge Structure
-

Earthfill Section
-

16' Wide Multi-Use Path
-

1st Avenue NE Protected Bike Lane (PBL)/Multi-Use Path

- A 16-foot wide and 1,900-foot long pedestrian/bicycle facility, including a 360-foot crossing of I-5.
- An east approach ramp located within the WSDOT park and ride on the east side of I-5, that will connect to grade level at 1st Avenue NE and NE 100th Street.
- A bridge connection over 1st Avenue NE connecting to the Northgate Link Light Rail station.
- A west approach consisting of an earthfill embankment with retaining walls that touch down on the NSC campus.
- A 16-foot wide multi-use path on the NSC campus linking the facility with College Way N.
- A 10-foot wide protected bike lane along the west side of 1st Avenue NE from NE 92nd Street to NE 103rd Street.
- A multi-use path on the east side of the 1st Avenue NE from NE 103rd Street to Northgate Way.

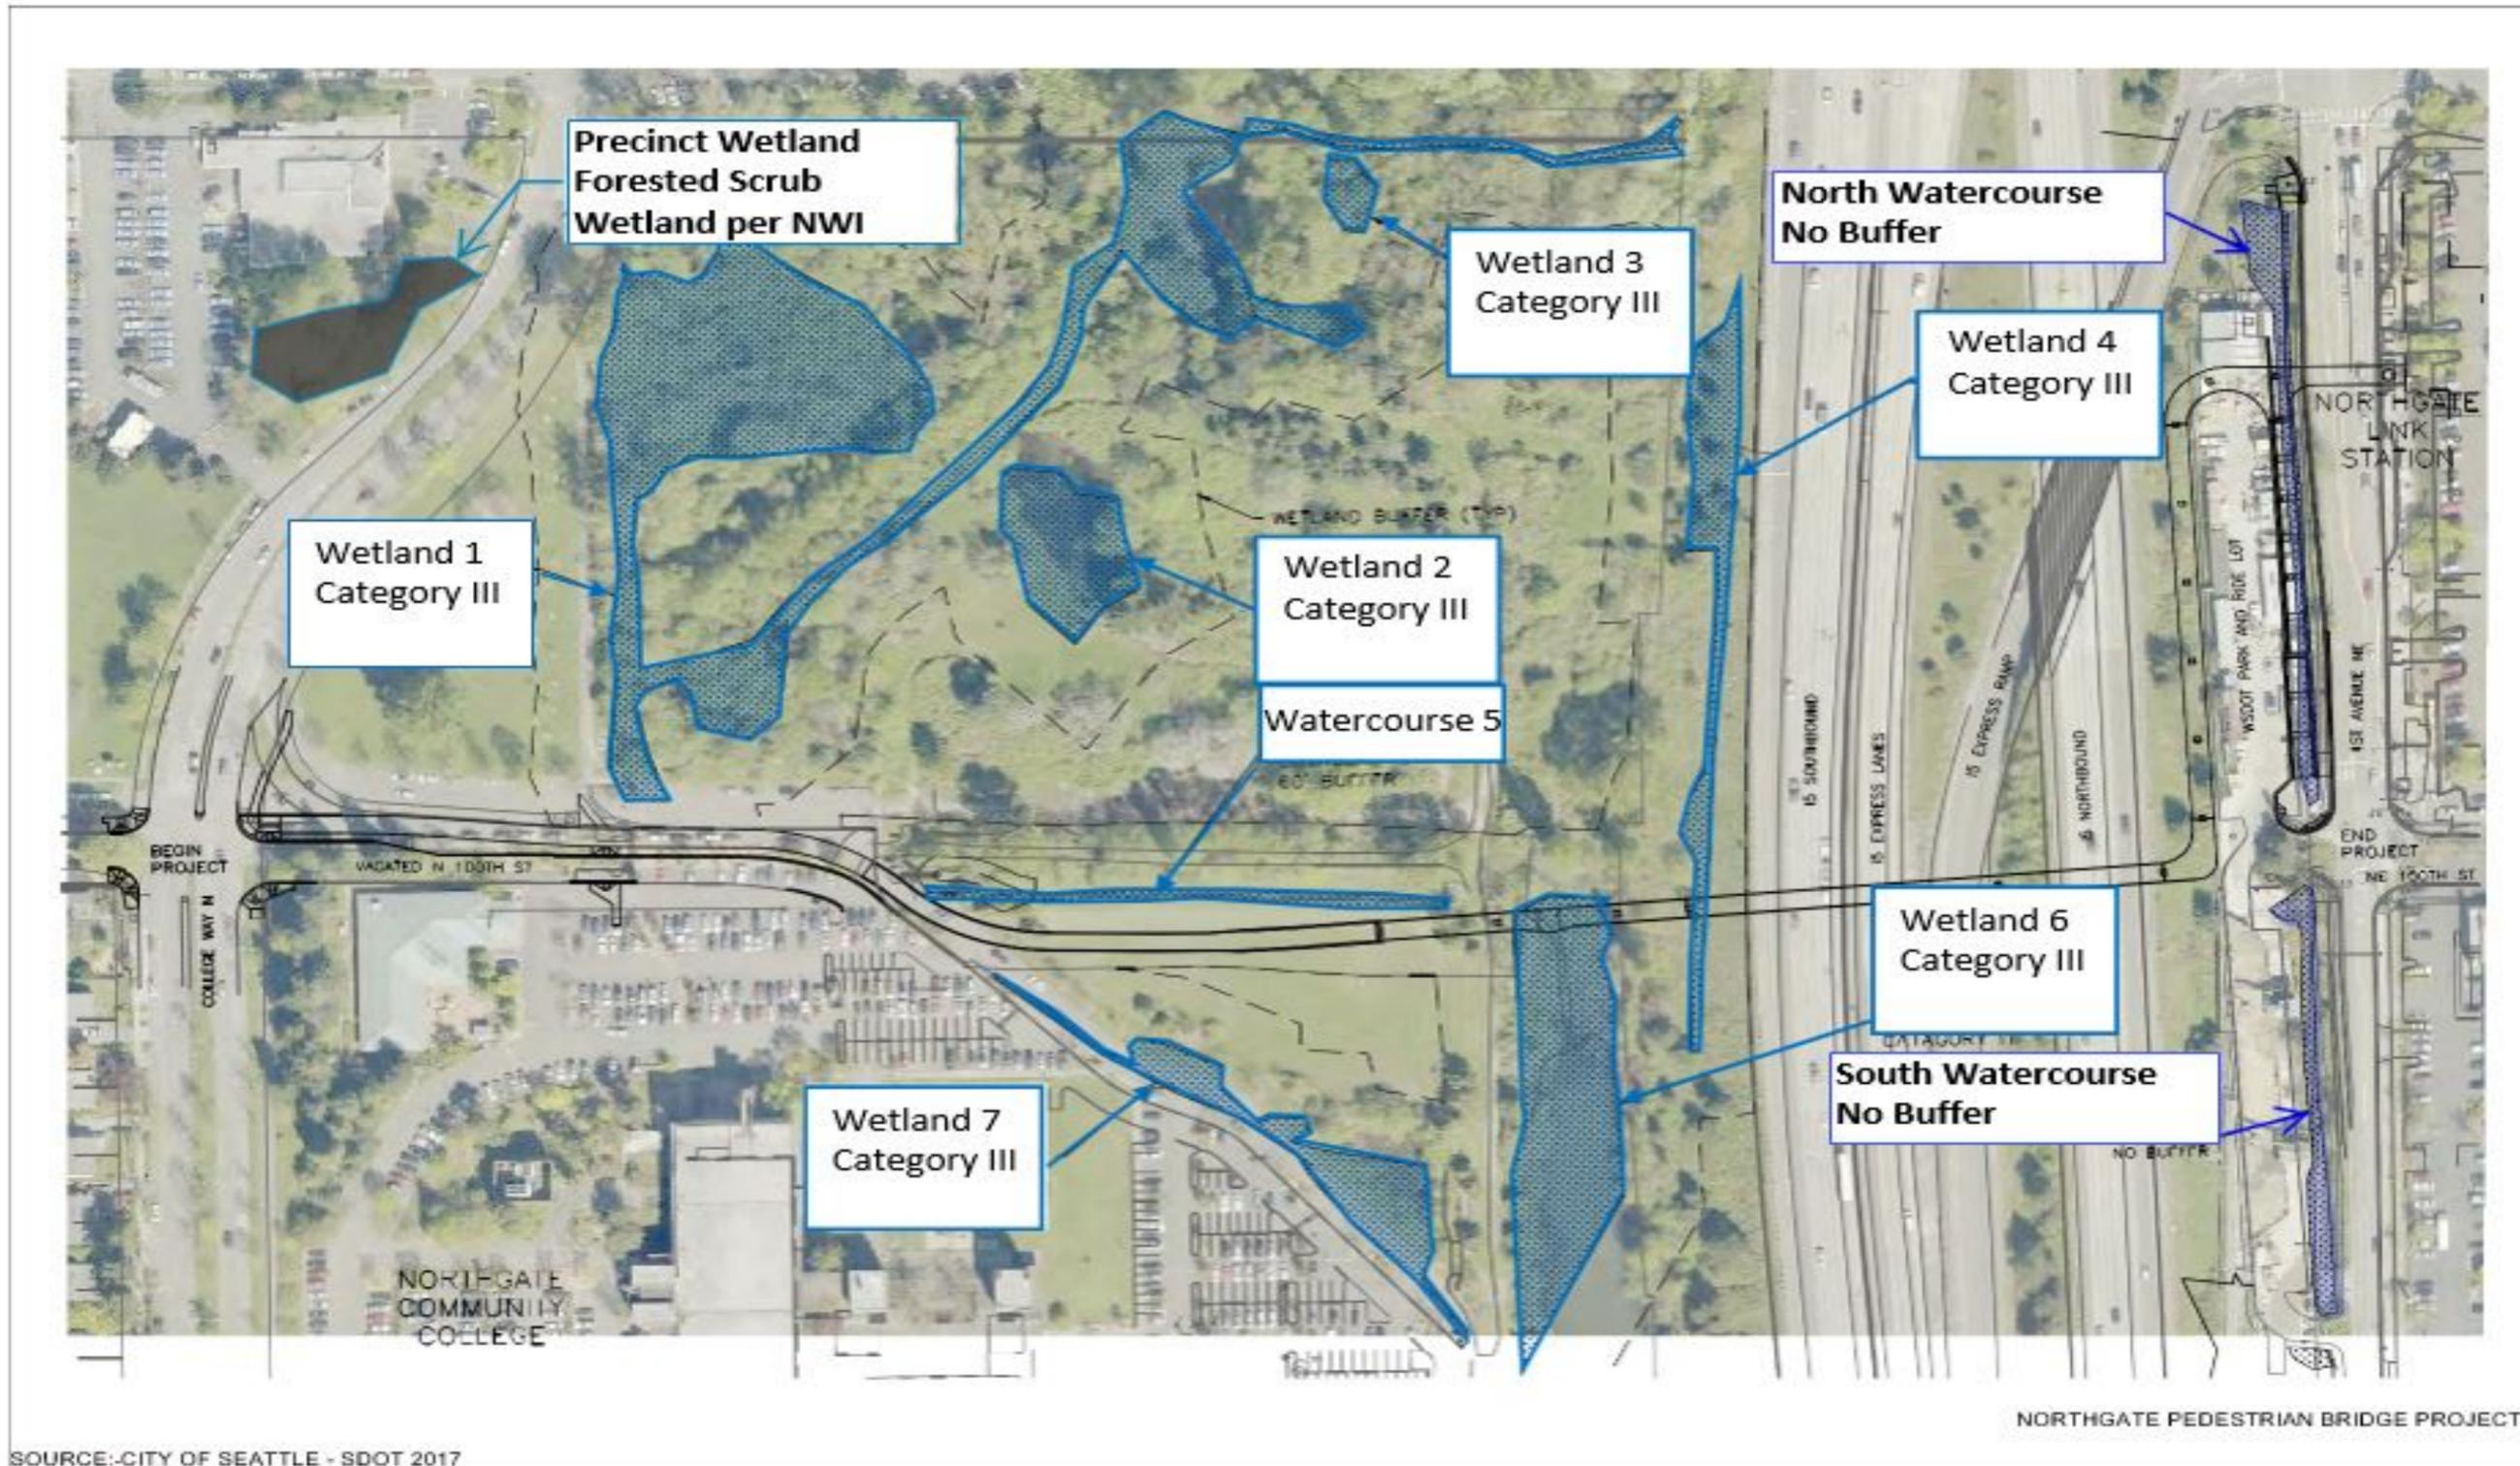
Figure 3: Project Site Map Water Resources and Bridge Alignment Overlay

the I-5 freeway. The eastern portion of the project lies within SDOT and WSDOT right-of-way. The western portion of the project lies within WSDOT right-of-way and lands owned by the NSC. Water resources within the project area are shown within Figure 3.

There are numerous wetlands and several watercourses in the project area and in the vicinity of the project (Figure 3). All wetlands and watercourses are connected hydraulically either by pipe, surface flow, or groundwater.

On the NSC campus there are several wetlands and one watercourse (Figure 3). All are connected hydraulically either by pipe, surface flow or groundwater. Flows from the Precinct Wetland are piped under Campus Way N to Wetland 1.

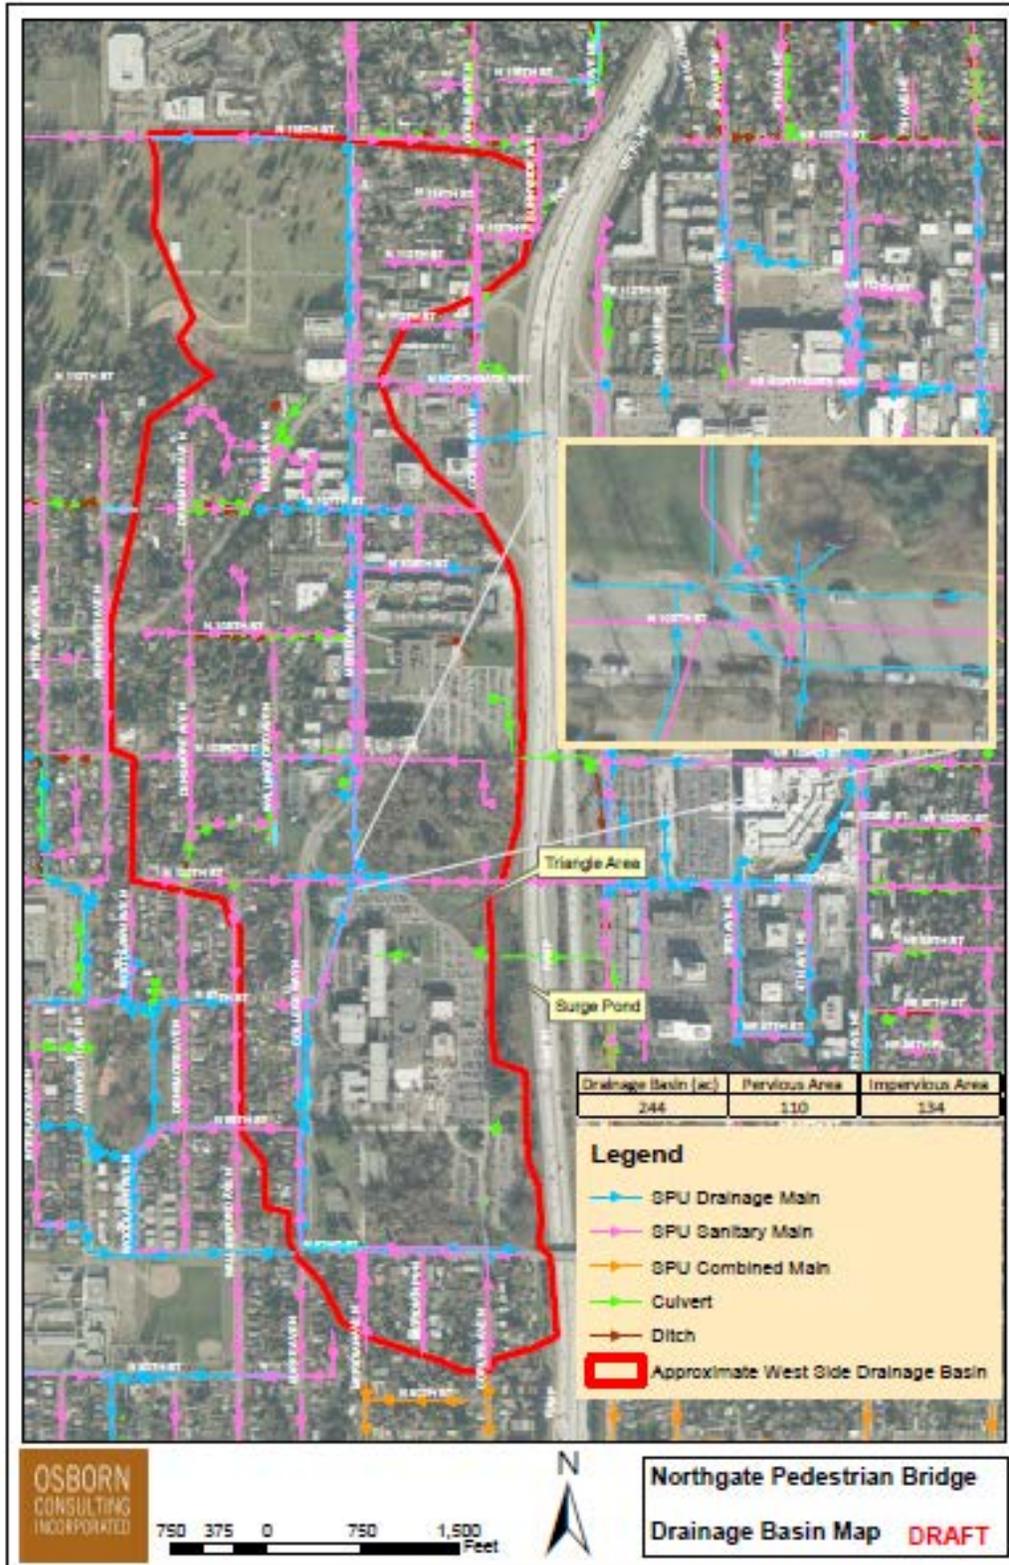
Figure 4: Drainage Features Map

The South Watercourse receives water from NSC Wetland 6 via a 72" culvert that crosses I-5.

The North Watercourse receives water from the I-5 right-of-way.

The North and South Watercourses flow via pipes in NE 100th Street to a water quality treatment facility that conveys flows through Thornton Place, a condominium development.

From here, water is discharged downstream to the South Branch of Thornton Creek at NE 103rd Street and 5th Avenue NE via 0.18 mile of enclosed drainage and 0.15 mile of open channel.

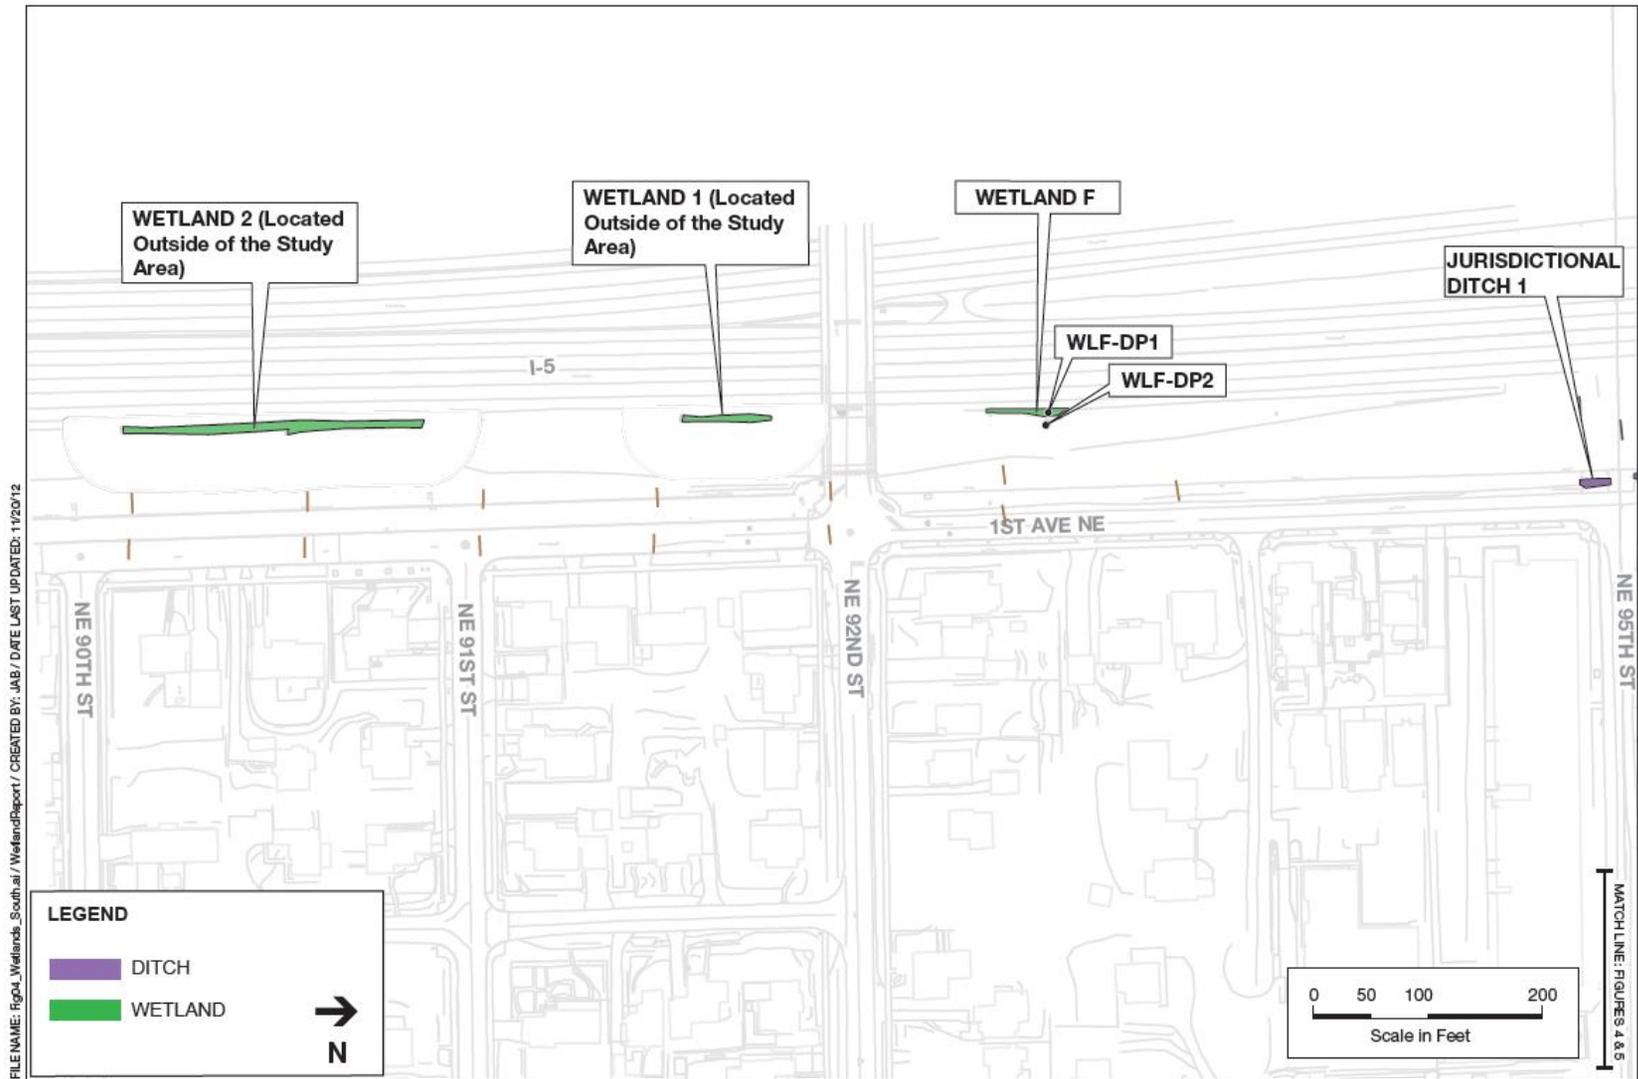
Figure 5: Eastern Side of I-5 Aquatic Resources - South

On the east side of I-5, there are four wetlands (wetlands A, D, E, F) two ditches (Ditch 1 and 2), and two watercourses (North and South watercourses) as shown in figures 5, 6, and 7.

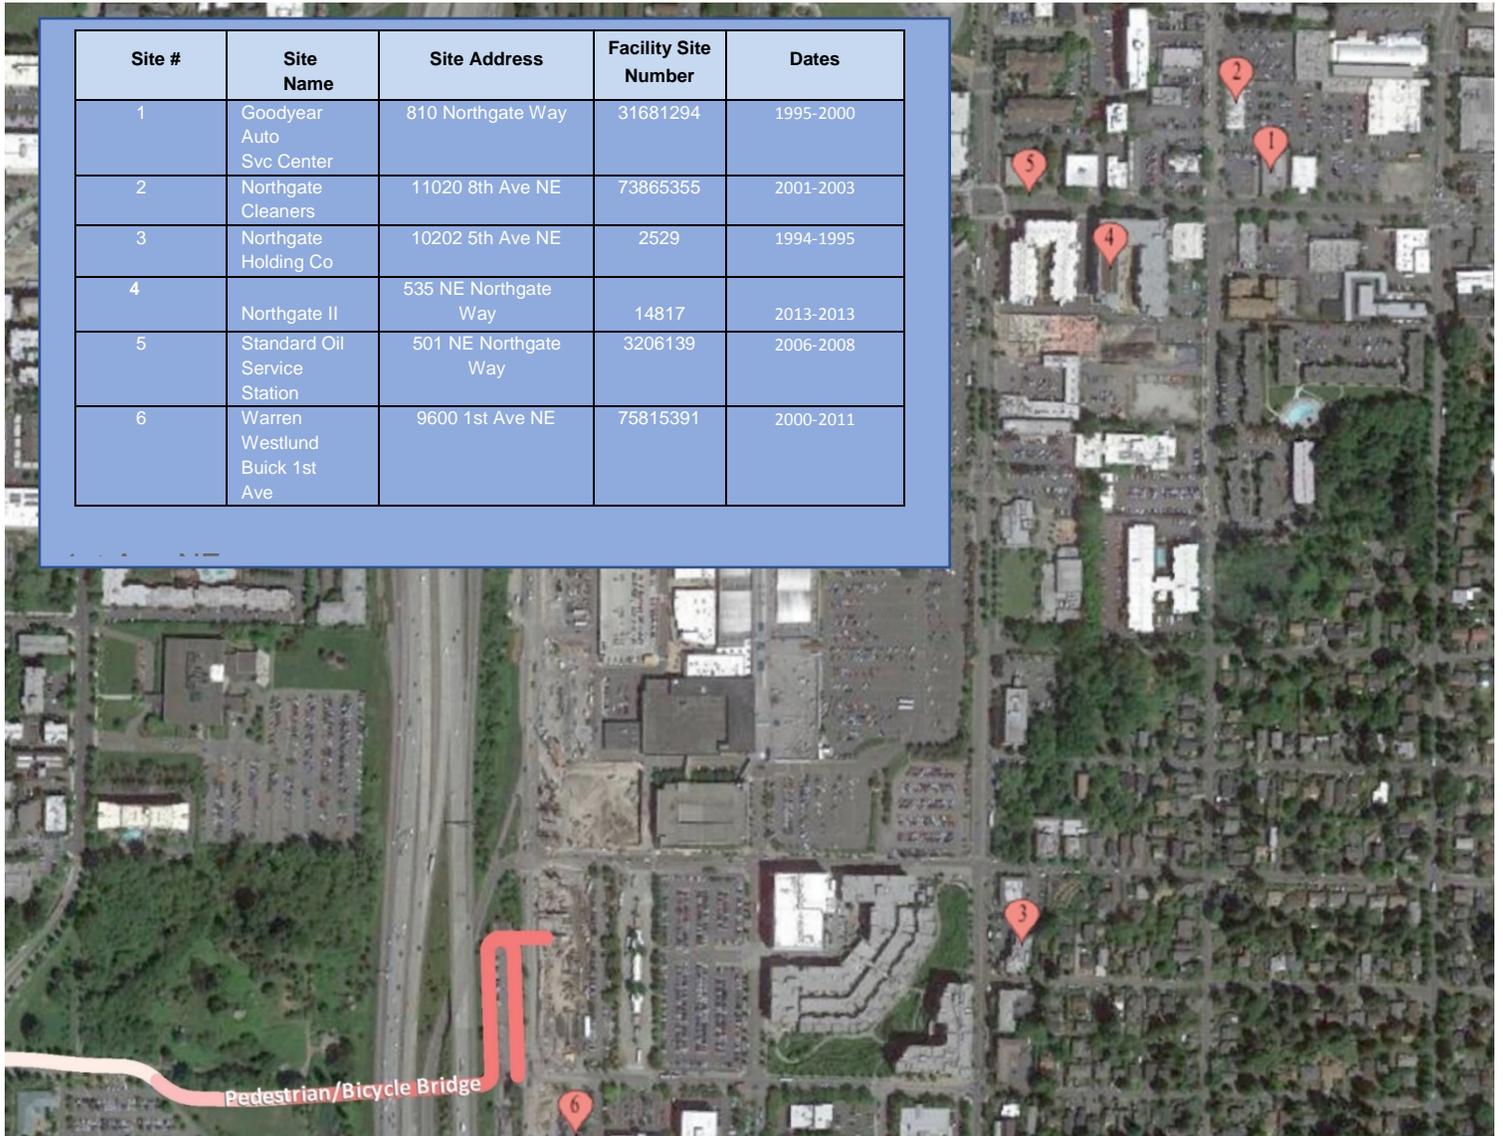
Figure 8: Hazardous Materials Sites

The review of environmental records and site-specific history shows that none of the six sites identified near the Northgate Bridge Project are sites of concern. All identified sites were listed as having completed cleanup actions according to state and federal requirements (Figure 8).

A review of the state and federal data bases in 2017 was used to update the list of all sites in the vicinity of the project site that contain, or could potentially contain, hazardous materials. Six sites were identified in the Washington State Department of Ecology (Ecology) databases within one mile of the project site¹, in 2015. These same sites were identified in 2017 and are shown in Table 1. Information contained in the records for each site was evaluated to determine the potential for environmental impacts to the Northgate Bridge Project. As in 2015, there are no United States Environmental Protection Agency superfund sites within one mile of the project site.

It is unlikely that any of the six sites should present a risk of encountering hazardous materials in the Northgate Bridge Project during construction activities. This is based on local topography, the inferred direction of shallow groundwater flow, the regulatory status of the listed sites, and information contained in the regulatory database.
