Combined Sewer Overflow Program

Long-Term Control Plan

Volume 5 Phases 2-3 Flow Monitoring Report

**PHASES 2 AND 3 FLOW MONITORING REPORT
2009–2010 DRY AND WET SEASONS**

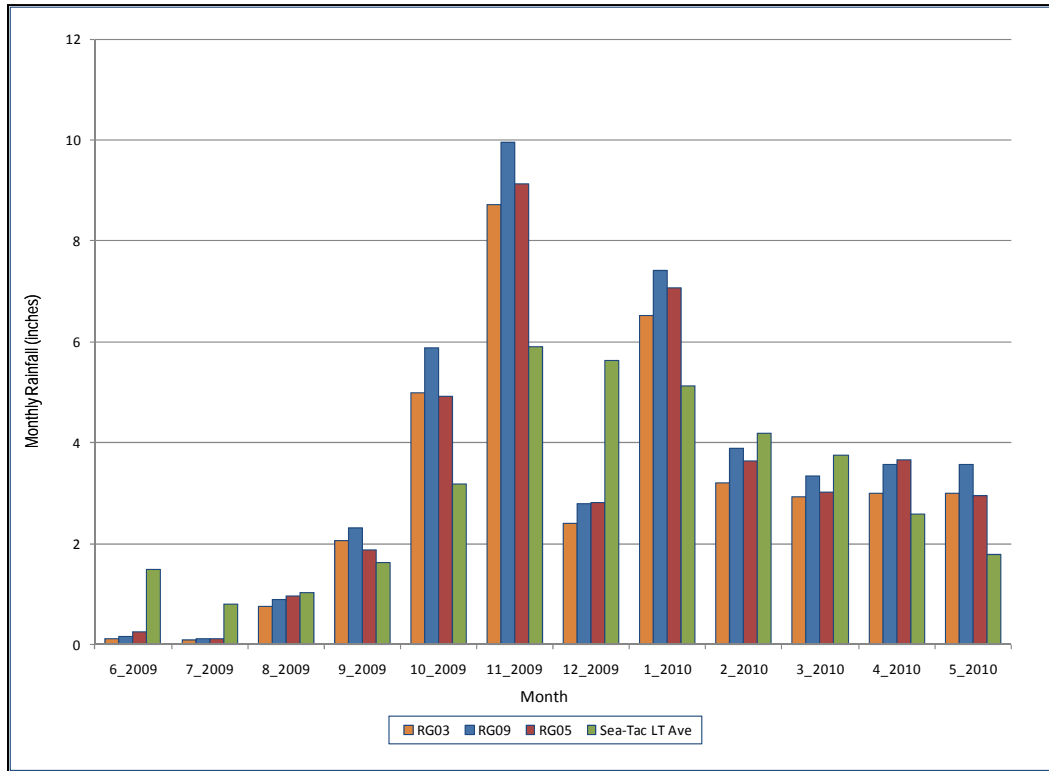
Figure ES-1. Monthly average precipitation at three SPU gauges compared to the long-term average

Rainfall during the fall and winter of the Phases 2–3 monitoring period can be characterized generally as above average in volume and number of significant events at most gauges. Figure ES-1 shows the monthly long-term Sea-Tac average rainfall together with the observed rainfall at three rain gauges spanning the system. June through August 2009 showed minimal rainfall. Significant events occurred in September, October, and November 2009 and in the first half of January 2010. The months of February through April 2010 were average in total rainfall, and May 2010 was above average due to two large events.

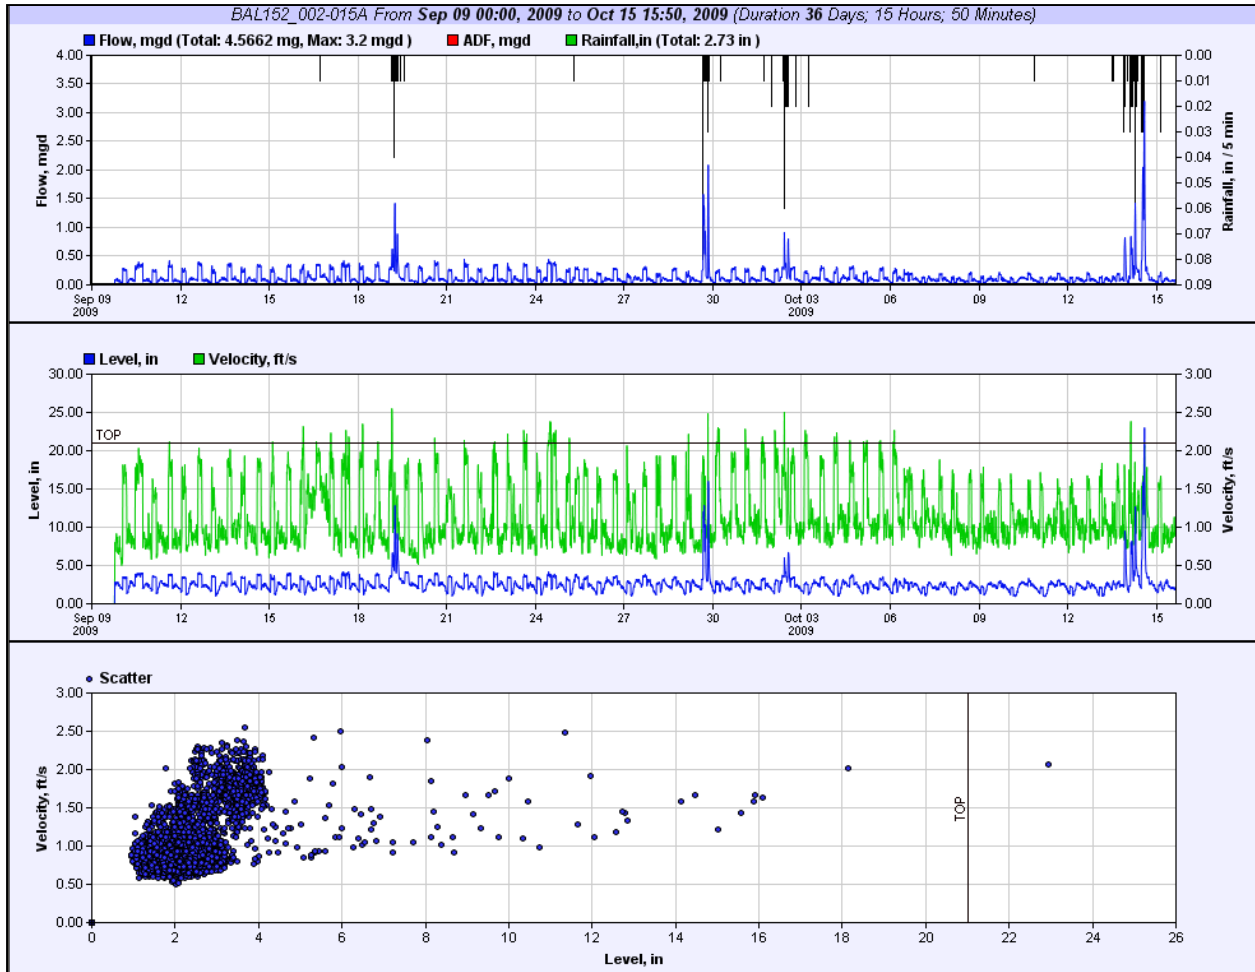
Figure 3-4. ADS FlowShark meter "low flow" scattergraph at BAL152_002-015A

BAL152_002-015A remained installed at the conclusion of Phase 3 monitoring.

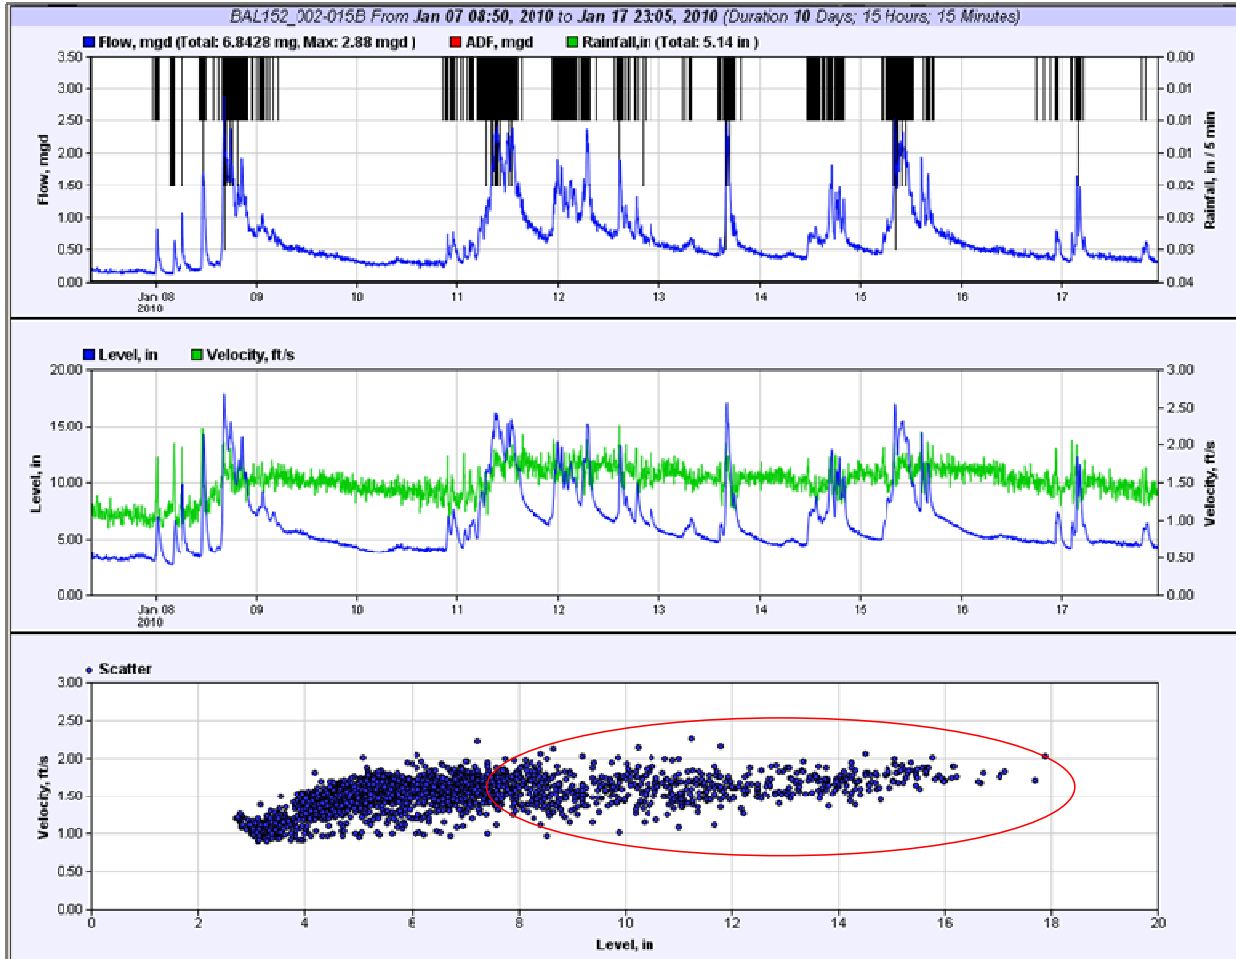
Figure 3-5. Backwater condition at BAL152_002-015

BAL152_002-015B was located in the same manhole as 002-015A. The data captured confirmed the readings by the ADS FlowShark meter at BAL152_002-015A. Backwater condition was identified at this site during large storm events. Figure 3-5 shows the flattened scattergraph during a storm event, which is characteristic of backwater conditions. A subsequent analysis of upstream piping verified that the observed backwater conditions would not extend far enough upstream to affect the monitoring data recorded by the Micromonitor at MH 001-009. The quality of data was classified as "Good" for Phases 2–3. The data collected at this site could be used in conjunction with the data collected at BAL_152-015A for model calibration purposes.

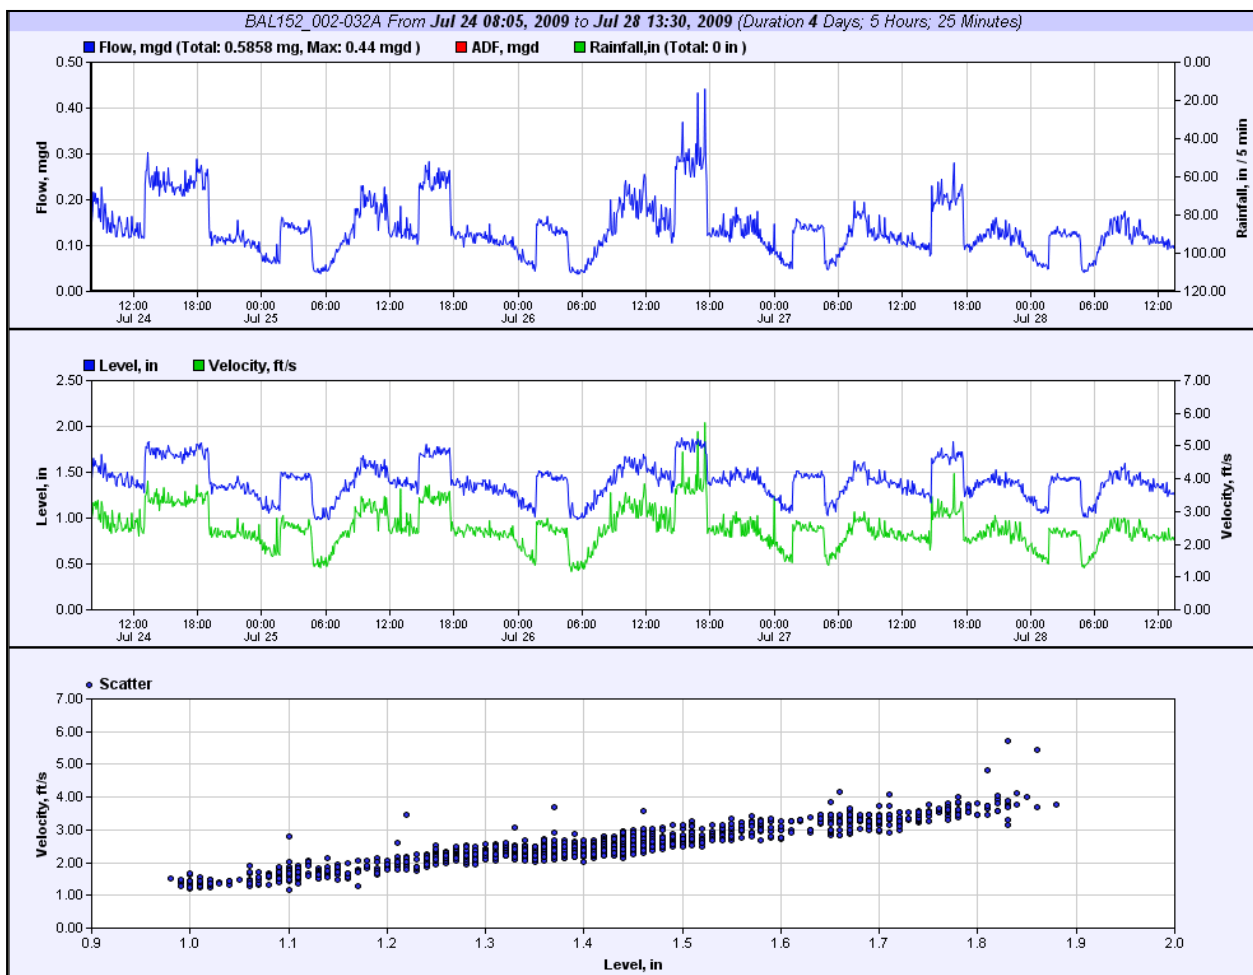
Figure 3-6. Influence of potable water flushing station on data signature at BAL152_002-032A

The potable water flushing station flows (described for BAL152_002-016A above) are observable within the BAL152_002-032A flow data. The effects of the potable water flushing station can be observed in the data prior to November 2008 and after June 2009 (Figure 3-6). The data quality was classified as “Good” for Phases 2–3. The quality classification of the data collected during Phase 1 was classified as “Excellent.” All wet weather flow data for Phases 2–3 are suitable for model calibration. Dry weather flow should be used with caution.

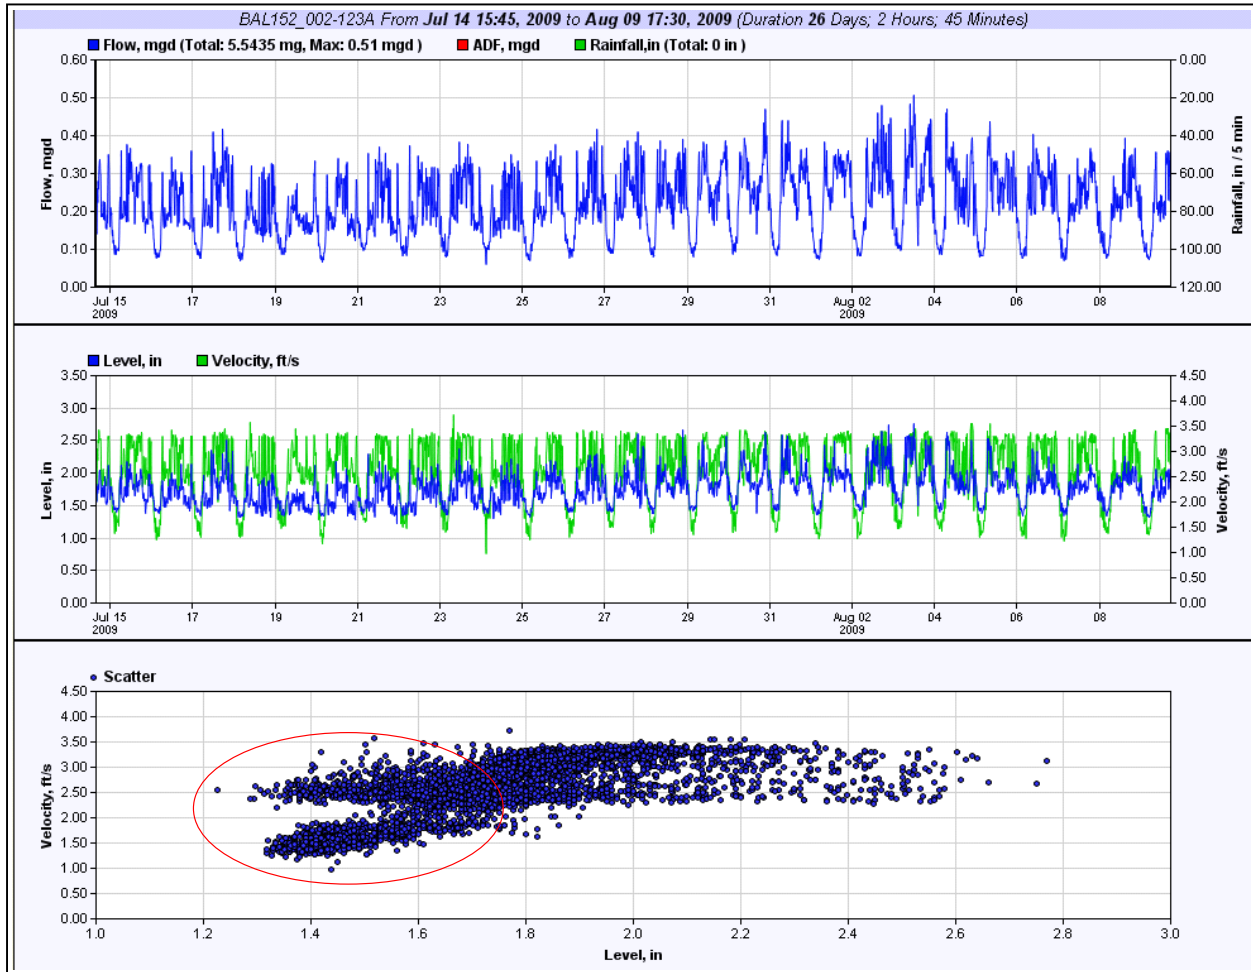
Figure 3-7. Pooling behind meter effect captured at BAL152_002-123A

The data at this site captured two flow regimes during low flows attributed to pooling behind the meter (Figure 3-7). During storm events the meter responded very consistently and collected suitable velocity and level data. The data quality—particularly the storm flow data—was classified as “Good” for Phases 2–3, which matches the quality classification of the data collected during Phase 1 monitoring. All wet weather data for Phases 2–3 are suitable for model calibration.

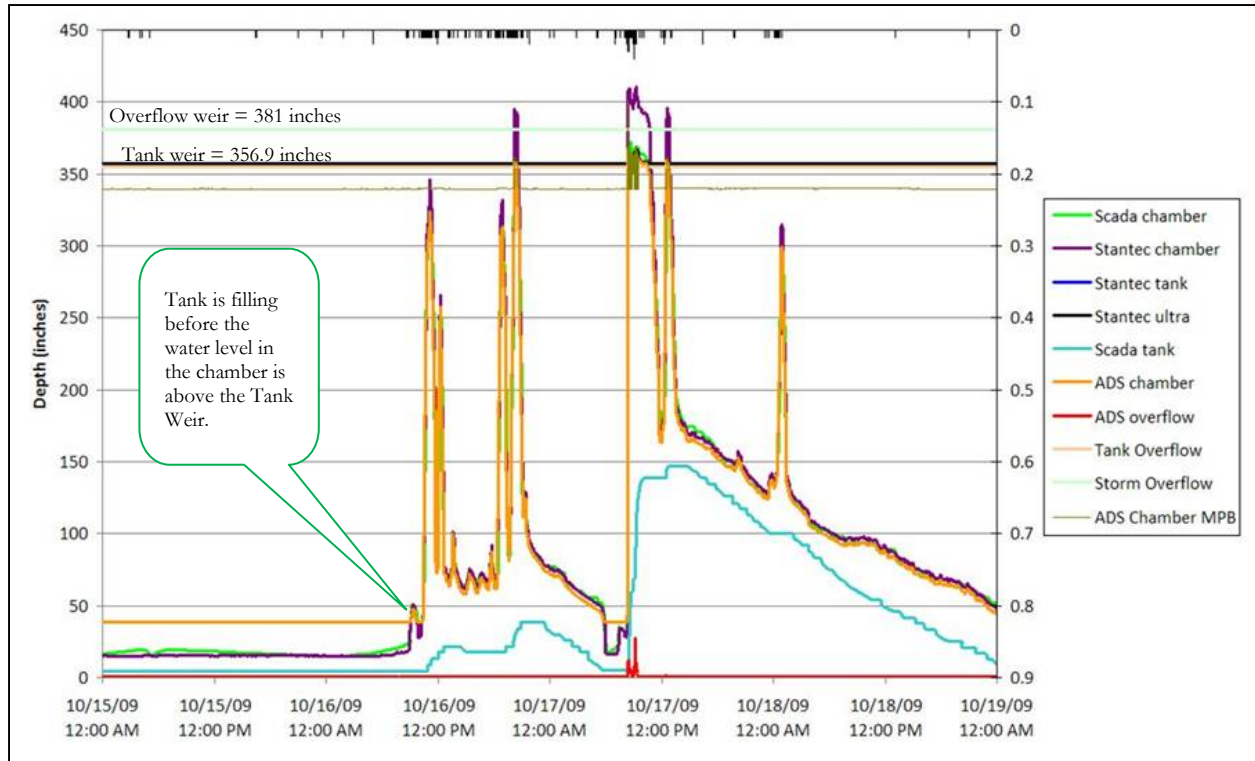
Figure 3-10. DEL168_069-408A (Stantec Ultra): Leaking duckbill valve, note level increase in storage tank prior to depth of storage tank weir

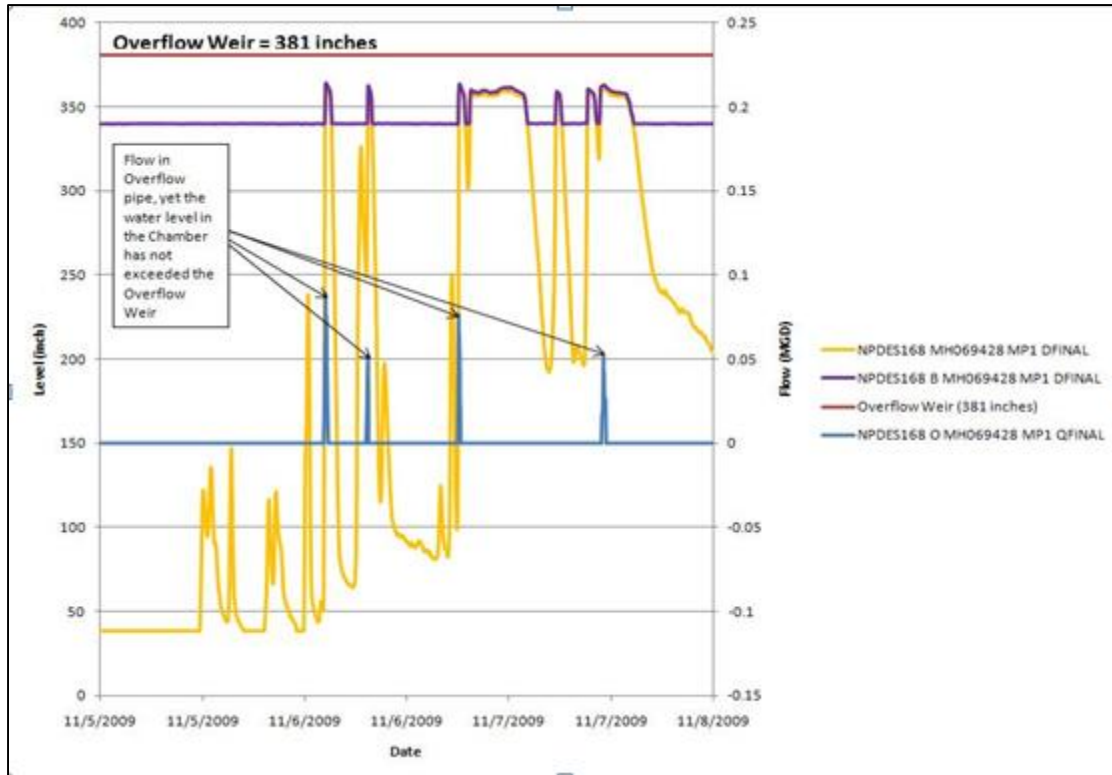
Figure 3-11. NPDES168_O_MH069428: Overflow estimated in overflow pipe, yet the water level in the chamber has not exceeded the overflow weir

The site was removed on 1/6/2010 because it was decided to report CSOs based on level data in MH 069-428 as it recorded more accurate data.

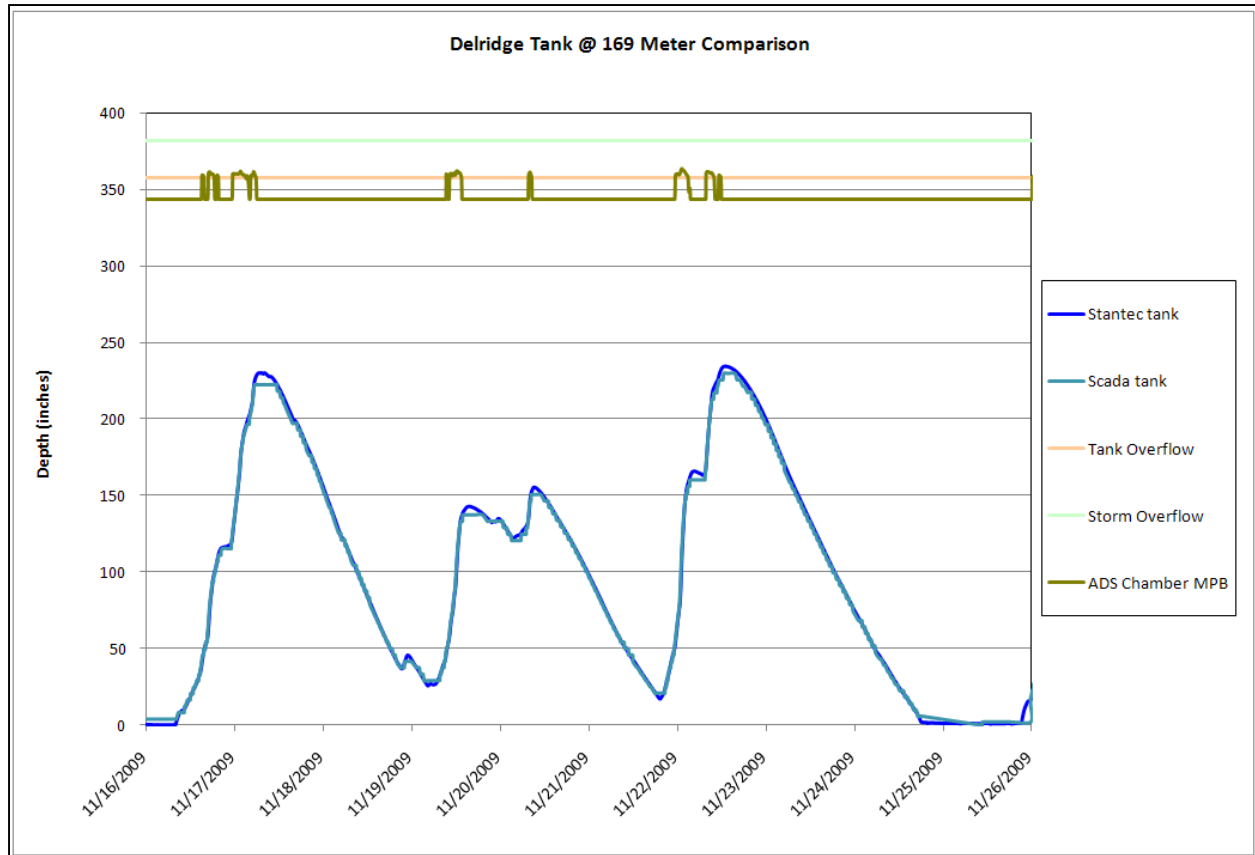
Figure 3-14. DEL169_076-366A (Stantec Tank): Leaking duckbill valve, note level increase in storage tank prior to depth of storage tank weir

The pressure depth probe was mounted on the floor of the storage tank. The site captured suitable data for Phases 2–3. During Phases 1–3 monitoring, data indicated leakage from the CSO chamber through the duckbill check valves, as seen in Figure 3-14. The data quality was classified as “Excellent” for Phases 2–3, which matches the quality classification of the data collected during Phase 1. All data from Phases 2–3 are suitable for use in model calibration.

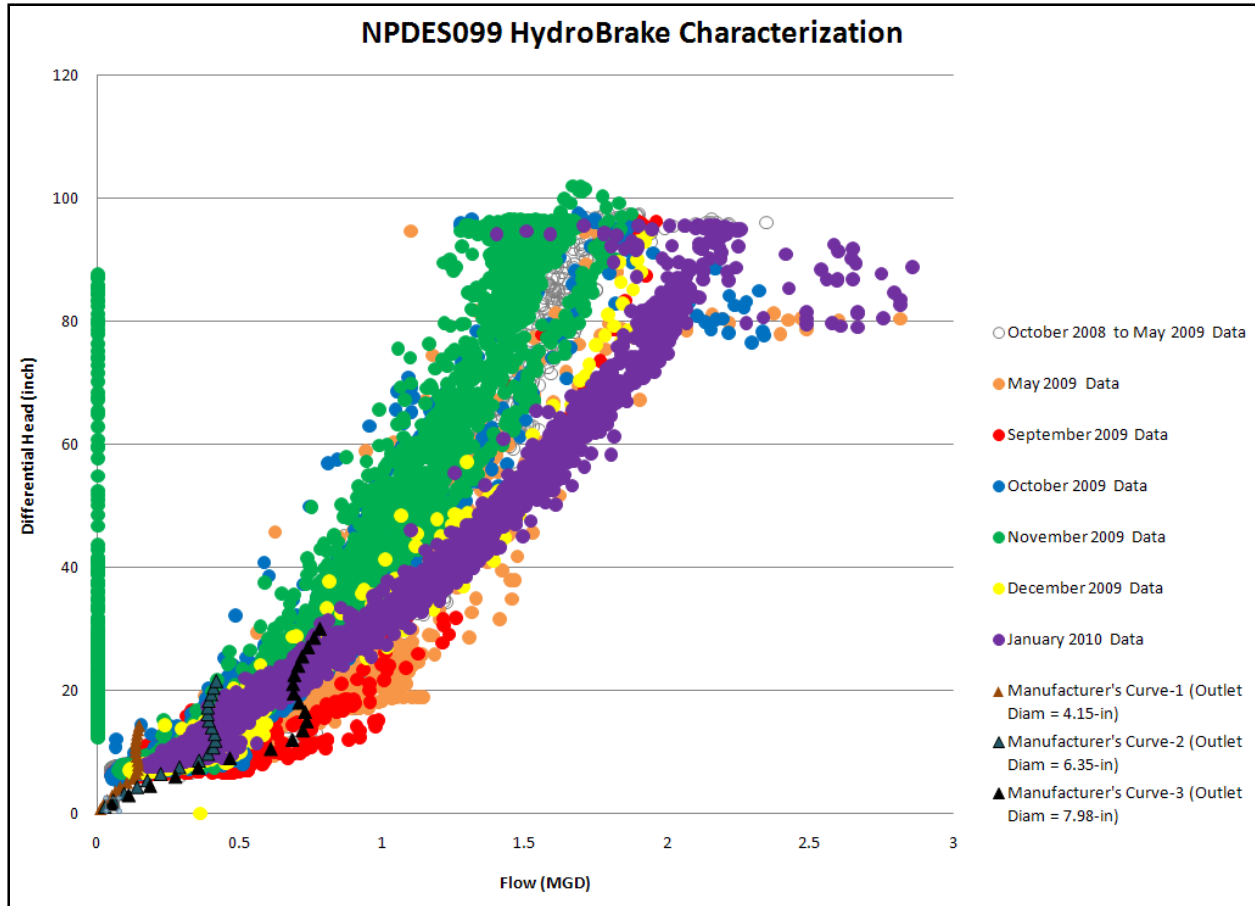
Figure 3-17. NPDES099 Basin HydroBrake characterization

Figure 3-17 shows the HydroBrake curves based upon monitoring data at the upstream meter DEL99_055-175 and the downstream meter DEL99_055-165 with respect to the HydroBrake location. The level data at the upstream meter 044-477 was used for the HydroBrake analysis. The level and flow data at the downstream meter 055-165 were also used for the analysis. The gathered data were then compared to the HydroBrake manufacturer's curve. Figure 3-17 shows October 2008 to May 2009 data (Phase 1 monitoring data), May 2009 data, and September 2009 through January 2010 data.

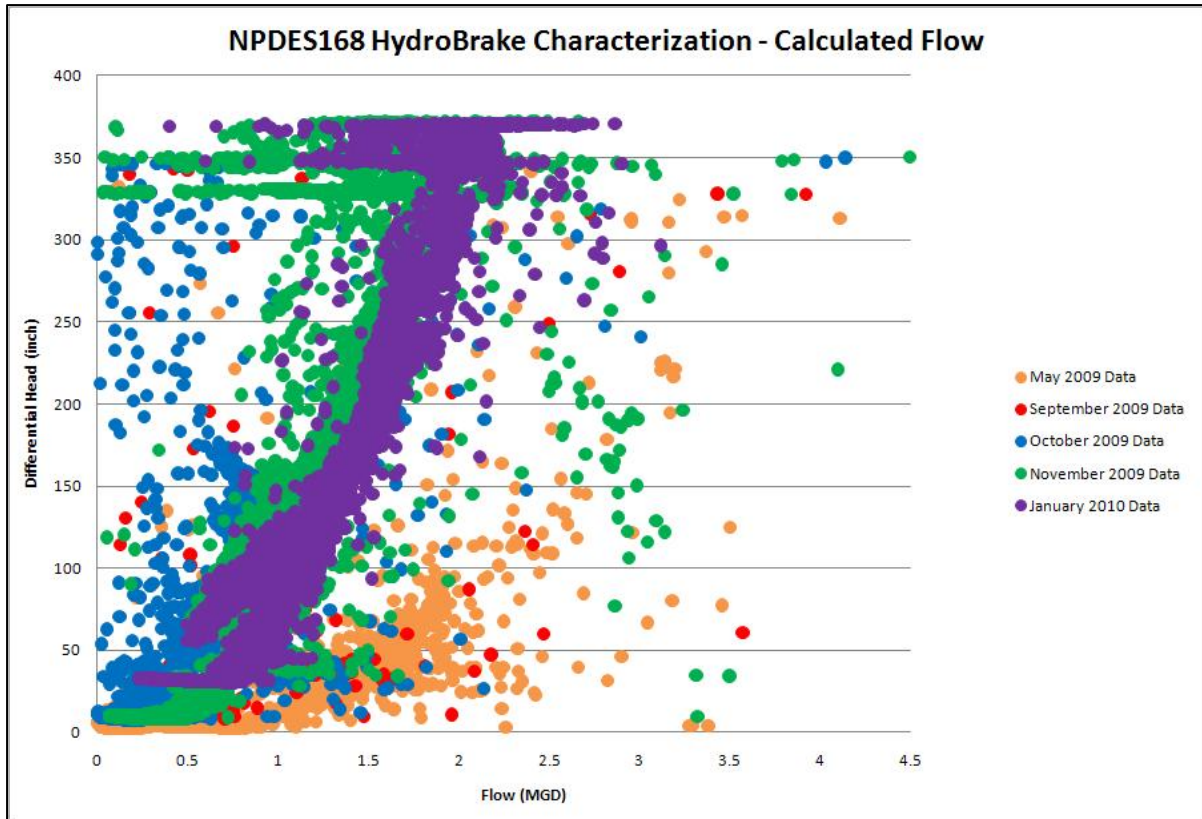
Figure 3-18. NPDES168 Basin HydroBrake characterization: calculated flow

As explained above, the meter at DEL168_069-406 has a history of underestimating flow; therefore, the HydroBrake curve was developed by using a mass balance based on measured upstream flow and storage. The flow rate through the HydroBrake was calculated by using the change in volume in the storage tank and chamber. Figure 3-18 shows the resulting HydroBrake characterization curve.

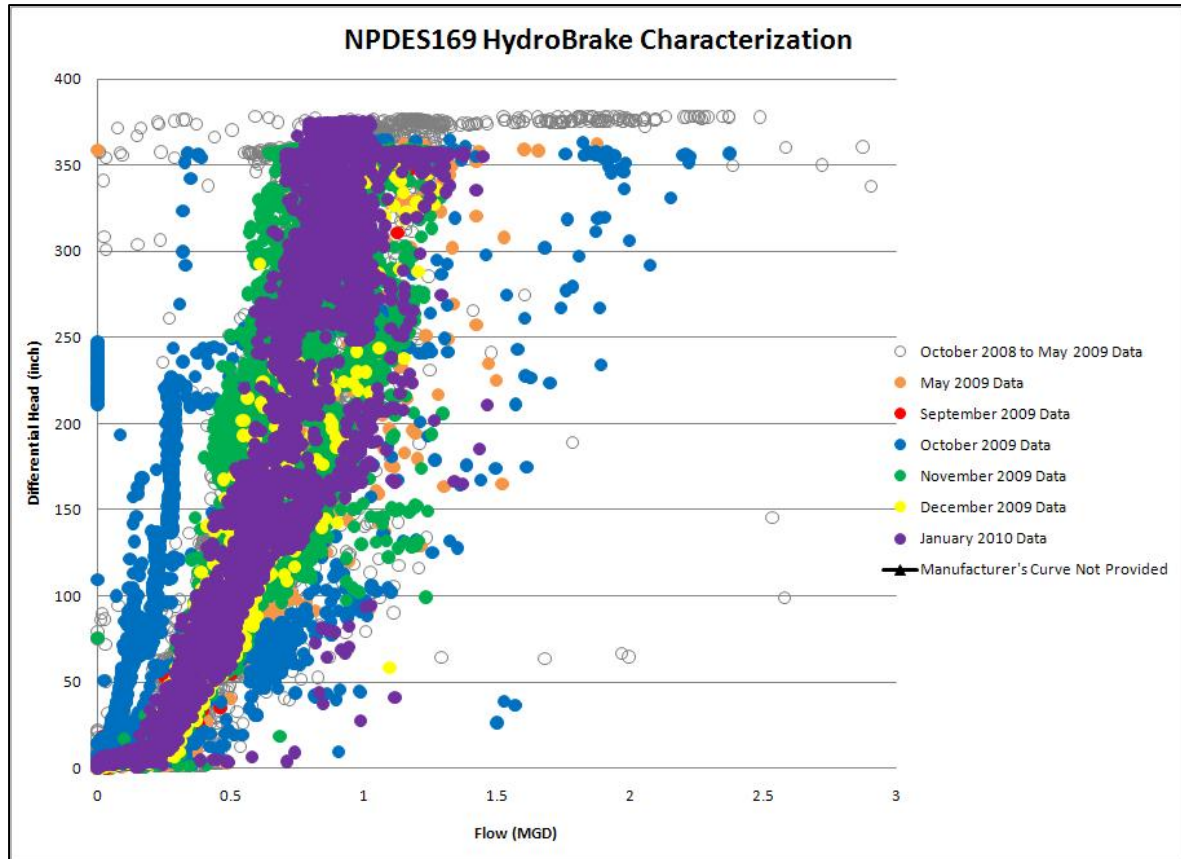
Figure 3-19. NPDES169 Basin HydroBrake characterization

Figure 3-19 shows the HydroBrake curve based upon monitoring data at an upstream meter and a downstream meter with respect to the HydroBrake location. The level data at upstream meter 076-367 were used for the HydroBrake 076-367 analysis. The level and flow data at downstream meter 076-362 were also used for the analysis. The HydroBrake manufacturer's curve was not available for this HydroBrake. Figure 3-19 shows October 2008 to May 2009 data (Phase 1 monitoring data), May 2009 data, and September 2009 through January 2010 data. The flat line of data at approximately 382 inches indicates the overflow height of the weir in the control chamber. The horizontal series of points at the 357.9-inch height indicate flow into the storage tank from the control chamber.

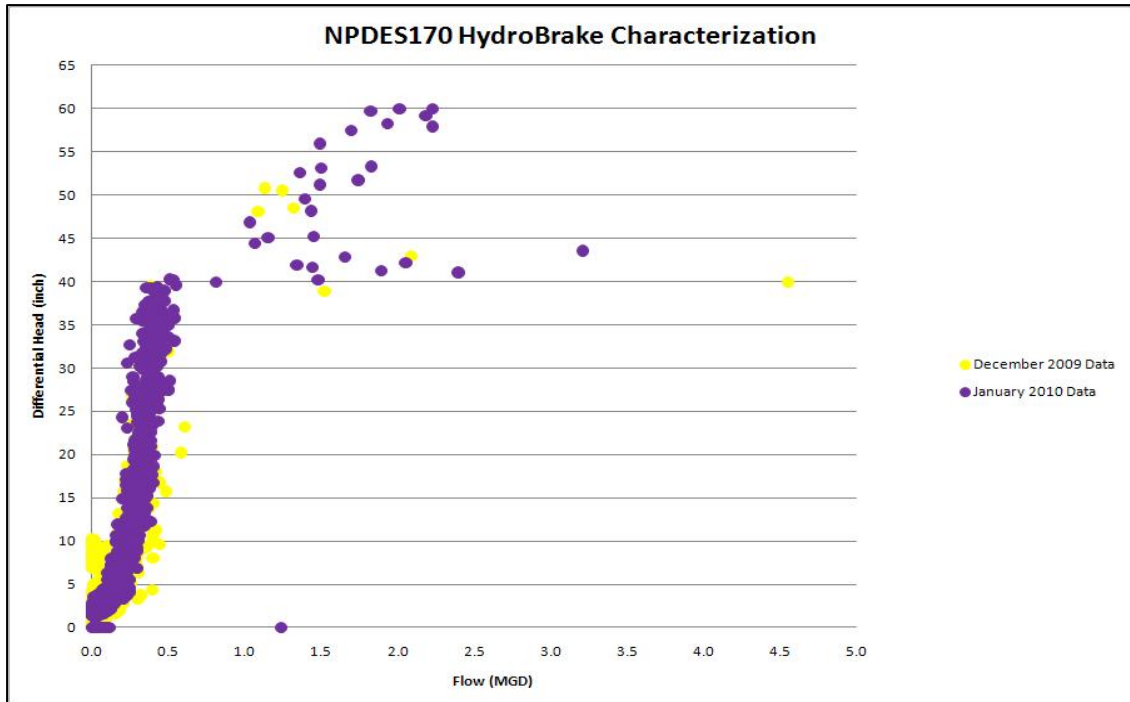
Figure 3-20. NPDES170 Basin HydroBrake characterization

During Phase 2, meters were installed in December 2009 in the storage tank and in the HydroBrake chamber to provide characterization of the HydroBrake. Figure 3-20 shows December 2009 and January 2010 data for the HydroBrake. Because it was not possible to accurately measure the flow out of the HydroBrake at this location, the characterization curve was derived from a mass balance using measured inflow to the chamber together with depths measured in the HydroBrake chamber and storage tank. The horizontal series of points at 40 inches indicates flow into the storage tank from the control chamber.

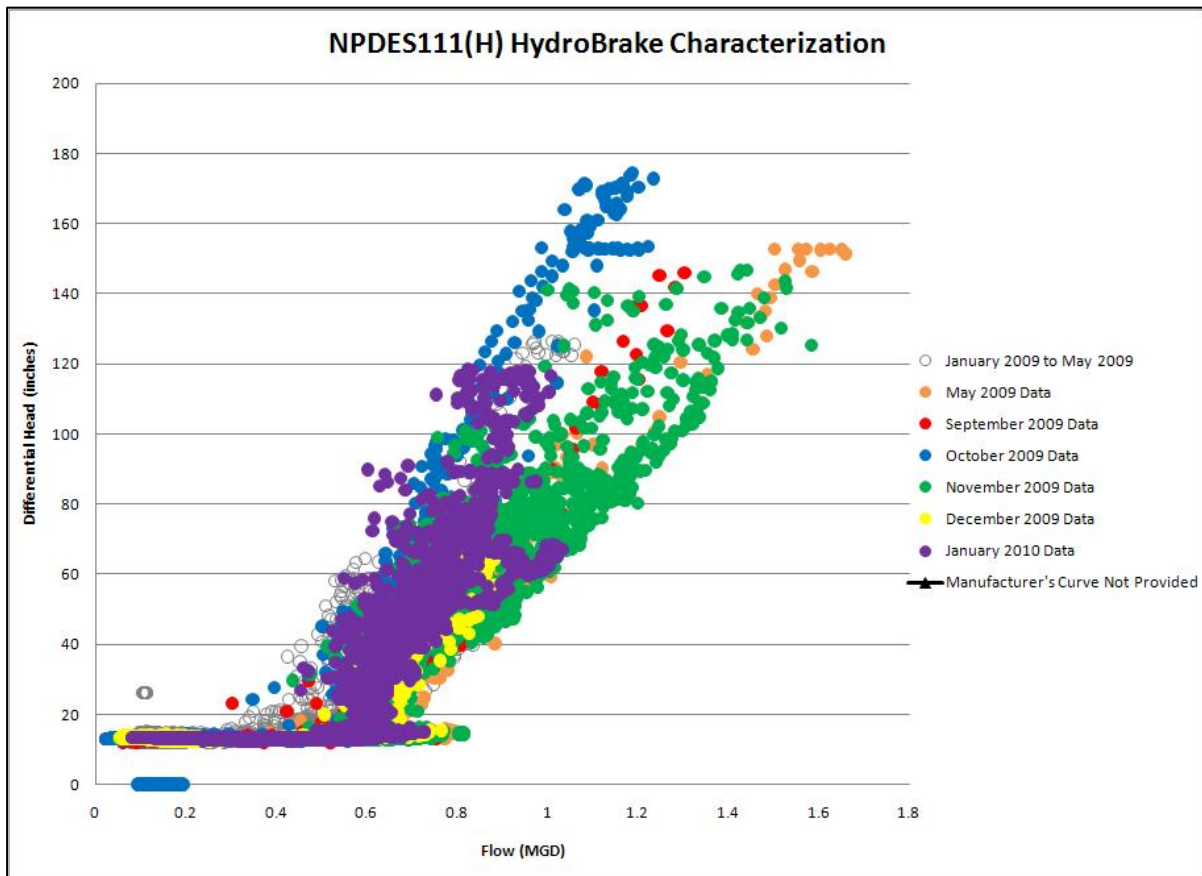
Figure 3-22. NPDES111(H) Basin HydroBrake characterization

Figure 3-22 below shows the HydroBrake curve based upon monitoring data at an upstream meter and a downstream meter with respect to the HydroBrake location. The level data at upstream meter 057-350 and downstream meter 057-229 were used to calculate the head at the HydroBrake. The level and flow data at downstream meter 057-229 were used to calculate the flow going through the HydroBrake. The HydroBrake manufacturer's curve was not available for this HydroBrake. Figure 3-22 shows January 2009 to May 2009 data (Phase 1 monitoring data), May 2009 data, and September 2009 through January 2010 data.

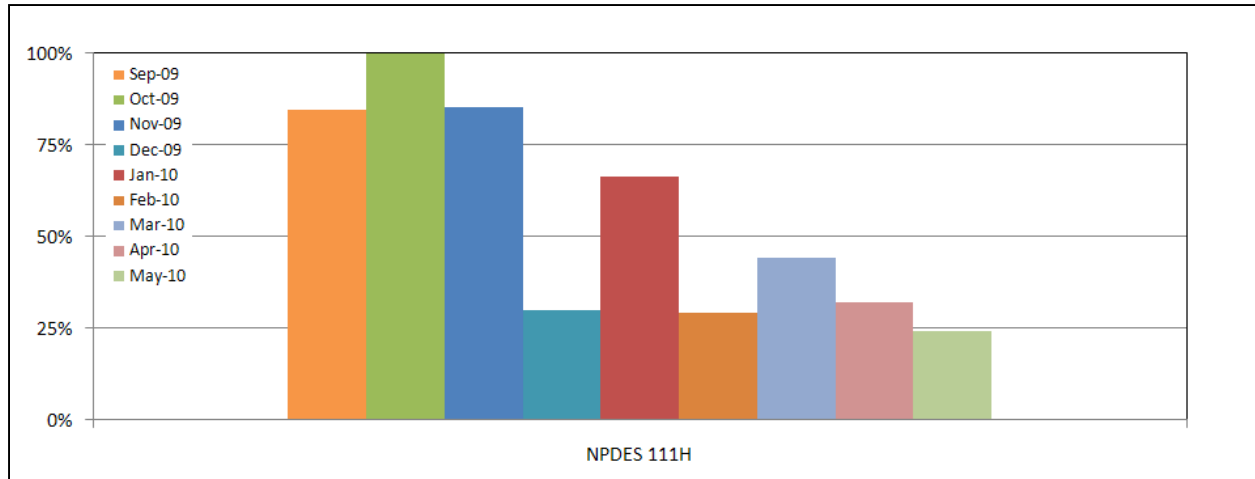
Figure 3-23. Duwamish Basin storage utilization

During large wet weather events, the flow begins to fill the dual-tank system. Each tank is 64 feet long, 10.5 feet wide, and 12 feet deep. The storage was fully utilized during the two October 2009 overflow events as seen in Figure 3-23.

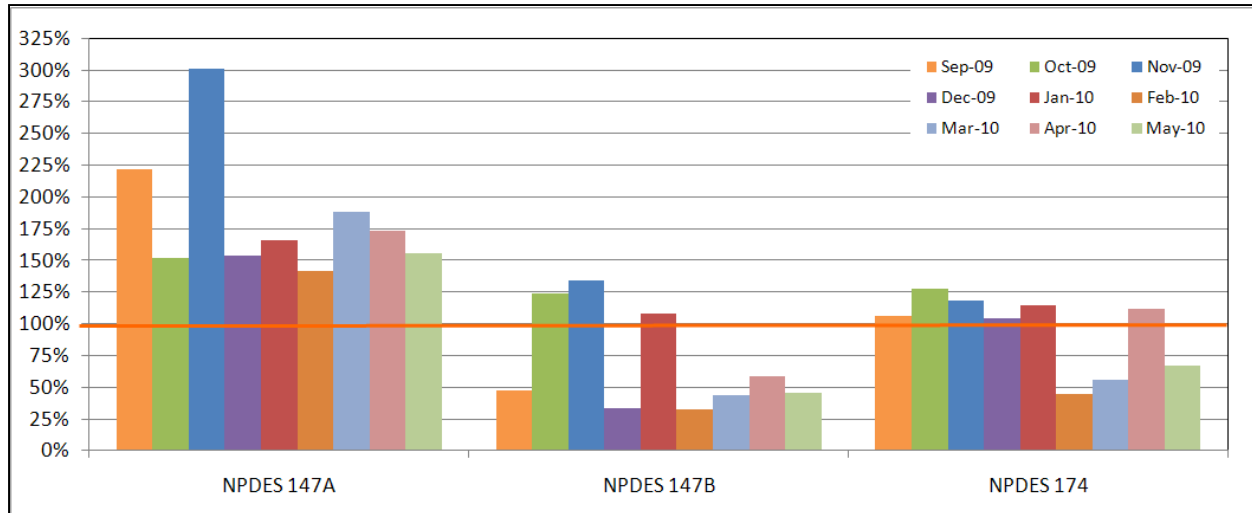
Figure 3-29. Maximum recorded levels in the Fremont/Wallingford Basin compared to weir heights for major events

a. The level on the outfall side of the overflow weir at NPDES147(A) was above the weir elevation, indicating a submerged flow condition over the weir.

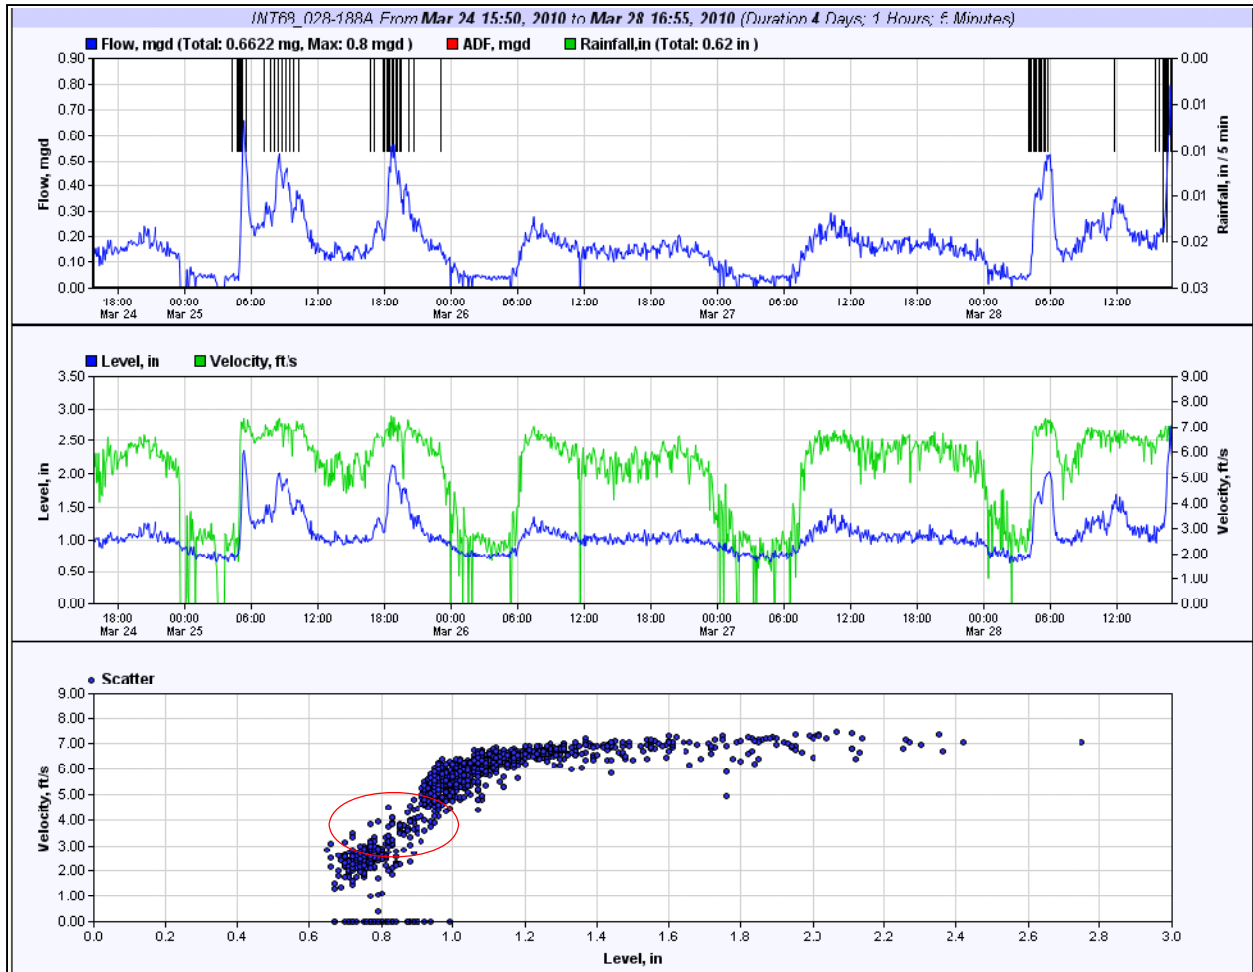
Figure 3-31. Data signature showed jumps over the velocity sensor at INT68_028-188A

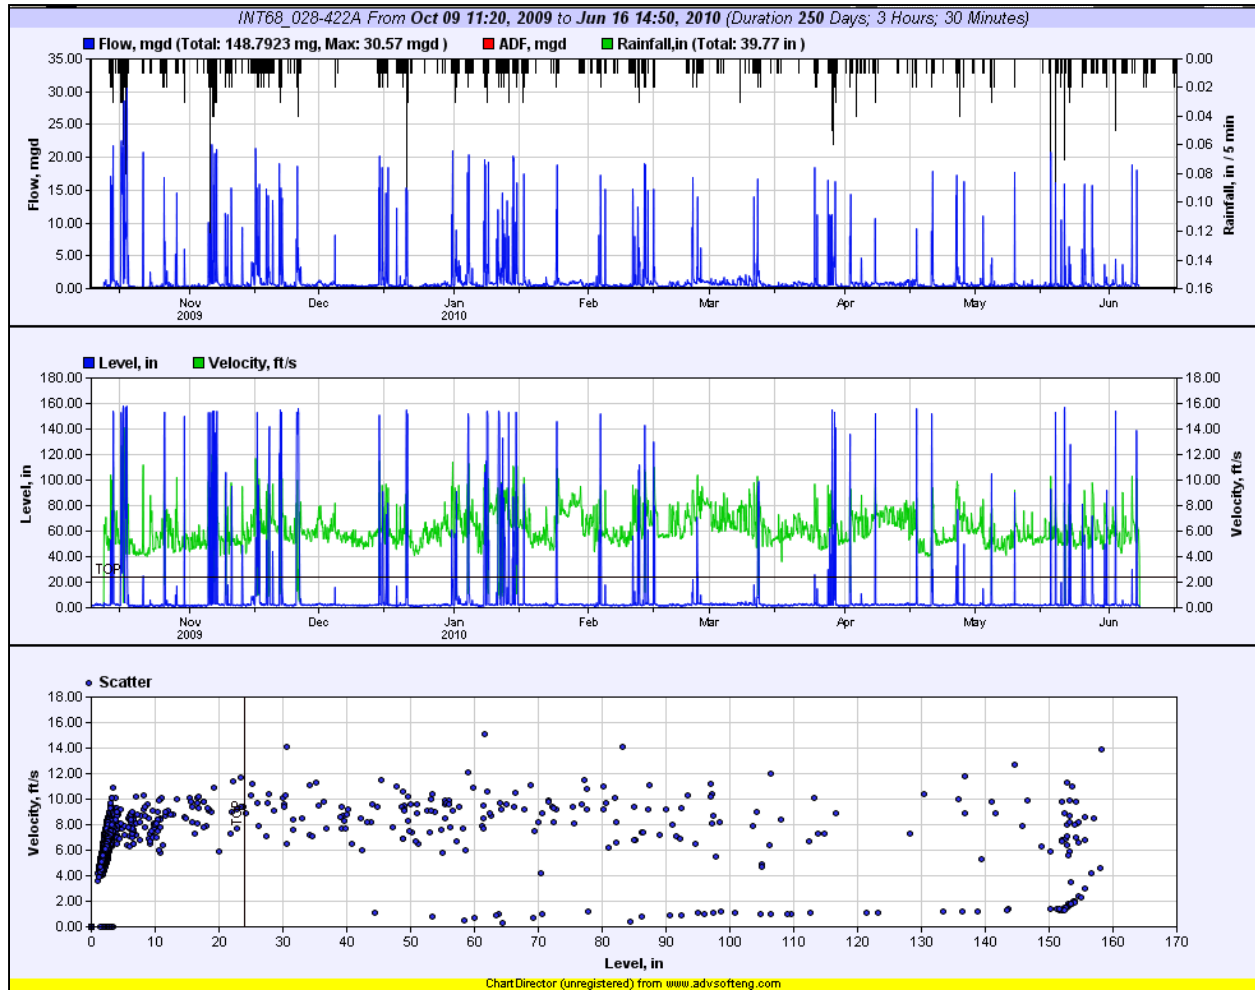
Figure 3-32. INT68_028-422A was surcharged during storm events

INT68_028-422A is located downstream of the overflow structure and just upstream of the HydroBrake in the NPDES068(A) Subcatchment. The site was surcharged during storm events due to the downstream HydroBrake (Figure 3-32). Velocity data are not suitable; only level will be used for model calibration purposes.

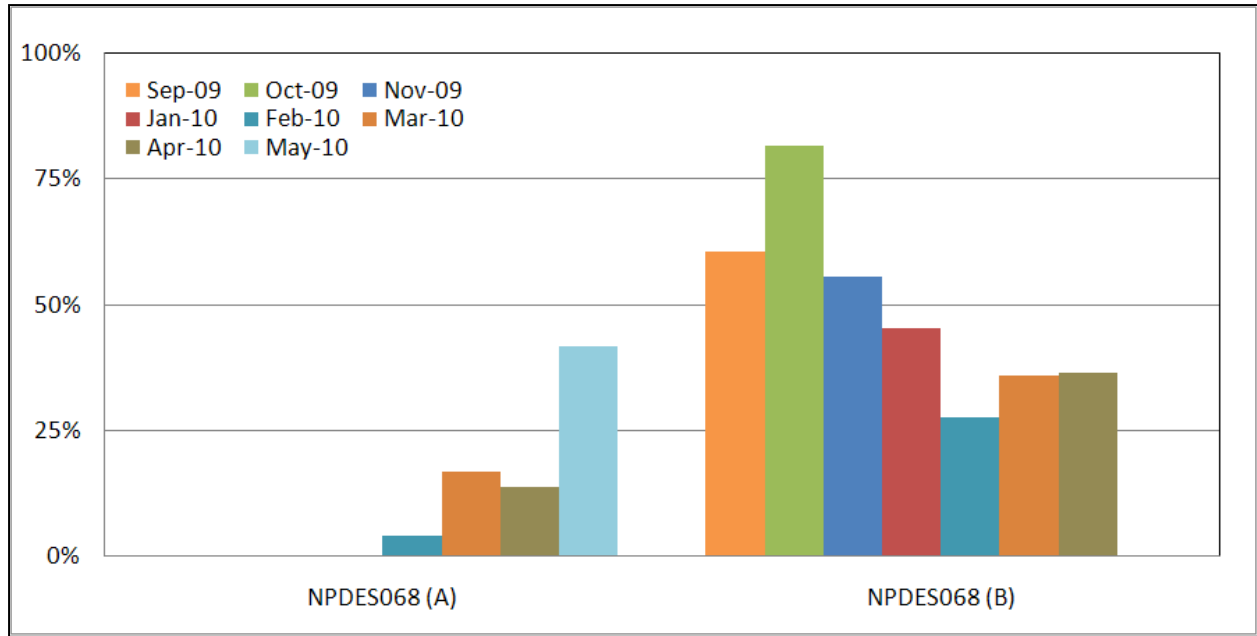
Figure 3-34. Storage utilization in Interbay Basin for major events

The estimated storage utilization in the Interbay Basin is shown in Figure 3-34. Storage utilization was estimated by using the maximum depth recorded at the permanent meter for the NPDES 68(B) Subcatchment and the depth recorded at INT68_028-440A for NPDES068(A). The water depth was compared to the invert level and crown level of the storage structure in order to estimate the percentage of the volume that was used

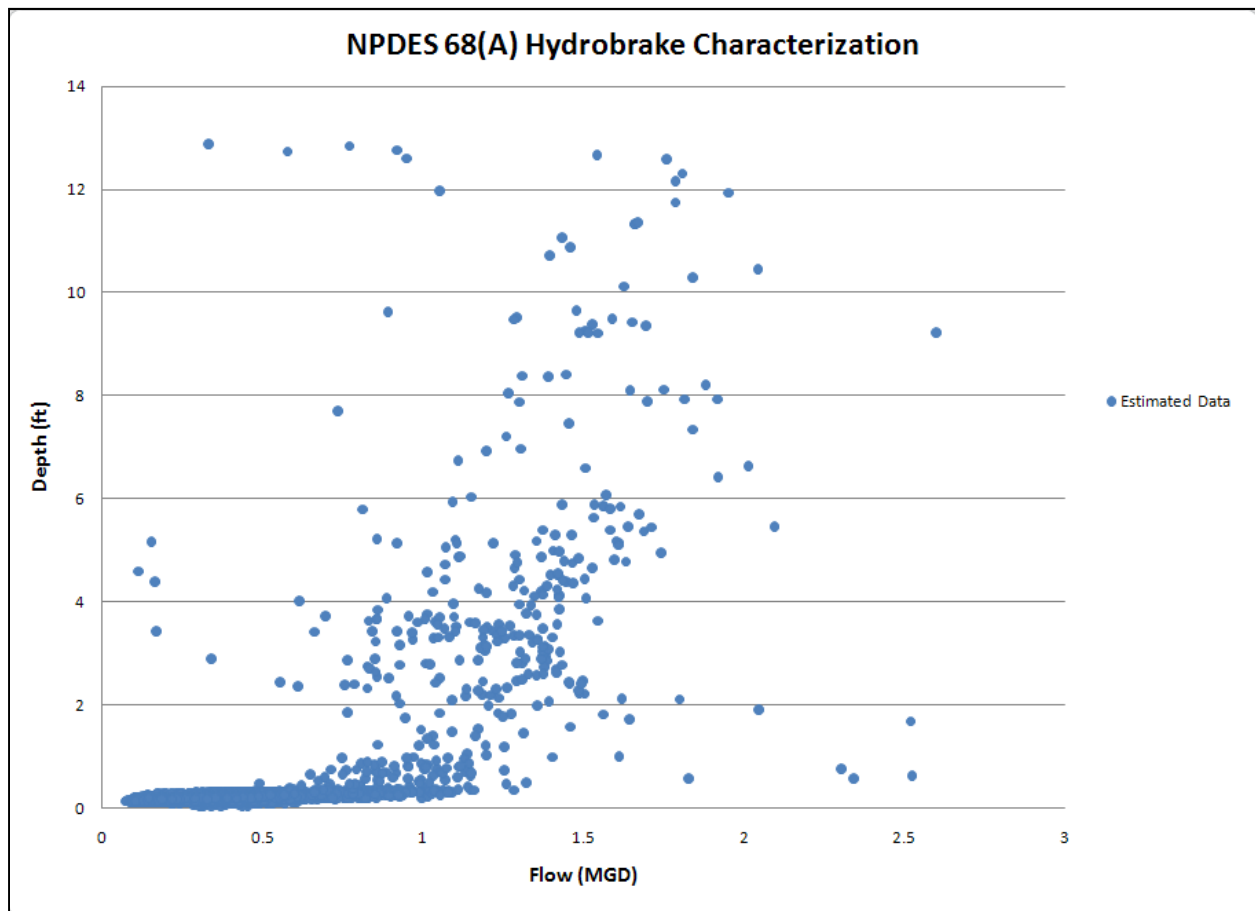
Figure 3-36. NPDES068(A) Subcatchment HydroBrake characterization

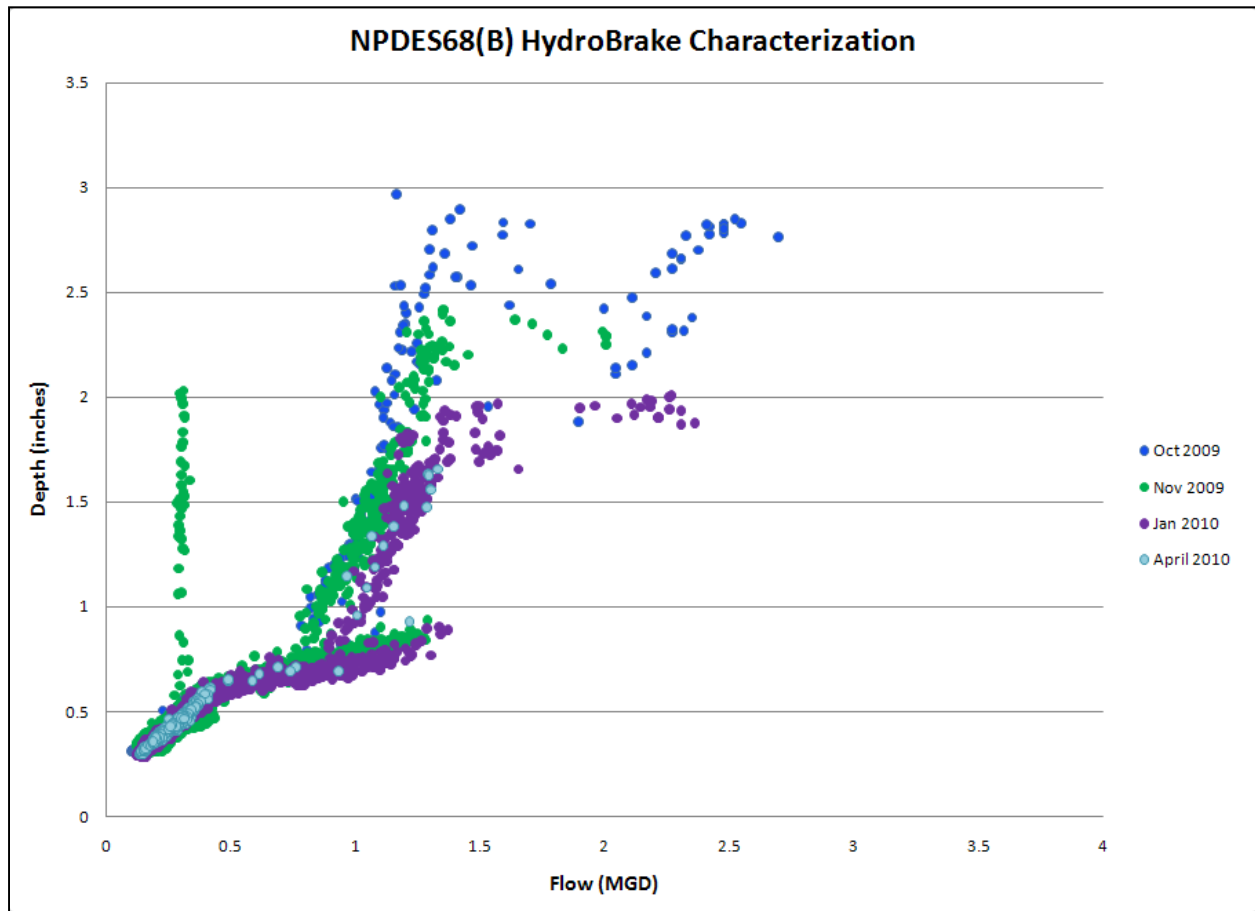
Figure 3-37. NPDES068(B) Subcatchment HydroBrake characterization

HydroBrake 028-431 is located downstream of the overflow structure in CSO Facility 33B. During storm events, the HydroBrake triggers and flows are stored in the 379-foot-long, 48-inch-diameter pipe and the 368-foot-long, 72-inch-diameter pipe upstream. The entire storage was utilized during the October 2009 storm event, which almost produced an overflow. Once the water level reaches the weir elevation at 108 inches above the invert, flows overflow into the drainage system and eventually to Elliot Bay. HydroBrake characterization for NPDES068(B) was performed using flow data collected at MH 028-430A and depth data from the permanent site at NPDES068(B). Data showed two distinct curves based on whether the downstream MH 028-430 was submerged as shown in Figure 3-37.
