Combined Sewer Overflow Program

Long-Term Control Plan

Volume 5 Phases 2-3 Flow Monitoring Report

**PHASES 2 AND 3 FLOW MONITORING REPORT
2009–2010 DRY AND WET SEASONS**

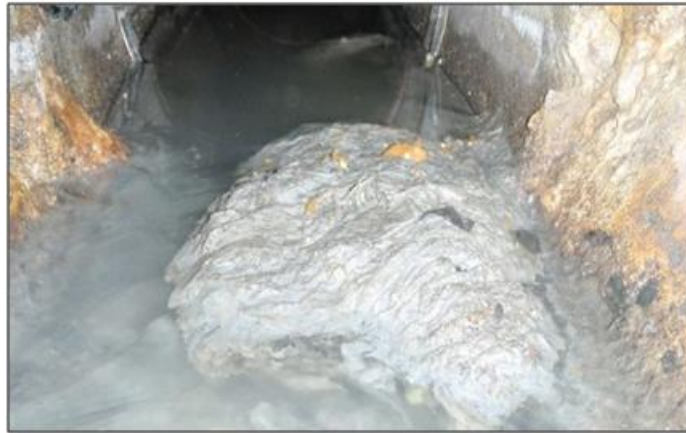
Figure 3-38. Bump upstream of meter at LES026_042-270

LES26_042-270A was located downstream of the NPDES026 Overflow Structure. The collection of reliable data from this site was difficult due to a bump in the channel upstream of the meter (Figure 3-38). During storm events, the meter responded better and there are no data gaps during significant storms. The data quality was classified as “Some Limitations” for Phase 2, which matches the quality classification of the data collected during Phase 1 monitoring. The meter was removed at the end of Phase 2. A limited amount of data may be suitable for model calibration.

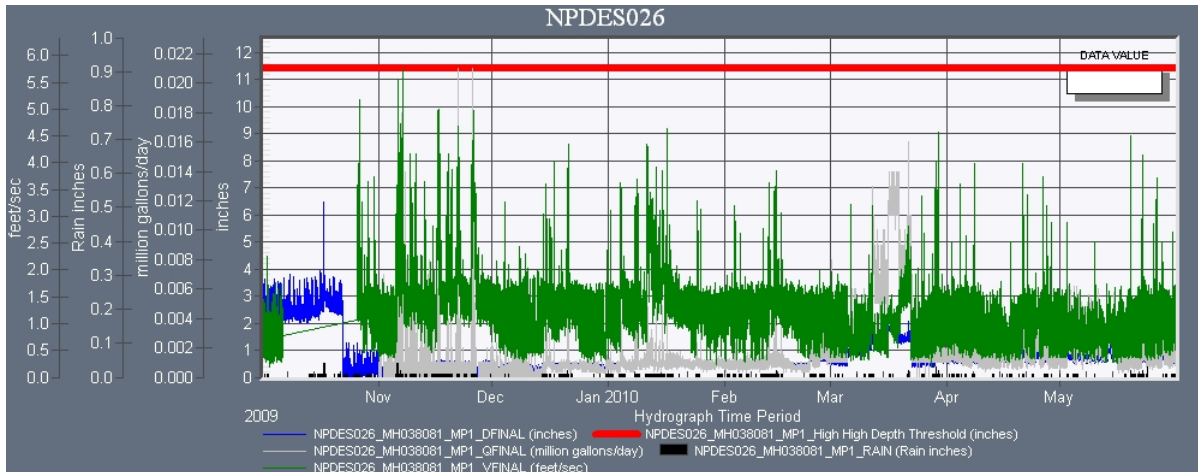
Figure 3-39. NPDES026_MH038081 data signature after cleanout performed by SPU in November 2009

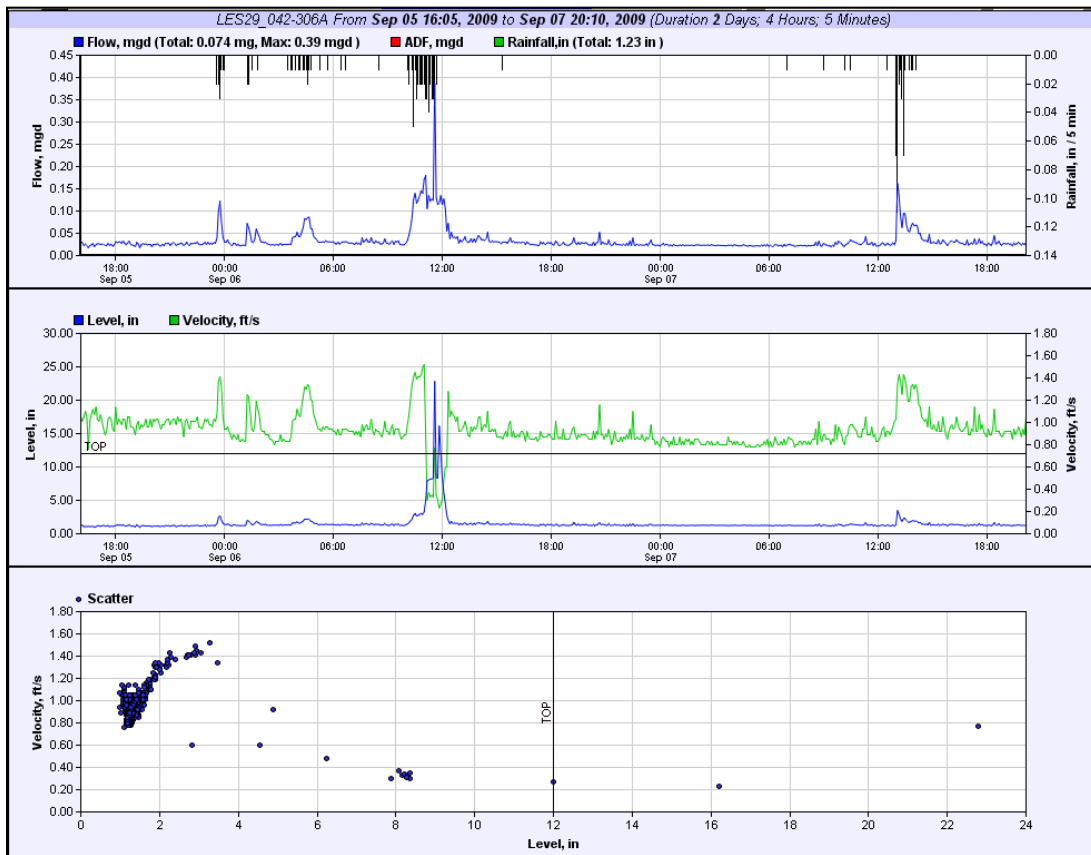
Figure 3-42. LES29_042-306A snapshot of surcharge signature

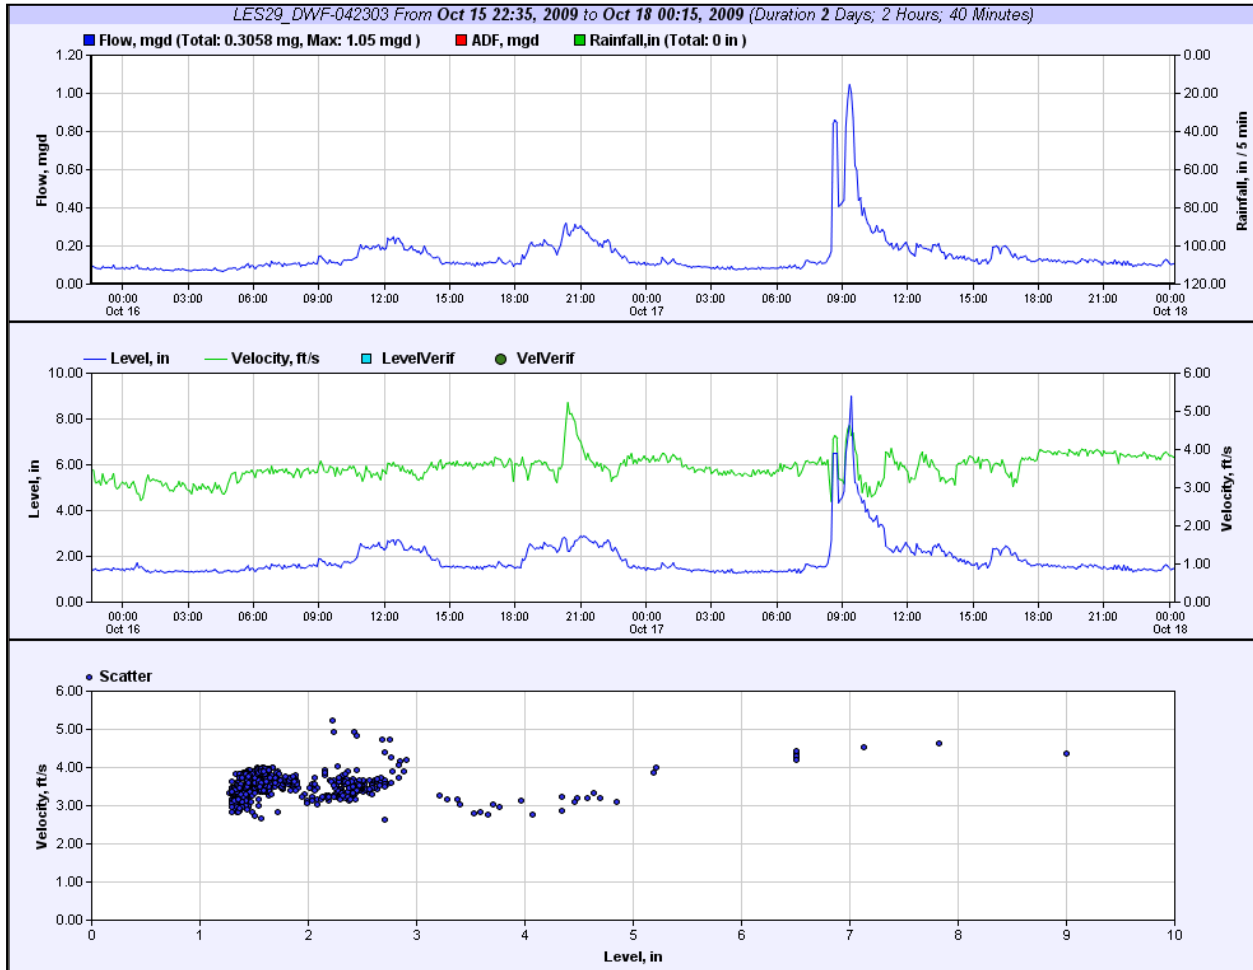
Figure 3-43. Backwater conditions captured at LES29_DWF-042303

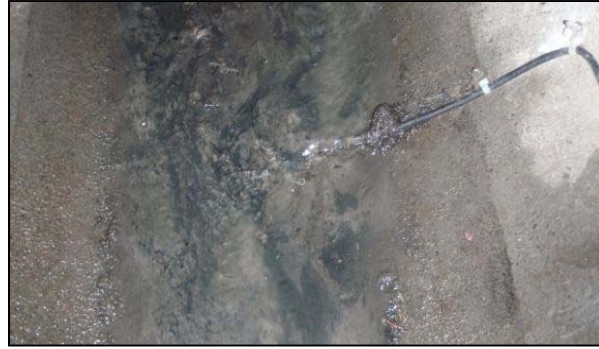
Figure 3-44. LES30_042-205A covered by debris

During Phases 2–3, debris built up at the site, which appears to occur during high flows when the sluice gate is shut and water backs up into the storage pipe (Figure 3-44). The data quality was classified as “Excellent” for Phases 2–3, which matches the quality classification of the data collected during Phase 1 monitoring. All data from Phases 2–3 are suitable for use in model calibration.

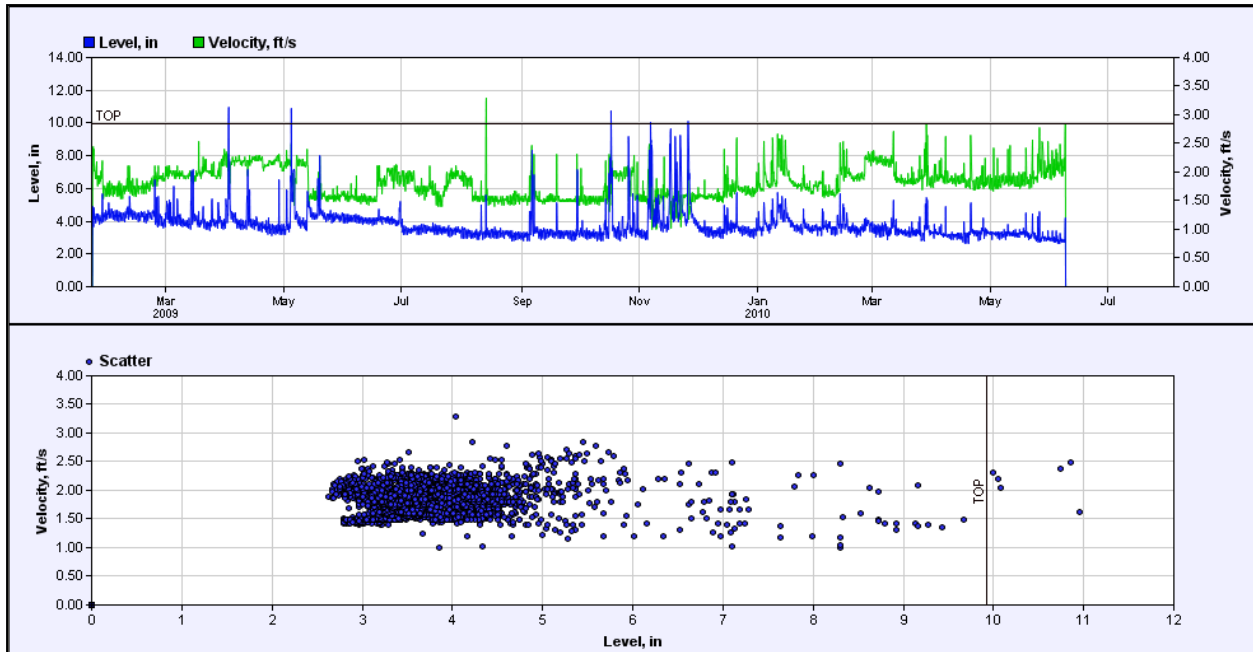
Figure 3-45. LES30_042-206B data signature; velocity was edited heavily during data finalization

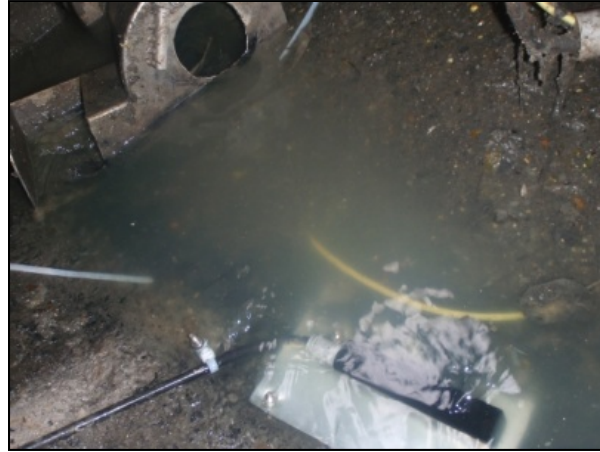
Figure 3-54. LES35_046E-138 HydroBrake cleanout gate open

On 10/9/2009, the cleanout gate on the HydroBrake was permanently opened to simplify the understanding of this structure (Figure 3-54).

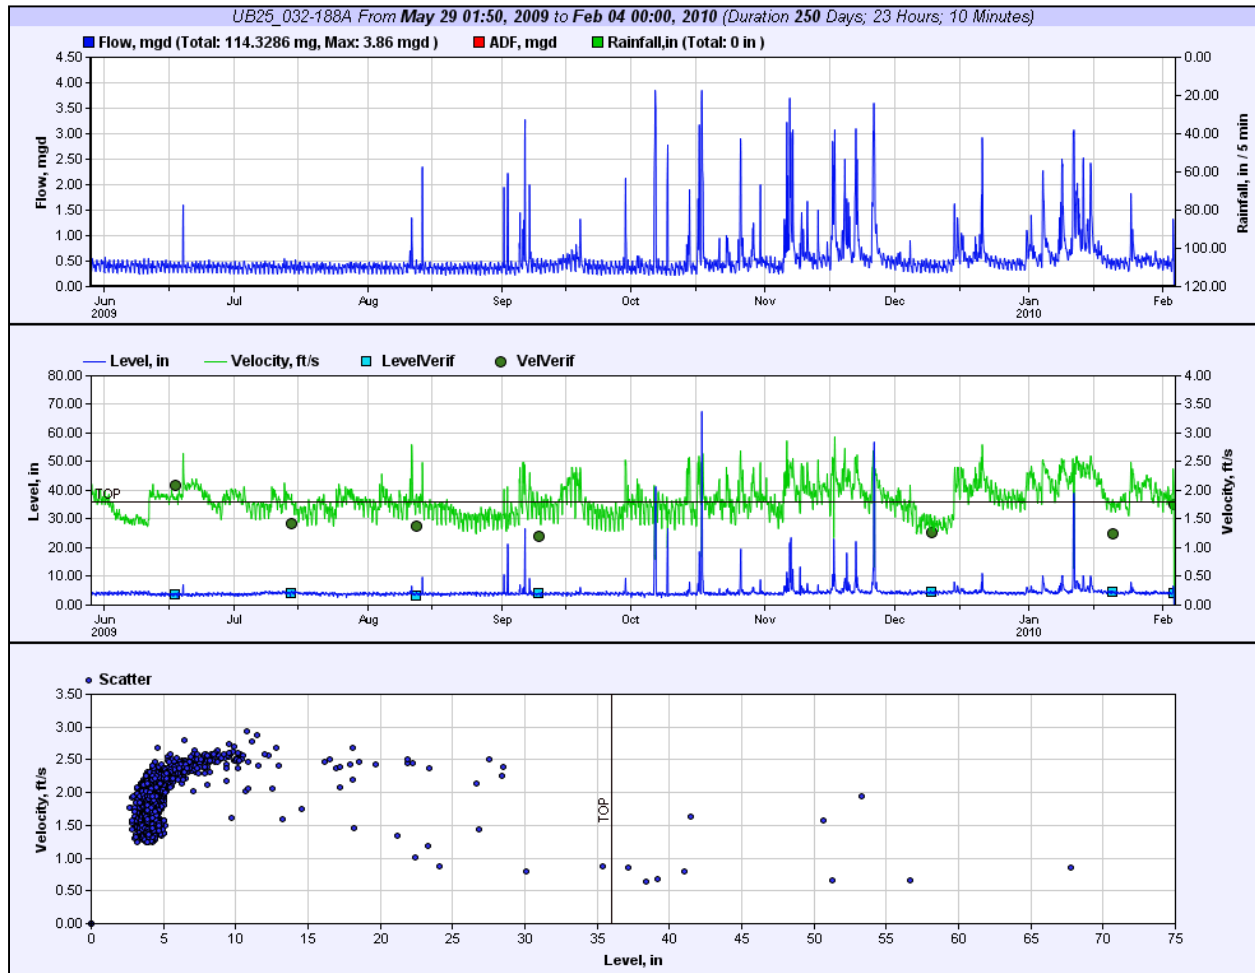
*Figure 3-64. Surcharging and apparent flow overestimation at UB25_032-188A.
Overestimation of velocity could be a result of waves caused by downstream pump station.*

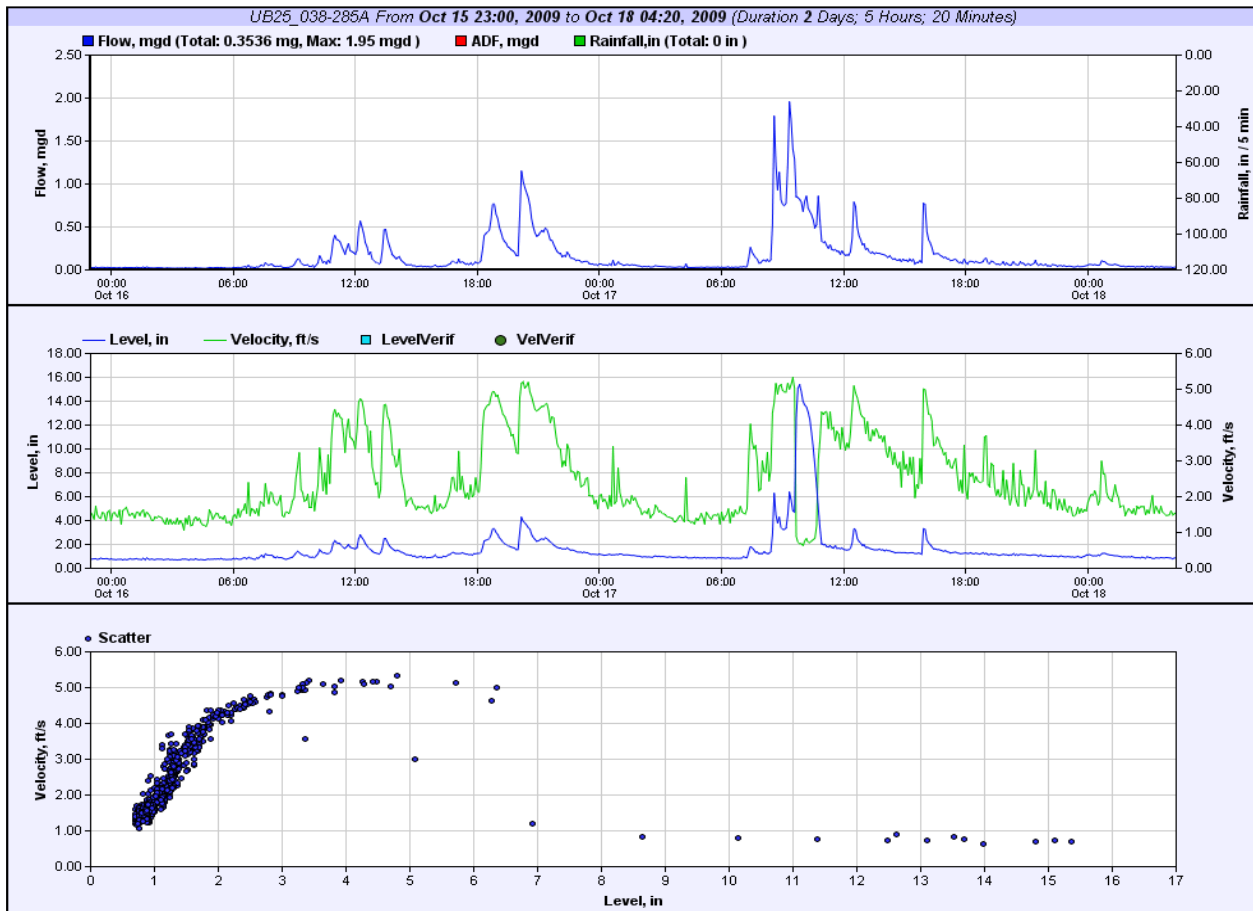
Figure 3-65. Backwater effect during peak flows at UB25_038-285A

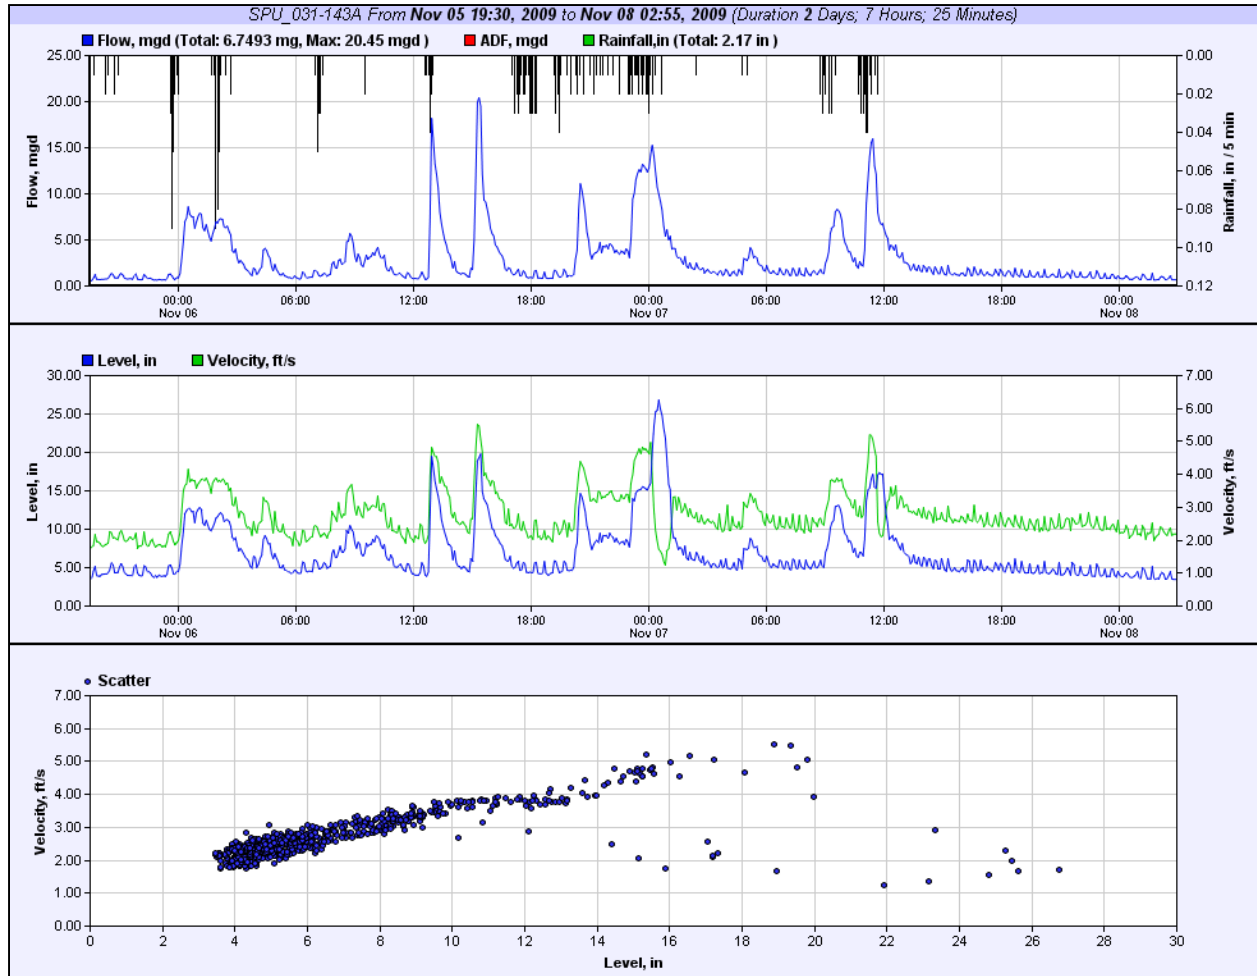
Figure 3-68. Backwater conditions during peak of storm events at SPU_031-143A

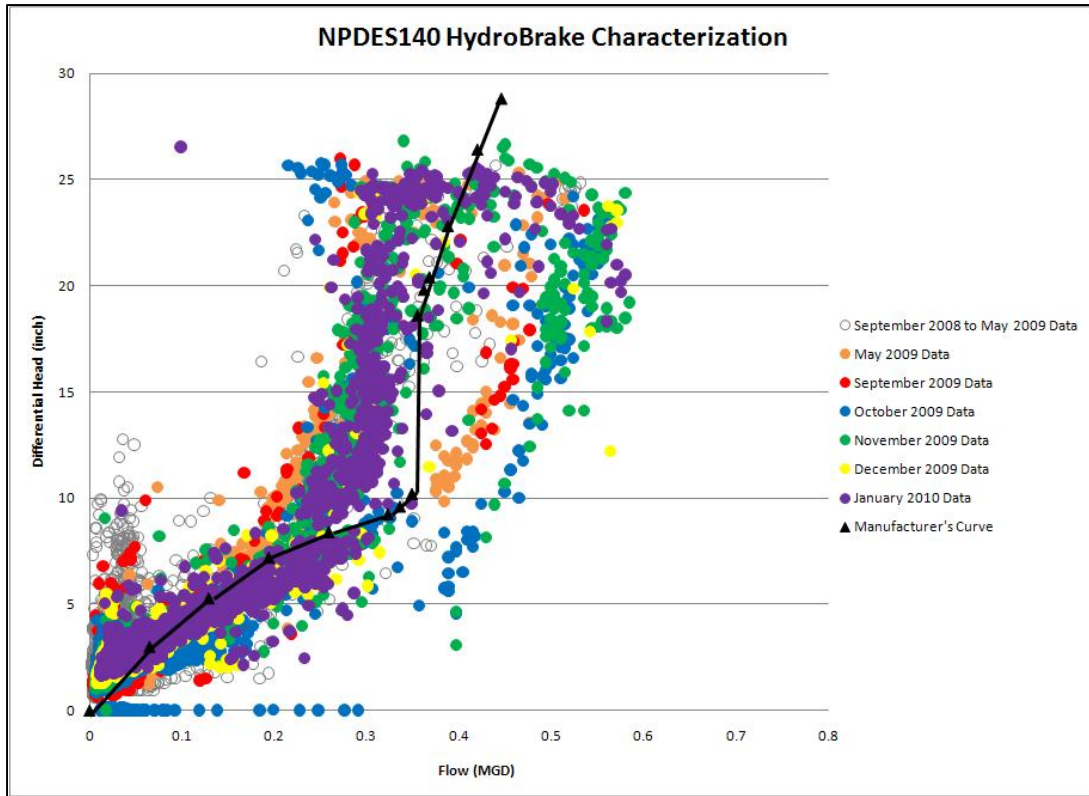
Figure 3-71. NPDES140 Basin HydroBrake curve

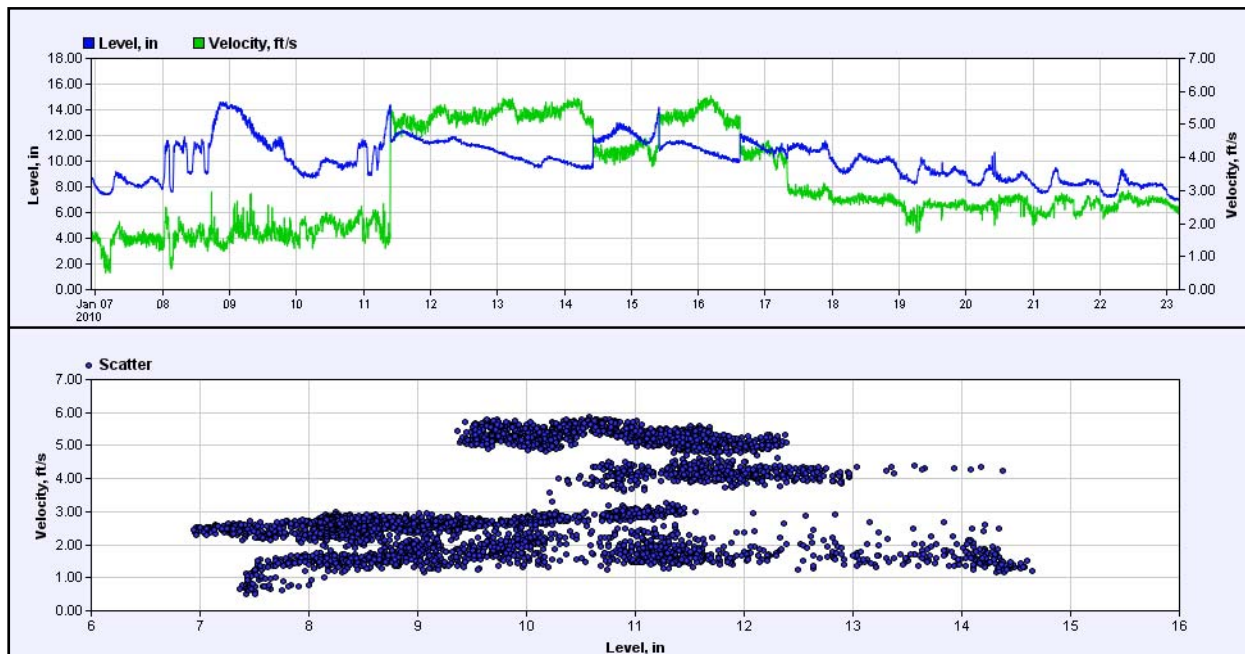
Figure 3-72. Siphon effect at NUB18_016-197A hydrograph and scattergraph from 1/7/2010 to 1/23/2010

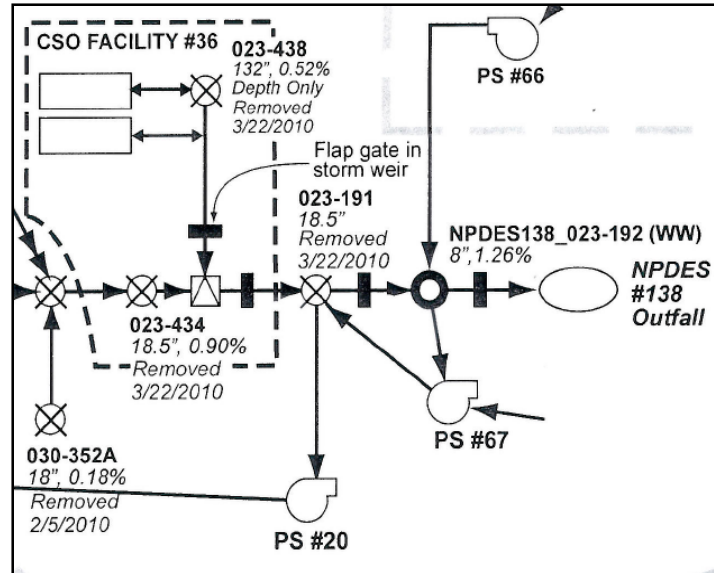
Figure 3-85. Flow schematic of CSO Facility 36

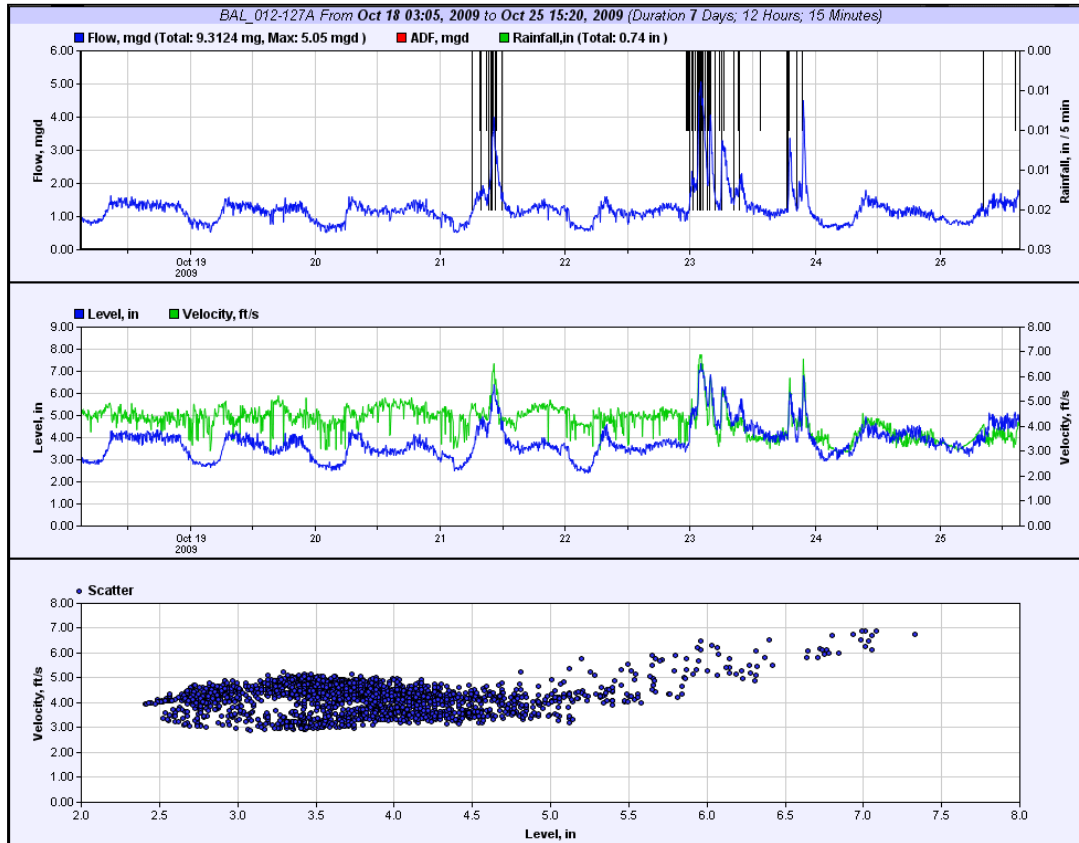
Figure 3-86. BAL_012-127 data signature showing indication of debris accumulation

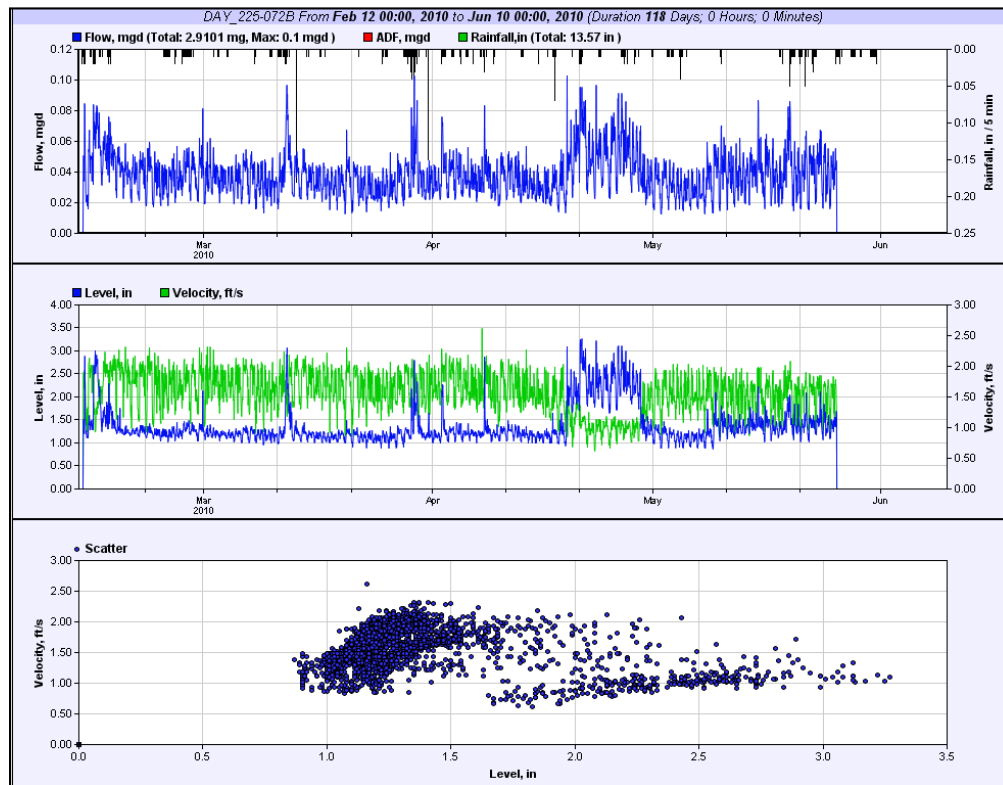
Figure 3-91. DAY_225-072B shows poor relationship between velocity and level

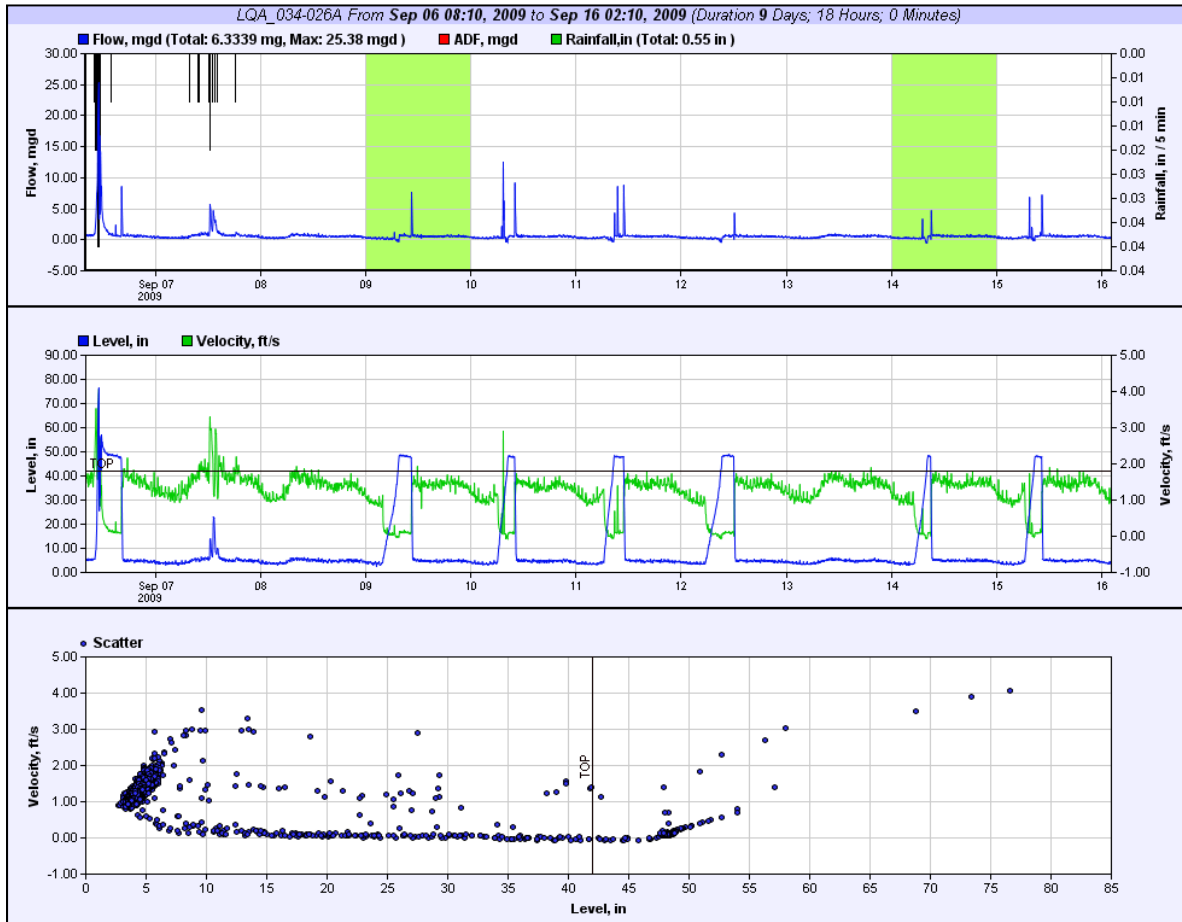
Figure 3-101. LQA_034-026A daily backup due to operation of King County's Denny Way regulator

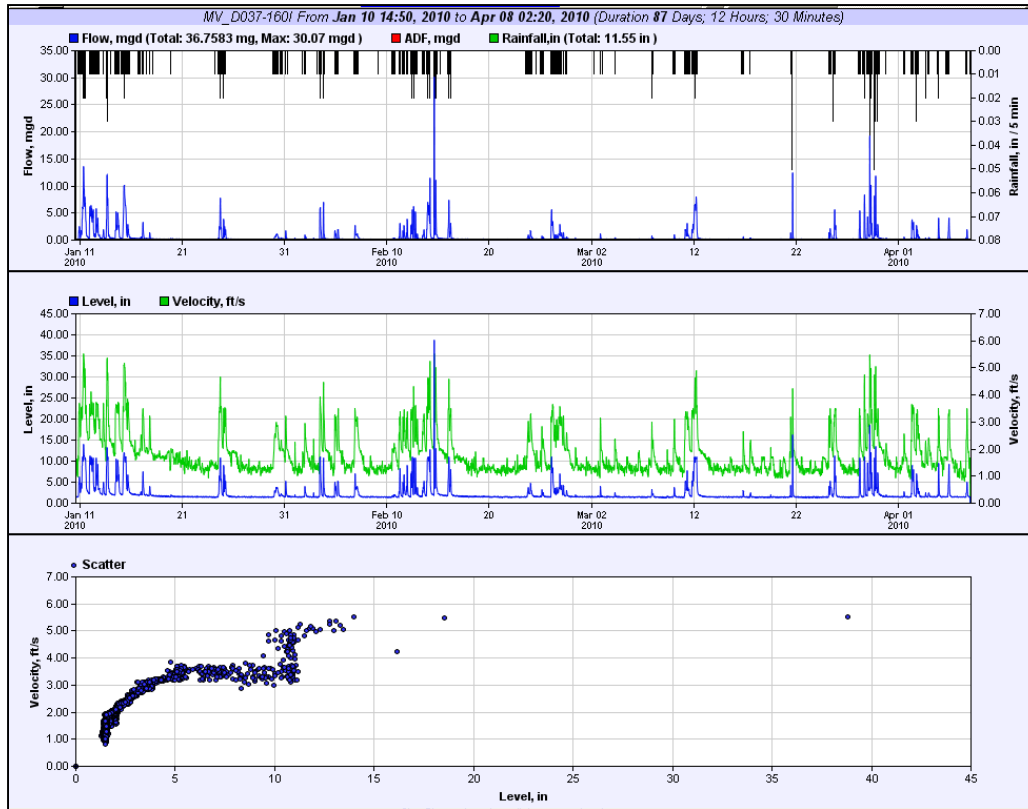
Figure 3-104. MV_D037-160I data show the effect of the gates operations
