Sledge Seattle Residential Deconstruction Case Study

2 EXECUTIVE SUMMARY

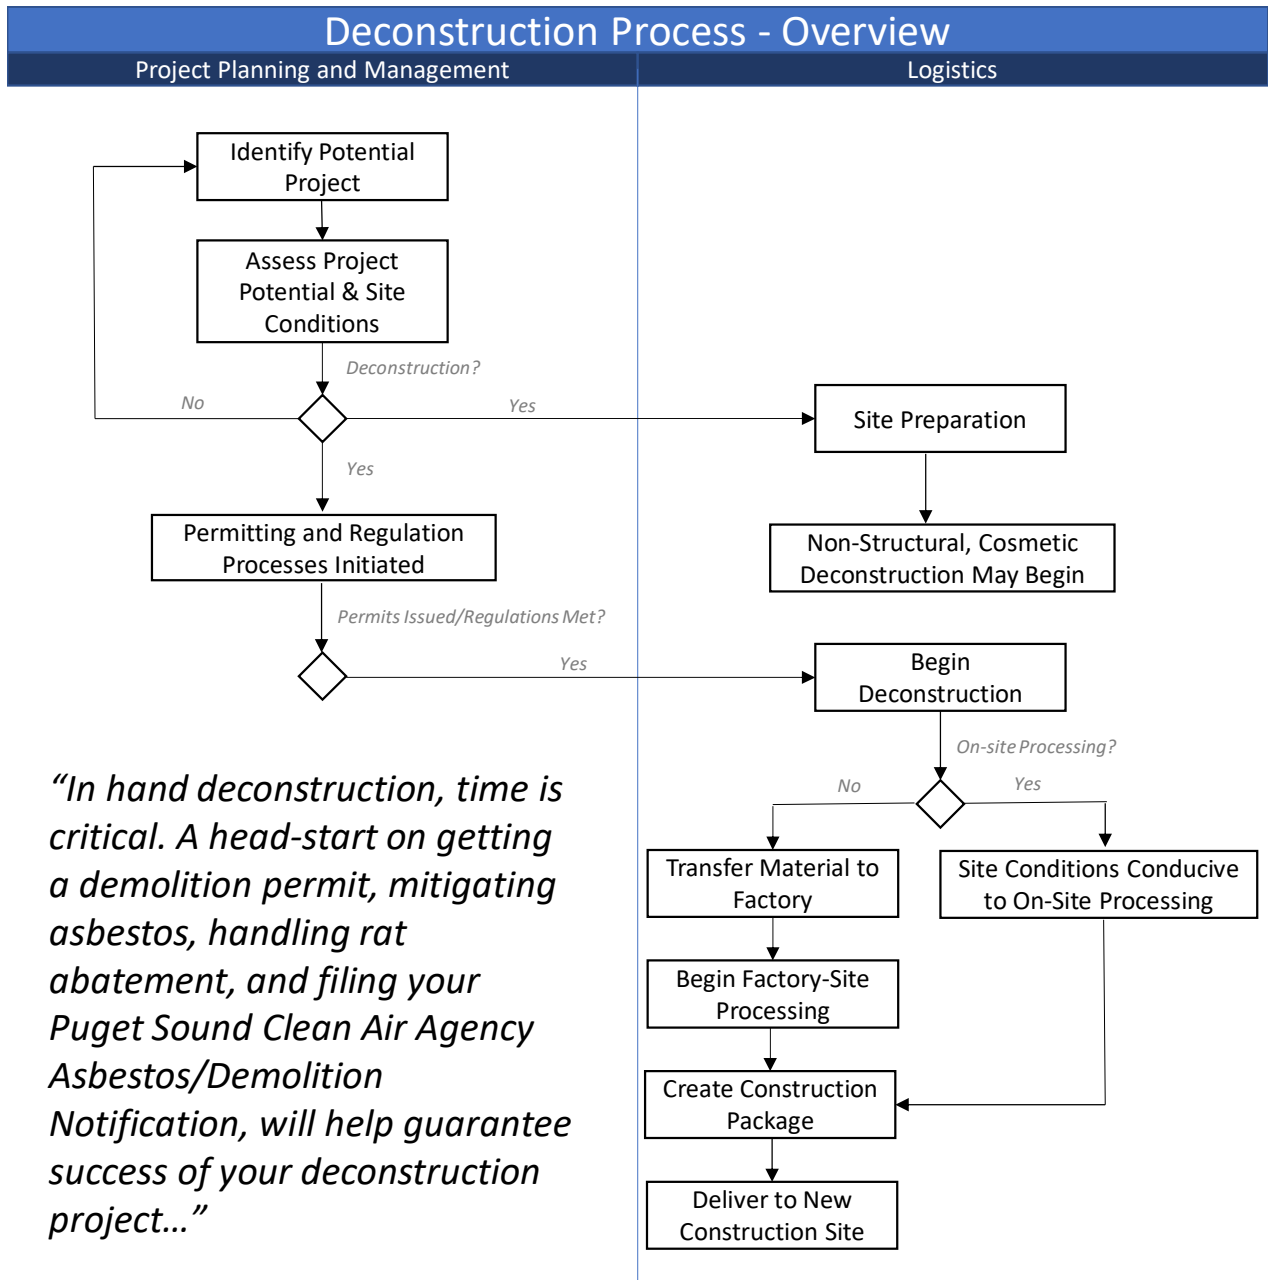
Figure 1 - General Flow of Seattle Sledge Deconstruction Process

The following illustration provides the general flow of the Sledge Seattle deconstruction process.

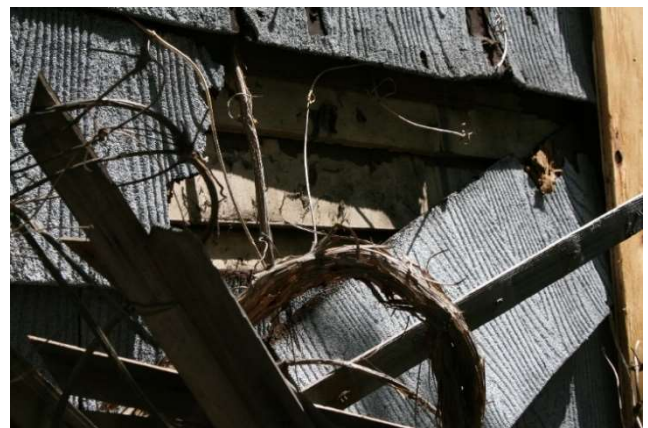
Figure 3 – Newer asphalt siding pulled aside to reveal the original wood siding beneath.

- The building year (1915) was in the timeframe of higher quality (old growth) wood, and a time when only nails were used in building instead of newer adhesives or other petroleum derived building material products.
- The home was platformed framed, and the wood is the most valuable of existing materials, particularly the shiplap which was extensively used on all assemblies (walls, & floors)
- Douglas Fir accounted for most of the framing and finishes
- There was little indication of decay, which harms future resale value
- The lot was difficult to access with traditional demolition equipment, thereby giving the owner more incentive to agree to a more time-consuming hand deconstruction process.

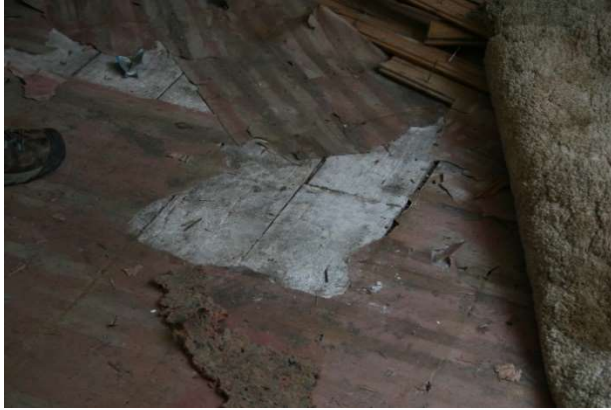
Figure 4 - Flooring materials removed to expose underlying floor joists

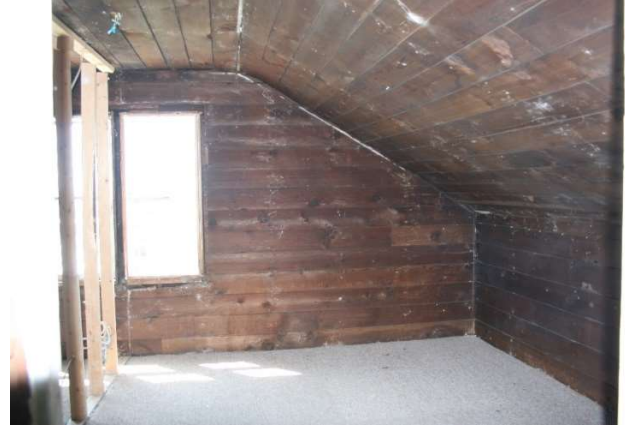
Figure 6 - Unfinished top floor with shiplap

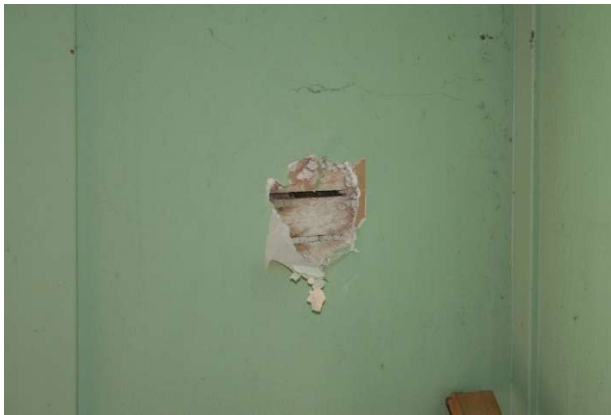
Figure 5 - Dry wall removed revealing lath.

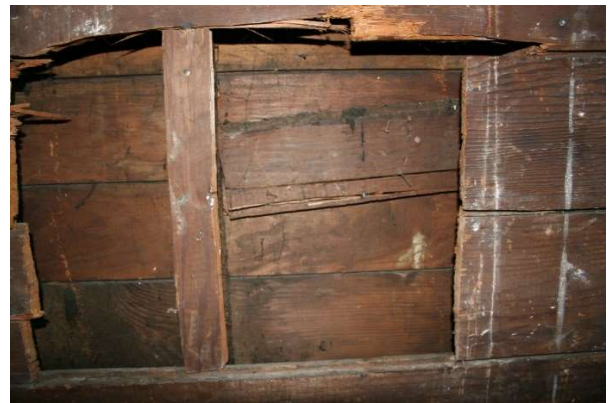
Figure 7 - Cutaway area of top floor showed an additional layer of shiplap

ShipLap produced an abnormally large amount of lumber because it had shiplap both outside (typical) and inside (atypical in our experience) the framing. The materials harvested, broken out by type, are listed in the following table.

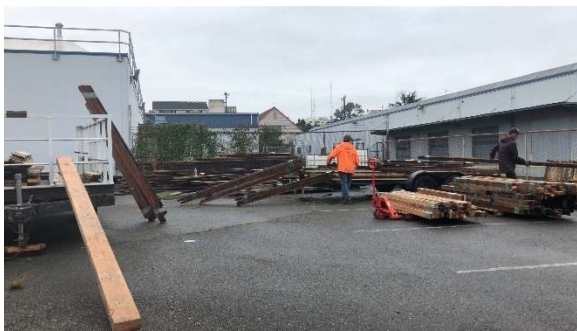
Figure 11 Crew unloading harvested wood from ShipLap at the Curtain Factory

Trailer loads of harvested lumber were stacked in the large parking area. Inside the processing area wood was stripped, trimmed, and then finished. The finished wood was stacked to dry, and then sorted by length.

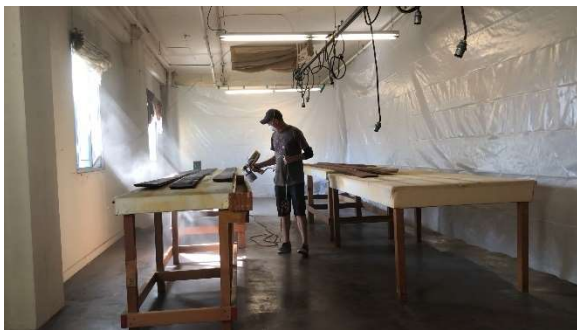
Figure 12 Crew member Ron Ammann finishing processed lumber

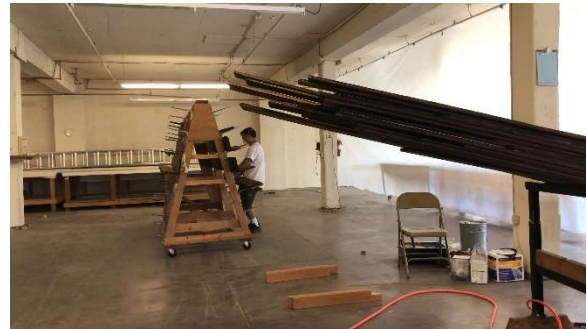
Figure 13 Crew member Joshua Inman stacking finished lumber for drying

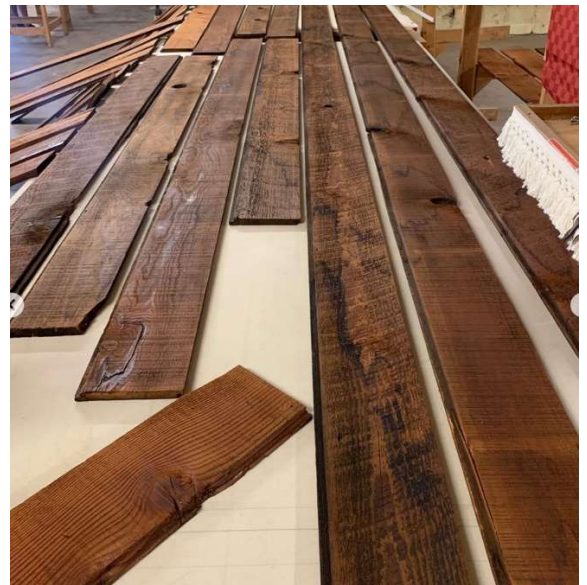
Figure 14 Re-milled and stained wood

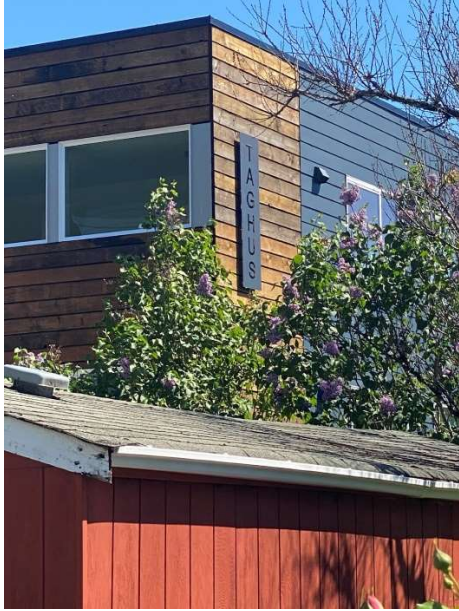
Figure 17 Taghus shiplap siding, north view

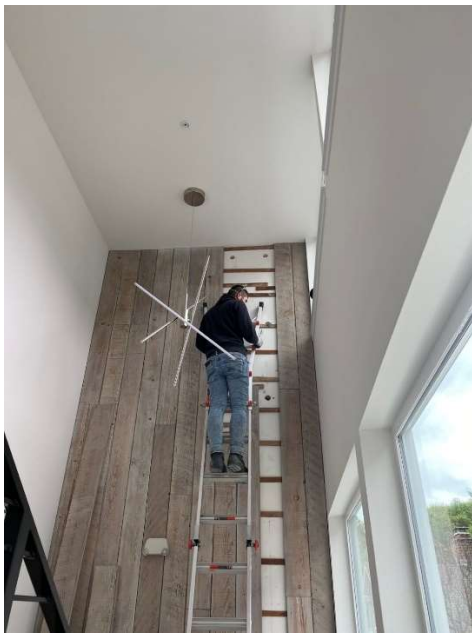
Figure 18 Painted shiplap being installed at Taghus

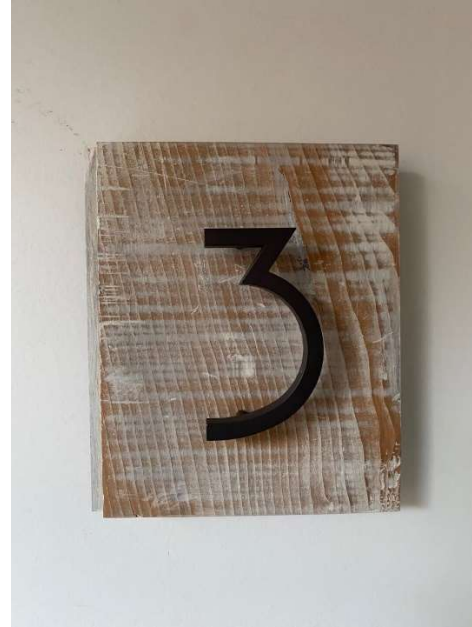
Figure 19 Exterior feature created with shiplap

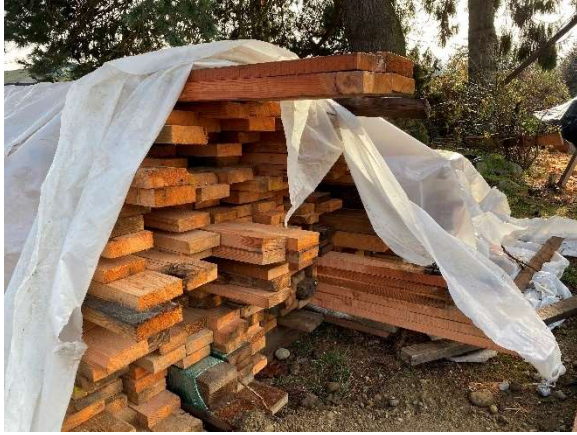
Figure 20 Lumber package, wood harvested from ShipLap, stored at the Maple Lane building site

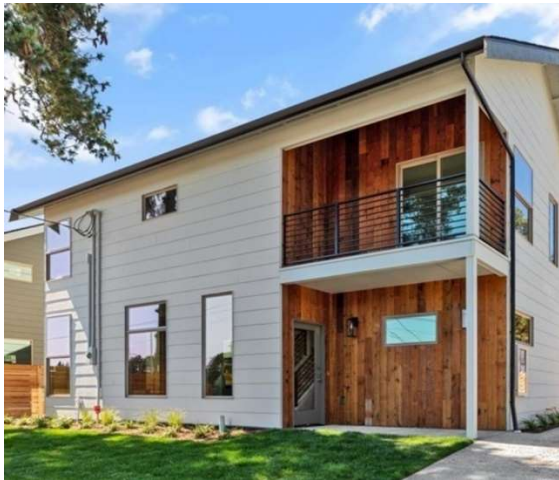
Figure 21 ShipLap product as decorative exterior siding on the homes at Maple Lane

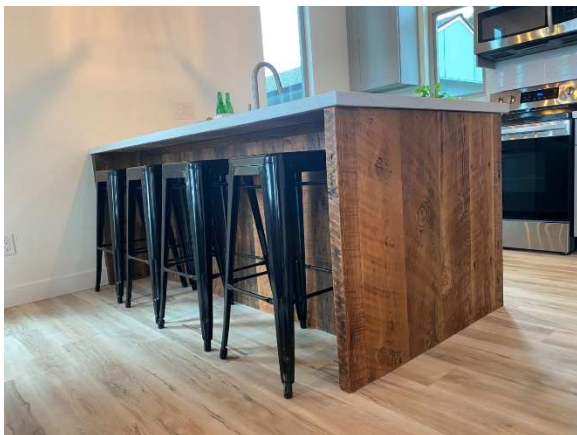
Figure 22 Closeup of kitchen island made with shiplap

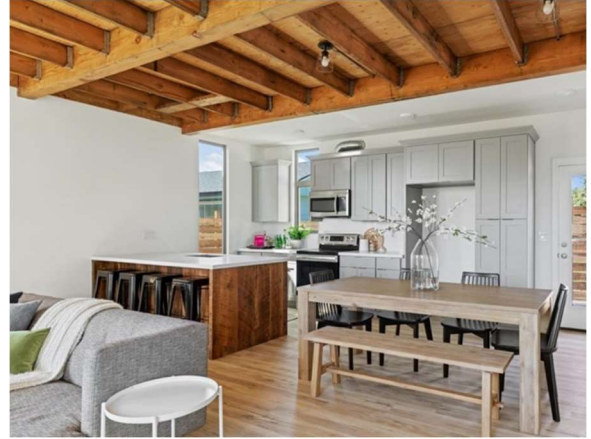
Figure 23 ShipLap product used for kitchen island finish and ceiling joists

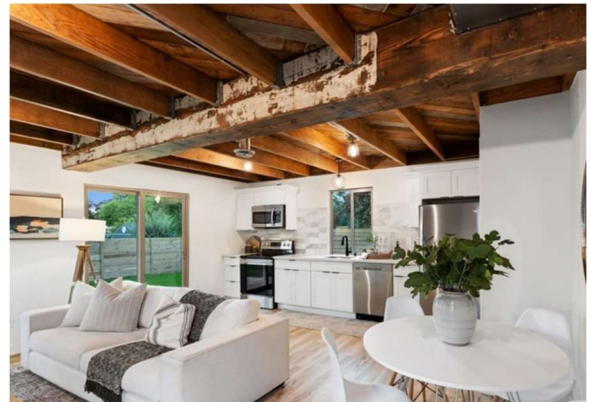
Figure 24 ShipLap product as ceiling joists in second Maple Lane home

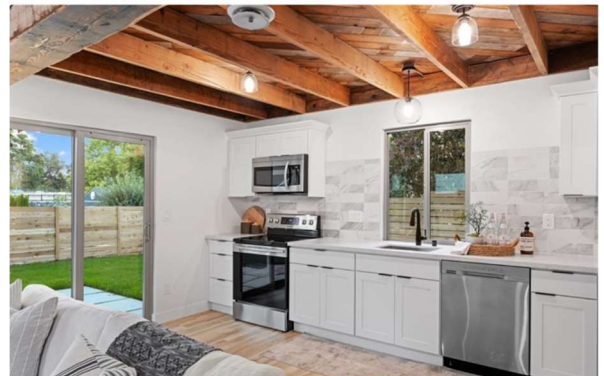
Figure 25 ShipLap product as ceiling joists in third Maple Lane home

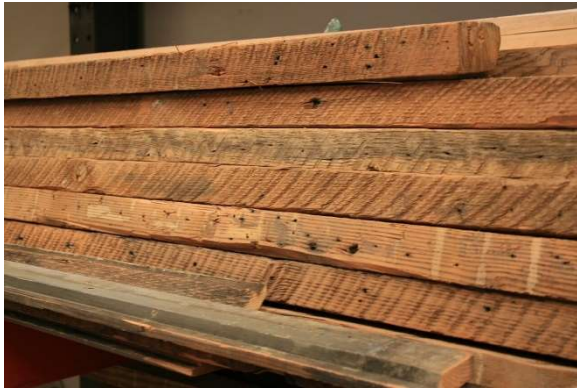
Figure 26 Rough sawn salvage used for interior features
