POPULATION HEALTH FACILITY

UNIVERSITY OF WASHINGTON
SEATTLE, WA
SDCI#: 3028469

STREAMLINED DESIGN REVIEW
SEPTEMBER 25, 2017

The Miller Hull Partnership, LLP
71 Columbia Street - 6th Floor
Seattle, WA 98104

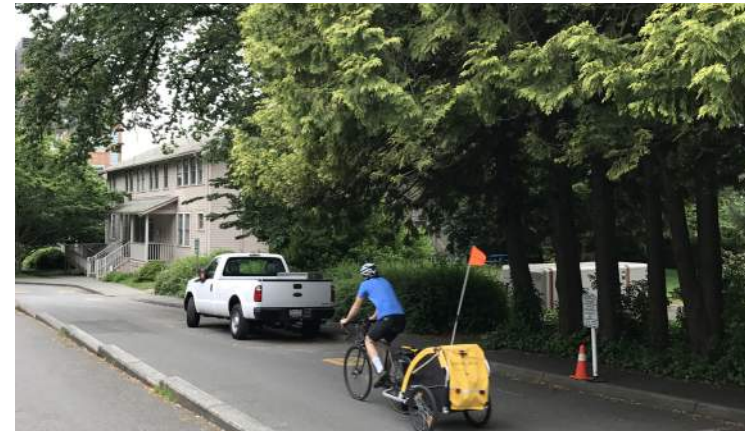
(1) Existing parking lot commonly used as bicycle route.

Primary bicycle circulation into the Population Health Facility site is from the two-way protected bike lane on NE 40th (See Image 3) and from sharrow on Okanogan Lane, W Stevens Way NE and Grant Lane NE. Currently, the C8 parking lot (See Image 1) and its driveway are the primary bicycle route through the site. Though there are no cyclists on 15th Ave NE, this roadway is occasionally used by skilled cyclists.

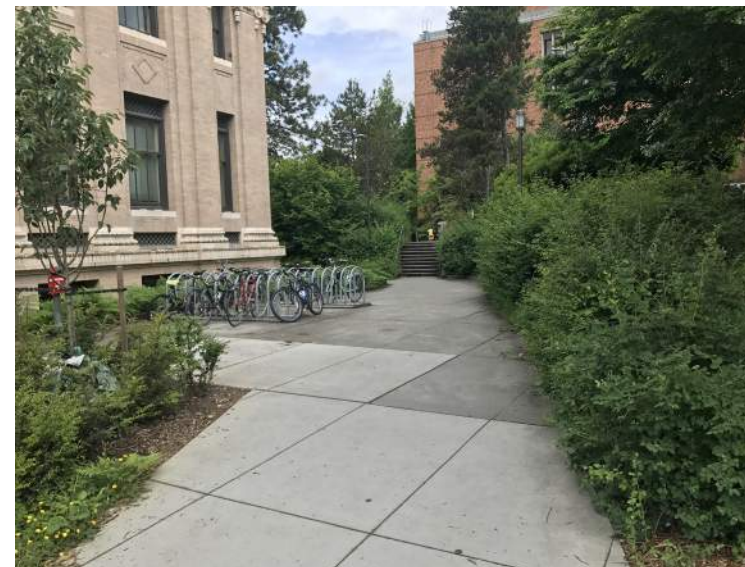
(2) Existing bicycle parking at Architecture Hall

Bicycle parking is currently located at three locations around Architecture Hall and along the south edge of Guthrie Hall. Physics has located some of its bike parking within its loading dock.

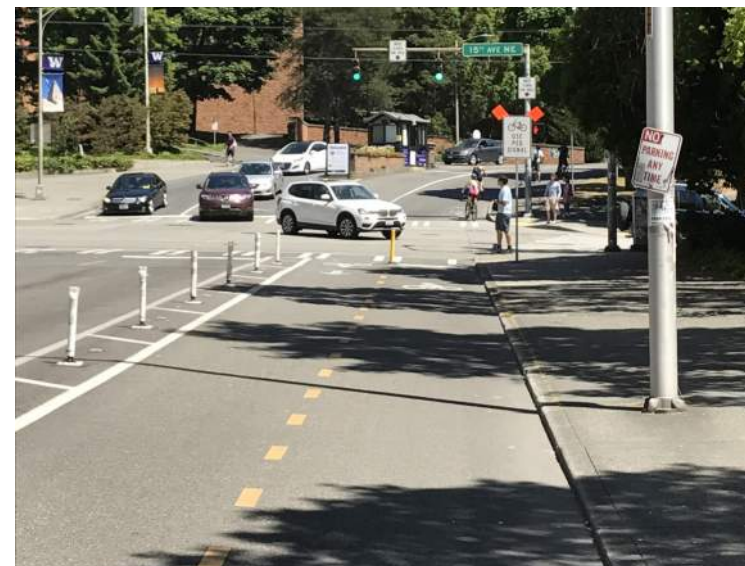
(3) Existing two-way protected bicycle lanes on NE 40th St.

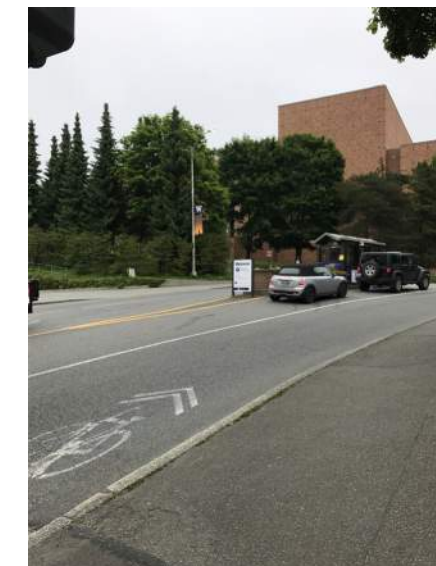
(4) Existing sharrow on Grant Lane NE.

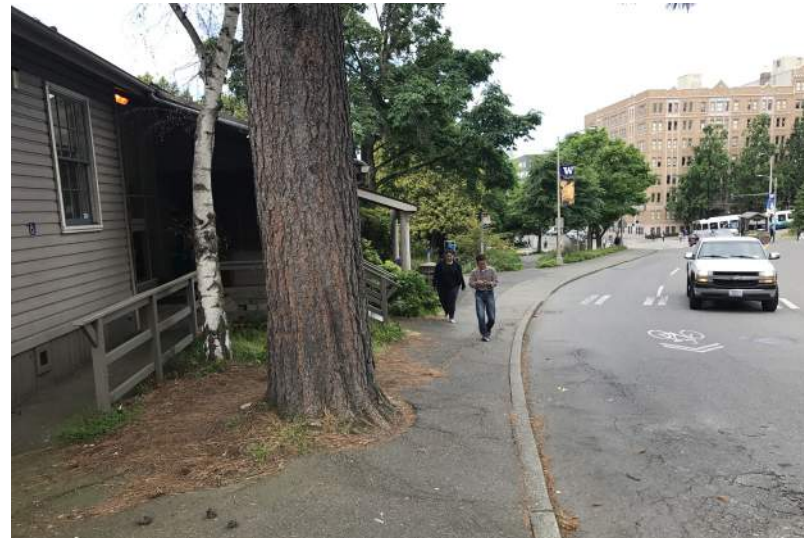
(1) Tree in sidewalk along Grant Place

NE Grant Lane - Each side of the street has a sidewalk that has no buffer from the roadway. Currently there is not a direct ADA path along NE Grant Lane into Central Campus. An existing Ponderosa Pine has impacted the sidewalk creating a difficult surface to navigate (See Image 1).

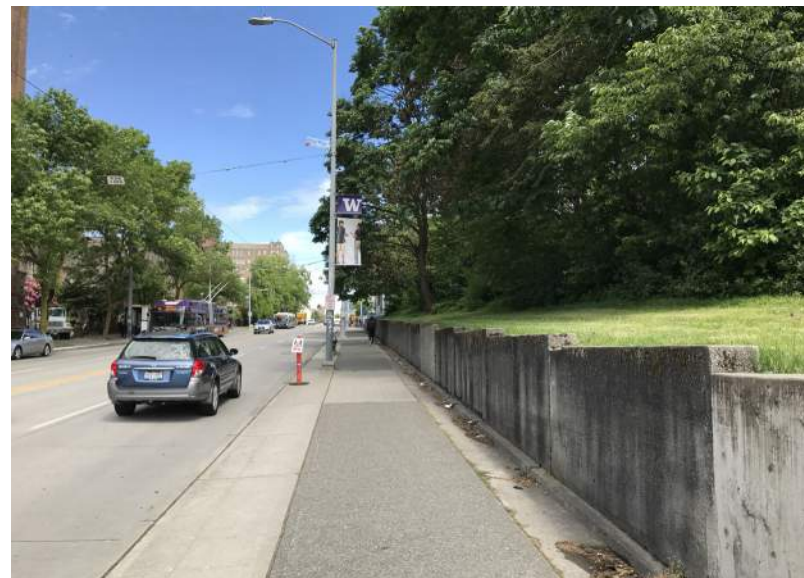
(2) Sidewalk along 15th Ave

15th Ave NE - The sidewalk along 15th Ave NE has a retaining wall that steps with the slope creating an impenetrable edge to the campus. The entrance to the shared Guthrie Hall and Physics Astronomy Building loading dock is located at the south edge of the site. The loading dock is framed by vegetation and two stairways that connect 15th to an upper courtyard. There is an existing mid-block crossing of 15th Ave NE at the south end of the site that provides pedestrians from West Campus access to the stairways adjacent to the loading dock entrance.

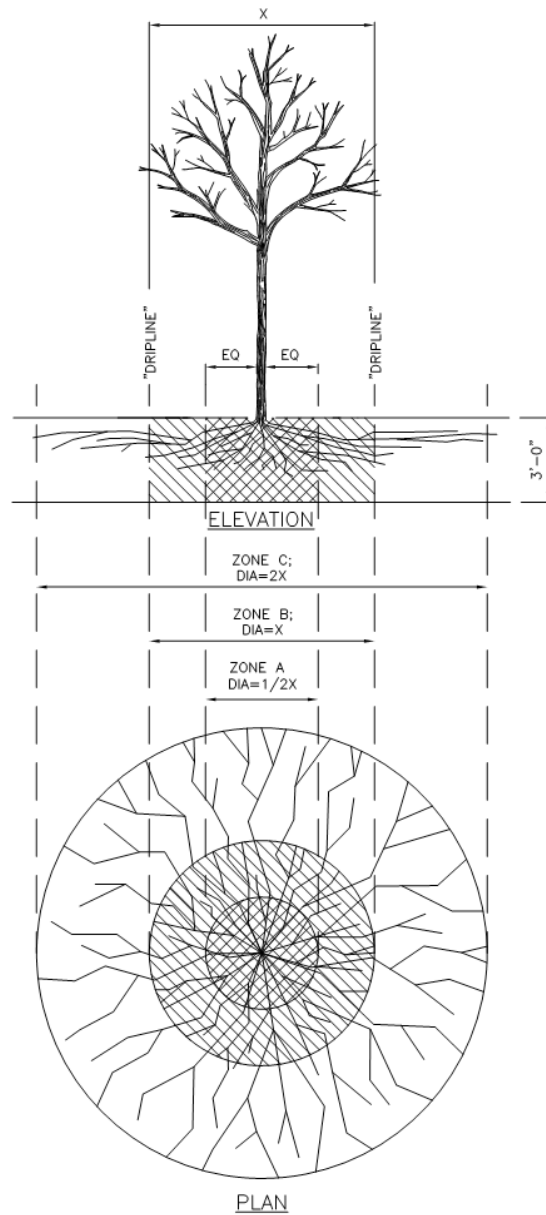
PLAN

1. NO DISTURBANCE ALLOWED WITHOUT SITE-SPECIFIC INSPECTION AND APPROVAL OF METHODS TO MINIMIZE ROOT DAMAGE
2. SEVERANCE OF ROOTS LARGER THAN 2" DIA REQUIRES ENGINEER'S APPROVAL
3. TUNNELING REQUIRED TO INSTALL LINES 3'-0" BELOW GRADE OR DEEPER

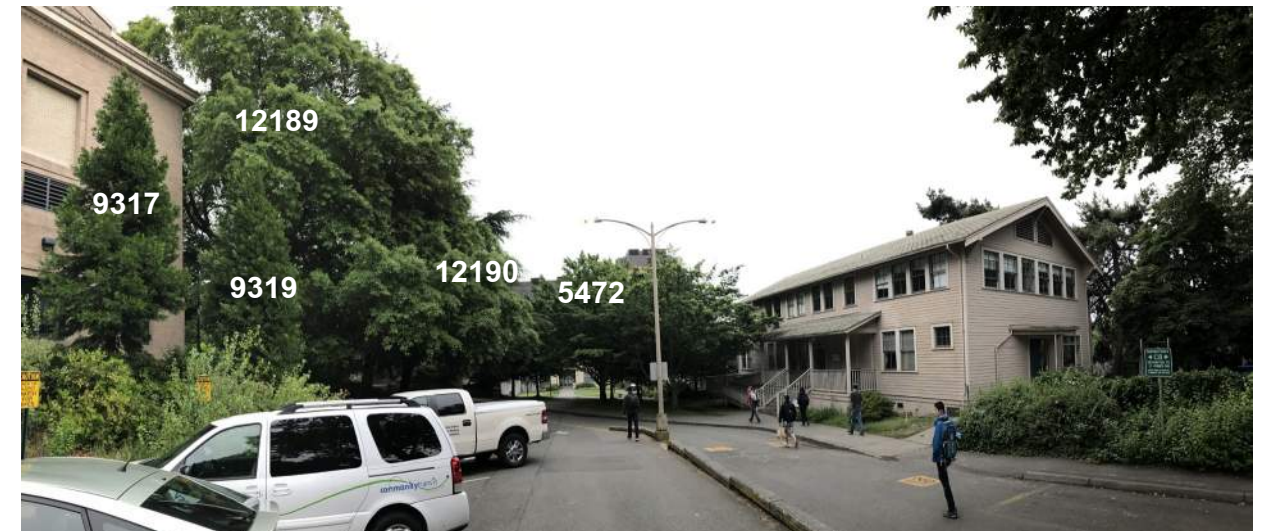
Existing C8 parking lot and Guthrie Annex 02 to be demolished. Tree #12189, an exceptional Water Oak, is to be preserved.

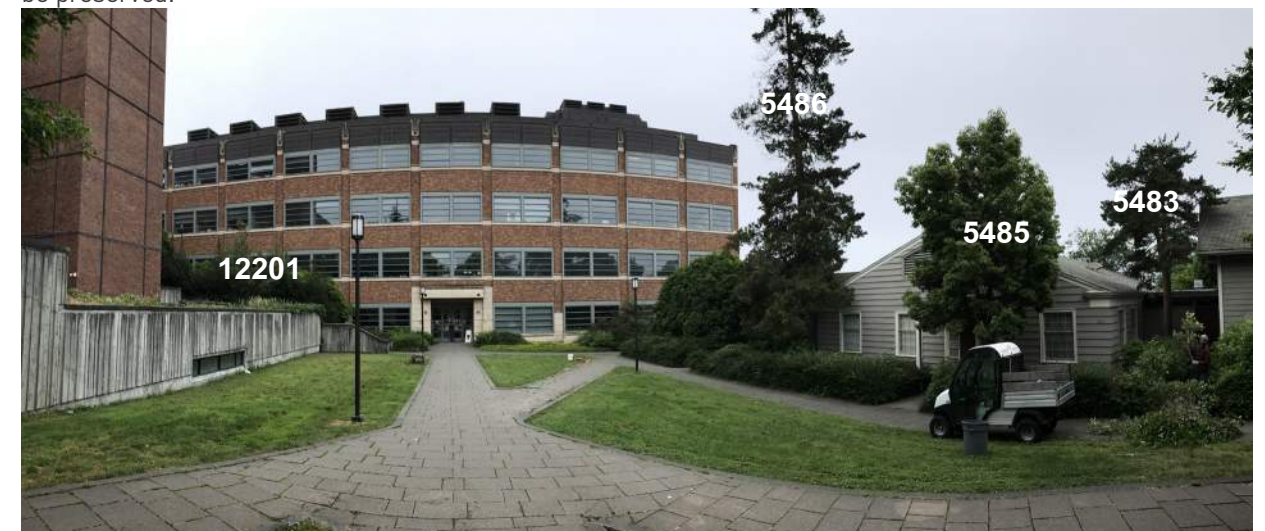
Guthrie Annex 01 on the right hand side to be demolished.

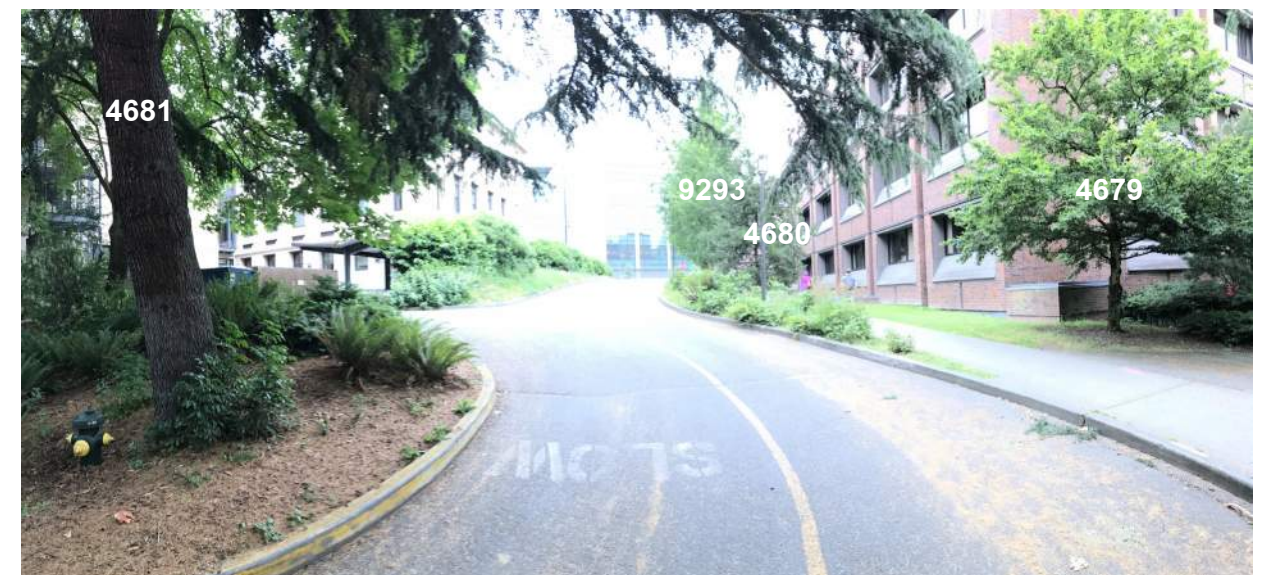
Asotin Place NE to be re-built and regraded to provide an ADA accessible, pedestrian oriented route.

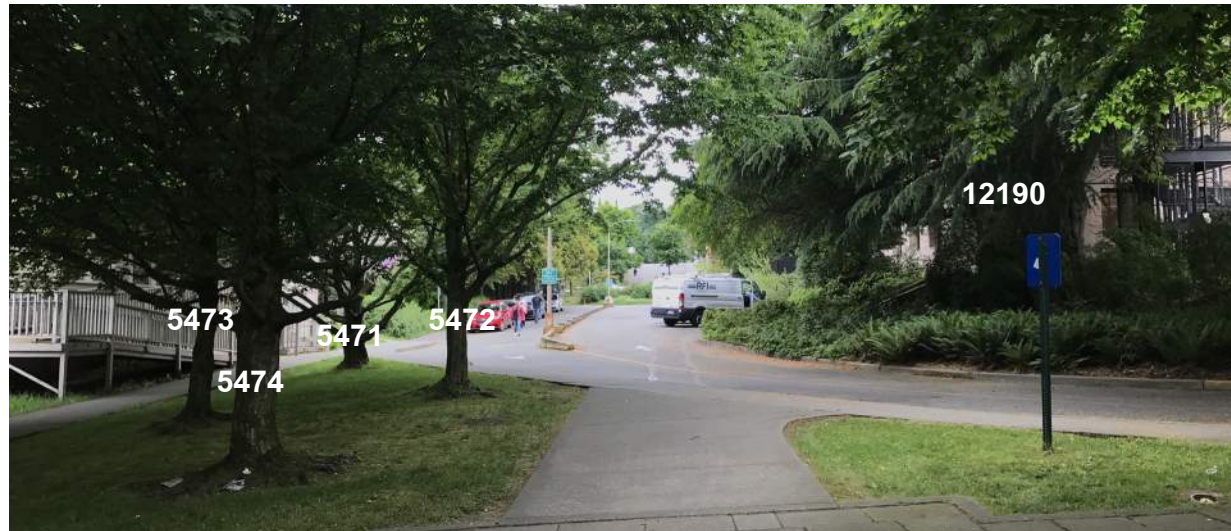
Existing trees to be removed as part of building construction, C8 parking lot demolition, pedestrian and accessibility improvements.

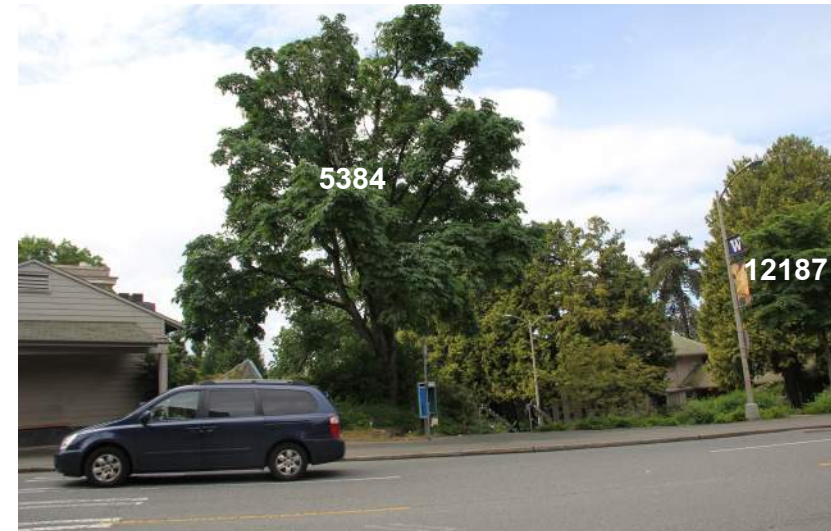
Existing trees along Grant Lane to be demolished as part of pedestrian circulation and accessibility improvements.

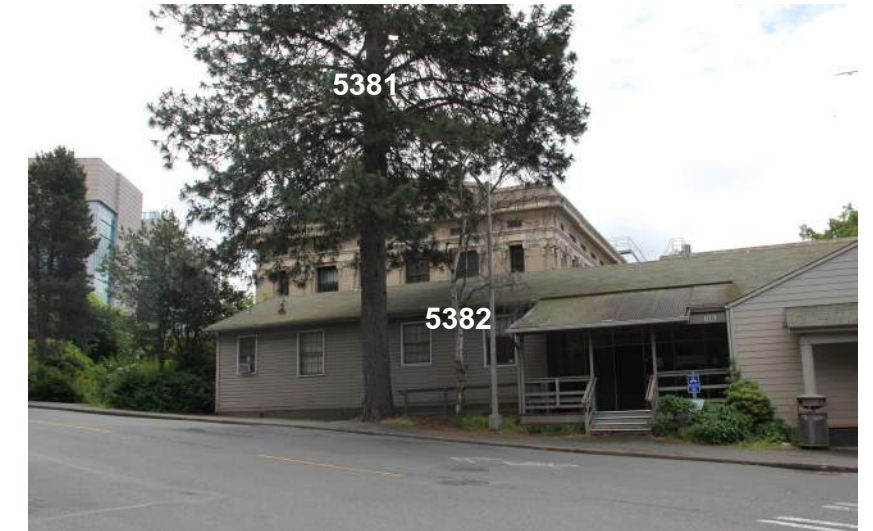
Guthrie Annex 04 to be demolished. Existing Tree #5381, an exceptional Ponderosa Pine, to be preserved.

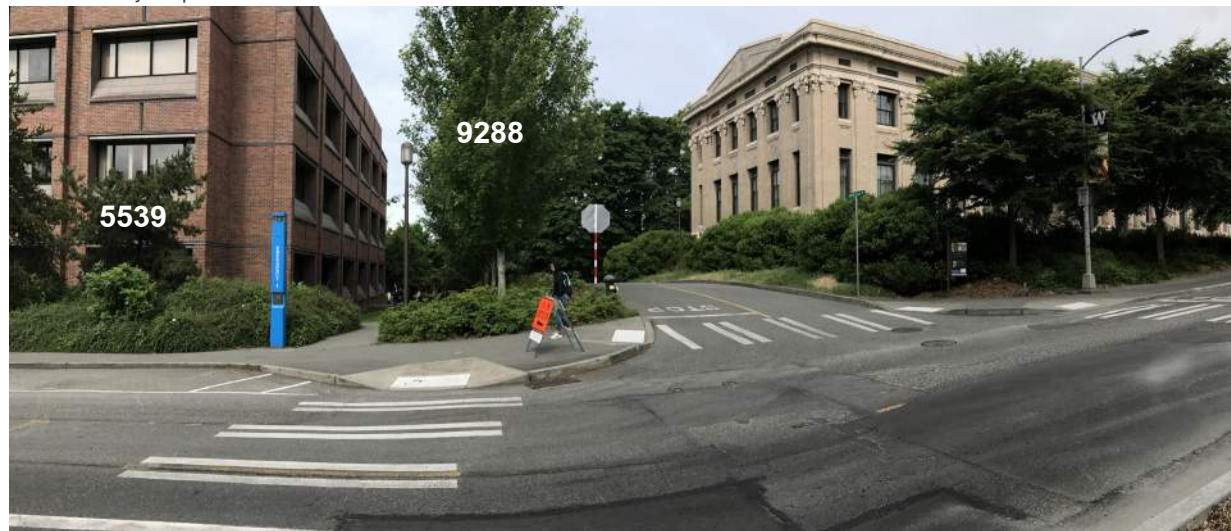
Asotin Place to be rebuilt and regraded to provide a pedestrian oriented accessible route.

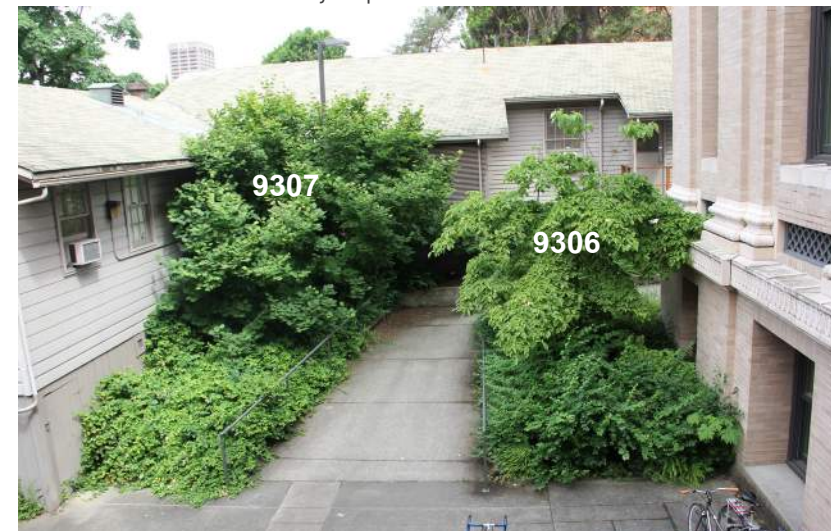
Guthrie Annex 04 and associated existing trees and pathway to be demolished to provide improved pedestrian routes along Grant Lane NE.

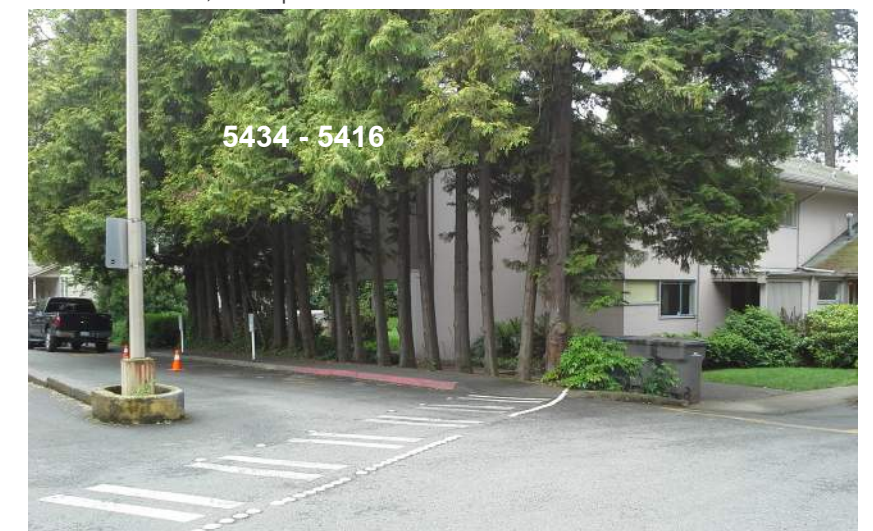
C8 parking lot, existing trees and Guthrie Annex 03 to be demolished for building construction.

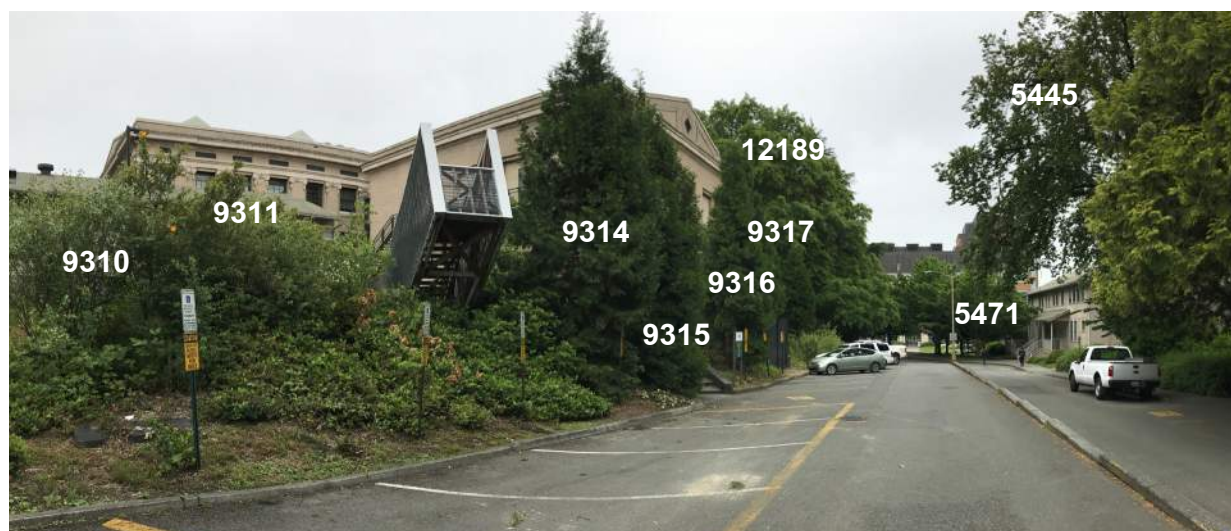
Existing C8 parking lot to be demolished for building construction and to create a pedestrian oriented, ADA accessible route. Existing tree #12189, an exceptional Water Oak to be preserved, is visible in the background.

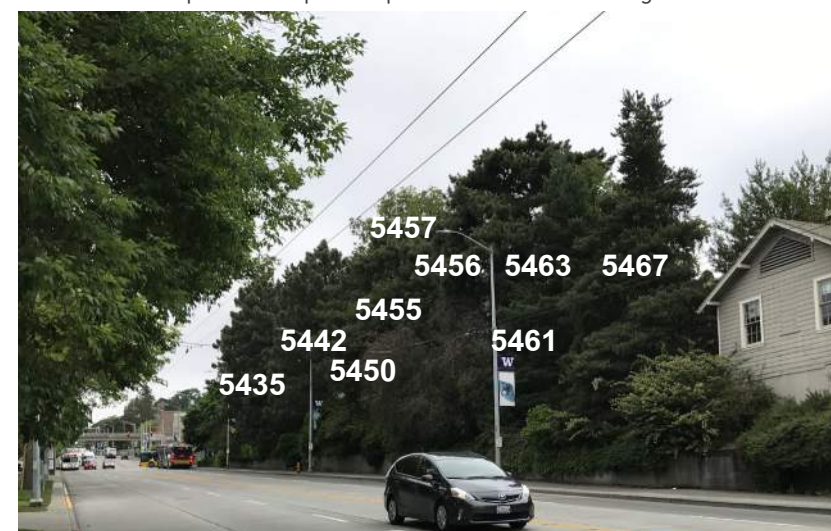
Existing trees at the top of the 15th Ave NE retaining wall to be demolished to provide streetscape improvements.

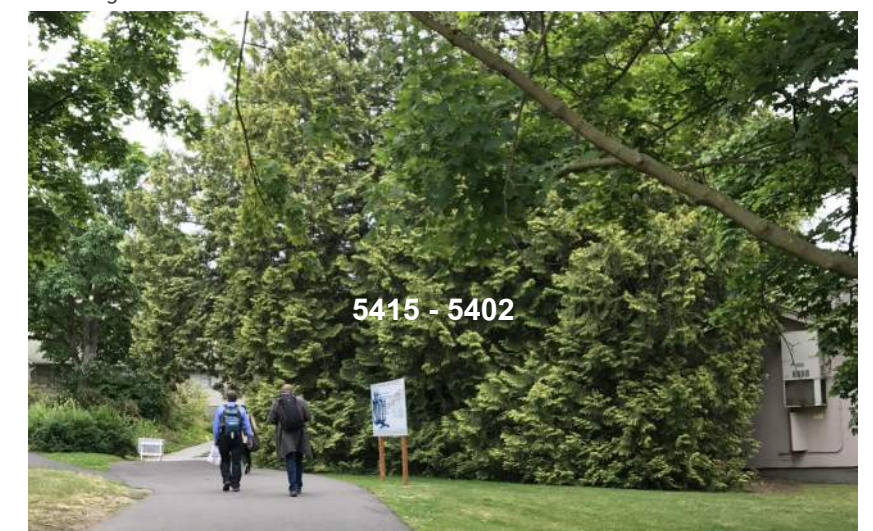
Guthrie Annex 03 and associated trees to be demolished.

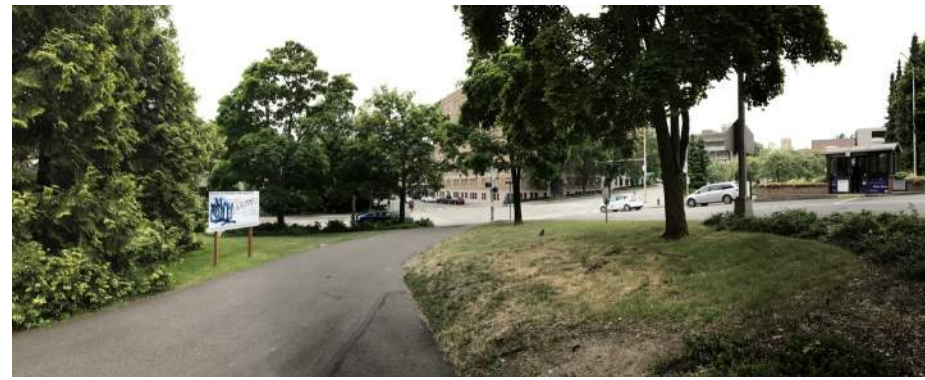
Grant Lane The Grant Lane corridor will have a mix of large canopy trees and small/medium deciduous trees with a low and open understory to allow for open views along a highly used pedestrian and bicycle route.

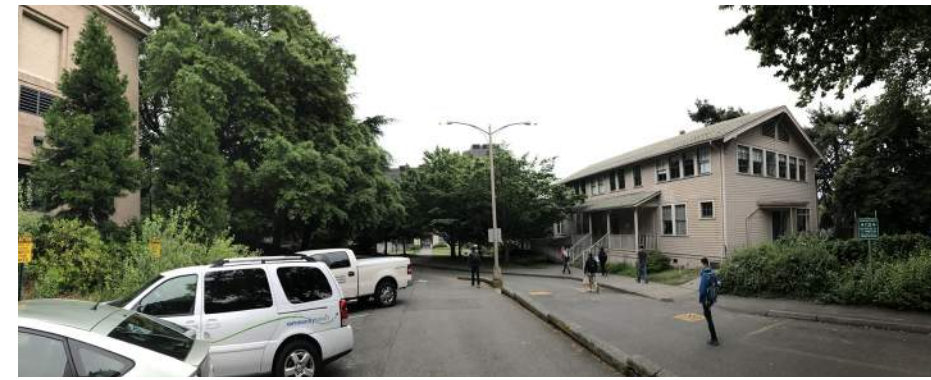
Garden Walk The garden walk will have a lush variety of native and NW adapted tree species to create a wellness experience between Architecture Hall and the Population Health facility and along Asotin Place with a dense understory of perennials, shrubs and groundcovers.

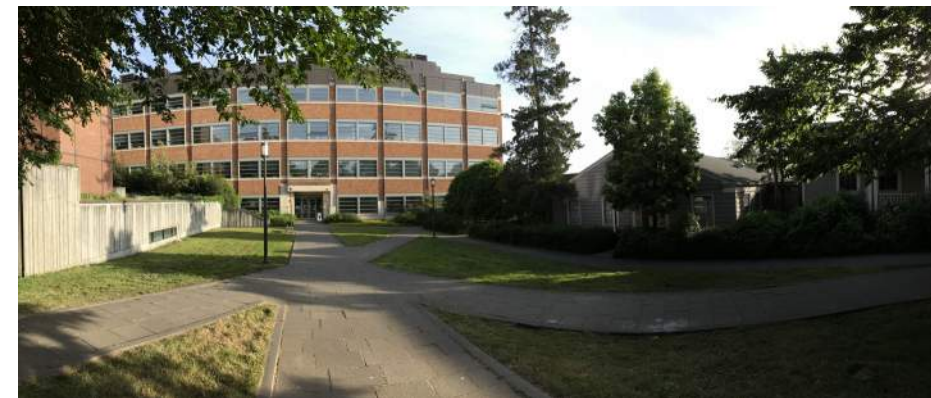
South Court Most of the existing South Court currently does not have existing trees as it is over the existing Physics/Astronomy and Guthrie Hall loading dock. New tree plantings will be located at the perimeter of this area and along the new public staircase entry to the Campus from 15th Avenue NE.
