CITY OF SEATTLE

MARCH 2009

Shoreline Characterization Report

DRAFT

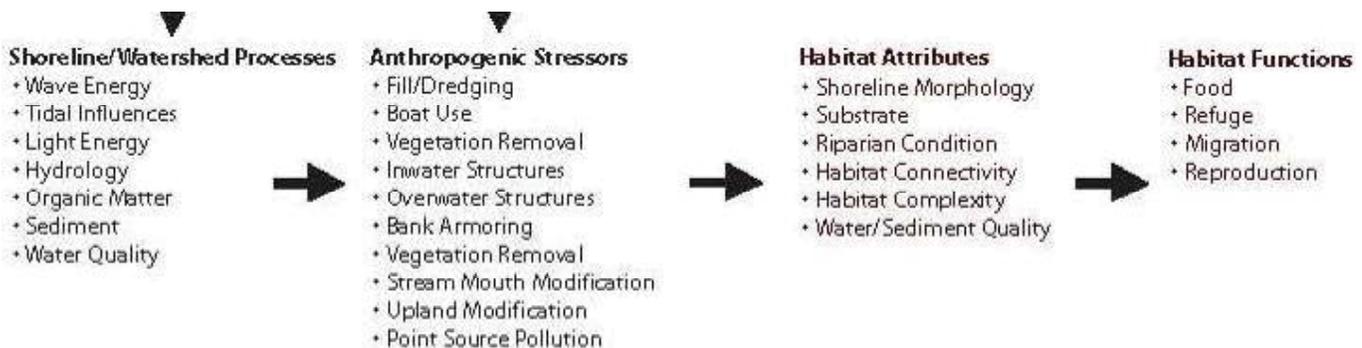
Figure 2-1: Conceptual Model of Watershed Processes, Stressors, and Habitat

The type and functional quality of aquatic habitats result from the interaction of physical, chemical, and biological processes that occur in both the aquatic system and adjacent terrestrial areas (Naiman et al. 1995). In the Washington State Department of Ecology’s (Ecology’s) Guide to Watershed Planners to Understand Watershed Processes (Stanley et al. 2005), the authors use the term watershed processes to refer to “the dynamic physical and chemical interactions that form and maintain the landscape at the geographic scales of watersheds to basins (hundreds to thousands of square miles).” These processes and their natural controls and human-caused (anthropogenic) stressors combine to create, maintain, or destroy habitat. The resulting changes in habitat attributes also impact the functions that the habitat supports for organisms. Therefore, the distribution and behavior of plants and animals are a response to the watershed processes that occur and the structure of habitat that is created. This is illustrated in the simple conceptual model shown in Figure 2-1.

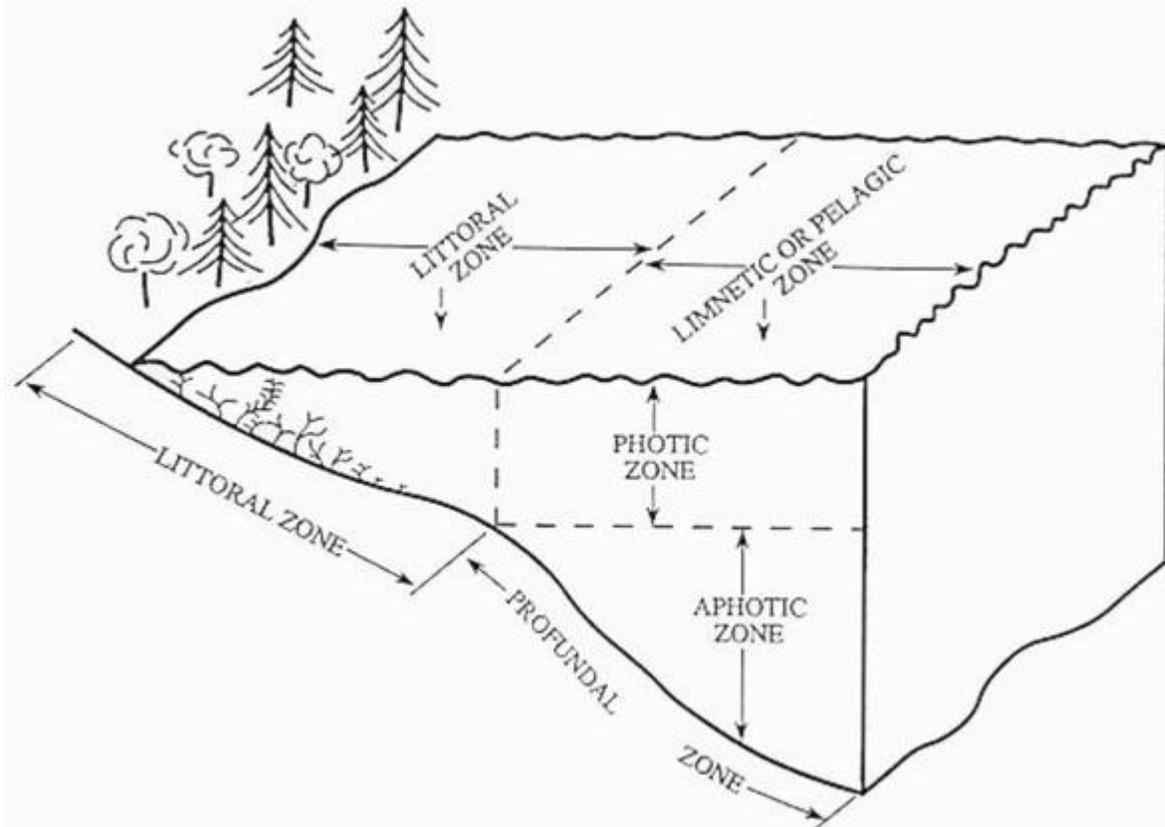
Figure 2-2: Lake Structure Zones

Aquatic scientists divide lake habitat into several zones, each with unique features: littoral, benthic, and pelagic (also called limonitic) zones (Figure 2-2). Littoral zones are those within the shallow area of the lake, adjacent to and associated with the lake shoreline. The littoral zone extends out from the shoreline and encompasses the shoreline region between the highest seasonal water level and the lowest elevation of submerged rooted or attached aquatic plants (Wetzel 1983). The lowest extent of growth by submerged aquatic plants typically occurs at a depth where light is low enough to dramatically reduce photosynthesis (Wetzel 1983; Schindler and Schuerell 2002), but it is important to note that the depth at which light penetrates water is variable depending on several factors (e.g., turbidity and phytoplankton densities).

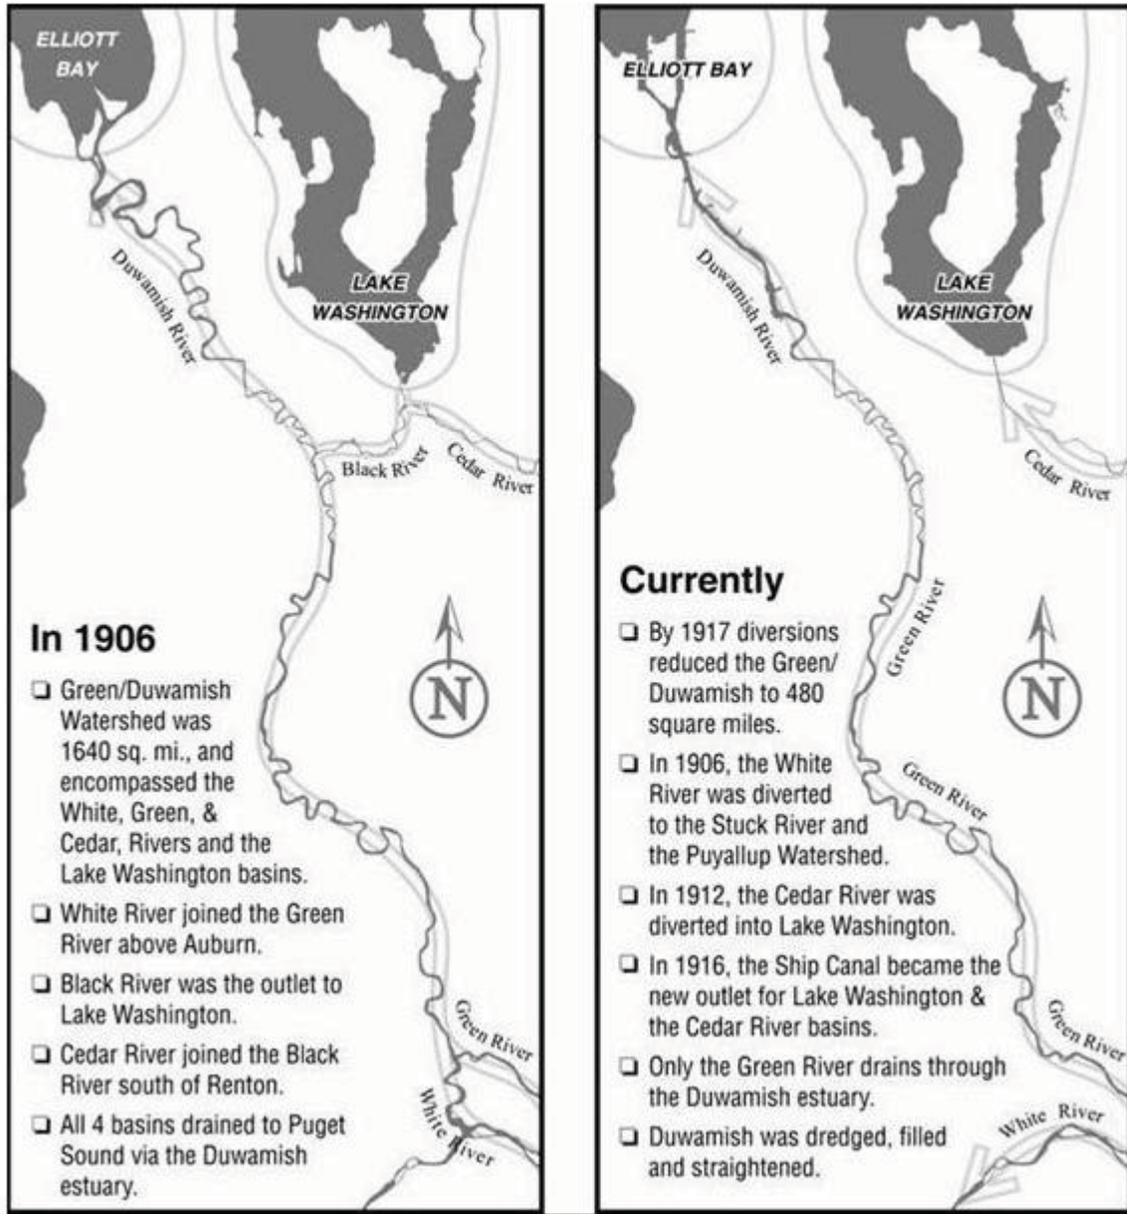
Figure 4-1: Lake Washington Drainage Basin Before and After 1917

Changes to the Lake Washington basin substantially altered the frequency and size of floods. Historically, lake elevations peaked in winter and declined in summer. In 1903, the average lake elevation was about 32 feet. Today, lake elevation peaks at 22 feet in May and reaches its lowest level, 20 feet, in December. Water is regulated at the Ballard Locks to keep seasonal fluctuations to within 2 feet annually (SPU and USACE 2008). The U.S. Army Corps of Engineers (USACE) regulates the lake level based on lake level forecasts and measurement and projected demand for smolt passage flumes, saltwater drain, and lock operations.
