***Boundary Hydroelectric Project (FERC No. 2144)***

***Study No. 23***  
***Aesthetic/Visual Resources Study***  
***Final Report***

**Prepared for  
Seattle City Light**

**March 2009**

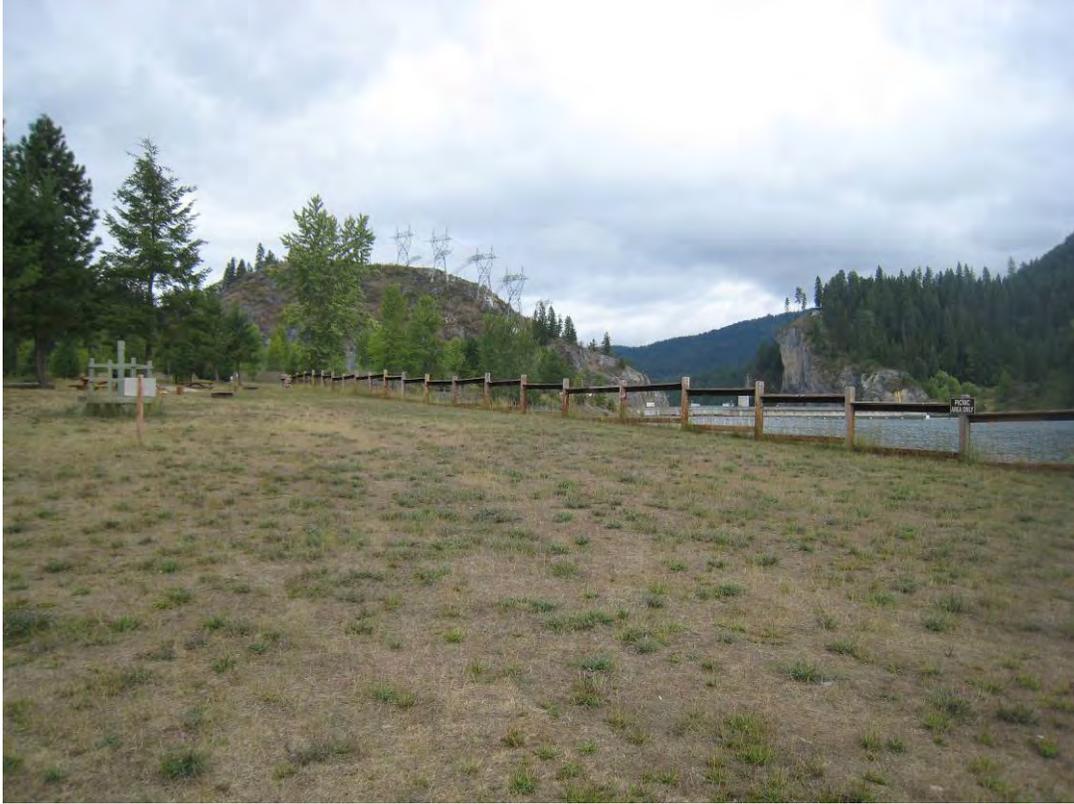
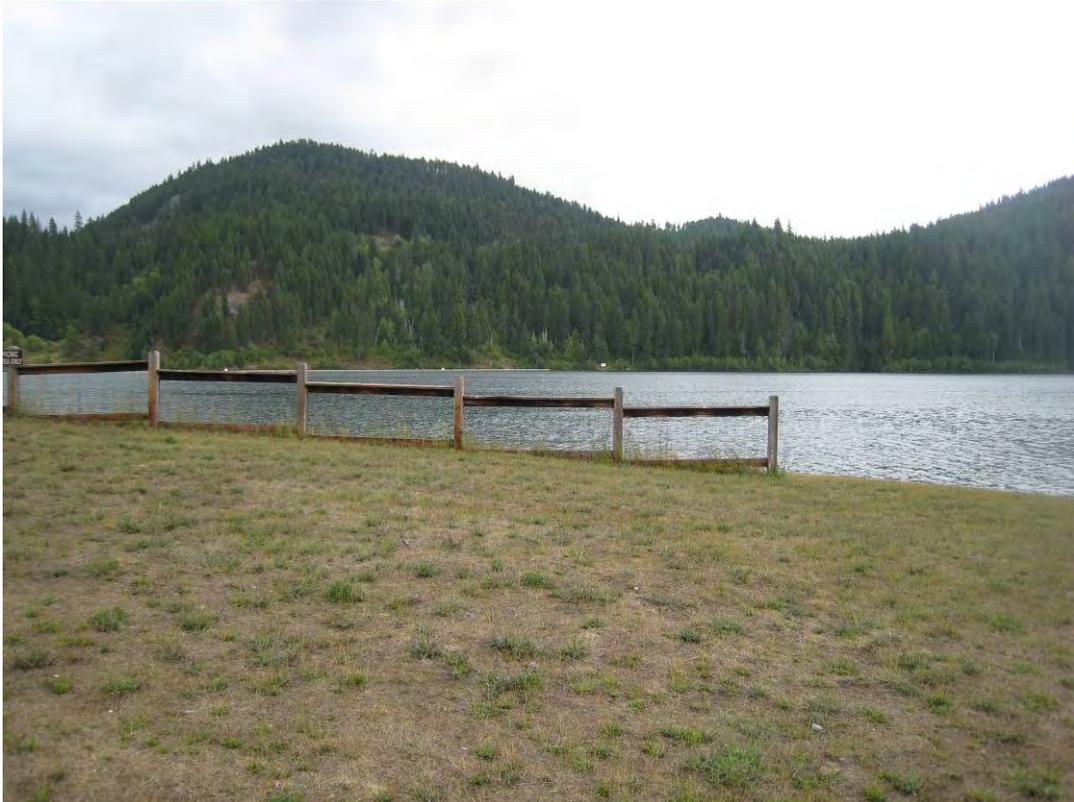
Figure 5.2-2. Forebay Recreation Area views.

No prominent or offensive smells were noted at KOP 1. Several types of sounds were present, including a slight hum from equipment at the dam, lapping of water on the shore and against a boat at the dock, and infrequent noise from vehicles traveling on the Boundary Dam West-Side Access Road, which cannot be seen from the KOP because of the tree cover.

- Project roads that are visible from specific KOPs are associated with other Project facilities, and the visual contrast created by these roads is included in the observed conditions documented for KOPs 1, 2, 3, and 9.

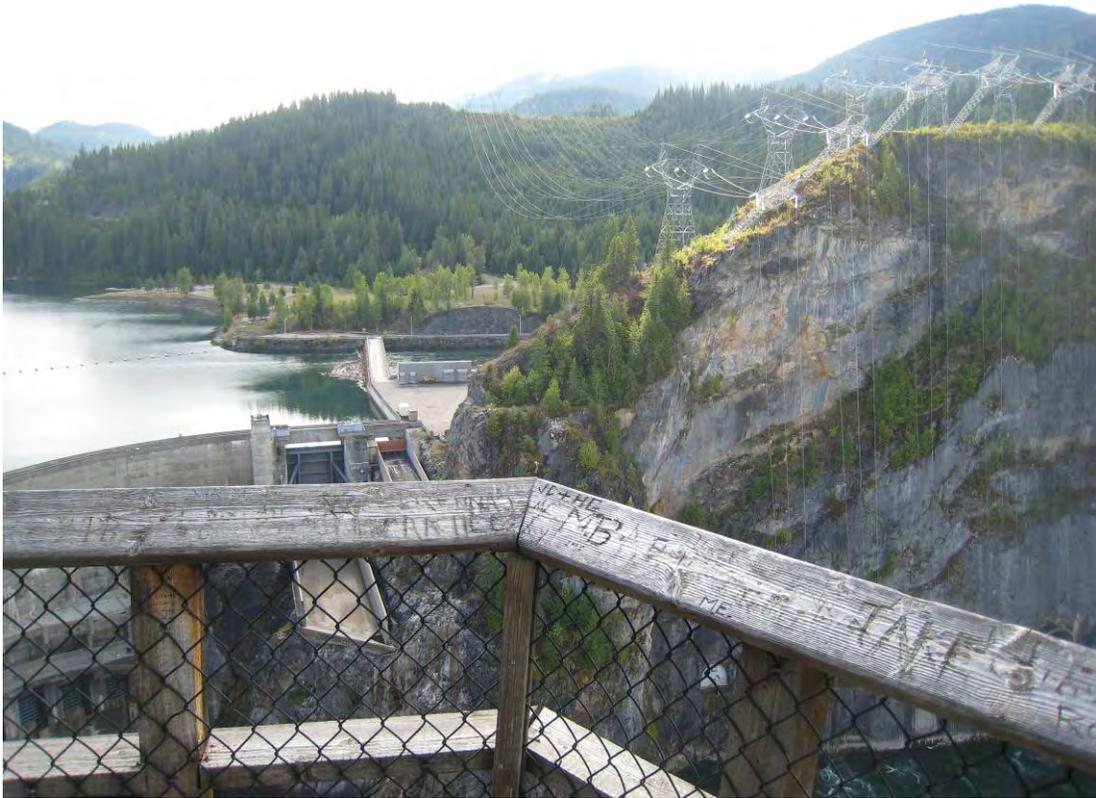
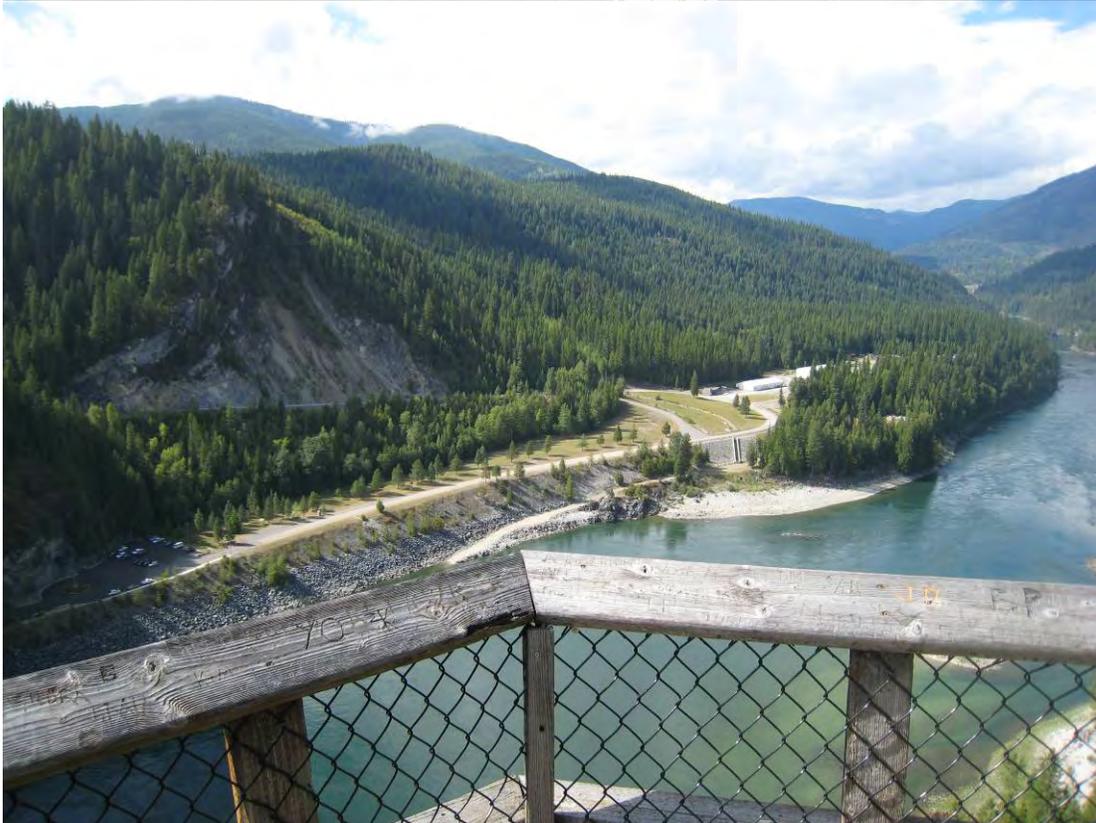
Figure 5.2-6. Vista House views.

A high amount of user activity was noted from this KOP, primarily because of the operational functions at the dam and powerhouse area that are visible from the site. The Vista House receives an estimated 2,200 recreational visits during the 2007 season, but visit durations are typically short and the number of visitors present at any particular time is generally small. A constant auditory hum from equipment operating at the dam and powerhouse was noticeable.

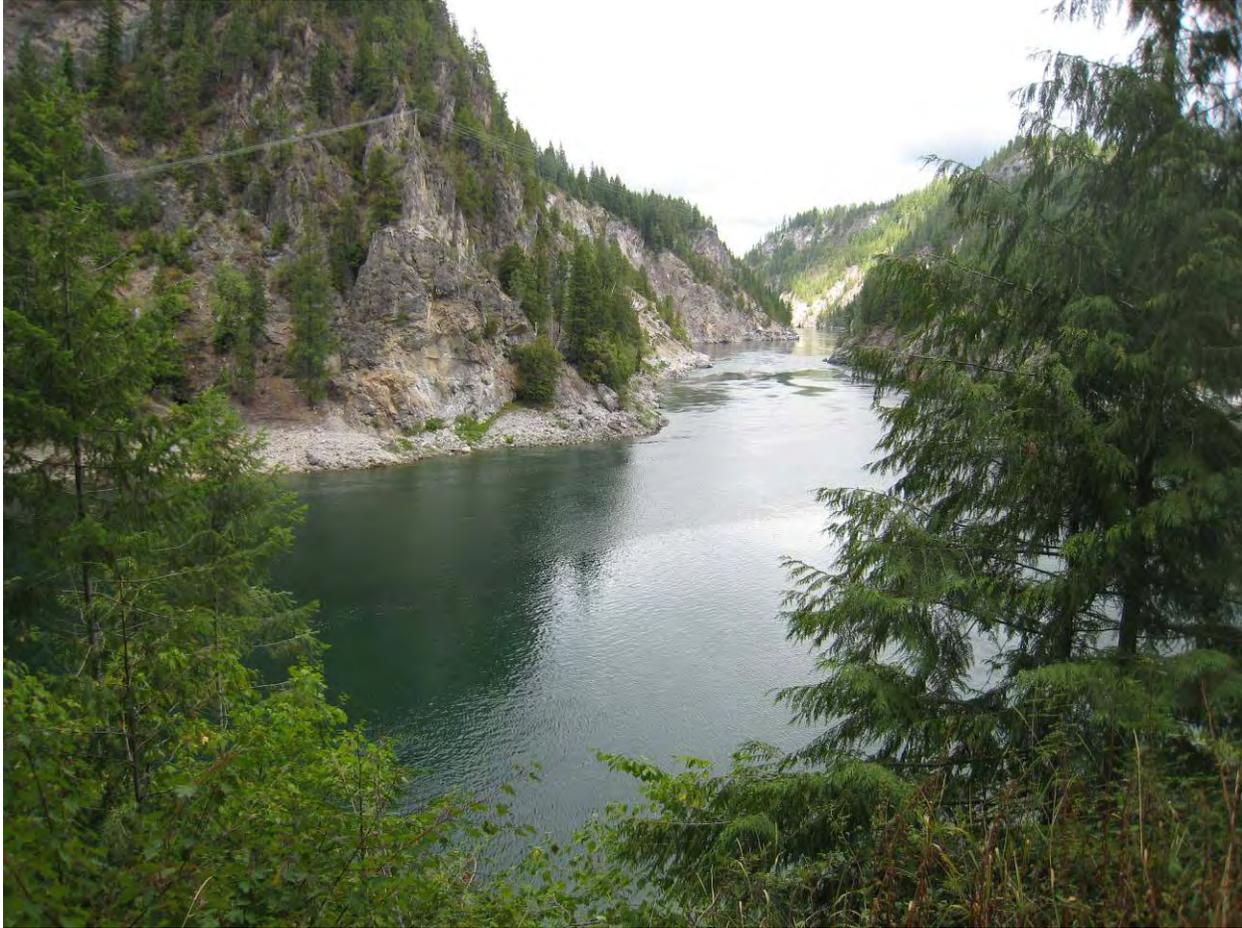
**Figure 5.2-12.** North Pend Oreille Scenic Byway, Metaline Falls Viewpoint.

Figure 5.2-11 shows the location of KOP 6 relative to surrounding features and the orientation of the photograph taken at this location. Figure 5.2-12 illustrates the primary existing view at this location, which is to the north in the direction of the reservoir. The Visual Conditions Form entries and the evaluation of overall scenic integrity for KOP 6 are based on this view. As shown by the additional photographs included in Appendix 2 (for context only), trees and structures block views to the east and west at this location. Although part of the downtown area of Metaline Falls is visible to the south, the viewer's interest is naturally drawn toward the water. The photograph in Figure 5.2-12 was taken slightly back from the rock wall at the edge of the viewing area. The view location is within approximately 100 feet of the reservoir in horizontal distance, and is elevated approximately 50 feet above the water. The scene from this location is typical of views available to local residents, commuters/travelers, and tourists/recreational users.

The overall scenic integrity at this viewpoint is rated as Moderate, based on conditions for the primary field of view as discussed above. The utility line crossing the reservoir introduces a noticeable color contrast and horizontal line. Although this and other deviations are evident, they appear visually subordinate to the natural landscape.

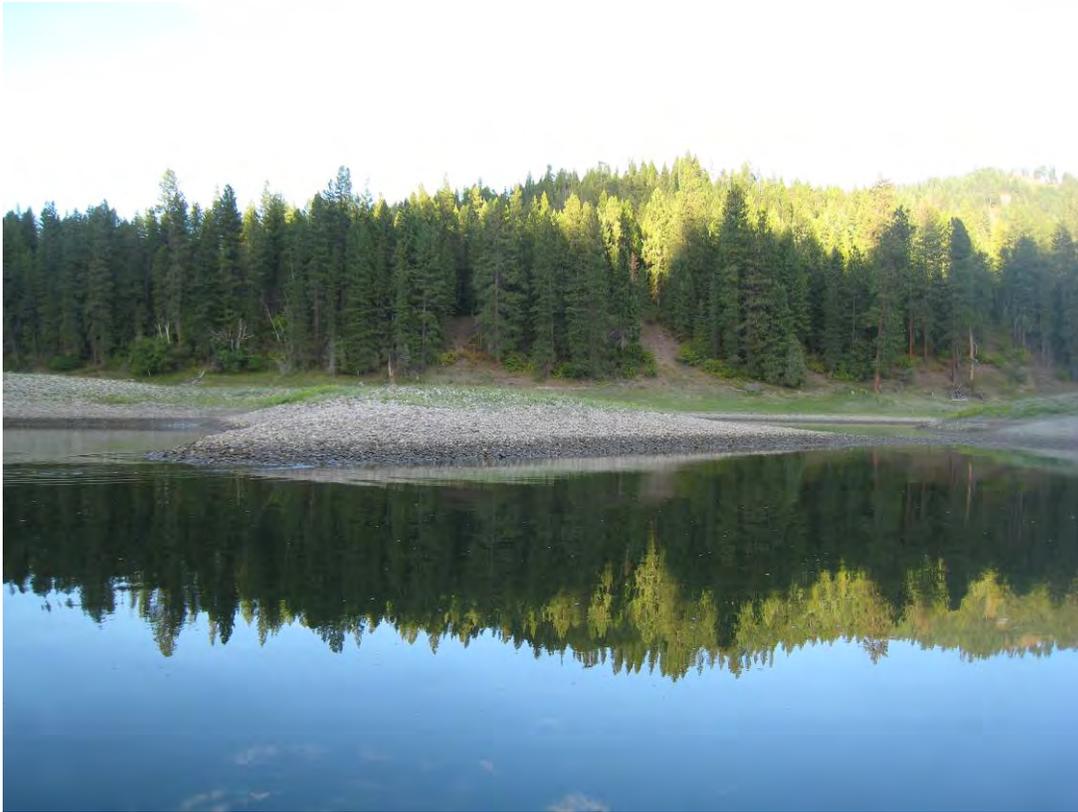
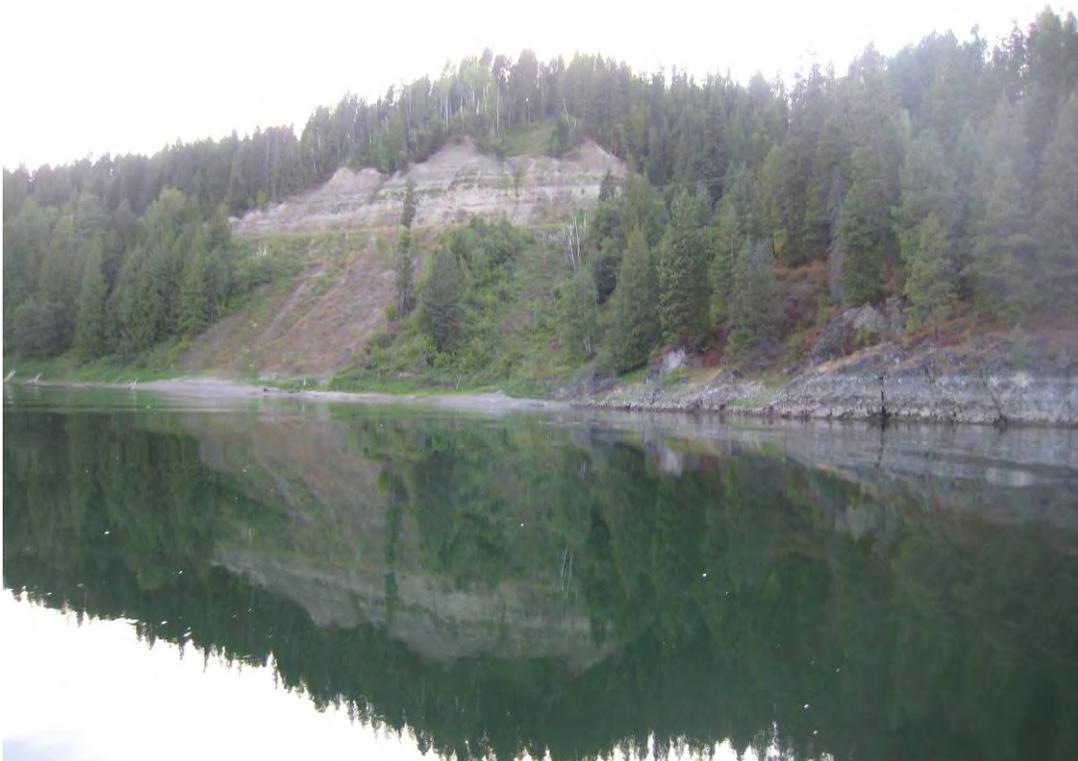
**Figure 5.2-26.** Upper Boundary Reservoir, Wolf Creek Area views.

There is a high amount of user activity observed from this KOP given the highway location, and sounds from the highway were prevalent. Study 21 (SCL 2009a) identified the gravel bar area at Wolf Creek as a dispersed recreation site, although no recreational use was observed at the time KOP 13 was inventoried. There was an unpleasant, dank, musty odor of unknown origin noticeable at this site during the observation. Views in most directions are cut off at foreground distance by trees and slopes adjacent to the reservoir.

The overall scenic integrity of the landscape at this viewpoint is rated as Moderate, or slightly altered, considering the conditions evident in the full field of view. The natural landscape character is dominant in most directions, whereas deviations are prominent toward SR 31 to the west and are very slightly evident to the east.

The visual condition of the shoreline when the reservoir is at the low end of this normal range does not include exposure of extensive area of the reservoir substrate (i.e., there is no prominent “bathtub ring”). Figure 5.2-26 illustrates a common condition with respect to Project operations and the visual appearance of the upper reservoir area. This photograph of the Wolf Creek area was taken in the early evening (6:30 p.m.) on a weekday. At the time, the reservoir elevation was approximately 1,990.4 feet NAVD 88 (1,986.4 feet NGVD 29), or 3 feet below its maximum point for the day of 1,993.7 feet NAVD 88 (1,989.7 feet NGVD 29), which occurred at approximately 11:00 a.m. that day. It is evident from this close-in view that the water level had recently been higher, and that the lower water surface elevation later in the day had exposed minimal additional gravel bar areas.

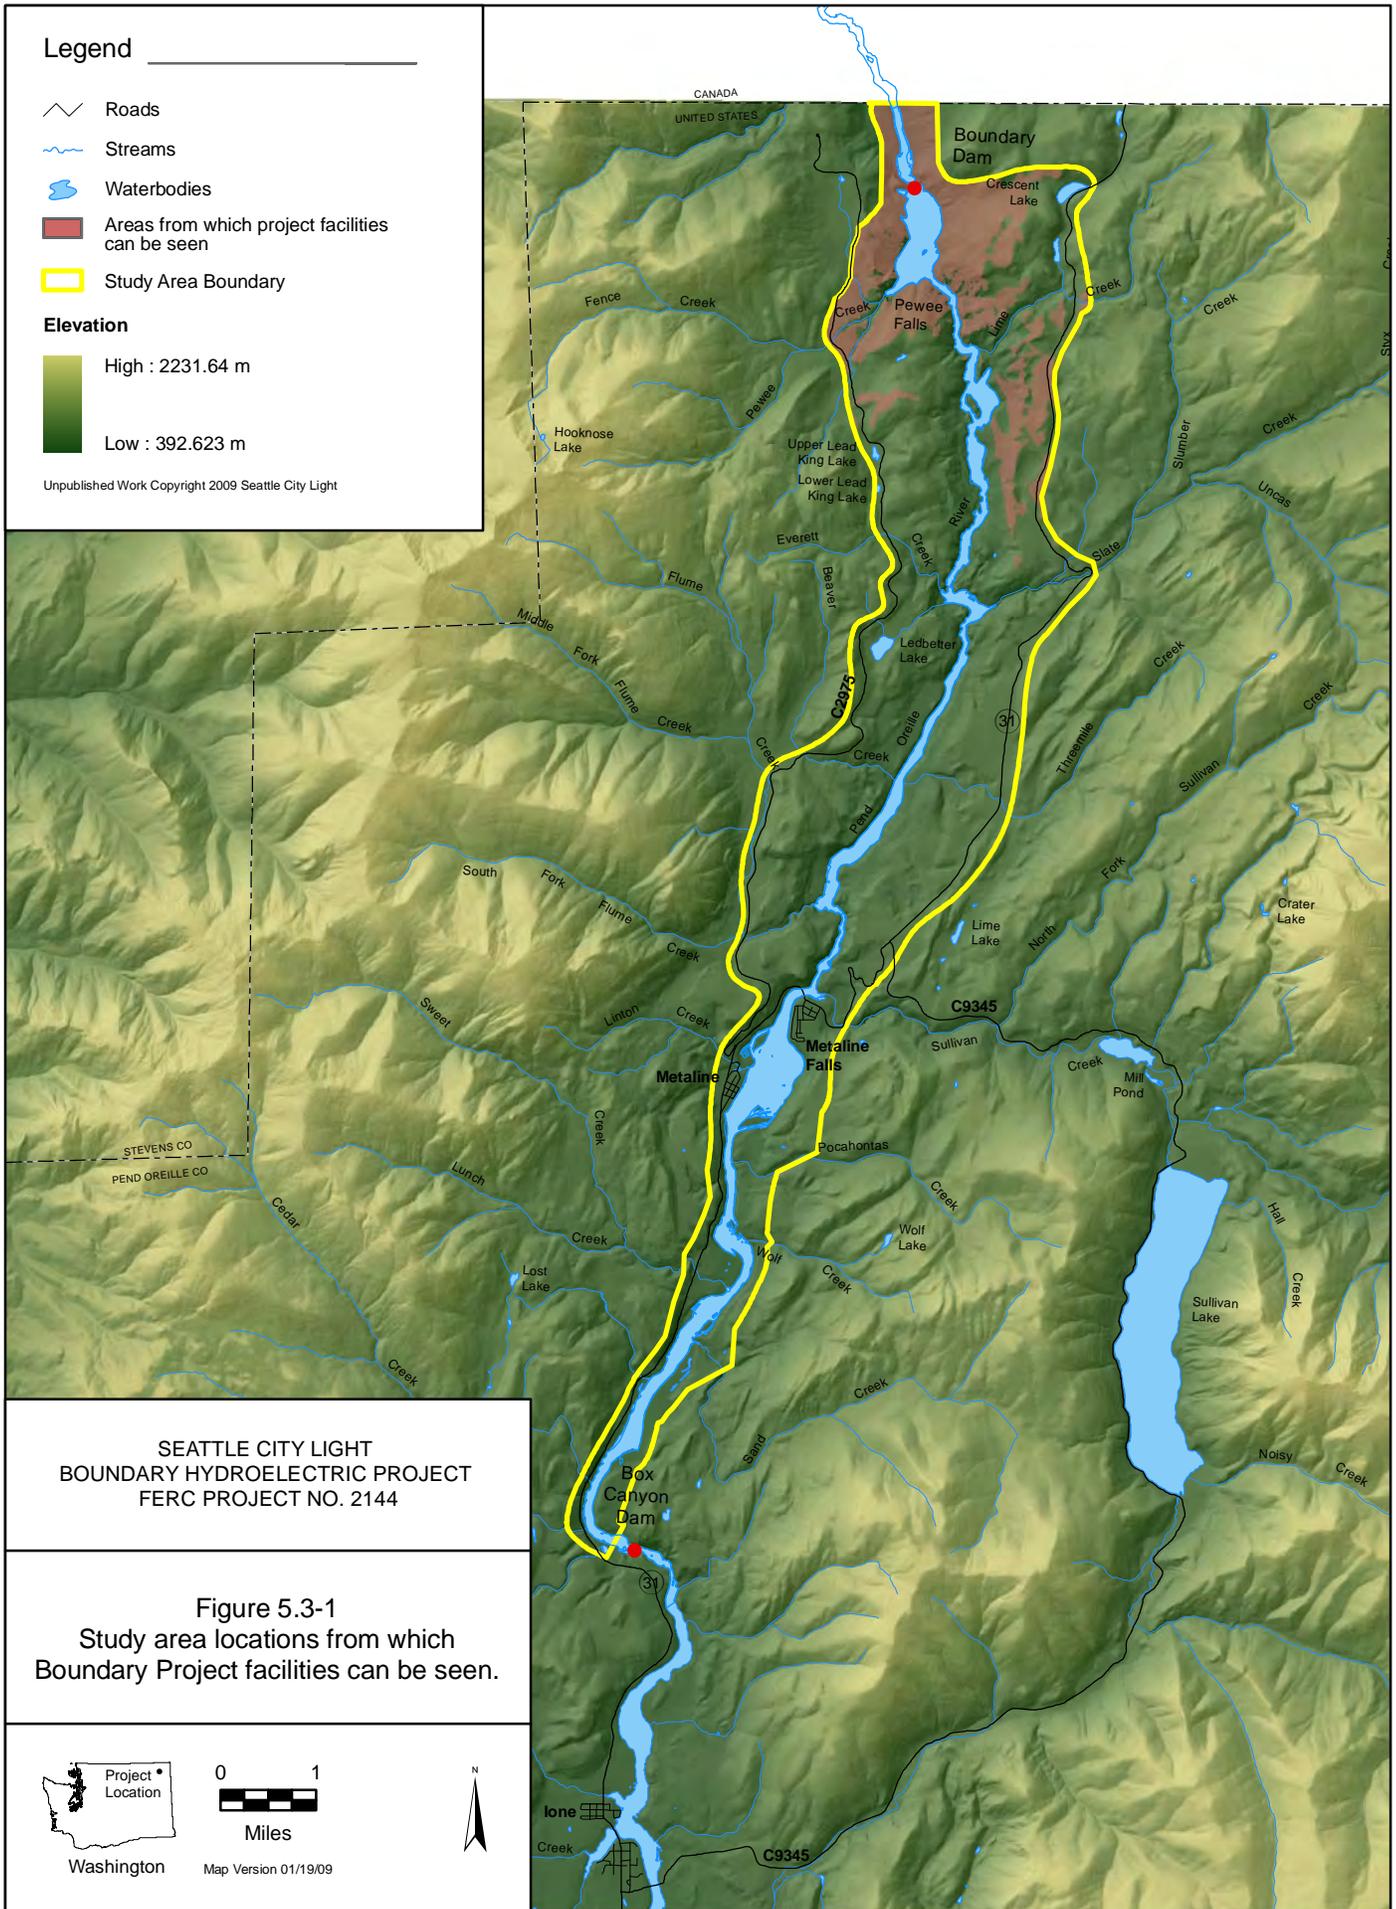
Figure 5.3-1  
Study area locations from which  
Boundary Project facilities can be seen.

A likely cause of this type of viewer reaction is that almost everyone who sees Project facilities is at one of those facilities and presumably knows in advance they are going to a hydropower project. Stated in different terms, there is a strong degree of self-selection involved on the part of viewers who are exposed to the visual contrast created by the Project facilities. For example, with very few exceptions, tourists/recreational users who see the Project facilities from the Tailrace Recreation Area have come to that location specifically to see the dam and powerhouse, usually as part of a group tour. Similarly, SCL constructed the Vista House specifically to provide a recreational attraction for people interested in seeing Boundary Dam and associated facilities, and selected a location with a commanding, elevated view of the dam.

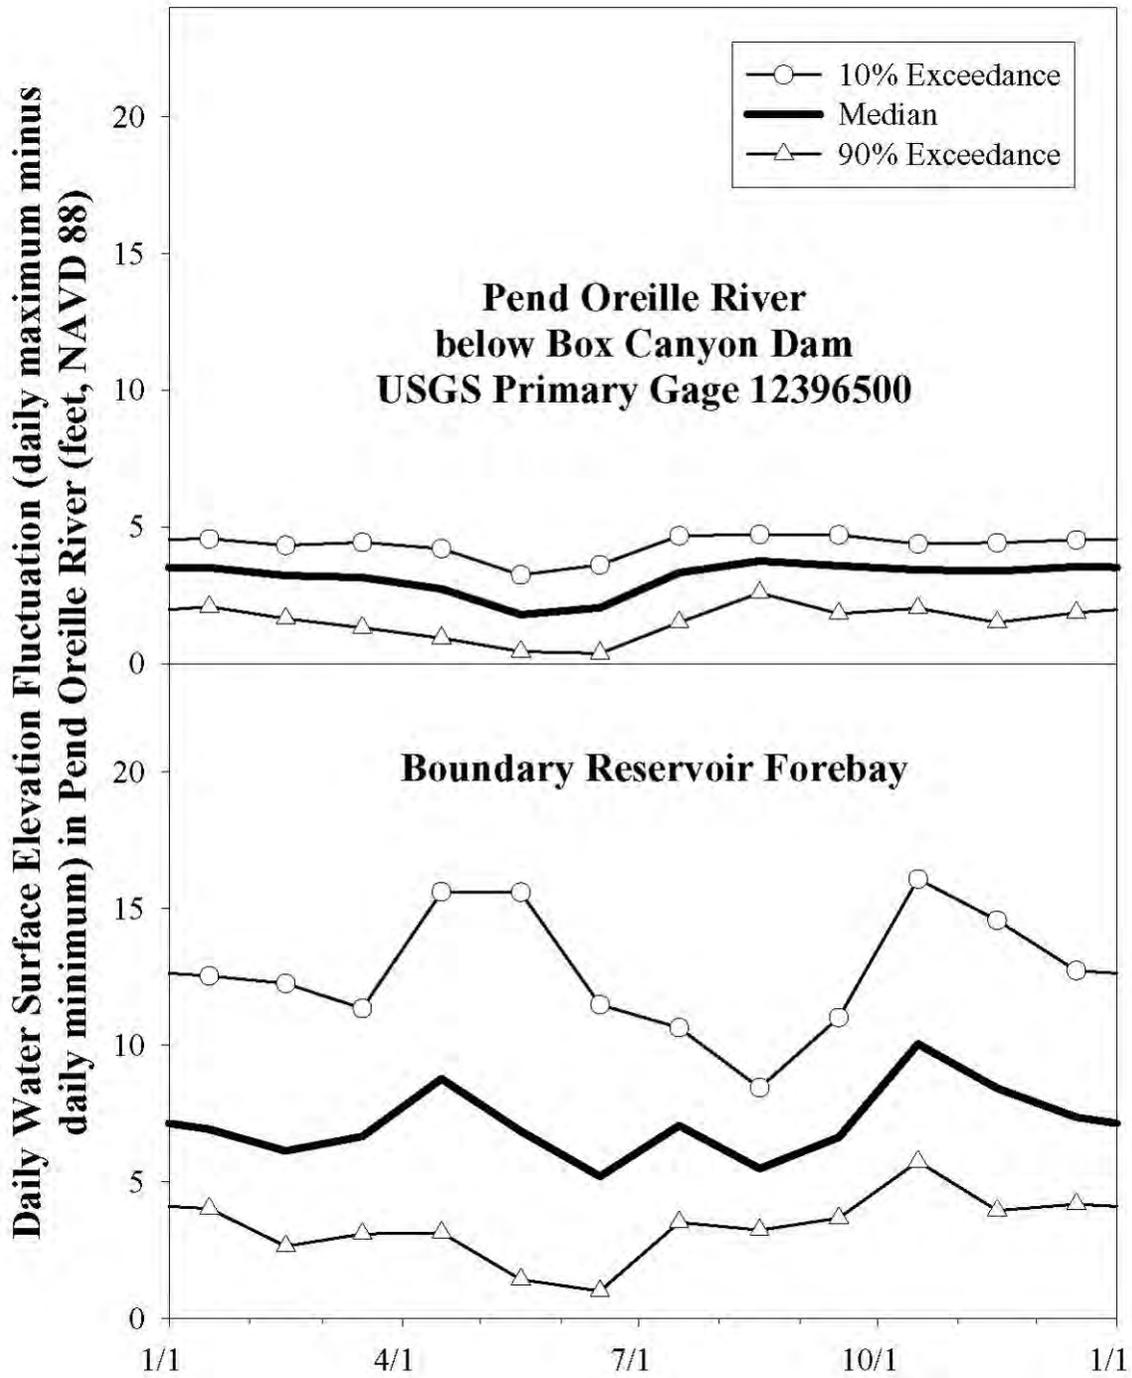
Figure 5.3-3. Patterns of daily water surface fluctuation in Boundary Reservoir.

In summary, the hydrologic data for the period of record indicate that the range of daily reservoir fluctuations under normal Project operations during the summer period has been limited to approximately 7 feet at the forebay and only 3 to 4 feet in the upper reservoir above Metaline Falls. Because the topography and bathymetry around the upper reservoir are relatively moderate, compared to the steep conditions that are typical for the lower reservoir, the greater potential for reservoir fluctuations to result in noticeable shoreline exposure applies to the upper reservoir area. As indicated by the observed conditions at the upper reservoir KOPs, however, the degree of visual contrast along the shoreline that results under the typical range of daily fluctuations is minimal. The limited contrast that may occur at daily minimum elevations is unlikely to be detected by many viewers or prompt them to react adversely.
