**UNCONFINED COMPRESSIVE STRENGTH  
 DATA REPORT  
 ASTM D7012**

Project: ASPET Gorge 2nd Tunnel HMA Project No.: 08-175  
 Boring ID: B-1 Tested By: GW  
 Sample ID/Depth: B-1-100.7 Reviewed By: JAM

# Petrographic Report #XRN

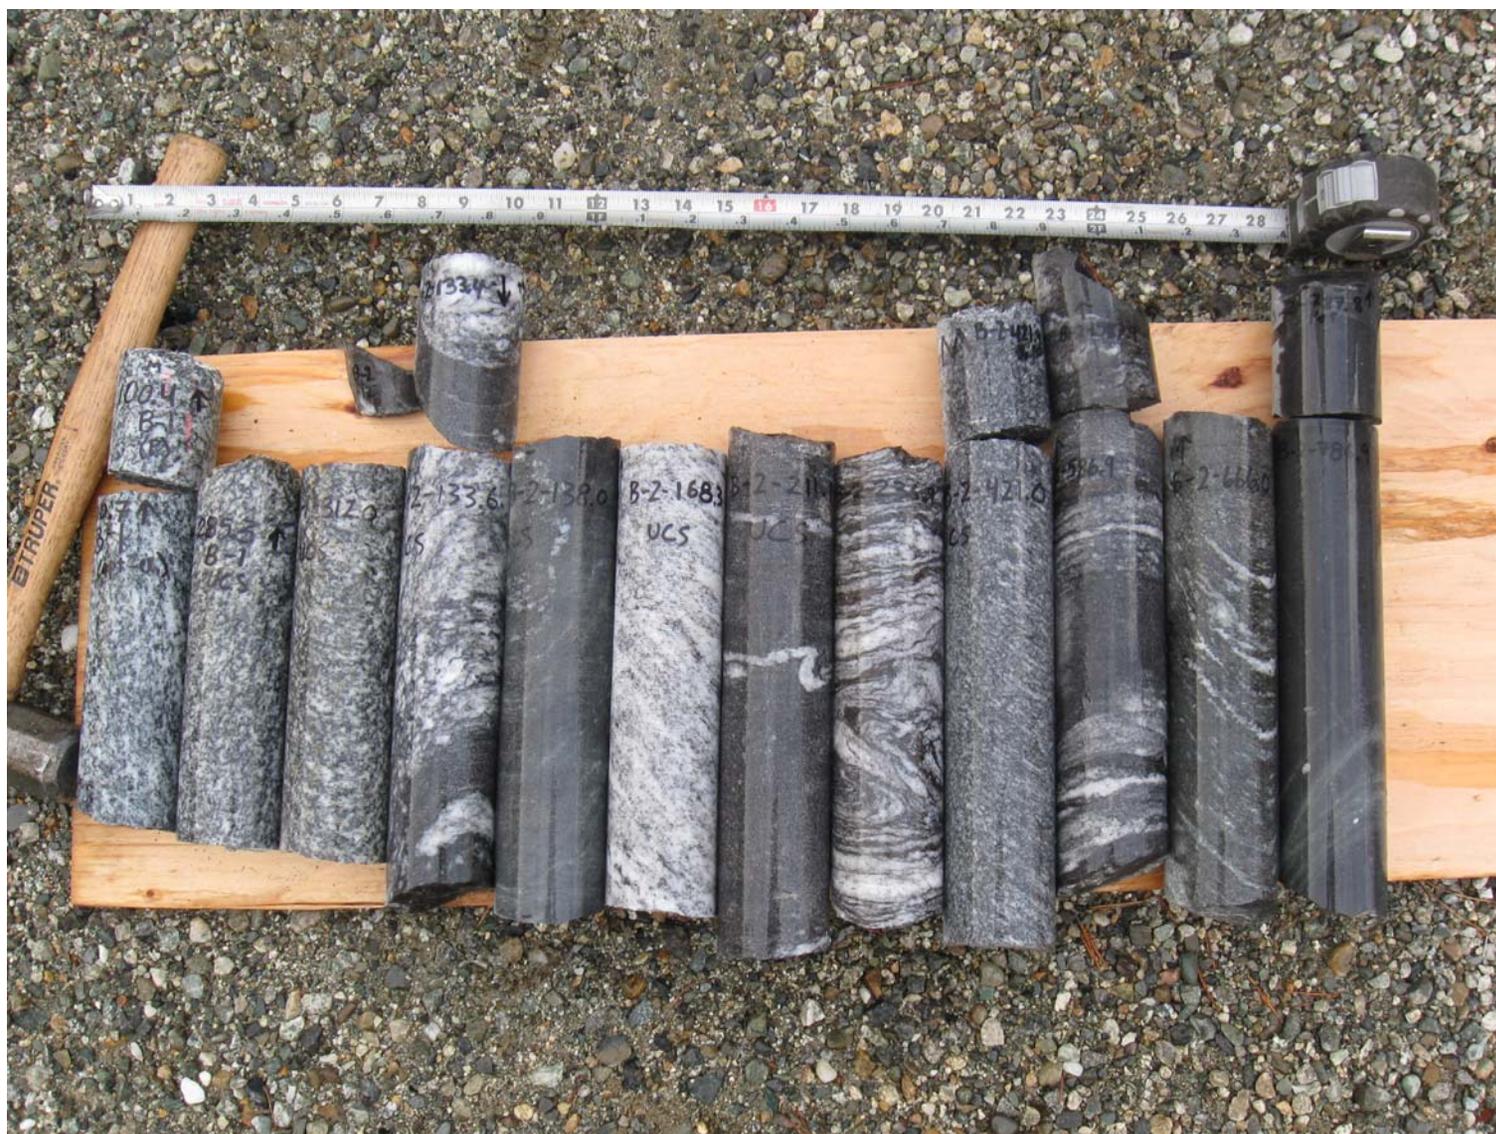
UCS and petrographic samples for B-1 and B-2: B-1-100.4, B-1-285.3, B-1-312.0, B-2-133.6, B-2-138.0, B-2-168.3, B-2-211.1, B-2-236.9, B-2-421.0, B-2-586.9, B-2-666.0, B-2-786.9

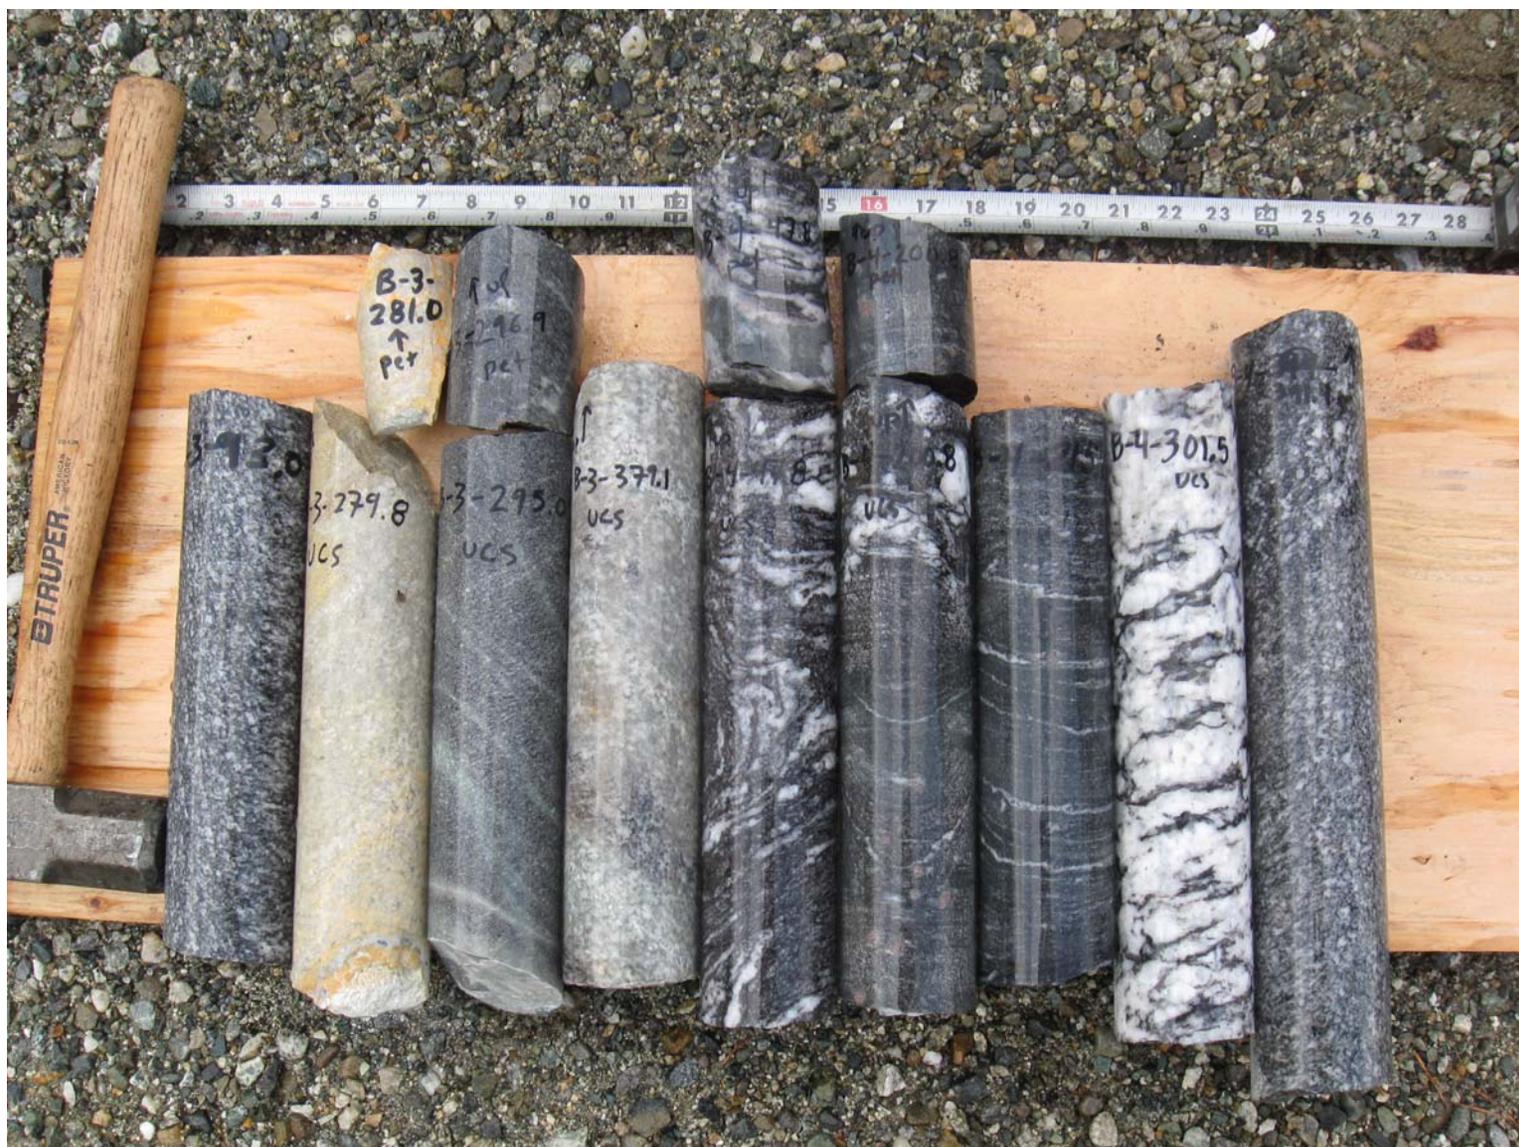
UCS and petrographic samples for B-3 and B-4: B-3-93.0, B-3-279.8, B-3-293.0, B-3-379.1, B-4-47.8, B-4-200.8, B-4-215.0, B-4-301.5, B-4-391.4

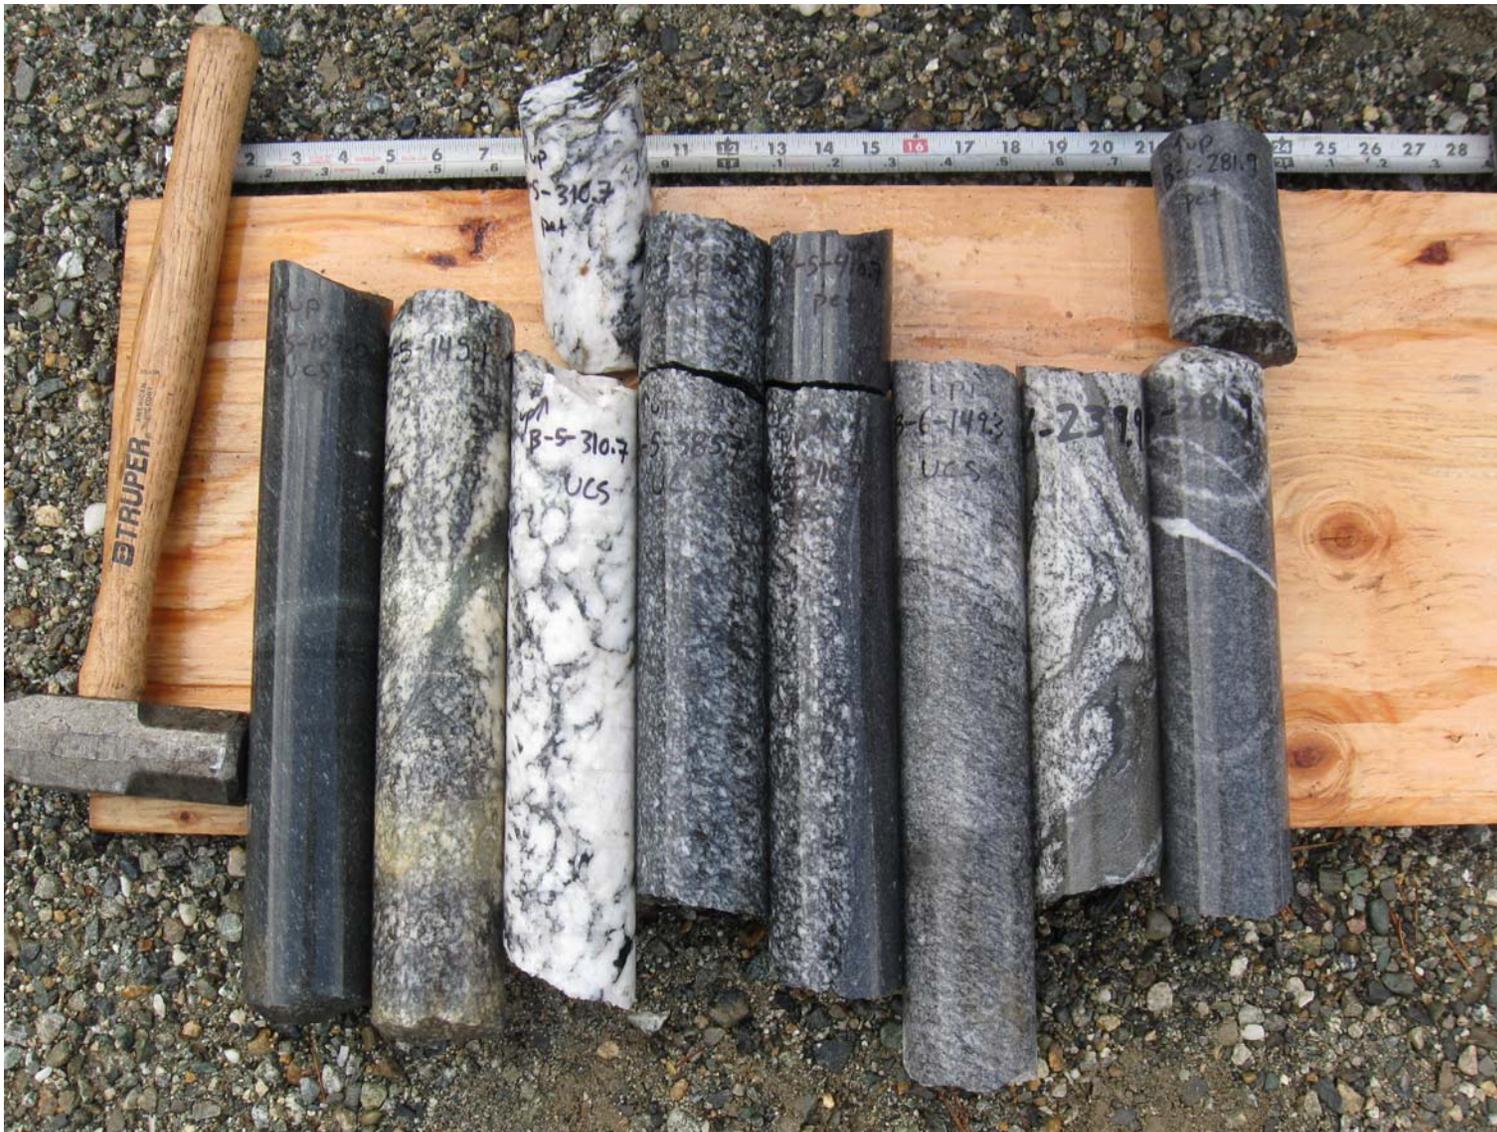
UCS and petrographic samples for B-5 and B-6: B-5-109.0, B-5-145.1, B-5-310.7, B-5-385.7, B-5-410.7, B-6-149.3, B-6-239.9, B-6-281.9

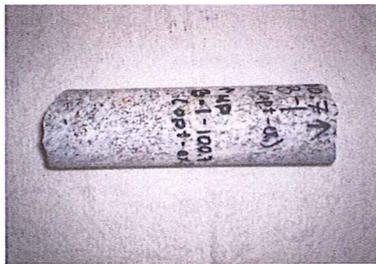
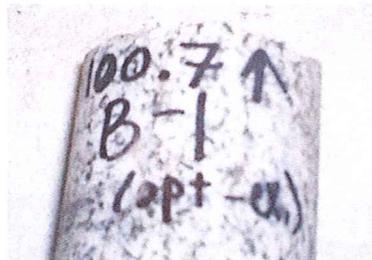
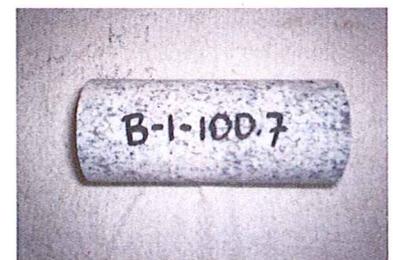
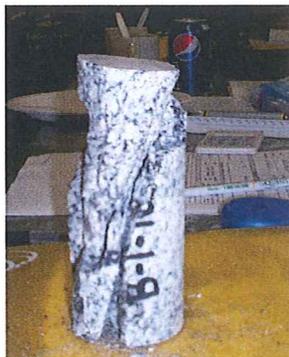
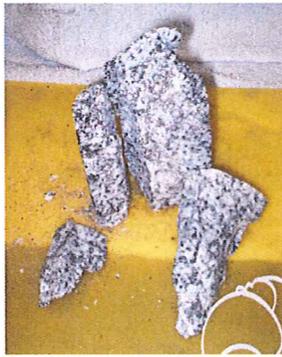
Images:

SAMPLE ID	LAB No.	DATE OF TEST	AVERAGE LENGTH	AVERAGE DIAMETER	MAXIMUM LOAD (lbs)	AVERAGE CROSS SECTION AREA (inch <sup>2</sup> )	COMPRESSIVE STRENGTH (psi)	TYPE OF FRACTURE <small>(Specify radial, conical, or other)</small>
B-1-100.7	6893-5	11/04/2009	5.04	2.38	64820	4.45	14570	radial

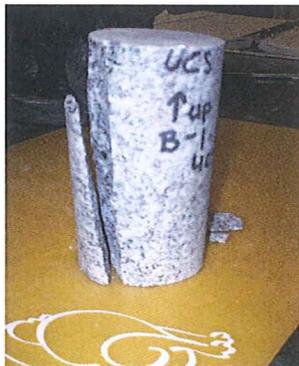
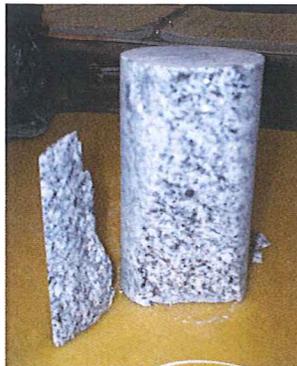
SAMPLE ID	LAB No.	DATE OF TEST	AVERAGE LENGTH	AVERAGE DIAMETER	MAXIMUM LOAD (lbs)	AVERAGE CROSS SECTION AREA (inch <sup>2</sup> )	COMPRESSIVE STRENGTH (psi)	TYPE OF FRACTURE <small>(Specify radial, conical, or other)</small>
B-1-285.3	6893-23	11/10/2009	4.79	2.4	22600	4.52	5000	radial

Remarks: Fracture indicats poor failure mechanism, resulting in compressive strength that is likely low and non-representative

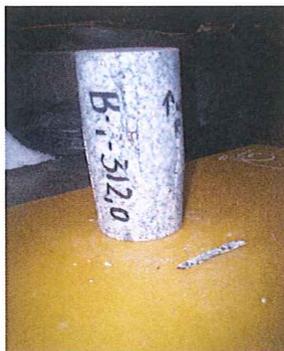
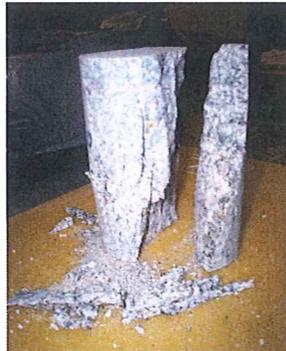
Images:

SAMPLE ID	LAB No.	DATE OF TEST	AVERAGE LENGTH	AVERAGE DIAMETER	MAXIMUM LOAD (lbs)	AVERAGE CROSS SECTION AREA (inch <sup>2</sup> )	COMPRESSIVE STRENGTH (psi)	TYPE OF FRACTURE <small>(Specify radial, conical, or other)</small>
B-1-312.0	6893-17	11/09/2009	4.93	2.40	40130	4.52	8880	radial

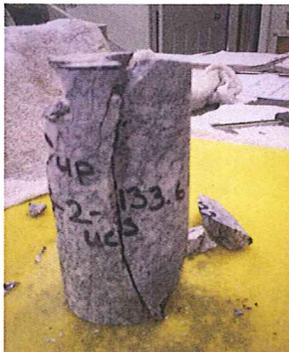
Images:

SAMPLE ID	LAB No.	DATE OF TEST	AVERAGE LENGTH	AVERAGE DIAMETER	MAXIMUM LOAD (lbs)	AVERAGE CROSS SECTION AREA (inch <sup>2</sup> )	COMPRESSIVE STRENGTH (psi)	TYPE OF FRACTURE <small>(Specify radial, conical, or other)</small>
B-2-133.6	6893-4	11/04/2009	5.11	2.39	39230	4.49	8740	con/rad

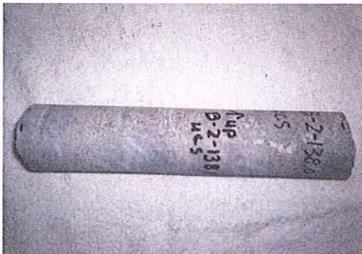
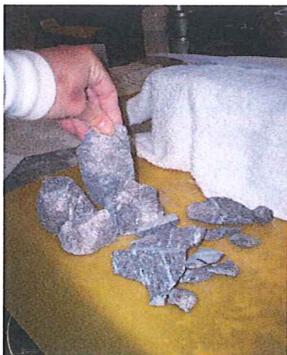
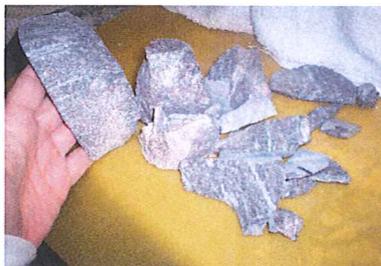
Images:

SAMPLE ID	LAB No.	DATE OF TEST	AVERAGE LENGTH	AVERAGE DIAMETER	MAXIMUM LOAD (lbs)	AVERAGE CROSS SECTION AREA (inch <sup>2</sup> )	COMPRESSIVE STRENGTH (psi)	TYPE OF FRACTURE <i>(Specify radial, conical, or other)</i>
B-2-138.0	9893-11	11/06/2009	5.09	2.39	74590	4.49	16610	radial

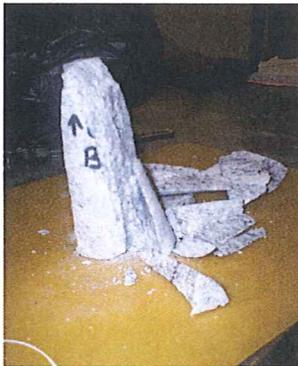
SAMPLE ID	LAB No.	DATE OF TEST	AVERAGE LENGTH	AVERAGE DIAMETER	MAXIMUM LOAD (lbs)	AVERAGE CROSS SECTION AREA (inch <sup>2</sup> )	COMPRESSIVE STRENGTH (psi)	TYPE OF FRACTURE <small>(Specify radial, conical, or other)</small>
B-2-168.3	6893-22	11/10/2009	4.93	2.39	44130	4.49	9830	radial

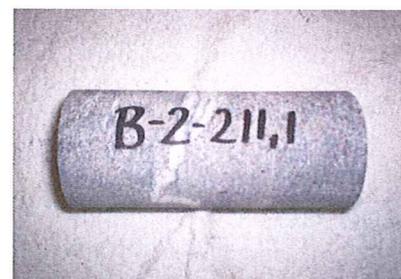
SAMPLE ID	LAB No.	DATE OF TEST	AVERAGE LENGTH	AVERAGE DIAMETER	MAXIMUM LOAD (lbs)	AVERAGE CROSS SECTION AREA (inch <sup>2</sup> )	COMPRESSIVE STRENGTH (psi)	TYPE OF FRACTURE <small>(Specify radial, conical, or other)</small>
B-2-211.1	6893-18	11/09/2009	5.03	2.40	44450	4.52	9830	radial

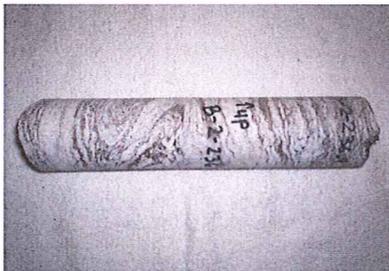
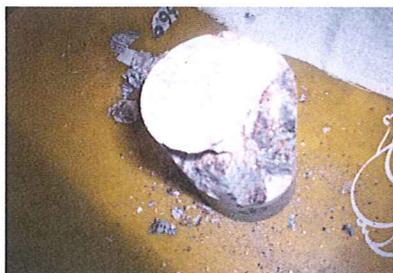
Images:

SAMPLE ID	LAB No.	DATE OF TEST	AVERAGE LENGTH	AVERAGE DIAMETER	MAXIMUM LOAD (lbs)	AVERAGE CROSS SECTION AREA (inch <sup>2</sup> )	COMPRESSIVE STRENGTH (psi)	TYPE OF FRACTURE <small>(Specify radial, conical, or other)</small>
B-2-236.9	6893-7	11/06/2009	5.07	2.38	35220	4.45	7910	con/rad

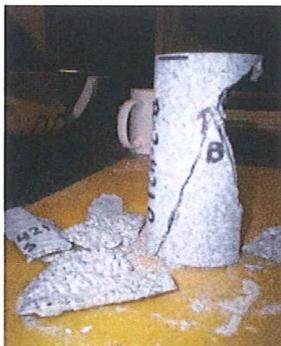
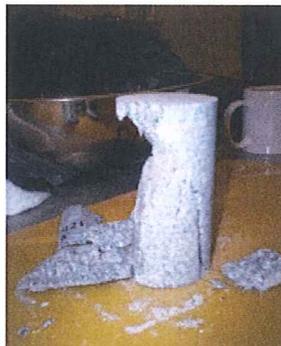
Images:

SAMPLE ID	LAB No.	DATE OF TEST	AVERAGE LENGTH	AVERAGE DIAMETER	MAXIMUM LOAD (lbs)	AVERAGE CROSS SECTION AREA (inch <sup>2</sup> )	COMPRESSIVE STRENGTH (psi)	TYPE OF FRACTURE <small>(Specify radial, conical, or other)</small>
B-2-421.0	6893-15	11/09/2009	5.05	2.39	52770	4.49	11750	conical

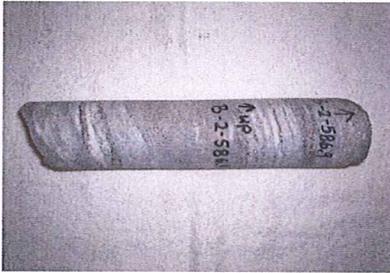
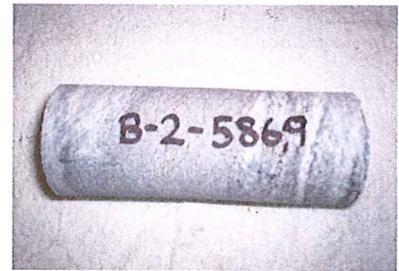
Images:

SAMPLE ID	LAB No.	DATE OF TEST	AVERAGE LENGTH	AVERAGE DIAMETER	MAXIMUM LOAD (lbs)	AVERAGE CROSS SECTION AREA (inch <sup>2</sup> )	COMPRESSIVE STRENGTH (psi)	TYPE OF FRACTURE <i>(Specify radial, conical, or other)</i>
B-2-586.9	6893-19	11/09/2009	5.57	2.39	24840	4.49	5530	shear

Remarks: Limited area of shear at top of core, possible low compressive strength result

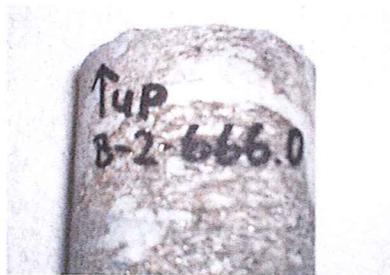
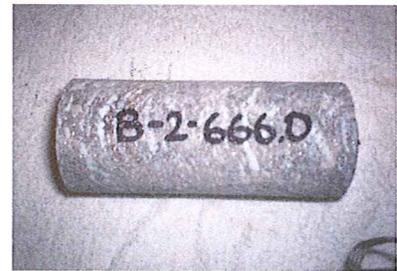
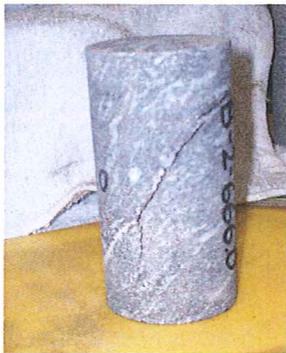
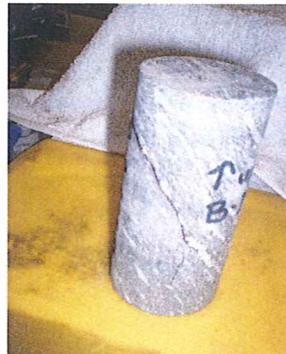
SAMPLE ID	LAB No.	DATE OF TEST	AVERAGE LENGTH	AVERAGE DIAMETER	MAXIMUM LOAD (lbs)	AVERAGE CROSS SECTION AREA (inch <sup>2</sup> )	COMPRESSIVE STRENGTH (psi)	TYPE OF FRACTURE <small>(Specify radial, conical, or other)</small>
B-2-666.0	6893-6	11/04/2009	5.01	2.39	13570	4.49	3020	shear

Remarks: Failure visible on existing bedding plane

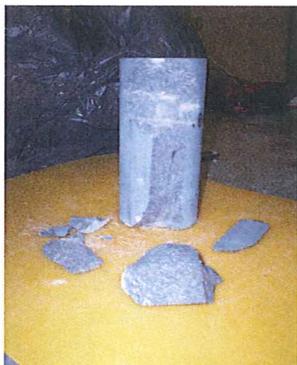
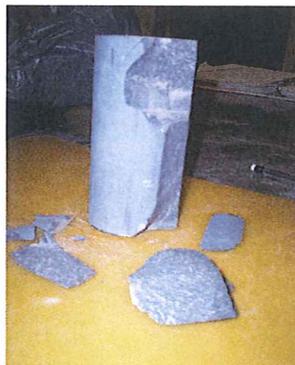
Images:

SAMPLE ID	LAB No.	DATE OF TEST	AVERAGE LENGTH	AVERAGE DIAMETER	MAXIMUM LOAD (lbs)	AVERAGE CROSS SECTION AREA (inch <sup>2</sup> )	COMPRESSIVE STRENGTH (psi)	TYPE OF FRACTURE <small>(Specify radial, conical, or other)</small>
B-2-786.9	6893-20	11/09/2009	5.07	2.39	30990	4.49	6900	con/rad

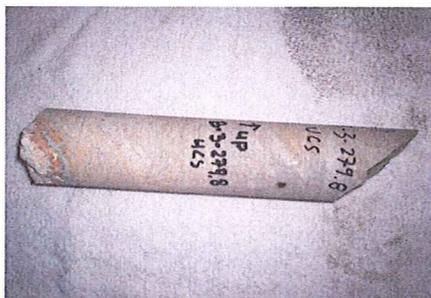
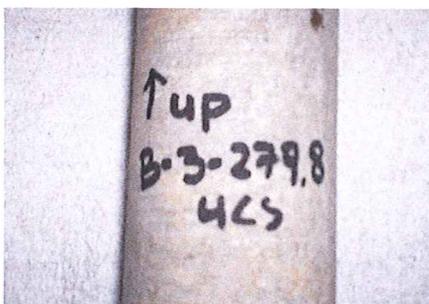
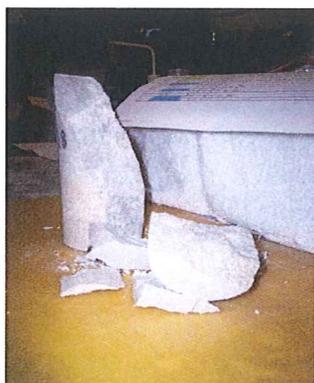
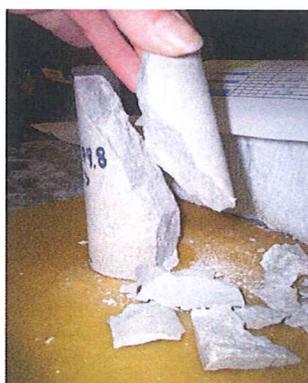
SAMPLE ID	LAB No.	DATE OF TEST	AVERAGE LENGTH	AVERAGE DIAMETER	MAXIMUM LOAD (lbs)	AVERAGE CROSS SECTION AREA (inch <sup>2</sup> )	COMPRESSIVE STRENGTH (psi)	TYPE OF FRACTURE <small>(Specify radial, conical, or other)</small>
B-3-279.8	6893-10	11/06/2009	5.08	2.40	35960	4.52	7960	conical

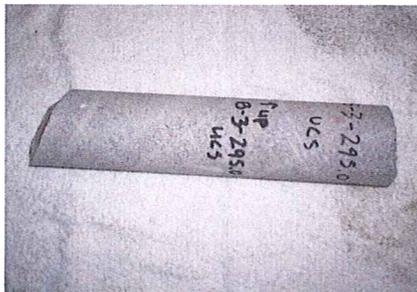
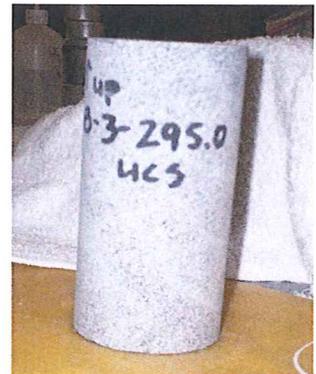
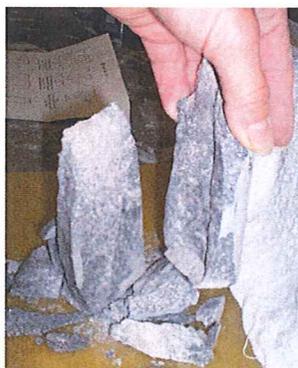
SAMPLE ID	LAB No.	DATE OF TEST	AVERAGE LENGTH	AVERAGE DIAMETER	MAXIMUM LOAD (lbs)	AVERAGE CROSS SECTION AREA (inch <sup>2</sup> )	COMPRESSIVE STRENGTH (psi)	TYPE OF FRACTURE <small>(Specify radial, conical, or other)</small>
B-3-295.0	6893-12	11/09/2009	4.94	2.40	55730	4.52	12330	radial

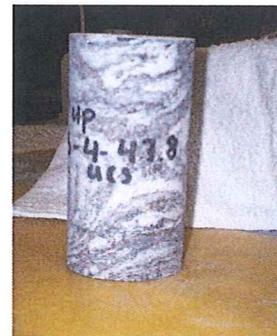
Images:

SAMPLE ID	LAB No.	DATE OF TEST	AVERAGE LENGTH	AVERAGE DIAMETER	MAXIMUM LOAD (lbs)	AVERAGE CROSS SECTION AREA (inch <sup>2</sup> )	COMPRESSIVE STRENGTH (psi)	TYPE OF FRACTURE <small>(Specify radial, conical, or other)</small>
B-4-47.8	6893-8	11/06/2009	4.97	2.39	37850	4.49	8430	shear

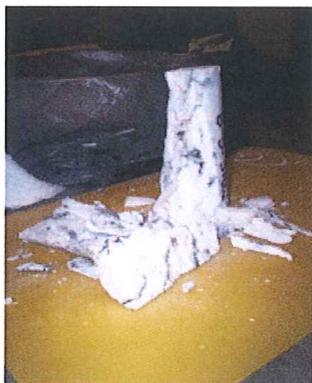
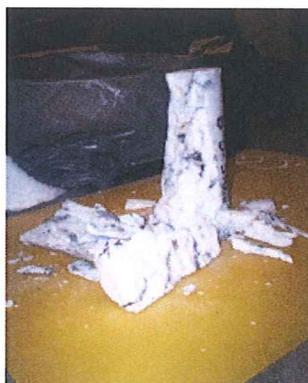
SAMPLE ID	LAB No.	DATE OF TEST	AVERAGE LENGTH	AVERAGE DIAMETER	MAXIMUM LOAD (lbs)	AVERAGE CROSS SECTION AREA (inch <sup>2</sup> )	COMPRESSIVE STRENGTH (psi)	TYPE OF FRACTURE <small>(Specify radial, conical, or other)</small>
B-5-310.7	6893-16	11/09/2009	4.88	2.39	24170	4.49	5380	radial

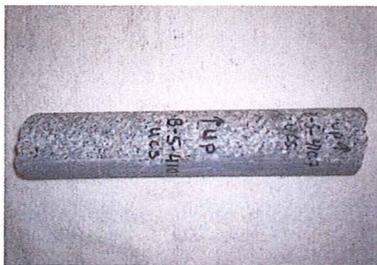
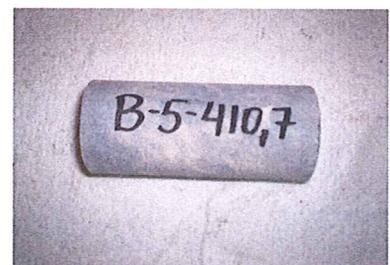
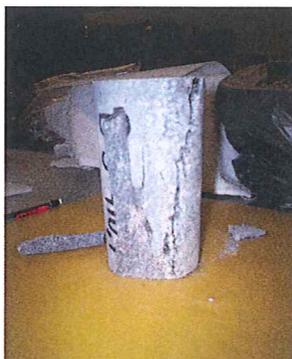
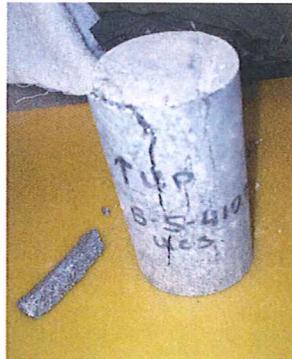
SAMPLE ID	LAB No.	DATE OF TEST	AVERAGE LENGTH	AVERAGE DIAMETER	MAXIMUM LOAD (lbs)	AVERAGE CROSS SECTION AREA (inch <sup>2</sup> )	COMPRESSIVE STRENGTH (psi)	TYPE OF FRACTURE <small>(Specify radial, conical, or other)</small>
B-5-410.7	6893-19	11/09/2009	5.04	2.40	50650	4.52	11210	radial

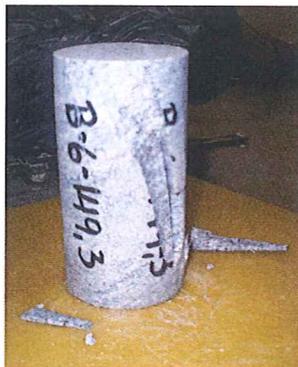
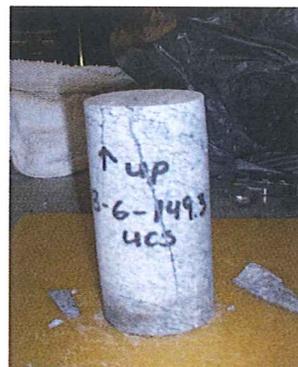
SAMPLE ID	LAB No.	DATE OF TEST	AVERAGE LENGTH	AVERAGE DIAMETER	MAXIMUM LOAD (lbs)	AVERAGE CROSS SECTION AREA (inch <sup>2</sup> )	COMPRESSIVE STRENGTH (psi)	TYPE OF FRACTURE <small>(Specify radial, conical, or other)</small>
B-6-149.3	6893-21	11/10/2009	5.08	2.40	46790	4.52	10350	radial

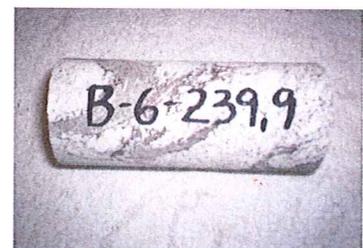
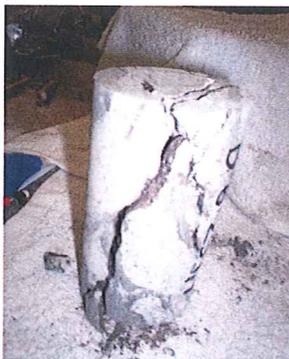
SAMPLE ID	LAB No.	DATE OF TEST	AVERAGE LENGTH	AVERAGE DIAMETER	MAXIMUM LOAD (lbs)	AVERAGE CROSS SECTION AREA (inch <sup>2</sup> )	COMPRESSIVE STRENGTH (psi)	TYPE OF FRACTURE <small>(Specify radial, conical, or other)</small>
B-6-239.9	6893-2	11/04/2009	5.06	2.38	18110	4.45	4070	con/rad

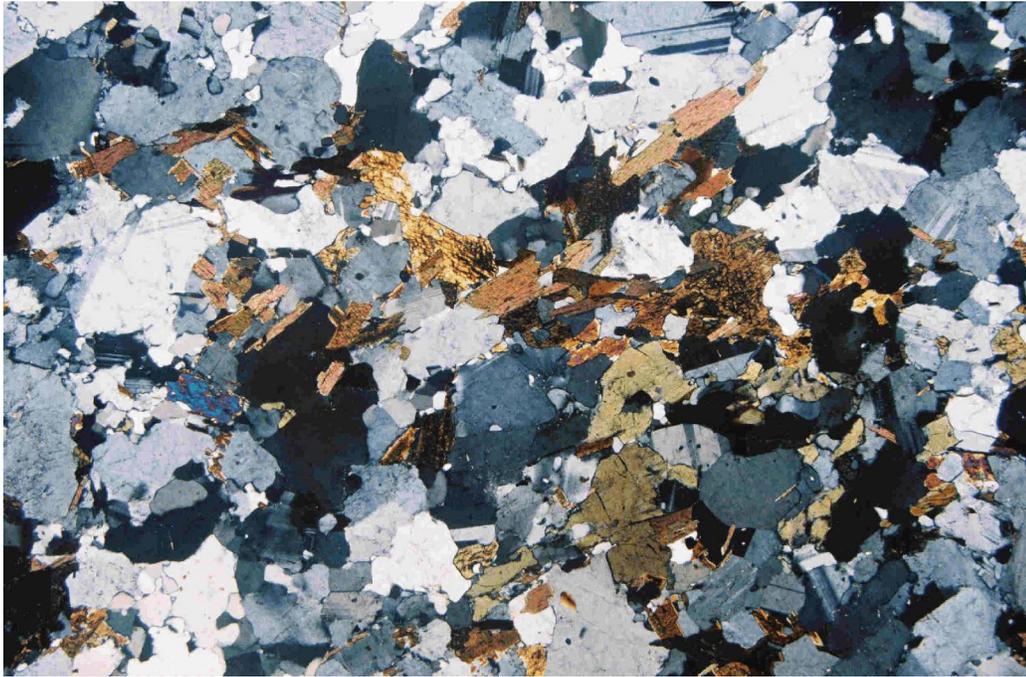
B-2-421.9 09034\_11.jpg/XPL/FOV = 4.00 x 5.83 mm/XRN BIOTITE-QUARTZ-PLAGIOCLASE SCHIST showing typical appearance (same view as 09034\_12.jpg).

**ROCK NAME** BIOTITE-QUARTZ-PLAGIOCLASE SCHIST-- probably formed by regional dynamothermal metamorphism of a quartzofeldspathic sedimentary protolith.

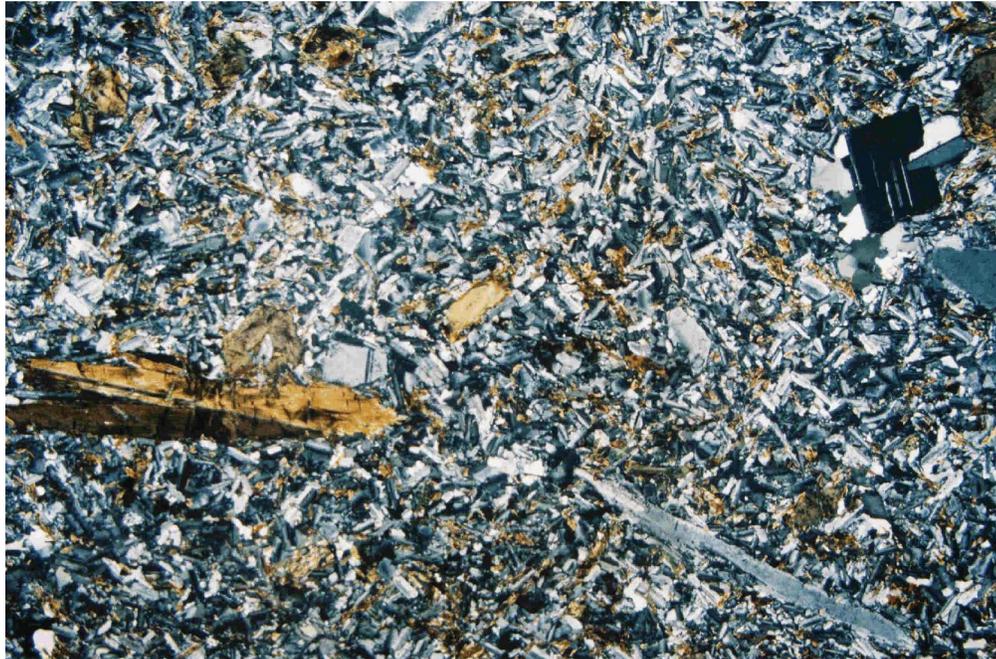
B-2-787.8 09034\_15.jpg/XPL/FOV = 4.00 x 5.83 mm/XRN ALTERED ANDESITE PORPHYRY showing typical appearance (same view as 09034\_16.jpg).

**ROCK NAME** ALTERED ANDESITE PORPHYRY -- probably formed by hydrothermal alteration (secondary biotite) from an andesite microporphyry porphyry flow or shallow intrusion.

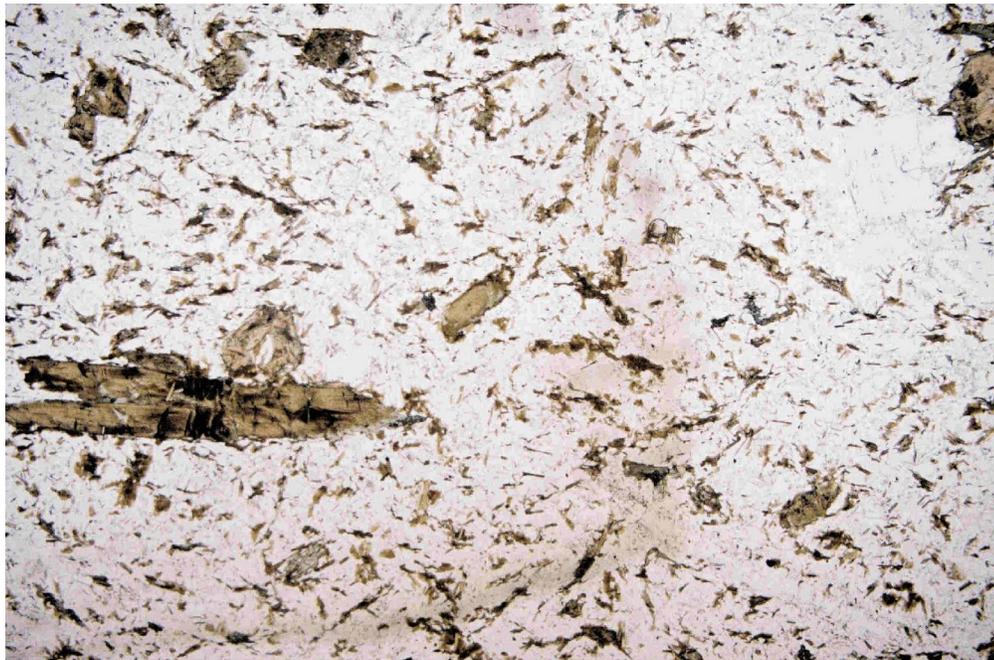
B-2-787.8 09034\_16.jpg/PPL/FOV = 4.00 x 5.83 mm/XRN ALTERED ANDESITE PORPHYRY showing typical appearance (same view as 09034\_15.jpg).

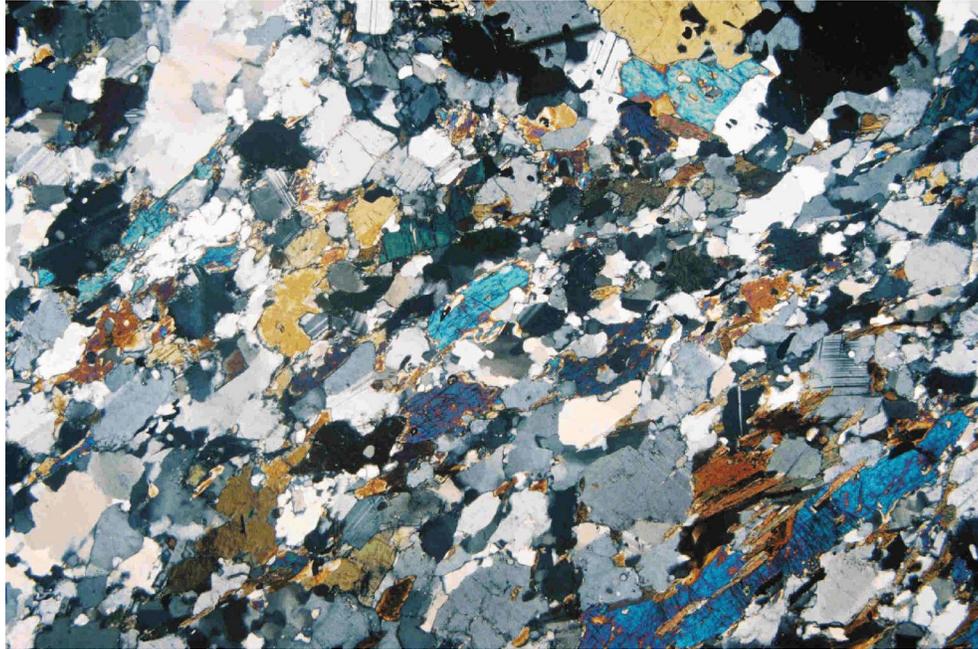
B-4-200.8 09034\_21.jpg/XPL/FOV = 4.00 x 5.83 mm/XRN GARNET-BIOTITE-ACTINOLITE-QUARTZ-PLAGIOCLASE SCHIST showing typical appearance (same view as 09034\_22.jpg).

**ROCK NAME** GARNET-BIOTITE-ACTINOLITE-QUARTZ-PLAGIOCLASE SCHIST-- probably formed by regional dynamothermal metamorphism of a calcareous quartzofeldspathic sedimentary protolith.
