SKAGIT - FERC PROJECT #553
EROSION CONTROL PROGRAM
2005 COMPLETION REPORT

North Cascades National Park and Seattle City Light

March, 2006

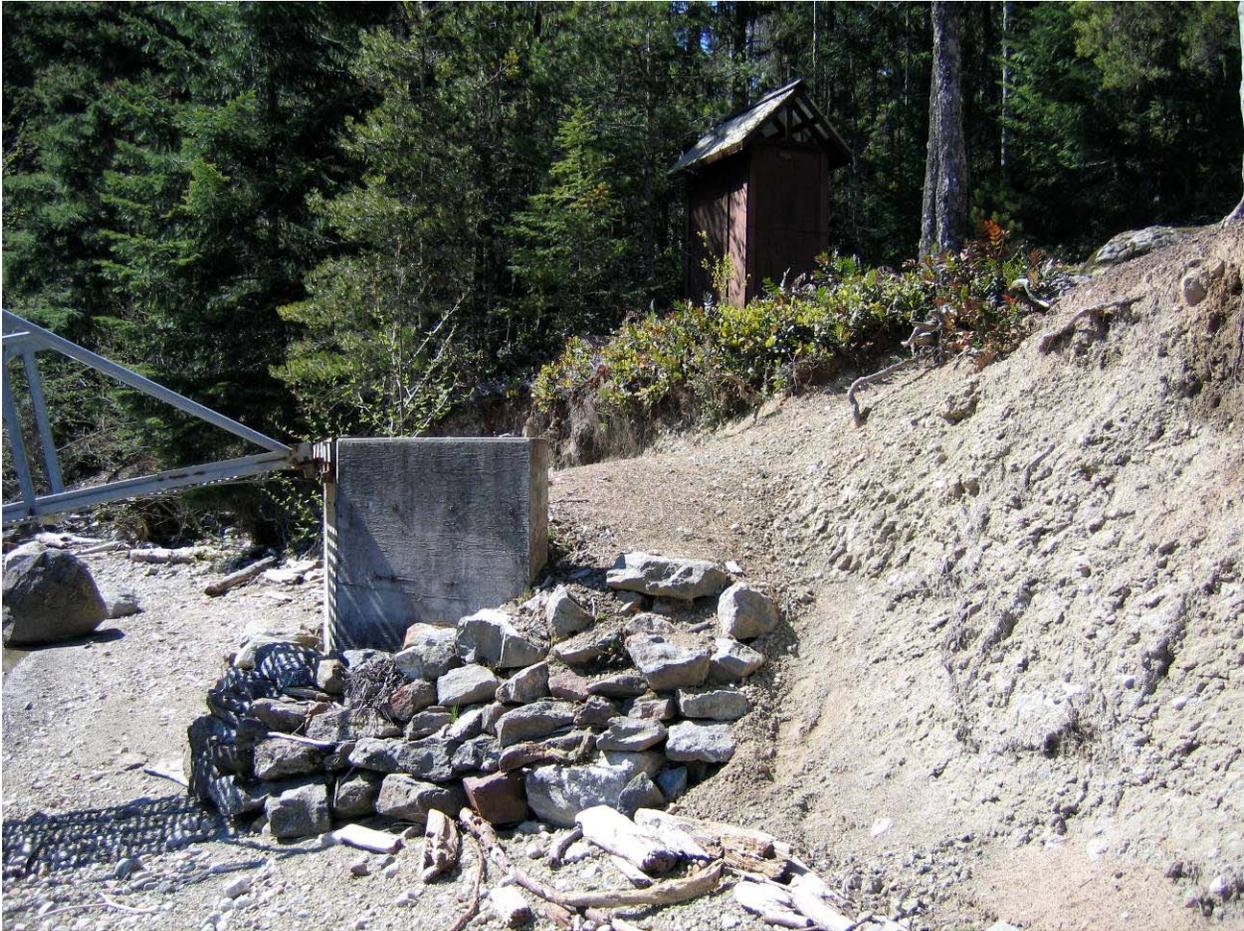
1) Thunder Point Campground Dock Bulkhead (before)

Approximately 250 ft of shoreline fronting the campground had become severely eroded. NPS erosion control crews in coordination with Seattle City Light barge, tug and boat crew imported 23 dump truck loads of building rock and one hundred yards of gravel. As per settlement agreement erosion control design, dry lay rock wall was installed to a height of 5' along the 250' of shoreline. Upon completion of dry wall, armor rock placed along the toe for the entire span. On the southwest end of the site, an additional 60' of eroded shoreline was protected by half burying stumps in the drawdown and locking in drift logs in between the buried stumps and the shoreline creating a wave energy break. (see attached photos).

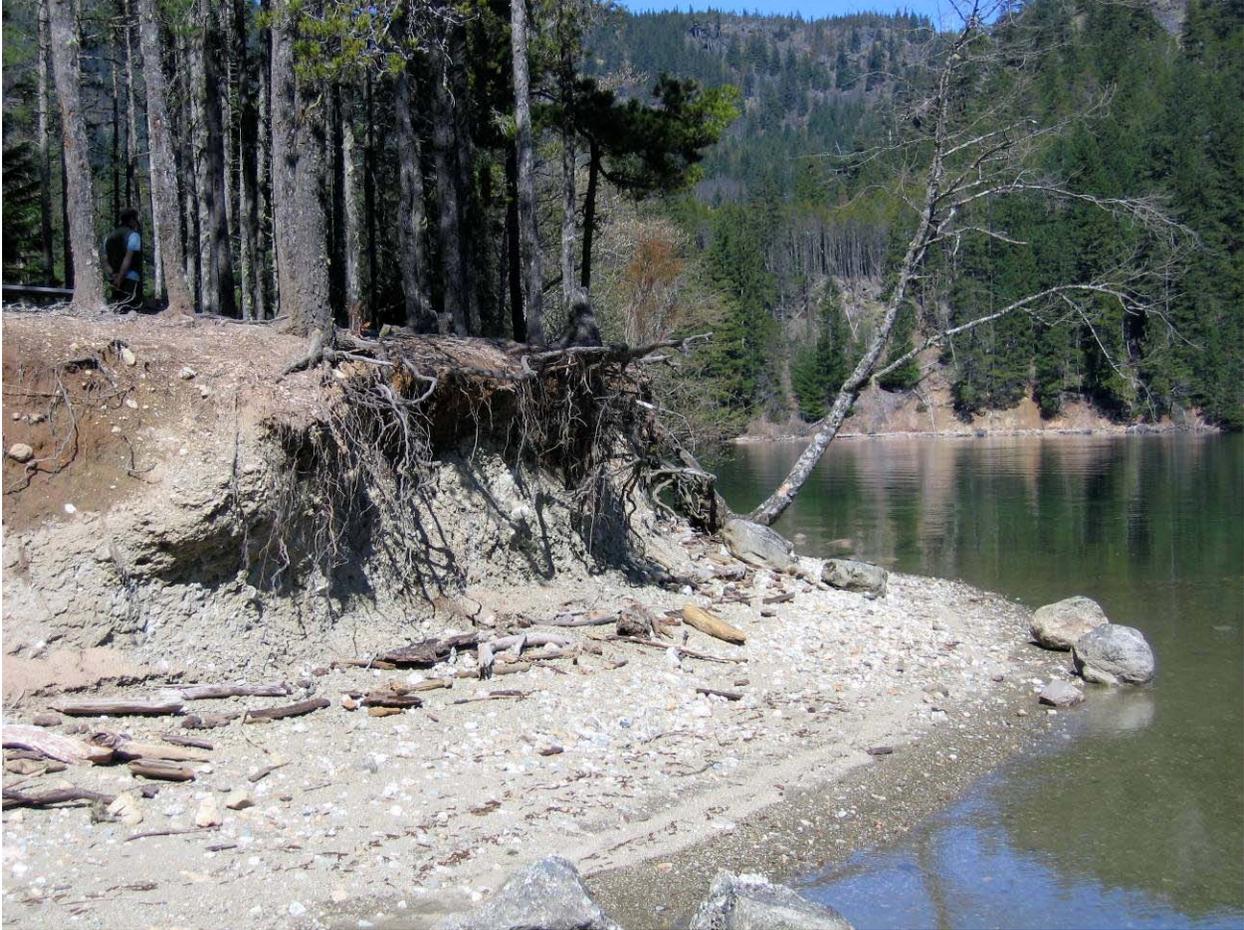
2)Thunder Point Campground Shoreline (before)

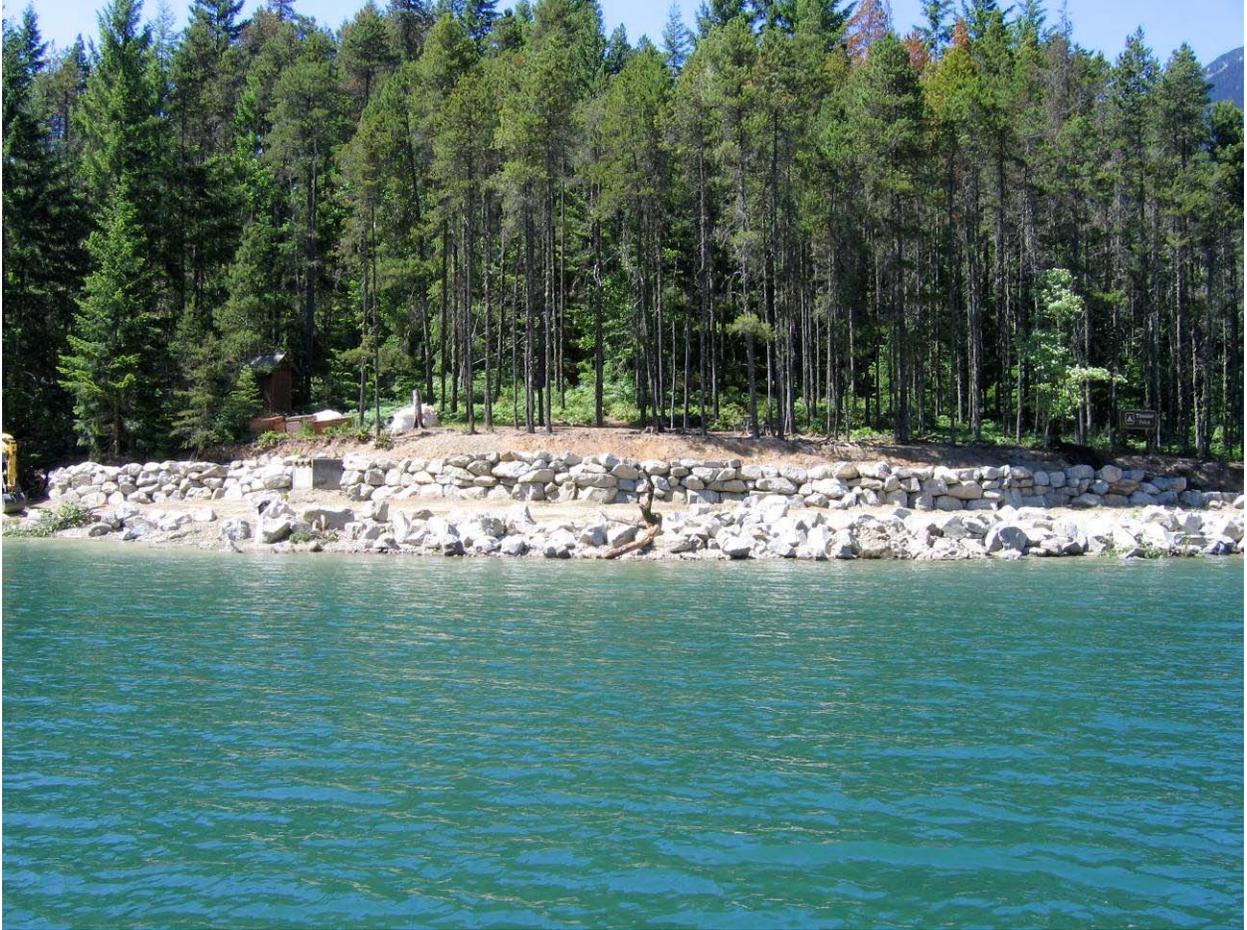
3)Thunder Point Campground (In progress)

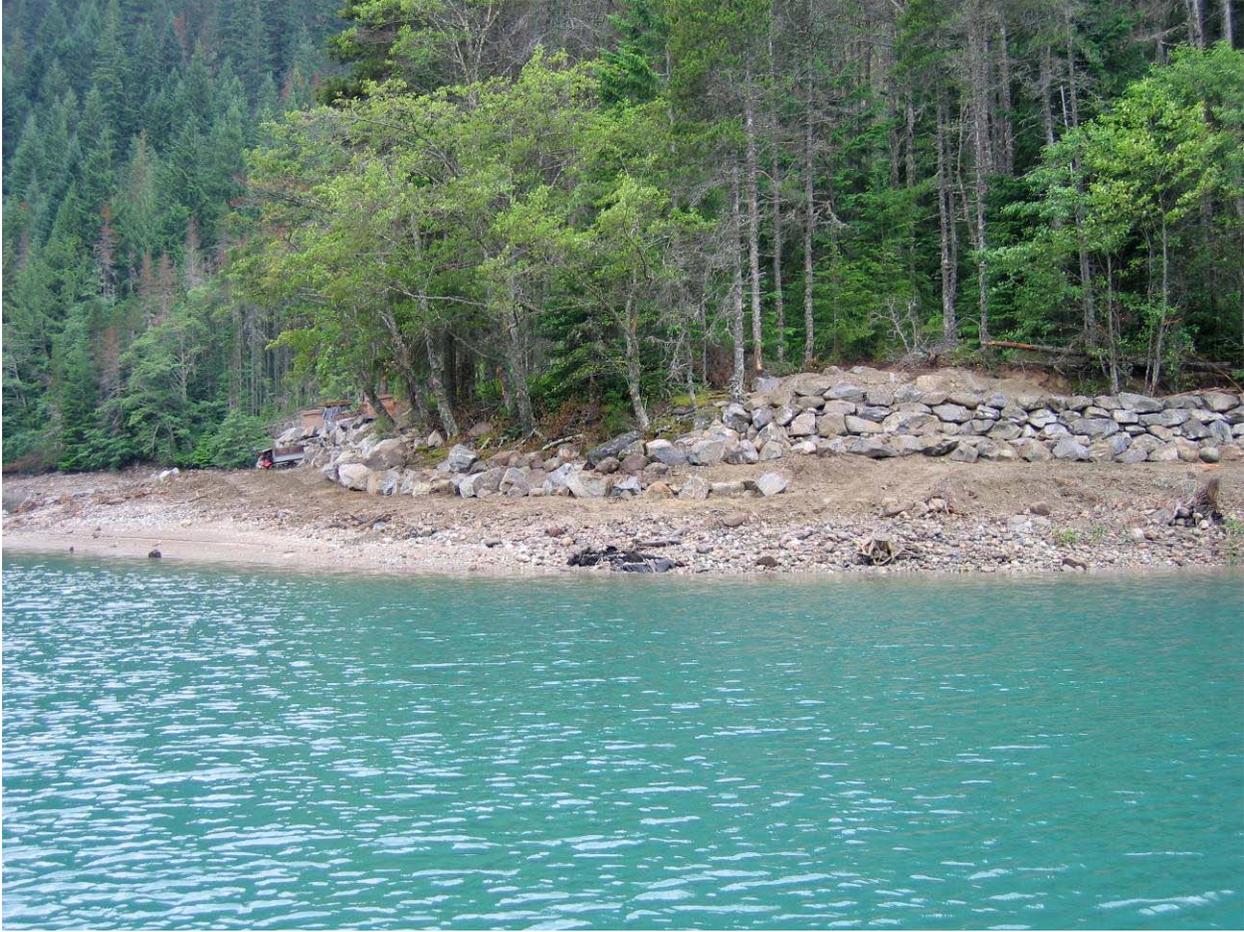
4)Thunder Point Campground (In progress)

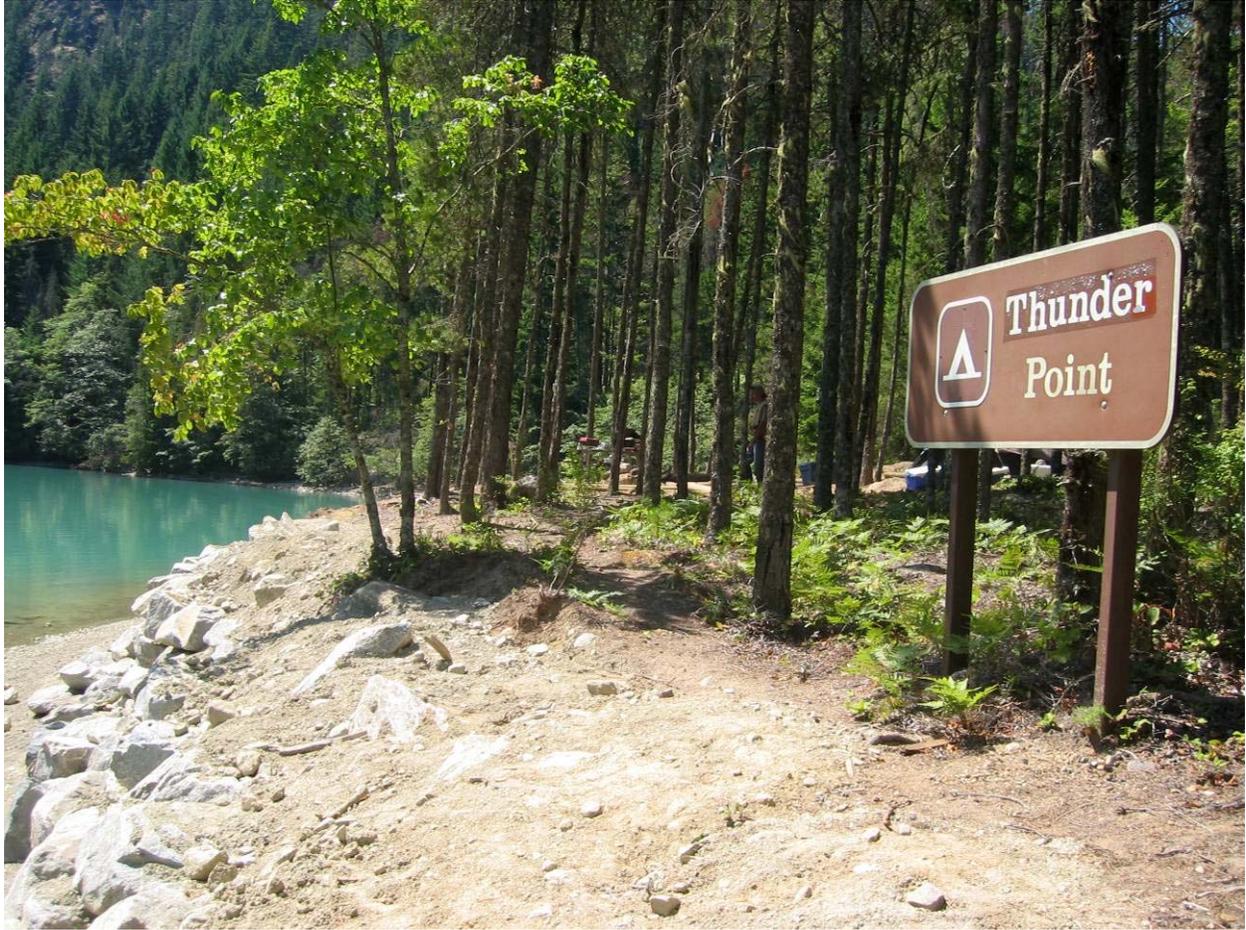
5)Thunder Pt. Campground (before revegetation)

NPS Greenhouse and Plant Propagation: the Ross Lake Plant Propagation Crew installed 317 plants, planted seeds and mulched at the Thunder Point Campground on Diablo Lake. Propagation work including seed and cutting collection and growing was continued in preparation for planting at two erosion control sites on Diablo Lake in 2006 as well as planting at existing and new sites on Ross Lake.

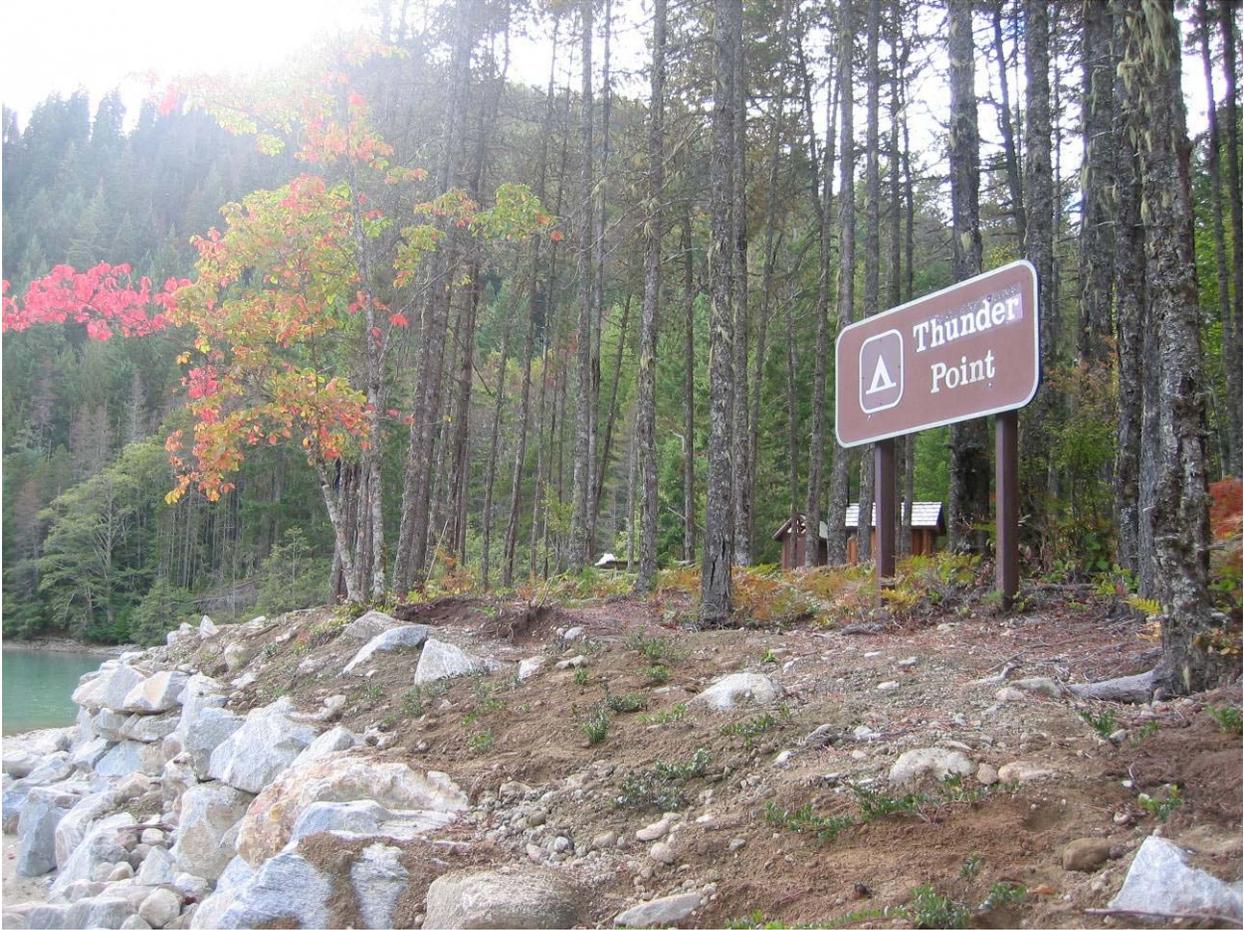
6) Thunder Pt Campground (after revegetation)
