RE: SKAGIT RIVER PROJECT (FERC NO. 553) 2015 INCIDENTAL TAKE STATEMENT FOR
BULL TROUT

**Annual Incidental Take Report for 2015 – Bull Trout
Skagit River Hydroelectric Project (FERC 553)
Seattle City Light**

Prepared by: Ed Connor, Aquatic Ecologist
March 31, 2016

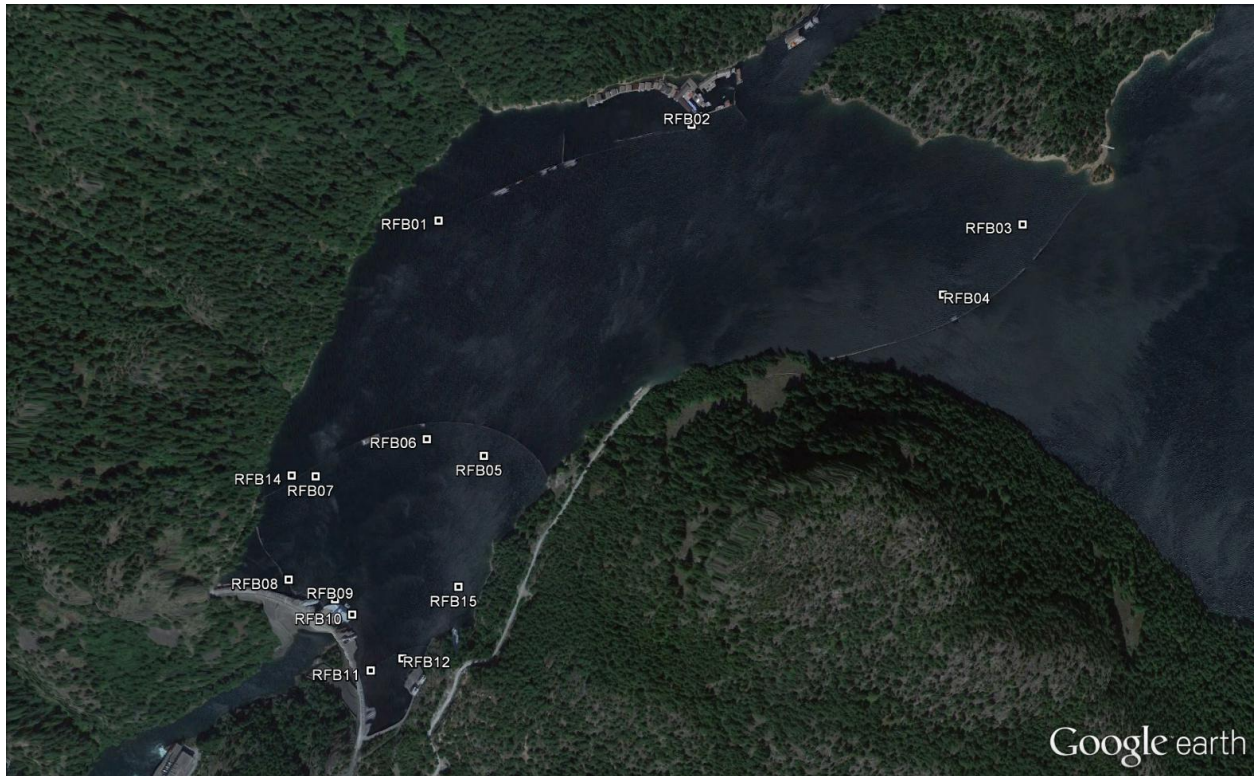
Figure 1. Acoustic receiver array in Ross Lake forebay for 2015.

A total of 18 acoustic receivers were active in Ross Lake for the 2015 monitoring period, with the majority of these receivers (14) placed in the forebay, the portion of the reservoir

immediately upstream of Ross Dam (Figure 1; Table 1). The monitoring effort was greatest in Ross Lake because it supports higher numbers of bull trout compared to the other two project reservoirs. The Ross Lake forebay acoustic receiver array was designed specifically to track the three-dimensional movement of tagged bull trout in the forebay over time. The configuration of forebay receivers allows for an accurate assessment of the vulnerability of bull trout in Ross Lake to entrainment into the hydroelectric project intakes. Two of the receivers (stations RFB11 and RFB 12) are located immediately in front of the Ross Dam intake structure to monitor the entrainment of bull trout into the power tunnel intakes. The power intake tunnel is located about 140 ft below the surface of the reservoir at full pool. These two receivers, along with receivers situated at the Ross Boat House (RFB10) and along the shore just north of the intake facility (RFB15), were used to monitor the area of the forebay where bull trout would be vulnerable to entrainment into the power intakes. The inner forebay of the Ross Dam, where fish would be vulnerable to entrainment into the spillways during spill events, was monitored by receivers RFB05, RFB06, RFB07, and RFB09, in addition to the four receivers that are located near the power intake facility located at the southern corner of the forebay (RFB10, RFB11, RFB12, and RFB 15). Four receivers were also used to monitor fish in the outer forebay of Ross Dam: RFB01, RFB02 (located at Ross Lake Resort), and RFB03 and RFB04 (both connected to outer log boom of forebay).

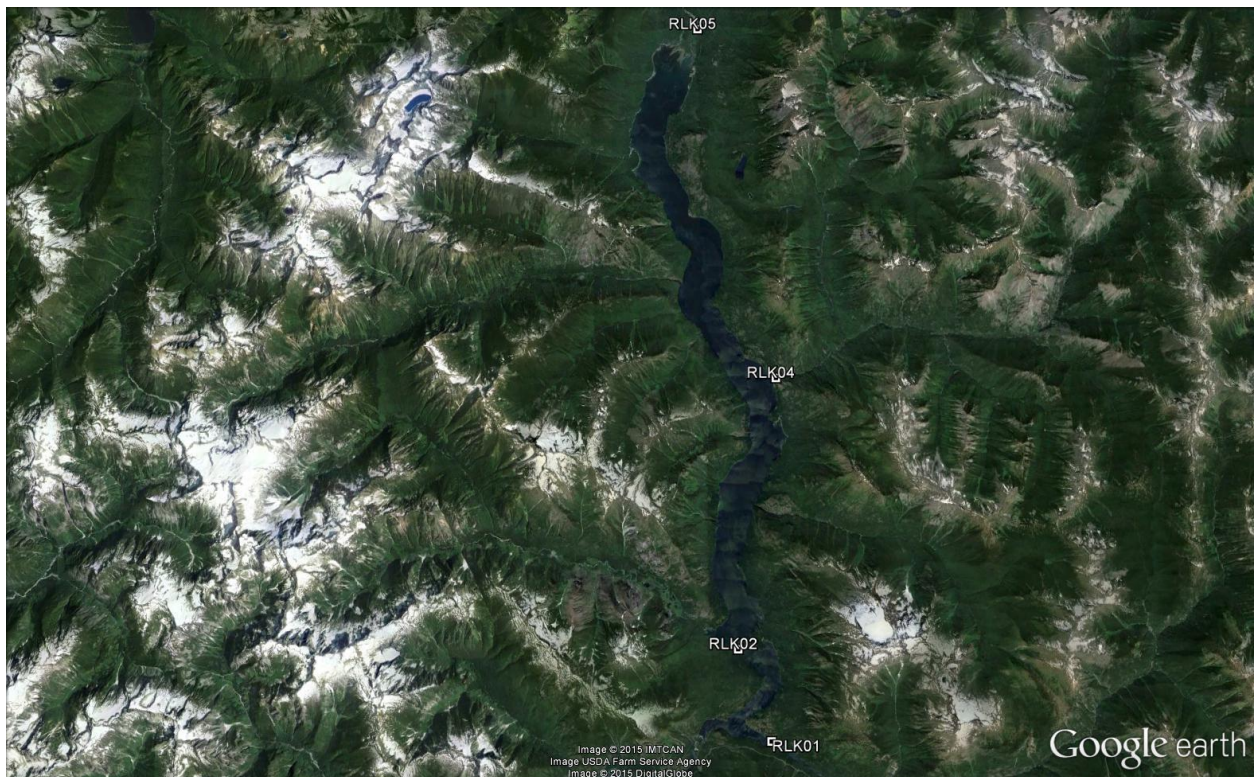
Figure 2. Acoustic receiver array in Ross Lake outside the forebay for 2015.

In addition to the forebay receiver array, four receivers were also stationed near the mouths of major tributaries to Ross Lake to detect the movement of tagged bull trout in these streams for spawning (Figure 2). Receivers were placed just outside of the mouth of Ruby Creek (RLK01), Big Beaver Creek (RLK02), and Lightning Creek (RLK04). A tributary receiver (RLK05) was stationed in the upper Skagit River, British Columbia, approximately 0.8 miles upstream of the reservoir. The Ross Lake receivers were downloaded in March and July 2015, and March 2016.

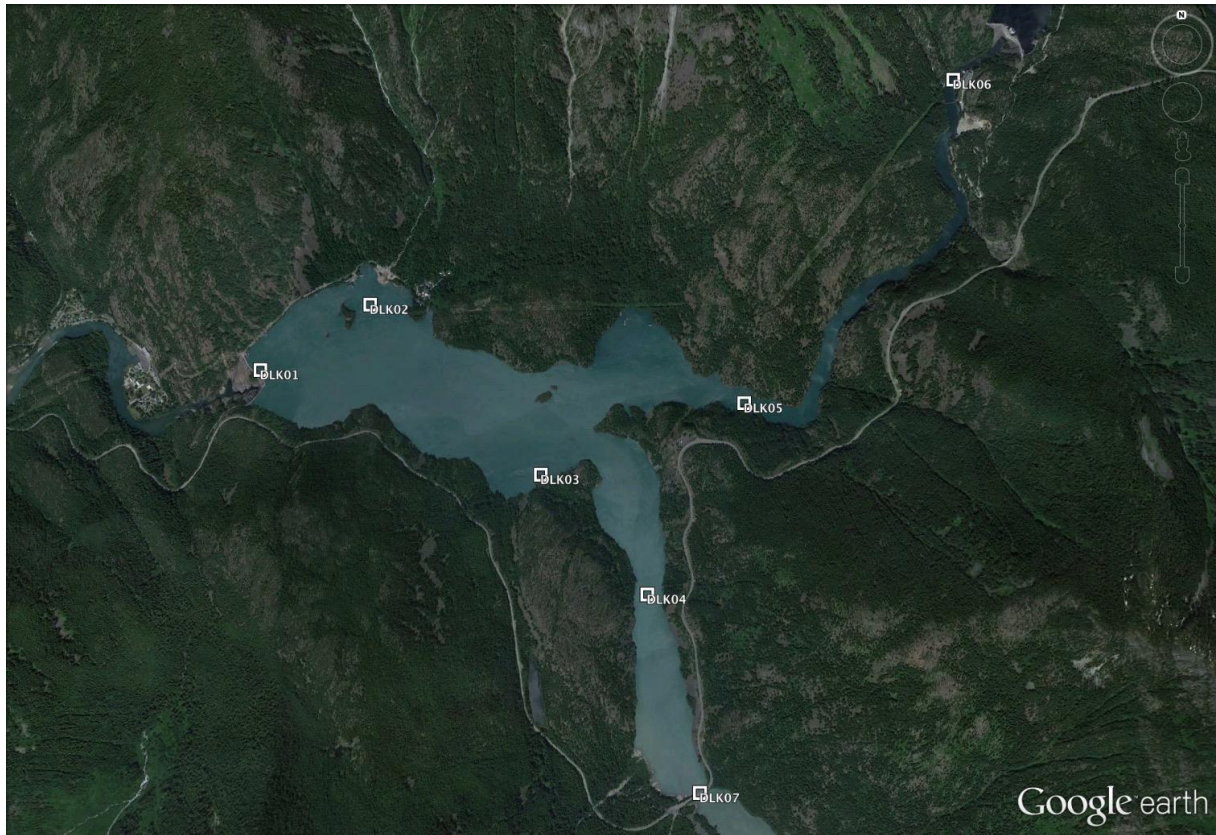
Figure 3. Acoustic receiver array in Diablo Lake for 2015.

A total of seven acoustic receivers were deployed in Diablo Lake for bull trout monitoring purposes in 2015 (Table 1; Figure 3). The most downstream of these receivers (DLK01) was stationed at Diablo Dam immediately in front of the power intake structure. Three were stationed around the main body of Diablo Lake receivers (DLK02, DLK03, and DLK05) to monitor the movement of bull trout within the reservoir. A receiver was also deployed in Thunder Arm of the reservoir near the outlet of Thunder Creek (DLK05) to monitor the movement of bull trout into this major tributary for spawning. An additional receiver was deployed near the mouth of Thunder Creek in 2015 (DLK07), which was used to improve the tracking of bull trout moving into this stream to spawn. The most upstream receiver (DLK06) was located in the tailrace of Ross Powerhouse. This receiver was used to detect any tags implanted in Ross Lake bull trout that were later entrained into the Ross Dam power tunnel intakes, then passed through the Ross powerhouse turbines, and finally released into Diablo Lake. The Diablo Lake receivers were downloaded in February and June 2015, and in January 2016.

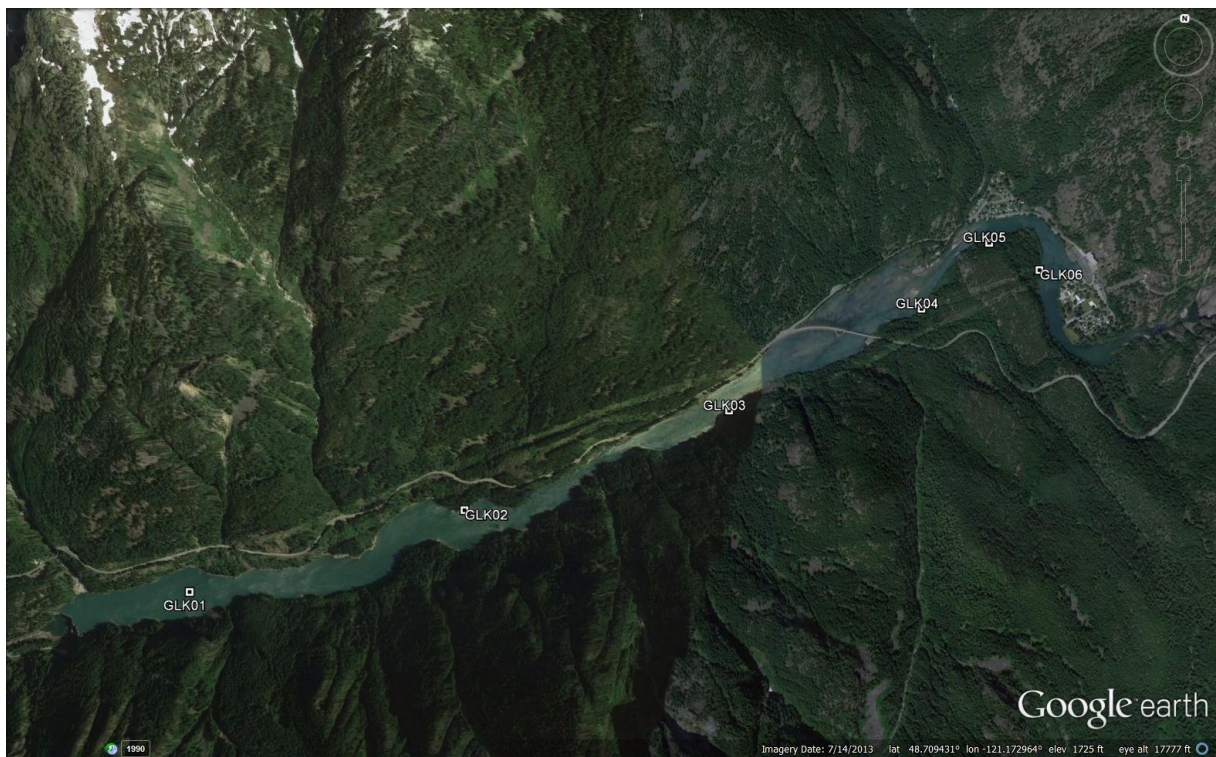
Figure 4. Acoustic receiver array in Gorge Lake for 2015.

A total of six receivers were maintained in Gorge Lake during the 2015 bull trout monitoring period (Table 1; Figure 4). The most downstream of these receivers (GLK01) was located in the forebay of Gorge Dam. This receiver was located just upstream of the Gorge Dam intake structure, and was used to detect the entrainment of tagged bull trout into the power intake tunnel. Any bull trout passing into this area of the reservoir would also be vulnerable to spillway entrainment during spill periods at Gorge Dam. Four receivers were situated throughout Gorge Lake (GLK02, GLK03, GLK04, and GLK05) to monitor the movement and habitat use of tagged bull trout in this reservoir. The uppermost of these receivers (GLK05) was positioned near the mouth of Stetattle Creek, and was used to monitor the movement of bull trout into this spawning stream. The most upstream receiver in the reservoir (GLK06) was located at the tailrace of Diablo Powerhouse, and was used to detect any bull trout tagged in Diablo or Ross lakes that were entrained through into the Diablo Dam power intakes or spillways and released into Gorge Lake. Finally, a seventh receiver (SKG01) was placed in the Skagit River immediately downstream of the Gorge Powerhouse tailrace (Table 1) to detect any tagged bull that were entrained into the power tunnel intake or spillway of Gorge Dam and passed downstream into the Skagit River. The Gorge Lake receivers were downloaded in February and June 2015, and in January 2016.

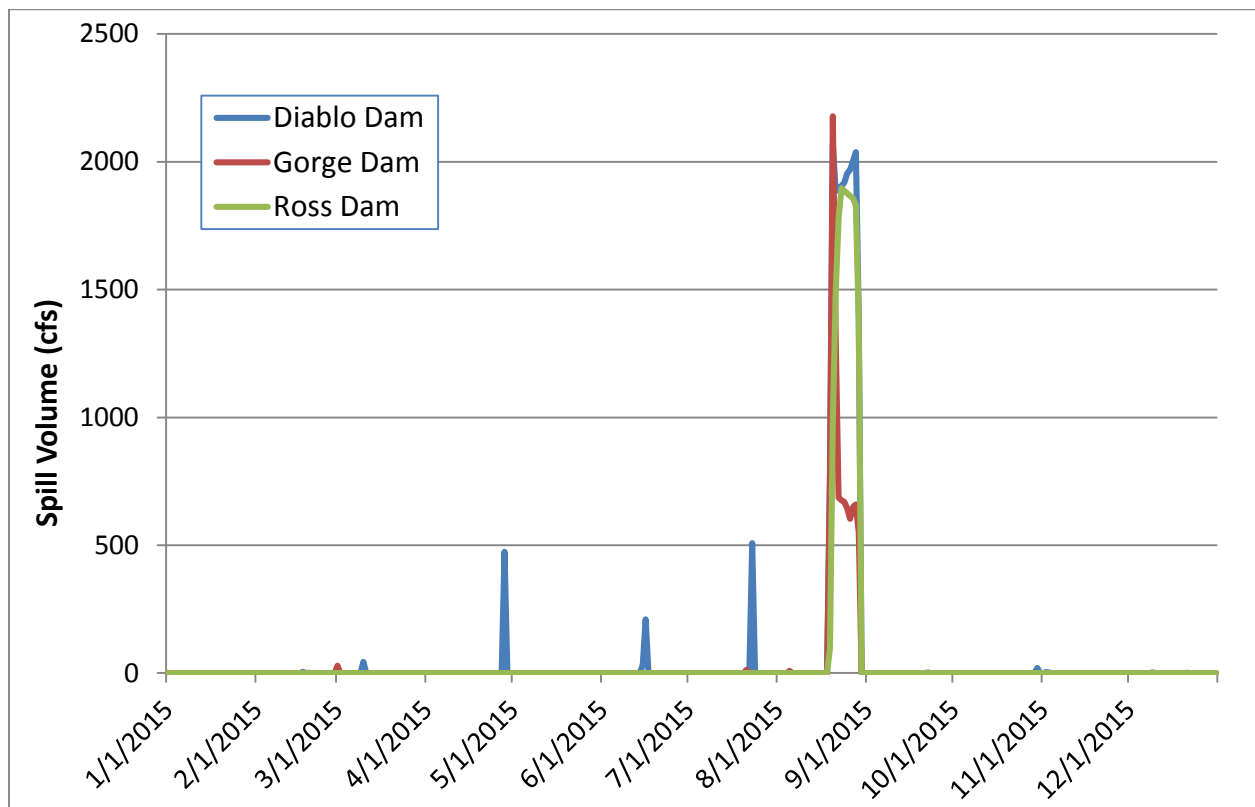
Figure 5. Spill volumes at Ross, Diablo, and Gorge dams in 2015.

During 2015, there were 10 days of spill observed at Ross Dam, 14 days of spill at observed at Diablo Dam, and 11 days of spill observed at Gorge Dam (see Figure 5). The number of spills occurring at Diablo and Gorge dams were very low compared to that observed in 2014, a result of a record dry year in 2015. Only three days of spill were observed at Diablo Dam during the spring snowmelt period, and no spill events were observed at Ross and Gorge dams during this period (Figure 5). The only significant spill event at all three dams occurred over a period of 10 consecutive days during the last week of August (Figure 5). These spills were caused by the emergency shutdown of all three facilities at the Skagit Hydroelectric Project, the result of a major wildfire that occurred within the project area. The fire damaged the dedicated project transmission lines, requiring City Light to stop power generation until the liens could be safely repaired. Spills were required at all three dams during this shutdown period to meet the fish flow requirements in the Skagit River downstream of the hydroelectric project.
