**GE-04 SKAGIT RIVER GEOMORPHOLOGY BETWEEN  
GORGE DAM AND THE SAUK RIVER STUDY  
INTERIM REPORT**

**SKAGIT RIVER HYDROELECTRIC PROJECT  
FERC NO. 553**

**Seattle City Light**

**March 2022  
Initial Study Report**

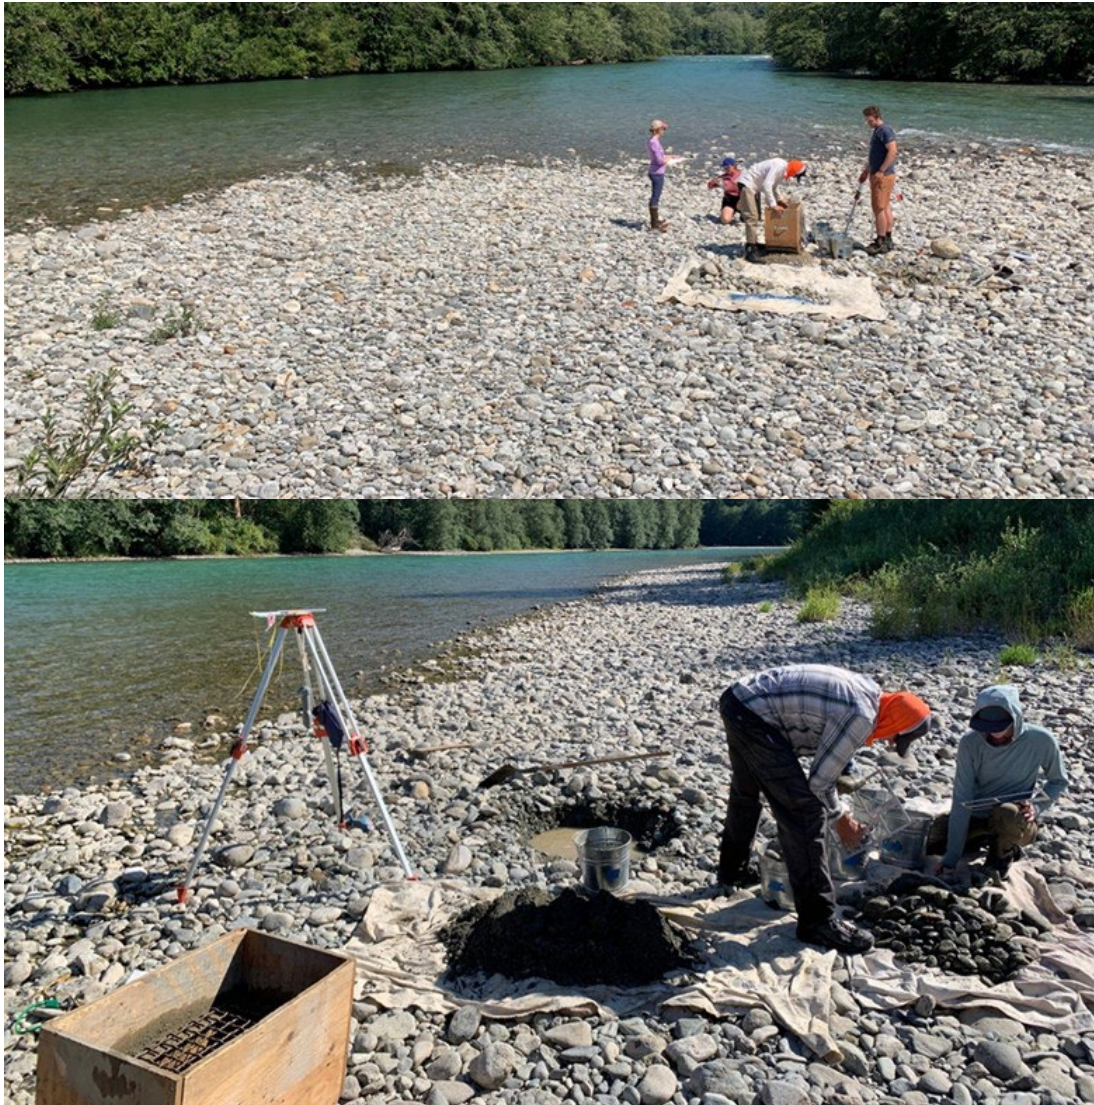
**Figure 4.4-1.** Examples of typical sediment sample locations, including the head of an island bar at PRM 90.2 (top) and head of a bank-attached point bar at PRM 78.4 (bottom).

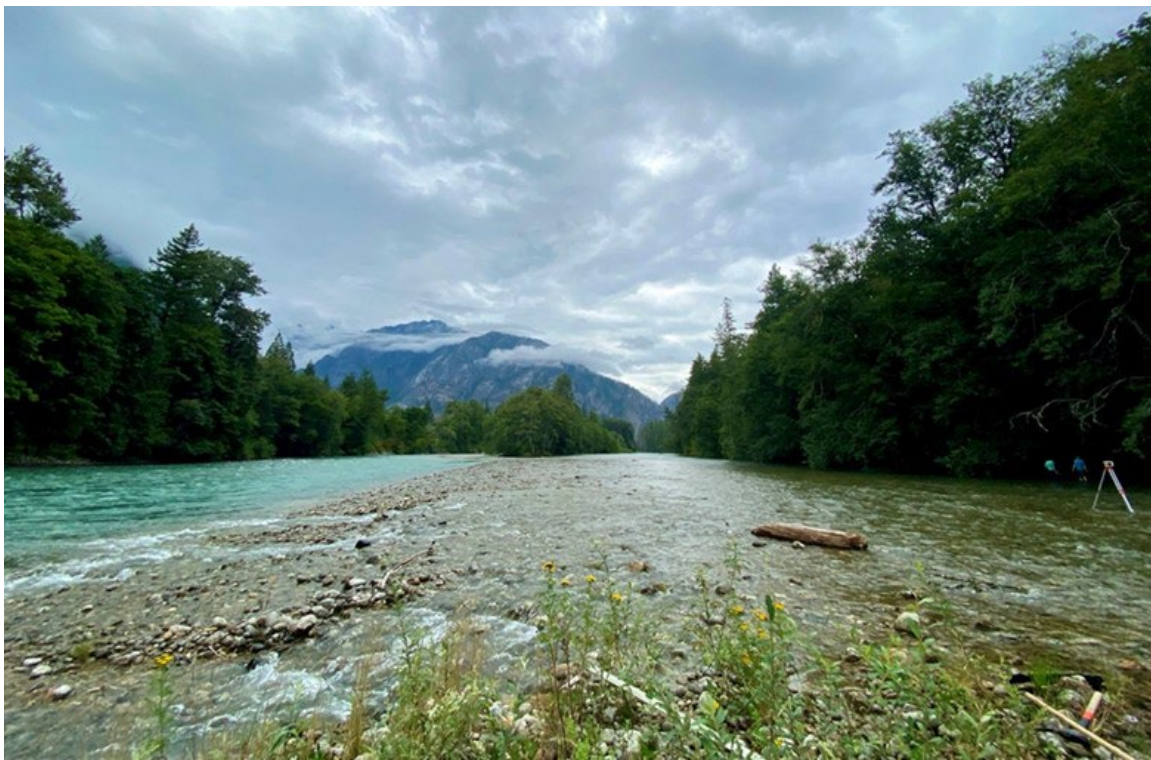
**Figure 4.5-2.** Example location of redd-focused scour monitoring array located along the left bank line (right side of image at site ABSS1 [above Shovel Spur]).

In August 2021, staff expanded the monitoring project to include a total of 19 scour arrays, the locations of which are shown in Figure 4.5-3. The purpose of this extension was to provide data at select locations representative of typical/controlling sediment transport, at the mouths of tributaries (to meet commitments in the June 9, 2021 Notice), and at bulk sample locations for select tributaries. Six of these locations include riffle crests in the mainstem channel where scour monitoring will aid in development and calibration of the 1-D sediment transport model. Other arrays include the confluence fans of Goodell and Bacon Creeks (the Newhalem Creek fan did not have substrate suitable for scour monitor installation) and locations on Cascade River and Bacon Creek to aid in calibrating estimates of tributary sediment loads. Attachment B is a map set showing individual scour monitor installation locations.

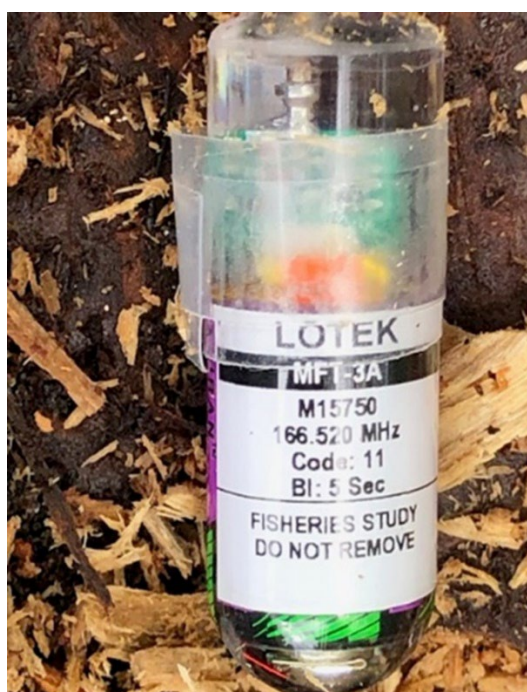
**Figure 4.7-1. Lotek MFT-3A radiotag used to track large wood.**

Active RFID (radiotags) manufactured by Lotek were used for tracking wood movement (Figure 4.7-1). The read range is greater than 1,000 ft when above water, and approximately 15 ft when below water. The tags have a lifespan of three to five years and frequency of 166.520 megahertz (MHz).

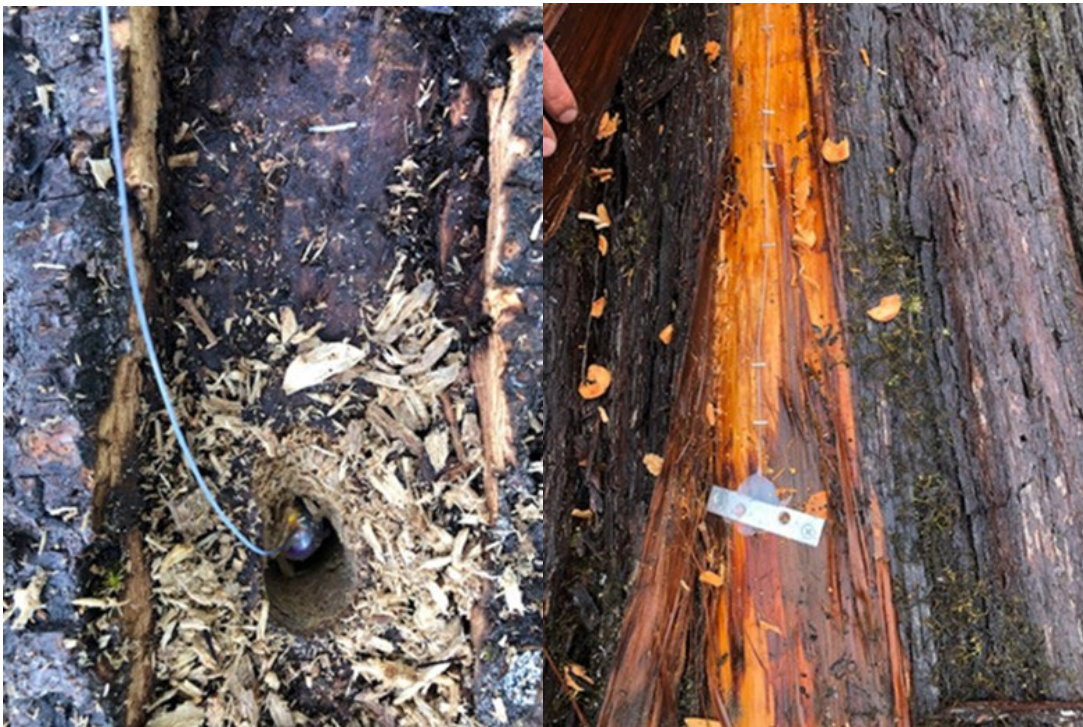
**Figure 4.7-2.** Large Wood installation of radiotags. Hole drilled and radiotag inserted (left). Hole filled with waterproof adhesive and metal brace screwed on top of hole and antenna stapled to log surface where bark was removed (right).

- A piece of large wood greater than 1-ft dbh and 25-ft length was identified.
- Bark was removed from the area where the radiotag was installed.
- A hole of 1-inch by 3.5-inch dimensions was drilled in the wood (Figure 4.7-2).
- Clear silicone caulk was installed on top of the radiotag (Figure 4.7-2).
- Metal plate was screwed on top of the caulk (Figure 4.7-2).
- Antennae was laid out and stapled along the wood (Figure 4.7-2).
- When possible, bark was replaced in the area where the tag and antennae were located.

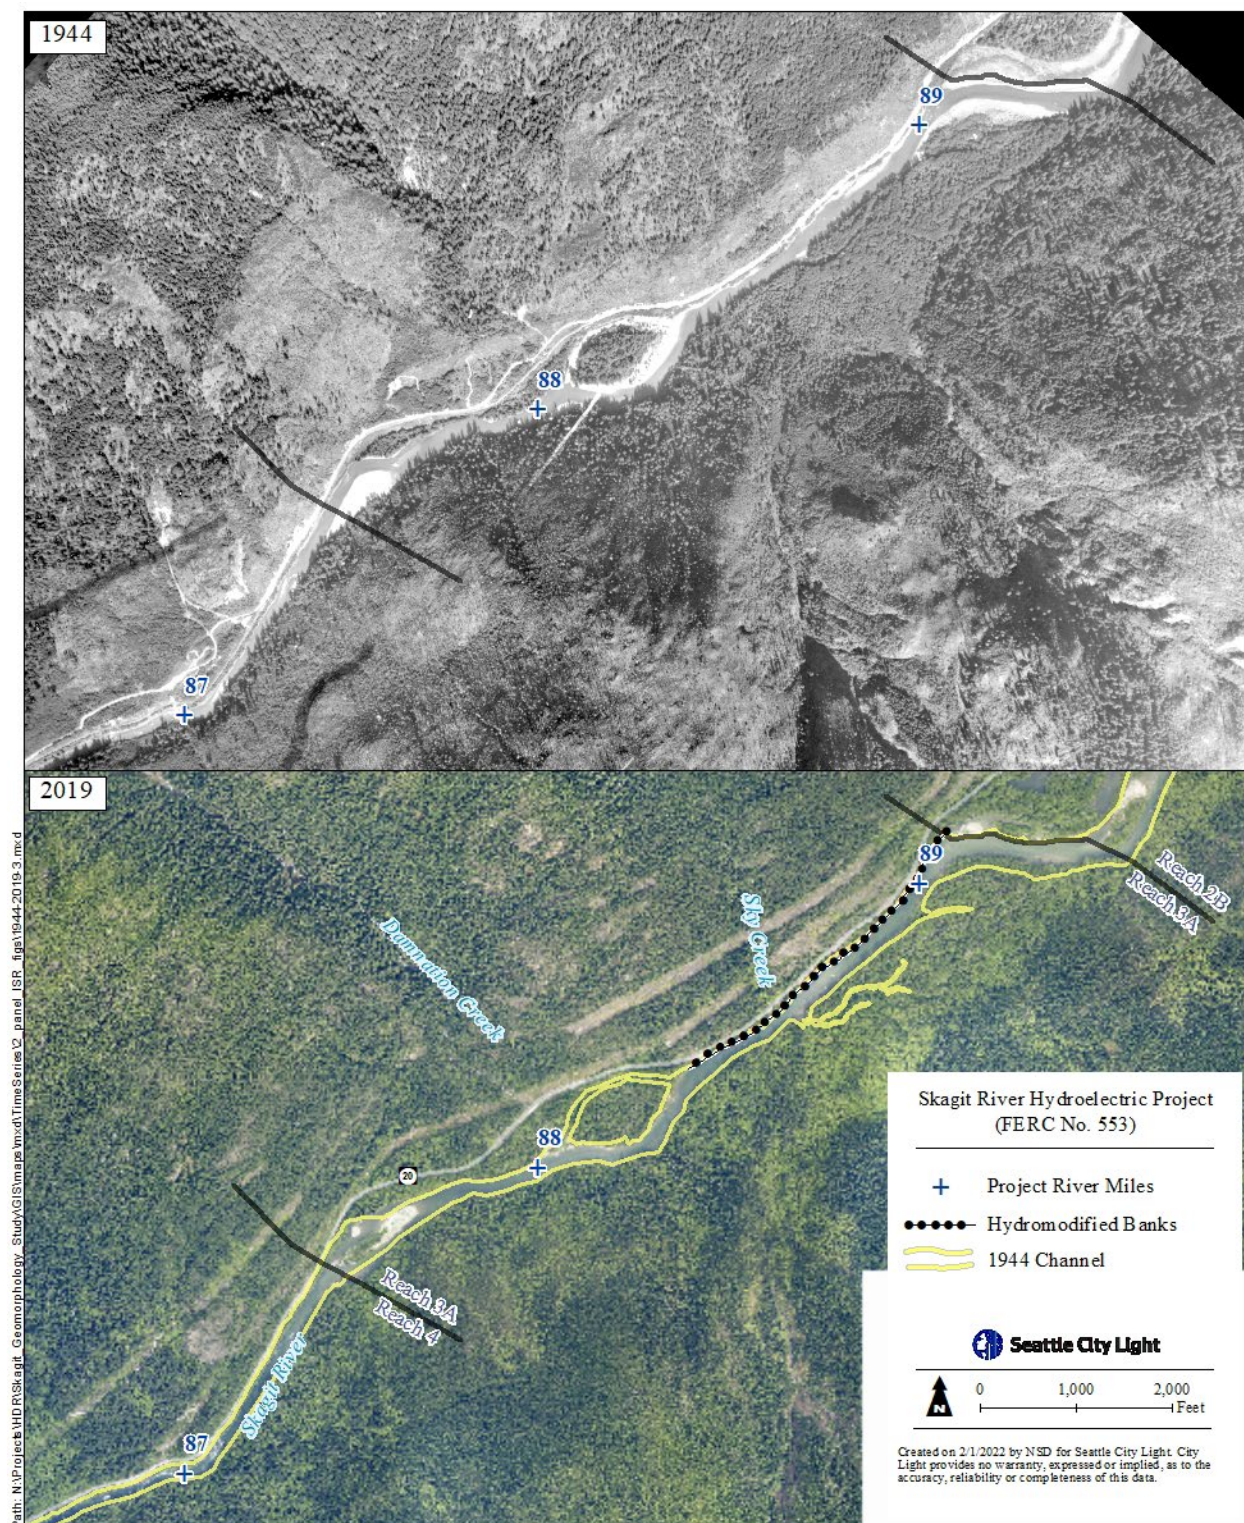
Figure 5.1-7. Comparison of 1944 and 2019 imagery in Reach 3A and upper segment of Reach 4.

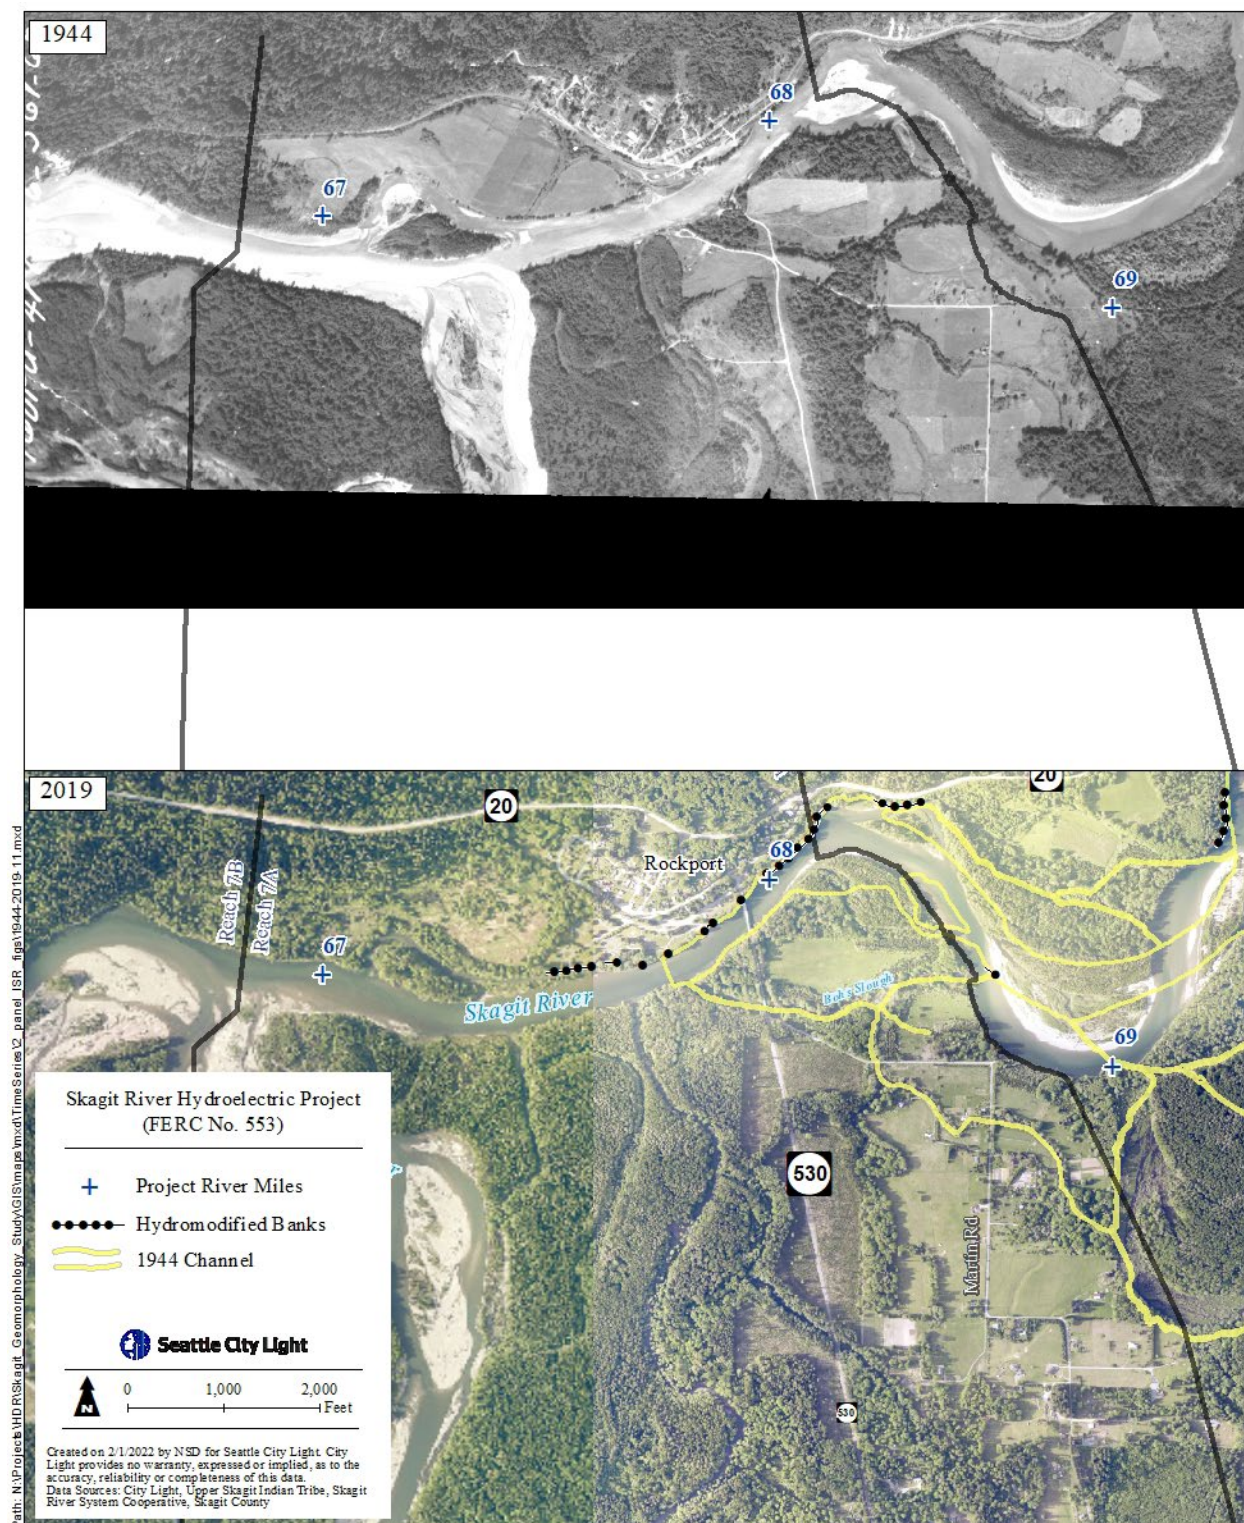
**Figure 5.1-15. Comparison of 1944 and 2019 imagery in Reach 7A.**

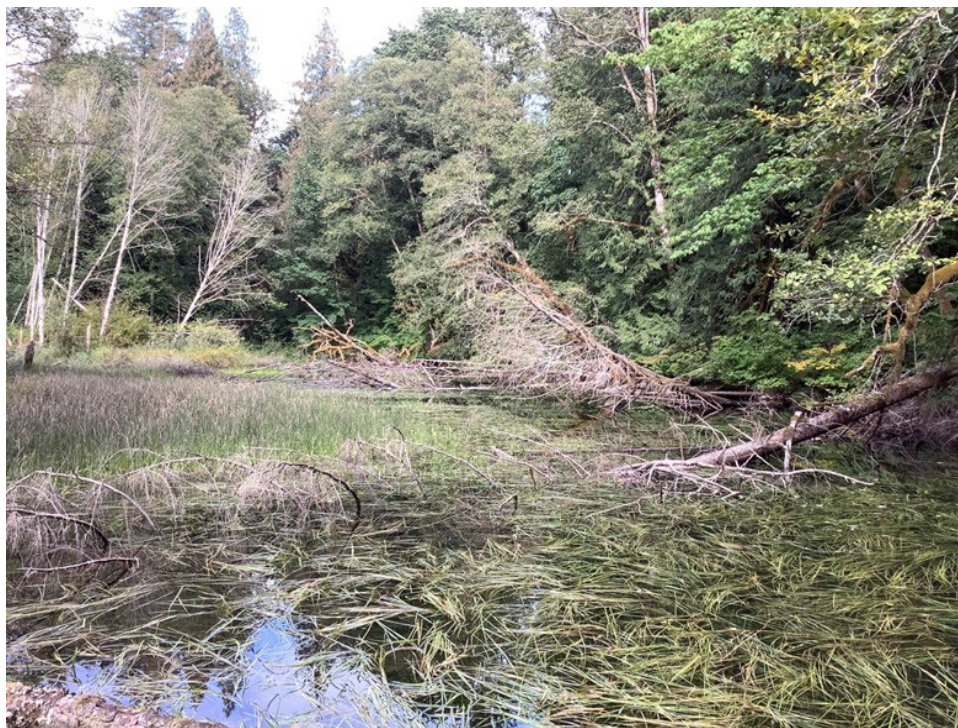
**Figure 5.3-6. Off-channel pond in side channel PRM 82.9-L.**

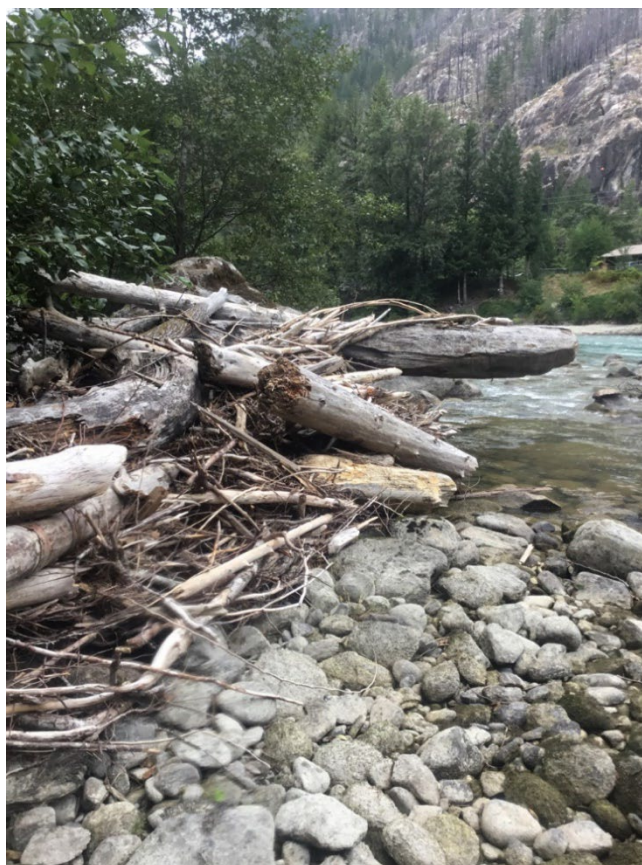
**Figure 5.6-2. Small log jam located on left bank at PRM 93.9. Photo taken August 20, 2021.**

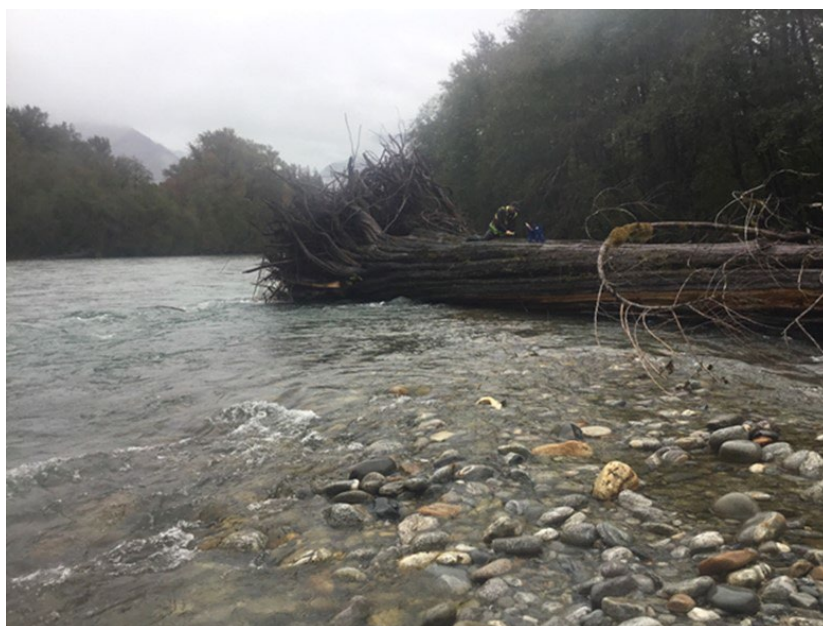
**Figure 5.6-5. A large wood Cedar piece (Tag ID 54) with a 6-ft dbh, 20-ft rootwad, and 70-ft length located at PRM 90.5 looking upstream. Piece forms a pool at rootwad. Photo taken on October 19, 2021.**

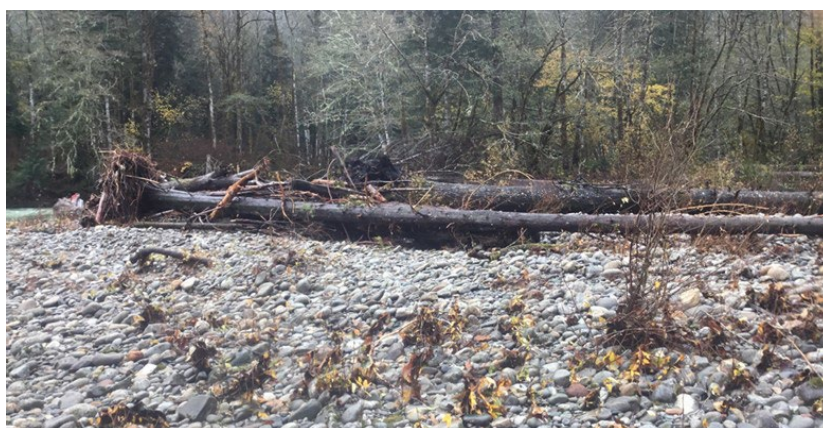
**Figure 5.6-6. Log jam on gravel bar at PRM 89.6. The key piece is an 11-ft rootwad, 67-ft long, 3-ft dbh cottonwood piece that is seen to the right racking a large Cedar piece. Flow is from left to right. Photo Taken on August 18, 2021.**

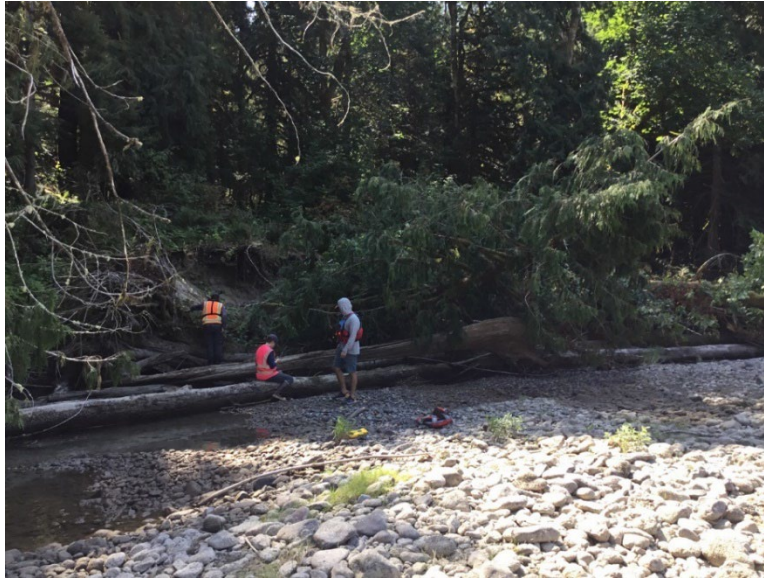
**Figure 5.6-9.** Side channel inlet log jam located on left bank at PRM 82.6. Photo taken August 4, 2021.

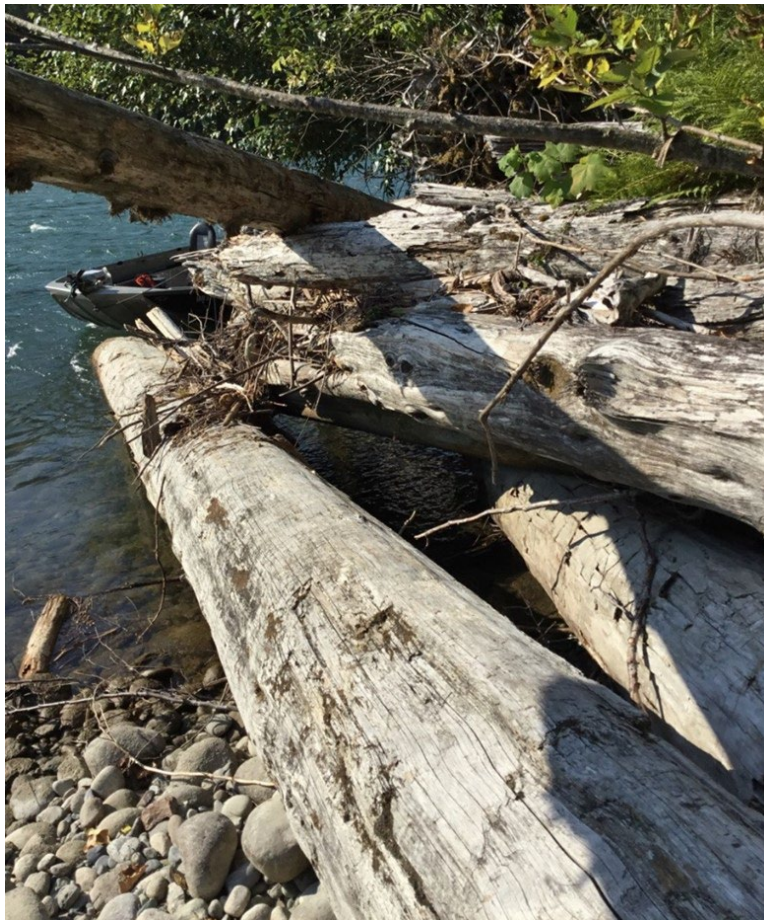
**Figure 5.6-10.** Bar apex jam on right bank at PRM 82.9. Jam forms 8-ft pool at left side of photo. Flow is from left to right. Photo taken August 4, 2021.

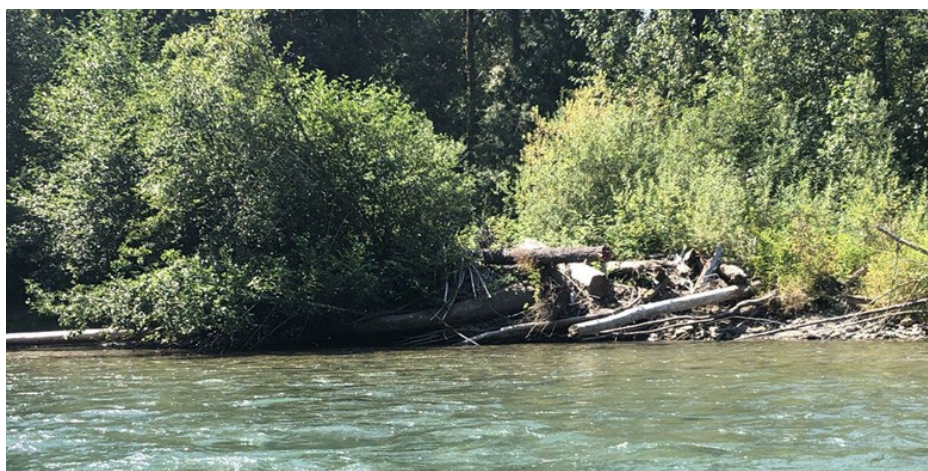
**Figure 5.6-16. Bar apex log jam located at PRM 81.6 on right bank. Looking from left bank to right bank, flow is from right to left. Photo taken August 4, 2021.**

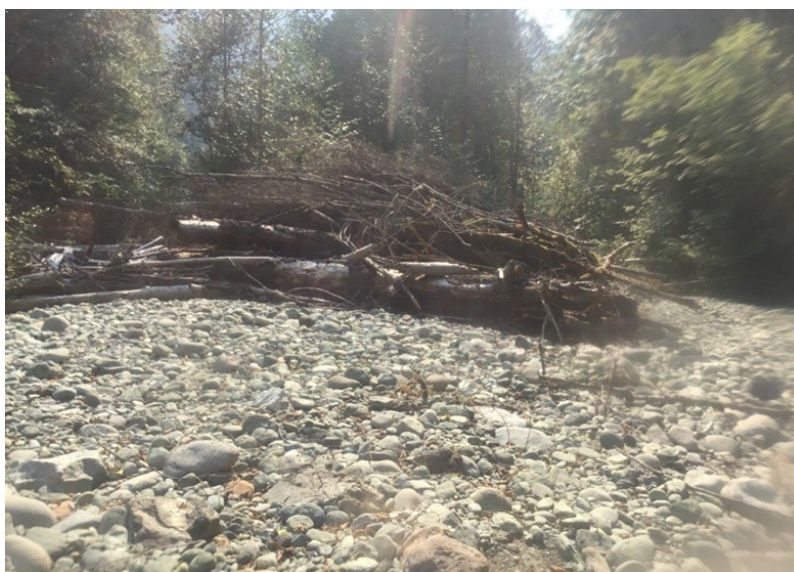
**Figure 5.6-17. Apex jam located in Diobsud Creek forming 2-ft pool. Large wood Tag ID 82 is racked onto this jam. Photo taken looking downstream on August 25, 2021. Between PRM 80.6 and 81.0 there are no pieces of large wood in the mainstem of the channel.**

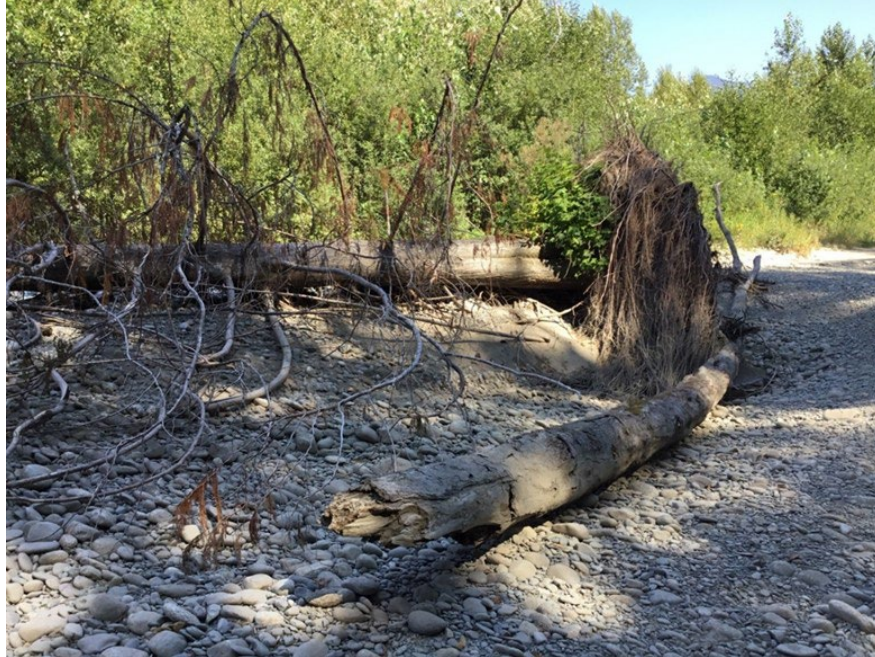
**Figure 5.6-20.** Individual large wood piece oriented parallel to flow with its rootwad upstream and forming a residual pool, located in PRM 77.7 ephemeral side channel (Tag ID 36). Flow is from right to left (looking upstream). Photo taken August 4, 2021.

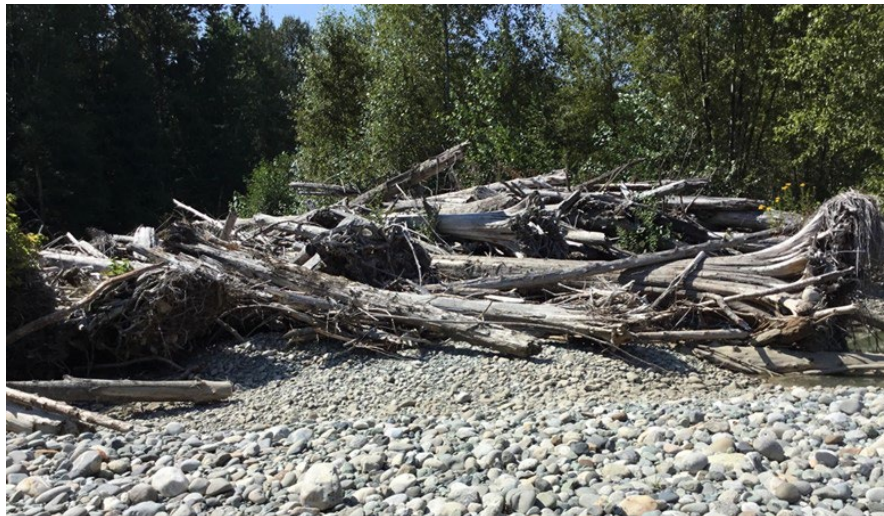
**Figure 5.6-21.** Bar apex jam located at PRM 77.7 on left side of Skagit river, flow is from left to right. Large wood Tag ID 32 and 33 are racked on this jam. Tag ID 32 is a 115-ft long, 5-ft-dbh, 16-ft-rootwad cedar piece. Tag ID 33 is an 80-ft long, 3-ft-dbh, 10-ft-rootwad cedar piece. Photo taken August 4, 2021.

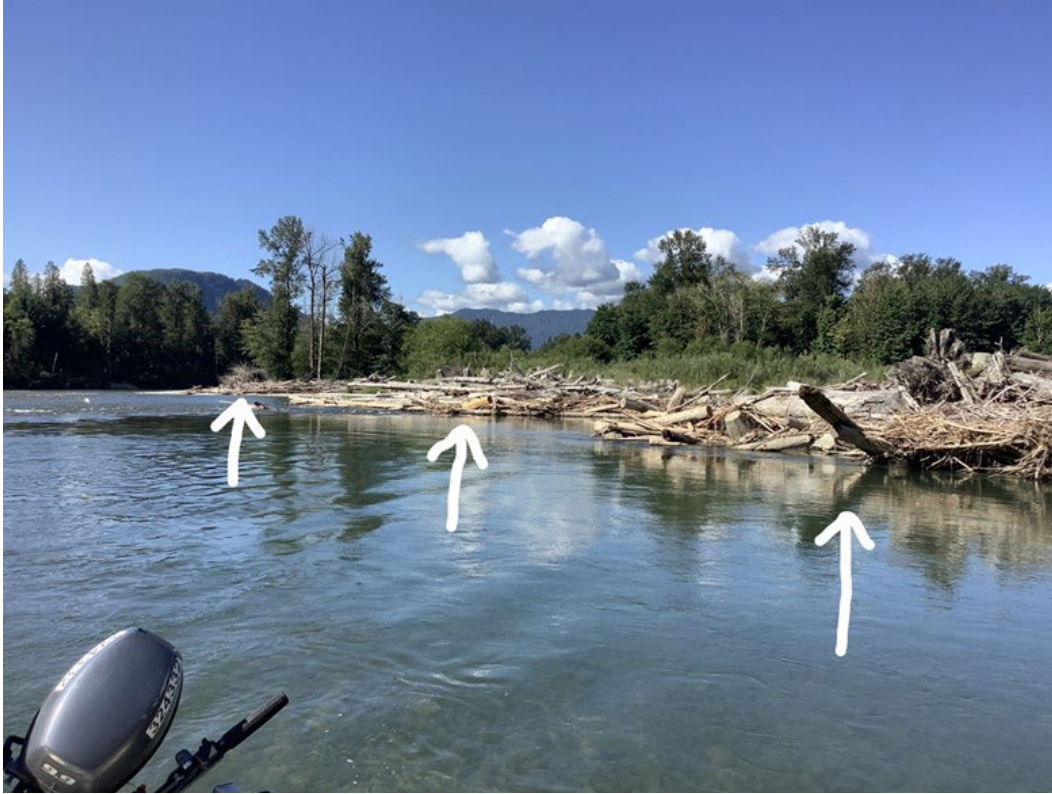
**Figure 5.6-25.** Looking downstream at PRM 72.1. Right arrow is dolotimber revetment structure along roadside bank, center arrow is dolotimber apex jam, and left arrow is natural apex jam at PRM 72.0. Large wood Tag ID 65 is in the central dolotimber apex jam. Large wood Tag ID 67 is in the natural apex jam on the left. Photo is taken August 5, 2021.

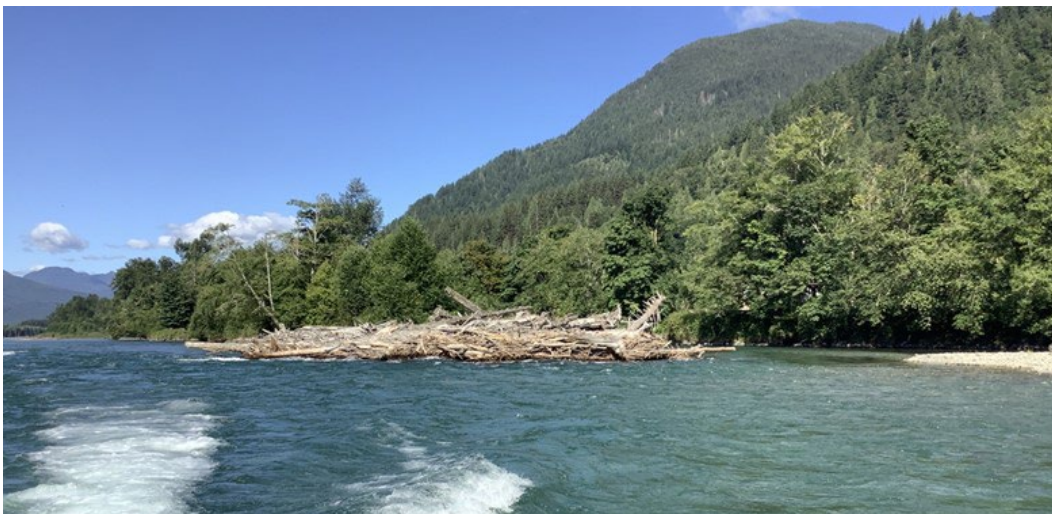
**Figure 5.6-26.** Large apex jam that has persisted for 42 years at head of forested island at PRM 71.4, looking downstream. Forested island contains two large wood pieces on the left side that are tagged (Tag ID 16 and 17). Photo taken August 5, 2021.

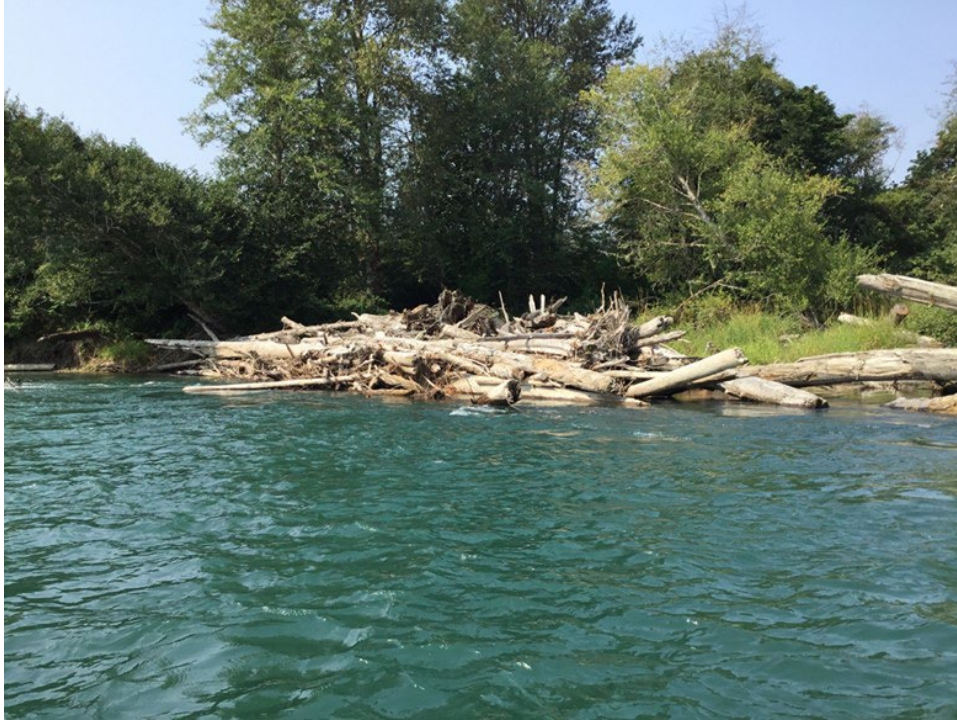
**Figure 5.6-27.** Bar apex inlet jam at entrance to Bohs Slough side channel located at PRM 68.6 on river left. Flow is from left to right. Inlet jam contains tagged large wood pieces 159 and 160. Photo taken August 3, 2021.

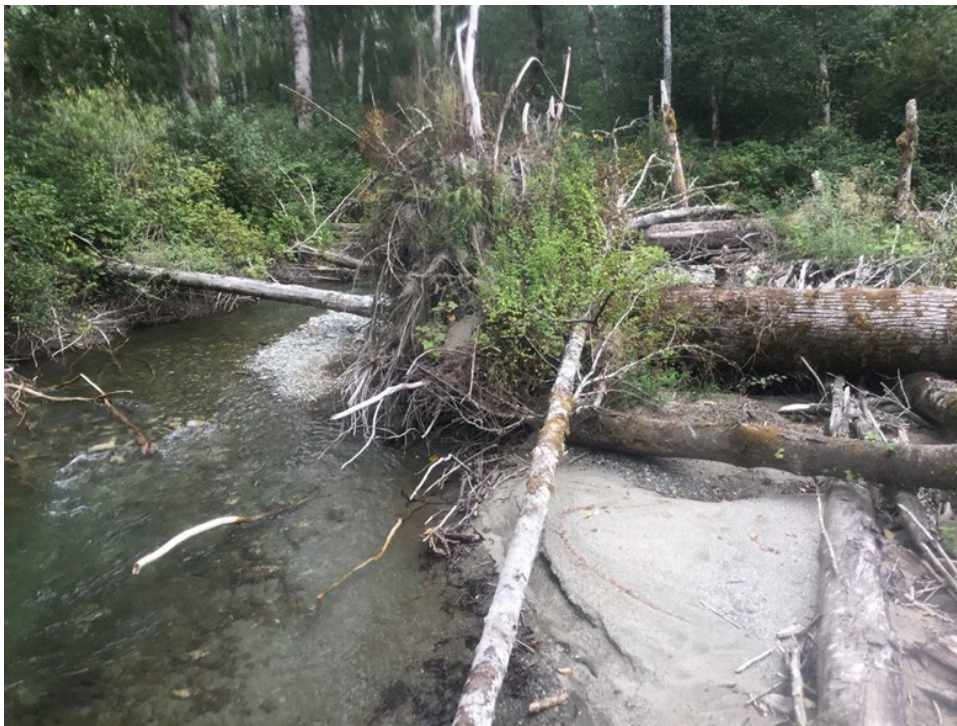
**Figure 5.6-28.** Dispersed log jam located on Illabot Creek just upstream of confluence with Illabot side channel complex. Photo is looking upstream taken on August 26, 2021.

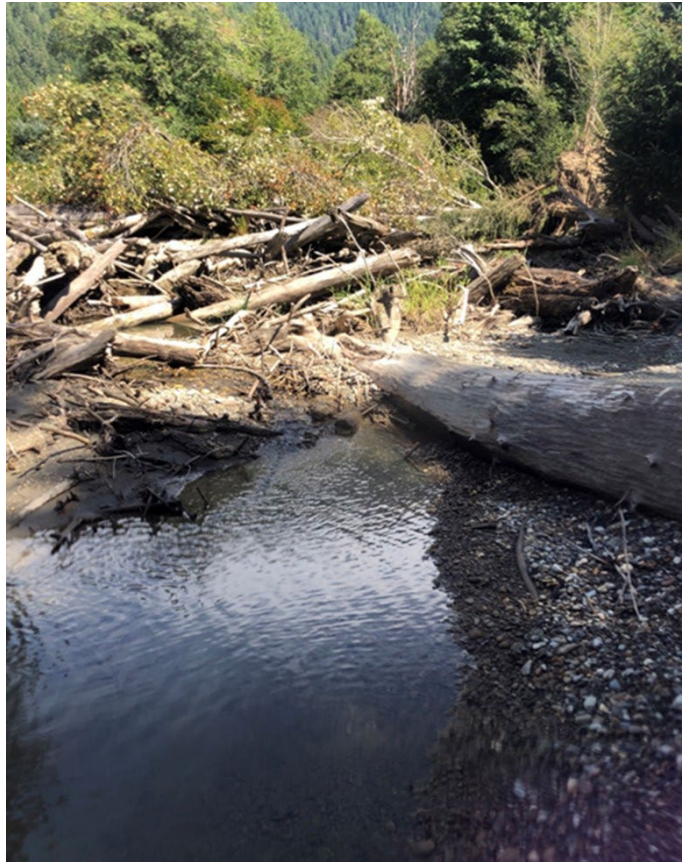
**Figure 5.6-30. Medium log jam located in Bohs Slough between PRM 67.6 and 68.6. Photo is looking upstream and was taken on August 10, 2021.**

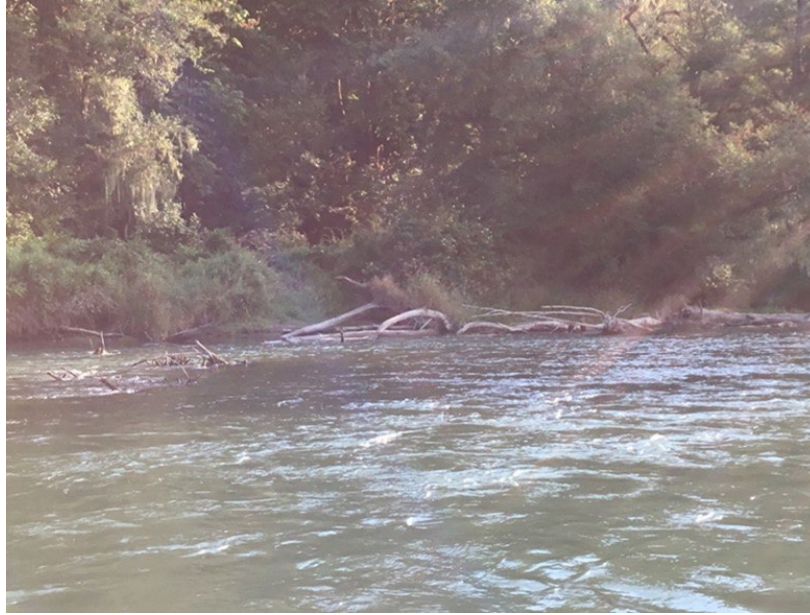
**Figure 5.6-31.** Four large wood pieces in Reach 7B at PRM 66.6 on river right. Flow is from right to left. Photo taken August 5, 2021.

Fieldwork for LWD inventory only included approximately 0.3 miles of the upstream area in Reach 7B. Figure 5.6-29 includes Reach 7A and 7B. Historical LWD inventory using aerial photos (1979-2019) was not completed in reach 7B because it is downstream of the primary study area. The total number of pieces counted in August 2021 was 20 of which four had rootwads. Four large wood pieces in Reach 7B at PRM 66.6 are presented in Figure 5.6-31.
