Lake Washington Blvd
Vegetation Management Study
Seattle, Washington

Site Plan with Lower One-Third Slopes and Slopes Flatter Than 70 Percent

Figure 3

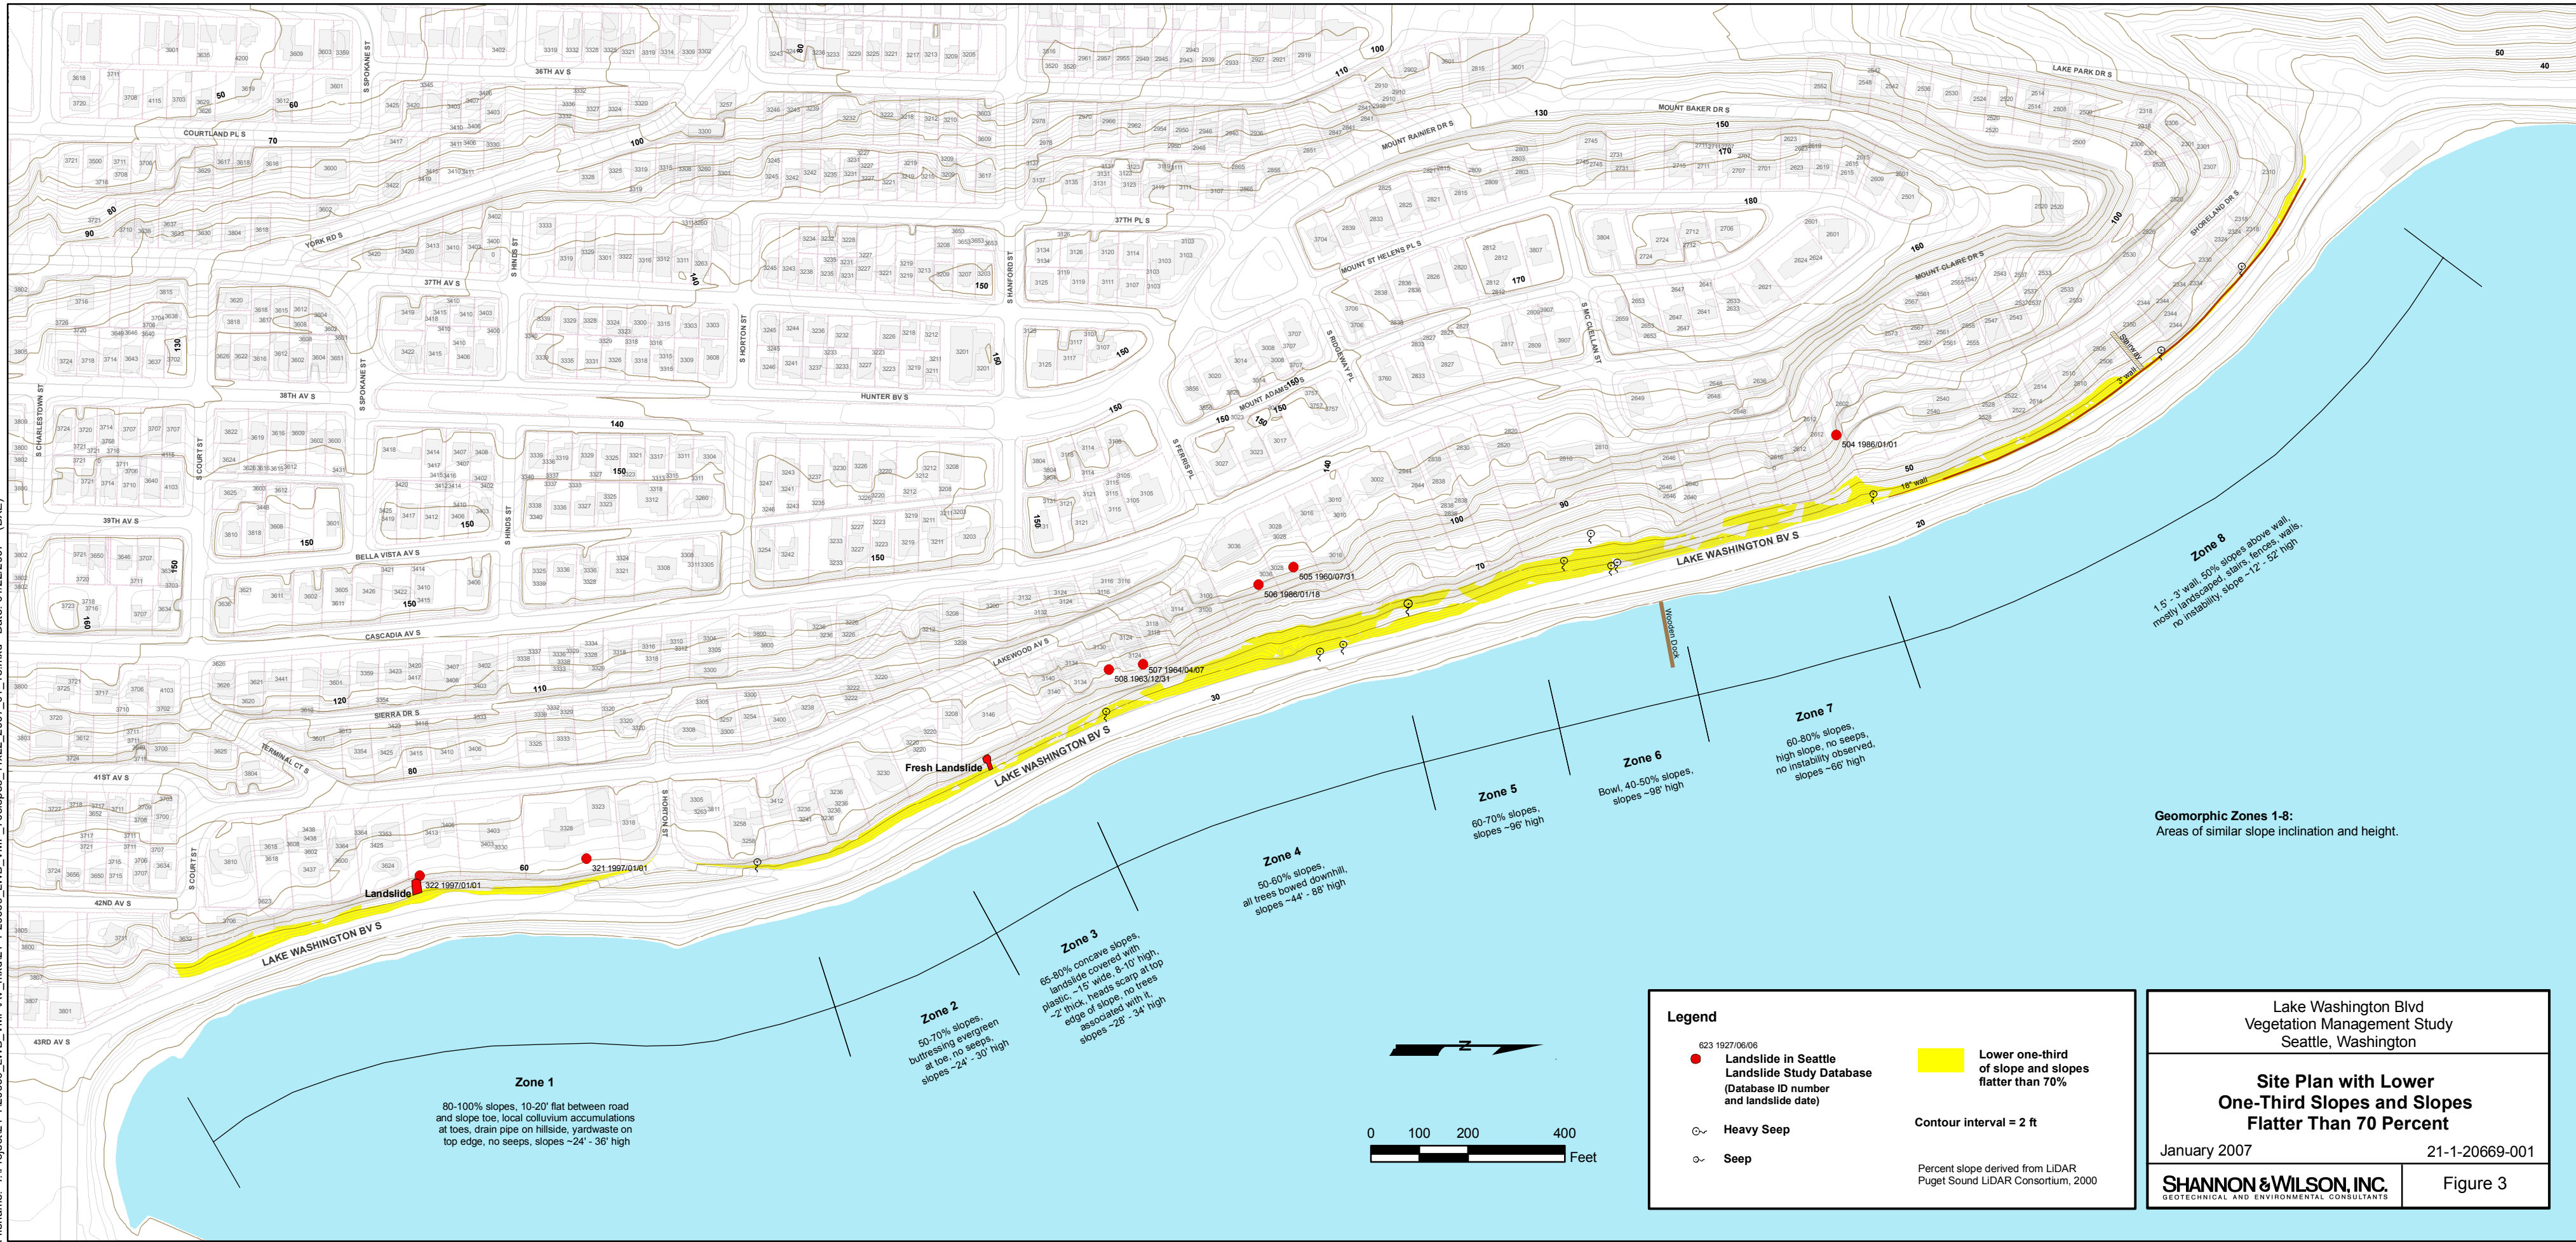
Zone 1
80-100% slopes, 10-20' flat between road and slope toe, local colluvium accumulations at toes, drain pipe on hillside, yardwaste on top edge, no seeps, slopes ~24' - 36' high

Zone 2
50-70% slopes, buttressing evergreen at toe, no seeps, slopes ~24' - 30' high

Zone 3
65-80% concave slopes, landslide covered with plastic, ~15' wide, 8-10' high, ~2" thick, heads scarp at top edge of slope, no trees associated with it, slopes ~28' - 34' high

Zone 4
50-60% slopes, all trees bowed downhill, slopes ~44' - 88' high

Zone 5
60-70% slopes, slopes ~96' high

Zone 6
Bowl, 40-50% slopes, slopes ~98' high

Zone 7
60-80% slopes, high slope, no seeps, no instability observed, slopes ~66' high

Zone 8
1.5' - 3' wall, 50% slopes above wall, mostly landscaped, stairs, fences, walls, no instability, slope ~12' - 52' high

Geomorphic Zones 1-8:
Areas of similar slope inclination and height.
