KING STREET STATION

r e s t o r a t i o n p r o j e c t

Before & After Album

Reviving History – The King Street Station Rehabilitation Project

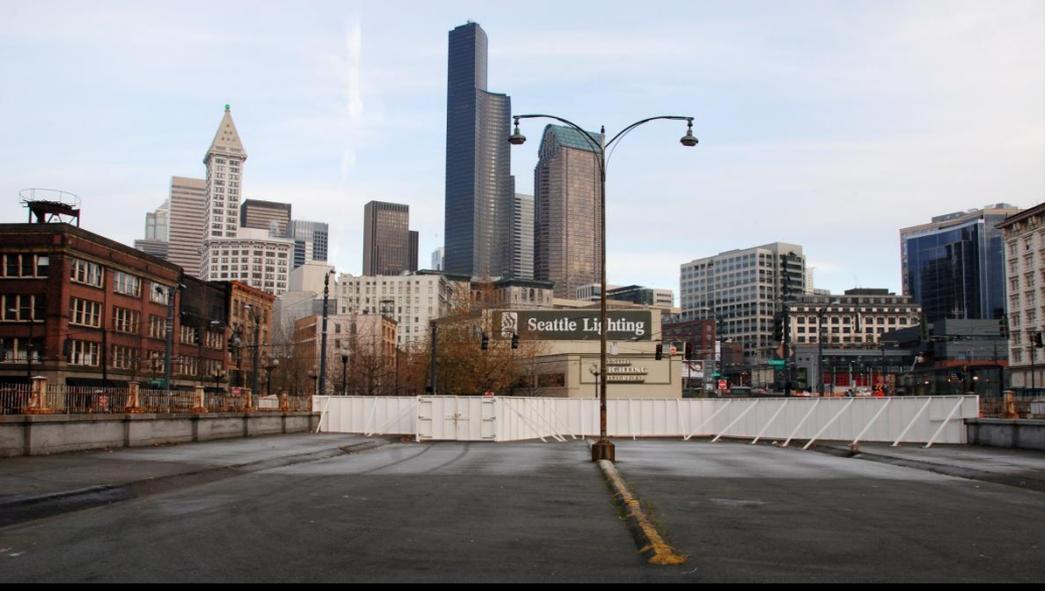
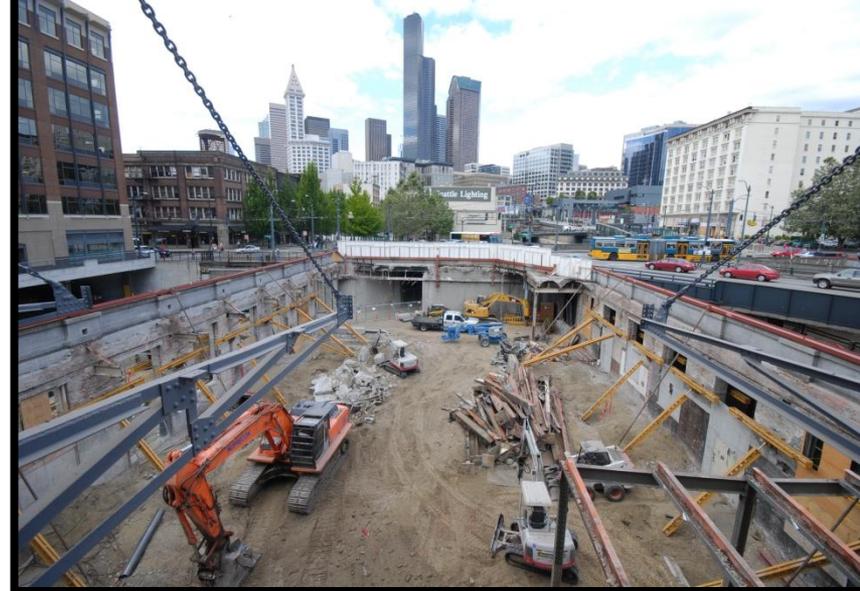
North Side – Jackson Street Plaza

- New brick pathway
- Exterior masonry restoration
- Jackson Plaza entrance reopened
- New signage

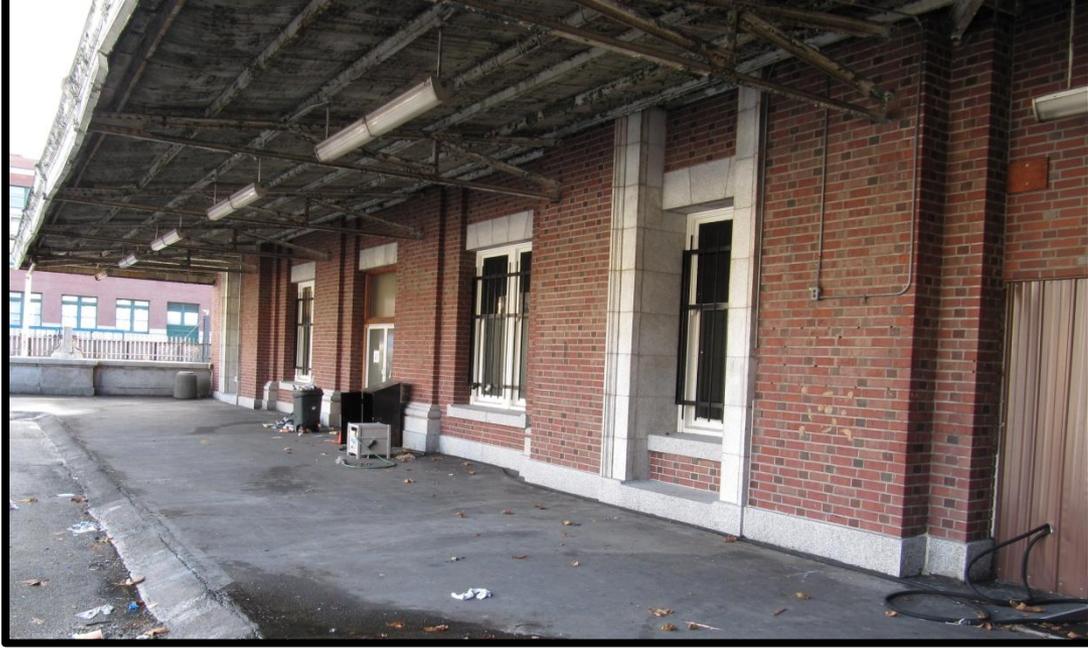
- New glass canopy
- New canopy LED lighting

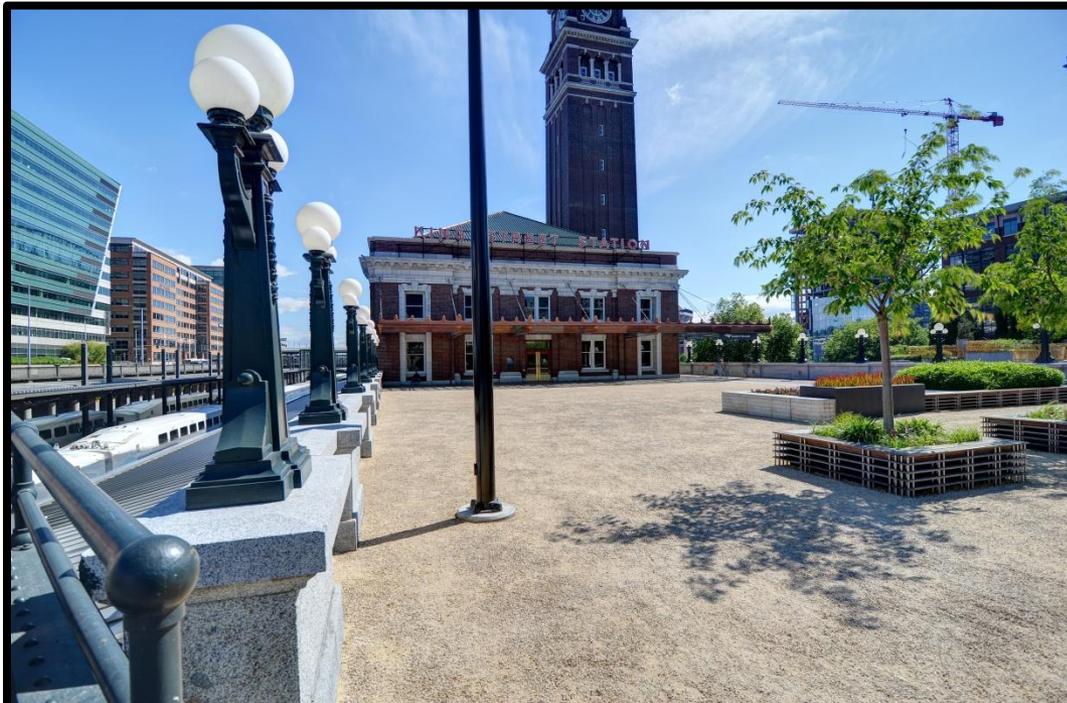
- New pedestrian plaza with landscaping & benches
- New historic replica LED lights
- Station entrance reopened
- New Geothermal wells with heat pump system installed beneath Jackson Plaza

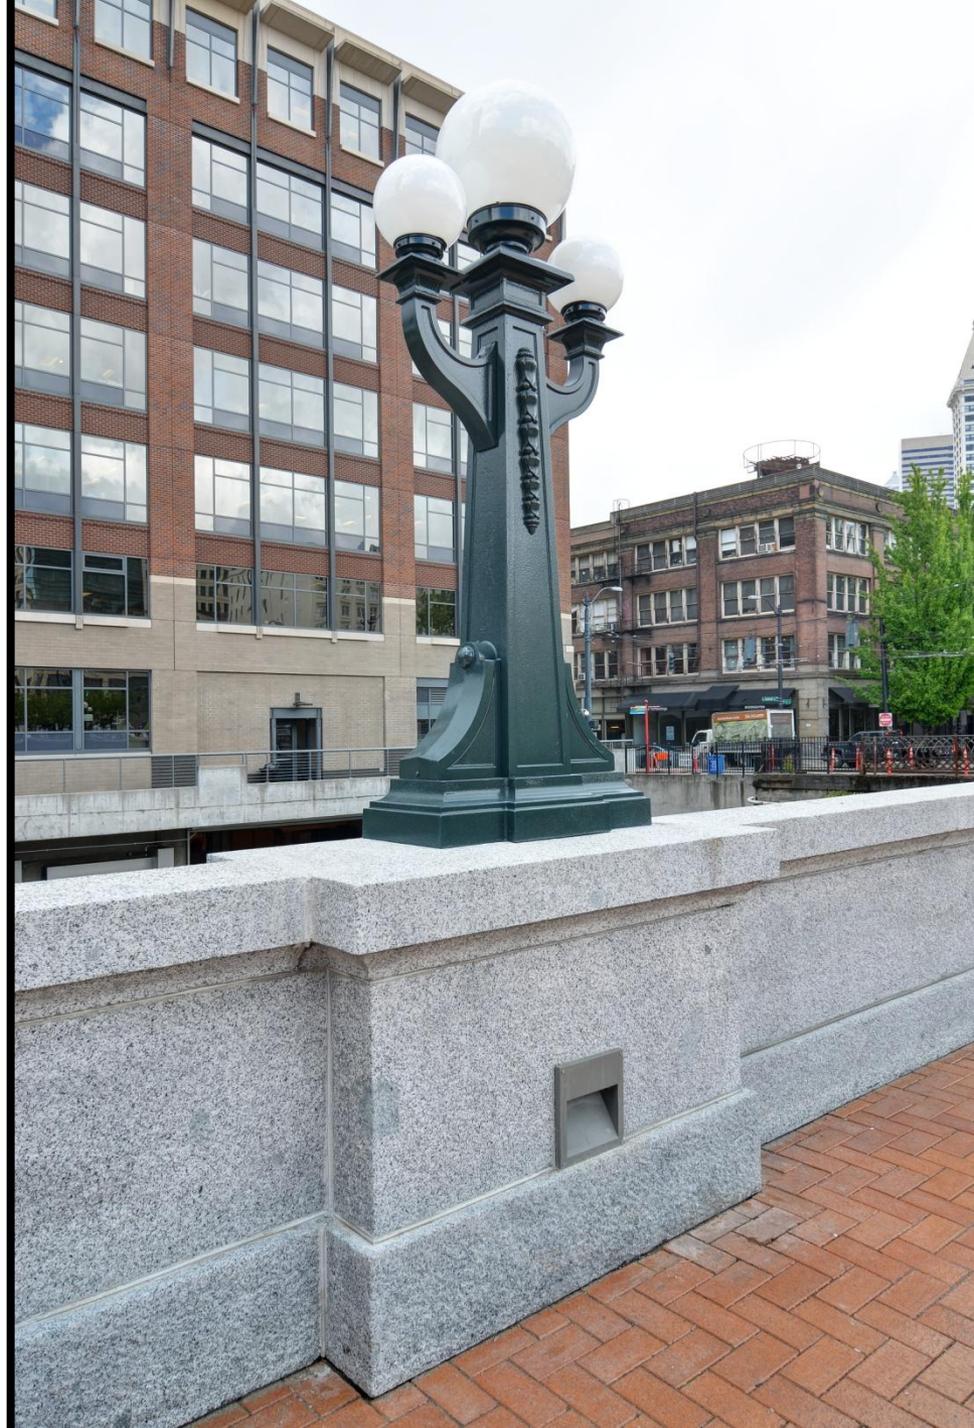
Historic Lights Jackson Plaza Level

- New cast iron “Gumby” LED light posts
- Granite balustrade repaired and restored

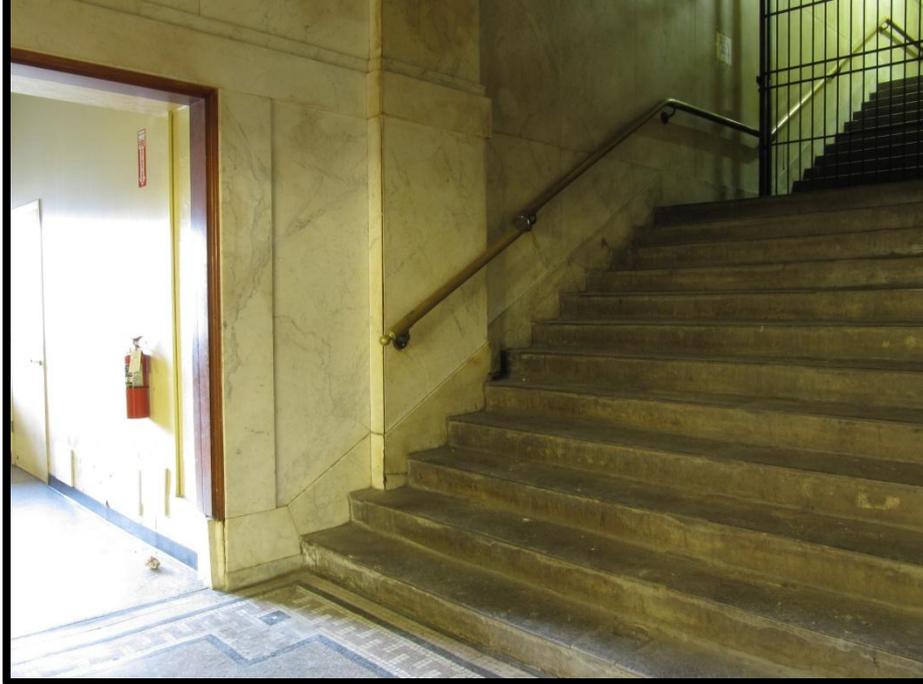
Grand Stairs King Street Plaza Level

- Enclosure for escalator removed
- Metal gate removed to restore access between levels
- New terrazzo treads
- Wall marble panels restored
- New drains on stair landings

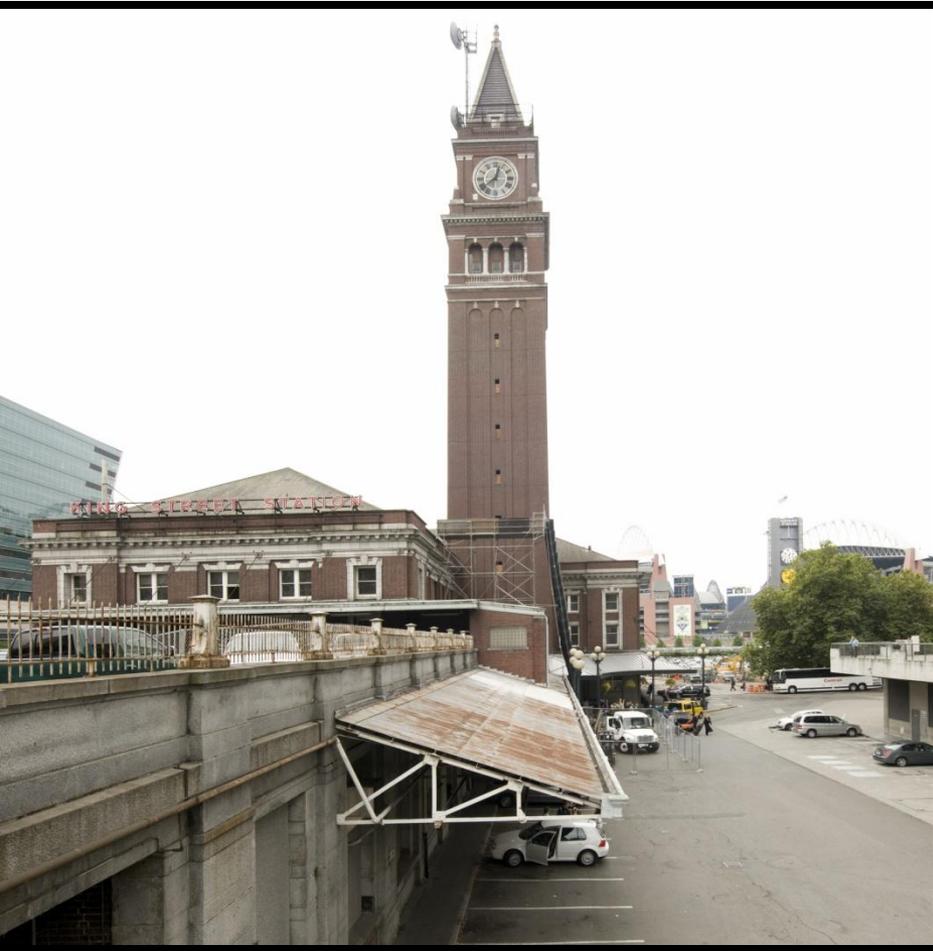
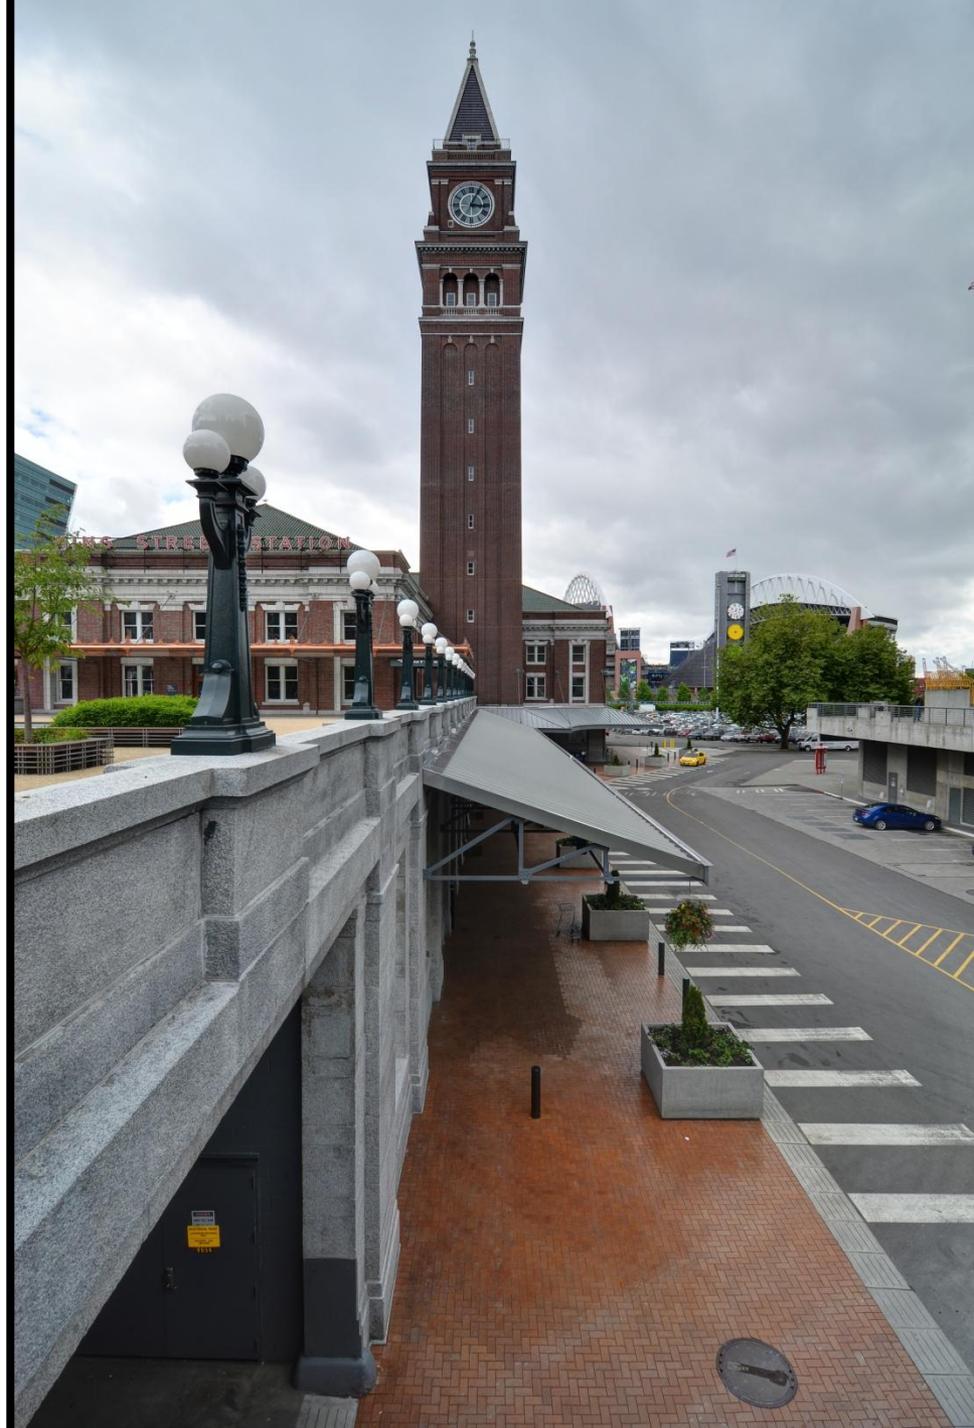
Northwest View Jackson Street Level

- New brick sidewalk with ADA access curbs
- New concrete planters
- New metal canopy

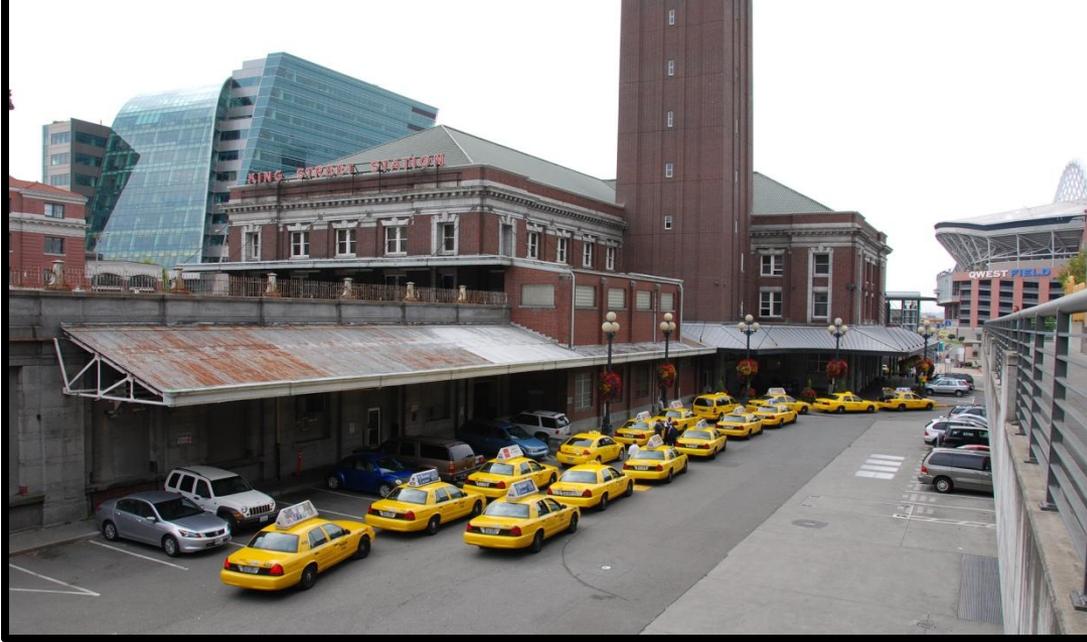
King Street Plaza

- New road markings to improve traffic circulation
- New concrete planters and bollards for pedestrian safety

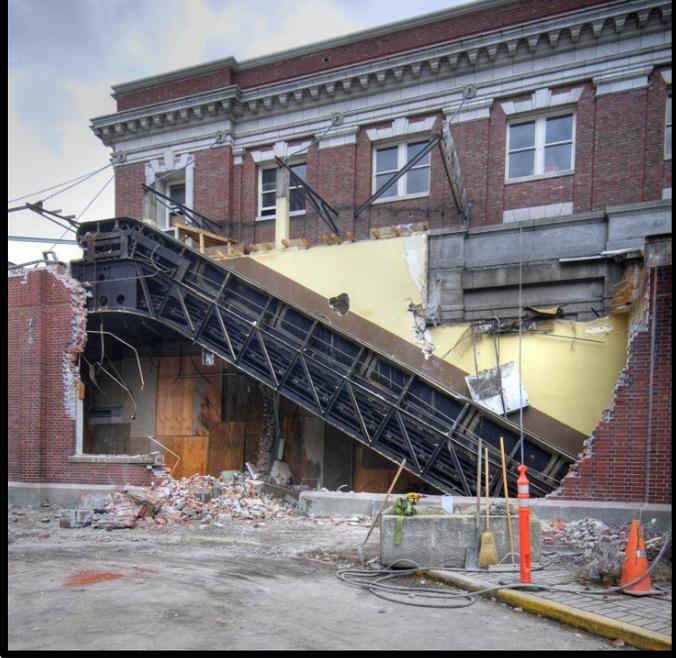
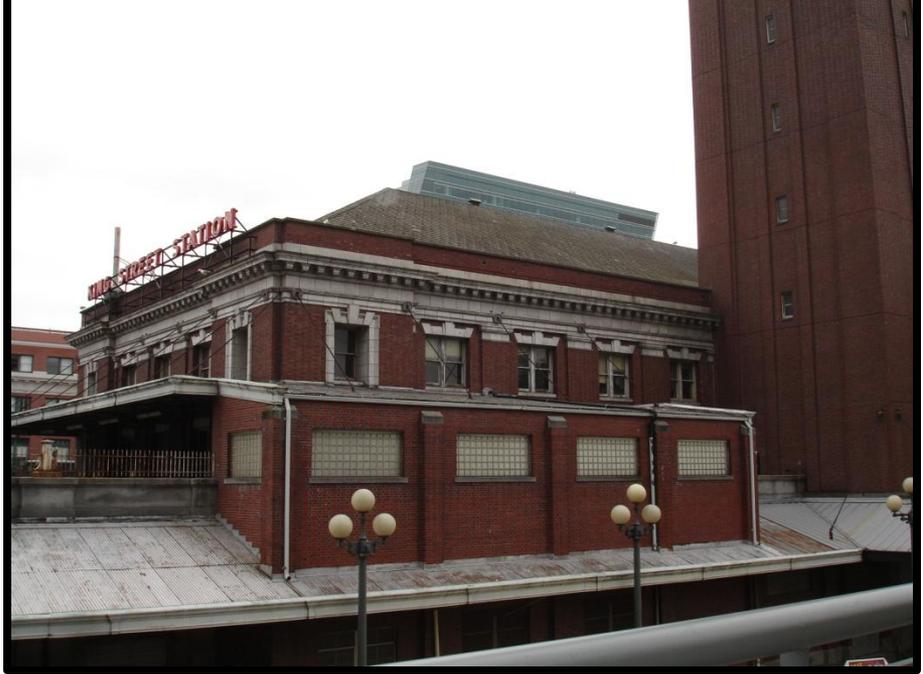
Escalator Removal

- Non-functioning escalator and enclosure removal
- Upper canopy and building exterior restored

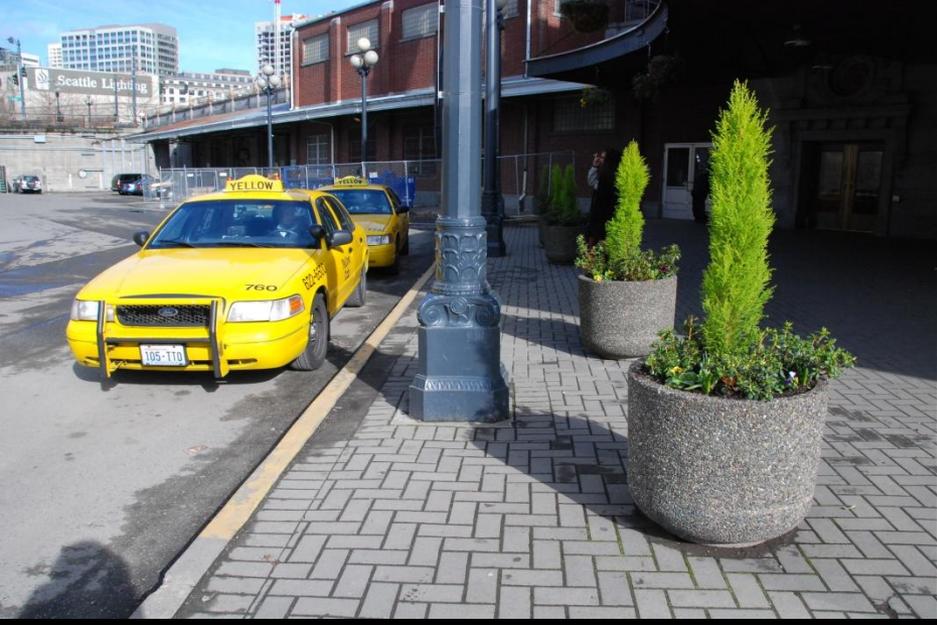
King Street Plaza

- Concrete pavers replaced with brick pavers
- ADA compliant curbsless entry
- Large planters and bollards
- New canopy lighting installed
- All double door entrances restored

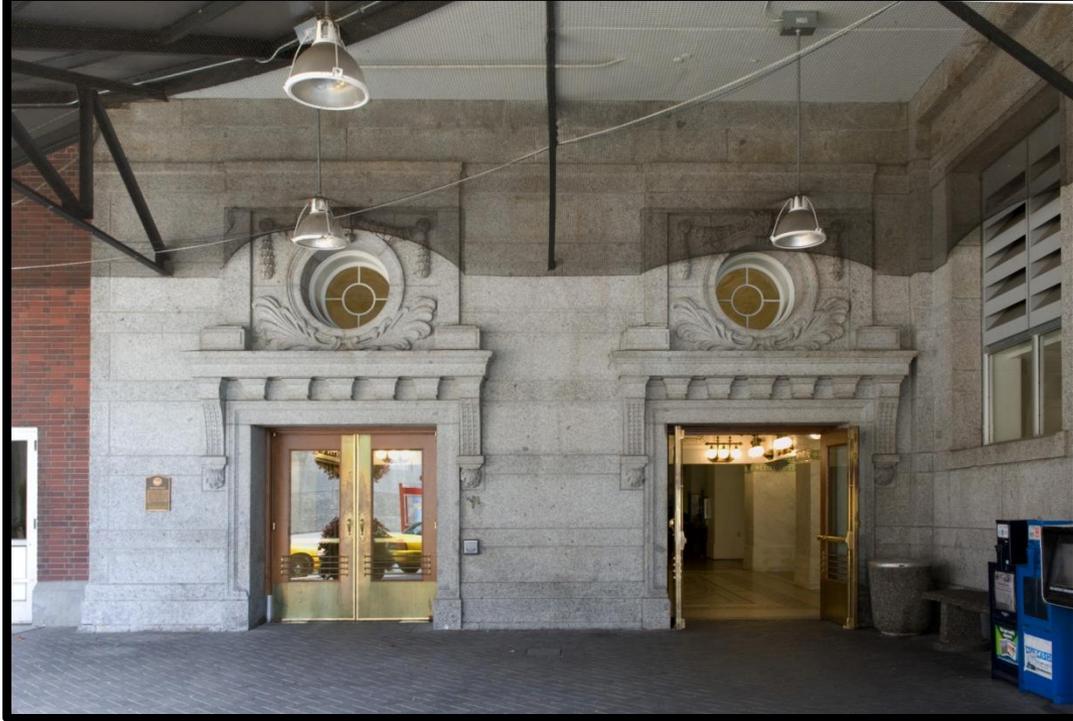
Station Entrance

- Under canopy netting removed
- New brick entrance pathway
- Exterior granite surfaces cleaned and restored
- Welcome mats and proper signage added

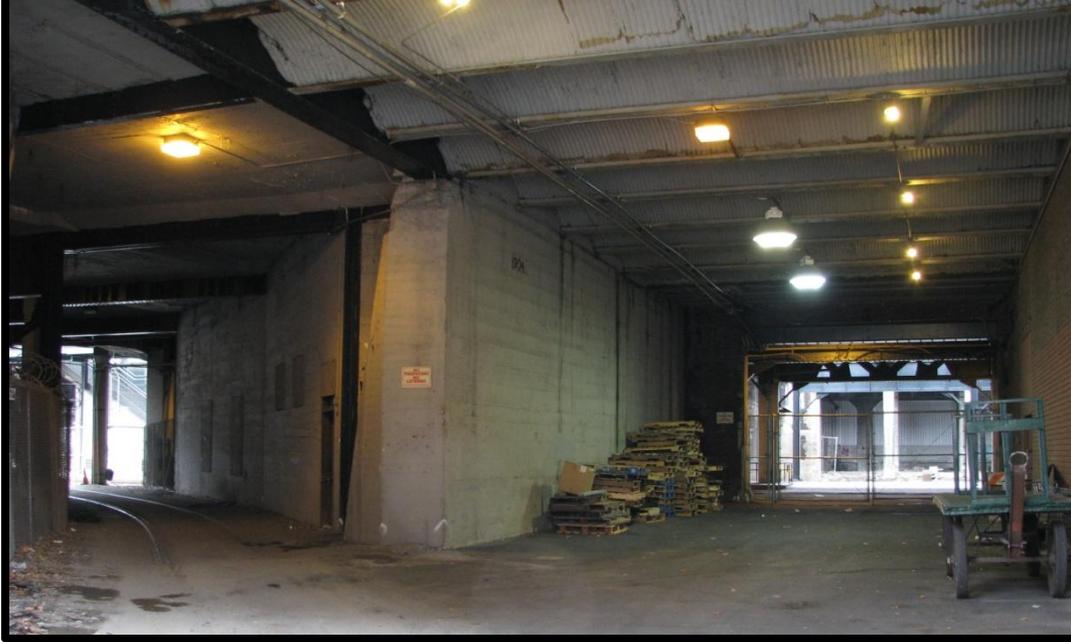
Tunnel

- Jackson Plaza as seen from below with new structural steel decking and support columns
- New expansion joint added between Jackson Plaza and Jackson Street

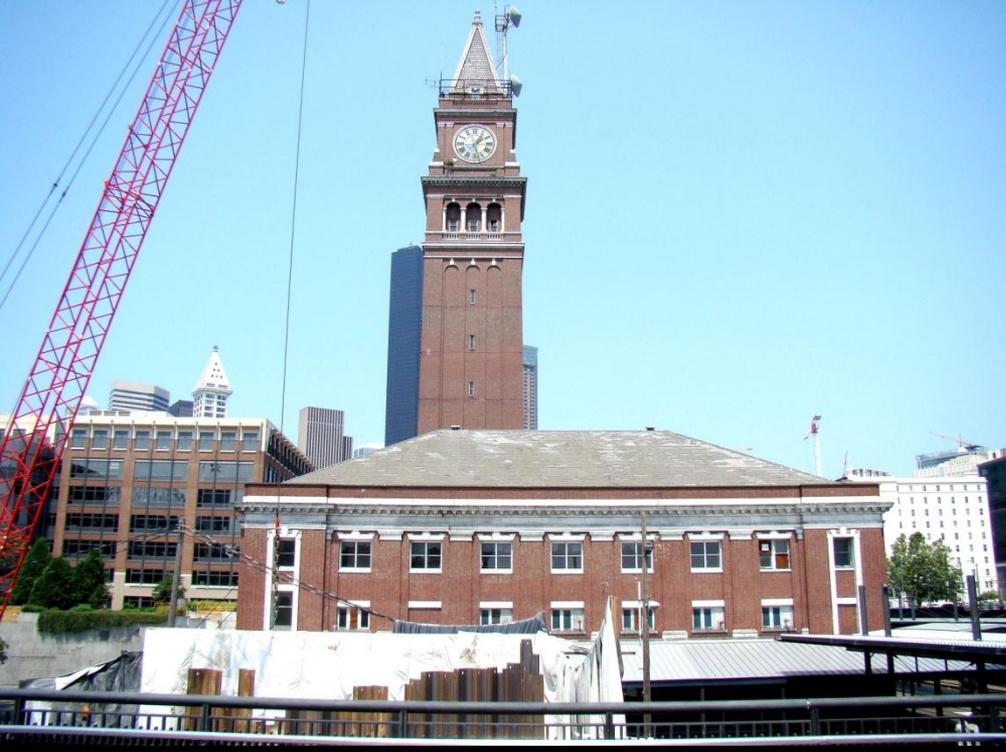
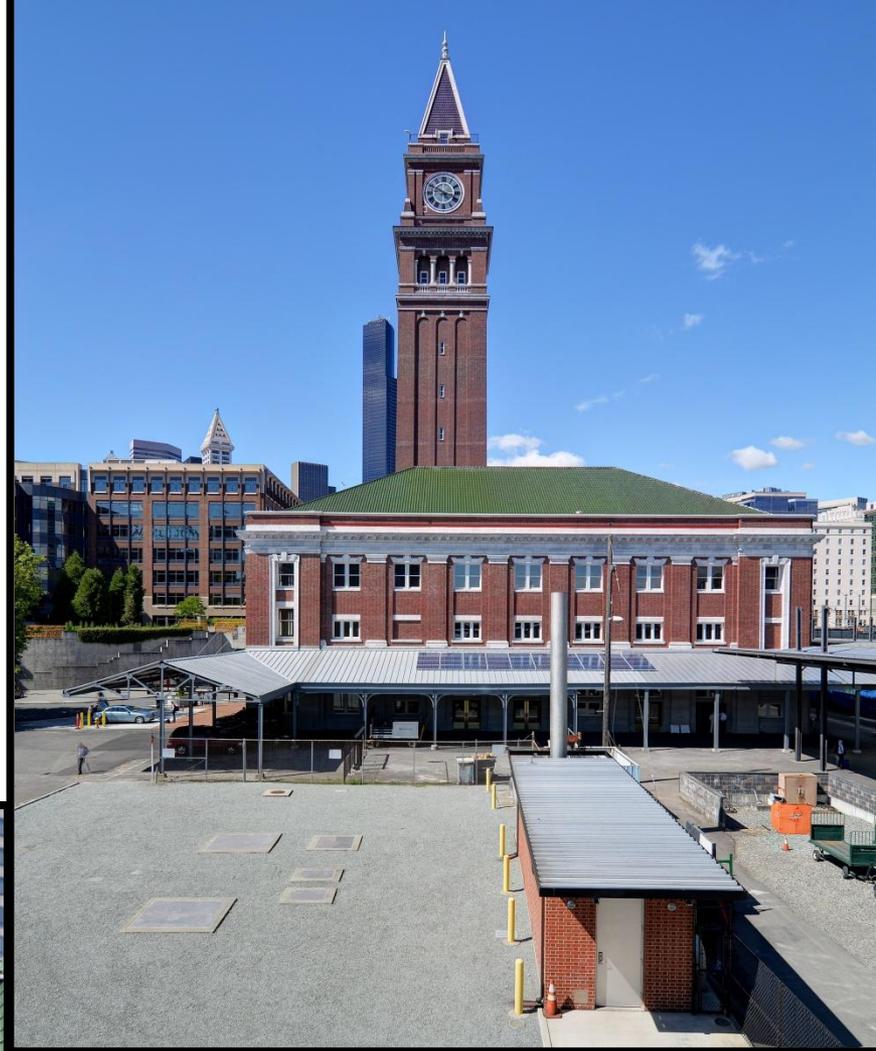
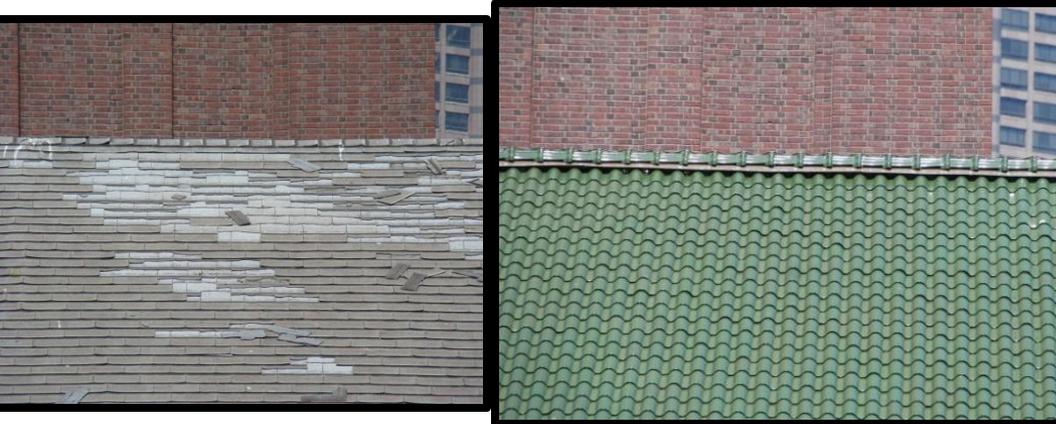
South Side Exterior

- New green roof tiles from original manufacturer
- New solar panels installed

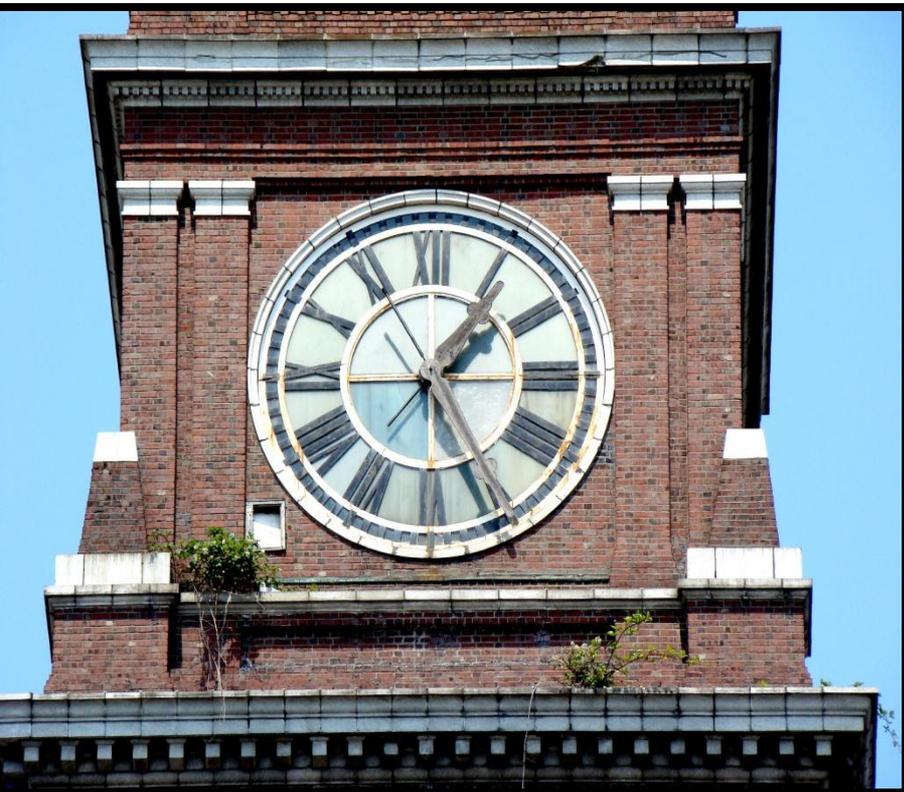
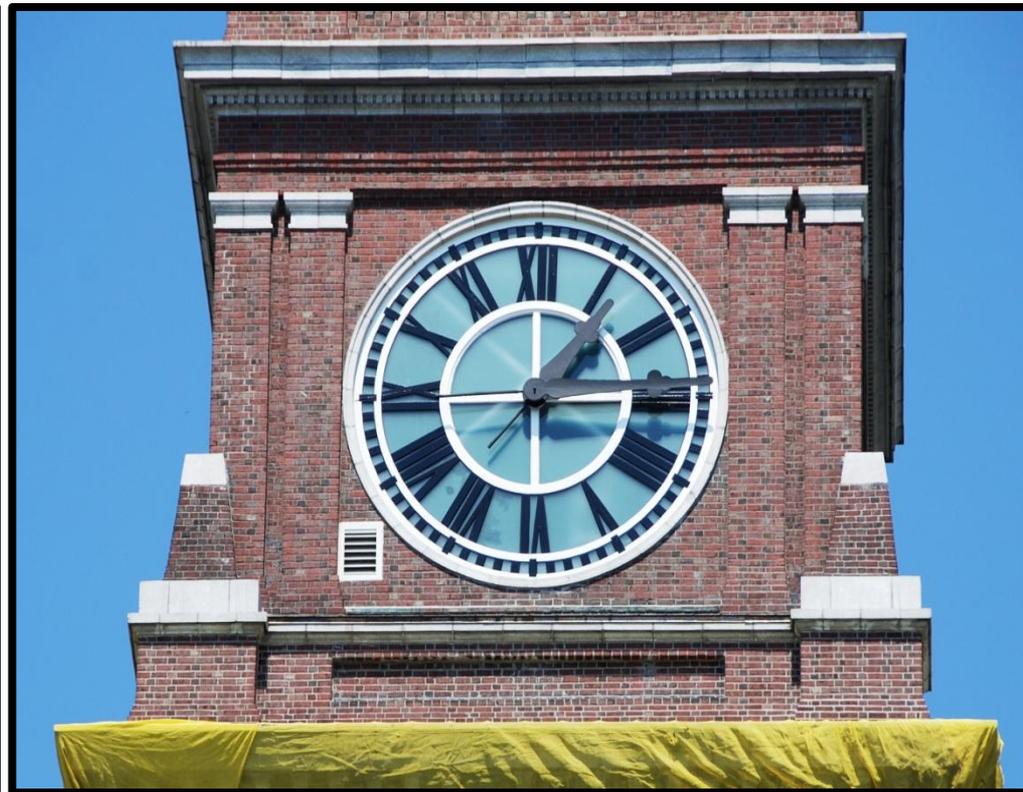
Station Clock

- New frosted glass for clock faces
- Wood clock hands and numbers refurbished and repainted
- Moss and plants removed
- Loose/damaged terra cotta trim repaired
- New clock system

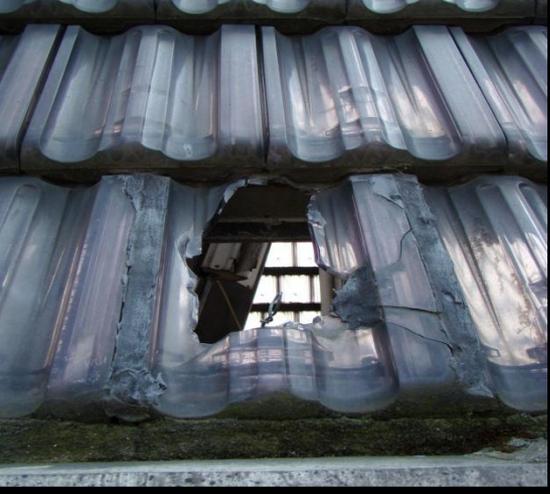
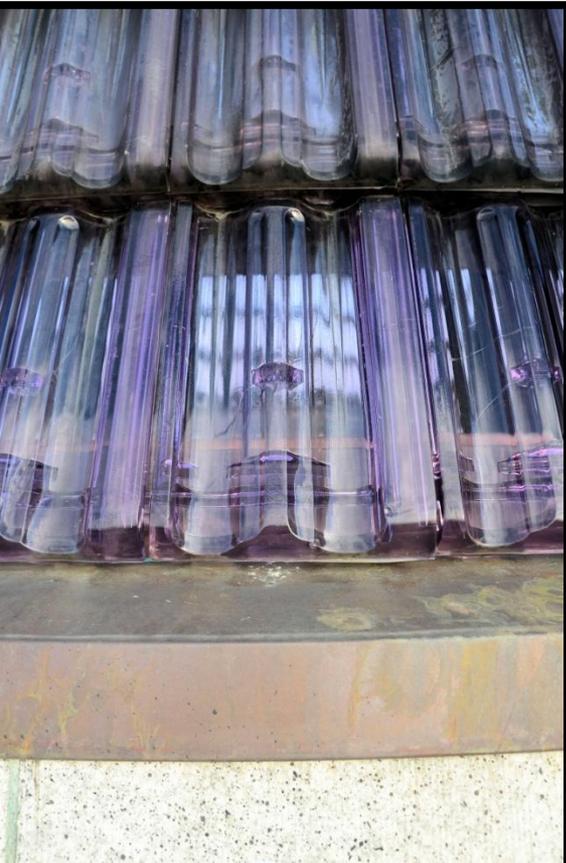
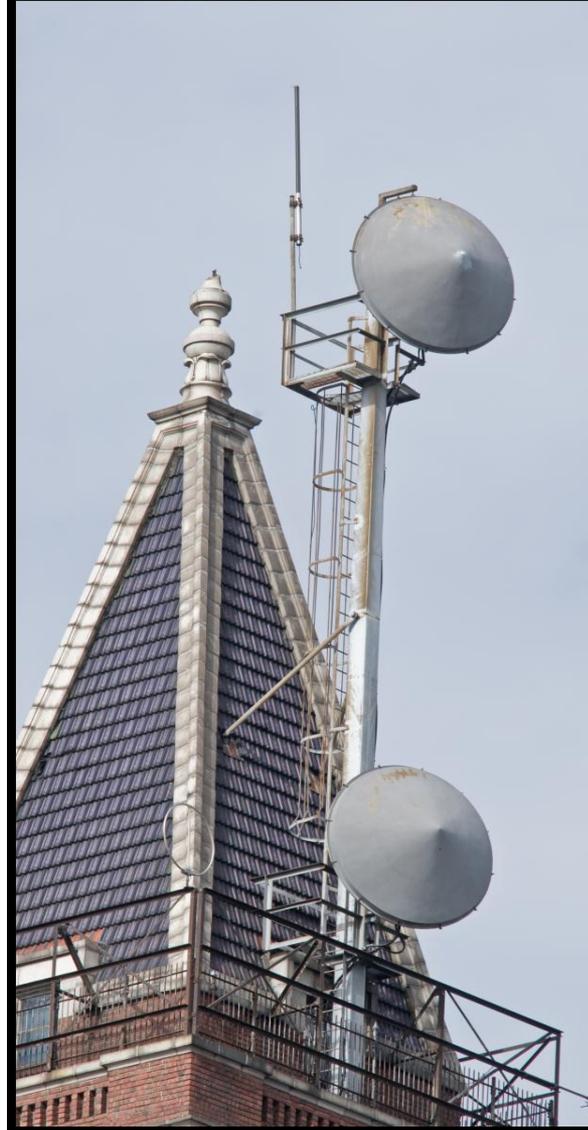
- Salvage glass tiles from Colorado used for replacing broken tiles
- Non original microwave tower removed
- New finial top

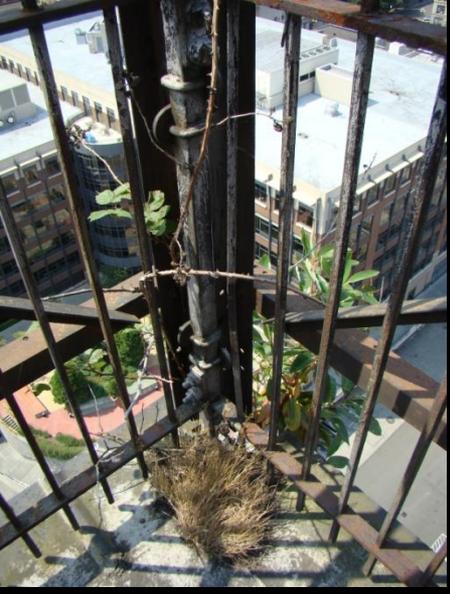
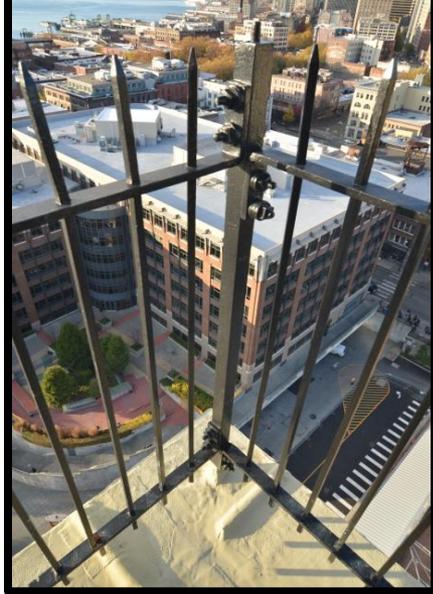
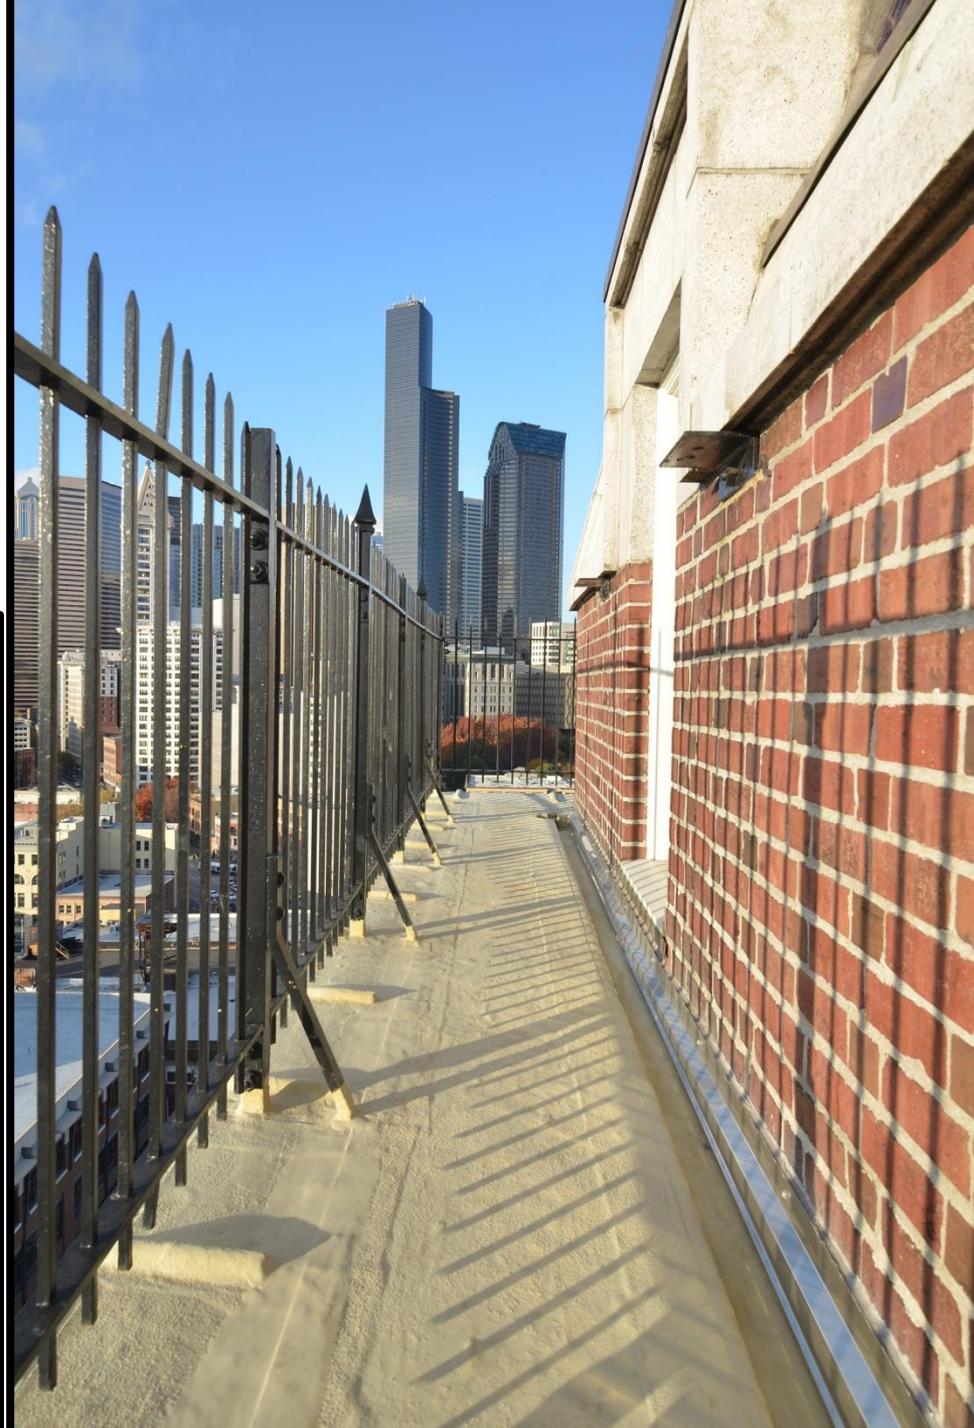
12th floor

- Balcony fence repaired and painted
- Vegetation removed
- New water proofing

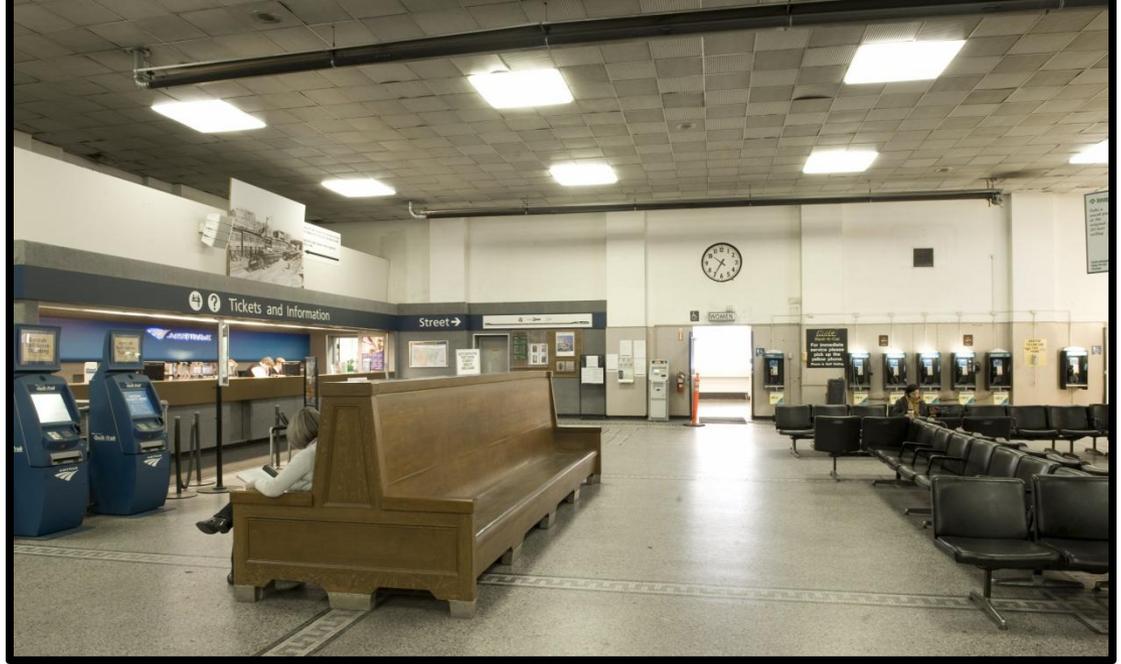
Main Waiting Room

- Amtrak ticketing office relocated
- New wall clock installed
- Restored second floor balcony now open to the public

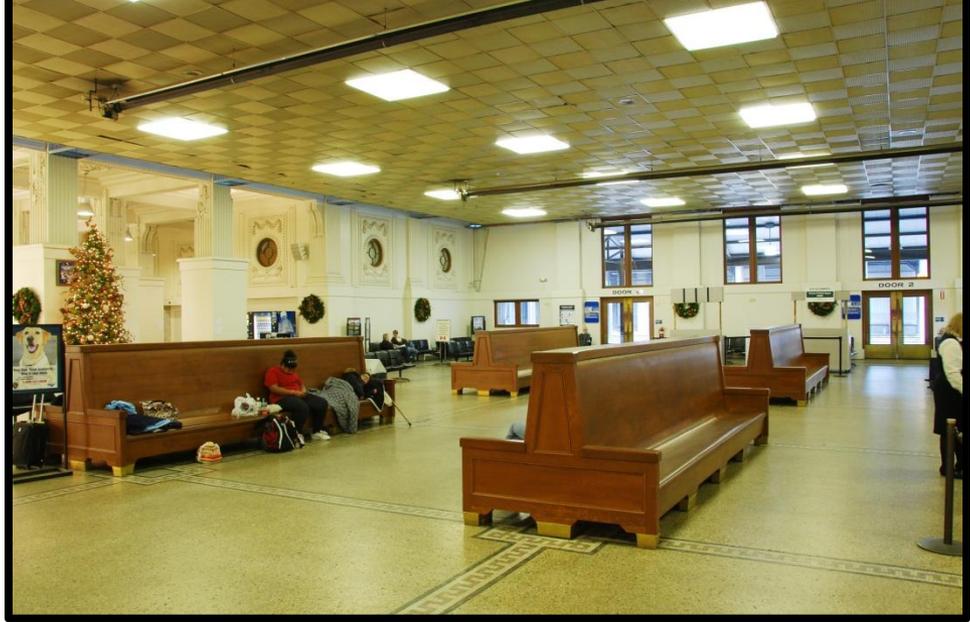
Main Waiting Room

- New and efficient LED replica historic chandeliers and sconces
- New power outlets added
- Automated windows actuators installed for ventilation

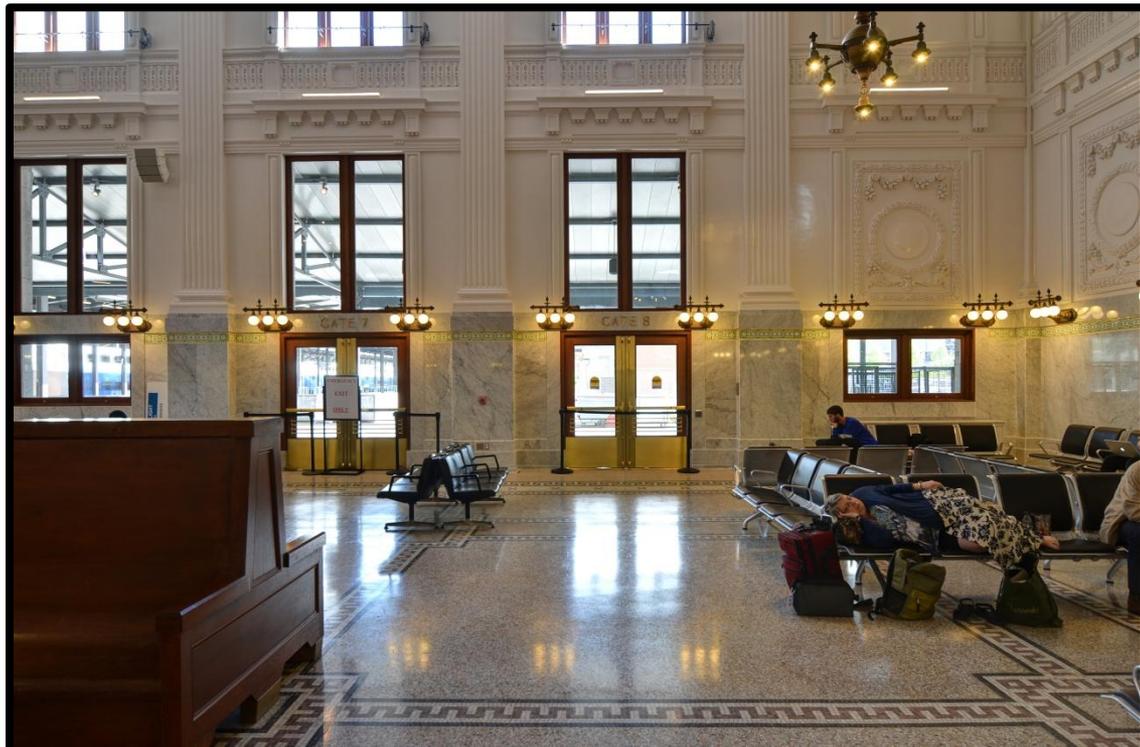
Main Waiting Room

- New restrooms
- New marble panels and glass mosaic tiles for all columns
- New pendant lights and sconces
- Plaster restoration

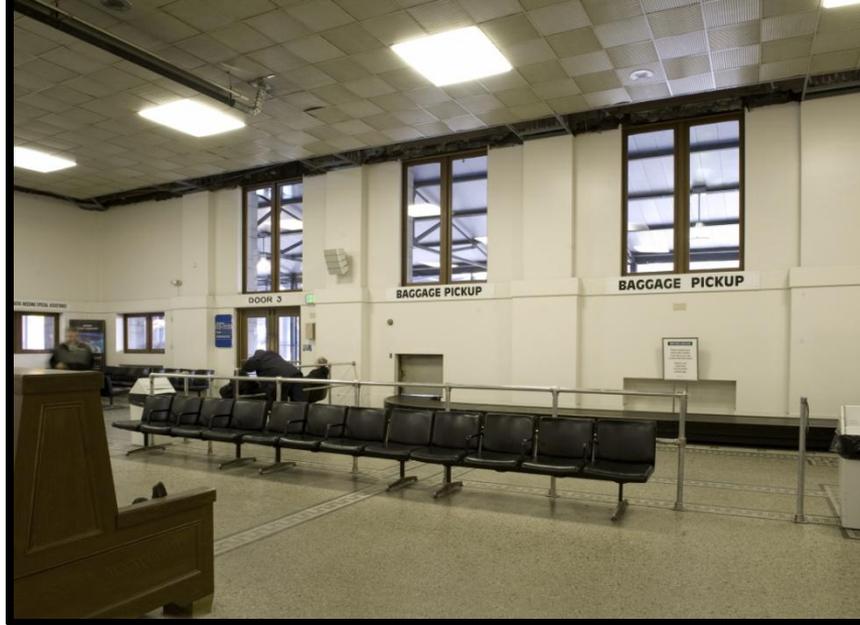
Main Waiting Room

- Baggage pick up carousel relocated to allow for a larger main waiting room

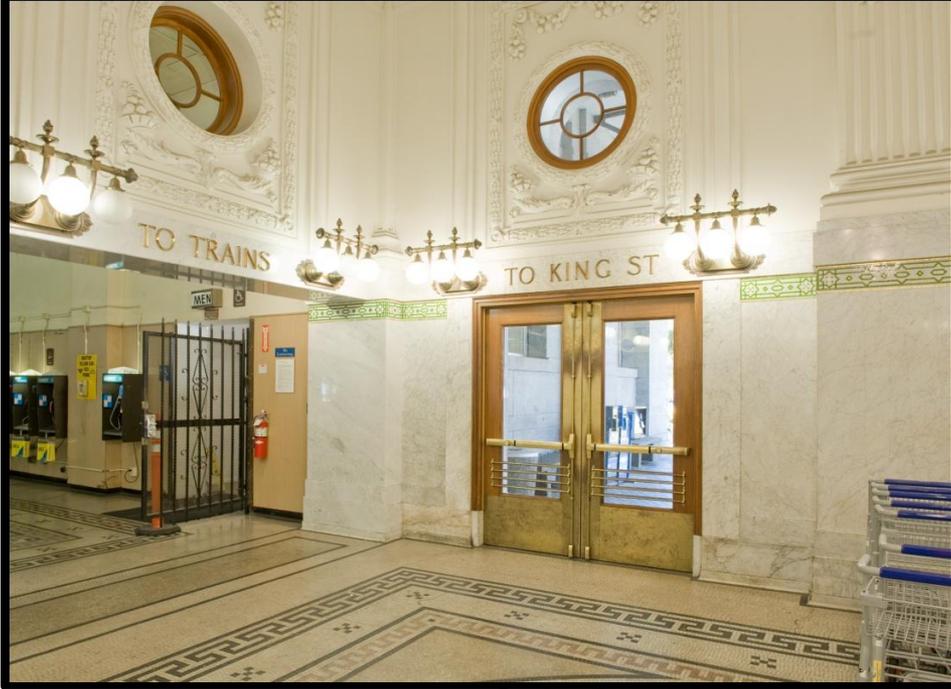
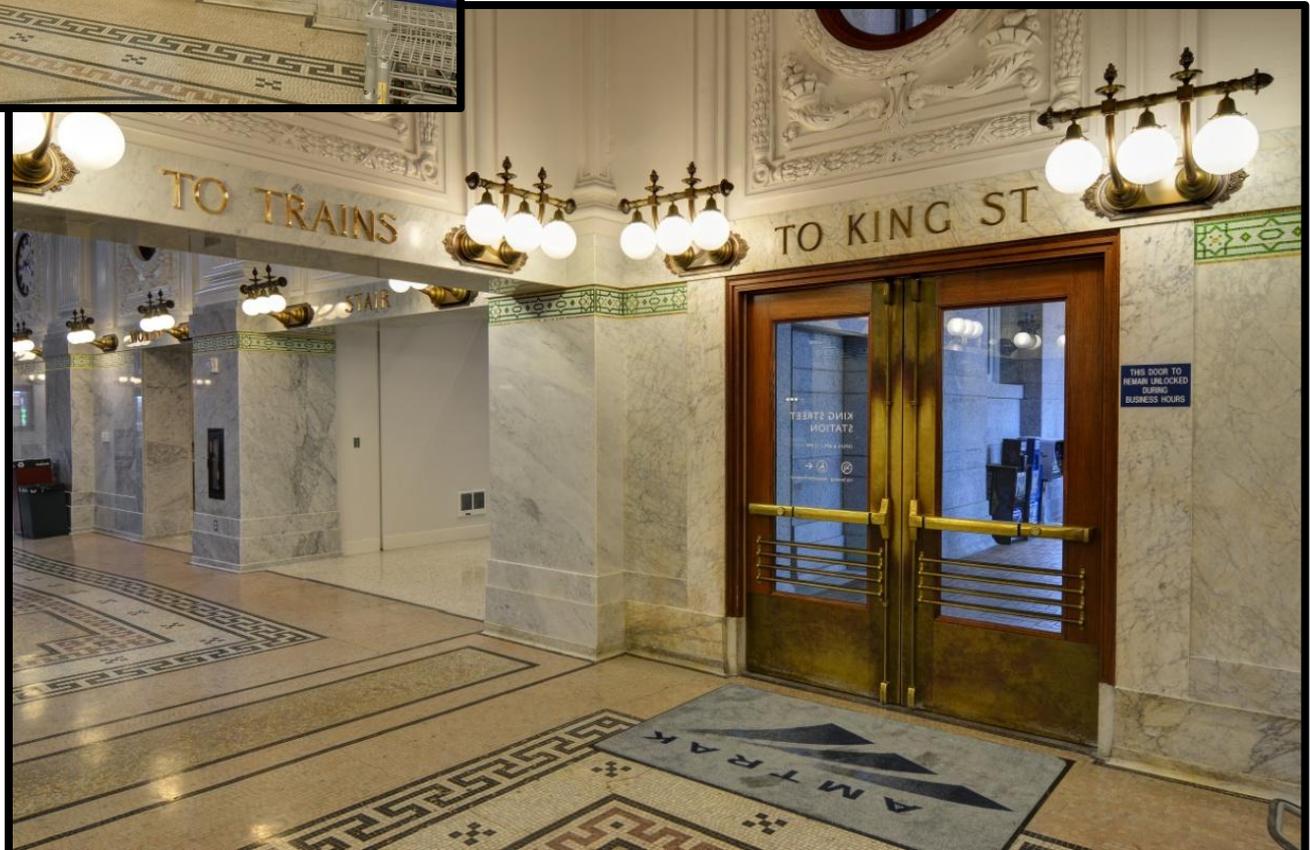
Main Waiting Room

- All windows and doors restored
- Fire extinguishers and evacuation maps updated
