KING STREET STATION

r e s t o r a t i o n p r o j e c t

Before & After Album

Reviving History – The King Street Station Rehabilitation Project

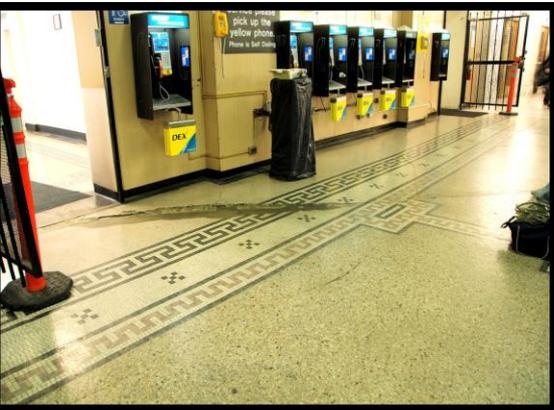
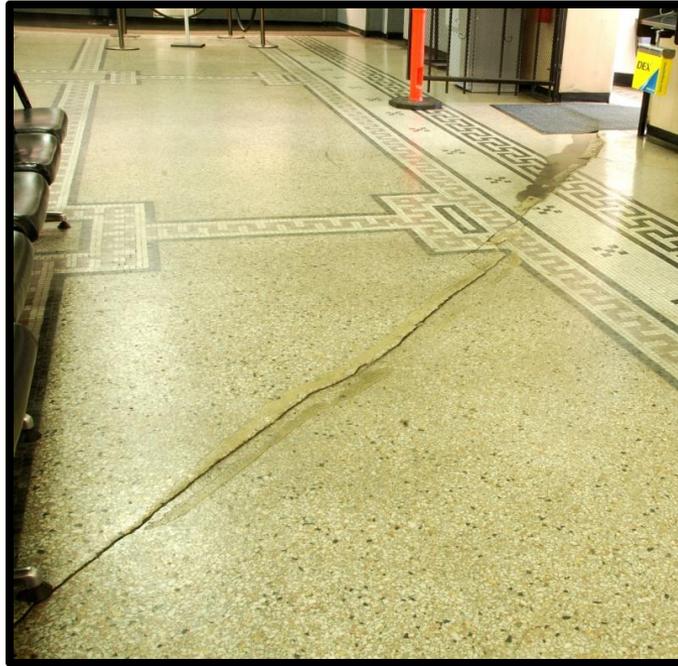
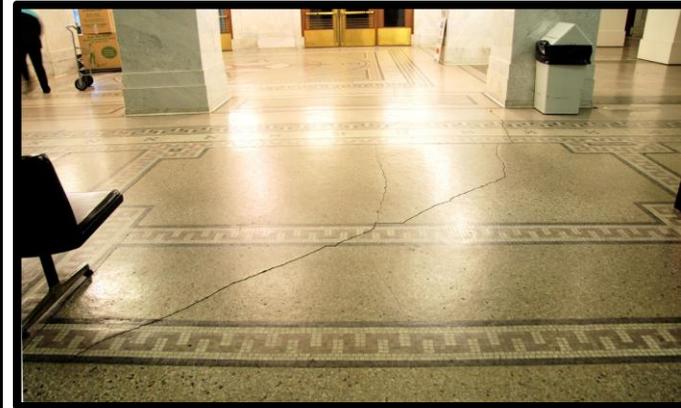
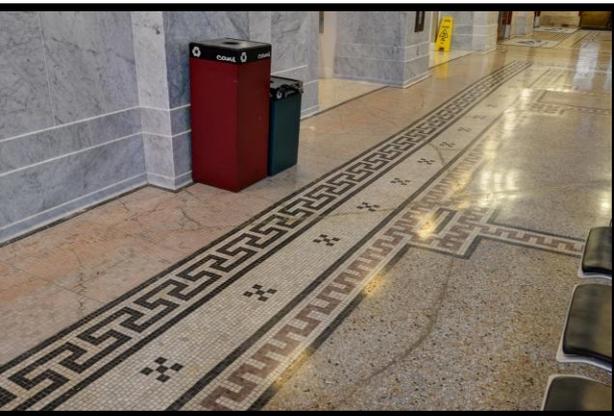
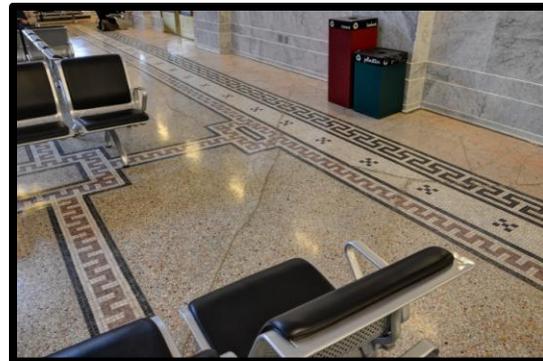
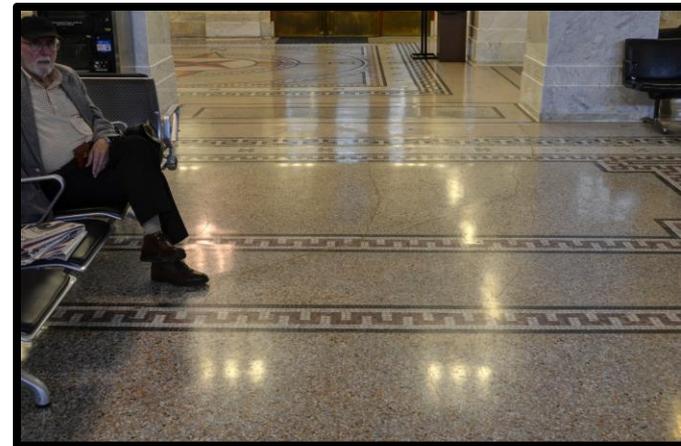
Main Waiting Room – Terrazzo Floor Repaired

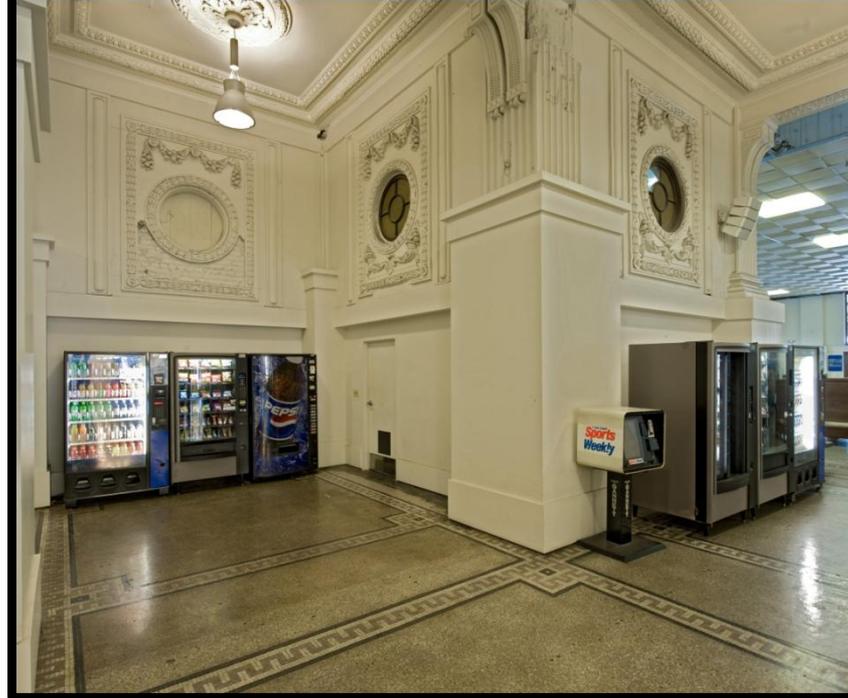
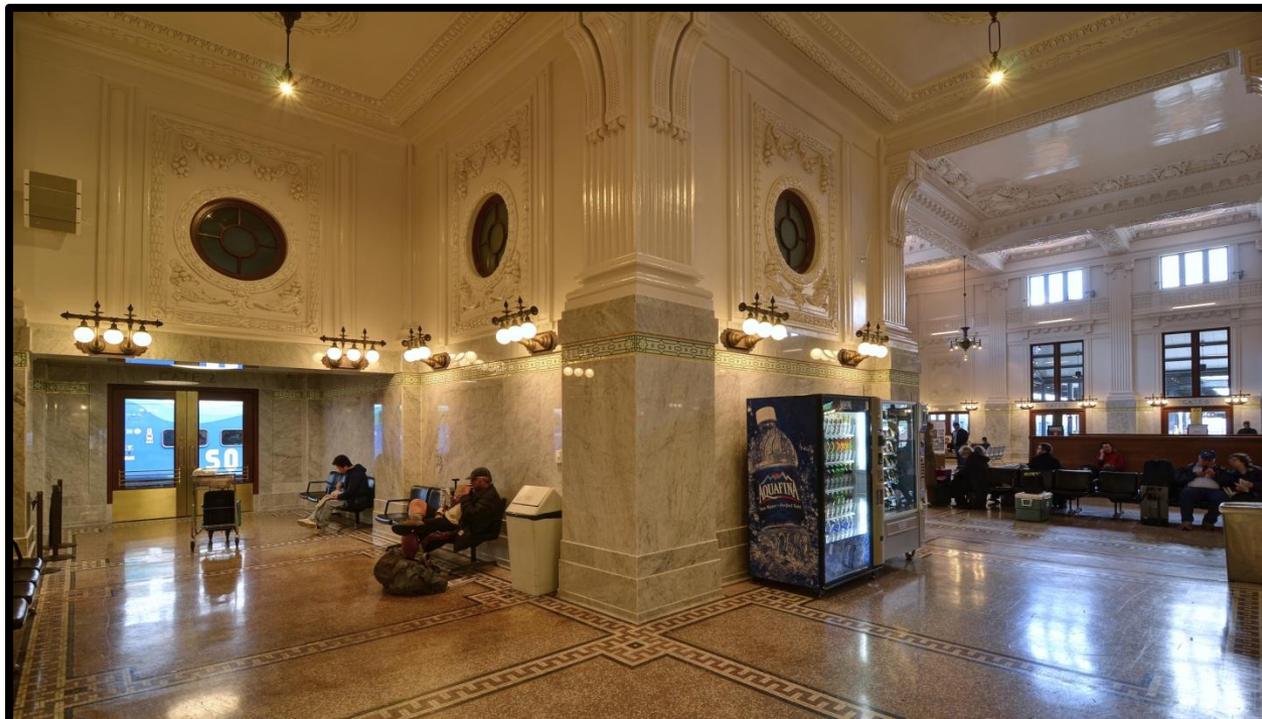
- Previous Amtrak lunch room converted to Men's restroom
- New interior matt foundation and reinforced seismic shear wall add to this corner
- New door opening to platform

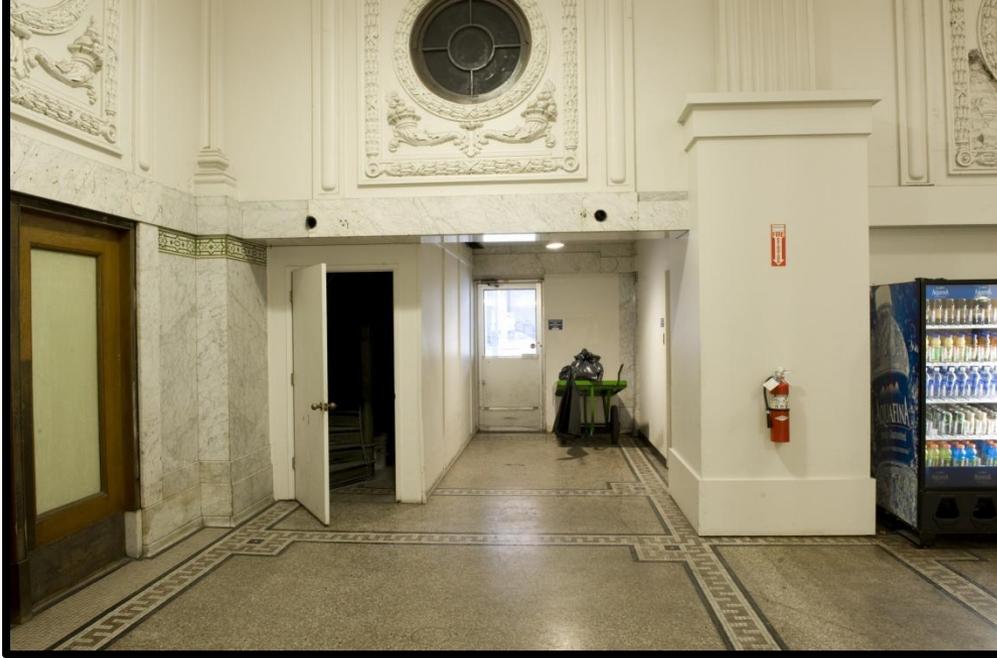
- Additional egress doorway
- Previous electrical room at mezzanine level relocated to 3rd floor
- Additional openings for new Ticketing office

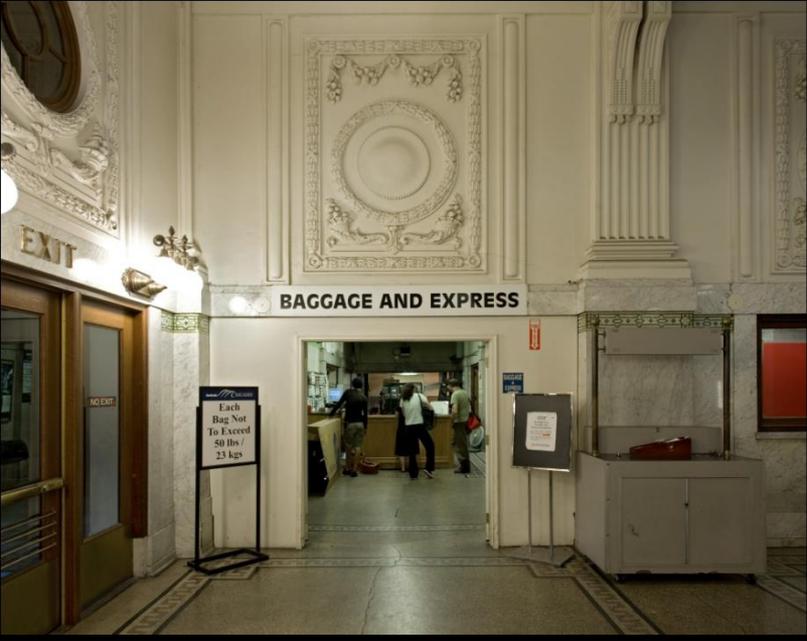
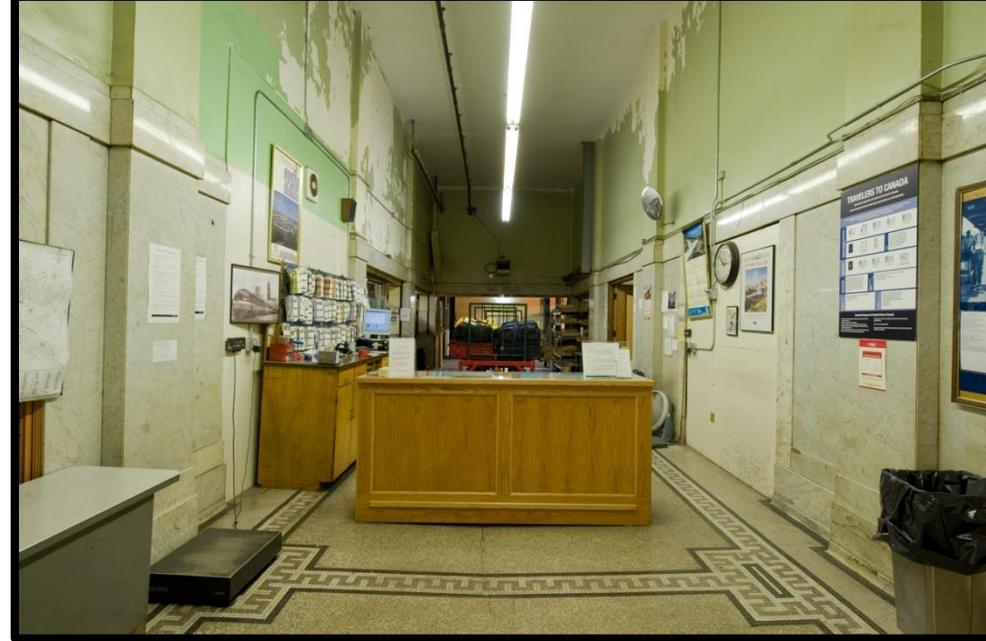
Baggage Room

- Previous baggage check in is now baggage claim room
- All non-original sheet rock walls removed and replaced with ornamental plaster wall and marble panels
- New terrazzo floor installed
- All new lighting fixtures installed

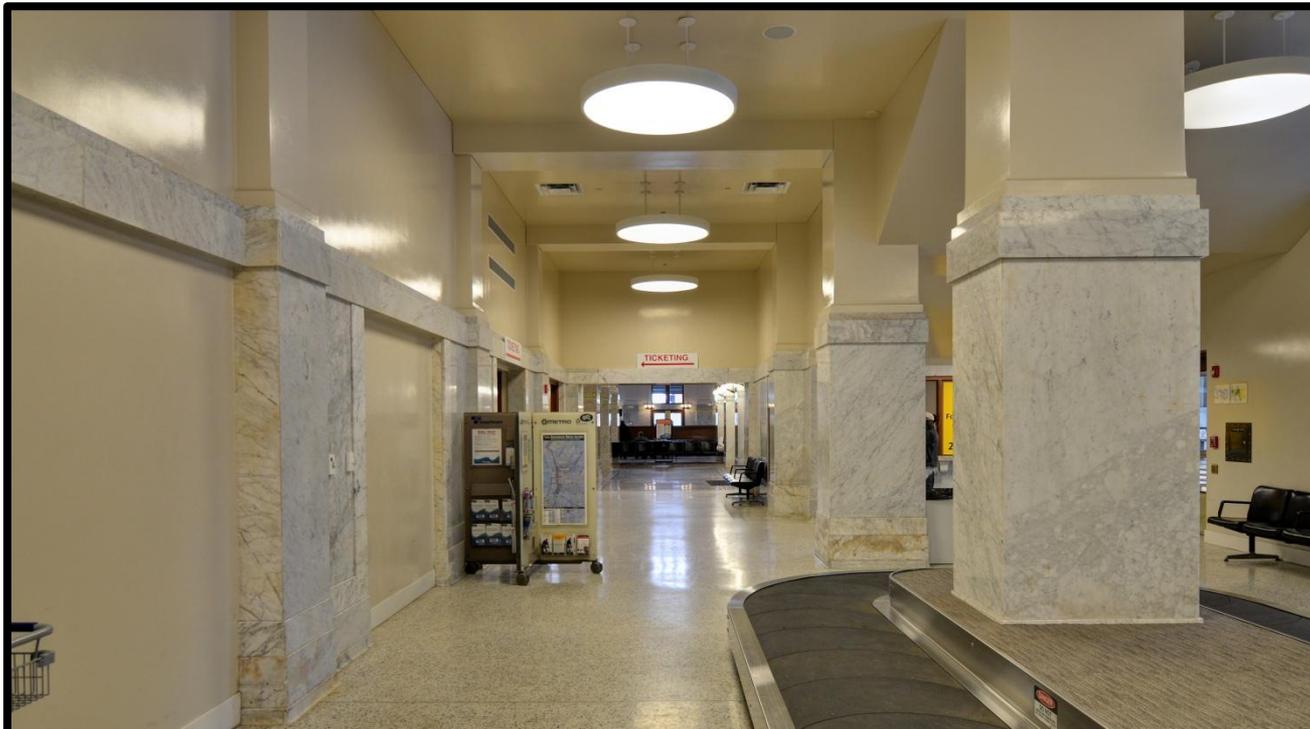
Baggage Room

- New baggage claim carousel installed

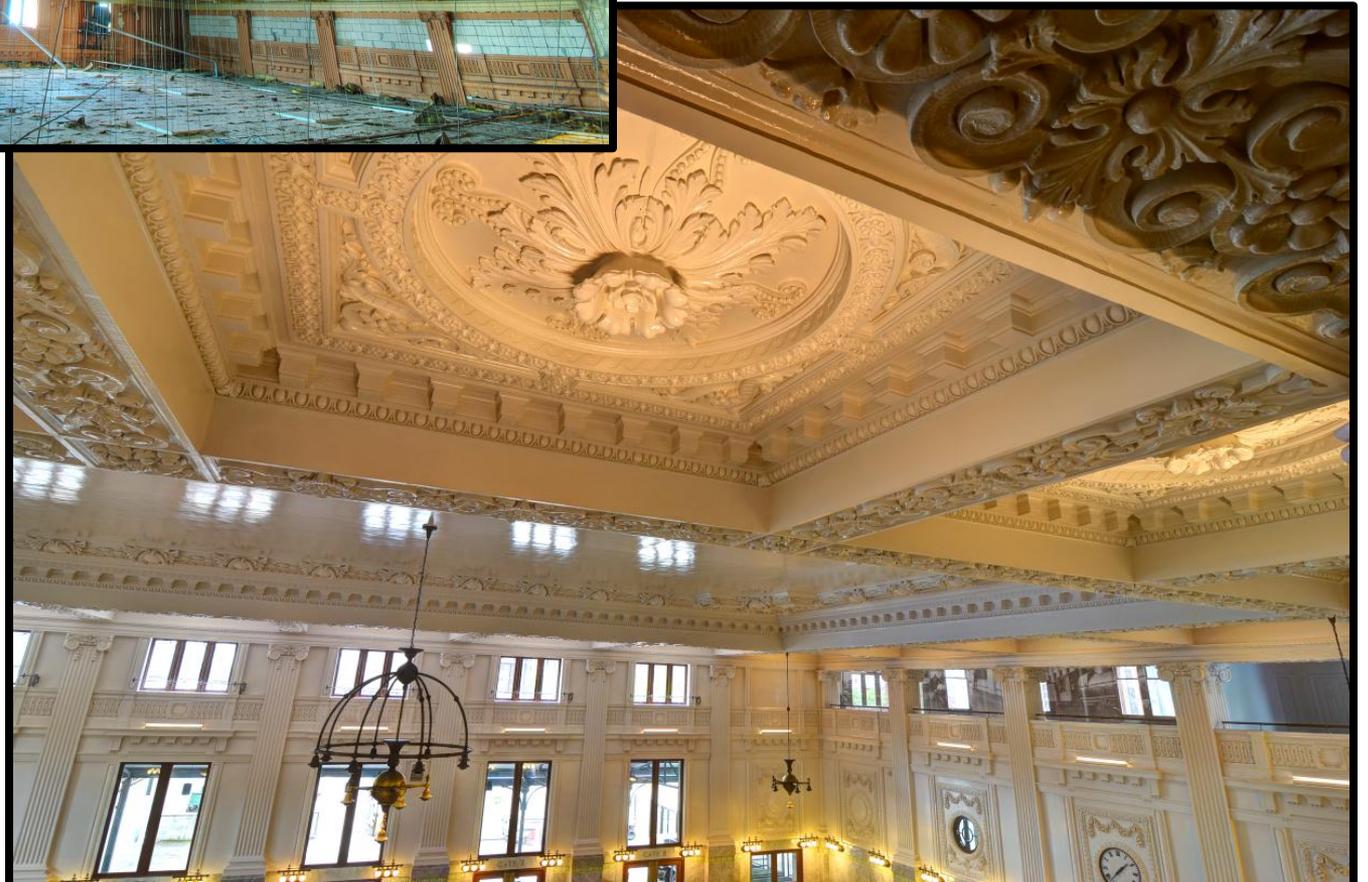
Ornamental Plaster Restoration

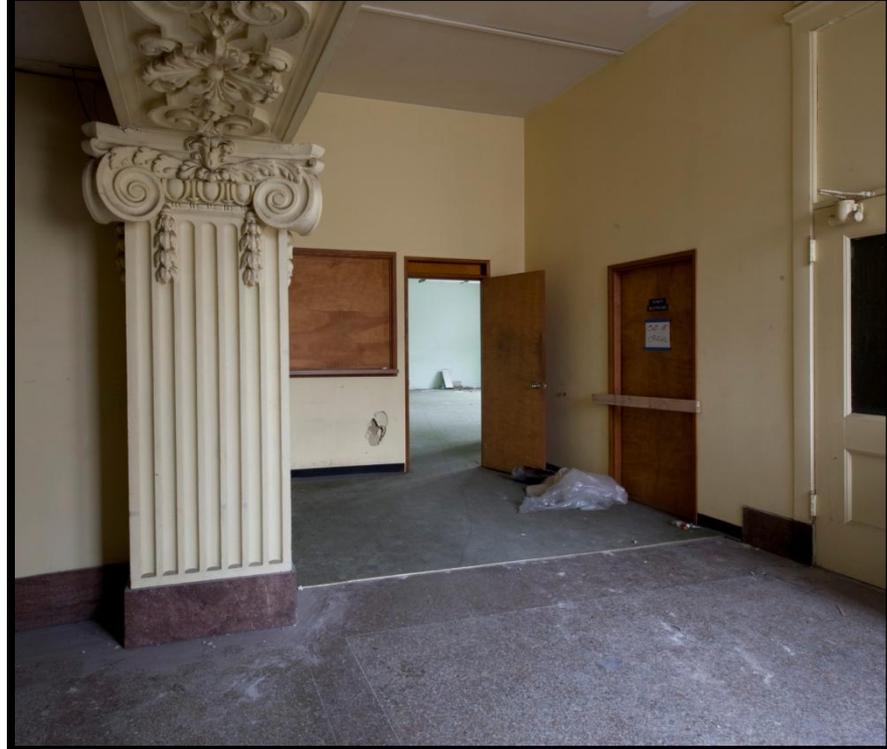
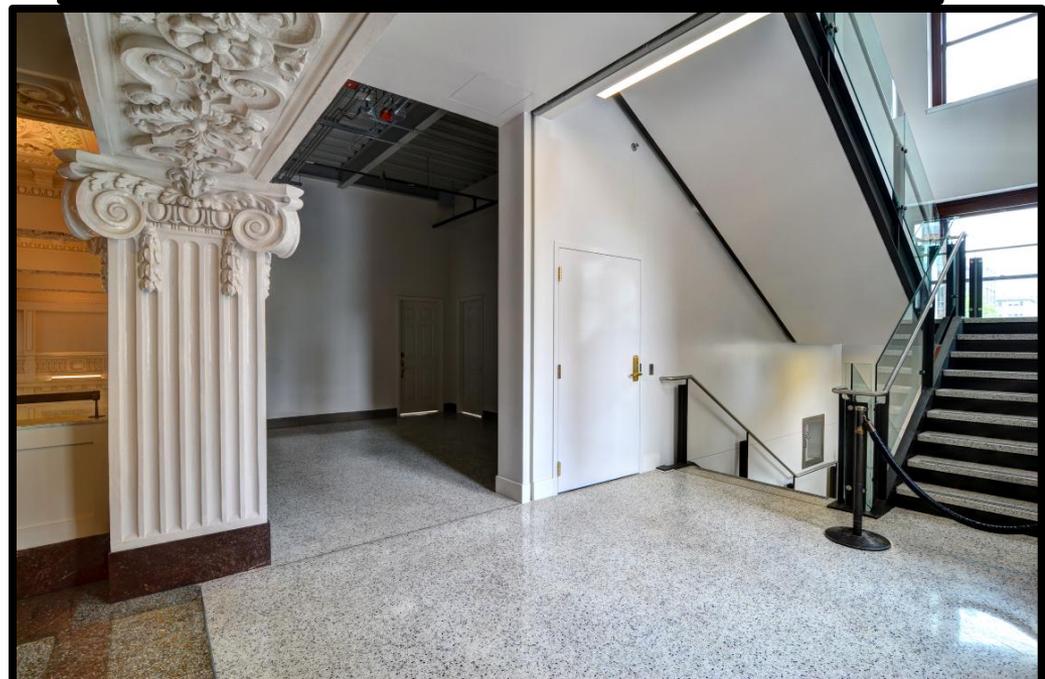
2nd Floor Balcony

- New stairway and elevator connects Main Waiting Room, 2nd floor balcony (Jackson Plaza level) and 3rd floor future tenant space

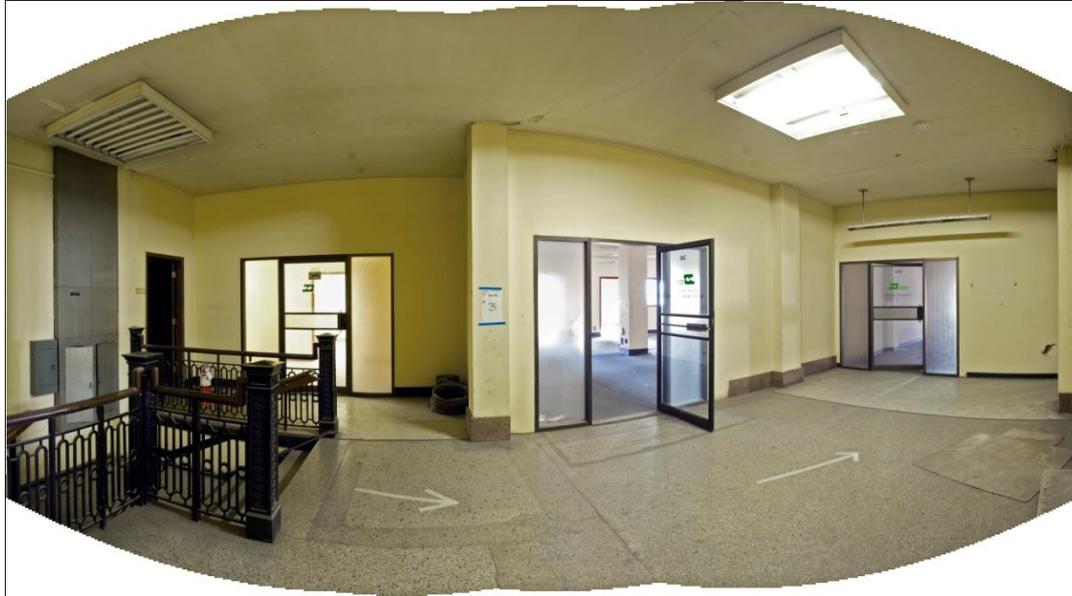
3rd Floor Future Tenant Space

- New seismic steel installed
- Historic stair boxed in for protection.

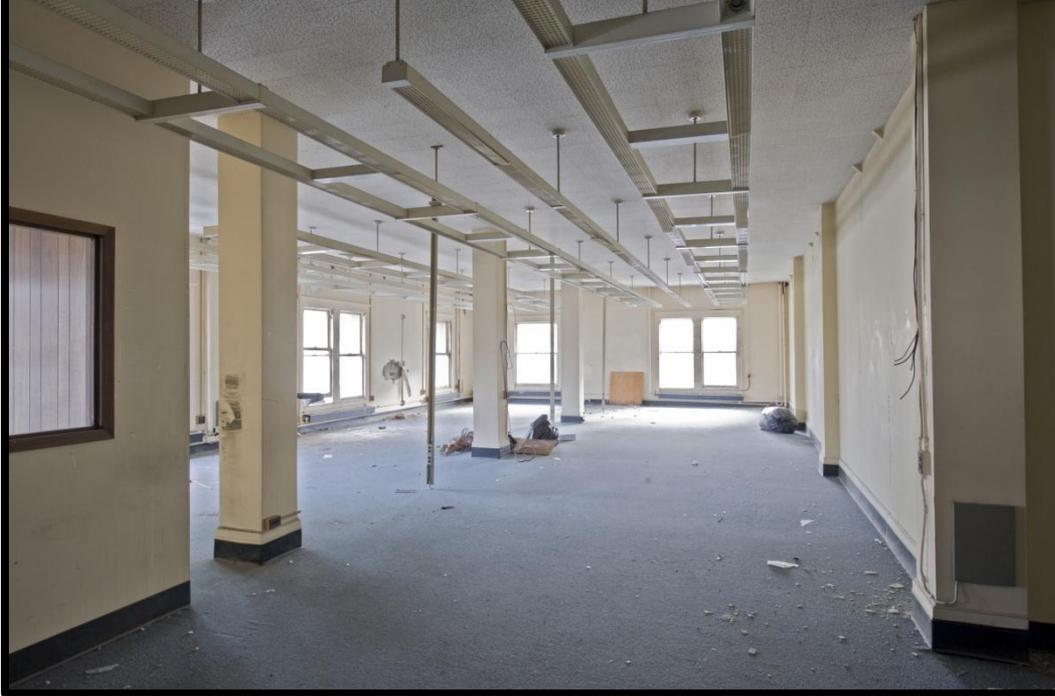
- Interior partition removed
- New sprinkler system
- New reinforced concrete floor slab
- New electrical and mechanical duct work installed

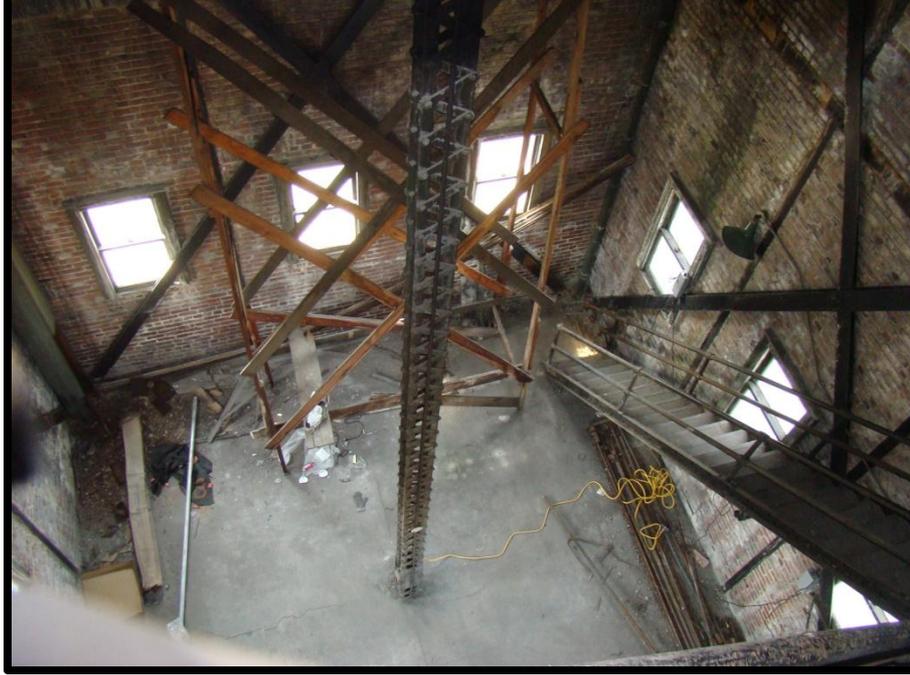
10th Floor

- New massive steel matrix ensures tower seismic stability

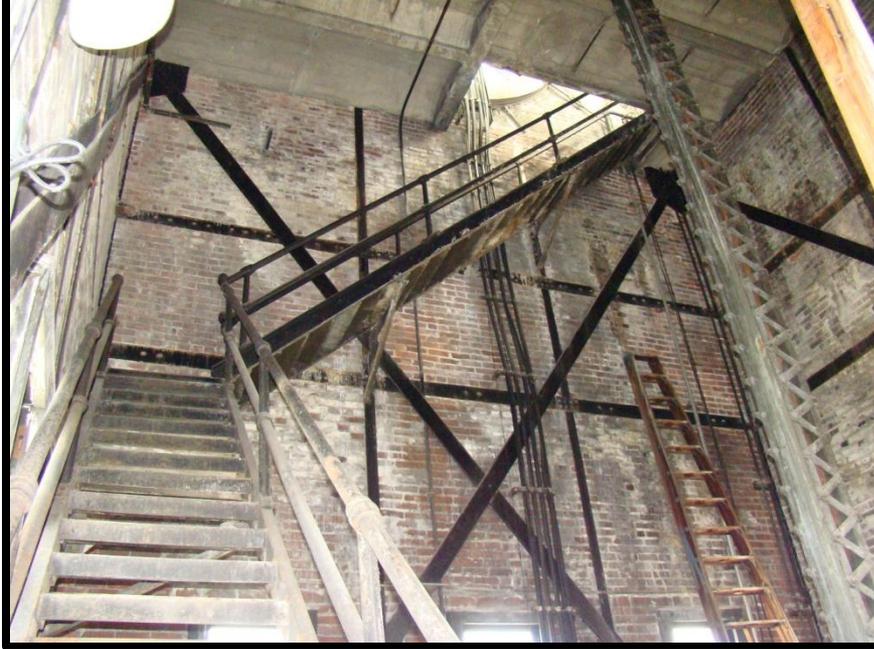
- Section of the tower stairway was narrowed due to the new seismic steel

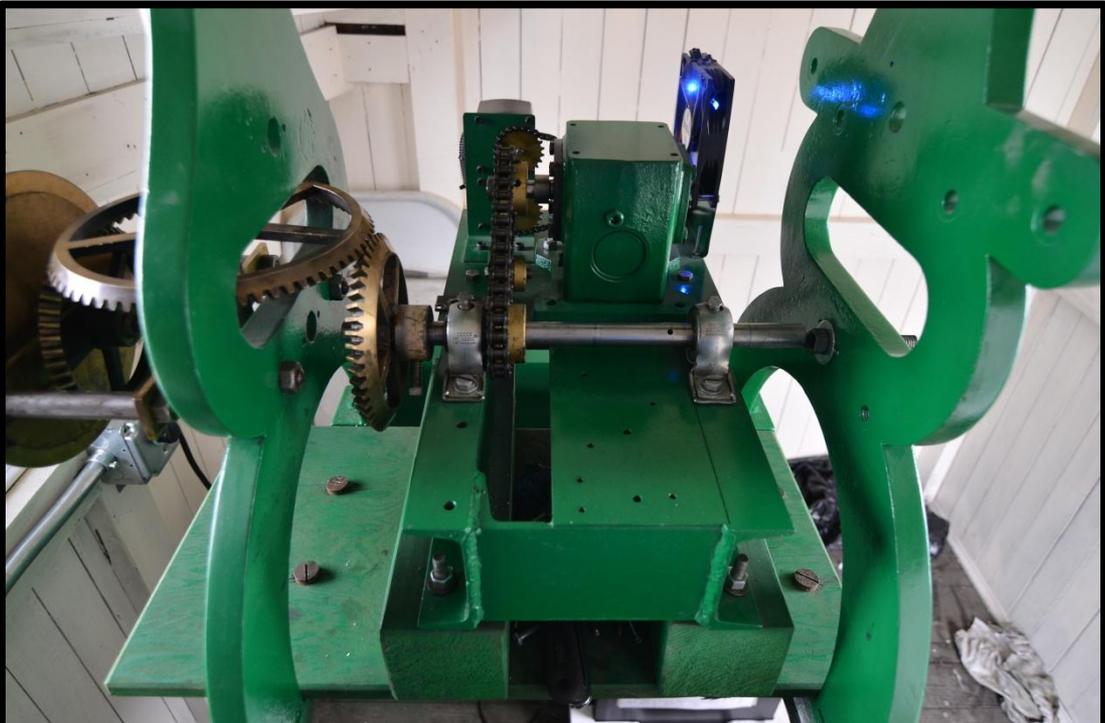
Clock Room

- New mechanical clock installed

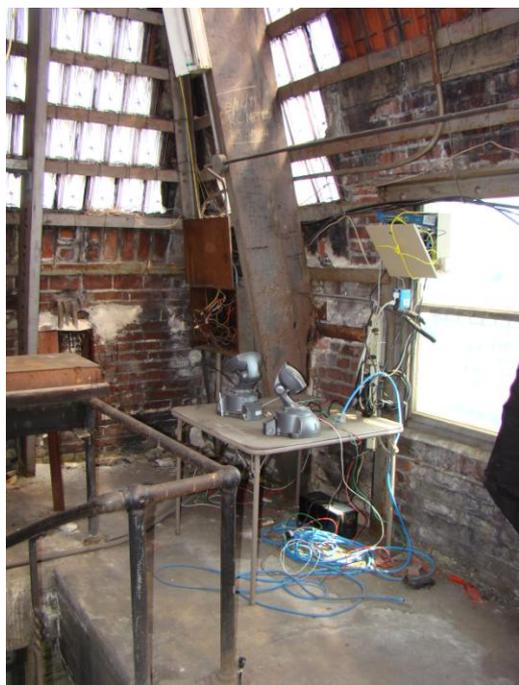
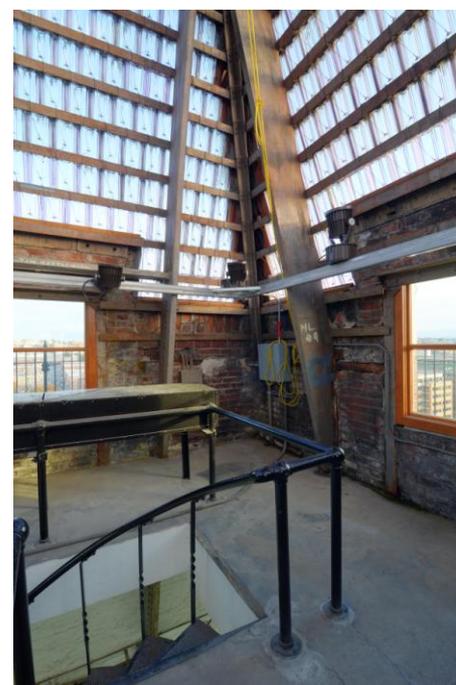
12th Floor

- All non original items removed
- Refurbished glass roof
- New evenly lit interior lighting
