Summary of result: November 17, 2005 Truck Rodeo

PREPARED FOR: Eric Tweit/SDOT
PREPARED BY: Stephen Mak, P.E./CH2M HILL
REVIEWED BY: Brian Shinn, P.E./CH2M HILL
COPIES: Roger Mason, P.E./CH2M HILL
DATE: December 28, 2005
PROJECT NUMBER: 314749

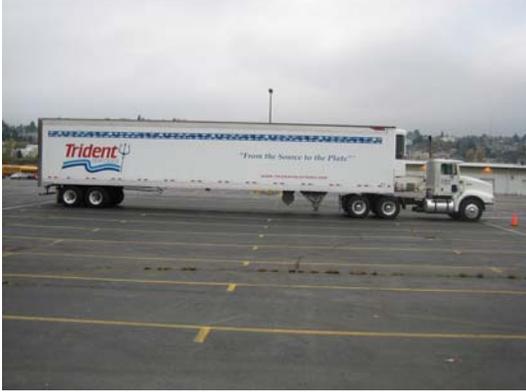
<p>A white semi-truck with a long trailer. The trailer has the Trident logo and the slogan "From the Source to the Plate".</p>	<p>Test Vehicle A Provider: Trident Seafood Length: 73.5' Wheel-base: 19.5' - 43.5' No. of Axles: 5 Legal/Overlegal: Legal GPS Equipment Mounted?: Yes</p>

a. Test Vehicle A - Trident Seafood

Vehicle A was a WB-67 vehicle provided by Trident Seafood. GPS units were mounted on the front left and right bumper and the left and right side of the rear axle. The following runs were performed:

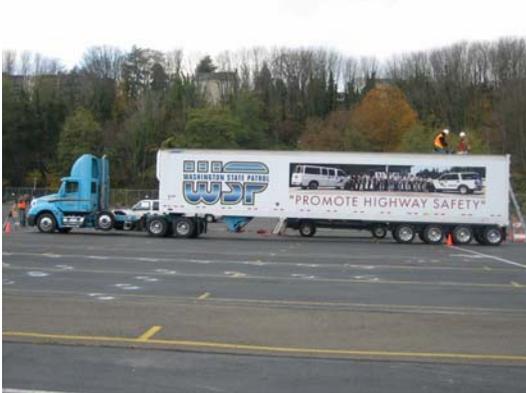
<p>A blue semi-truck with a white trailer. The trailer features the WSP logo and the slogan "PROMOTE HIGHWAY SAFETY".</p>	<p>Test Vehicle B Provider: Gordon Trucking Length: 72.5' Wheel-base: 20.5' - 45' No. of Axles: 7 Legal/Overlegal: Legal GPS Equipment Mounted?: Yes</p>

b. Test Vehicle B - Gordon Trucking

Vehicle B was about the same length as Vehicle A with a different axle arrangement. It had a wider sweep path. It was provided by Gordon Trucking Company. GPS units were mounted on the front center bumper and left and right of the rear axles. The following runs were performed:

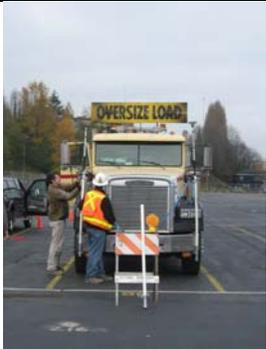
<p>A white semi-truck with a yellow sign on the roof that reads "OVERSIZE LOAD". Two people are standing near the front of the truck.</p>	<p>Test Vehicle C Provider: Nelson Trucking Length: 96' Wheel-base: 19' - 18' - 33' - 18' No. of Axles: 9 Legal/Overlegal: Overlegal GPS Equipment Mounted?: Yes</p>

c. Test Vehicle C - Nelson Trucking

Vehicle C was a 96' long triple articulated flat bed truck provided by Nelson Trucking. GPS units were mounted on the left and right front bumper and the center of the rear axles and the center of the second last rear axles. The City of Seattle issues special or annual permits for this type of truck with restricted operating hours from 6 am to 9 am and from 3 pm to 7 pm. Other requirements may also apply, such as an escort vehicle. The following runs were performed:

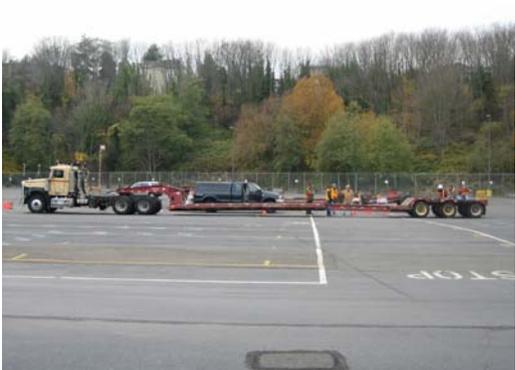
<p>A white semi-truck pulling a long trailer. The trailer is carrying a large piece of equipment.</p>	<p>Test Vehicle D Provider: Nelson Trucking Length: 89' Wheel-base: 19' - 62' No. of Axles: 5 Legal/Overlegal: Overlegal GPS Equipment Mounted?: Yes</p>

d. Test Vehicle D - Nelson Trucking

Vehicle D was an 89' long triple articulated flat bed truck provided by Nelson Trucking. GPS units were mounted on the front left and right bumper and left and right at the rear axles. The City of Seattle issues special or annual permits for this type of truck with restricted operating hours from 6 am to 9 am and from 3 pm to 7 pm. Other requirements may also apply, such as an escort vehicle. The following runs were performed:

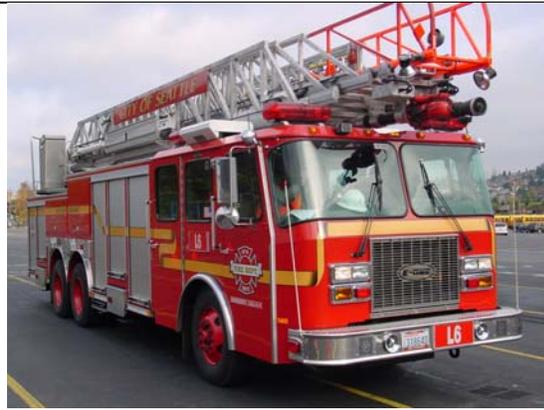
<p>Fire Engine Provider: City of Seattle' No. of Axles: 3 Legal/Overlegal: Legal GPS Equipment Mounted?: No</p>

e. Fire Engine

The fire engine is similar to a single unit truck provided by City of Seattle Fire Department. No GPS units were mounted. The following runs performed:

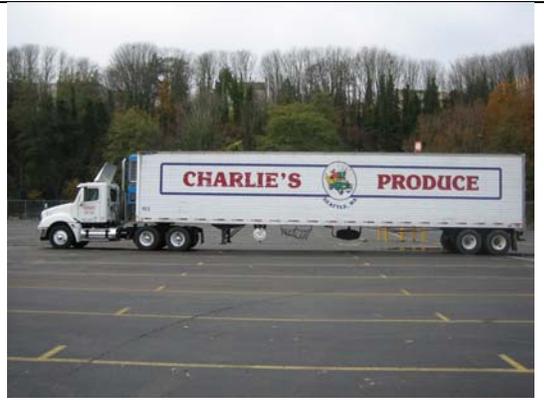
<p>Charlie's Produce Provider: Charlie's Produce Length: 65' No. of Axles: 5 Legal/Overlegal: Legal GPS Equipment Mounted?: No</p>

f. Charlie's Produce

This is a single articulated truck and is 65' long, provided by Charlie's produce. No GPS units were mounted. The following runs performed:

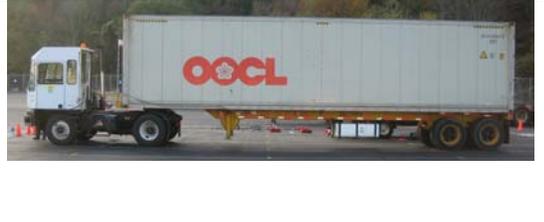
<p>Seattle City Ice Provider: Charlie's Produce Length: 55' No. of Axles: 4 Legal/Overlegal: Legal GPS Equipment Mounted?: No</p>

g. Seattle City Ice

This is a single articulated truck and is about 55' long, provided by Seattle City Ice. No GPS units were mounted. The following runs performed:
