Lower Duwamish Waterway SPU Source Control Program

Seattle Public Utilities
May 31, 2012

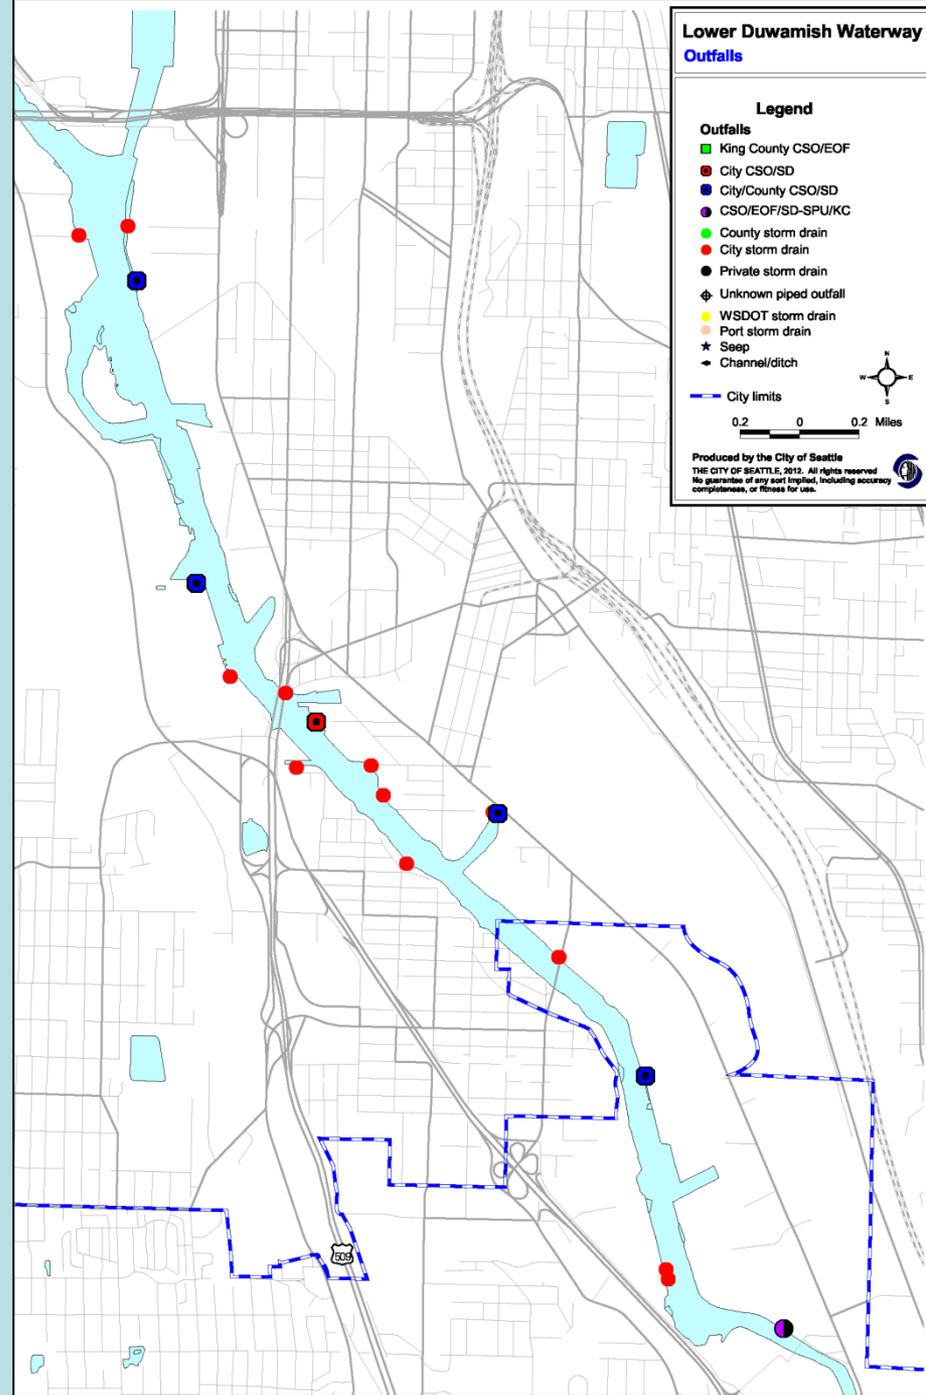
LDW Outfalls

17 City outfalls

- 15 storm drains
- 1 CSO
- 3 emergency overflows

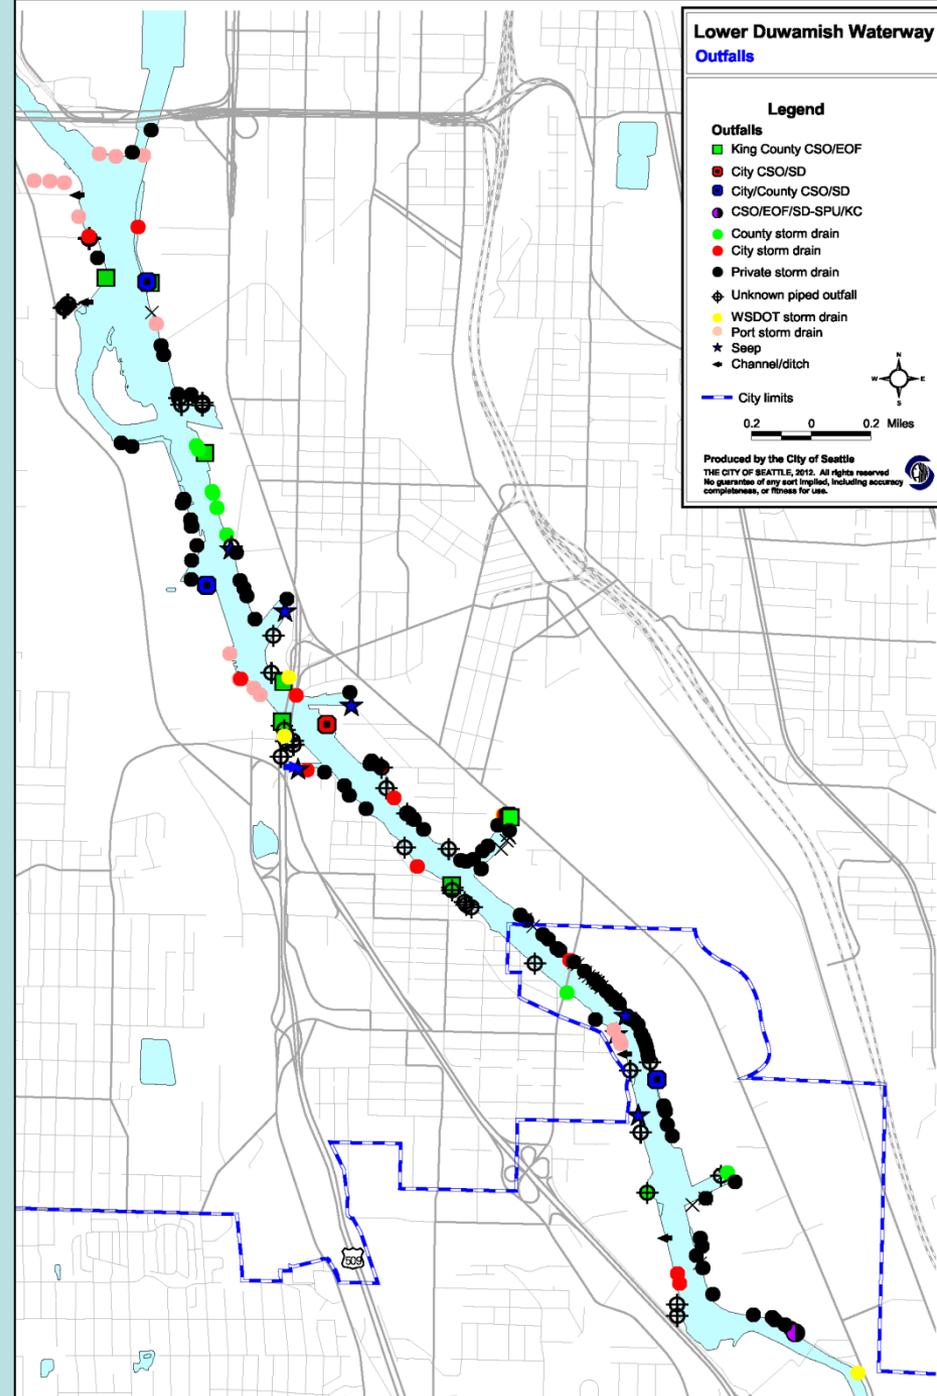
LDW Outfalls

17 City outfalls

- 15 storm drains
- 1 CSO
- 3 emergency overflows
- 218 total outfalls

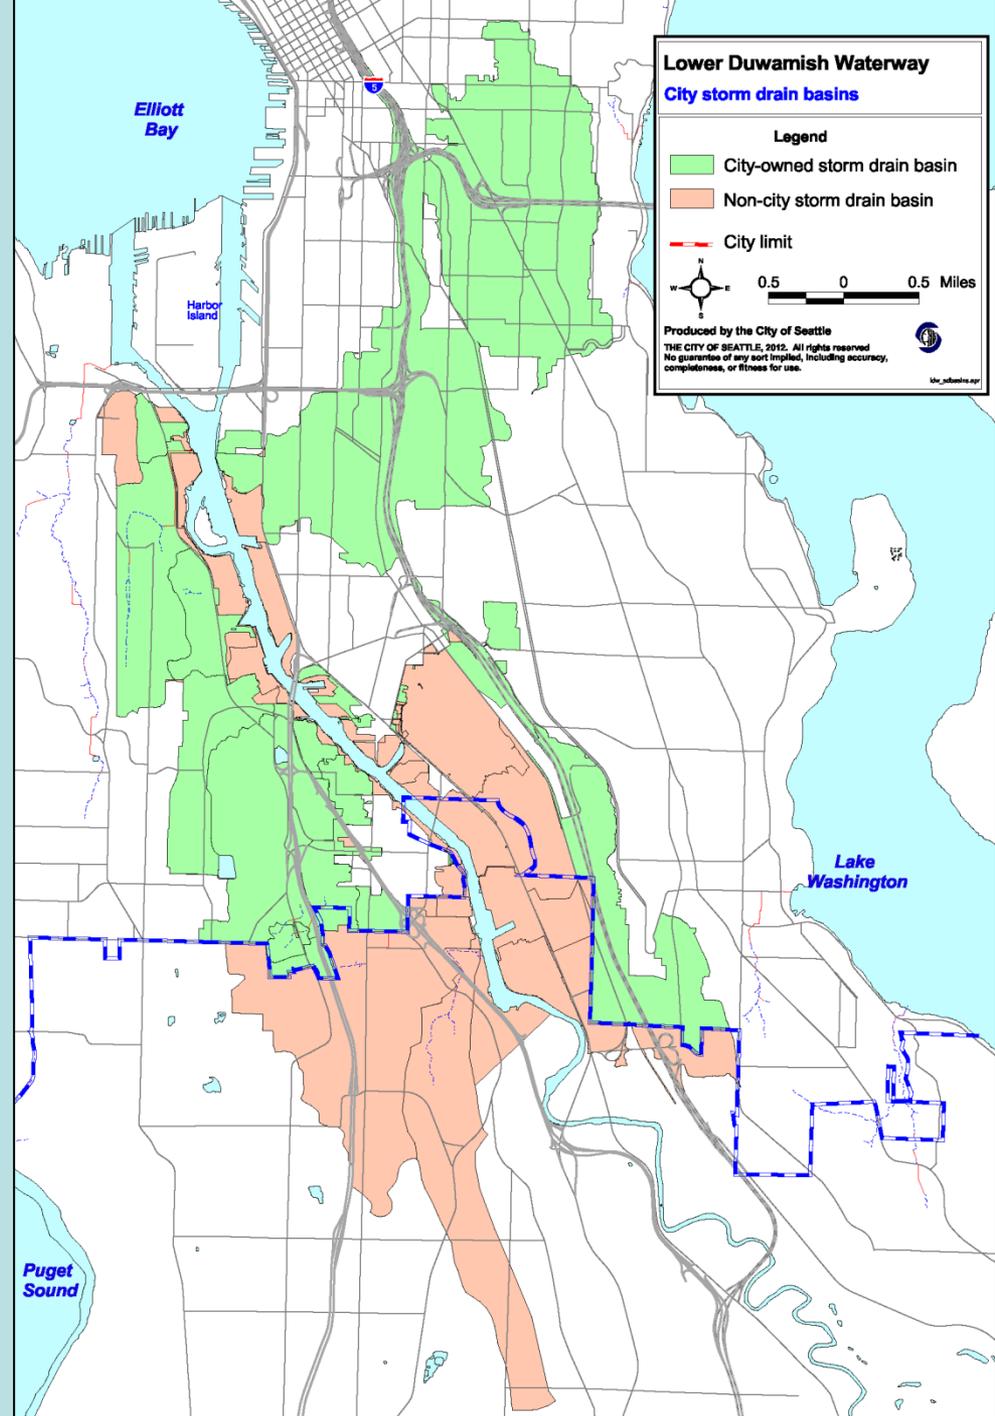
LDW Drainage Basin

Total LDW site: 8,940 acres

- 60% within City limits
- 40% outside City limits or served by non-City drainage system

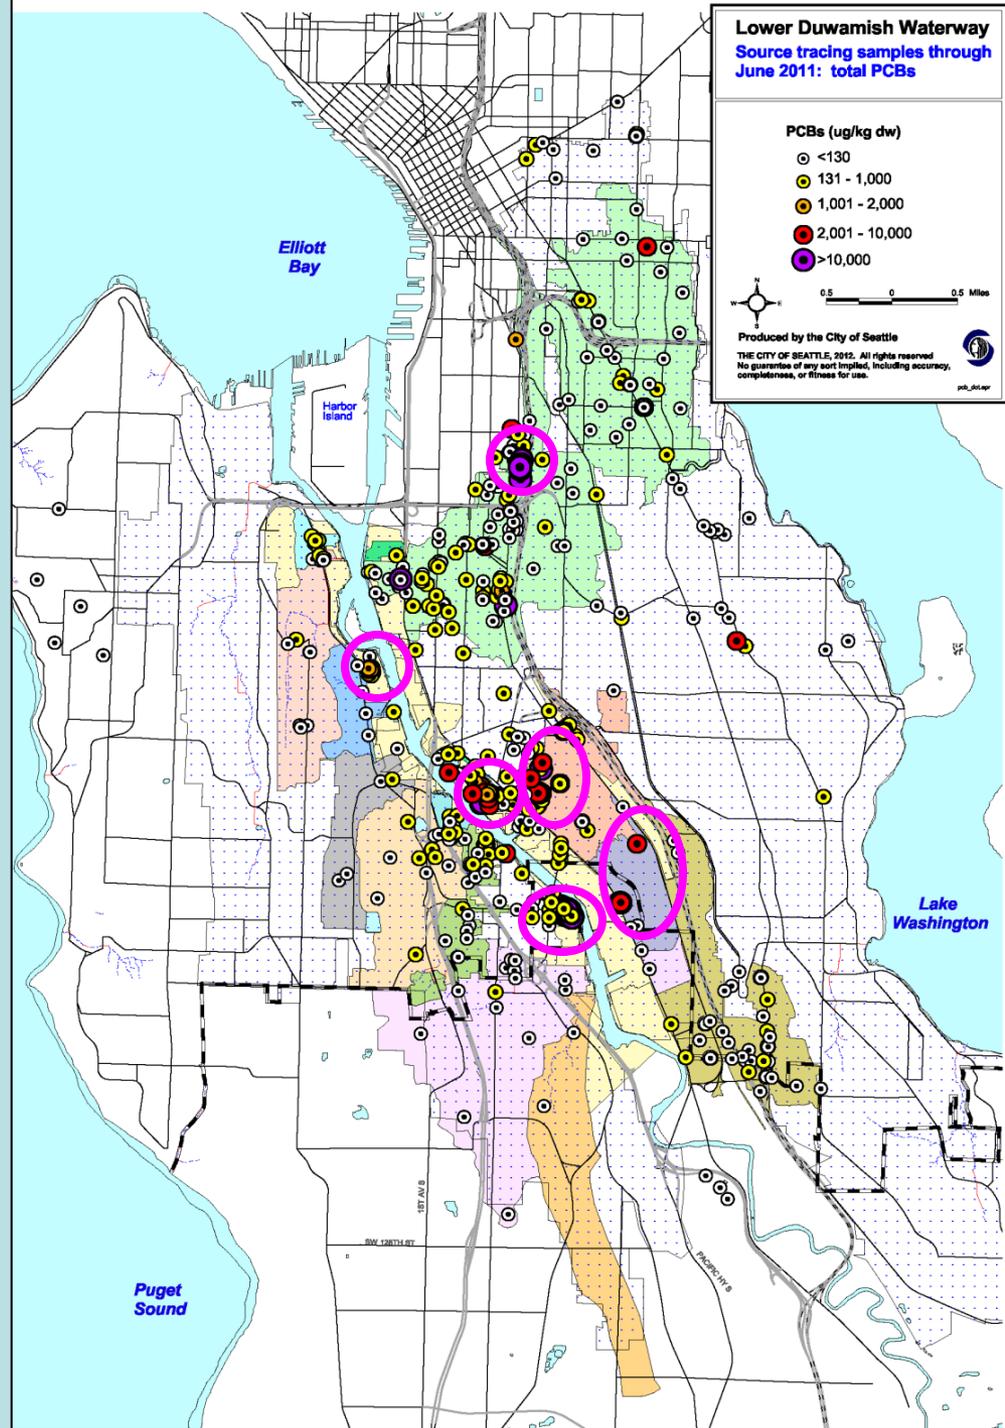
Source Tracing: PCBs

Samples through June 2011

Hotspots:

- T117
- GTSP/NBF
- Rainier Commons
- KC-Jorgensen SD
- Others

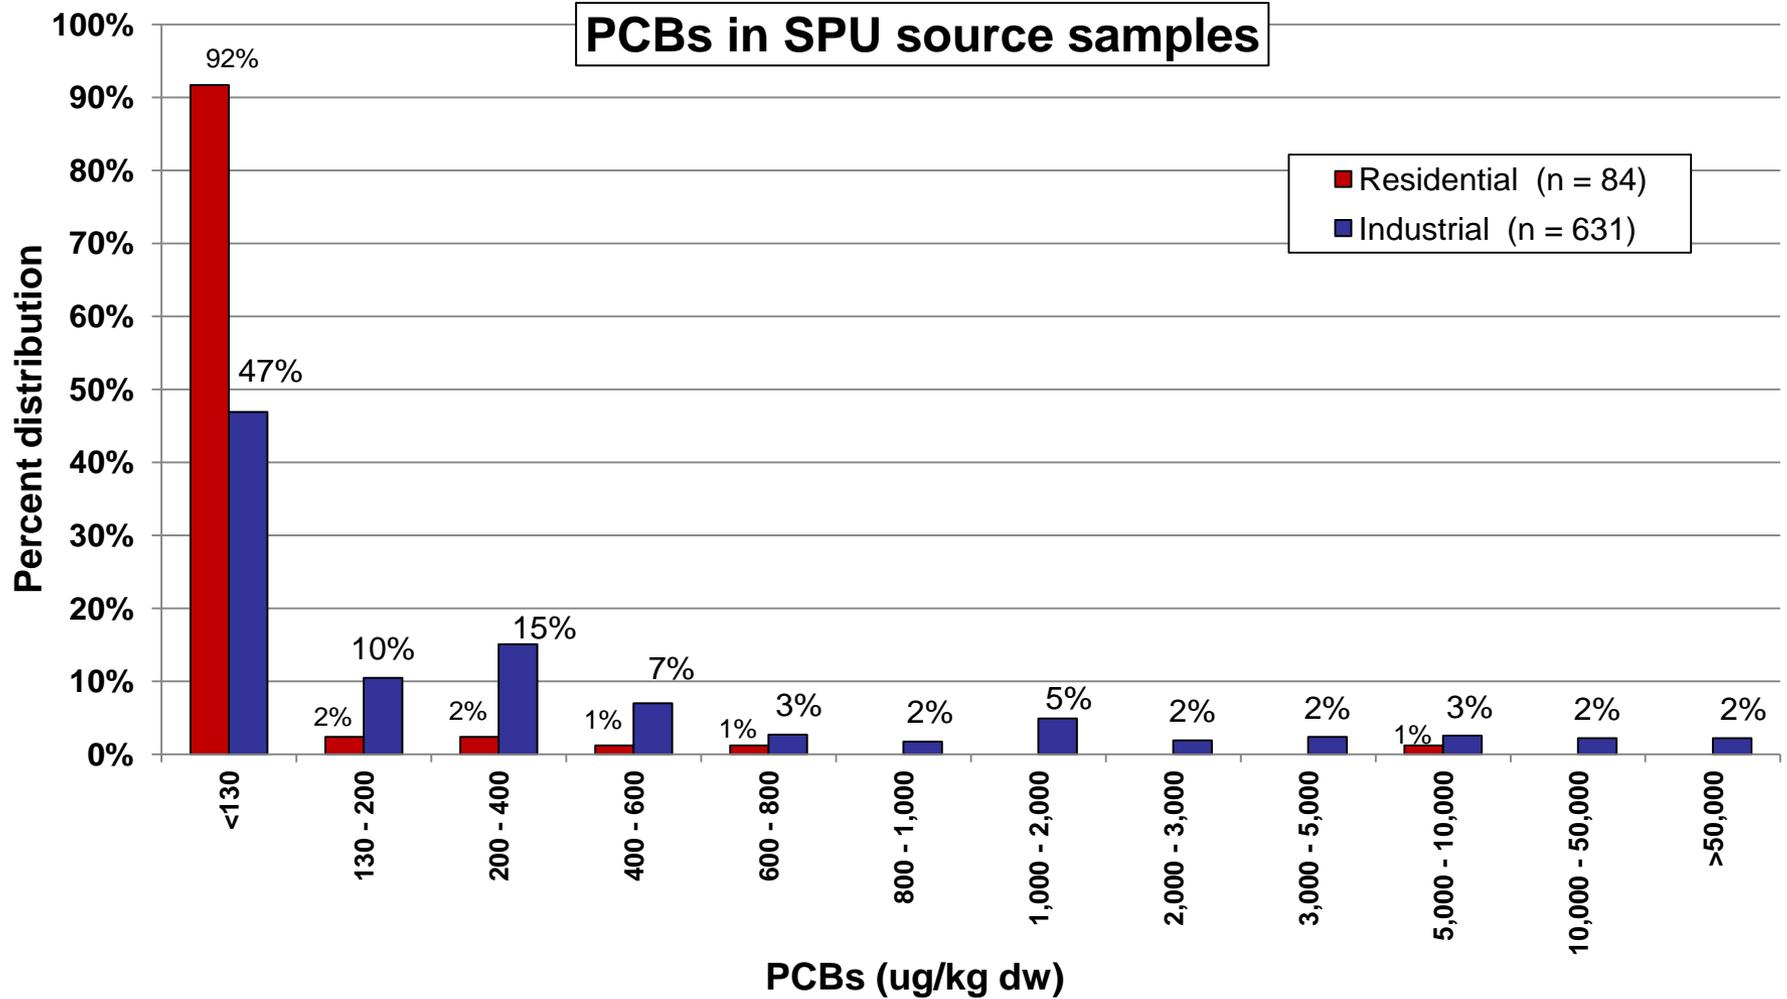
PCBs: Land Use

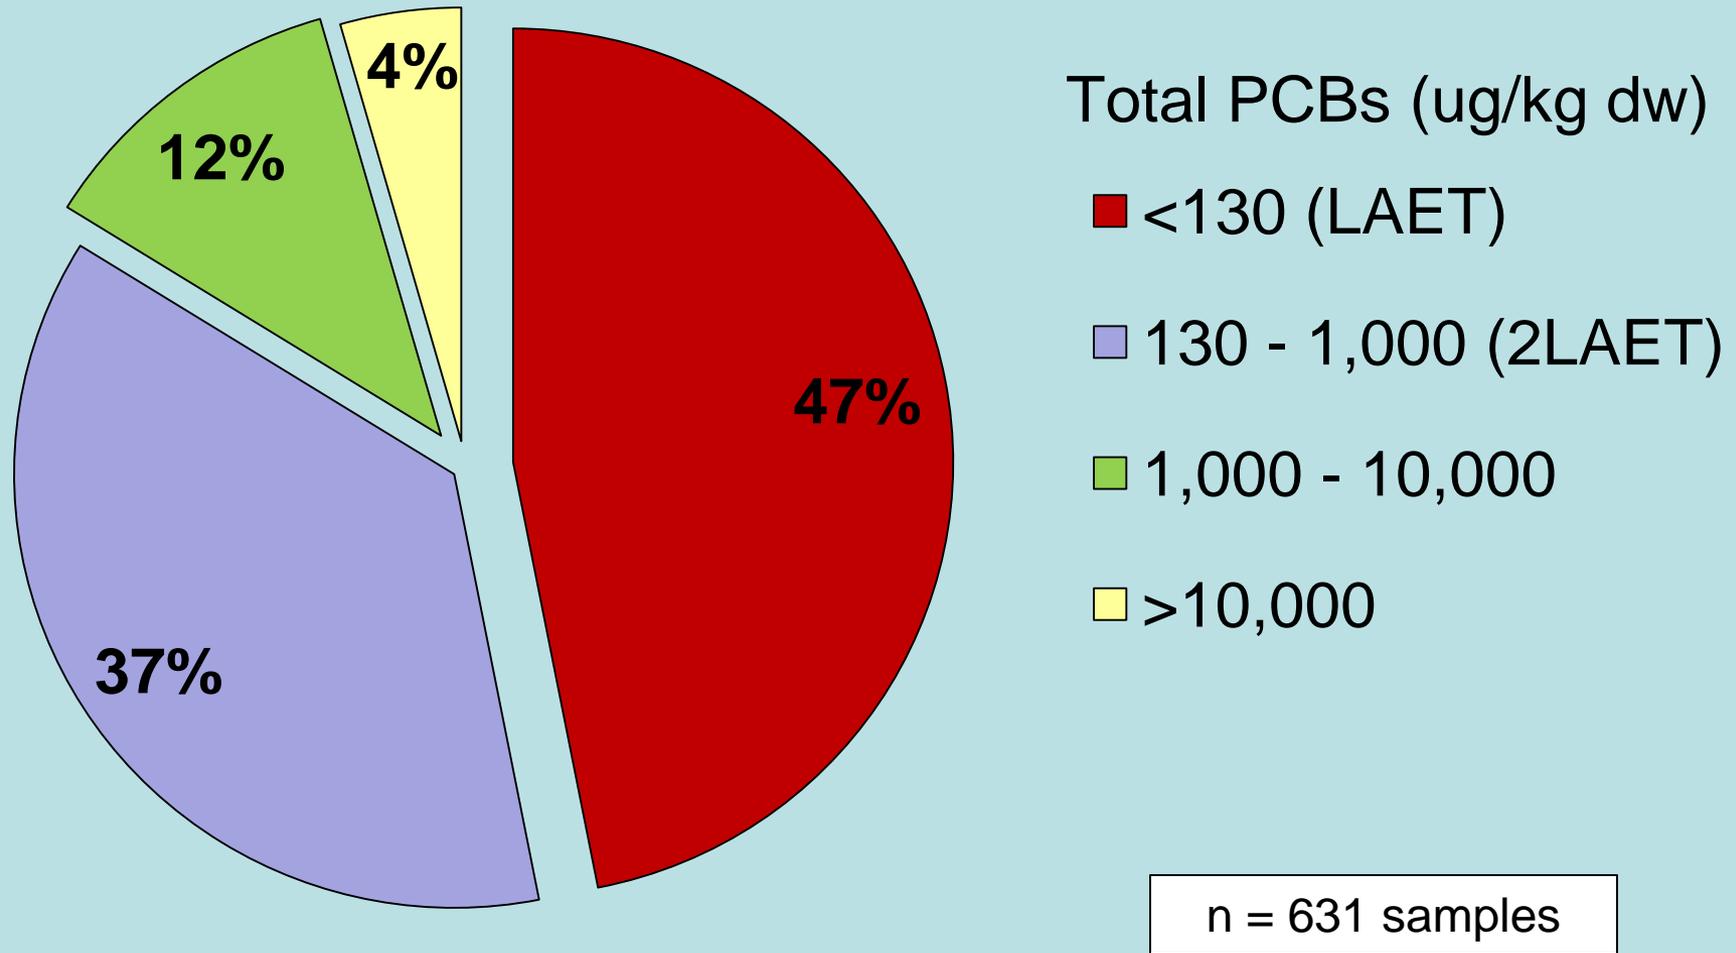
PCBs: Industrial Land Use

PCBs detected in 78% of samples

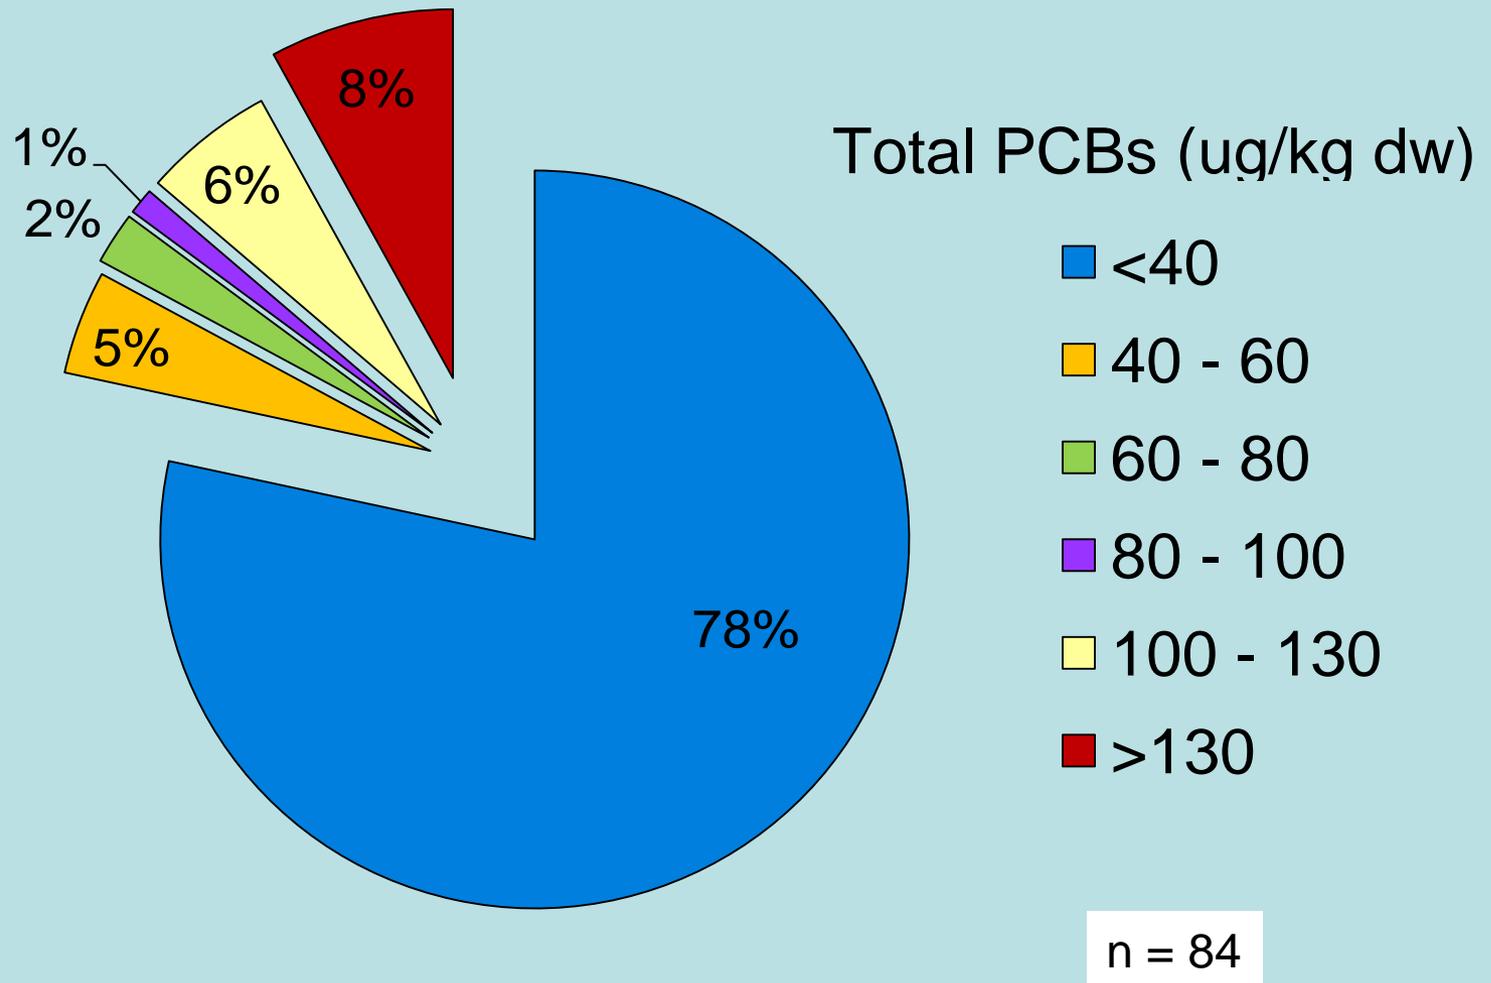
PCBs: Residential

PCBs detected in 32% of samples

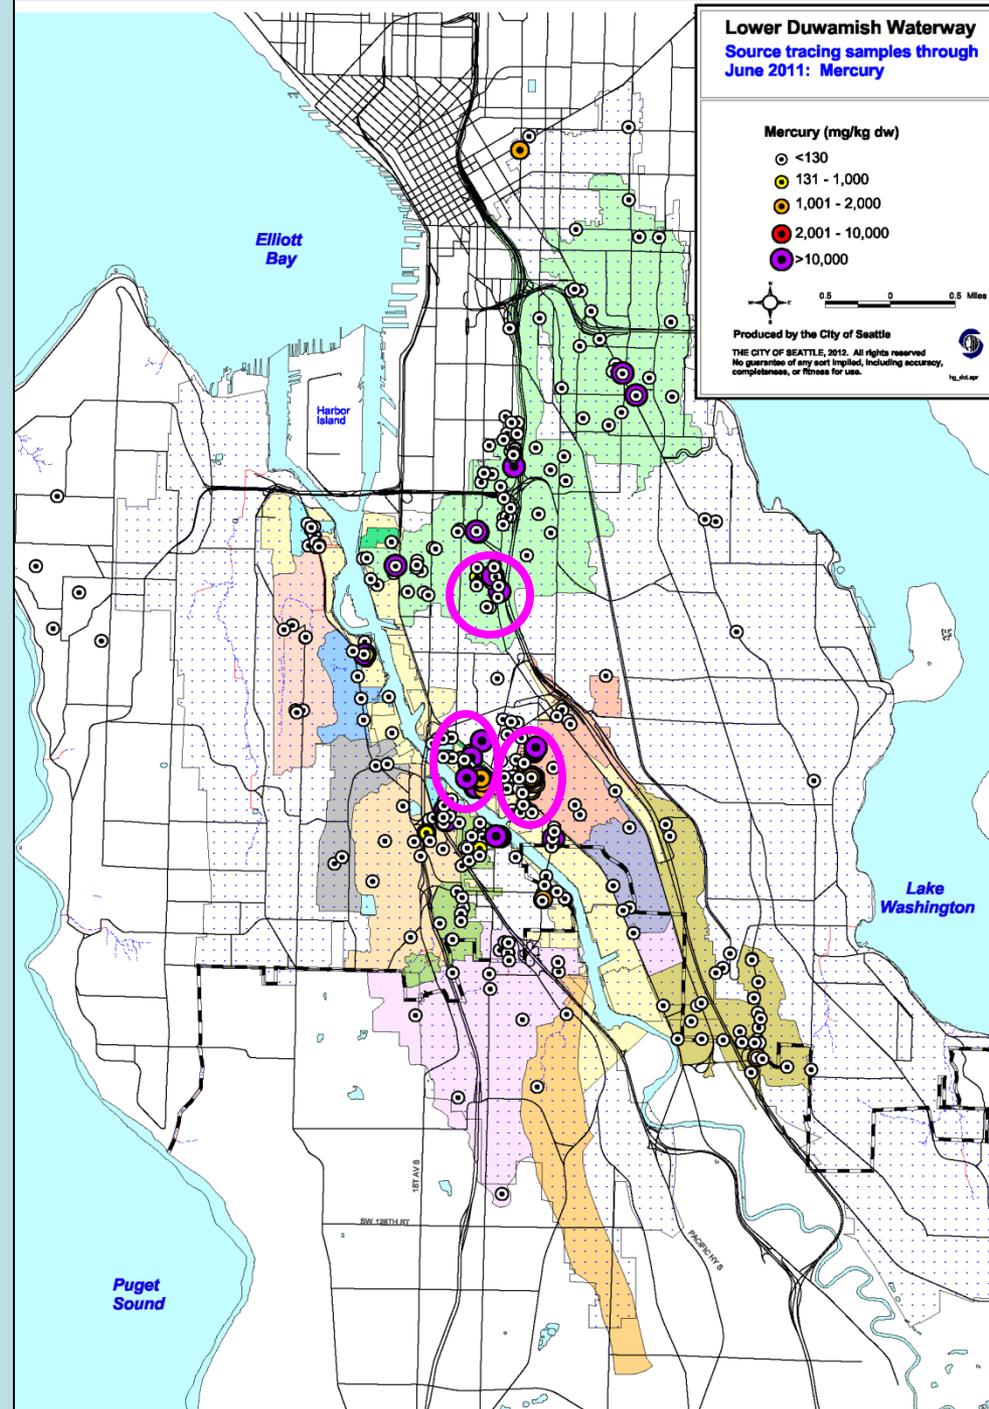
Source Tracing: Mercury

Samples through June 2011

Hotspots

- Old flume (replaced)
- Diagonal/Airport Wy S SD (cleaned)
- S Brighton/S Myrtle SDs (cleaned)
- Miscellaneous onsite CBs
- Sporadic hits at trap locations

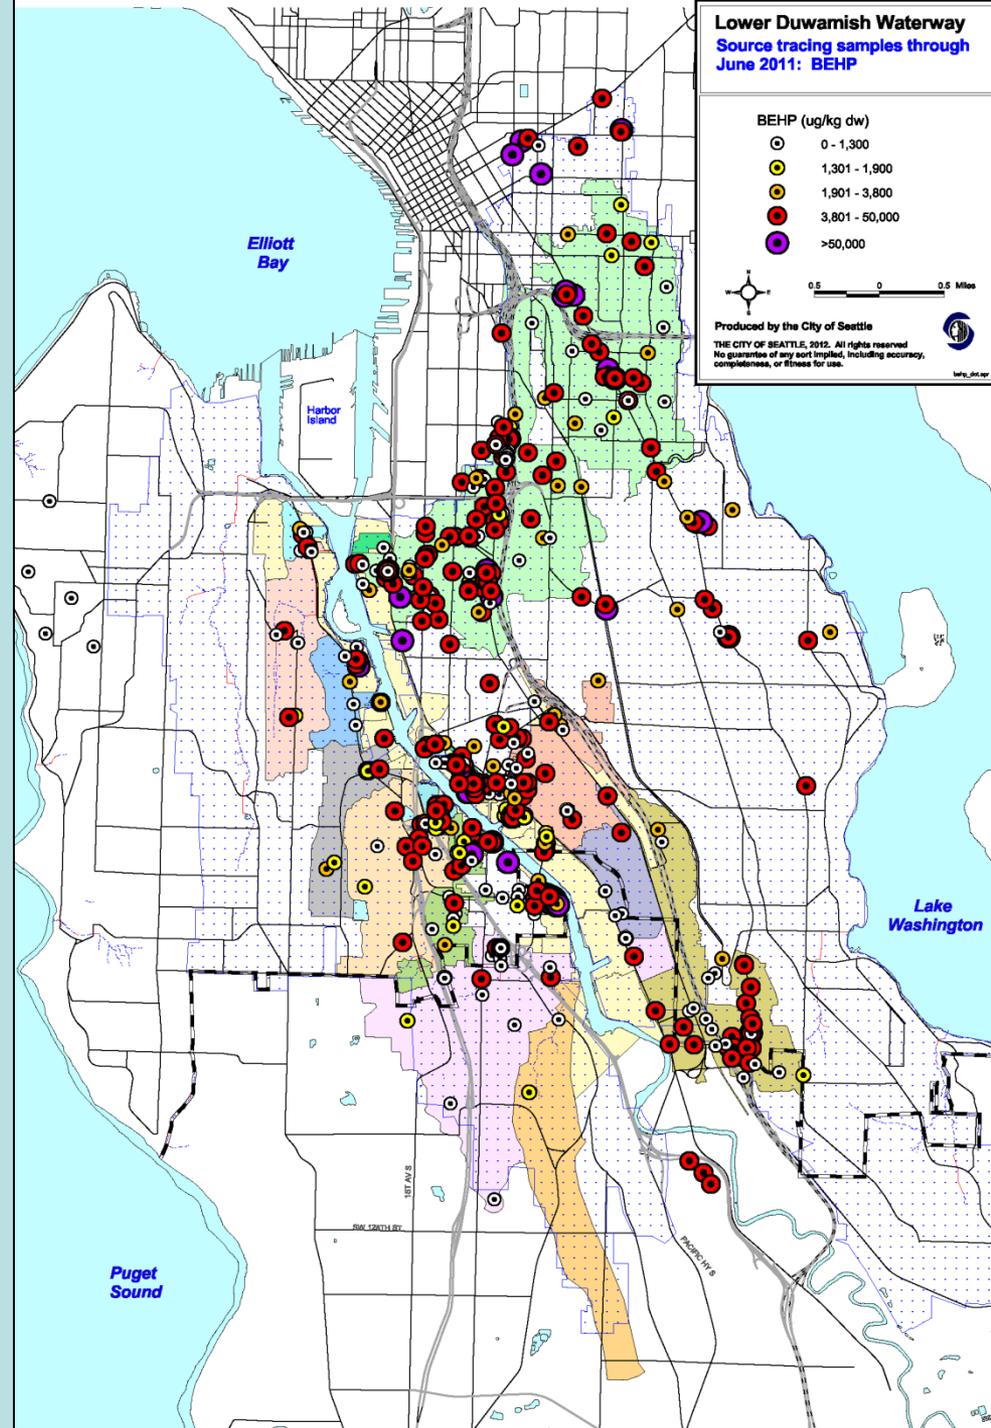
Source Tracing: BEHP

Samples through June 2011

- Most samples above LAET/2LAET benchmarks
- Many disperse sources
- No specific controllable source identified to date

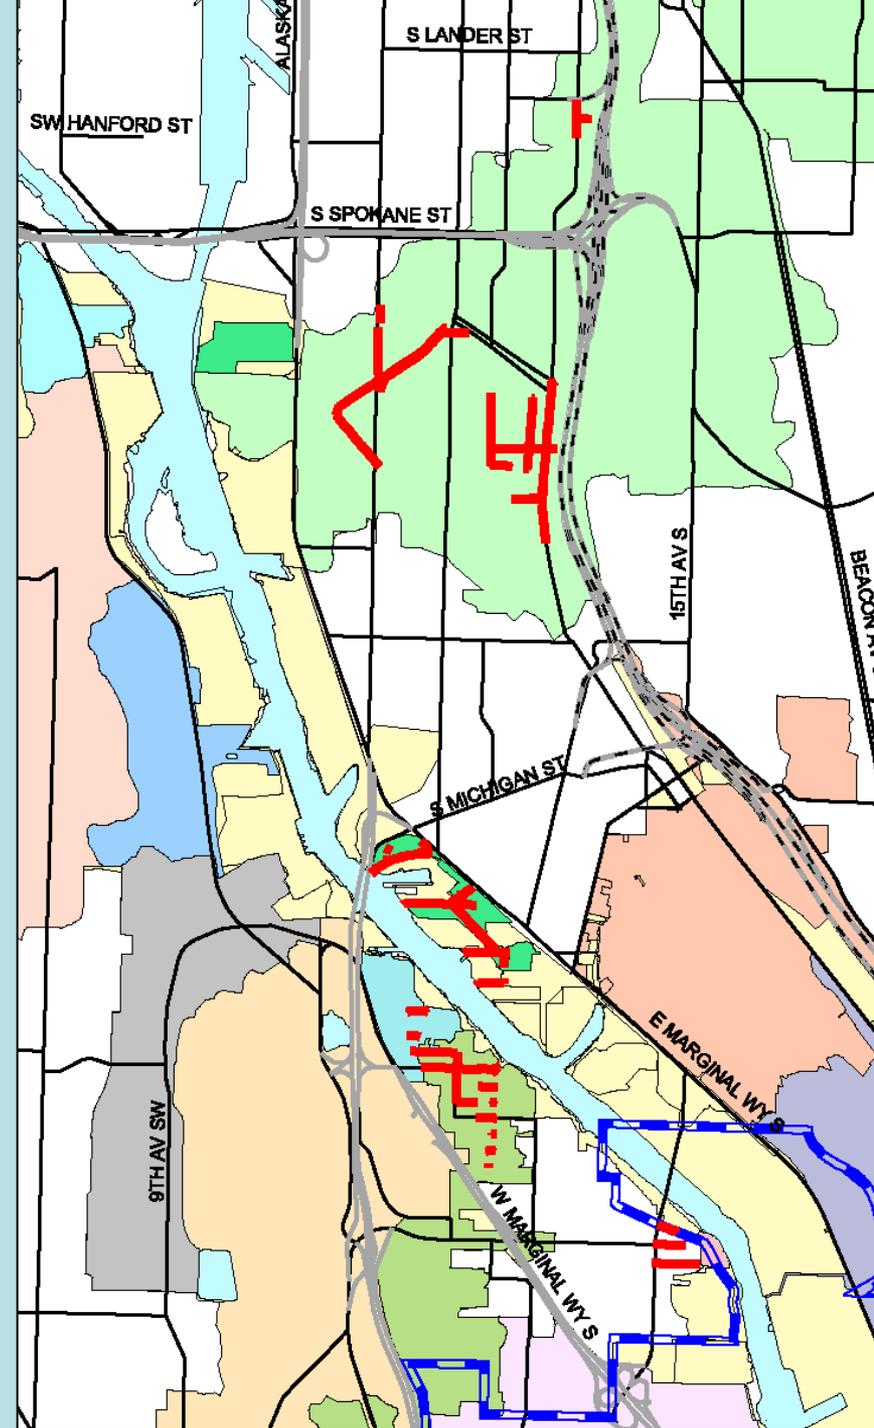
Line Cleaning

26,000 LF cleaned to date
2,000 TN removed

- S Myrtle St SD
- S Brighton St SD
- S Garden St SD
- S River St SD
- Diagonal Ave S SD
 - S Snoqualmie St
 - Airport Wy S/ S Stevens St
 - Lower mainline
- 2nd Ave S SD
- T117 CSS
- SW Idaho St SD (2012)

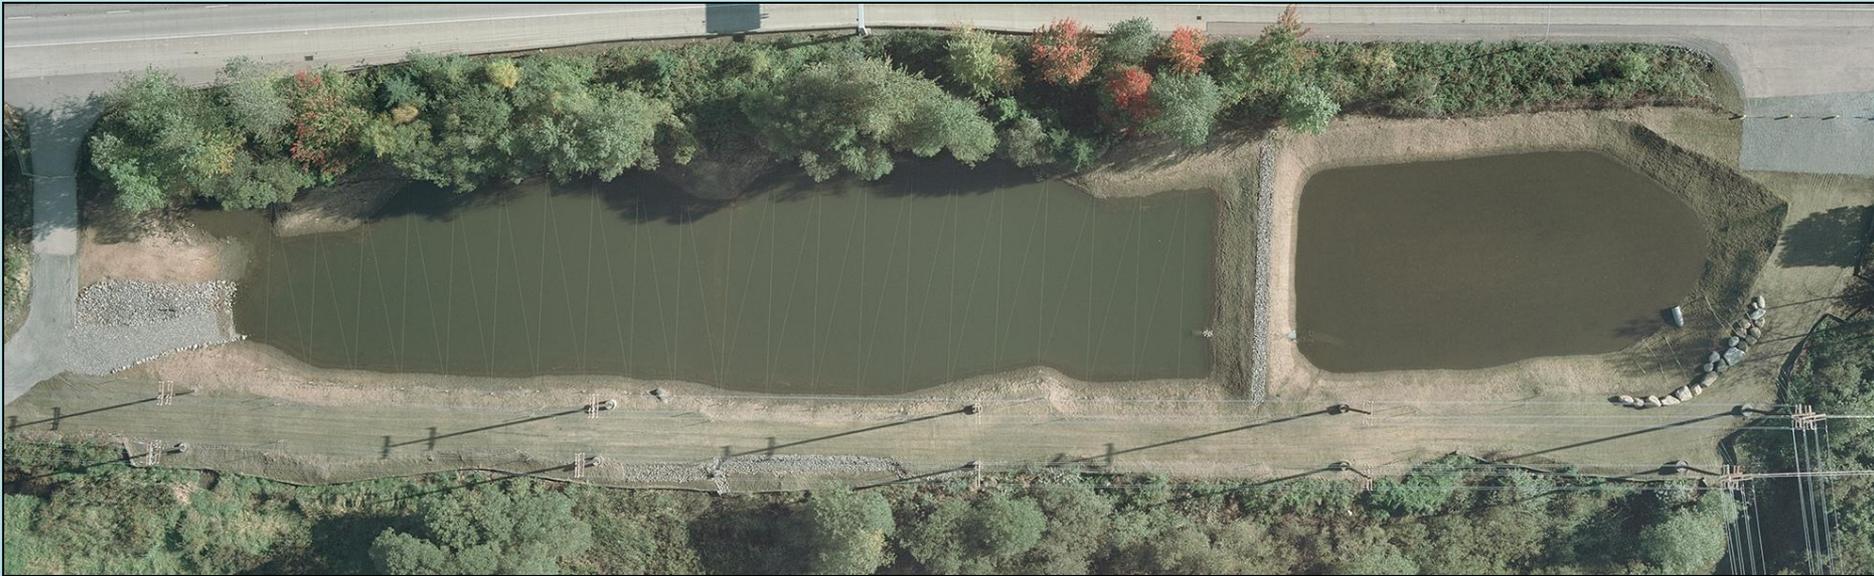
Citywide Programs: Structural Retrofits

Norfolk/MLK stormwater pond

- 5 acre-foot wet pond/constructed wetland
- Treats runoff from 224 Ac
- Constructed 2011
