City of Seattle State of the Waters 2007

Volume I: Seattle Watercourses

State of the Waters 2007

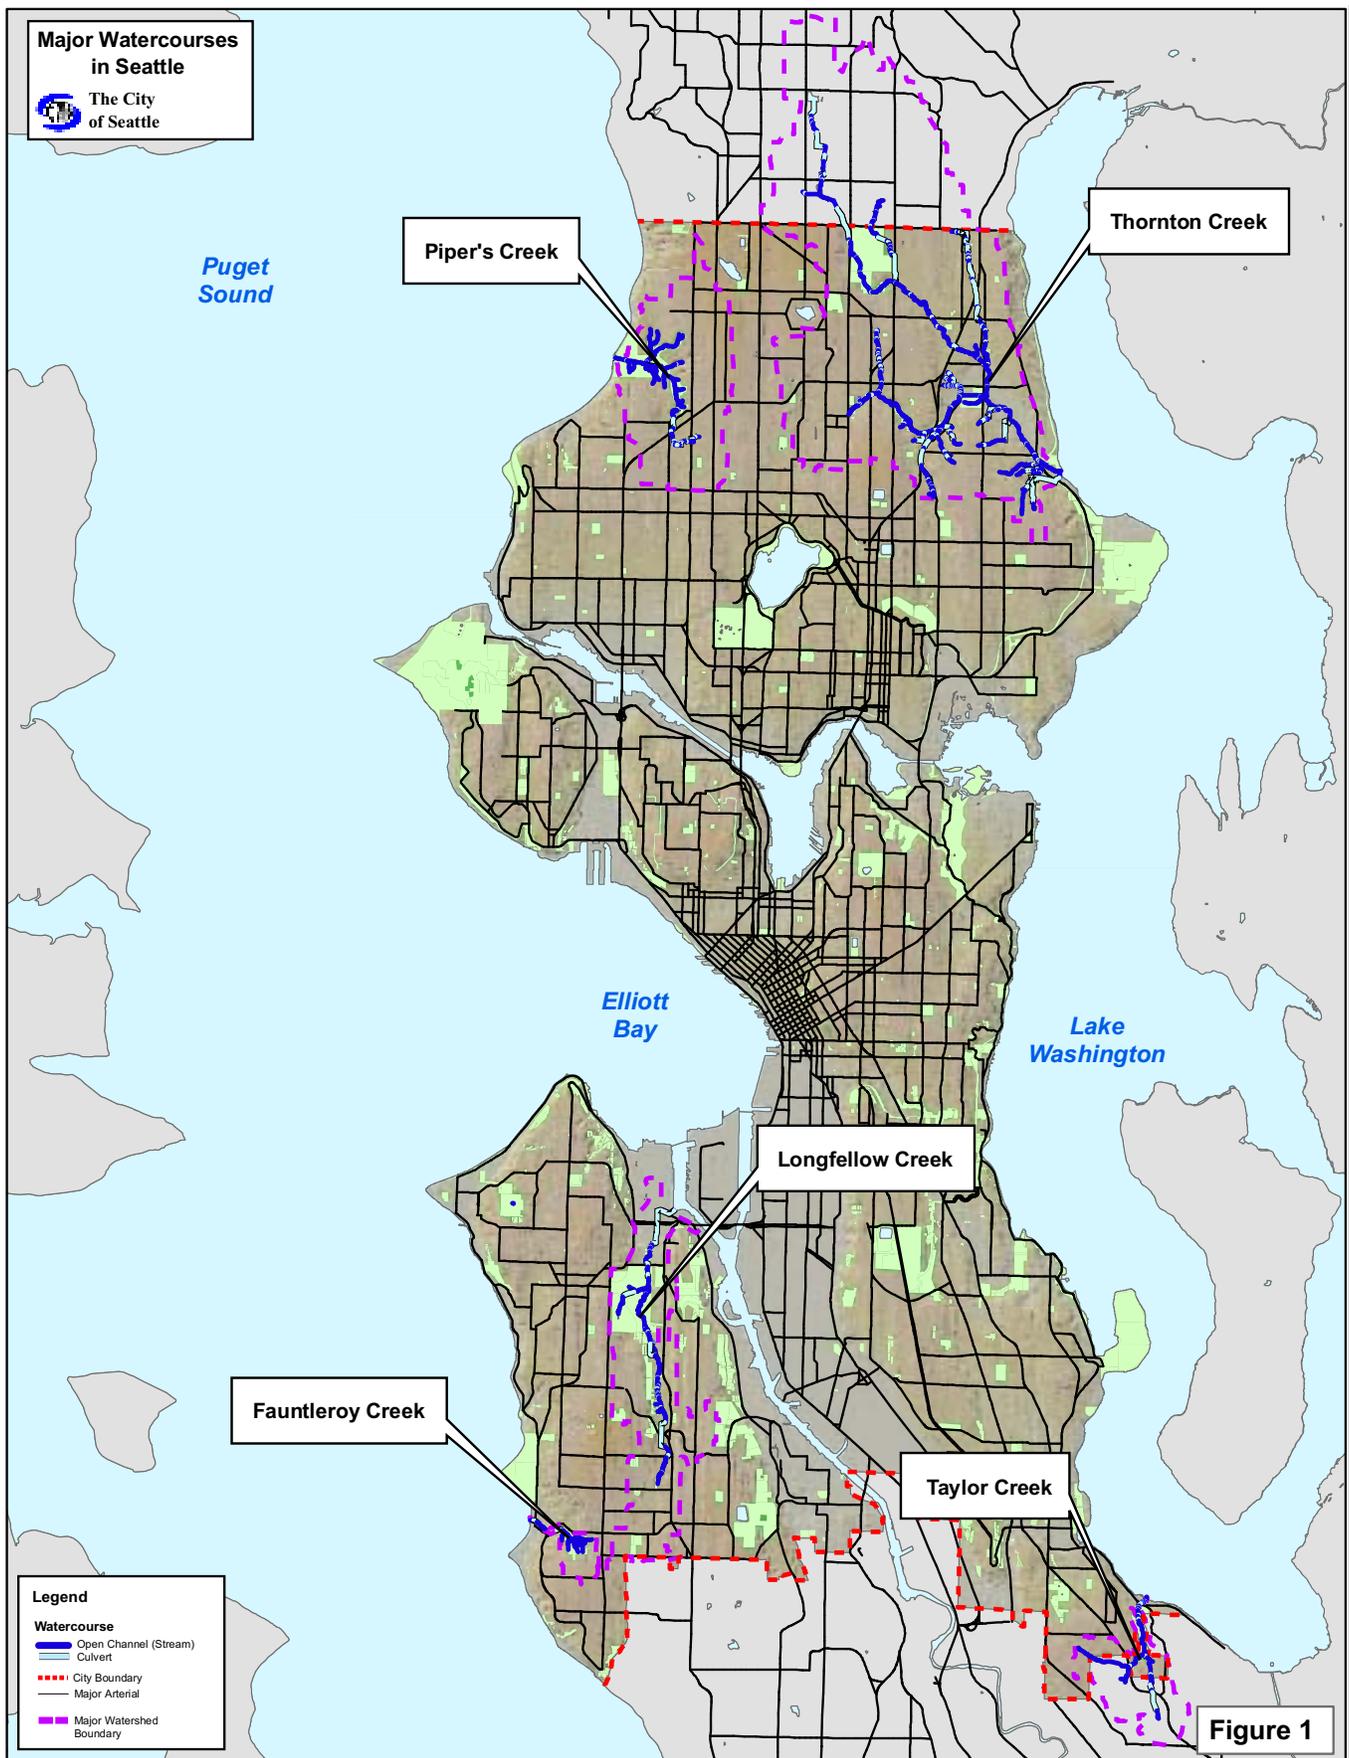
Figure 1. Major Seattle watercourses and regional water bodies.

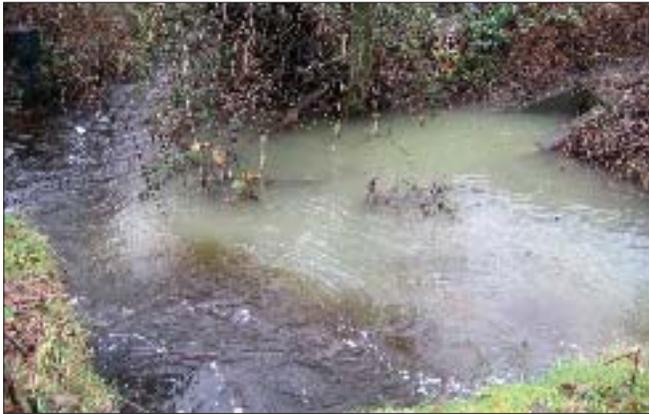
Turbid discharge into natural stream (photo by Bennett)

Particulates readily wash off paved surfaces and exposed soil during storm events. Construction sites, if not properly managed, can be a significant source of suspended solids in many urban environments. Other sources include windblown dust from automobiles and heavy equipment, sand and salt applied to icy roadways, and erosion from agricultural land or residential gardens and lawns. In addition, swift-flowing watercourses can erode stream banks and bottoms, thus aggravating suspended solid problems. Because urban development tends to increase the volume and rate of stormwater runoff, it can contribute to turbidity problems well downstream of the runoff site, where storm drains discharge into natural streams.

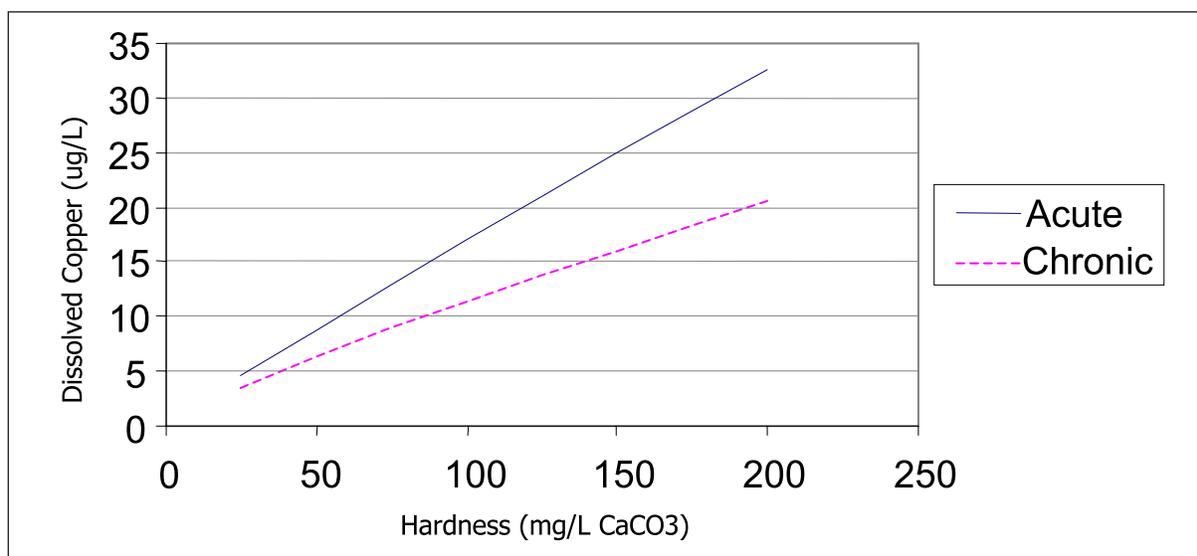
Figure 10. Dissolved copper water quality criteria correlated to water hardness.

Time series analyses are simple graphs of chemical concentration through time. These graphs are used in several instances in this report and its appendices. The overall scatter and distribution in the chemical values provide an indication of general trends and variability in the sample population. Where appropriate, water quality criteria are shown on the time series graphs. A special notation is used on the graphs for water quality criteria that are calculated based on other parameters; for example, criteria for some metals are based on the hardness of the water and ammonia, which is pH- and temperature-dependent. A sample result that exceeds a calculated criterion is shown with an asterisk (*) adjacent to the data point. A sample result that exceeds a criterion that is not calculated can be identified by its location with respect to the benchmark or water quality criterion indicated on the graph.

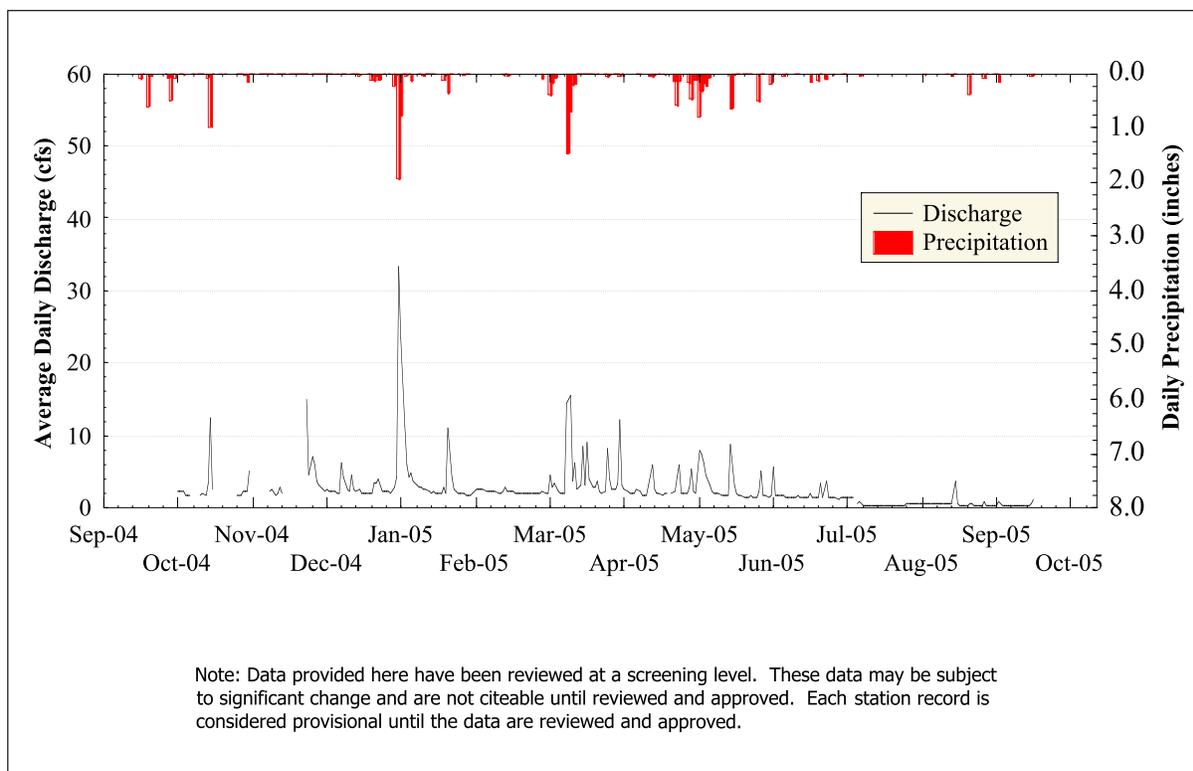
Figure 18. Longfellow mean daily flows recorded at West Seattle golf course gauge, November 2004–December 2005.

A 2-year storm event occurs every 2 years on average, or has a 50% chance of occurring any given year.

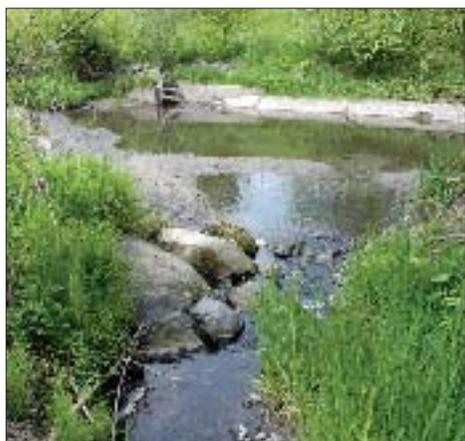
Webster detention pond along Longfellow Creek (photo by Bennett)

The areas that have the highest potential to contribute large storm flows quickly are located in the upper portion of the basin (Map 13 in the map folio accompanying this report). Although the upper portion of the basin has the lowest gradient, it is characterized by high levels of impervious surfaces and some areas with low permeability.

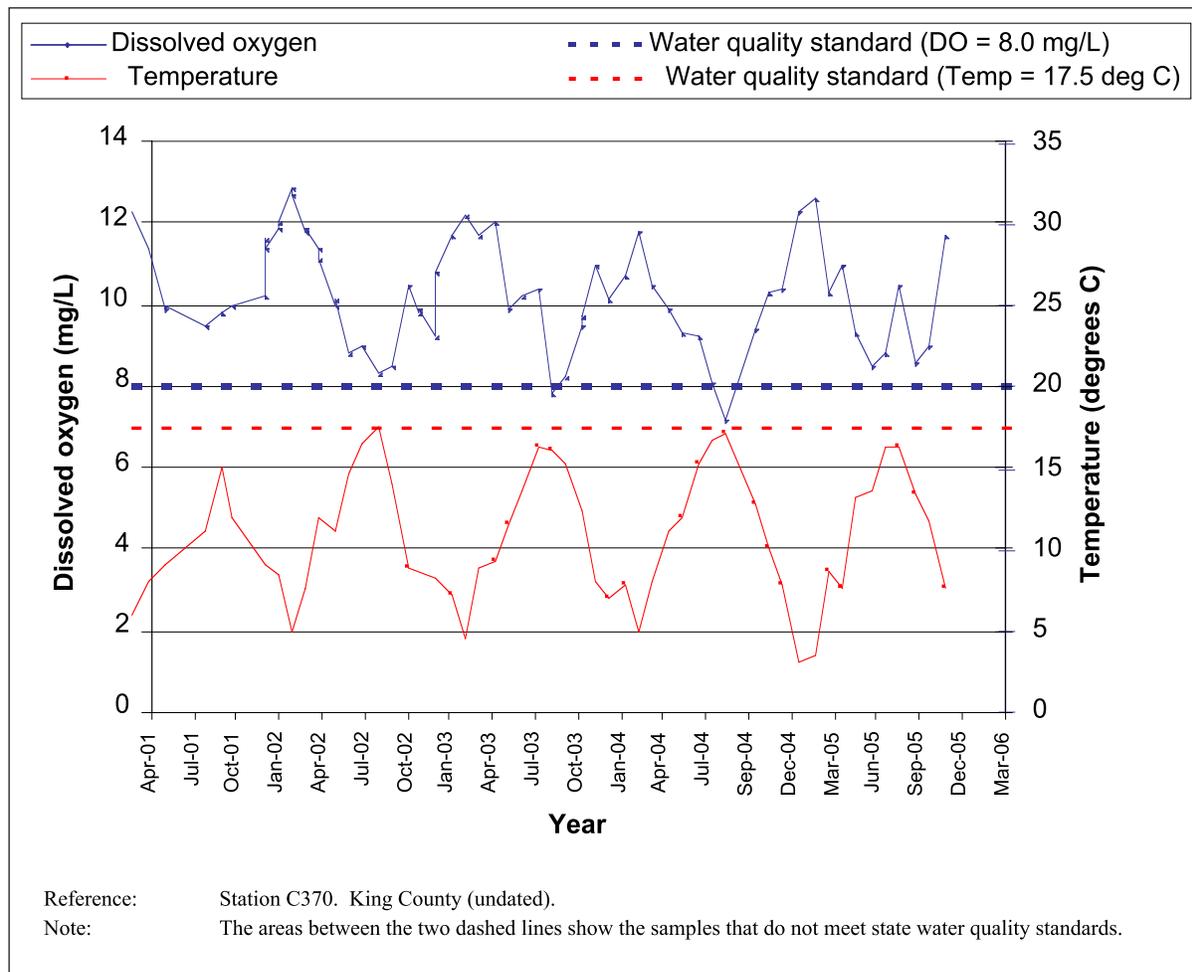
Figure 19. Longfellow dissolved oxygen and temperature measured near SW Yancy Street.

Dissolved oxygen and temperature have been measured monthly by King County during the period of record on Longfellow Creek at an upstream location (near SW Brandon Street) and a downstream location (near SW Yancy Street). At both locations, dissolved oxygen and temperature followed seasonal patterns, with temperature readings lowest in winter and highest in summer, and dissolved oxygen concentrations highest in winter and lowest in summer (Figure 19). These patterns are typical; as temperature increases, dissolved oxygen concentrations decrease based on changes in the solubility of oxygen.

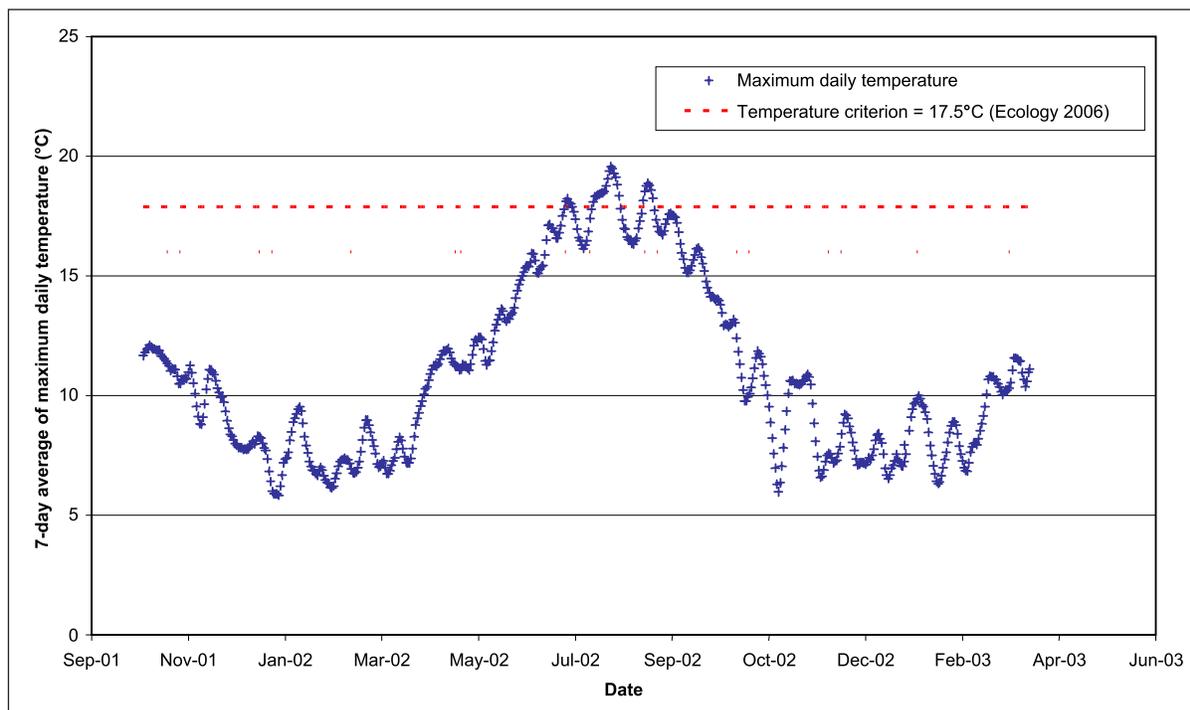
Figure 20. Longfellow temperatures measured near SW Yancy Street.

During the 2001–2003 period, SPU monitored temperatures in Longfellow Creek at 30-minute intervals to evaluate temporal patterns at the downstream location. These data can be compared to the Ecology (2006a) amended temperature criterion, which is based on the 7-day average of the daily maximum temperature. The updated temperature criterion for Longfellow Creek (17.5°C) was exceeded from mid-June into September (Figure 20). This pattern corresponds to approximately 7 percent of the samples collected between October 2001 and April 2003. A summary of dissolved oxygen and temperature sample statistics and time series plots is provided in Appendix B.

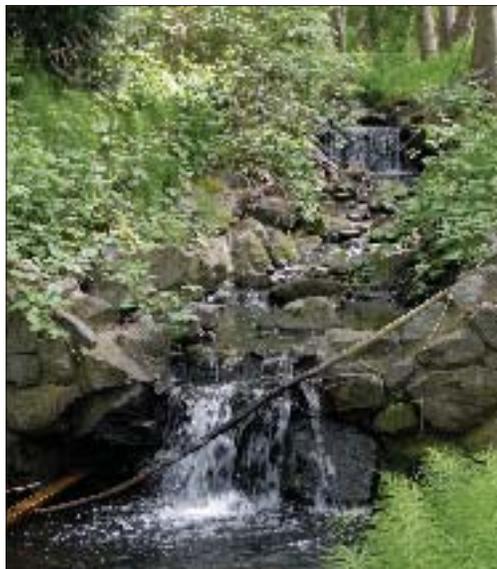
*Constructed weirs along Longfellow Creek
(photo by Bennett)*

The stream habitat in upper Longfellow Creek is in poor to moderate condition (Map 16). Under more natural conditions, this reach would be classified as pool-riffle and step-pool channel types (Seattle 2005). Although 18 percent of the open channel length is pool habitat and 39 percent is riffle habitat, this reach has the highest proportion of plane-bed channel in the system (44 percent; Map 14). Channel incision, lack of floodplain connections, and lack of instream structure contribute to this simple channel form. There are areas of step-pool habitat, mostly created by instream improvement projects and a series of rock weirs constructed upstream of the Webster detention pond (near SW Webster Street). The dominant substrates are gravel in the higher-velocity sections (downstream of SW Thistle Street) and sand in the lower-velocity sections (the backwater area upstream of the SW Webster culvert entrance).

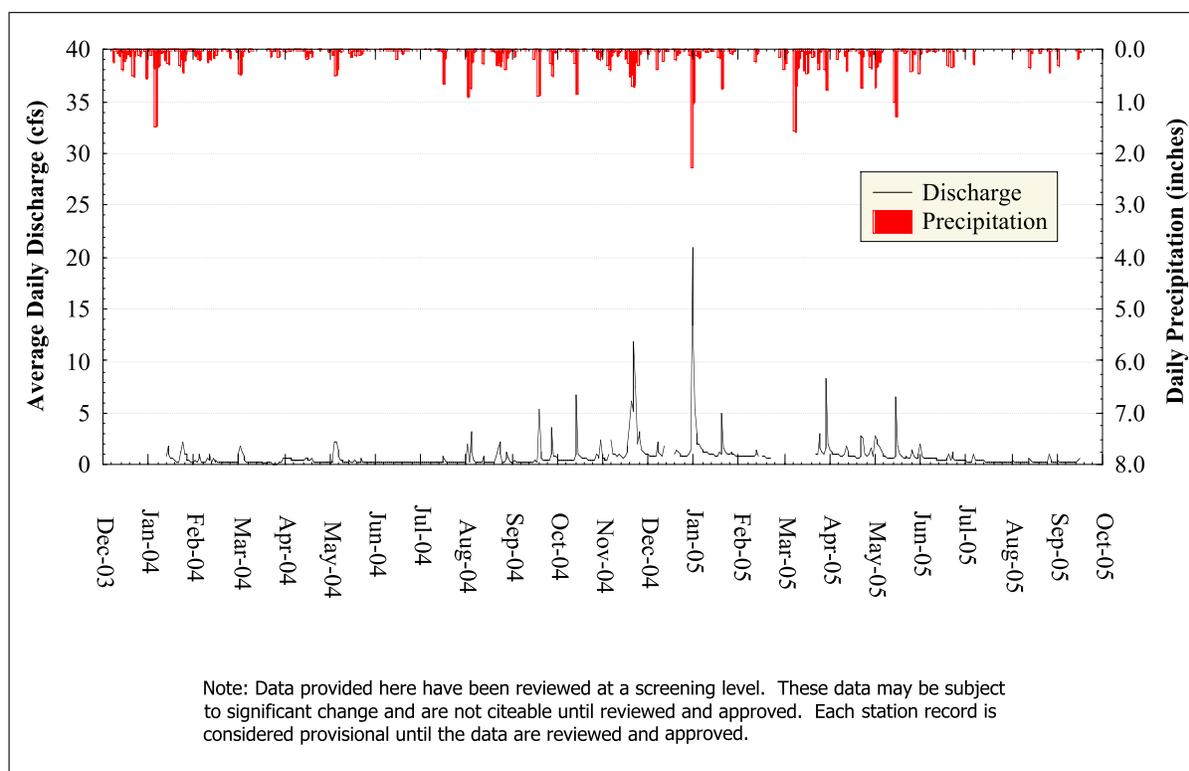
Figure 26. Taylor Creek mean daily stream flow from February 2004 to December 2005, measured near the mouth.

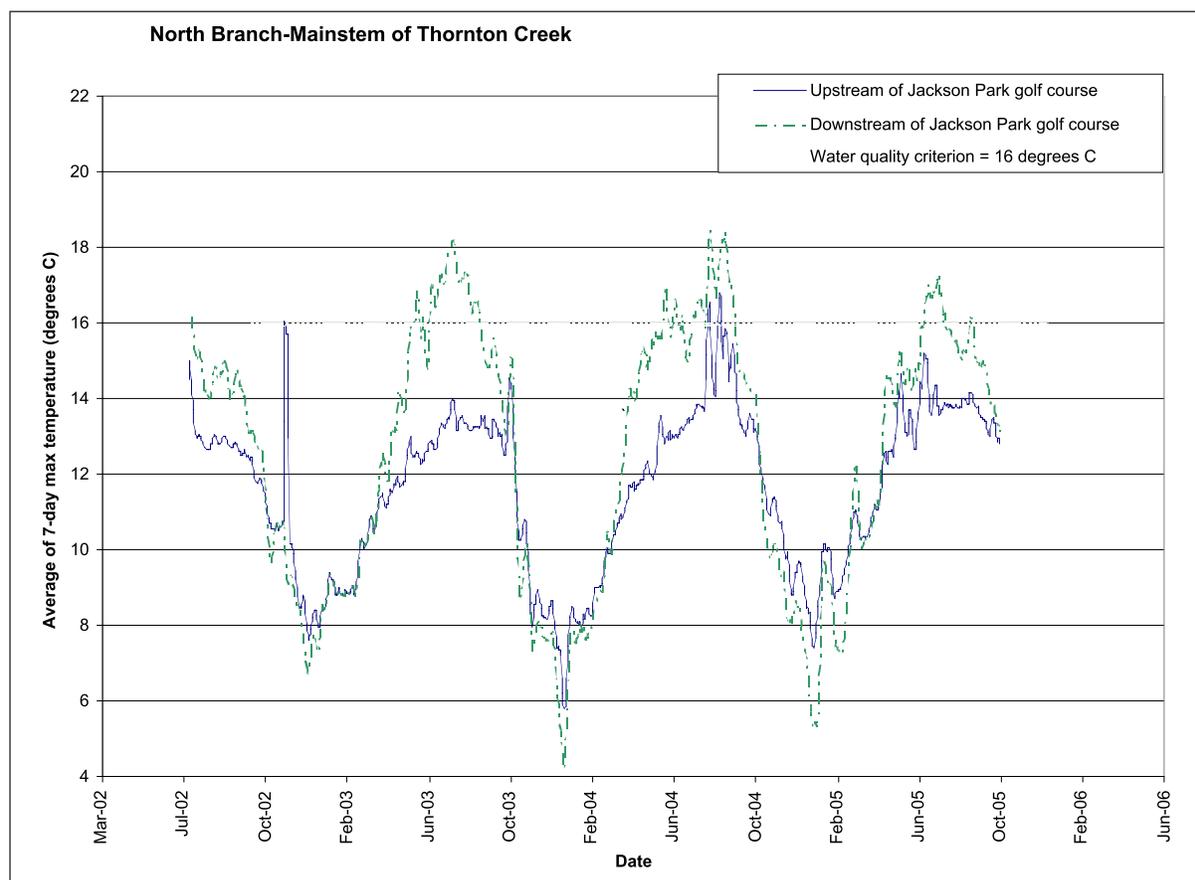
Figure 31. Thornton water temperature measured at the Jackson Park golf course, 2002–2005.

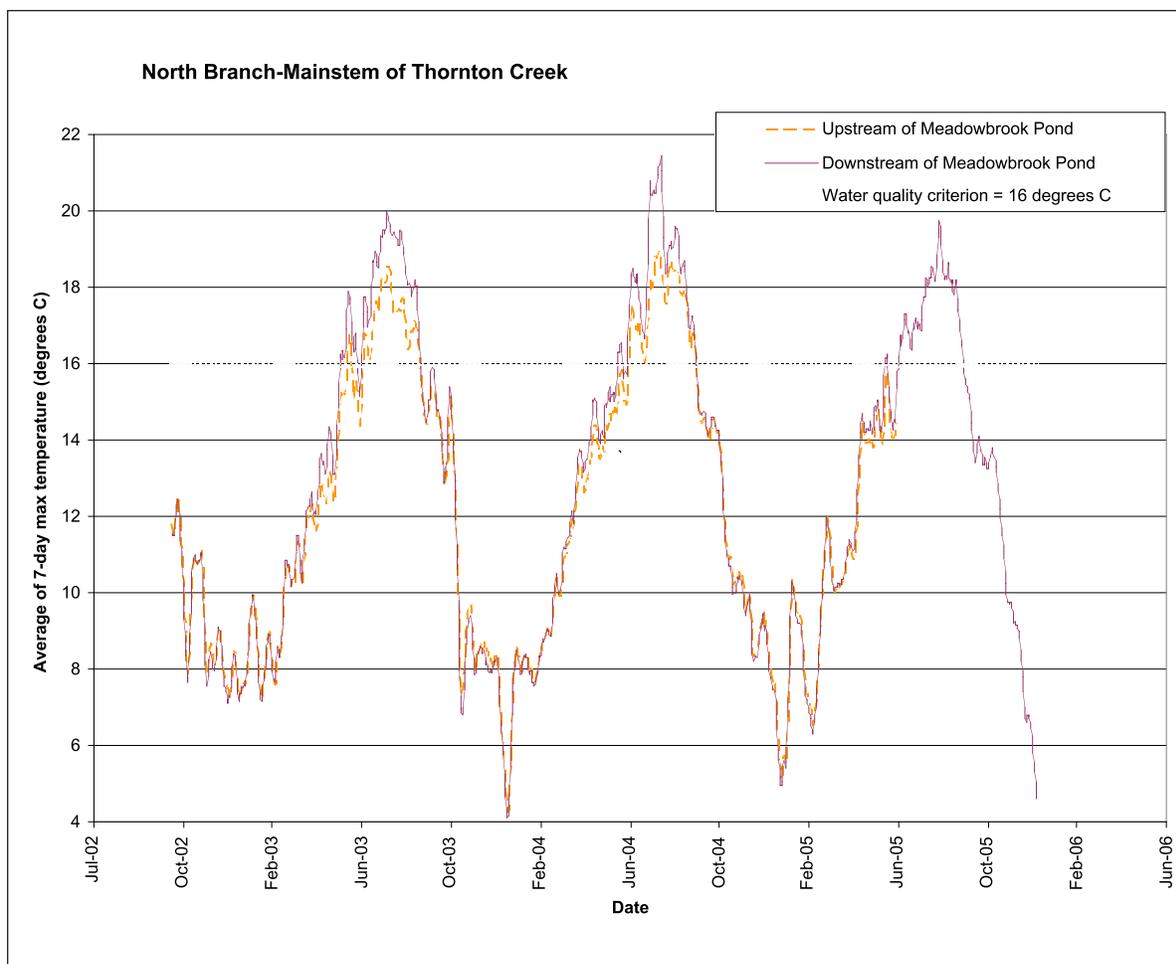
Figure 32. Thornton water temperatures measured at Meadowbrook pond, 2002–2005.

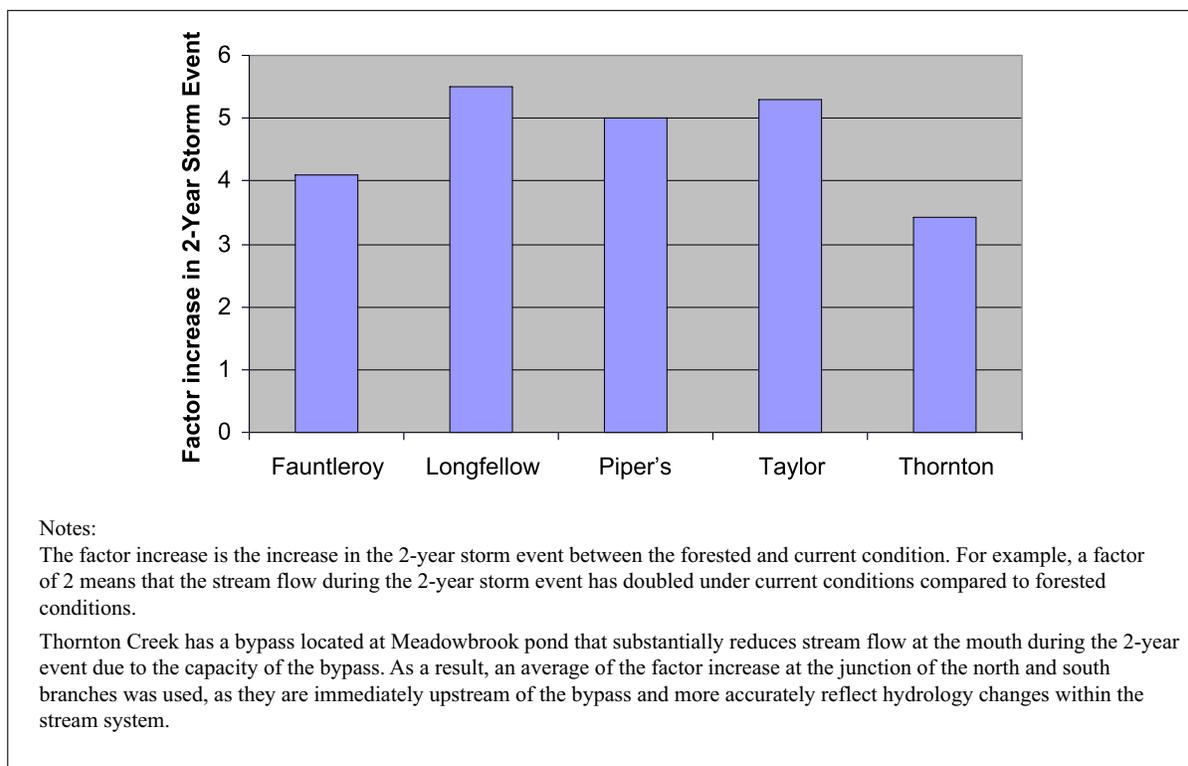
Figure 35. Increase in 2-year storm flow rates (forested conditions relative to current conditions) for each major watercourse in Seattle, modeled near the mouth.

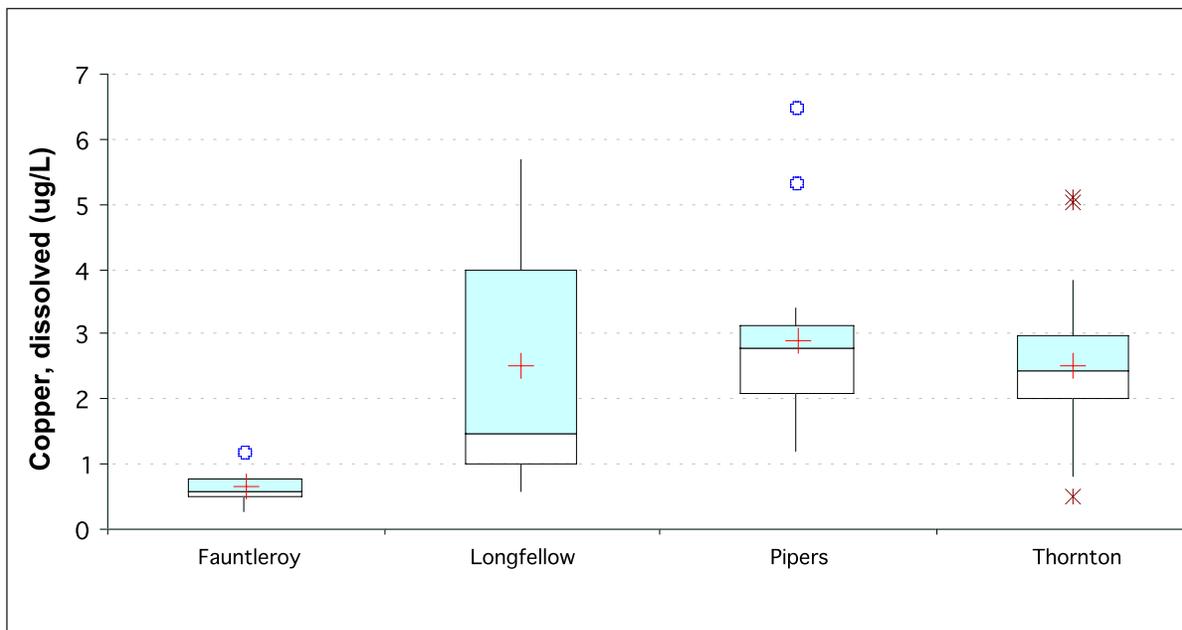
Figure 39. Comparison of dissolved copper concentrations in Seattle watercourses during non-storm flow conditions.

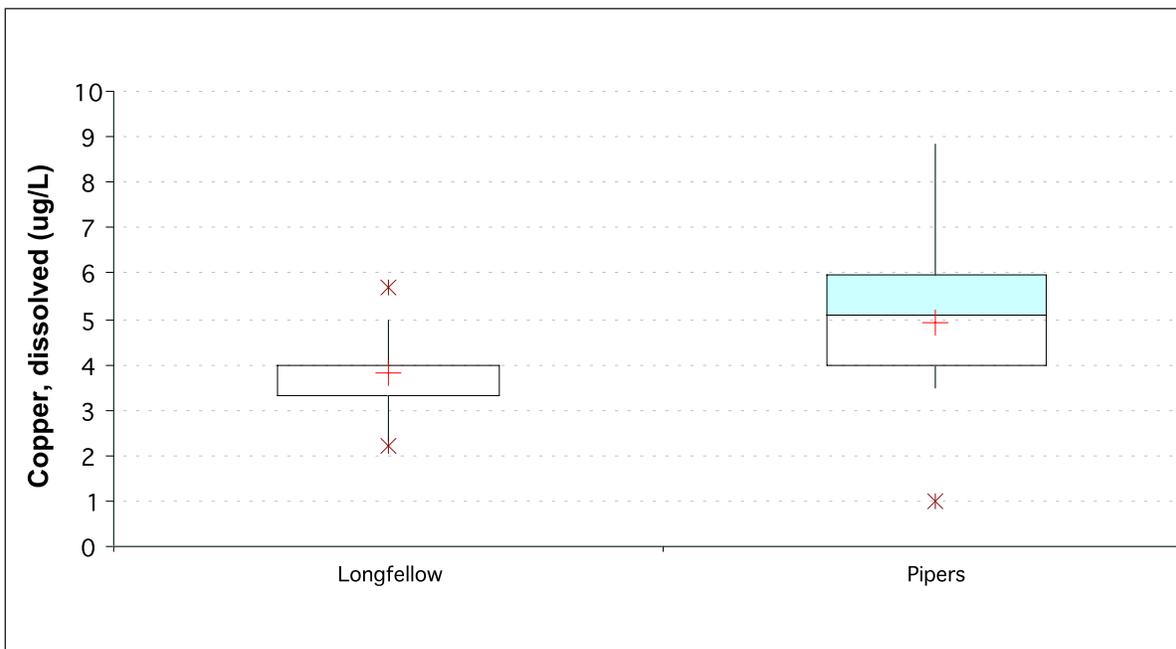
Figure 40. Comparison of dissolved copper concentrations in Seattle watercourses during storm flow conditions.

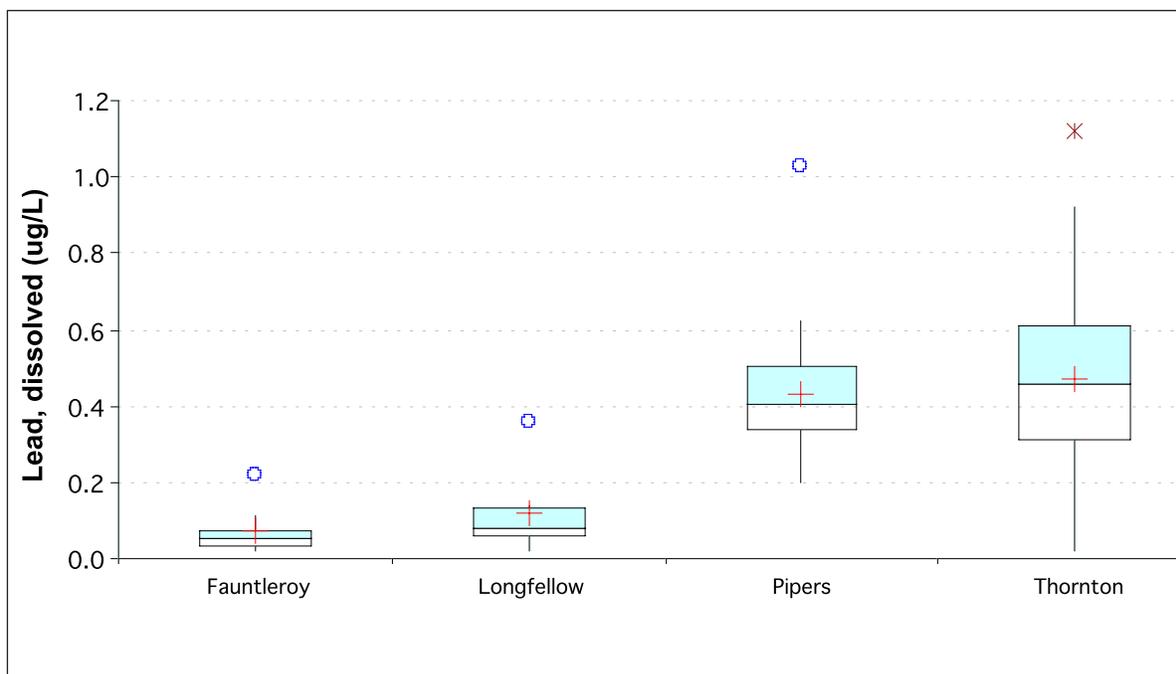
Figure 41. Comparison of dissolved lead concentrations in Seattle watercourses during non-storm flow conditions.

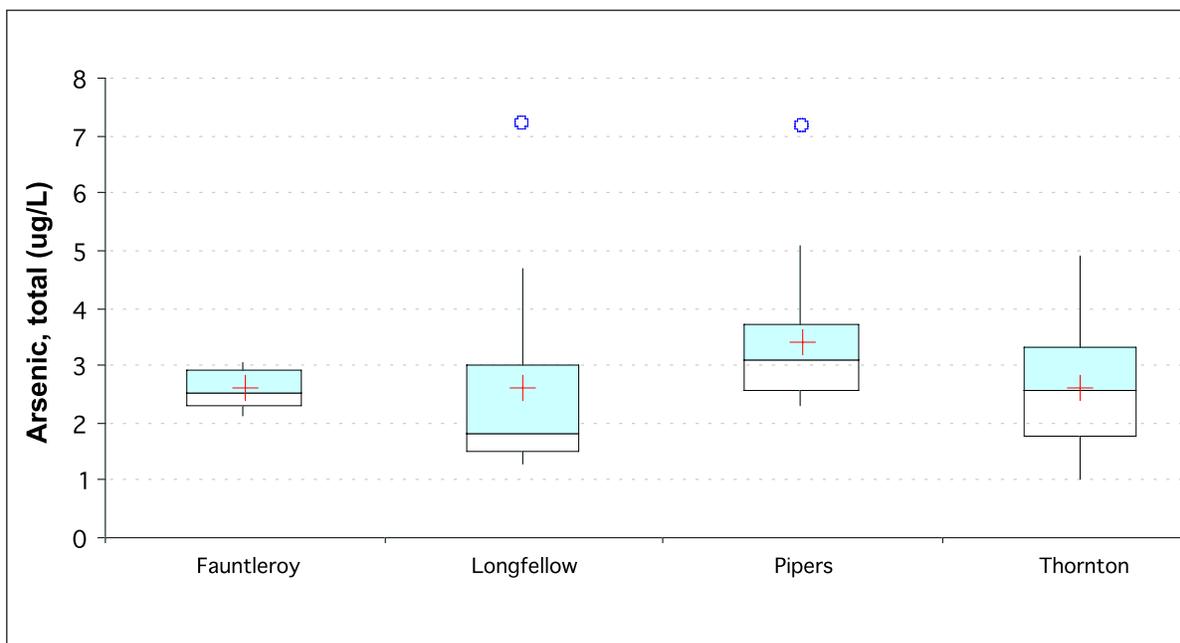
Figure 42. Comparison of total arsenic concentrations in Seattle watercourses during non-storm flow conditions.

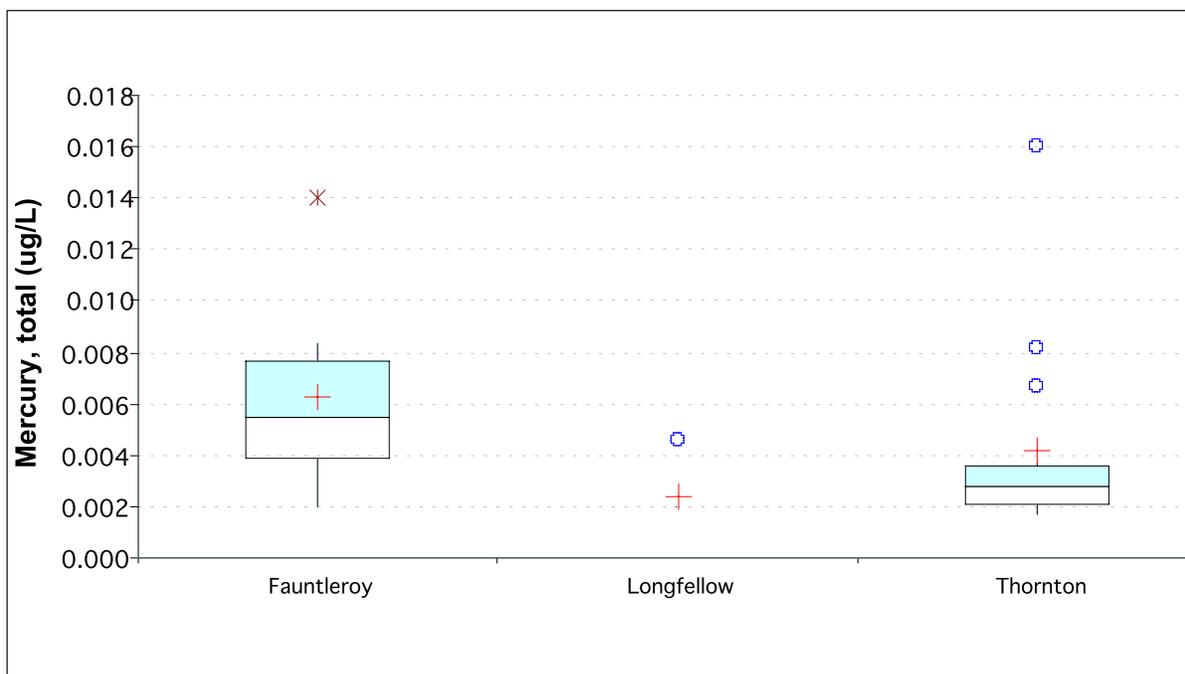
Figure 43. Comparison of total mercury concentrations in Seattle watercourses during non-storm flow conditions.

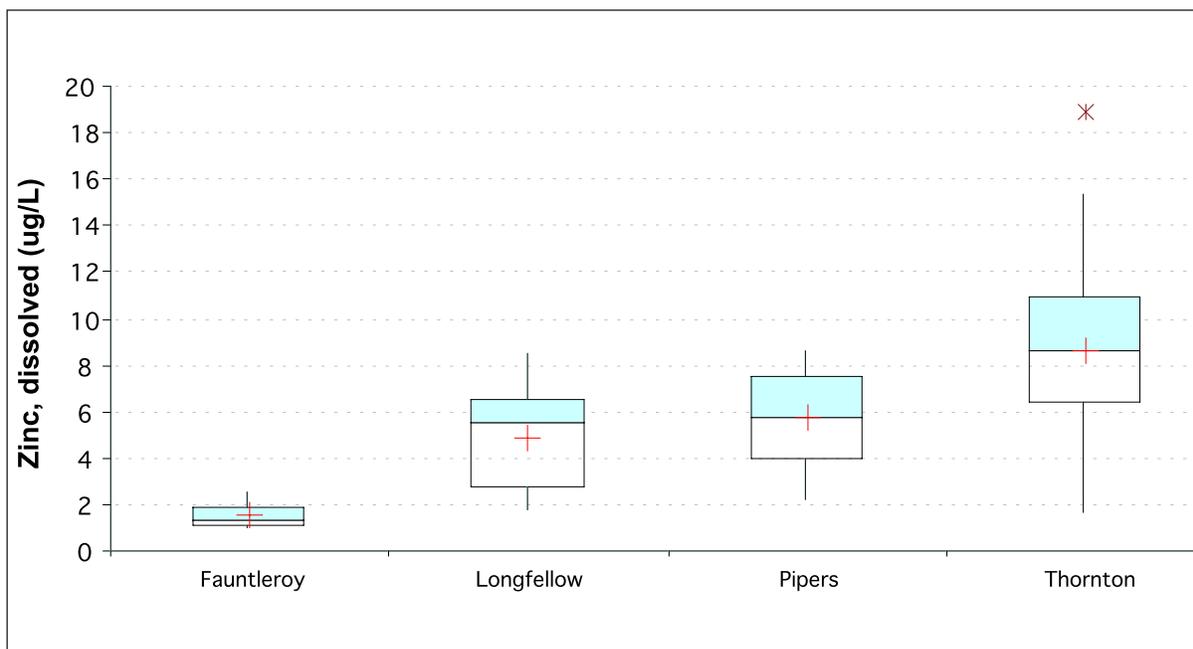
Figure 44. Comparison of dissolved zinc concentrations in Seattle watercourses during non-storm flow conditions.

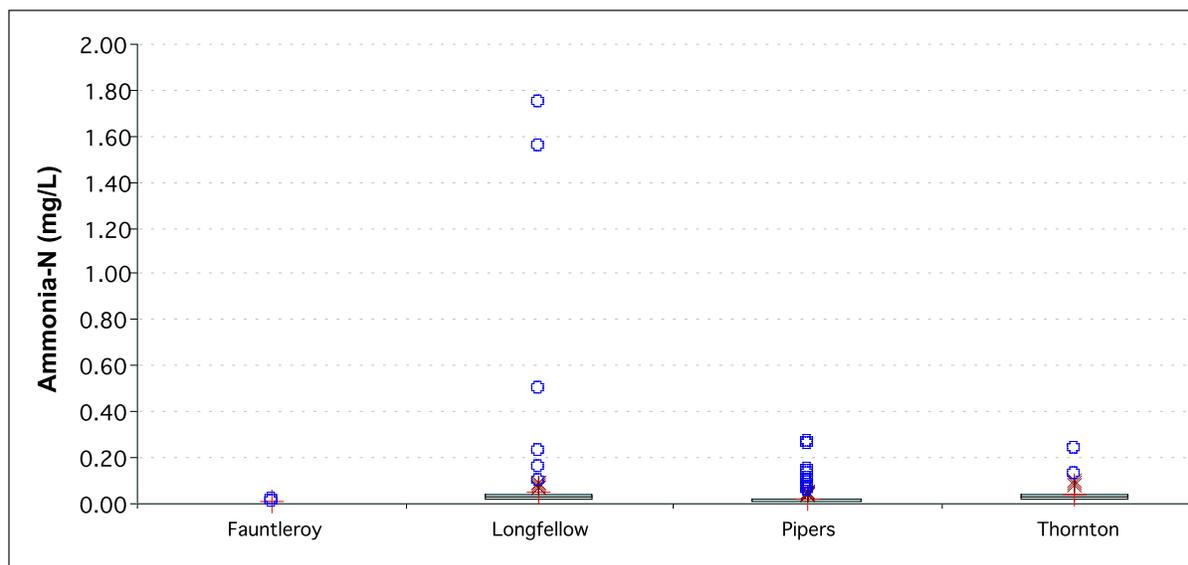
Figure 45. Comparison of ammonia concentrations in Seattle watercourses during non-storm flow conditions.

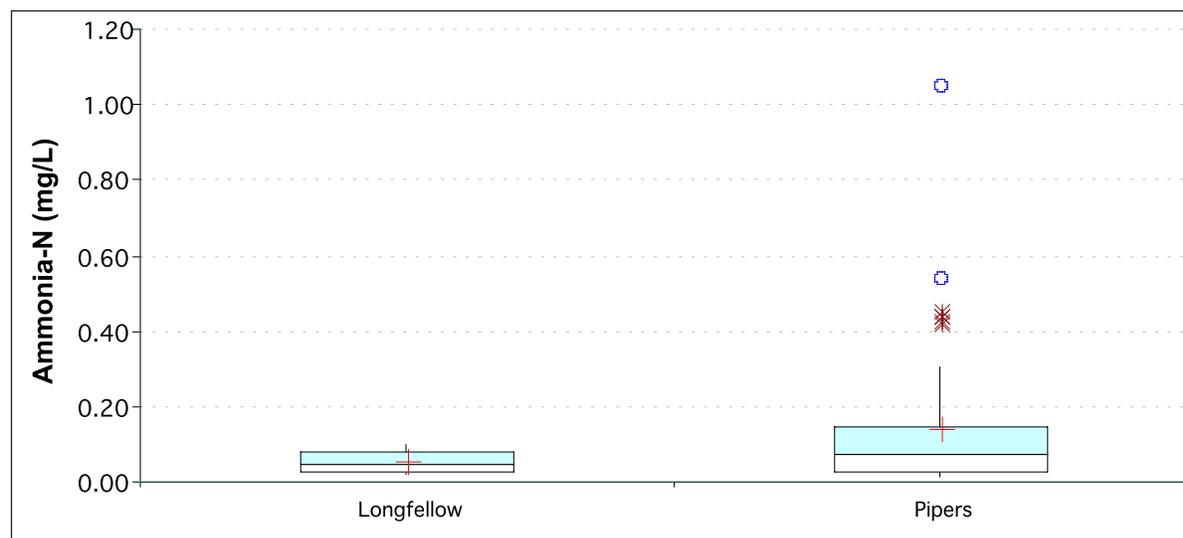
Figure 46. Comparison of ammonia concentrations in Seattle watercourses during storm flow conditions.

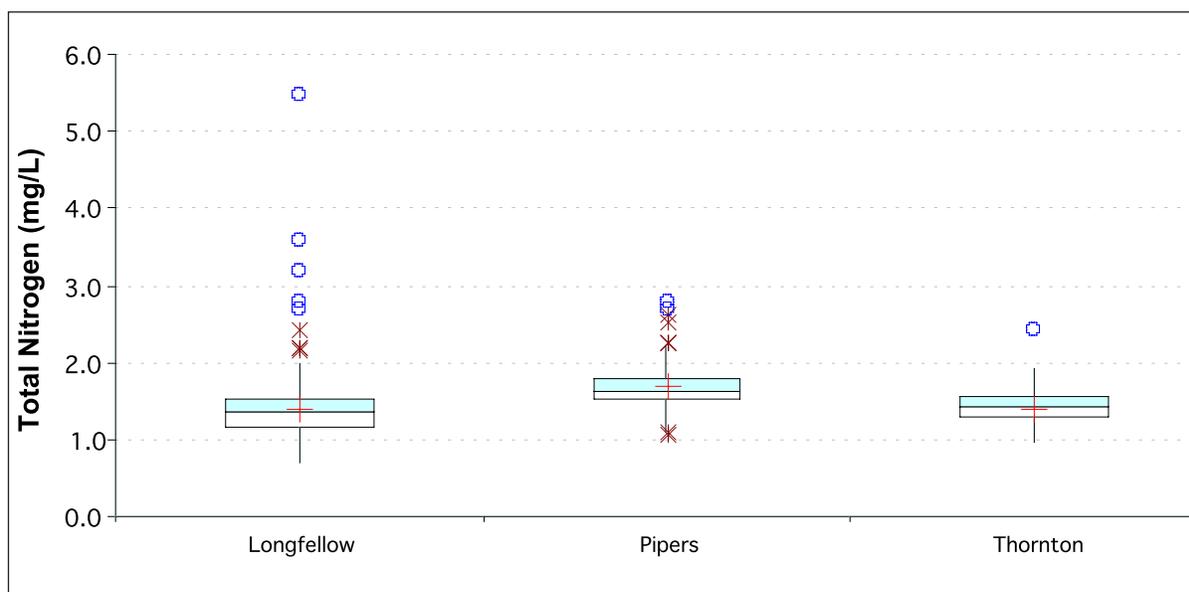
Figure 47. Comparison of total nitrogen concentrations in Seattle watercourses during non-storm flow conditions.

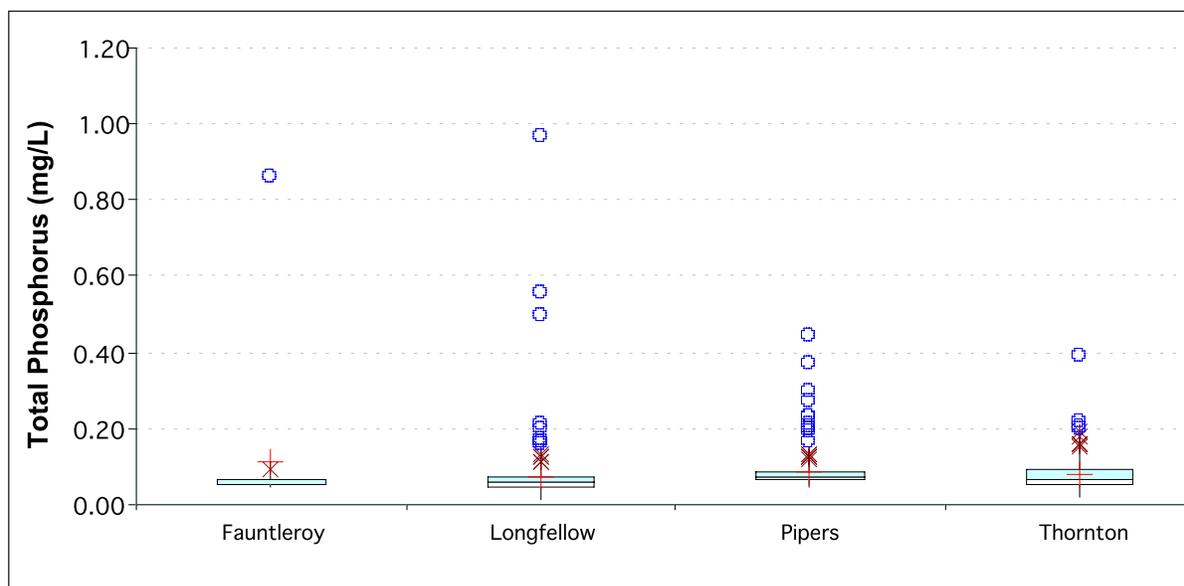
Figure 48. Comparison of total phosphorus concentrations in Seattle watercourses during non-storm flow conditions.

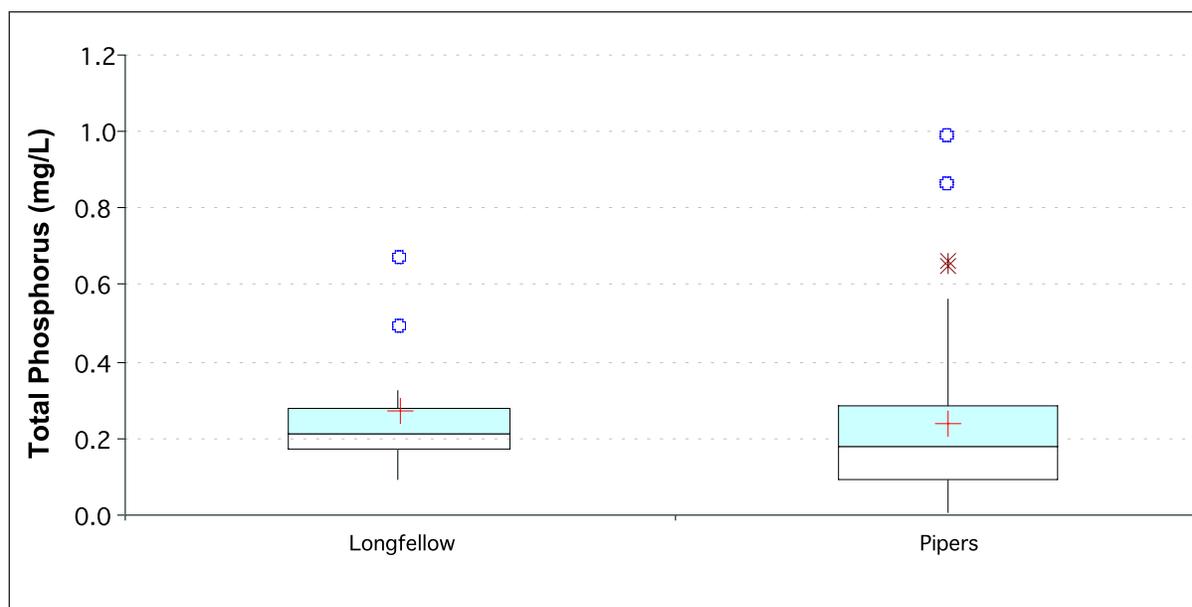
Figure 49. Comparison of total phosphorus concentrations in Seattle watercourses during storm flow conditions.

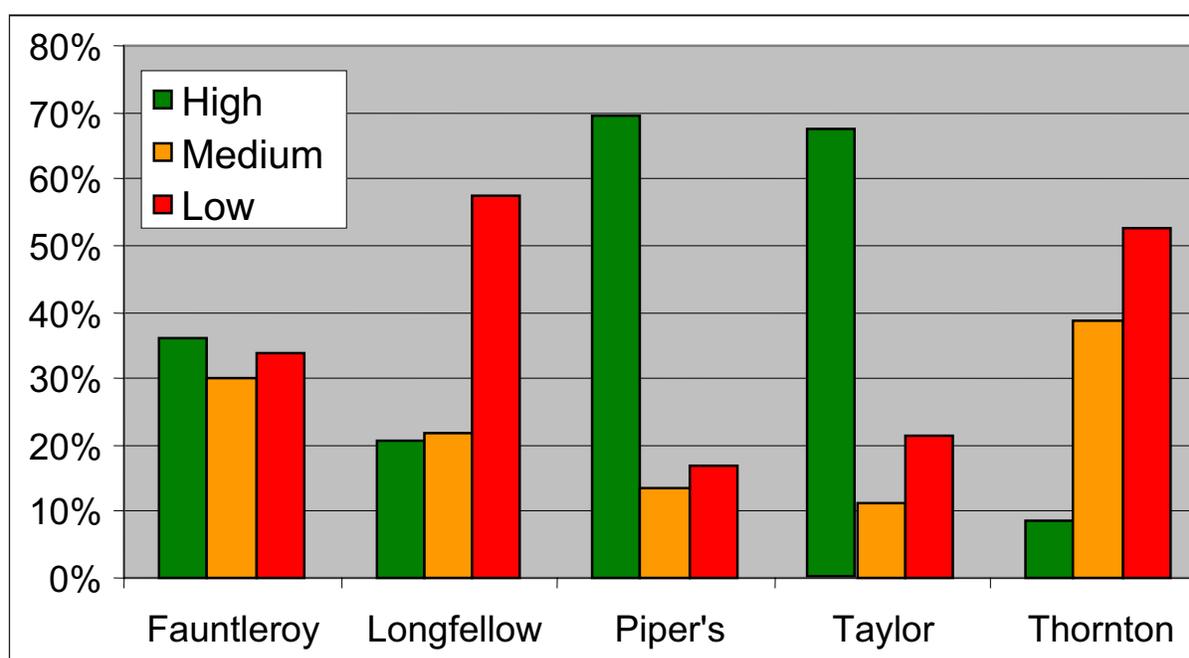
Figure 50. Percentages of high-, moderate-, and low-quality riparian habitat in each major Seattle watercourse.

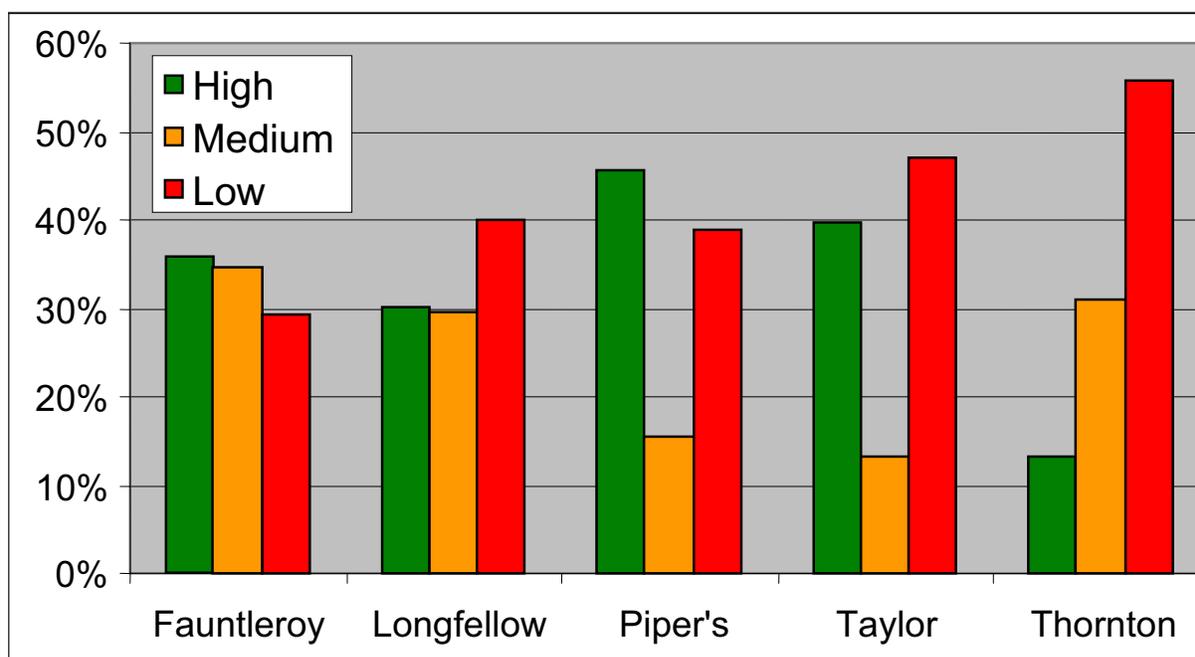
Figure 51. Percentages of high-, moderate-, and low-quality instream habitat in each major Seattle watercourse.
