North Shore Cedar

121.1 Road Forest Habitat Restoration Project

Project Plan and 2010/2011 As-Built Document

Watershed Services Division, Seattle Public Utilities

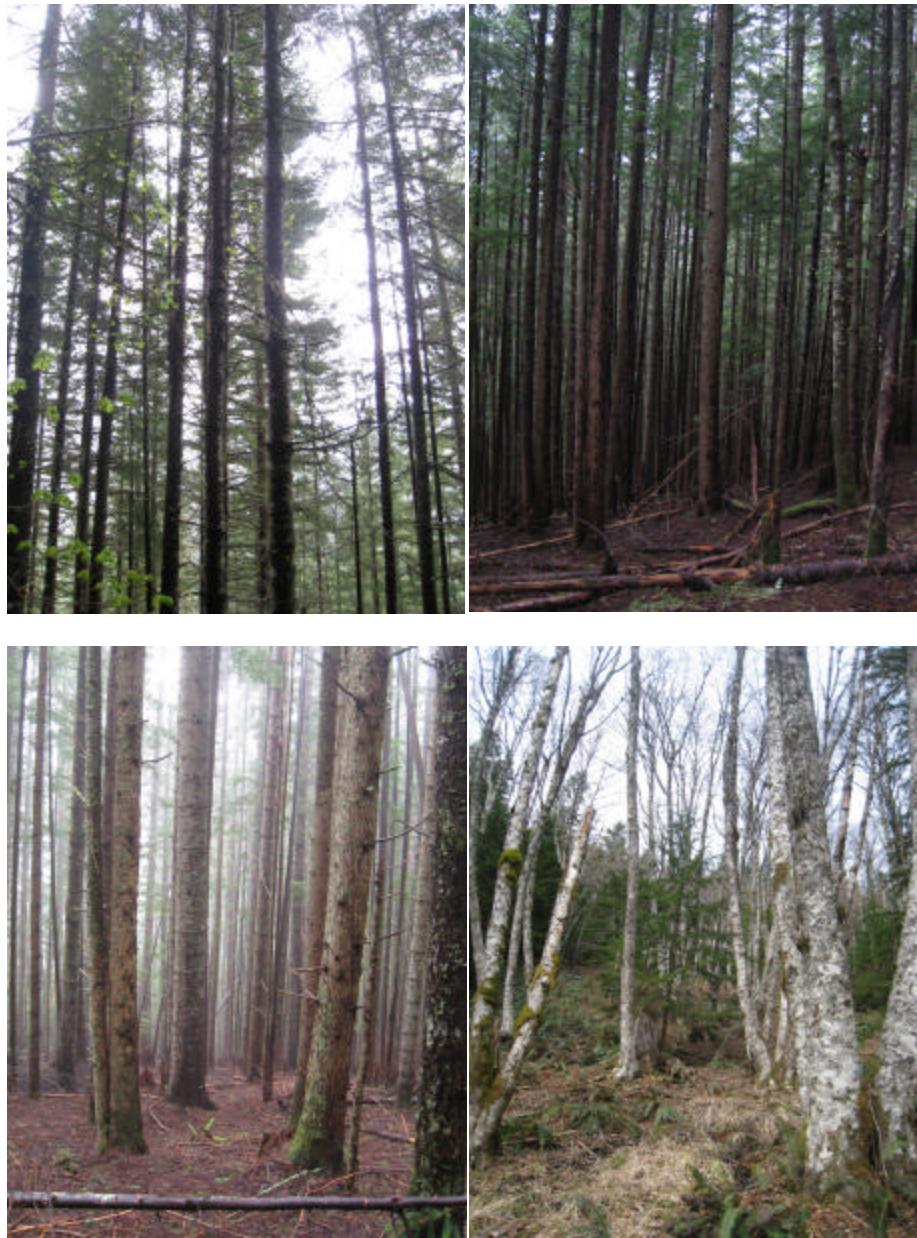
Figure 2. Varied forest stand conditions along the north ridge flanking the Cedar River. Top left photo shows typical high density Douglas-fir stand that is the primary target for thinning treatments. Top right photo shows high density mixed conifer stand (western hemlock, Douglas-fir, noble fir) that is also targeted for thinning (Transect 7A). Bottom left photo shows forest stand with large diameter noble fir. Bottom right photo shows alder dominated stand type with limited regeneration, which will be the target for riparian planting.

In summary, the entire hill slope from Cedar River to ridge top currently contains forest of varied ages, structures, and species composition, primarily dominated by conifer but with significant deciduous-dominated riparian areas (Figure 2). Within the project area, while there is some structural heterogeneity on the lower slopes, there are large patches of homogenous second-growth forest providing little dead wood or habitat complexity and poor habitat connectivity between the complex riparian habitats along the Cedar River and the late seral forest on the upper portions of the hill slope.

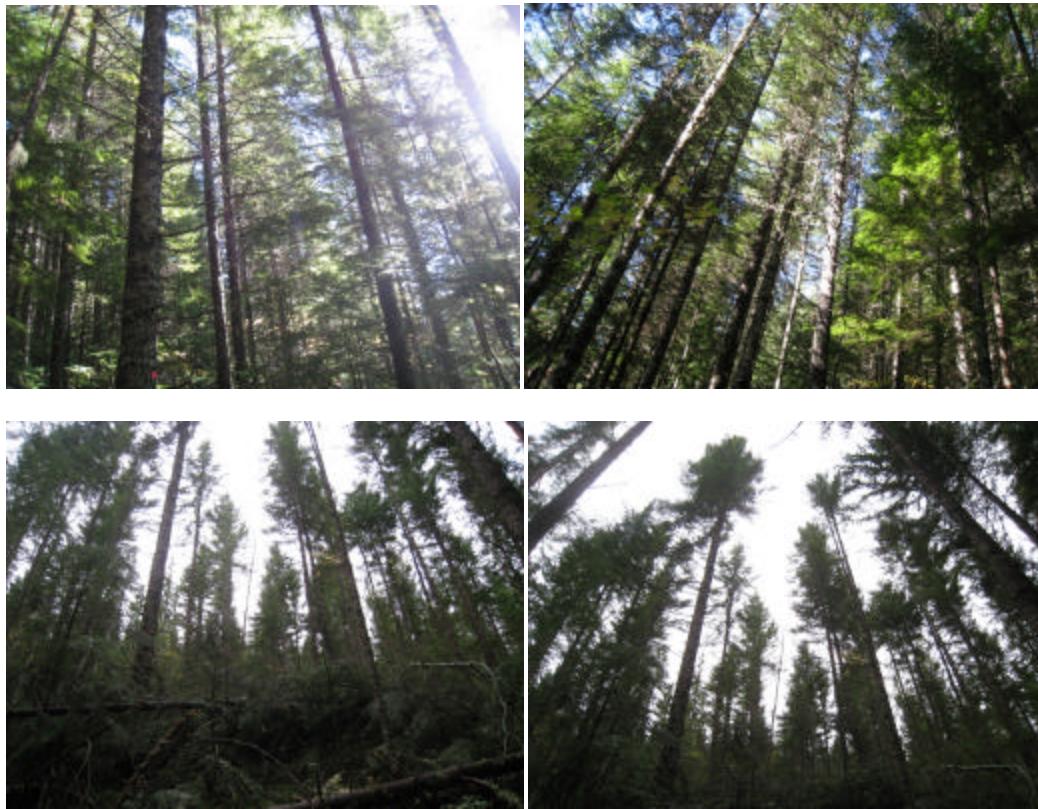
Figure 5. Example of pre-thinning (above) and post-thinning (below) forest canopy in a 2010 thin unit.

Overall, the prescriptions and implementation exceeded expectations in the amount of variability being created, both within the treatment units and over the hillside. The size and relative spacing of the treatment patches is very good, and the prescriptions appear to be highly successful in achieving our objectives. Light penetrates into the adjacent forest from both the gaps and thins. Leave trees within even the small gaps should not interfere with successful planting. Leave trees in gaps, edge trees of gaps, and trees within the more widely spaced thins should all have sufficient light to develop large branches (see Figure 5), which could provide future marbled murrelet habitat. The amount of down wood loading is large, but only in relatively small patches; it doesn't appear that wood loading will significantly impede planting or understory development. It should provide habitat for small mammals, birds, and small carnivores, while enhancing soil development.
