# The White Garage (Downtown Mini Storage)

Landmarks Nomination Report  
1915 Third Avenue, Seattle, WA  
September 2017

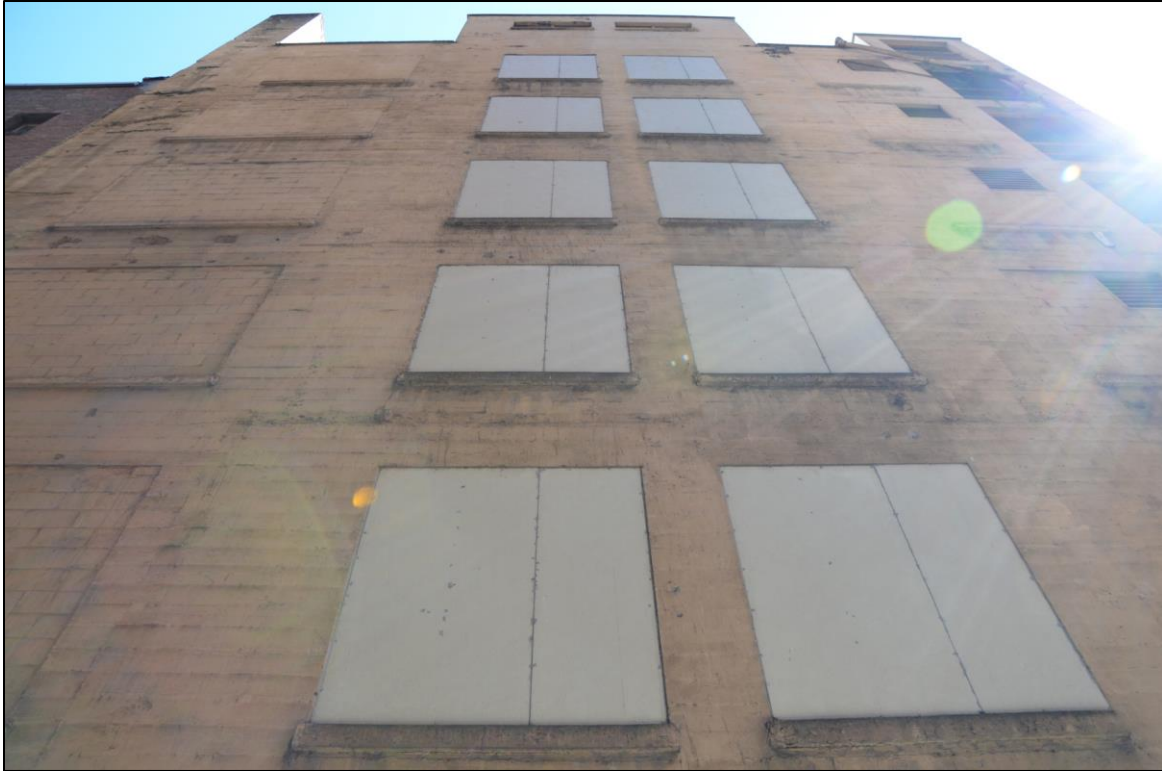
Figure 28. Infilled and covered windows on alley elevation.

The full west elevation is visible from the alley. The west side of the building was built with reinforced concrete with five columns of punched openings. A staircase at the southwest corner of the building has large openings on each landing that are protected by metal scrim. The north and south columns of window openings on the main body of the elevation are infilled with concrete masonry unit (CMU) block, and several of the southern window openings have been partially framed out for ventilation. The two central columns of window openings are covered with plywood or sheet metal; some of the original steel sash windows still exist behind these covers, but interior access to determine the number of windows and their condition was limited due to rental of storage units in these areas (Figure 42).

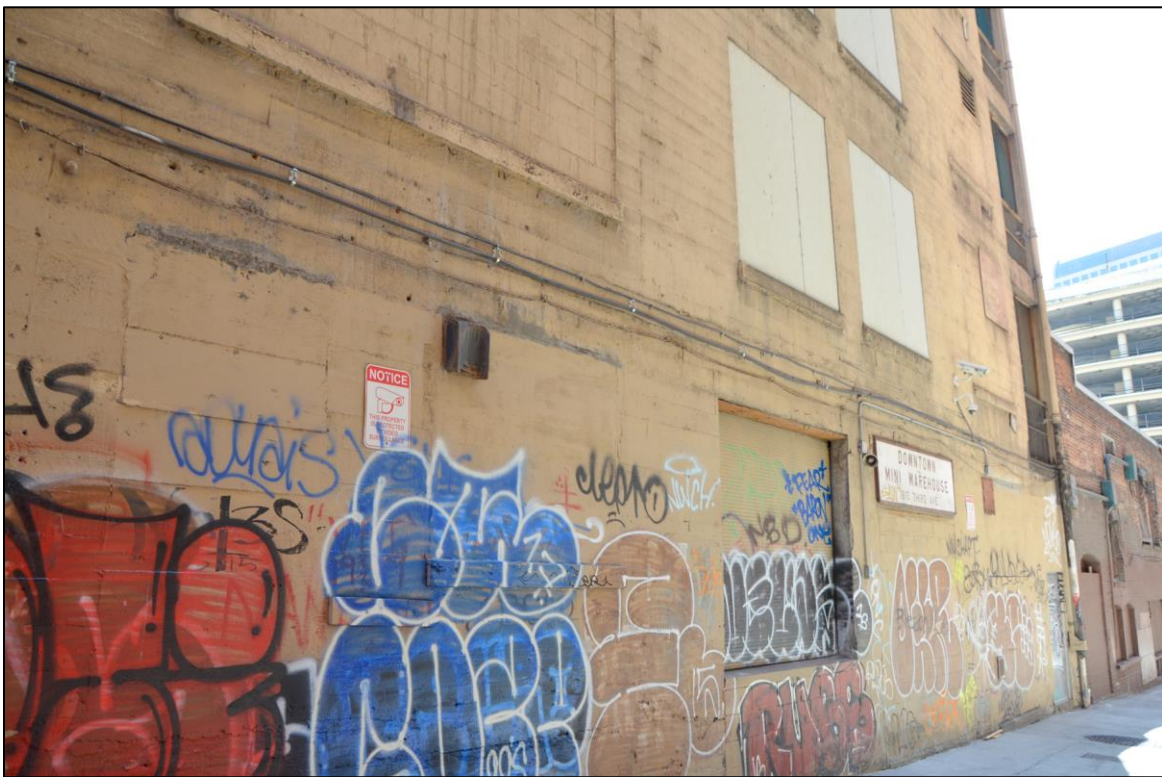
Figure 29. Loading door and exterior of mezzanine level, viewed from alley.

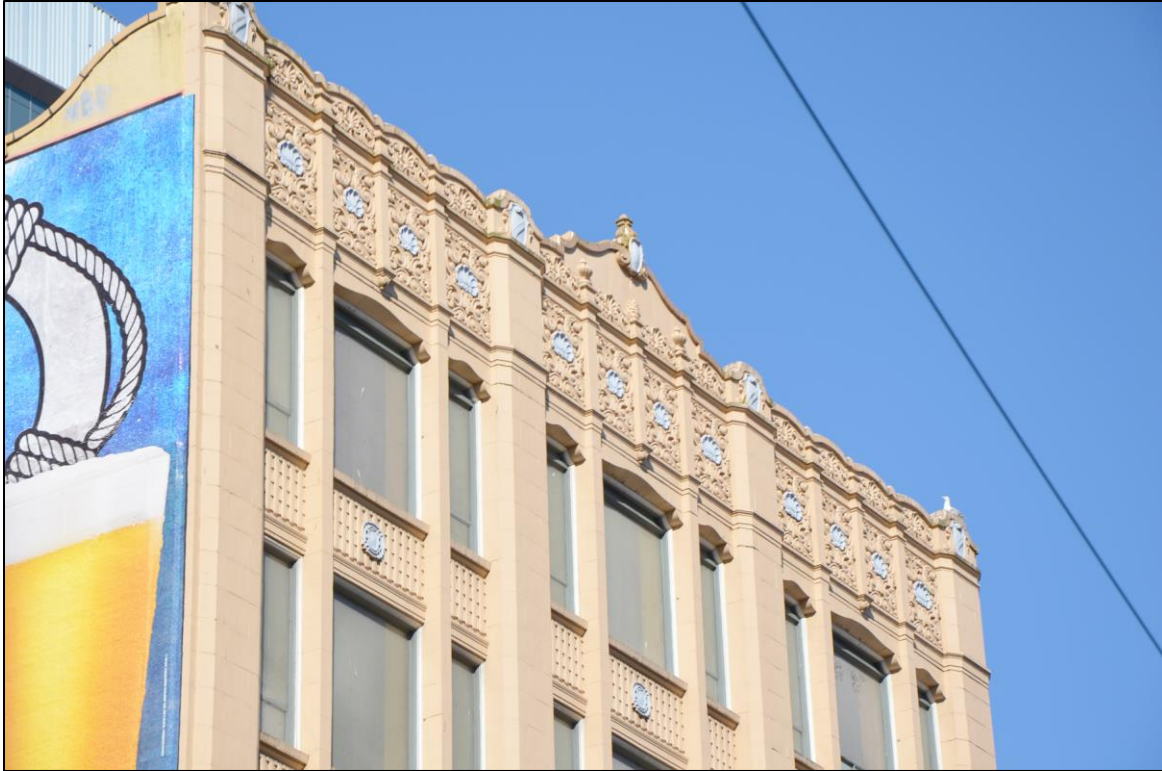
Figure 34. Detail of terra cotta above sixth floor.

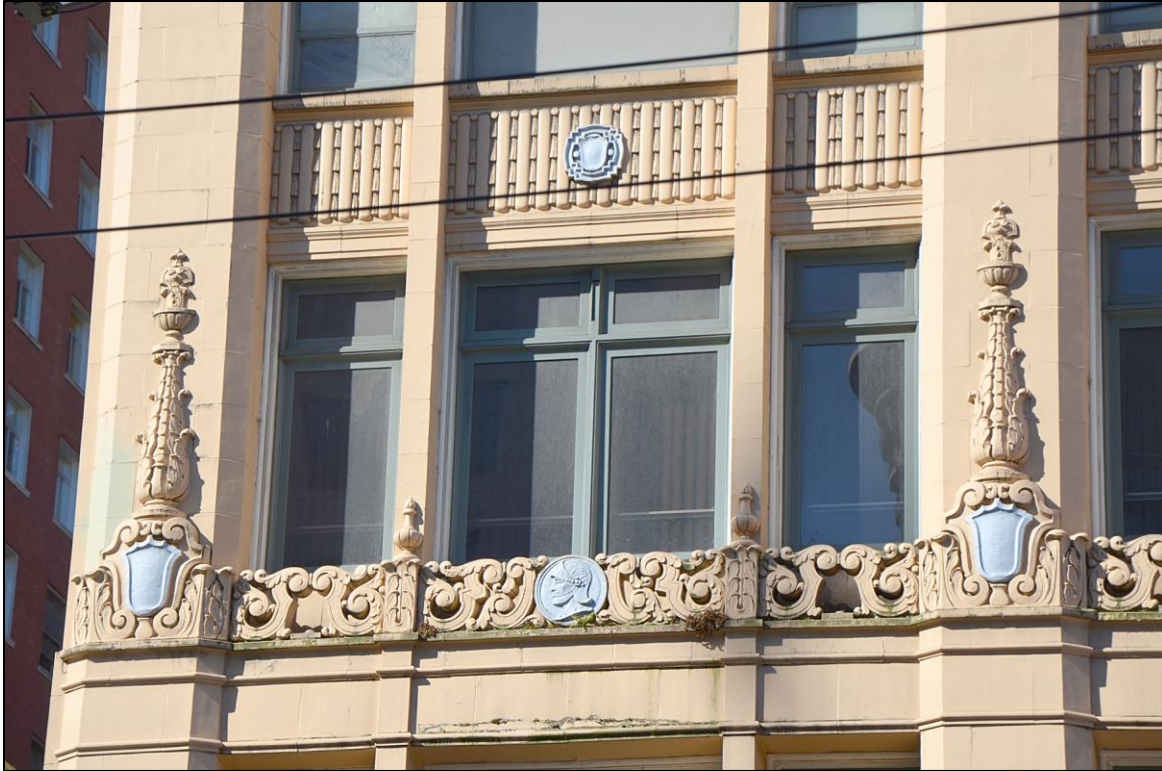
Figure 36. Detail of terra cotta and windows at third floor.

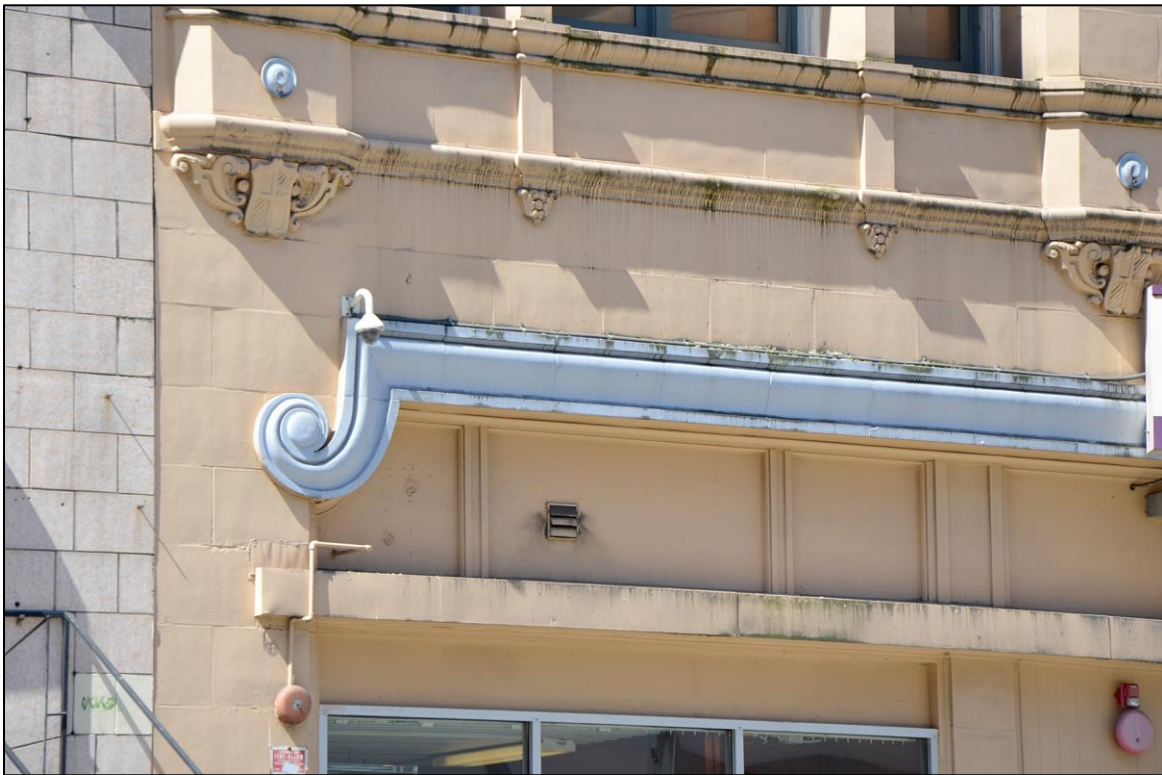
Figure 37. Detail of terra cotta above storefront.

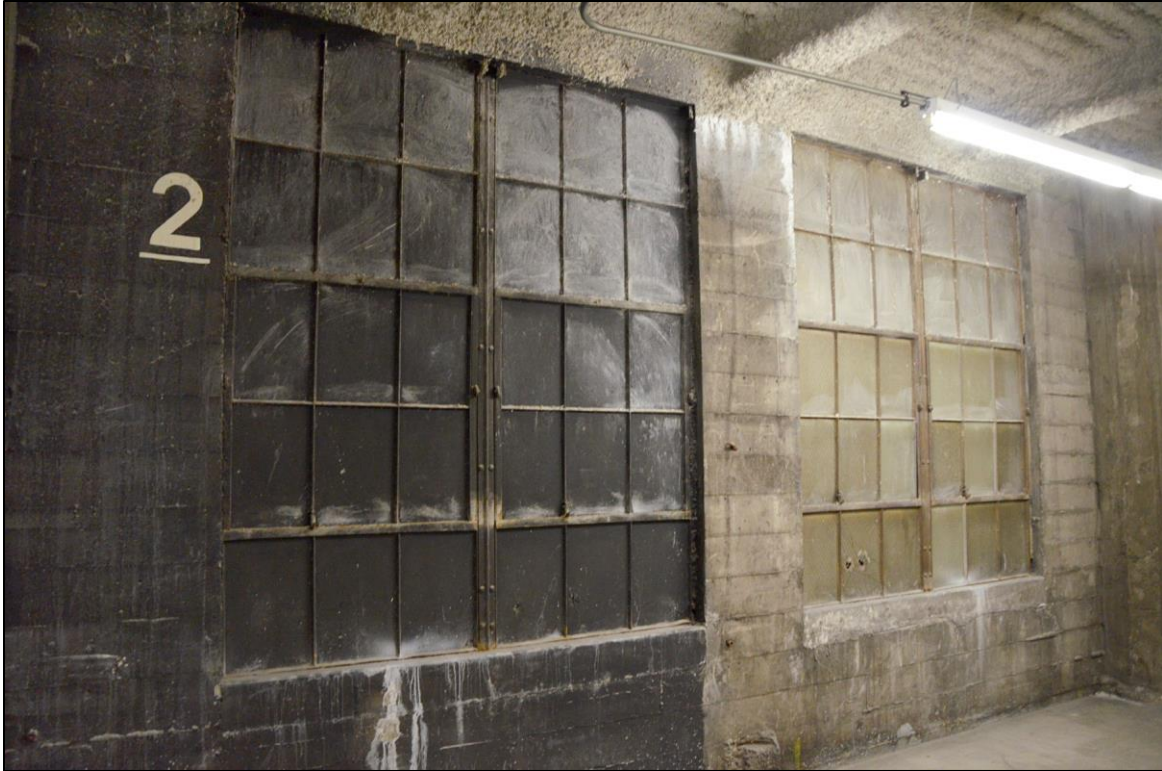
Figure 42. Steel sash on west (alley) façade, viewed from interior.

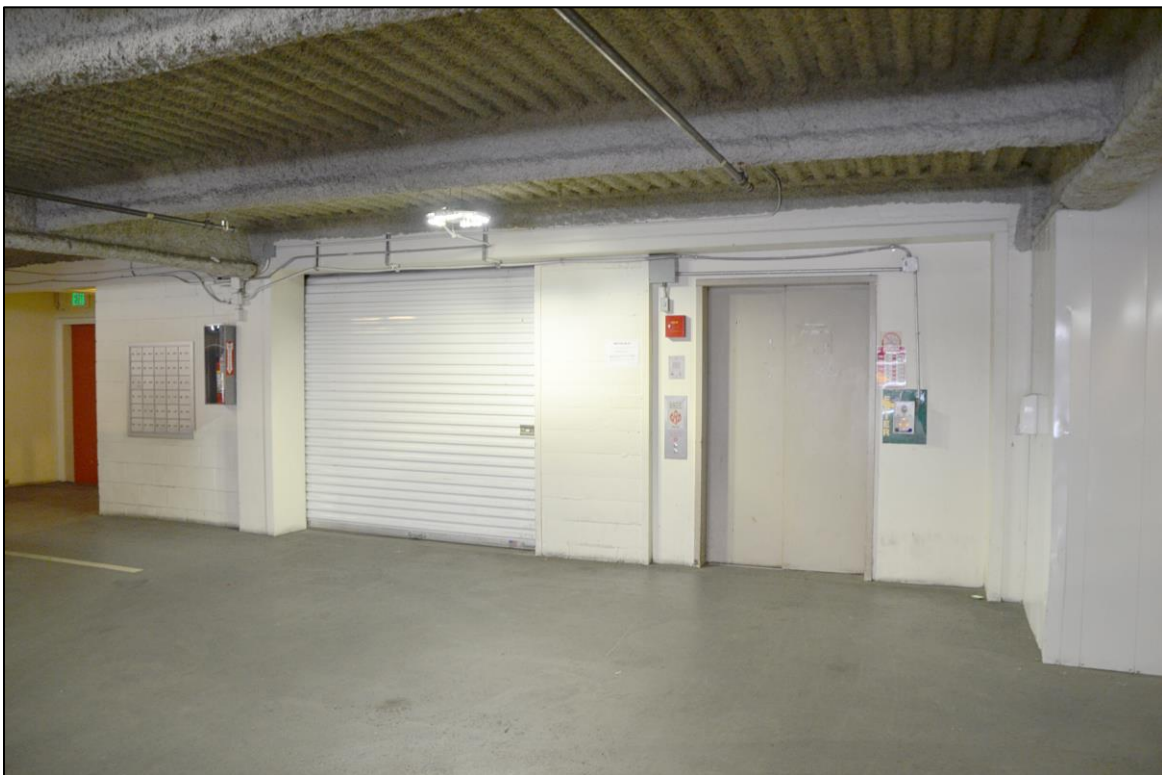
Figure 45. Freight elevator at former location of car elevators, ground level.

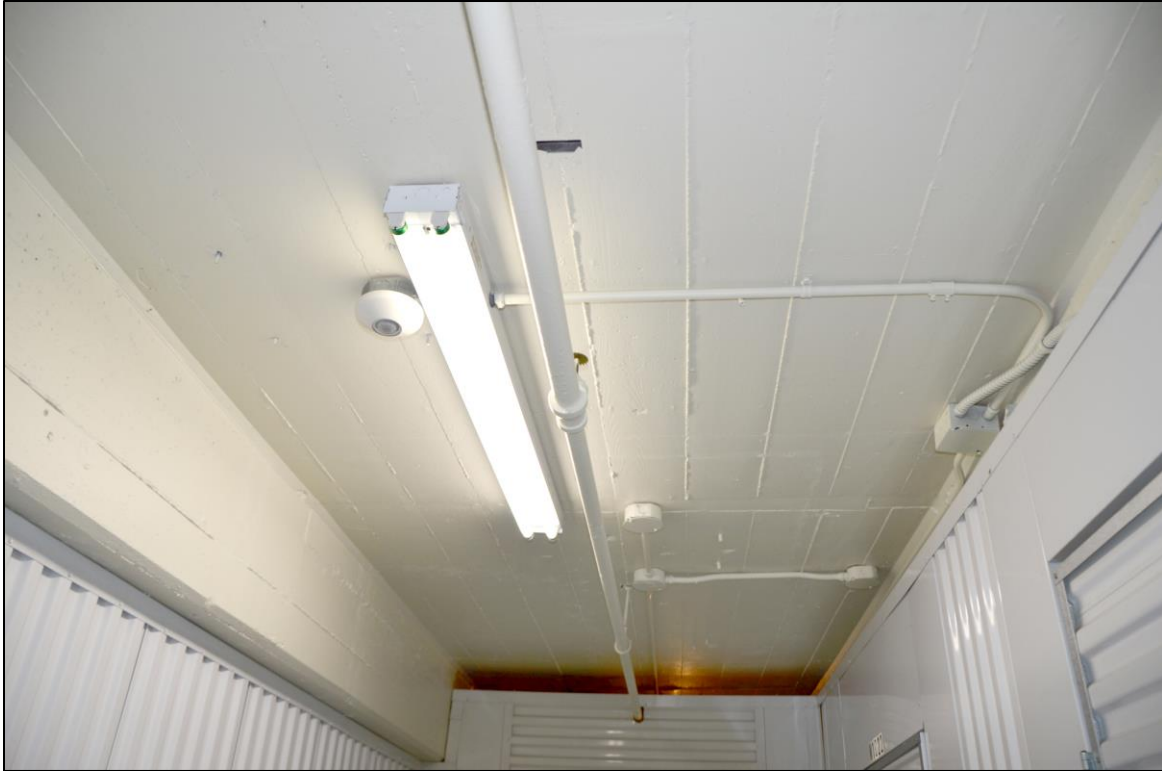
Figure 46. Reinforced concrete construction is visible in some areas between storage units.

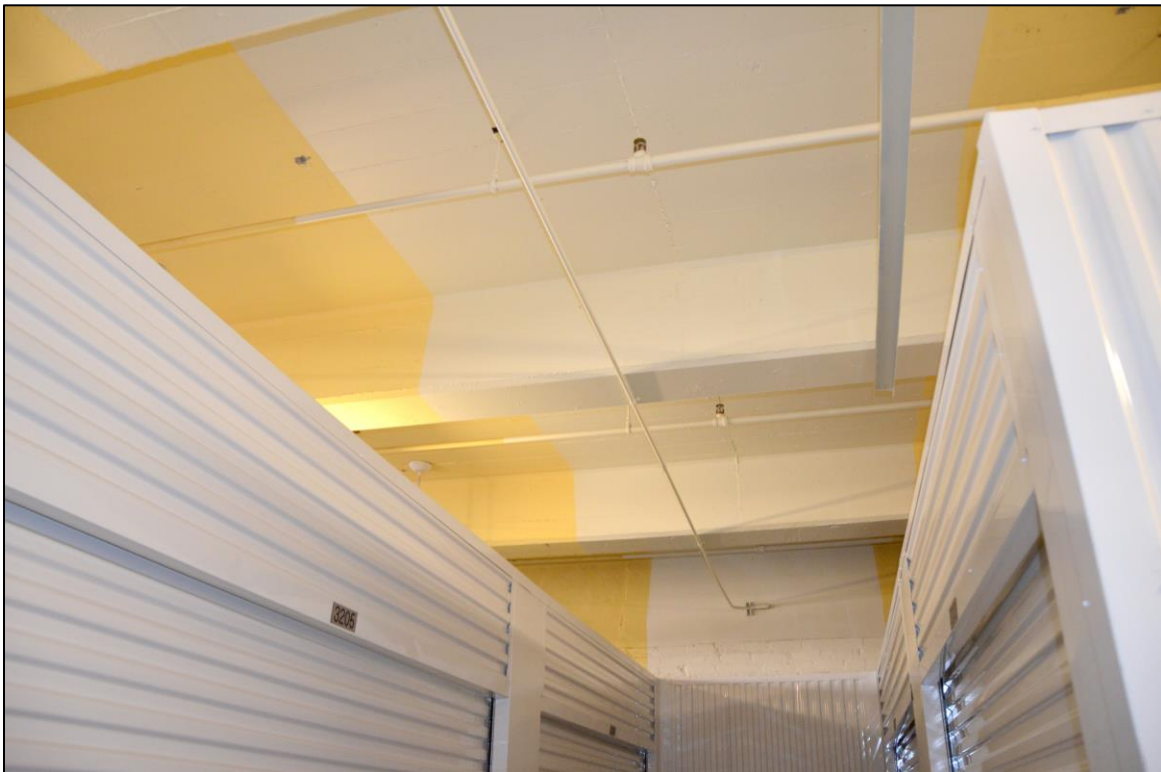
Figure 51. Reinforced concrete construction visible above storage units.
