CHEASTY GREENSPACE TRAIL

Critical Areas Study and Conceptual Mitigation Plan

Prepared for
City of Seattle Parks and Recreation

August 2018

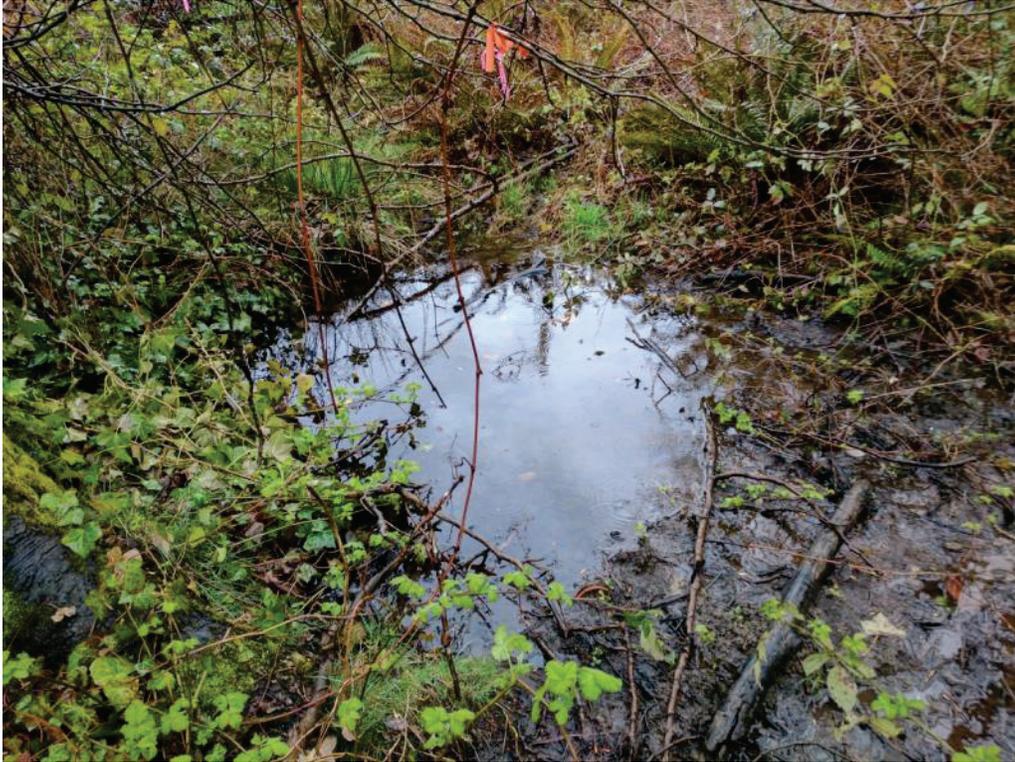
Photograph 1. Wetland 1, ponding in April 2017

Wetland 1 is a depressional/slope wetland on the south boundary of Cheasty Greenspace (Photograph 1). It is a forested wetland with a canopy of black cottonwood, and understory vegetation of Himalayan blackberry, soft rush, and English ivy. It also has a large unvegetated area that is seasonally ponded; the unvegetated area is quite hard (compacted) and may have been previously disturbed. The hydrology of Wetland 1 appears to be supported primarily by groundwater (hillside seeps) and precipitation. In October 2016, hydrology indicators observed in the wetland were surface soil cracks and sparsely vegetated concave surface. In April 2017, the wetland was saturated to the surface, and there was ponding of approximately 3 inches in the area that was sparsely vegetated. Soils within the wetland met hydric soil indicator A11 (Depleted Below Dark Surface). Data plots W1, DP-1 and W1, DP-2 characterize this wetland and adjacent upland, respectively. Habitat functions are low due to the lack of diversity in vegetation communities and habitats and poor access to habitat.

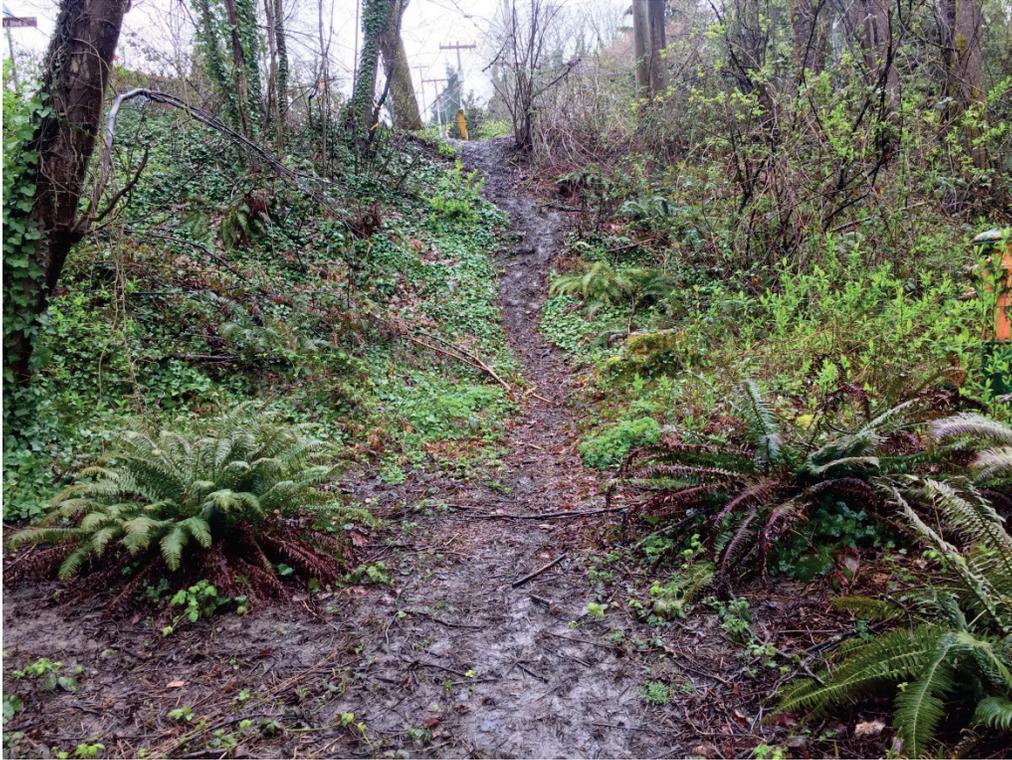
Photograph 7. Wetland 8 buffer (facing west, toward Cheasty Boulevard), April 2017

The buffer of Wetland 8 is forested, dominated by bigleaf maple and black cottonwood, with swordfern and some Himalayan blackberry in the understory. A cleared transmission corridor approximately 5 feet wide crosses the buffer of Wetland 8 from east to west along the Andover Street right-of-way. Also see Photograph 7. The buffer provides moderate protection as it is forested.

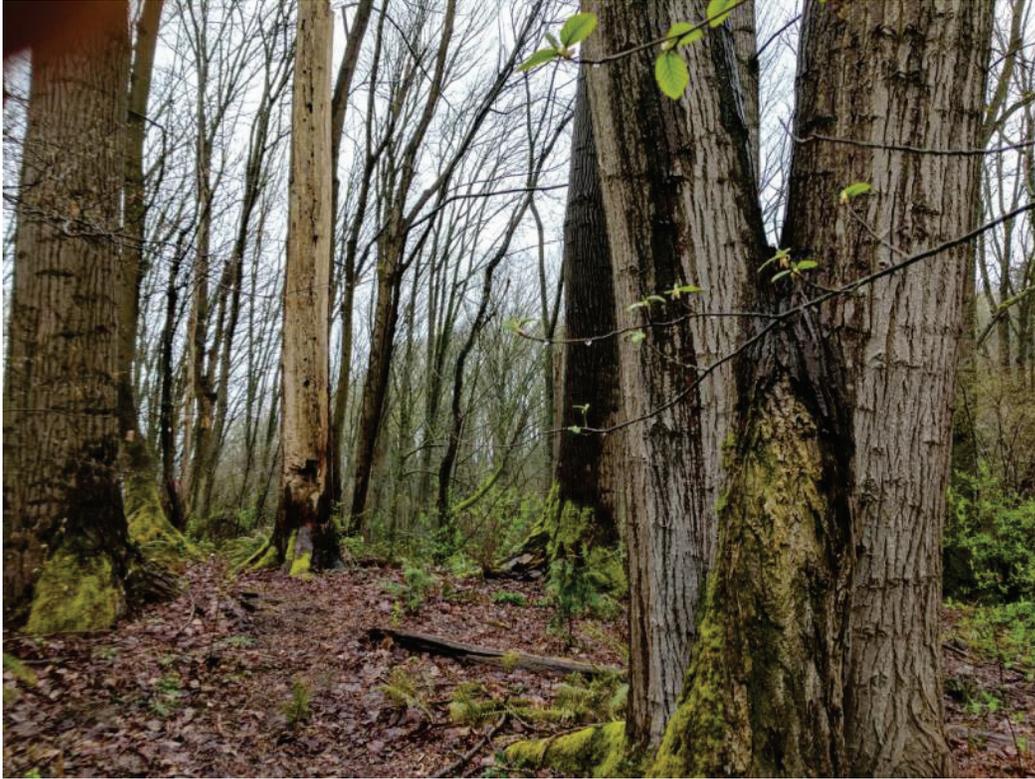
Photograph 13. Snags and black cottonwood in Westside Lowland Mixed Forest Habitat Type

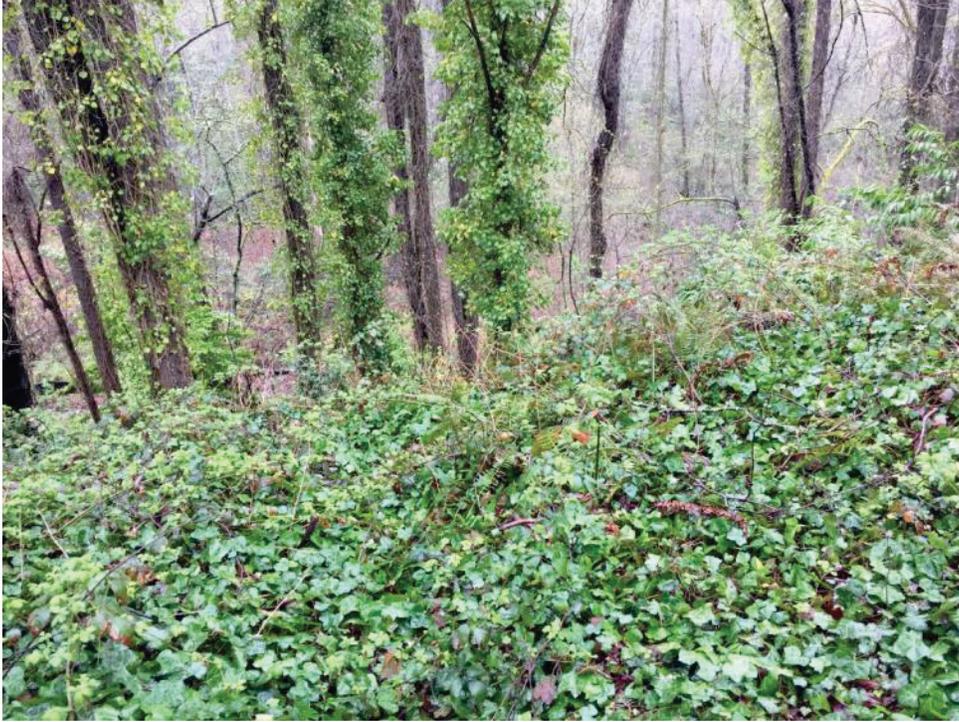
Photograph 17. Invasive species in Westside Lowland Mixed Forest Habitat Type
